Vermont Better Roads Grant Program

CATEGORY B/C/D

Road Name: **Handy Road** TH #: **14** Structure # (if applicable): # **25**

TOWN OF HUNTINGTON, VERMONT CULVERT INSPECTION FORM

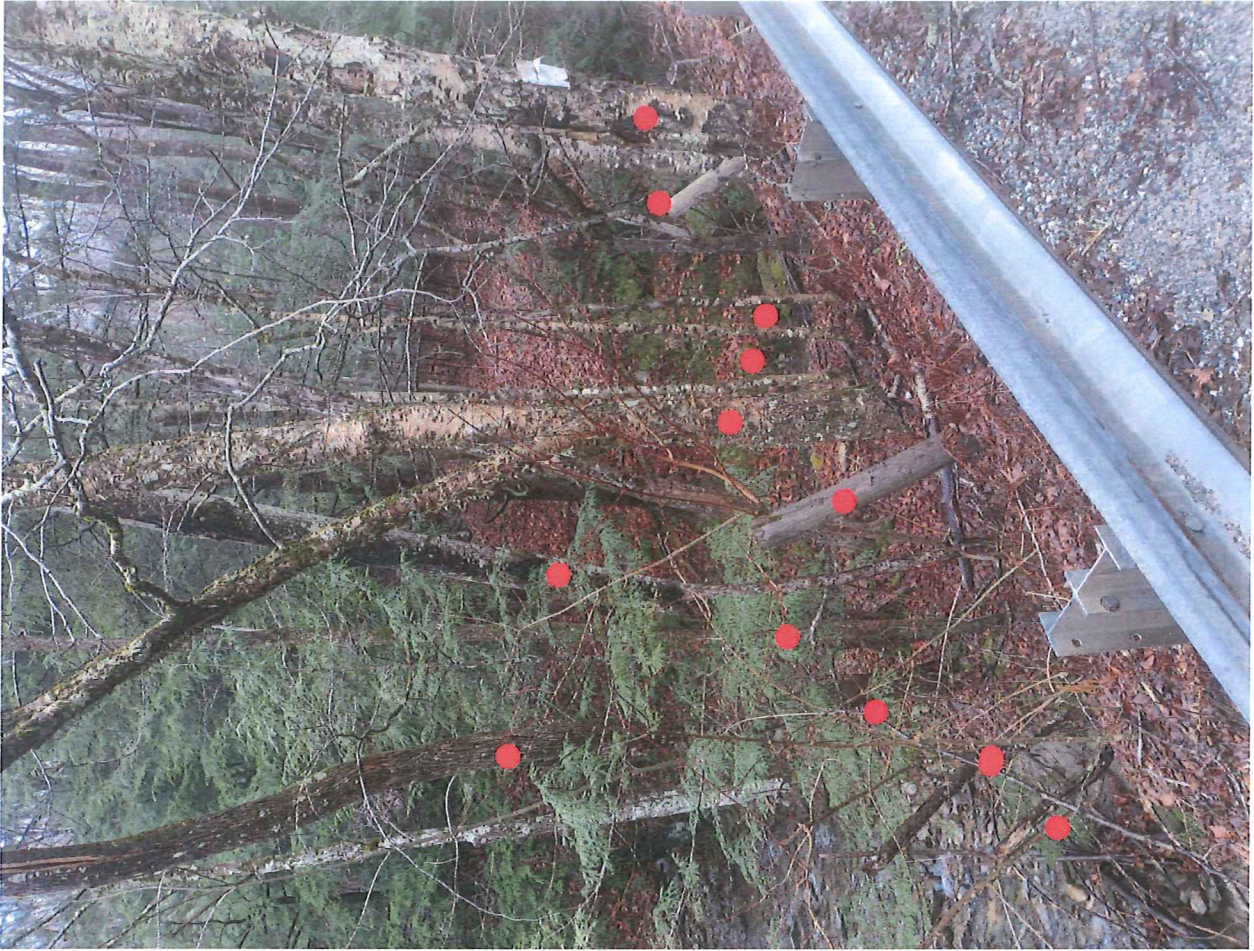
Photo 2 (25)
Inlet Elevation
Significant Culvert Damage/Debris Build-Up

Culvert 25 was the most critical finding from a hydraulic capacity standpoint. The culvert is approximately a six-foot diameter buried Corrugated Metal Pipe (CMP), approximately ten feet below Handy Road. The culvert exhibits signs of initial failure, with numerous locations of interior deformation along the culvert length. This results in a reduced hydraulic opening, creating an increased chance of debris accumulation within the CMP and developing a dam effect which could seriously affect Handy Road.

- 1 Recommend replacement. Major culvert damage.
- 2 Increase hydraulic opening on future structure.
- 3
- 4
- 5
- 6
- 7
- 8
- 9
- 10
