STATE OF VERMONT  
AGENCY OF TRANSPORTATION

**Scoping Report**

**Norwich IM 091-2(89)**  
**I-91 Bridges 48 N&S over VT Route 10A**

January 30, 2020

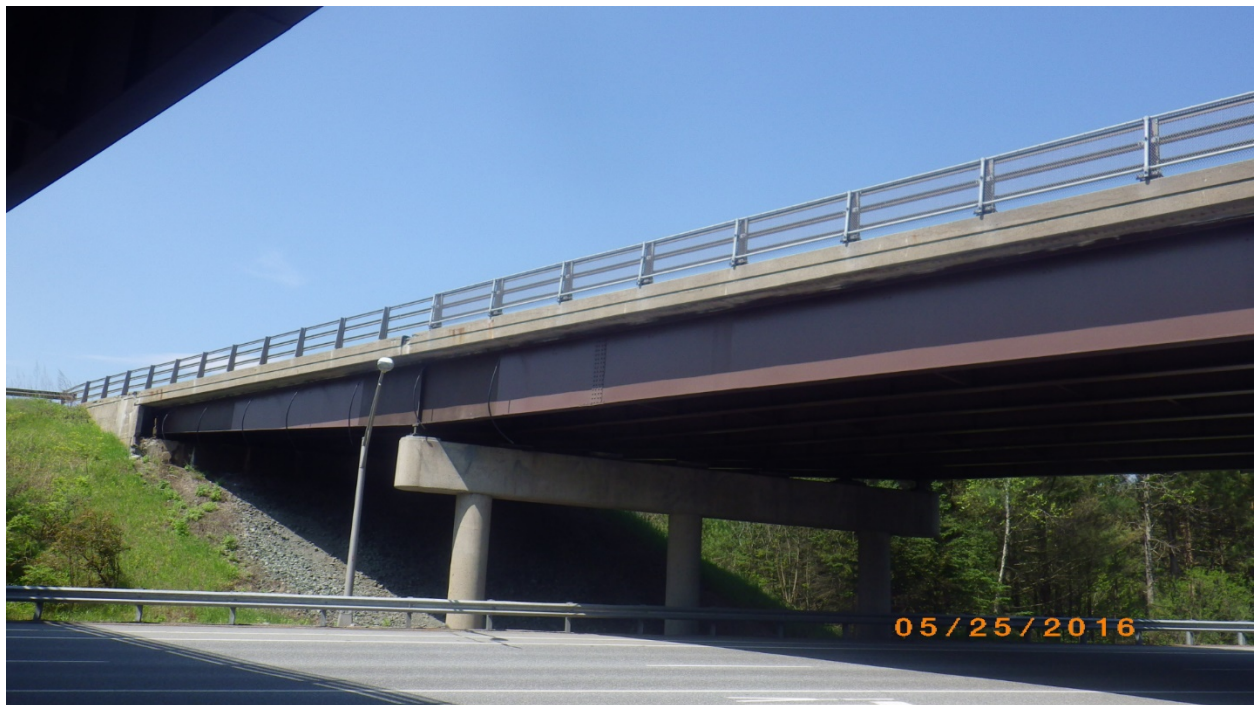
**Figure 3.2:** *Facing I-91 Southbound south abutment; note limited overhead clearance for drilling operations under existing bridge. [Inspection photo dated 2016]*

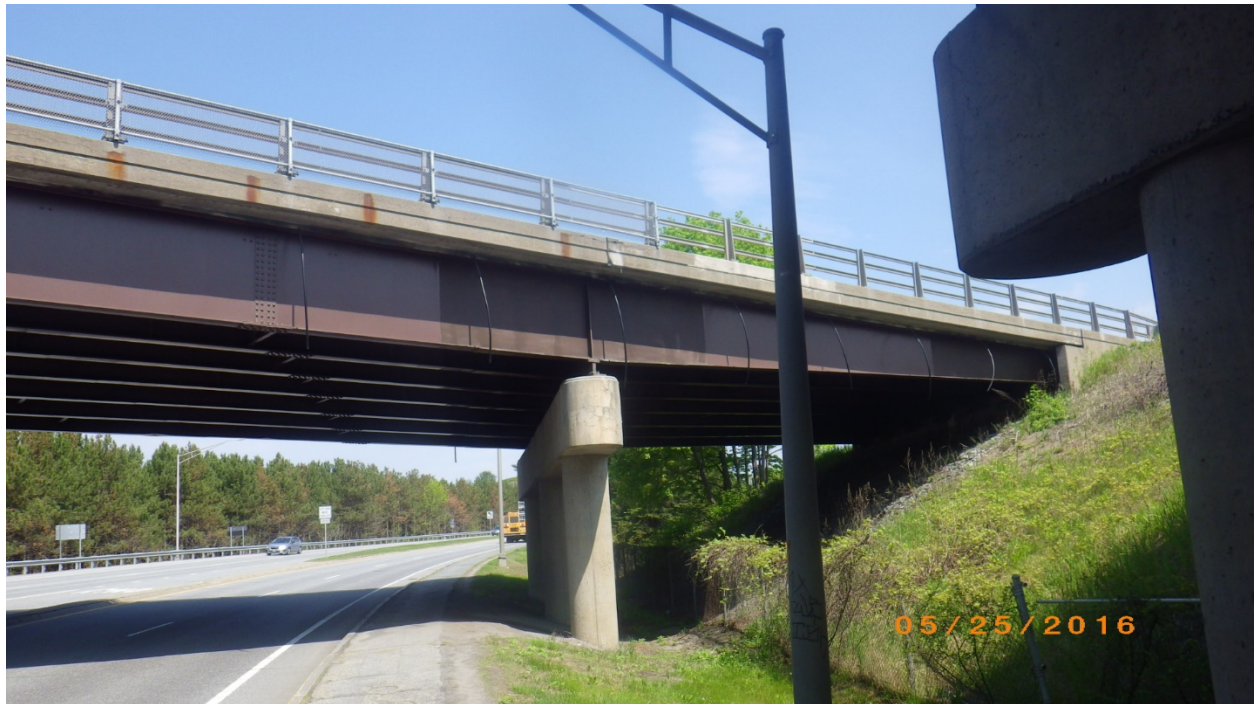
**Figure 3.3:** Facing I-91 Southbound north abutment; note limited overhead clearance for drilling operations under existing bridge deck. [Inspection photo dated 2016]

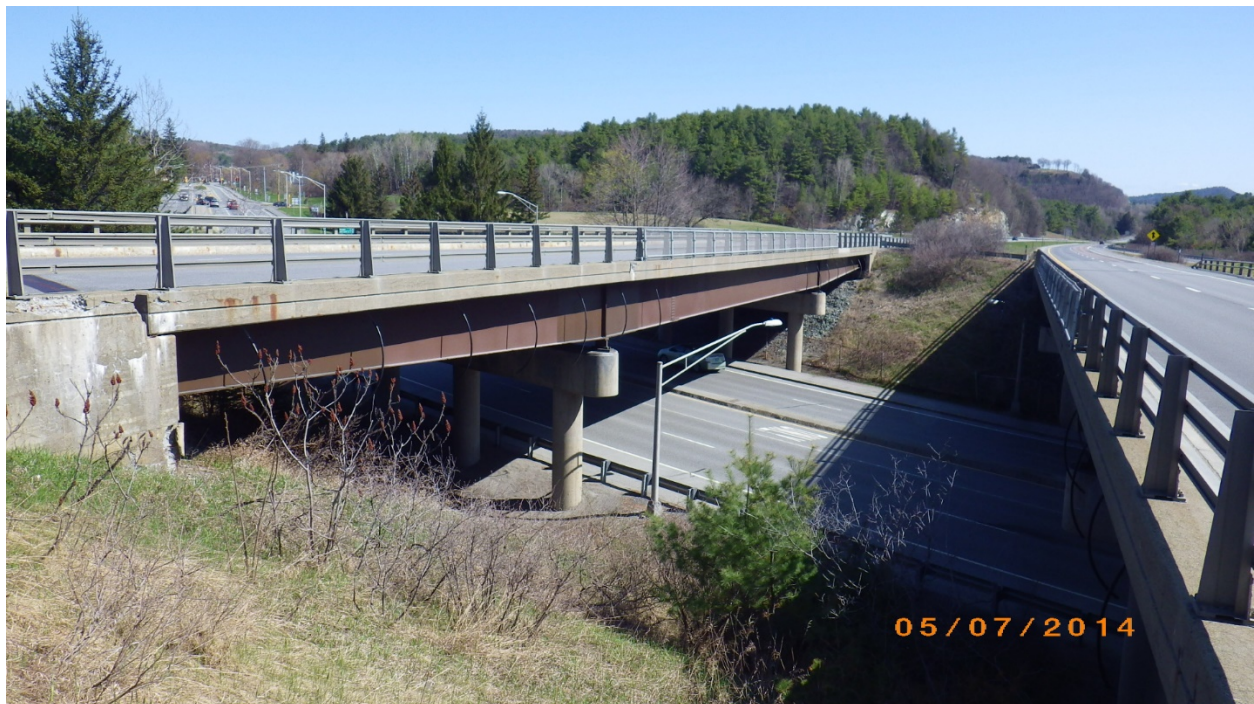
**Figure 3.4:** Facing west, southbound Bridge 48. [Inspection photo dated 2014]
