STATE OF VERMONT
AGENCY OF TRANSPORTATION

Scoping Report

Andover BHF 016-1(29)

VT ROUTE 11, BRIDGE 41 OVER MIDDLE BRANCH OF WILLIAMS RIVER

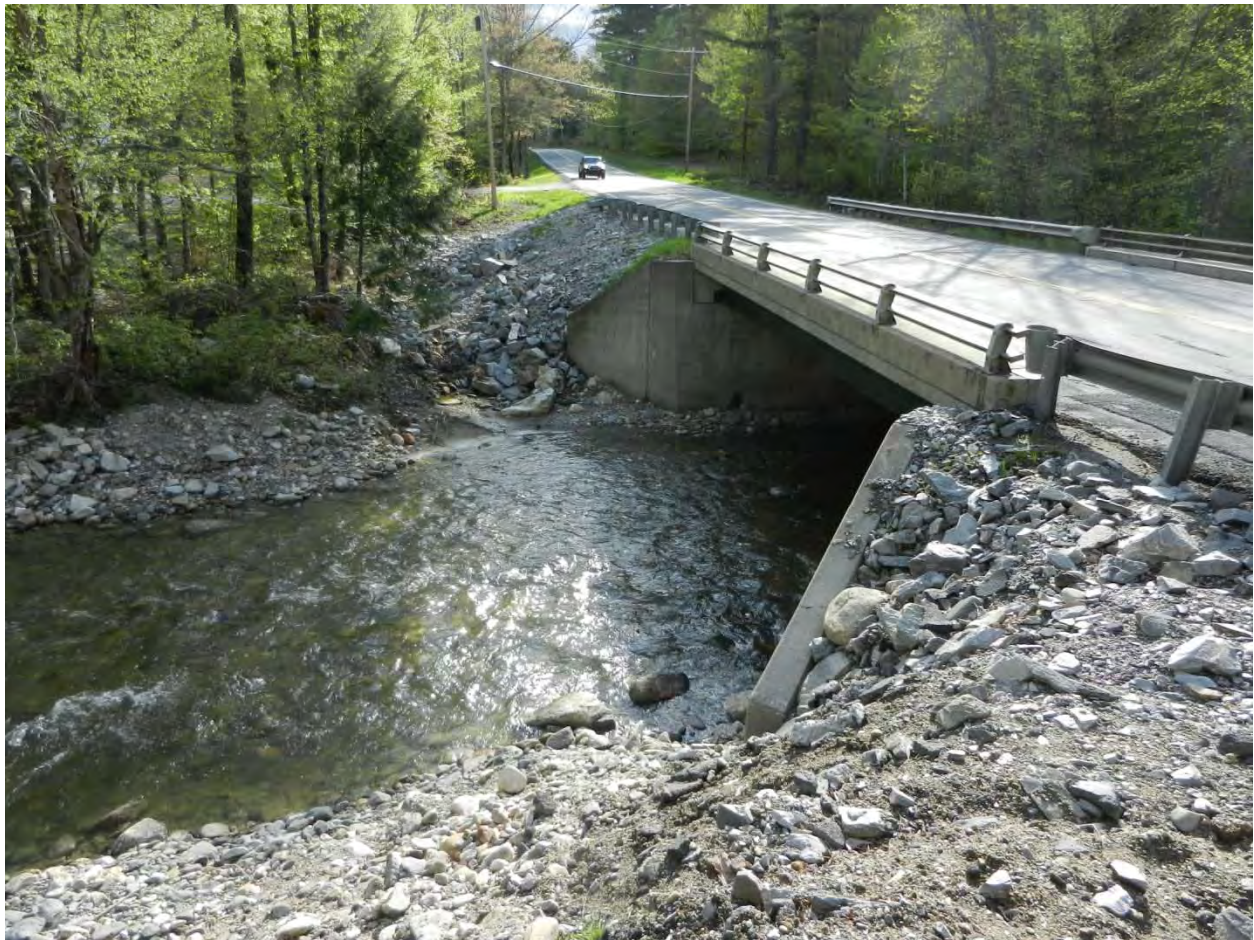
Figure 2. View of bridge, facing west.

Overhead power crosses the road before the bridge approach and runs along the south side of the road, which in combination with a power pole in the southwest corner, may interfere with the borings. Numerous cobbles and some small boulders were prevalent in the streambed and along the banks, which may also impede boring and construction operations. Several residential houses were noted in close proximity to the bridge, which will need consideration during the design and construction phases. These are seen in Figure 3.
