Town: 26 - BRATTLEBORO

| IDENTIFICATION | |
|---|---|
| (8) Structure Number | 200010005413022 |
| (6) Features Intersected | WHETSTONE BROOK |
| (7) Facility Carried | VT 00009 ML |

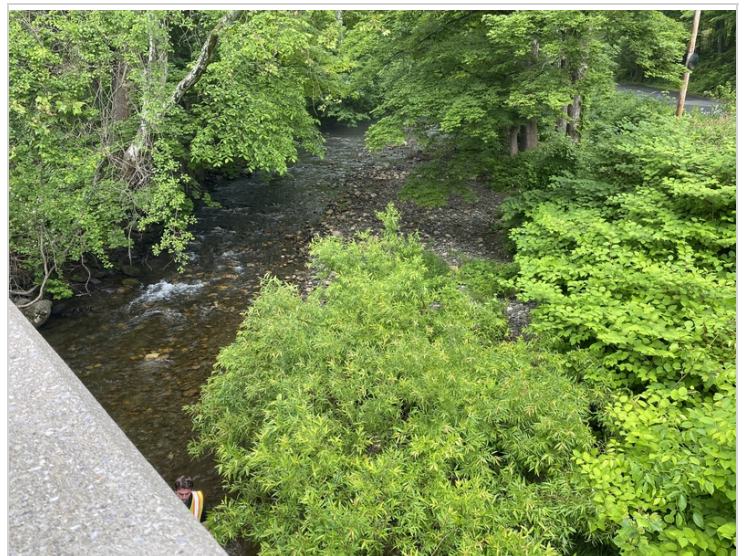
Upstream Channel

**61 - Channel Condition** (6 - Bank is beginning to slump. River control devices and embankment protection have widespread minor damage. There is minor stream bed movement evident. Debris is restricting the channel slightly.) Whetstone Brook flows at a moderate angle into structure with channel directed towards the eastern side of structure. Large gravel bar is present along the eastern side of channel upstream of structure that extends into structure. Channel bottom is mostly gravel and small stone. Large stone riprap and large trees line channel embankments with good brush growth. No protection in front of either footing.
