STATE OF VERMONT  
AGENCY OF TRANSPORTATION

Scoping Report

FOR  
Sharon IM 089-1(64)

Interstate Route 89, Bridges 17 N/S over the White River

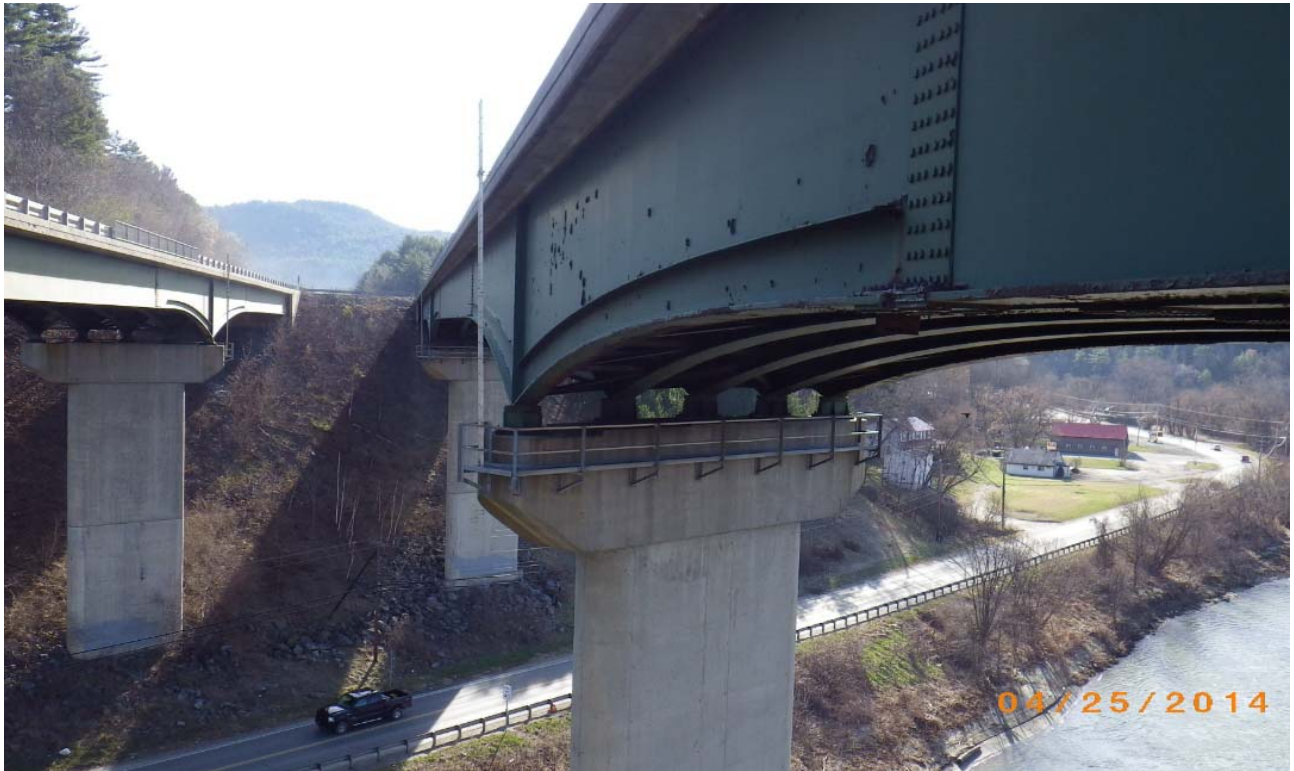
From Span 3, Bridge 17S (VT Route 14 below)

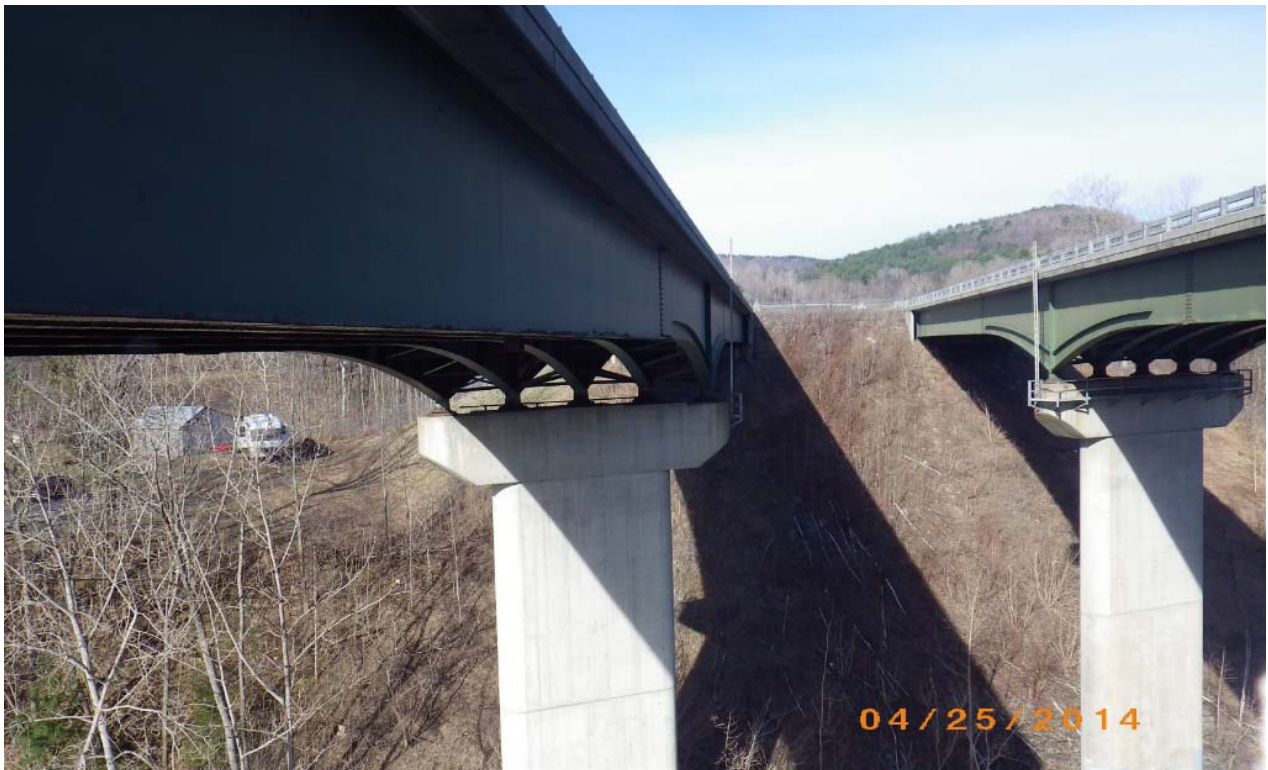
From Span 3, Bridge 17S - facing Abutments 3 and 4

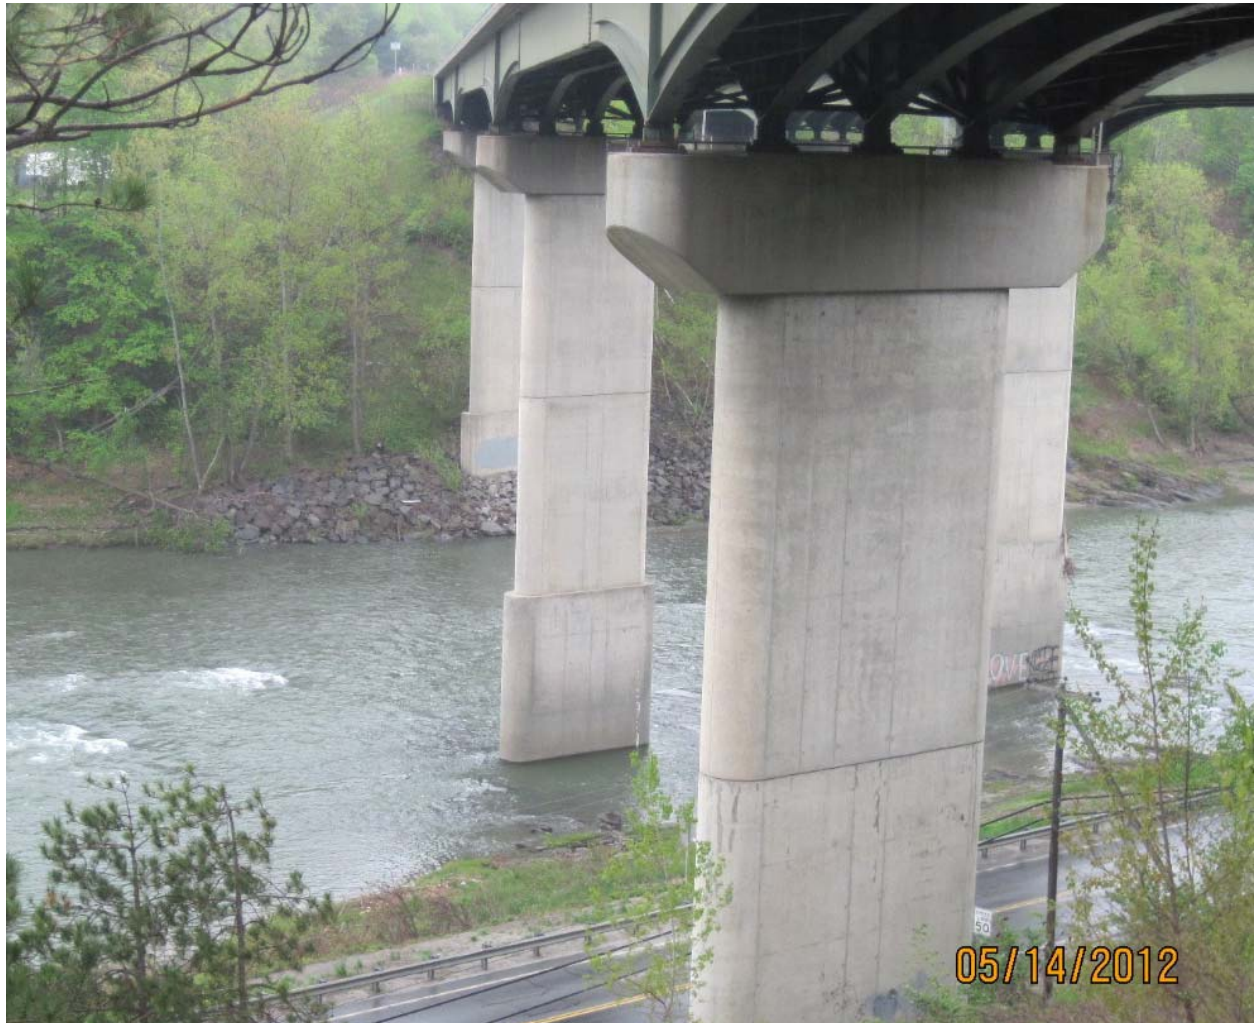
From embankment in front of Abutment #1 looking toward Pier #1, #3, and #5 (Below Bridge 17S)

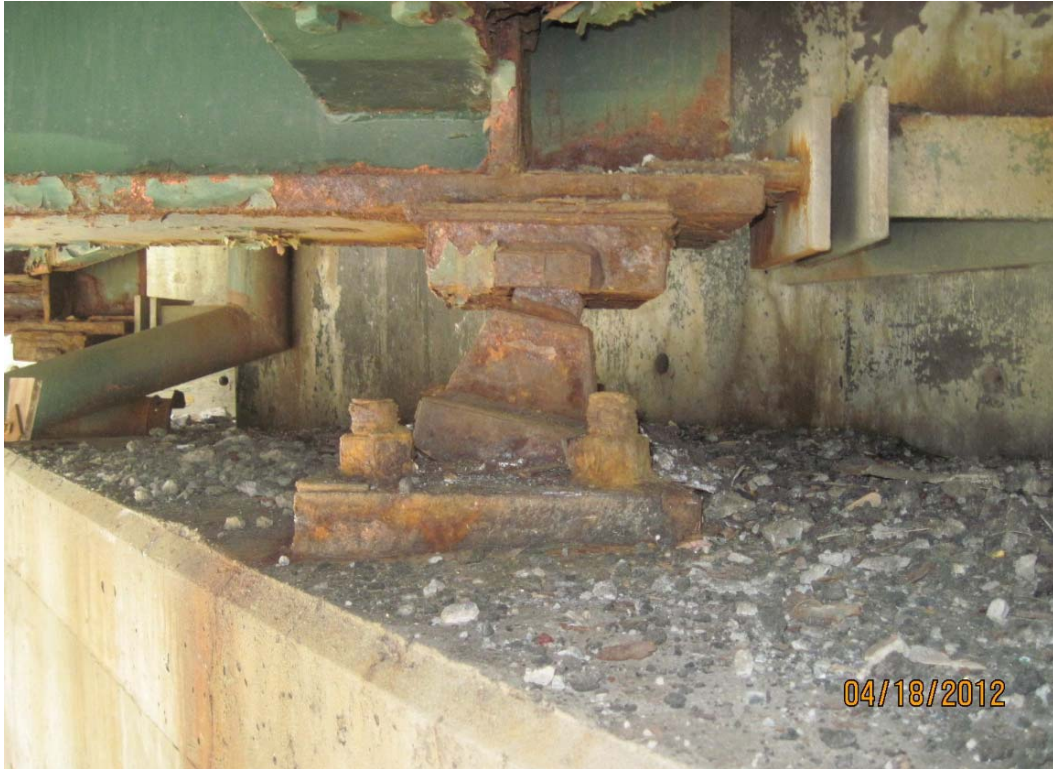
Tilted Bearing (Bridge 17N shown)

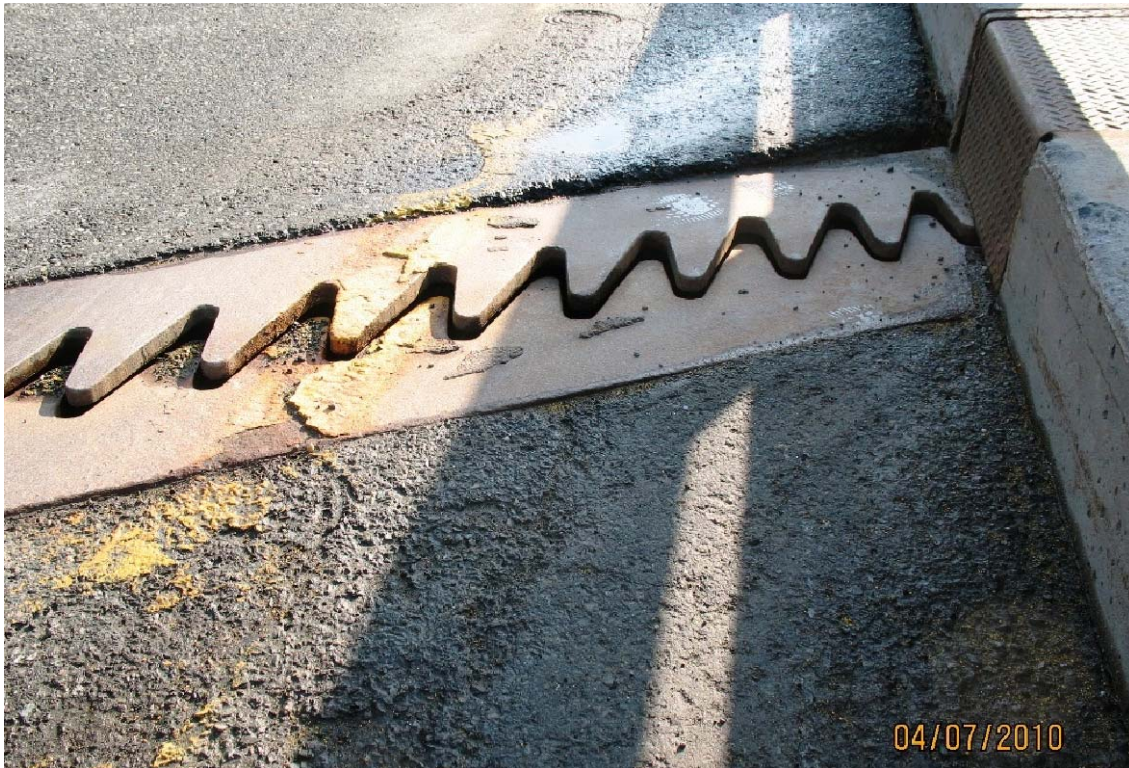
1. Finger joints are plugged and vertically misaligned
2. Abutment backwalls need patching (deterioration caused by leaking finger joint)
3. Deck drip tubes causing progressive deterioration of steel lateral bracing

*4/7/2010 – (Northbound and Southbound) Both finger plate joints need vertical realignment. Several diagonal braces between G1 to G2 and G4 to G5 in all span areas are in need of significant repairs. The entire steel structure is in need of full paint recoat. The drain tubes along both lines of 1 and 5 need to be repaired or sealed off. Heavy leakage drips along all girders on lines 1 and 5 causing progressive heavy corrosion deterioration. PLB*

Vertically Misaligned Finger Joint (Bridge 17N shown)

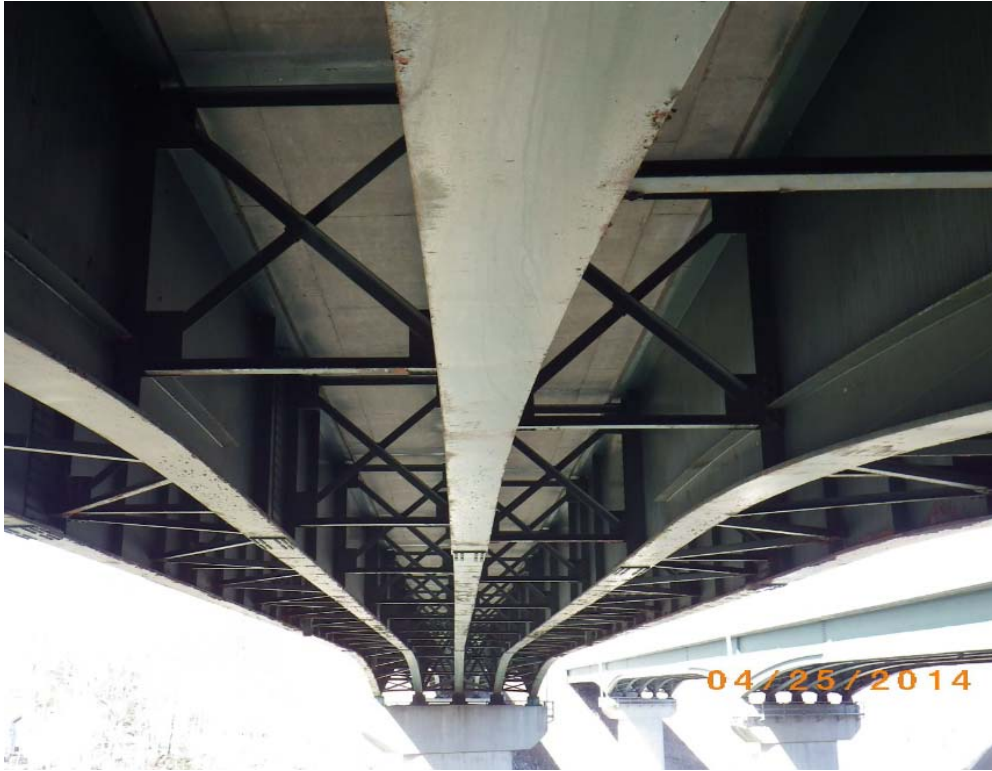
Underside of Bridge (Bridge 17S shown)

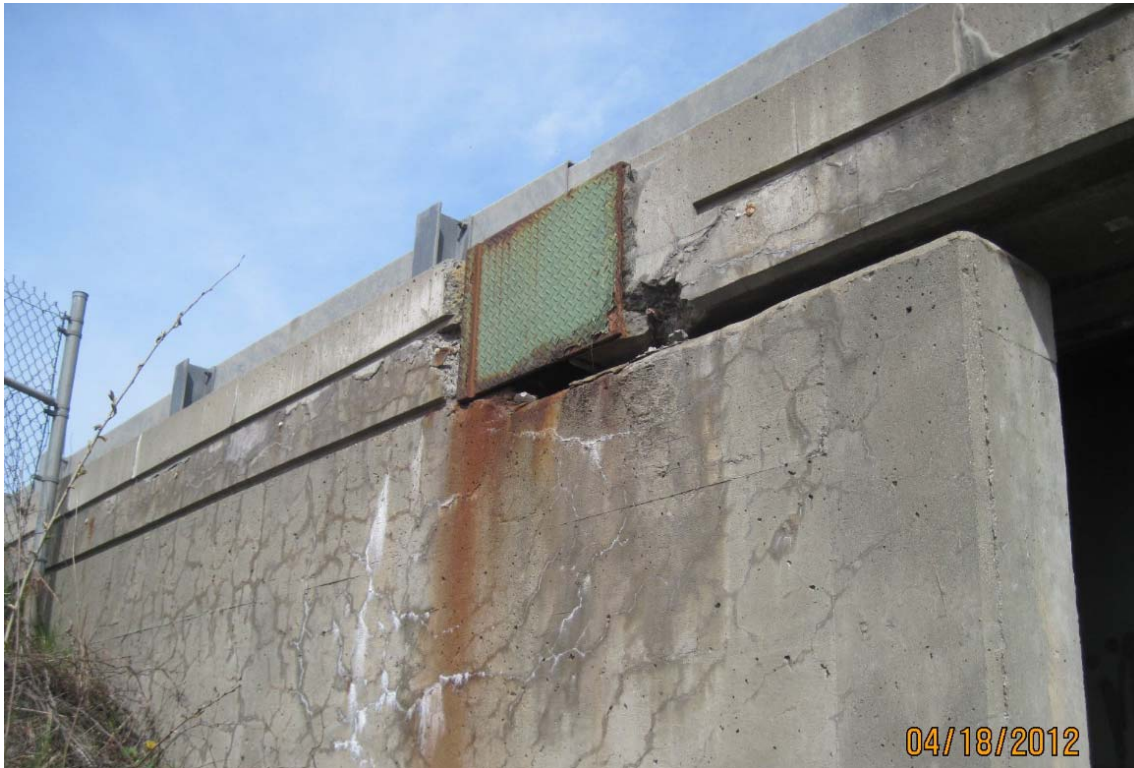
Wingwall and End of Deck (Bridge 17N shown)

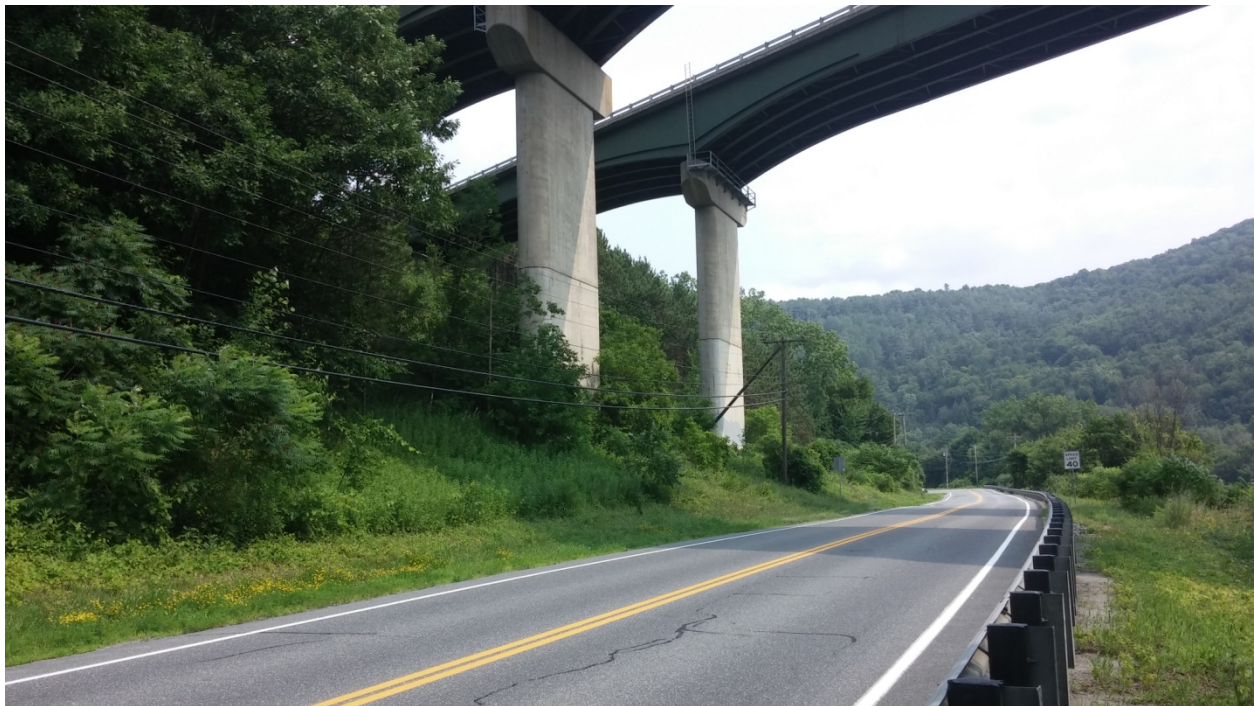
**Figure 2:** Bridge Piers Looking East

A preliminary site visit was conducted on July 25, 2014 to determine possible obstructions inhibiting boring operations and to make any other pertinent observations about the project. Overhead utilities run underneath the bridges on the eastern side of RT 14 in close proximity to two of the piers. The power lines can be seen in Figure 2.
