**STATE OF VERMONT
AGENCY OF TRANSPORTATION**

Scoping Report

**Springfield BF 0134(43)
VT ROUTE 11, BRIDGE 57 over UNNAMED BROOK**

October 13, 2017

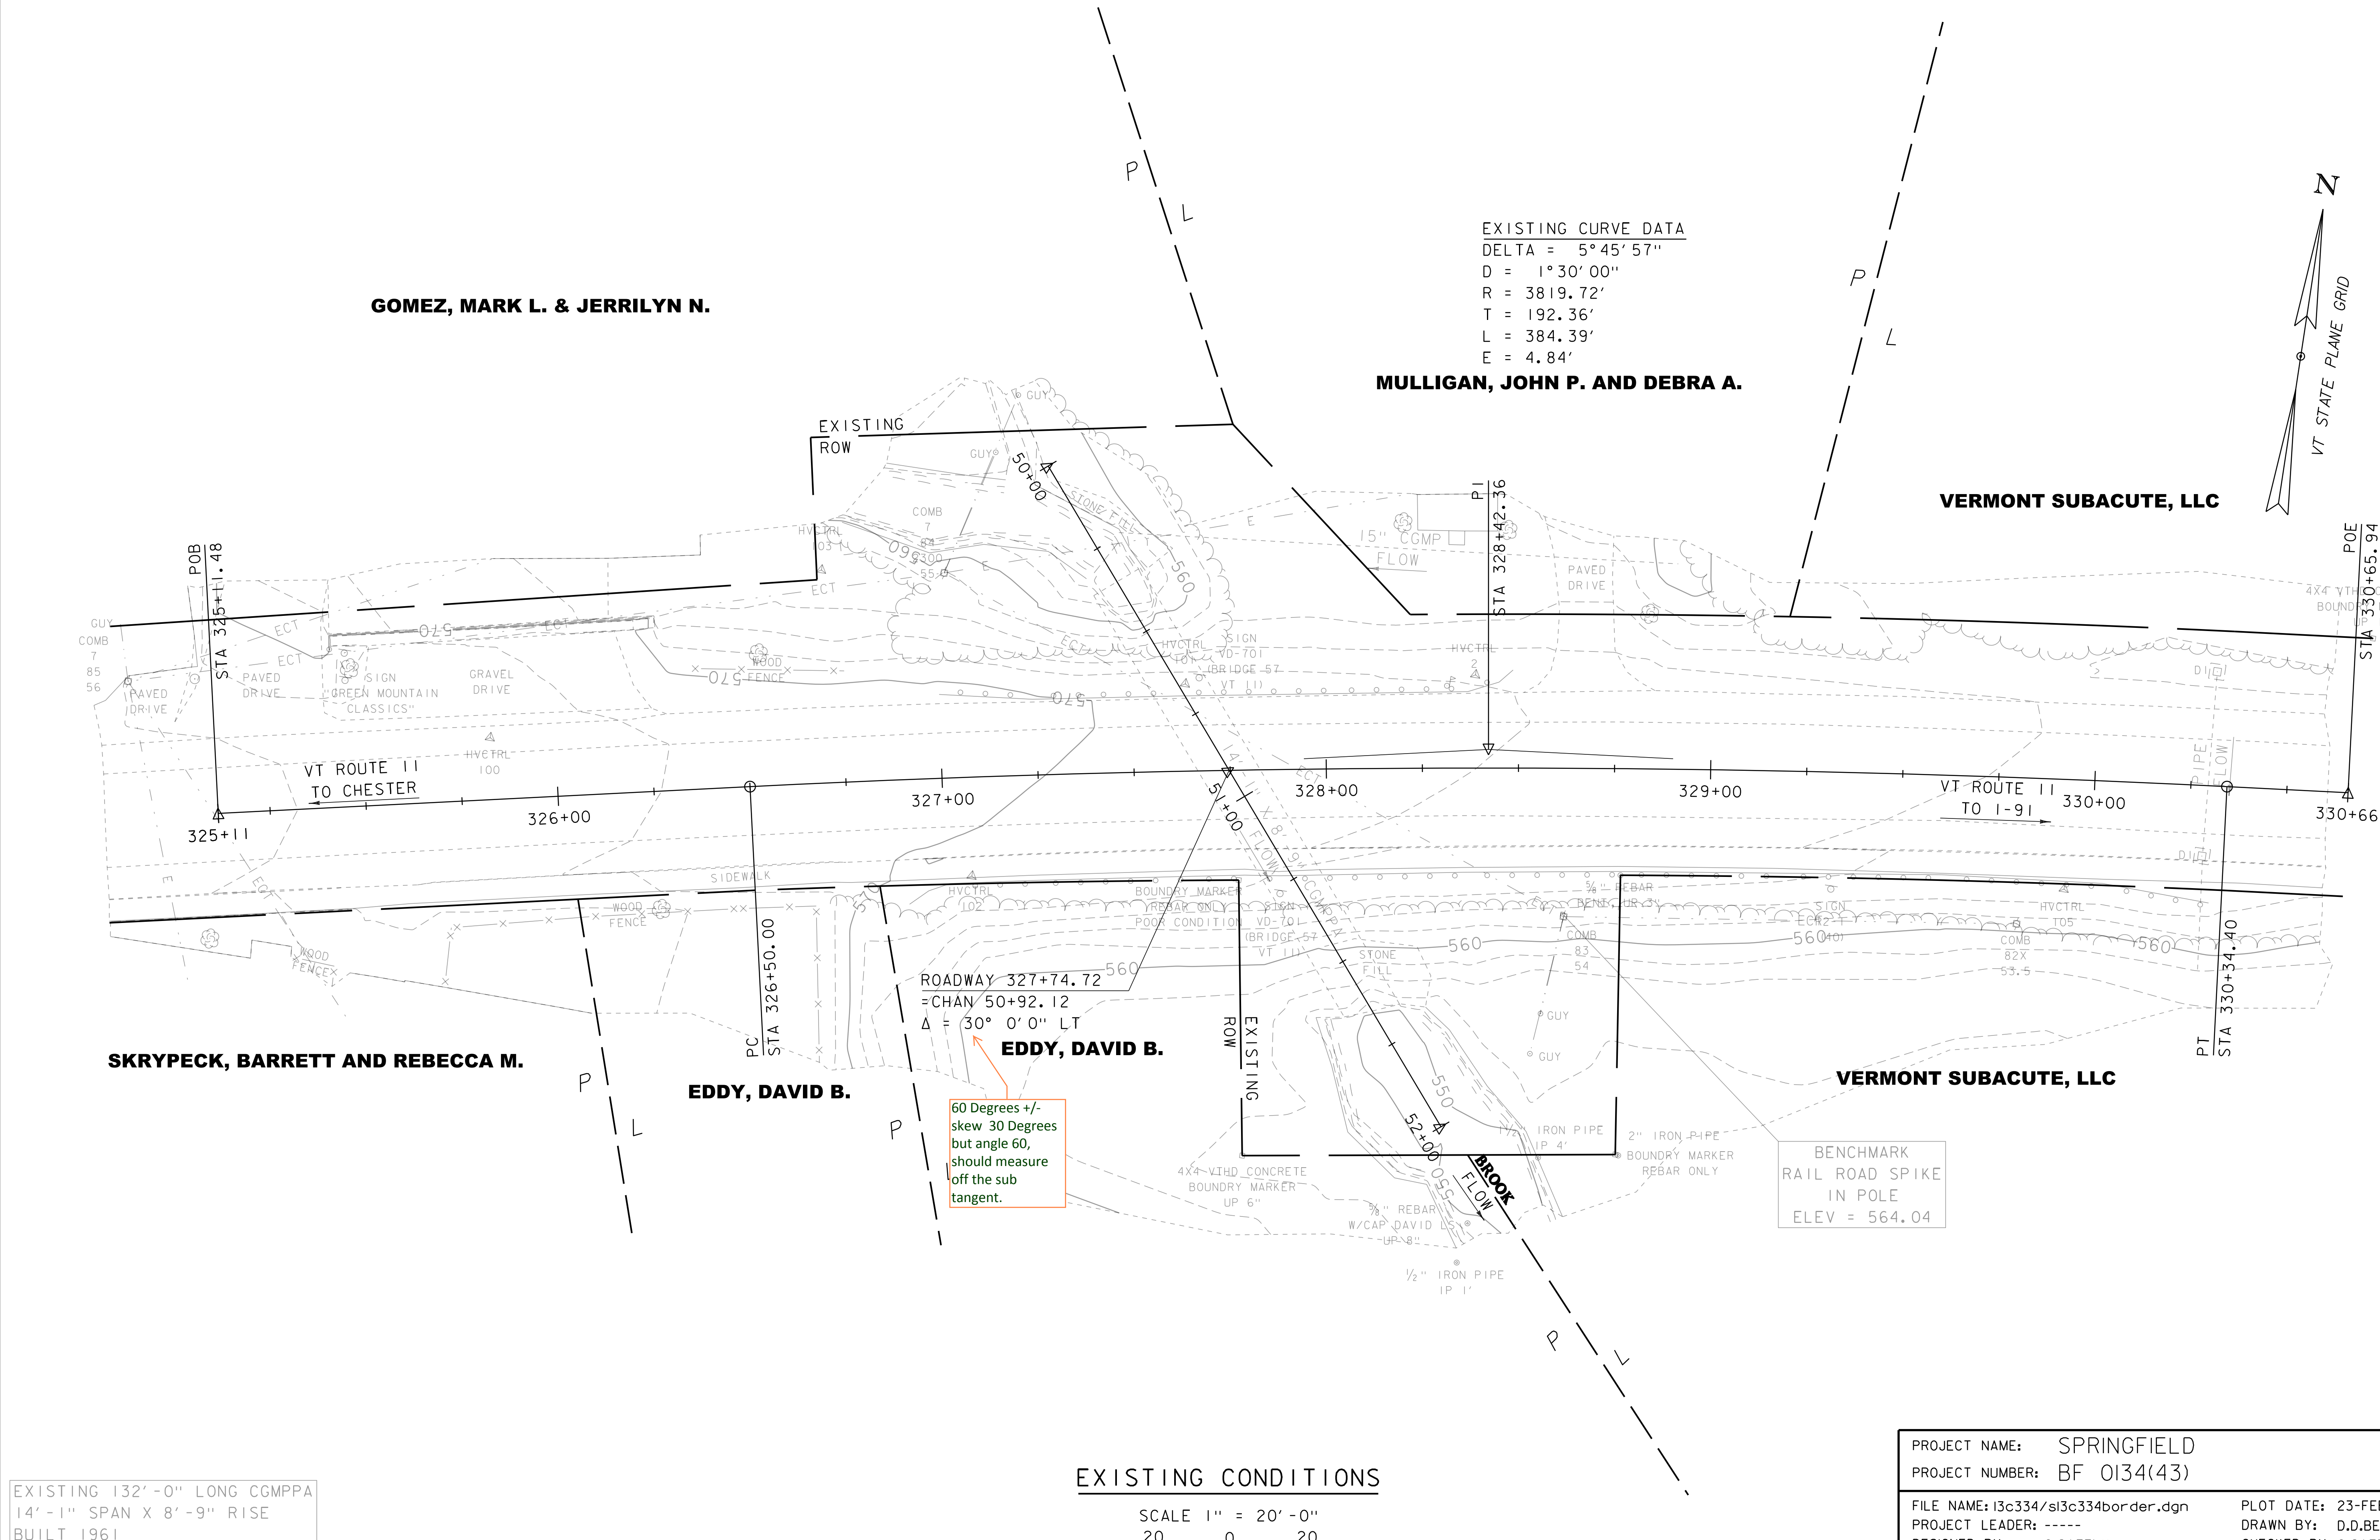
PROJECT NAME:	SPRINGFIELD	PLOT DATE:	23-FEB-2017
PROJECT NUMBER:	BF 0134(43)	DRAWN BY:	D.D.BEARD
FILE NAME:	I3c334/si3c334border.dgn	CHECKED BY:	G.SWEENEY
PROJECT LEADER:	-----	SHEET	I OF II
DESIGNED BY:	G.SWEENEY		
EXISTING CONDITIONS LAYOUT

EXISTING 132'-0" LONG CGMPPA
14'-1" SPAN X 8'-9" RISE
BUILT 1961
7' AVERAGE COVER
