STATE OF VERMONT  
AGENCY OF TRANSPORTATION  
**Scoping Report**

FOR  
**Addison BF 0172(9)**  
**VT ROUTE 125, BRIDGE 1 over WARDS CREEK**

Revised March 26, 2017

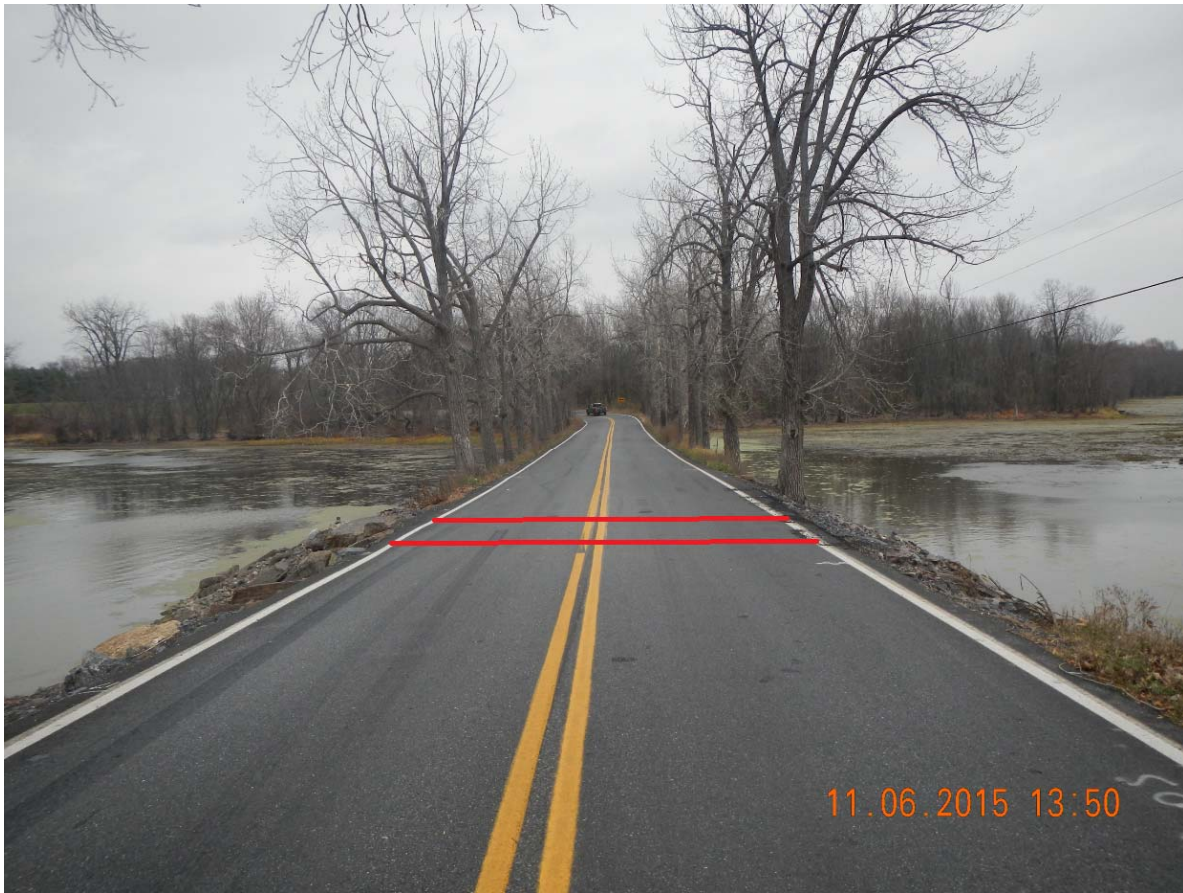
**Figure 4:** View at Culvert Location Looking North

A preliminary site visit was conducted on November 6<sup>th</sup>, 2015 to determine possible obstructions inhibiting boring operations and to make any other pertinent observations about the project area. Overhead power lines run along the east side of the existing culvert as shown in Figure 4. The culvert's approximate location is inside the red lines in Figure 4.

No visible bedrock was seen in the vicinity of the project during the site visit. Large stacked stone was used as make-shift wing walls to build up the roadway embankment on either side of the pipe. This stone exists around both the inlet and the outlet of the culvert. Smaller stone was used on top of the culvert inlet and outlet and appeared to exhibit erosion as seen in Figures 5 and 6.
