**STATE OF VERMONT
AGENCY OF TRANSPORTATION**

Scoping Report

**Chester BF 0134(50)
VT ROUTE 11, BRIDGE 51 over UNNAMED BROOK**

October 13, 2017

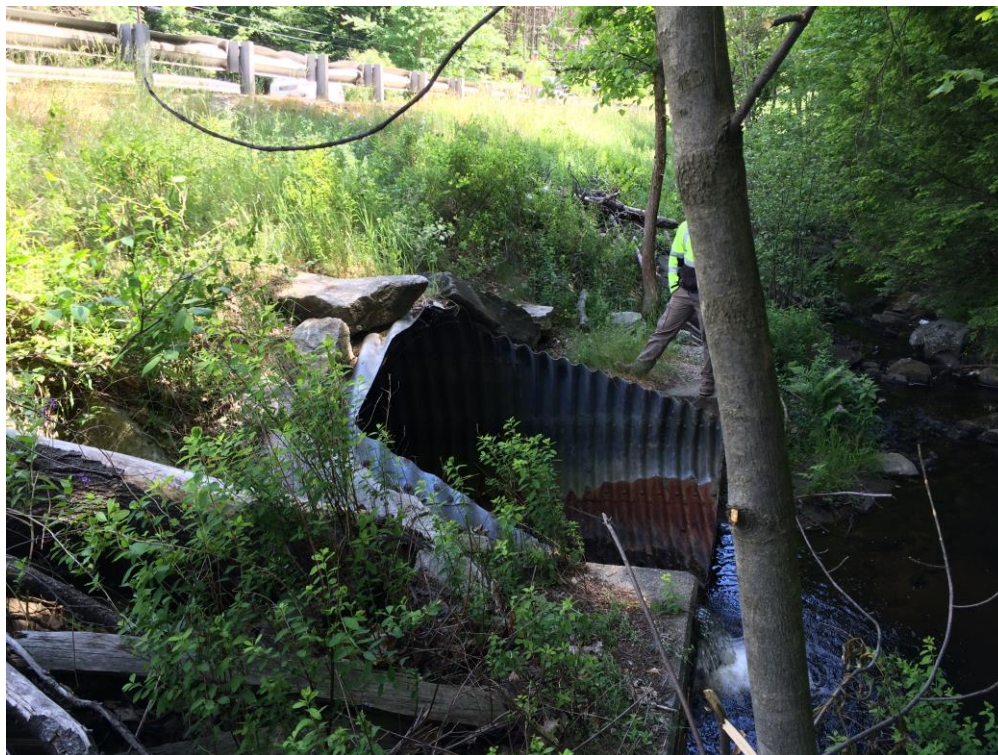
Constructed around 1965, 1.6 miles east of the Route 103-Route 11 junction, Bridge 51 runs beneath VT Route 11 and is a large, corrugated metal culvert with flat, cast concrete wing walls at its outlet (Figure 2). VTrans has determined that Bridge 51 does not appear eligible for inclusion in the National Register of Historic Places individually or as a contributing resource to a current or potential historic district. Although over 50 years of age, this culvert is unremarkable architecturally and historically.

Figure 2. Bridge 51 beneath VT Route 11, looking north.
