**STATE OF VERMONT
AGENCY OF TRANSPORTATION**

**Scoping Report
FOR
Springfield BM19201**

VT Route 106, Bridge 4 over Unnamed Brook

January 31, 2023

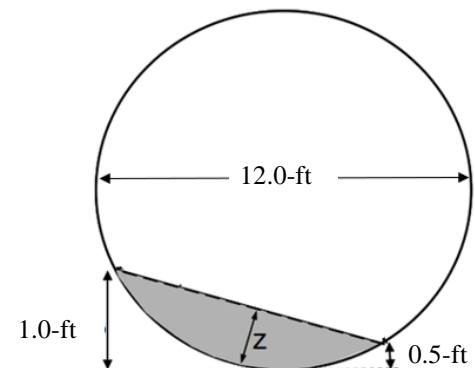
Option 1: Typical Section

Option 1: Rehabbed Existing Culvert (Slip Lined w/ Fish Baffles)

- This analysis assumed that the culvert is to be slip lined with a 12.0-ft CMP.
- Assumes that four (4) rock weirs or a rock ramp/step pool system will be constructed.
- The analysis assumed that fish baffles to be installed at 16.5-ft spacing with minimum and maximum height of 0.5-feet and 1.0-feet, respectively (as seen in Option 1).
- The installation of fish baffles would allow for adequate fish passage for Adult Brook Trout.
- The HW/D ratio would increase to 0.80 and 0.90 during the 2% and 1 % AEP, respectively. Headwater depths of 9.6-ft and 10.76-ft were determined during the design and check storm event, respectively.

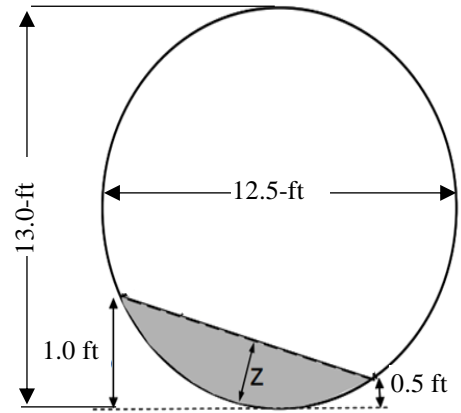
Option 2: Typical Section

Option 2: Rehabbed Existing Culvert (Spray Lined w/ Fish Baffles)

- This analysis assumed that the culvert is to be lined with a 6.0-inch thick liner which would provide a 12.5-ft span by 13.0-ft rise.
- Assumes that four (4) rock weirs or a rock ramp/step pool system will be constructed.
- The analysis assumed that fish baffles to be installed at 16.25-ft spacing with minimum and maximum height of 0.5-feet and 1.0-feet, respectively (as seen in Option 2).
- The installation of fish baffles would allow for adequate fish passage for Adult Brook Trout
- The HW/D ratio would increase to 0.71 and 0.80 during the 2% and 1 % AEP, respectively. Headwater depths of 8.91-ft and 9.94-ft were determined during the design and check storm event, respectively.

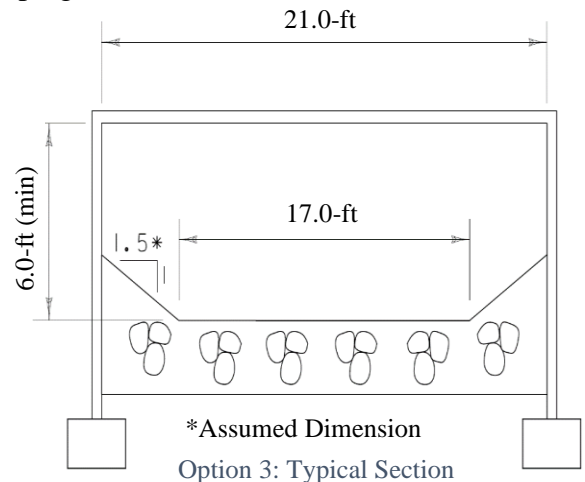
Option 3: Typical Section

Option 3: Bridge (3 sided), 21.0-foot span x 6.0-foot clear rise w/sloping fill

- There is approximately 1.25-feet of freeboard at the design AEP, providing a minimum waterway area of 123.3 sq. ft ±.
- Does not increase the 100-year base flood elevations
- Assumes no changes to the existing structure alignment/skew or slope.

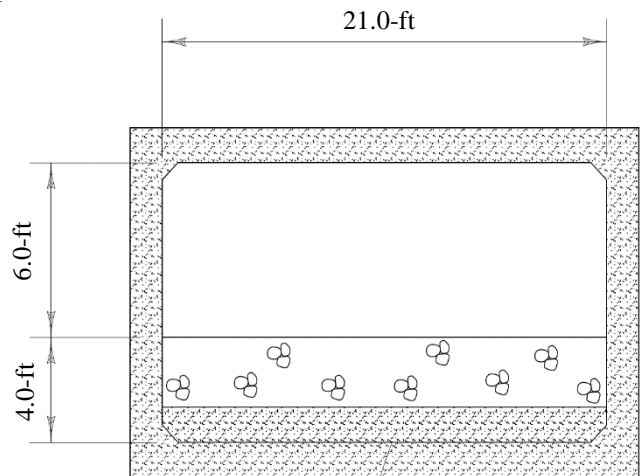
Option 4: Typical Section

Option 4: Four-Sided Concrete Box (closed bottom) 21-foot span x 10-foot rise

- There is approximately 1.25-feet of freeboard at the design AEP.
- Structure invert is to be buried 4-feet and provide a minimum waterway opening of 21-foot span x 6-foot clear height with a waterway area of 126.0 sq. ft.
- Bed retention sills should be added in the bottom of the structure. Sills should be 12 inches high across the full width of the box. Sills should be spaced no more than 8 feet apart throughout the structure with one sill placed at both the inlet and the outlet
- Does not increase the 100-year base flood elevations
- Assumes no changes to the existing structure alignment/skew or slope.

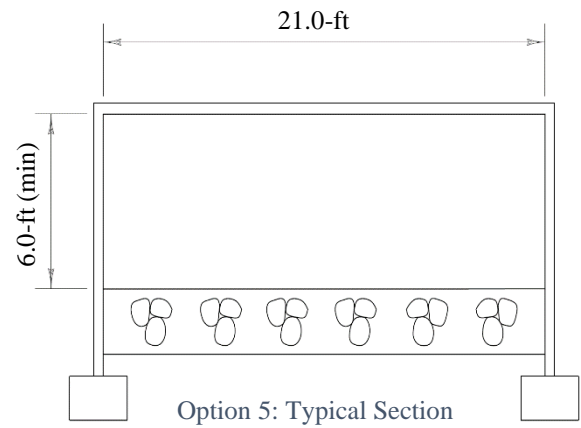
Option 5: Bridge (3-sided) 21-foot span x 6.0-foot clear rise

- There is approximately 1.25-feet of freeboard at the design AEP, providing a minimum waterway area of 126.0 sq. ft.
- Does not increase the 100-year base flood elevations
- Assumes no changes to the existing structure alignment/skew or slope.

For options 3 through 5, E-Stone, Type IV will need to be used to grade the channel through the respective structures. Stone Fill, Type IV shall be used to protect any disturbed channel banks or roadway slopes at the structure's inlet and outlet.

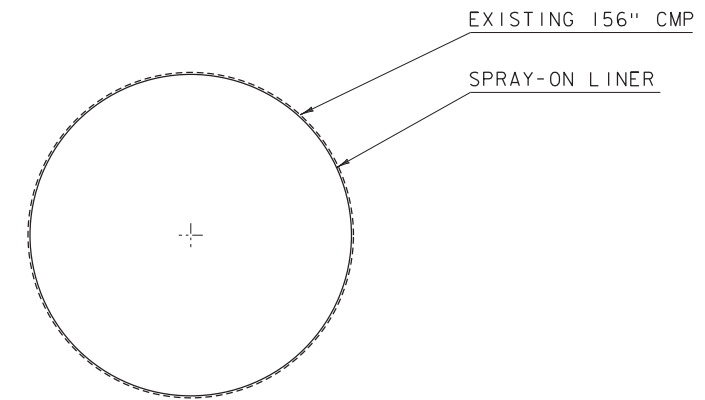
SPRAY ON LINER TYPICAL SECTION

Spray-On liners provide a new rigid interior surface for the pipe and use either cementitious materials (polymer-enhanced cement mortar) or polyurea. These liners are spray applied either by hand or machine, although some users have had better quality control with hand-applied methods. Cementitious liners installed by these methods can provide full structural support, depending on thickness applied. Proper curing is essential to using spray-on liners to avoid bond failures. There could be water quality impacts associated with the application of these liners, their degree of impact related to selection of materials, and adherence to curing requirements. If a spray-on liner is selected, the polymer-enhanced cement mortar is recommended for environmental and safety reasons. Spray-on liners are generally applicable for pipes up to 10-feet in diameter. It would be cost prohibitive to spray-line Bridge 4 due to its size.

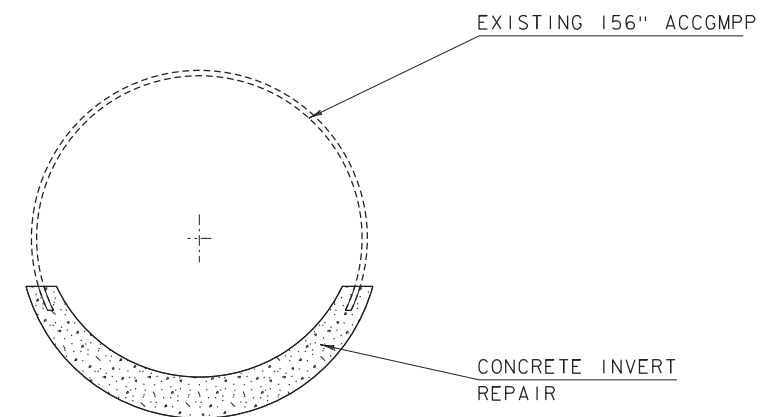
INVERT REPAIR TYPICAL SECTION

In many cases, invert repair is used to rehabilitate reinforced concrete pipe where the invert has eroded. Invert repair can be utilized on corrugated steel pipe, and typically consists of paving the invert or pouring a concrete invert. Much of the deterioration is located at the invert, making this a suitable repair for the culvert. This option involves removal of the degraded invert and pouring a 2-inch to 3-inch thick section of concrete in its place. Additionally, there may be repair of any holes along the circumference of the pipe. This option would have the least impacts to the hydraulic capacity of the existing culvert. While this option is a good solution to the current degradation of the culvert invert, it adds little structural stability to the current structure. There has been no evidence of crushing or squashing, and as such, additional structural capacity is not required.
