Springfield BM19201
Regional Concerns Meeting
VT Route 106 – Bridge 4 over unnamed brook

March 13, 2023

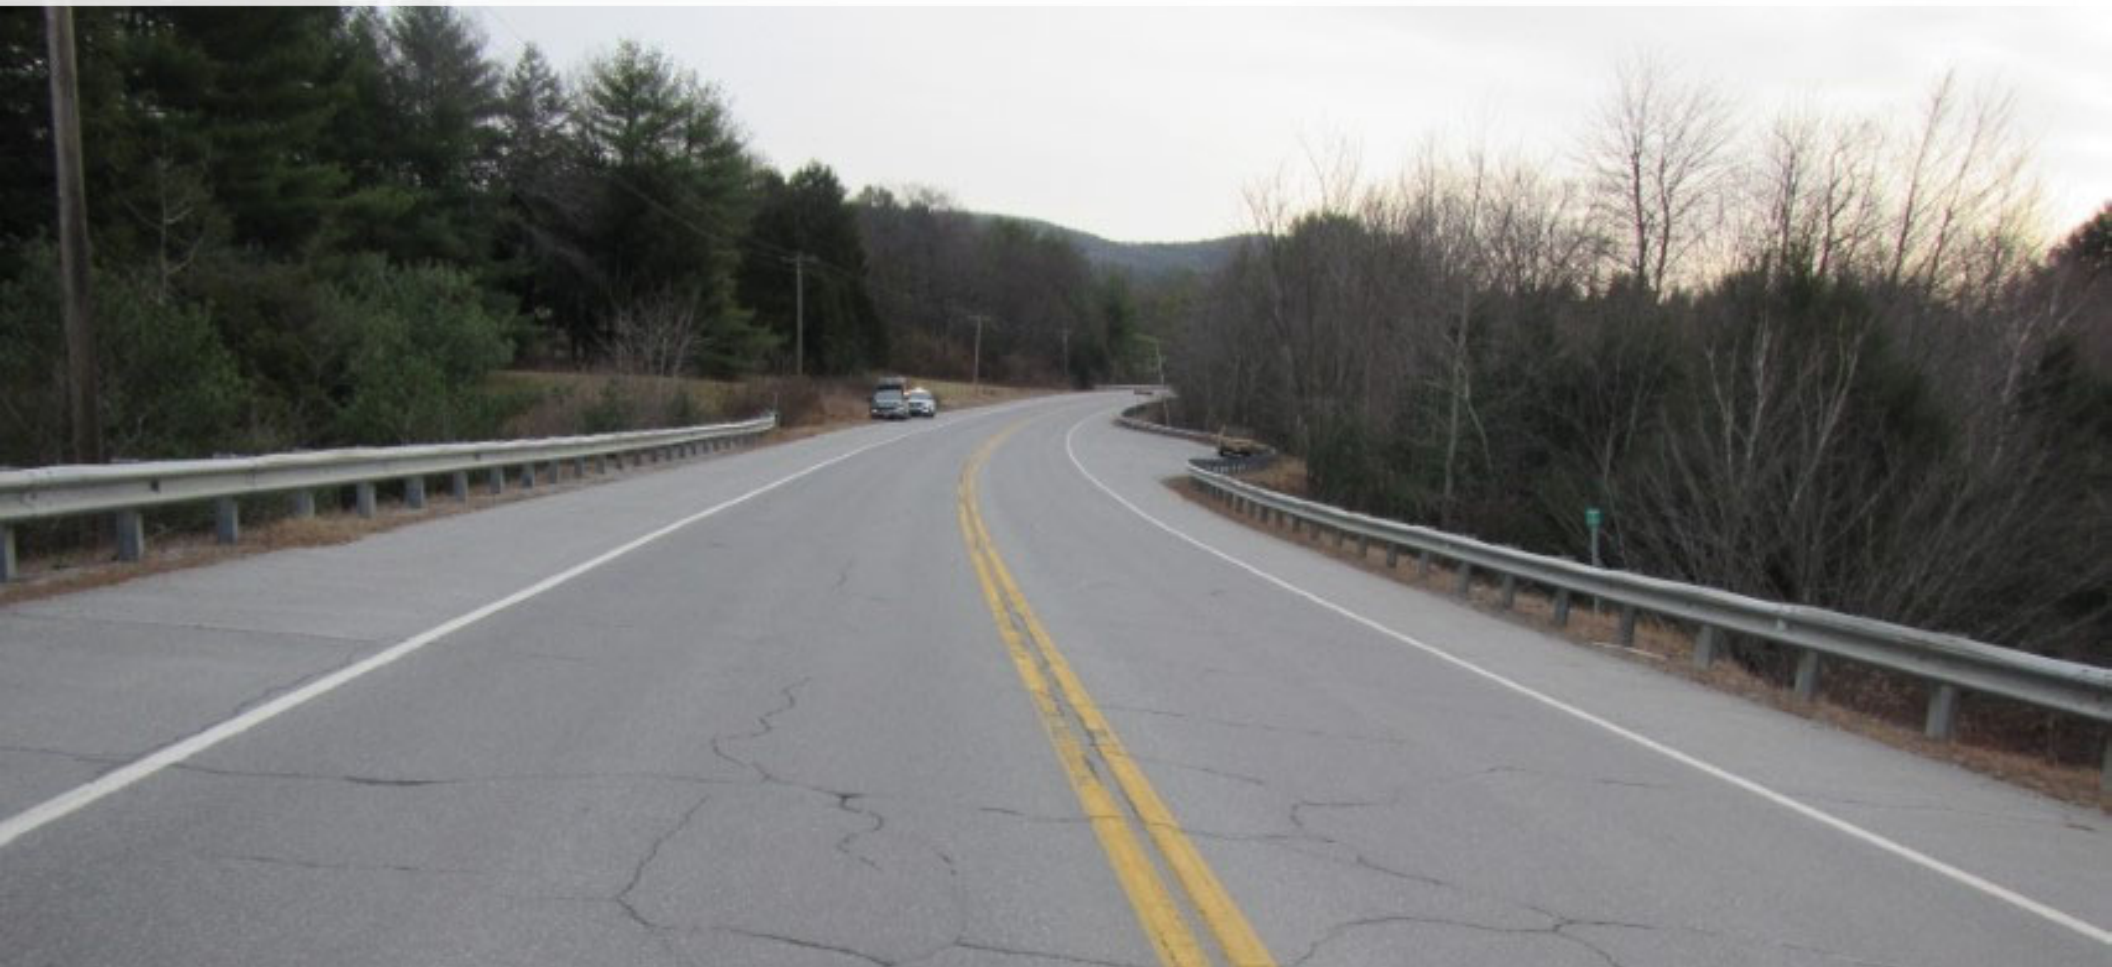
Looking East

- Roadway Classification – Major Collector
- Bridge Type – 13' Span, 176' long Corrugated Galvanized Metal Plate Pipe (CGMPP)
- Ownership – State of Vermont
- Constructed in 1958

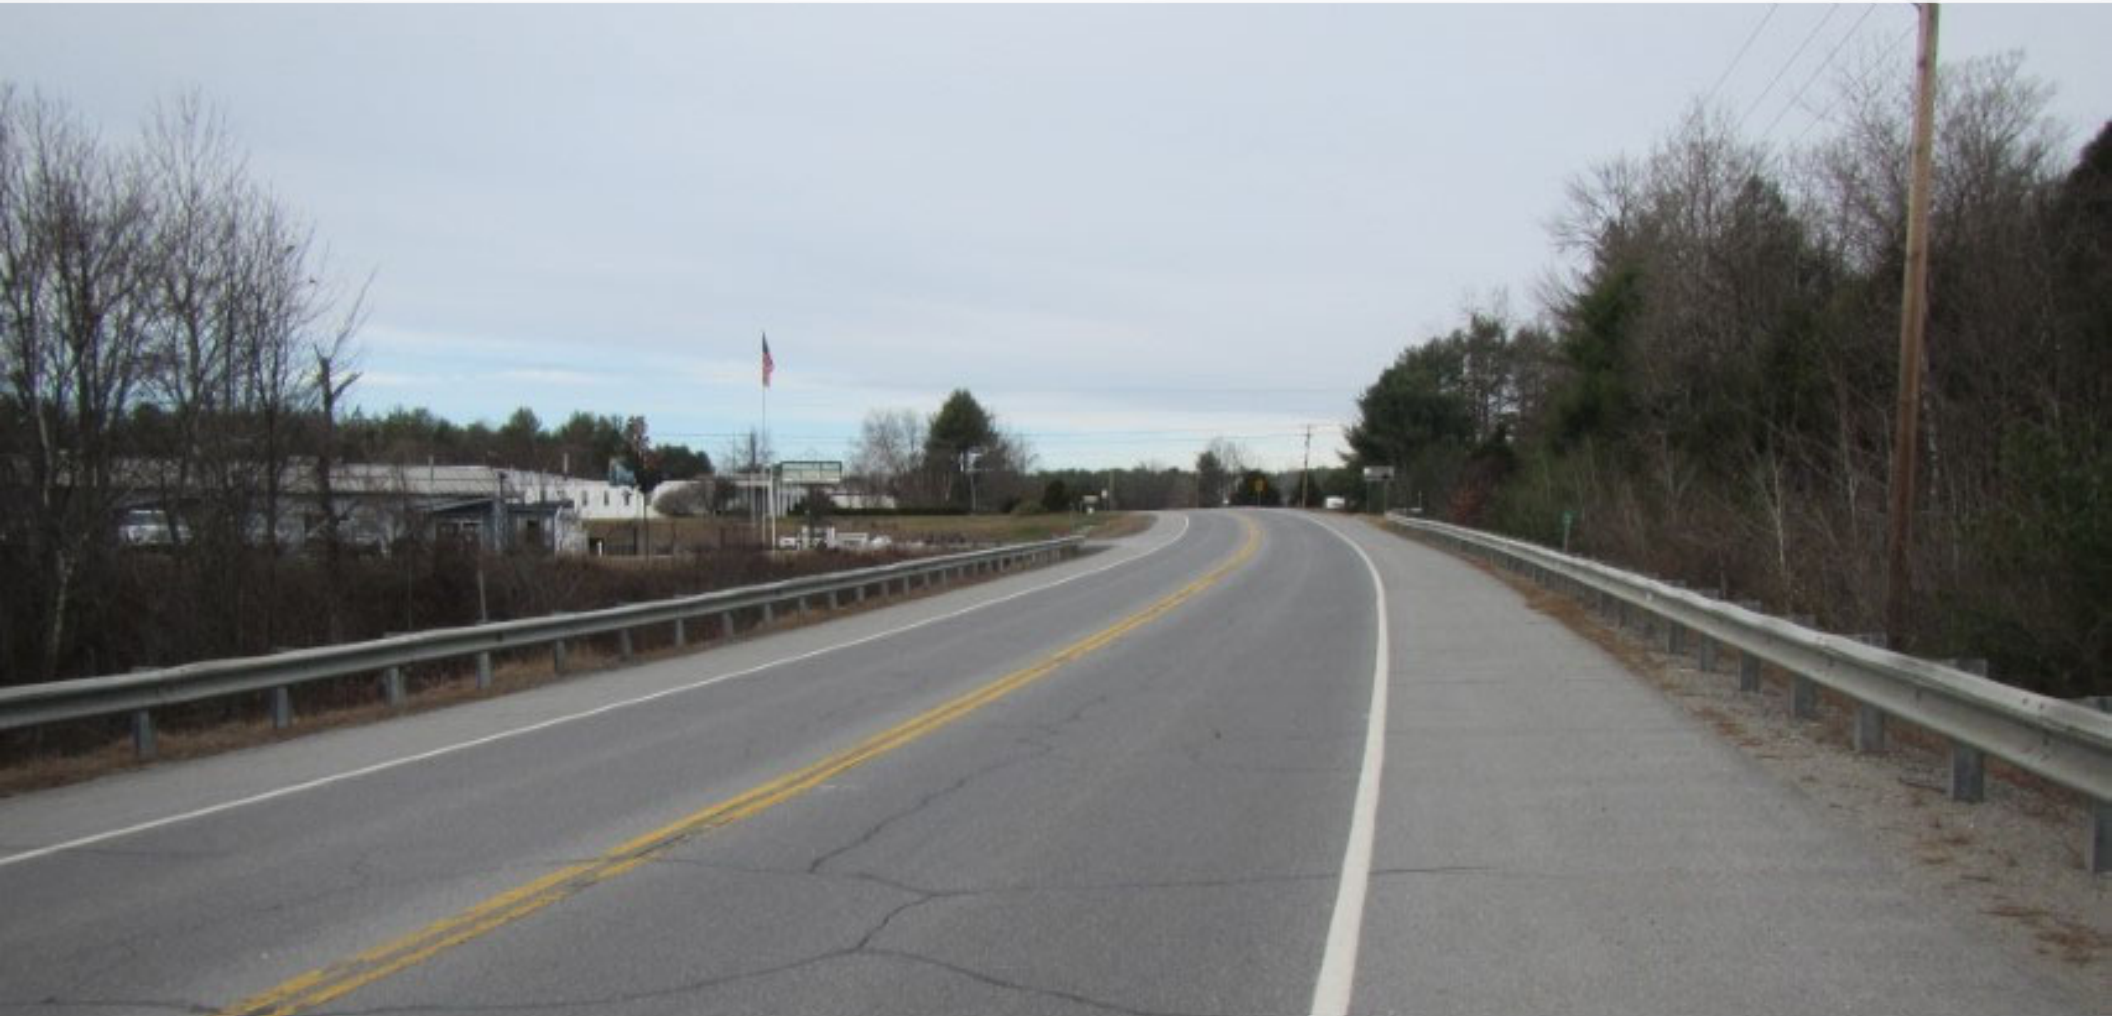
Looking West

- Municipal Utilities – None
- Public Utilities – Aerial: Green Mountain Power (Three Phase Electric); Comcast, LLC, and Firstlight Fiber, Inc.

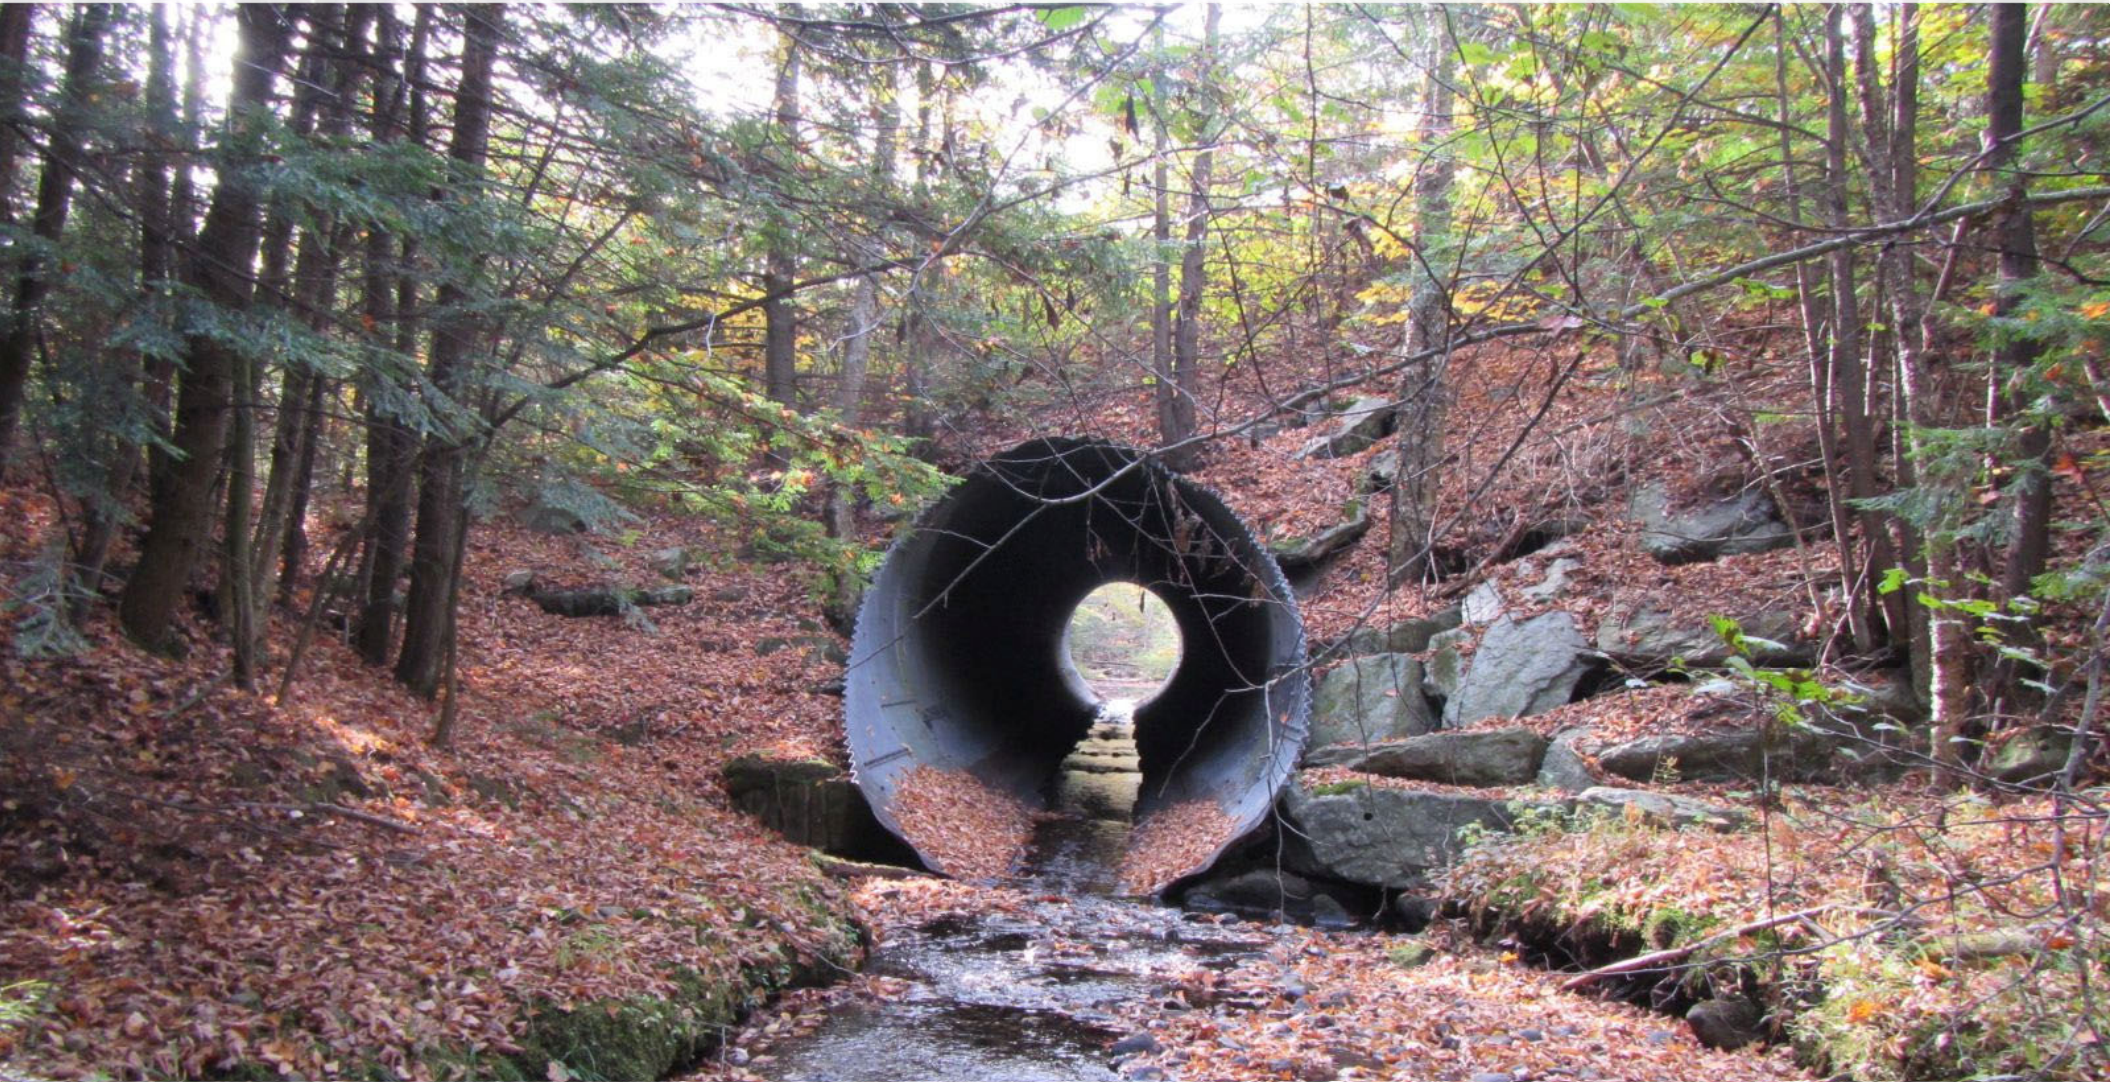
Looking North (Upstream)

- The culvert is in poor condition. The structure has heavy rust scale with deep pitting, moderate to heavy section loss, and scattered varying sized perforations along the rust/water line. The outlet end has perforations with visible piping occurring and measurable undermining of 8 to 9-inches. There are large perforations with much of the lower corrugation gone along the invert.
- The existing 13.5-foot clear span does not meet the state stream equilibrium standard of 21 feet for bank full width

- Culvert Rating 4 (Poor)
- Channel Rating 6 (Satisfactory)
