**STATE OF VERMONT
AGENCY OF TRANSPORTATION**

**Scoping Report
FOR
Irasburg STP DECK(50)**

Vermont Route 14, Bridge 124 over Black River

October 19, 2020

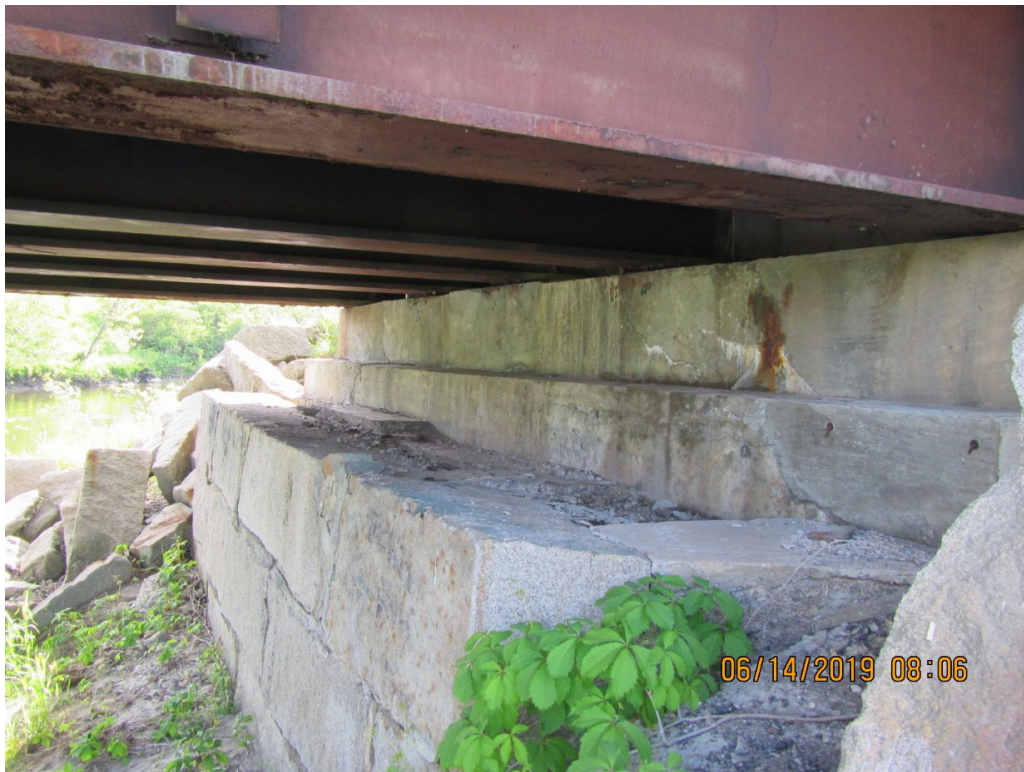
Picture 10: Bridge seat and abutment stem

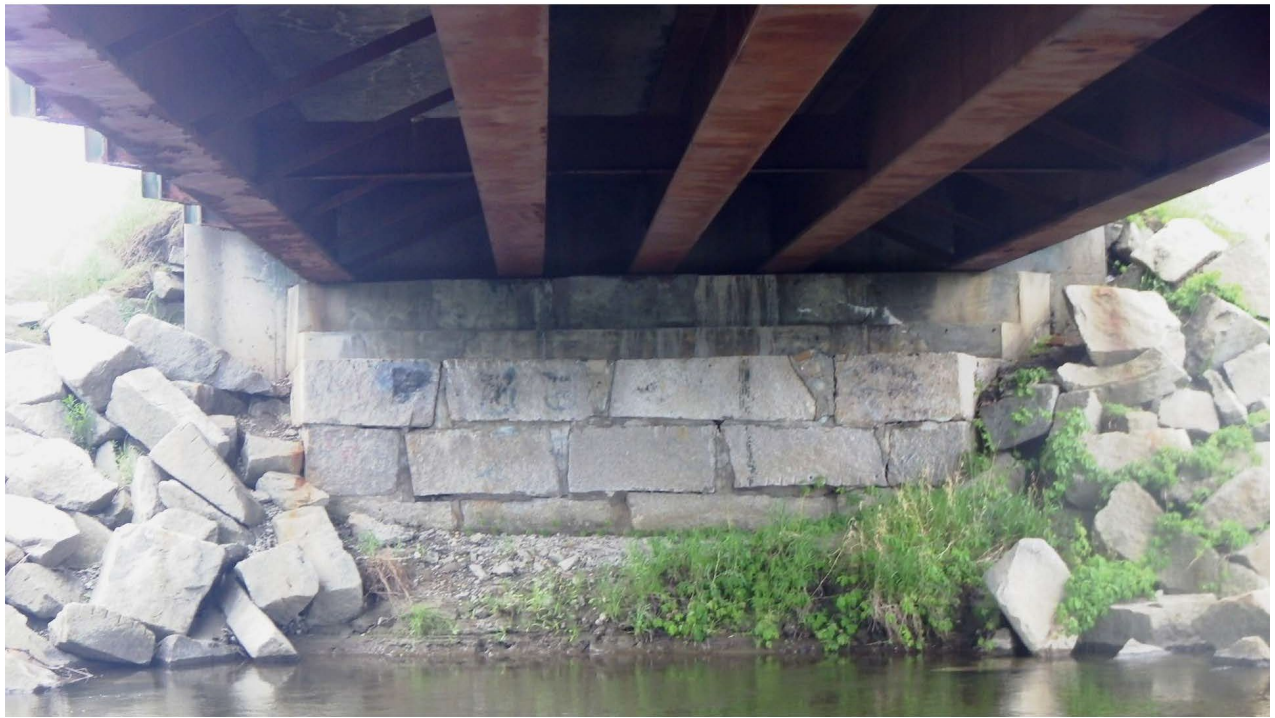
Metal rolled beam bridges possess lower significance within the context of bridge studies. The key character-defining features for significance include its beams, construction techniques, and any original rails, piers, wingwalls, or abutments. In the case of bridge number 124, the original rails are gone, however the structures abutments and substructure are in good shape (Figure 3).

Figure 3: Substructure and abutments for bridge number 124.
