Scoping Report

Clarendon BO 1443(55)
Kingsley Covered Bridge
Town Highway 39
Bridge 28 over Mill River

Prepared for:
Vermont Agency of Transportation

Hoyle, Tanner
& Associates, Inc.
www.hoyletanner.com
January 2021

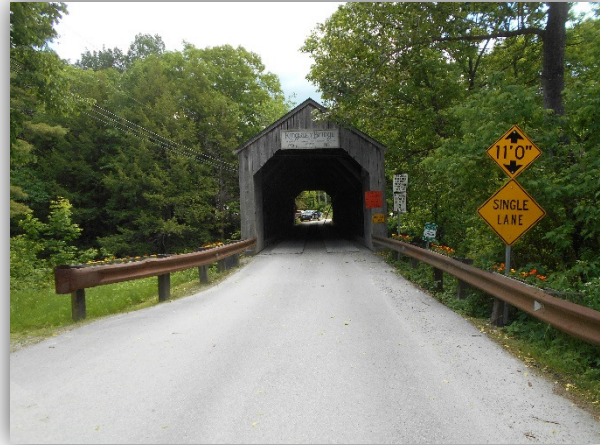
North Portal Signage
Looking South

The bridge is posted for no trucks, a weight limit of 3 tons and one car at a time crossing the bridge. It provides an approximate 14' width between the trusses and 12' maximum vertical clearance. The vertical clearance at the edges of the travel lane is approximately 9', however, the vertical clearance signs on each approach to the bridge indicate a height restriction of 11'-0".

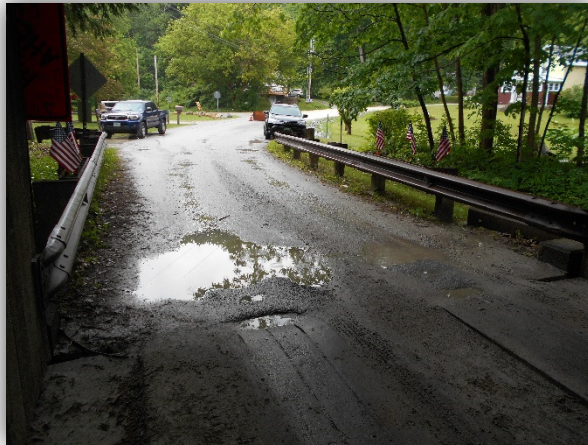
South Approach Ponding

The southern approach of East Street creates a low point approximately just south of the bridge and also intersects with Knipes Drive approximately 200' south of the bridge. This approach is paved from just north of the intersection with Knipes Drive to the bridge. South of Knipes Drive, East Street is a gravel road. Stormwater generally sheet flows off the roadway. Along the western side of the roadway there is a shallow stone-lined drainage swale, which collects the roadway stormwater and conveys it beneath a field access driveway via a 15" drain pipe and

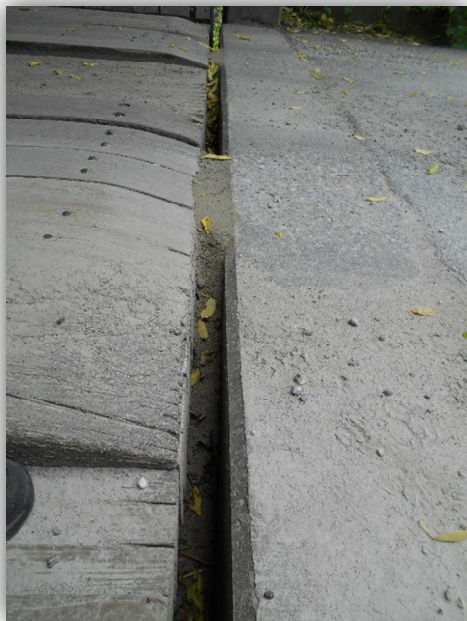
- The runner boards exhibit areas of moderate to heavy wear, rutting and splits. The runner boards are only located at wheel lines and pose a potential safety hazard because vertical differences between surfaces can affect vehicle stability and reduce a driver's ability to handle the vehicle.
- The runner boards also collect significant sand and debris due to uneven deck surfaces between the runners and the nail laminated deck.
- The runner boards are tapered down at each end of the bridge in order to match the concrete backwall elevation and create a "bump" for on-coming traffic.

Tapper Runner Boards at Abutments

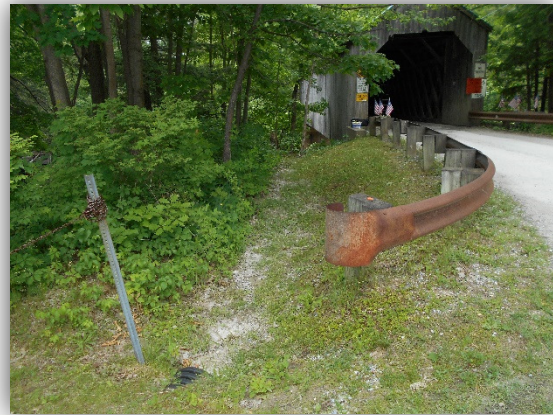
Galvanized w-beam guardrail begins at the bridge and continues south, flaring away from the roadway. There are no crashworthy end units on the guardrail. Side slopes are generally level off the roadway

Existing W-Beam Guardrail and Drain Pipe

Like the north approach, new steel backed timber guardrail is proposed to replace the w-beam guardrail matching existing lengths. A stop condition is proposed for the northbound traffic and will include a stop bar on the paved roadway, and a stop sign on the gravel shoulder.

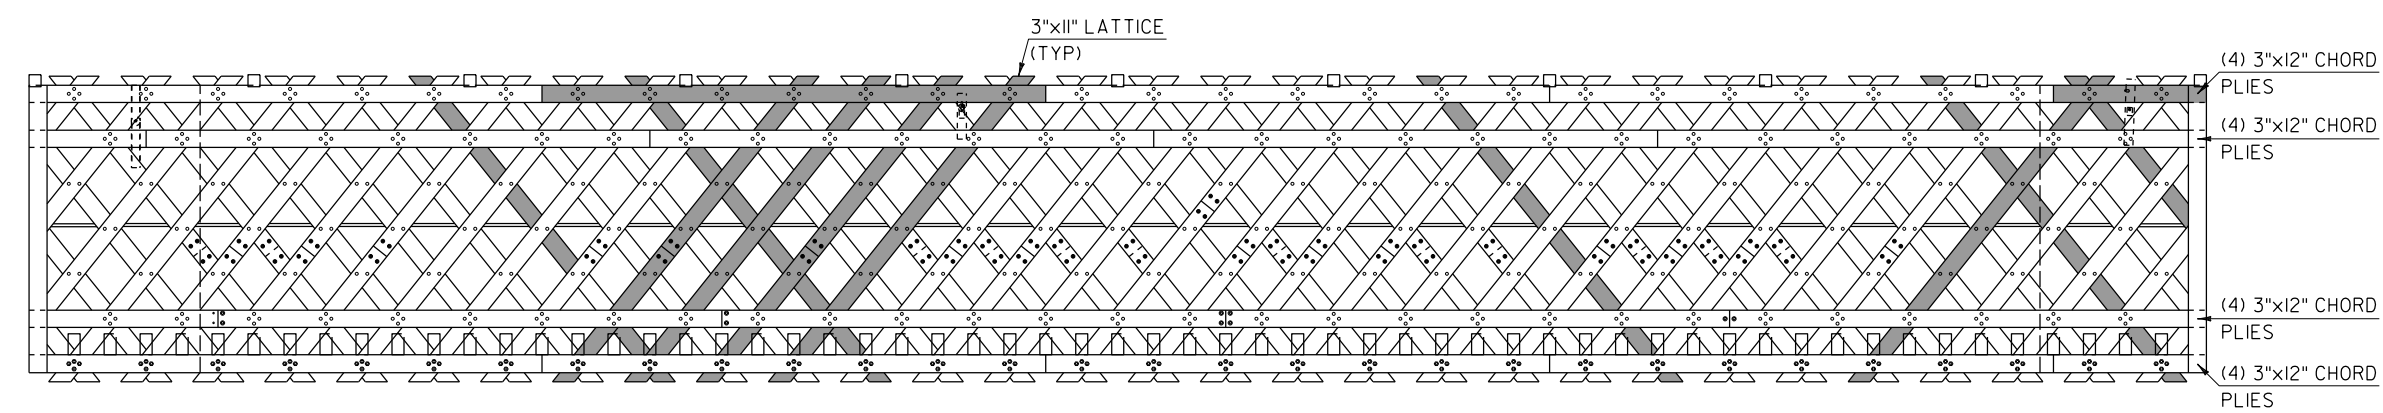
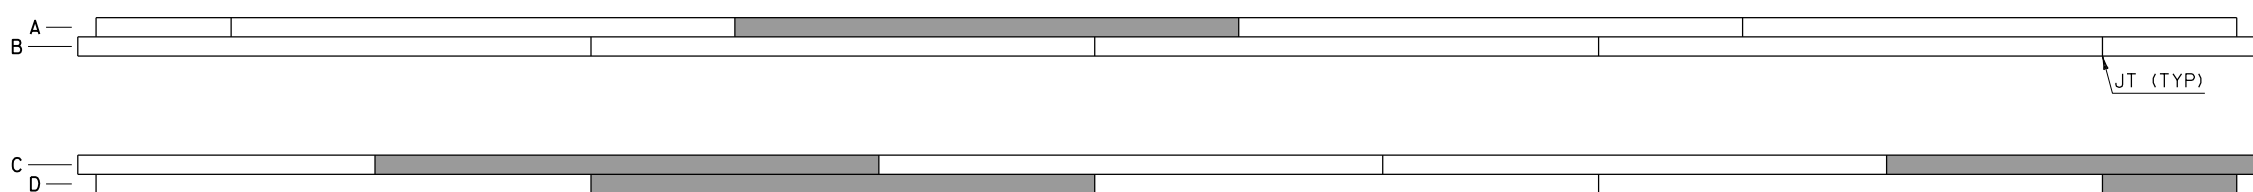
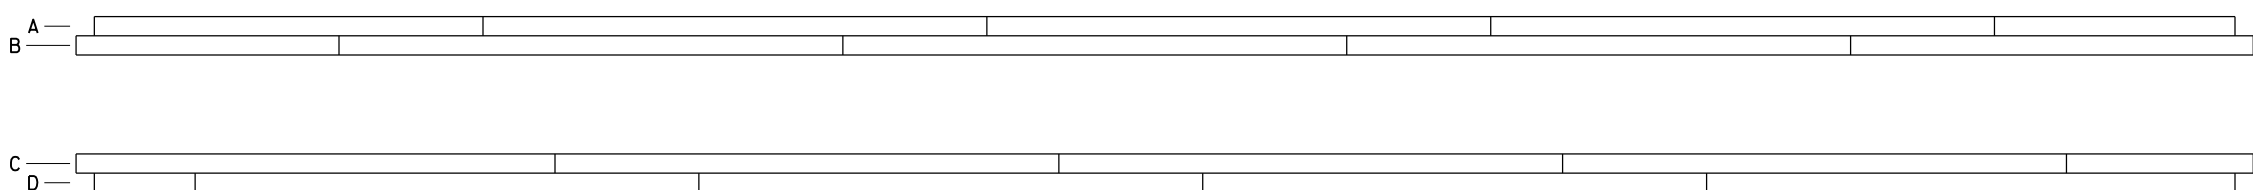
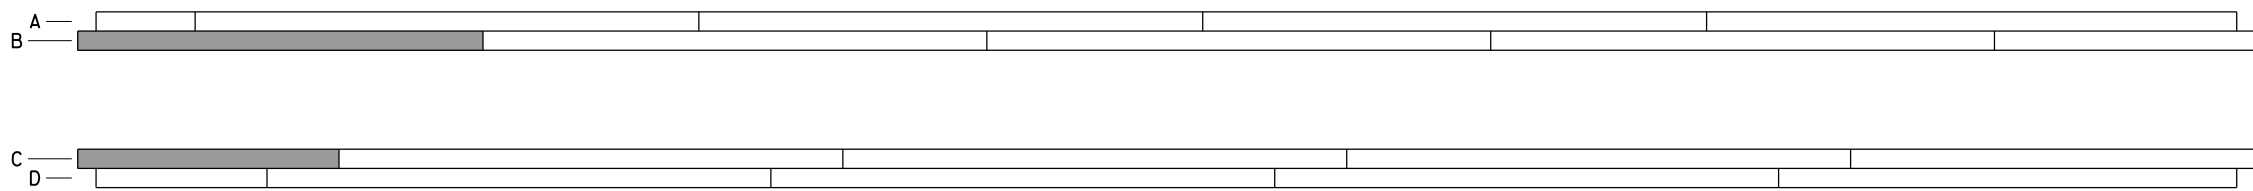
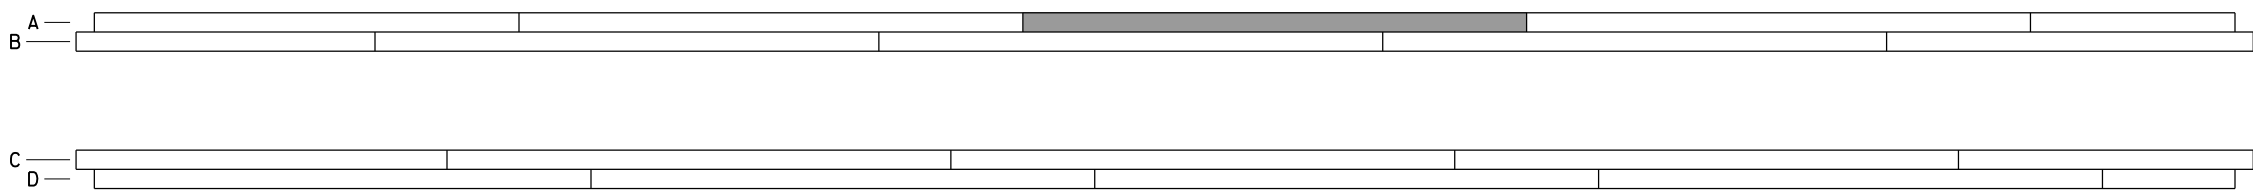
PROJECT NAME:	CLARENDON	FILE NAME:	z19j228sup3.dgn	PLOT DATE:	1/14/2021
PROJECT NUMBER:	BO 1443(55)	PROJECT LEADER:	L.STONE	DRAWN BY:	P.DUSTIN
		DESIGNED BY:	J.RIPLEY	CHECKED BY:	J.BICJA
		WEST TRUSS H3 LIVE LOADING		SHEET	8 OF 15

- Many lattice members are broken, rotted and exhibit through splits and insect damage. Refer to Appendix E sheets 8 and 9 for deteriorated lattice members that were identified in need of replacement due to condition.

- The upper chords exhibit extensive rot and insect damage. Carpenter ants were observed on the upper chord members. Refer to Appendix E sheets 8 and 9 for deteriorated chord members that were identified in need of replacement due to condition. Chord 4, Ply A near midspan is not deteriorated in these drawings, however, its replacement is required with stronger wood species and grade to meet the specified loading.

- The south end of the west (downstream) truss is out of plumb due to extensive rot of the bearing blocks over the south abutment. The upper chord was measured to be out of plane by ¾" over its height of 12".

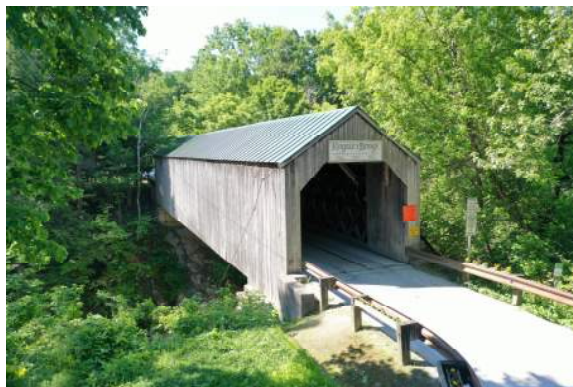
BRACING MEMBERS

Guy wires
not well
anchored

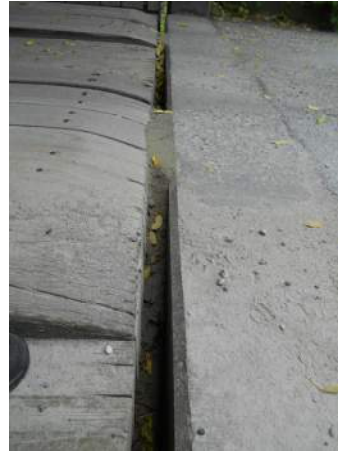
FLOOR MEMBERS

Runners Trap
Debris,
Ramps Each
End

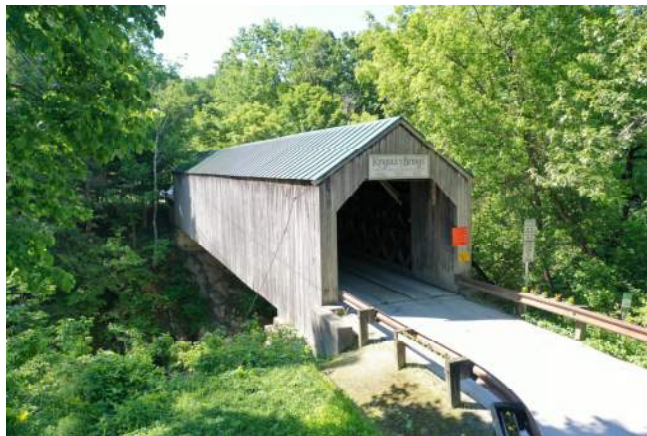
INSPECTION FINDINGS: BRACING MEMBERS

Guy wires
not well
anchored

- Existing Lateral Bracing not Adequate to allow removal of guy wiring.
- Strengthen Crossbeam to Chord connection or
- Add Additional Lateral Bracing Below the Crossbeam

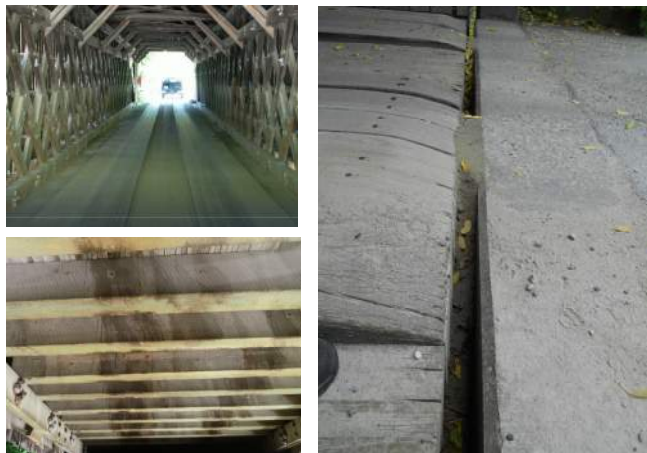
INSPECTION FINDINGS: FLOOR MEMBERS

Runners Trap
Debris,
Ramps Each
End

- Floor Members Include 8"x14" Floorbeams, 2"x6" Nail Laminated Deck and 3" thick Runner Boards
- Floorbeams are Southern Pine and Decking is Eastern Spruce
- Nail Laminated Deck Adequate for H20
- Floorbeams Adequate for H15
- Replace Runner Boards with full width Runners (PT 2)
- No Floorbeam/Deck Replacement or Repair Required

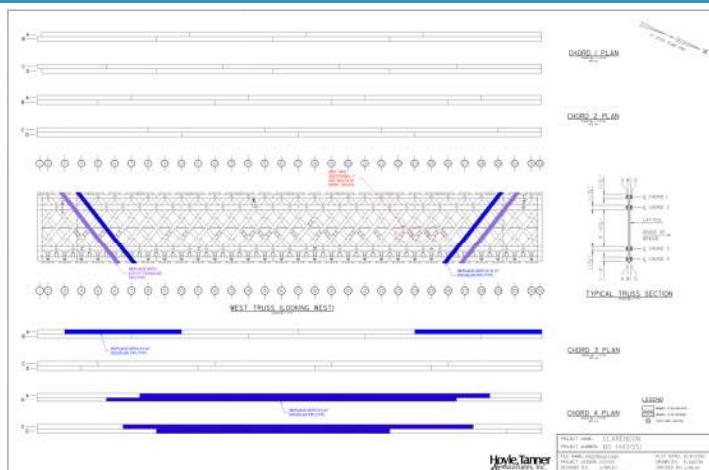
REHABILITATION ALTERNATIVES: H12 WEST TRUSS

Lattice Replacement +7%
Chord Replacement +20%

Blue – Replace due to Strength (PTN 2)
Purple – Replace due to Strength w/Larger Size (PTN 5)

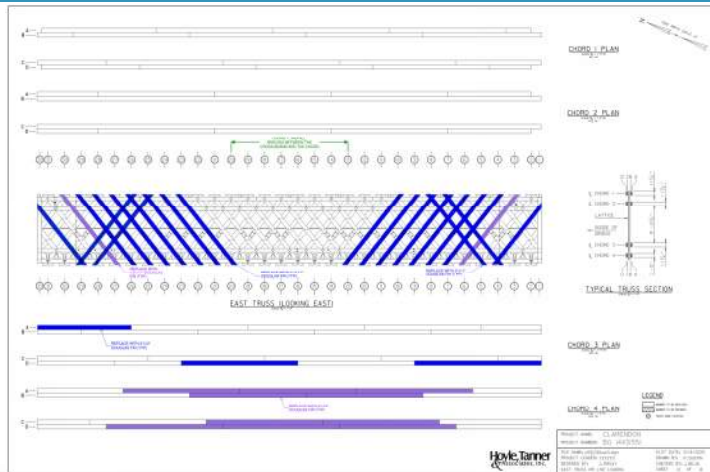
REHABILITATION ALTERNATIVES: HI5 EAST TRUSS

Lattice Replacement +37%

Chord Replacement +19%

Blue – Replace due to Strength (PTN 2)

Purple – Replace due to Strength w/Larger Size (PTN 5)

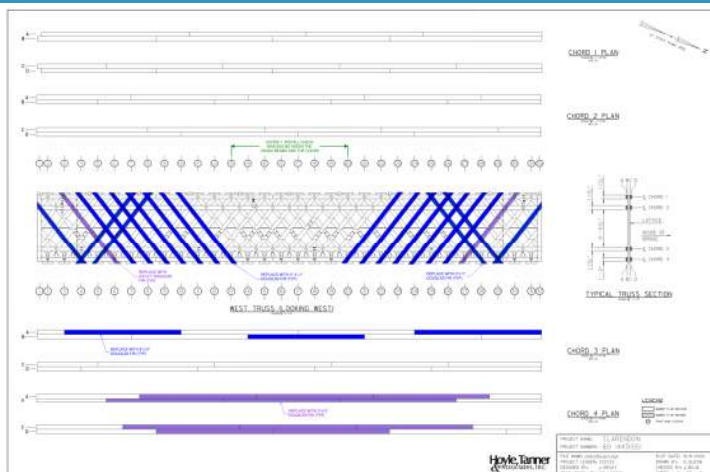
REHABILITATION ALTERNATIVES: HI5 WEST TRUSS

Lattice Replacement +37%

Chord Replacement +21%

Blue – Replace due to Strength (PTN 2)

Purple – Replace due to Strength w/Larger Size (PTN 5)

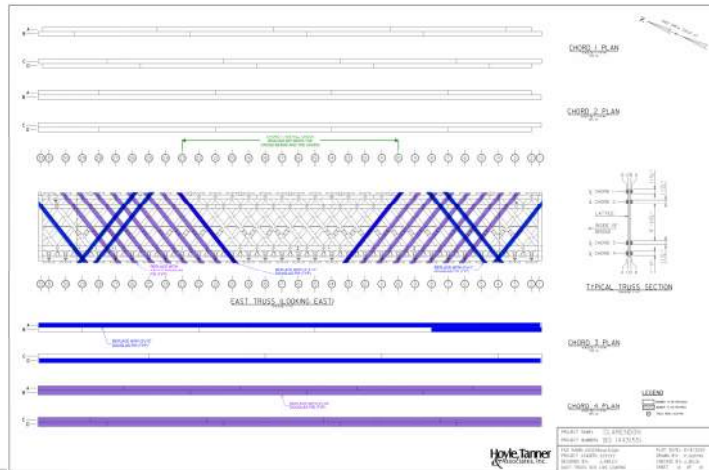
REHABILITATION ALTERNATIVES: H20 EAST TRUSS

Lattice Replacement +37%

Chord Replacement +39%

Blue – Replace due to Strength (PTN 2)

Purple – Replace due to Strength w/Larger Size (PTN 5)

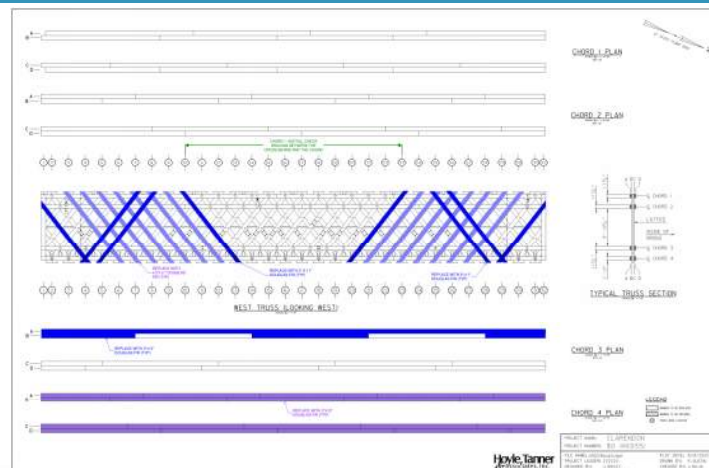
REHABILITATION ALTERNATIVES: H20 WEST TRUSS

Lattice Replacement +37%

Chord Replacement +41%

Blue – Replace due to Strength (PTN 2)

Purple – Replace due to Strength w/Larger Size (PTN 5)

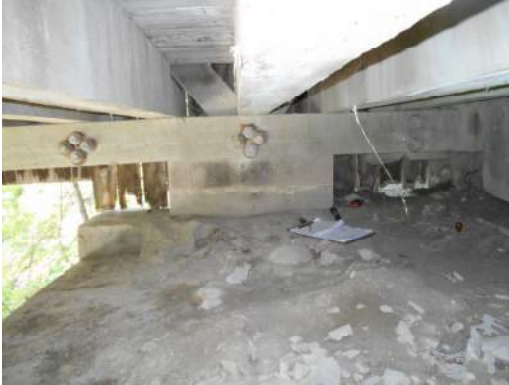
Existing Bearing Blocks

There are large (1 1/4") gaps in the lattice splices. Several lattice members have split ends. A considerable amount of rot was noticed and generally that indicates there is more rot in areas not visible. There is some racking and twisting of the top chord, with rot and insect damage present. The bearing timbers are rotted with some settlement of the truss evident.
