Local Concerns Meeting

Windsor BF 0113(88)

Bridge 55

US 5 over Mill Brook

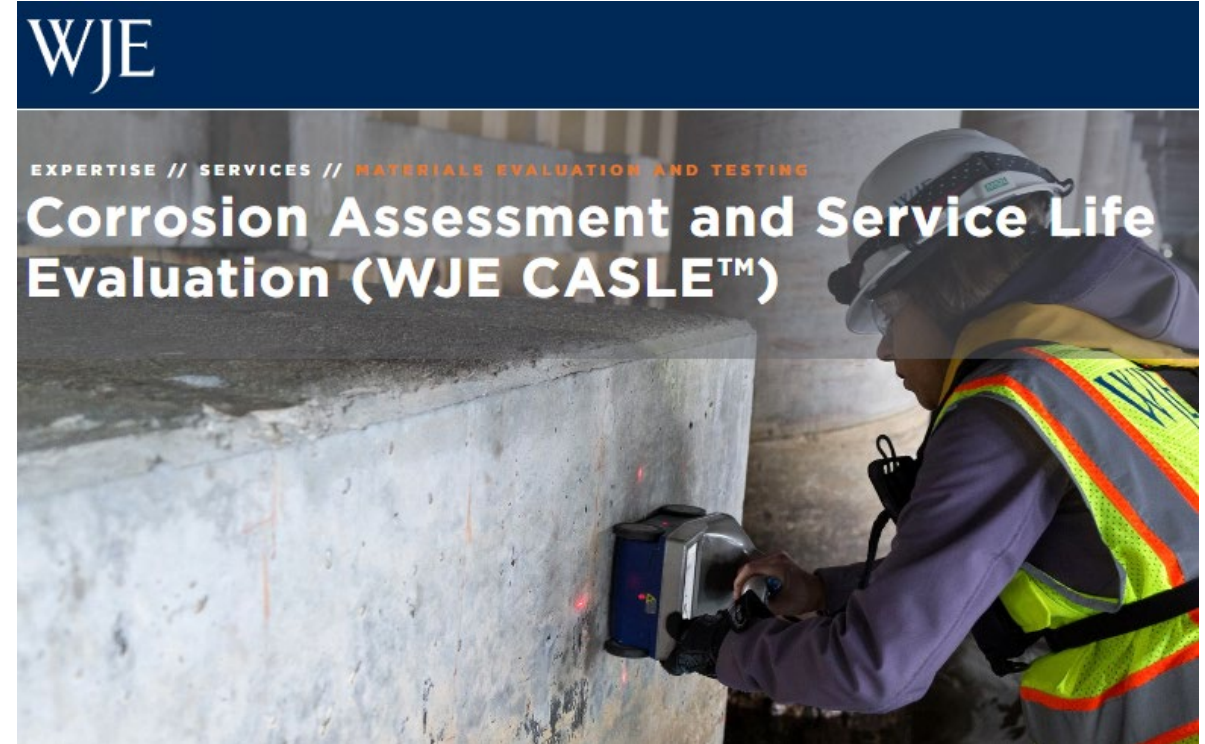
2024 In-depth Condition Assessment

- Chloride diffusion numerical model
- Carbonation propagation numerical model
- Empirical modeling (freeze-thaw, etc.)

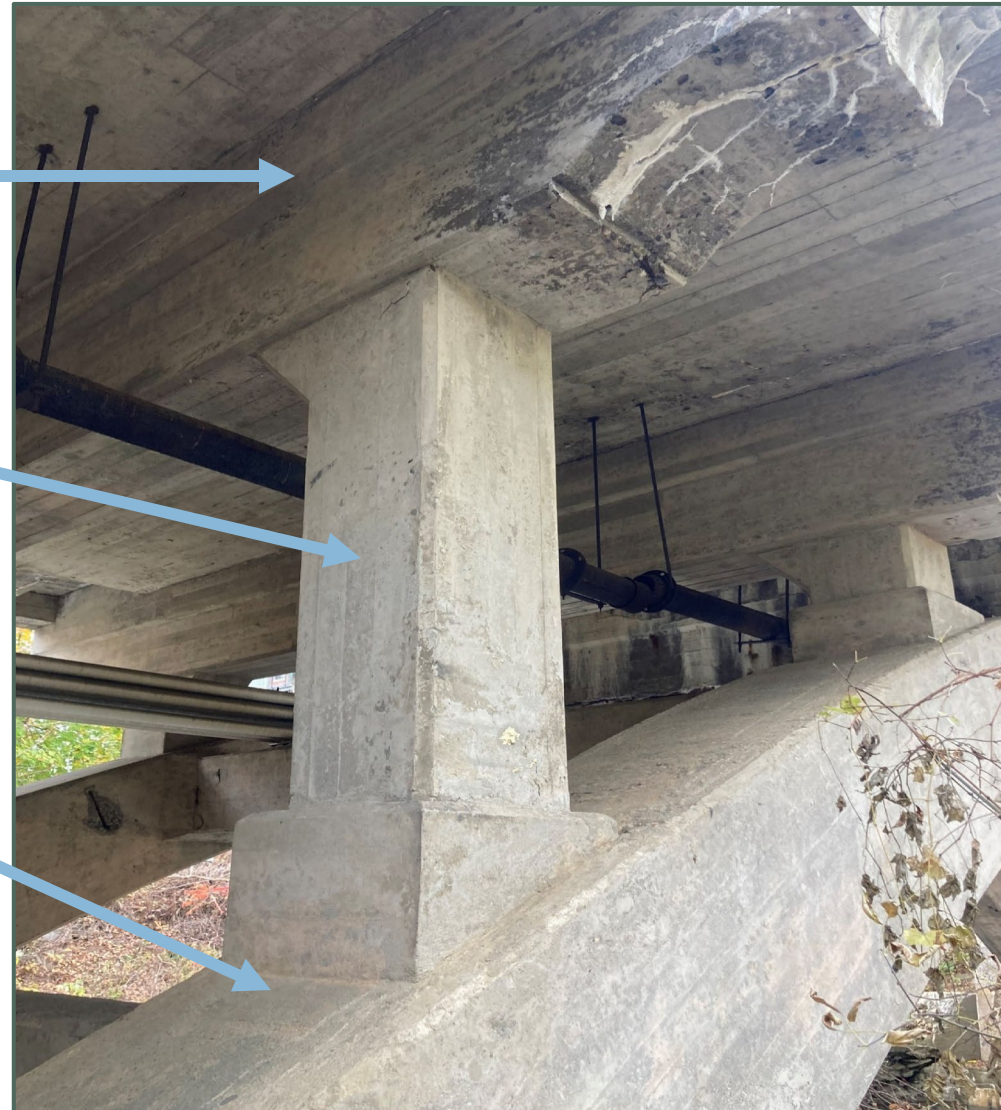
Existing Conditions – Primary Load Components

- Floor Beams

- Spandrel Columns

- Arch Ribs

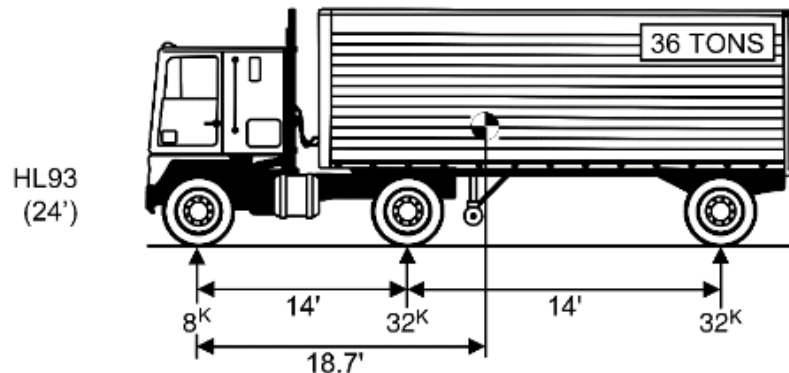
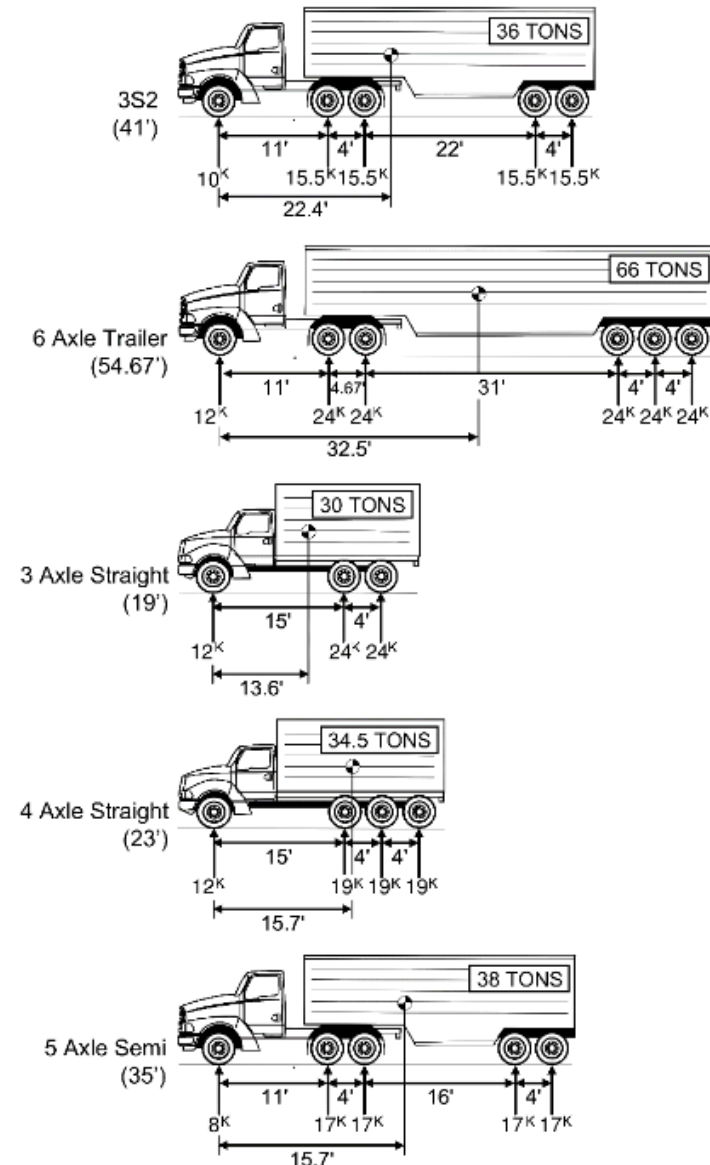
Existing Conditions – Load Carrying Capacity

- An evaluation of all members was completed for 3 types of vehicle loading:
 - *HL-93 Design Loading*
current design standard for new structures
 - *Legal Loads*
routine commercial traffic
not requiring overload permits
 - *SHV and EV Loading*
Specialized Hauling Vehicles (construction, utility)
and Emergency Vehicles

- Several members do not meet HL-93 Design loading
 - Deck, floorbeams, some locations in the arches
 - Not unexpected for historic bridges
- The deck and some floorbeams do not meet legal, SHV or EV loading
 - These members should be replaced
- Alternatives evaluation will consider the capacity of the existing members that are to remain
