Draft Scoping Report Upper Cox Brook Covered Bridge Town Highway 3 Bridge 10 over Cox Brook

Northfield BO CVBR(7)

January 24, 2026

Prepared for:
Vermont Agency of Transportation

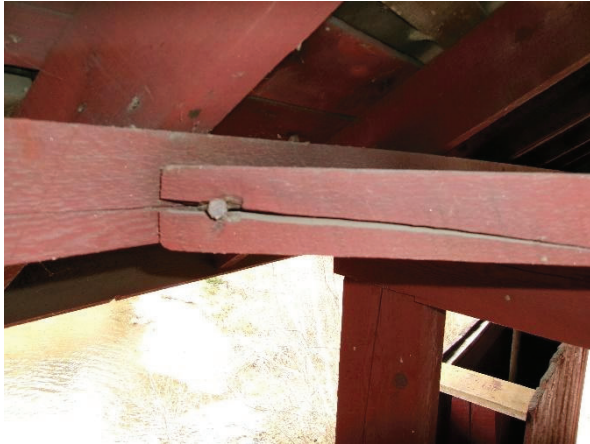
Split in Cross Beam

- Two cross beams exhibit splits. One of the split cross beams is also broken at a connection to a diagonal bracing member.
- Cross beams have been previously damaged from oversized vehicles and are not well connected to the vertical truss members.
- Some of the steel knee braces on the east truss have moderate section loss.

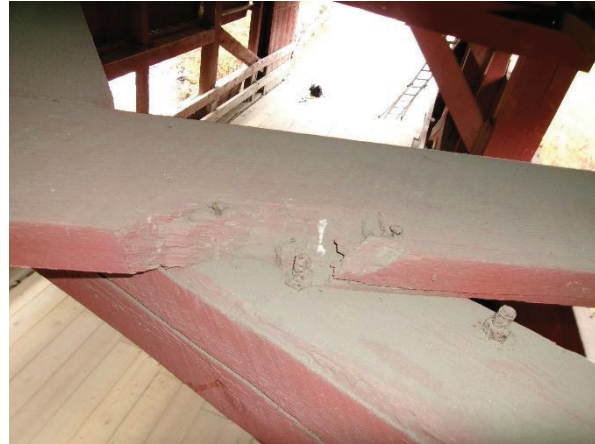
Broken Connection at Cross Beam and Diagonal

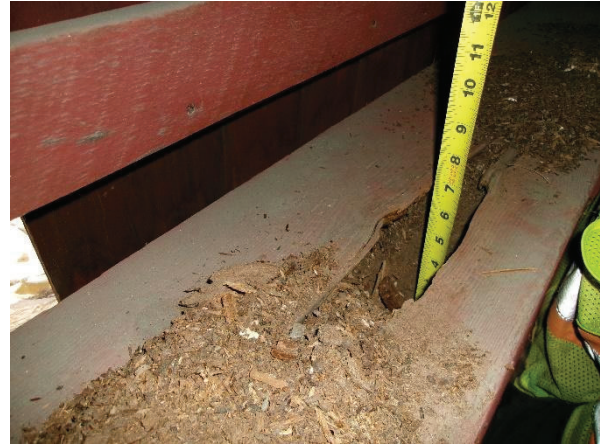
- The top chord of the east truss exhibits extensive rot and needs replacement due to its deteriorating condition. Refer to Appendix E for deteriorated chord members that were identified in need of replacement due to condition.
- The top chord of the west truss is in satisfactory condition with no deficiencies noted at the time of inspection.

East Truss Top Chord Rot

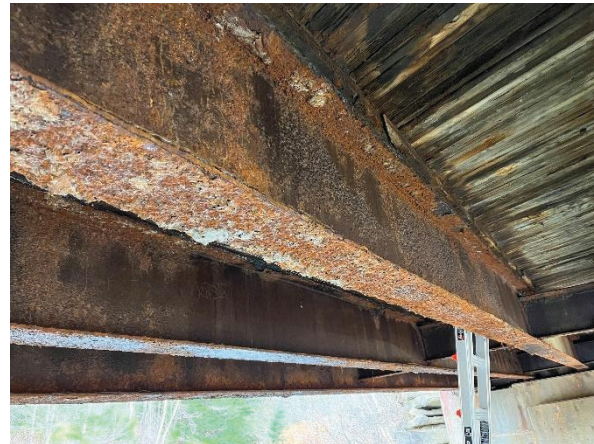
Interior Beam Rusting

- The runner boards are in good condition.
- The flanges are clipped at the abutments to accommodate the skewed centerline of bearing.
- The exterior beam on the west side (B1) has areas of section loss at the north abutment and at midspan that has been repaired using steel plates. The plate at the abutment does not appear to be welded. There is section loss up to ⅛" along the bottom flange for the entire length of the beam.

- The western interior beam (B2) has heavy laminar corrosion at both faces of the bottom flange along the entire length of the beam. There is a hole in the web at the south abutment up to 18" wide x 4" tall.

- The eastern interior beam (B3) has heavy laminar corrosion at both faces of the top and bottom flanges along the entire length of the beam.
- The exterior beam on the east side (B4) has areas of section loss at the north abutment up to ⅛" and has heavy laminar corrosion at both faces of the top and bottom flanges along the entire length of the beam.

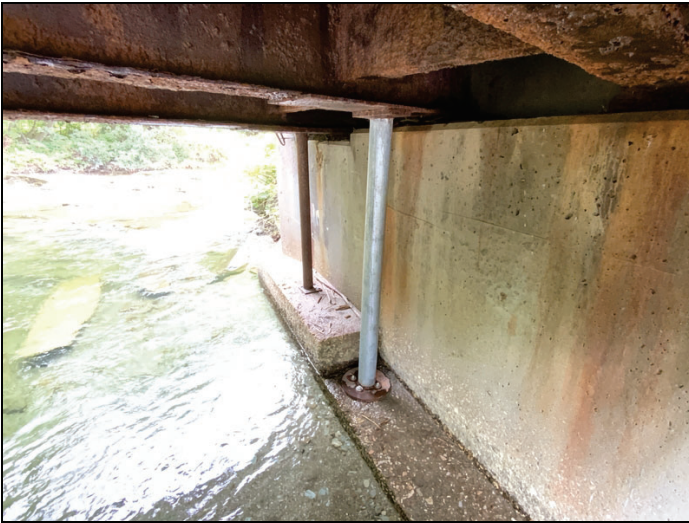
Abutment 2 beam ends

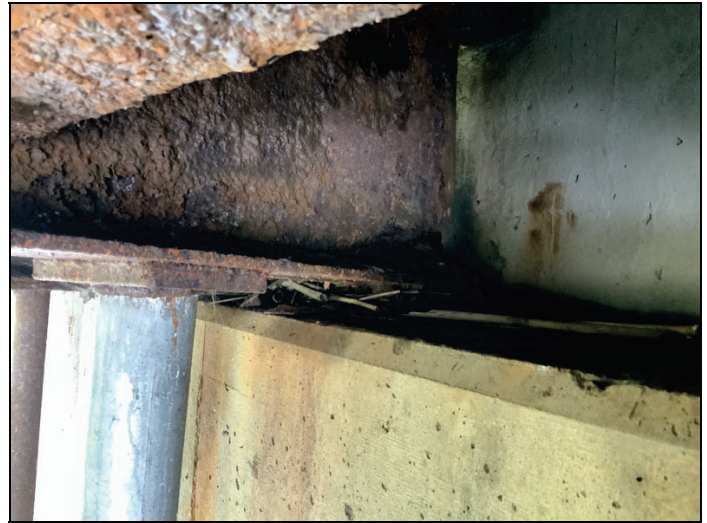
Beam 2 abutment 2 end

Rust scale and deep pitting throughout with moderate section loss. The grease coating has bubbled and is no longer adhered to much of the surface area of the beams allowing for saturation to stay trapped along the now bare steel. Beams 1 and 2 have had steel plate repairs made in the past and there is a steel post support under beam 1 where the beam previously had crushed. An additional steel post has been installed under beam 2 as there is visible crushing in the beam end over the bearing.

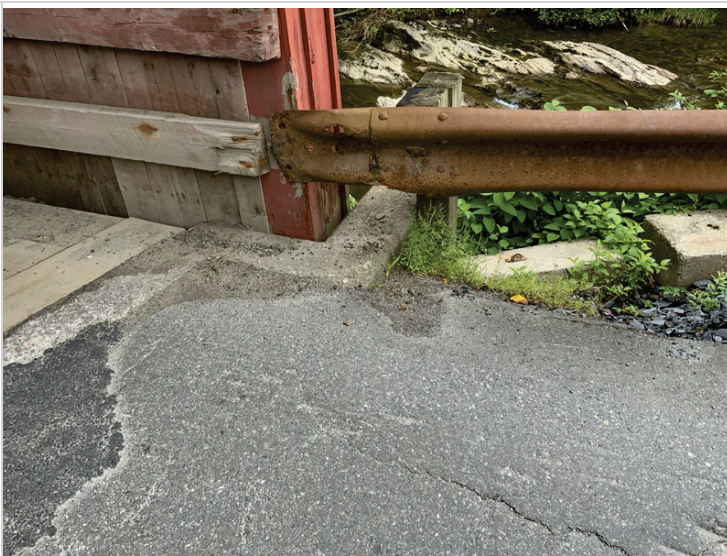
Heavy rust scale and section loss with varying sized perforations at the connecting bridge ends in the abutment 2 rails and upstream abutment 1 rail.

Abutment 2 transition rail

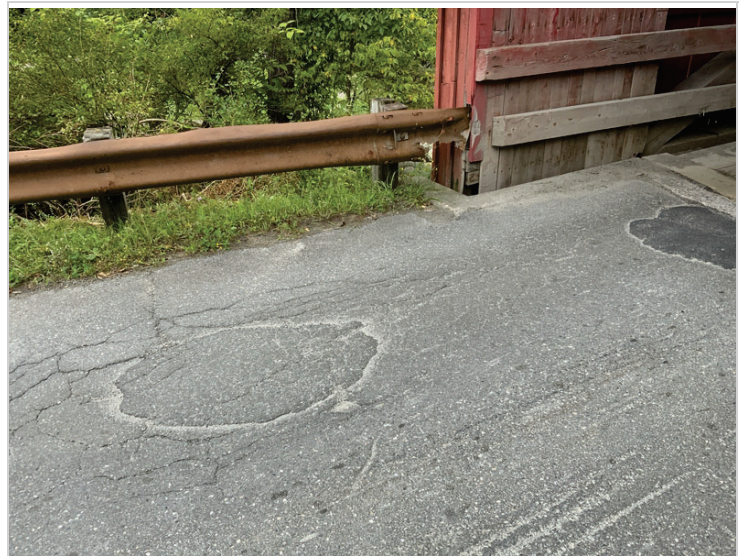
Abutment 2 transition rail

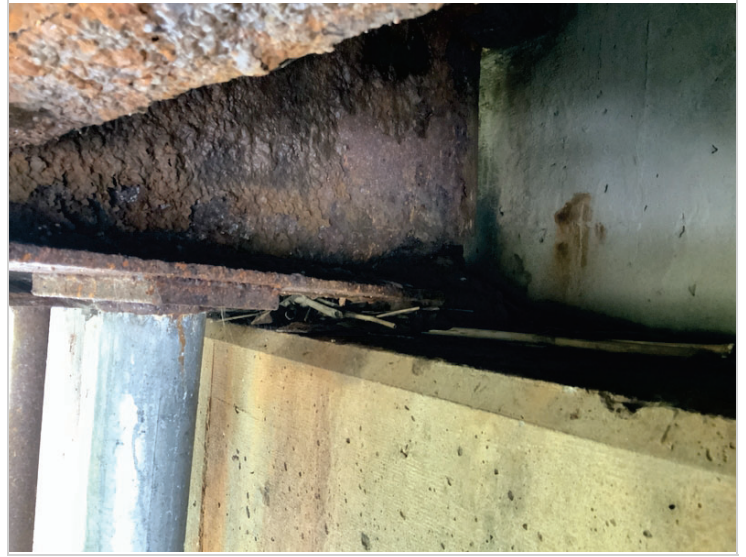
Beam 2 abutment 2 end

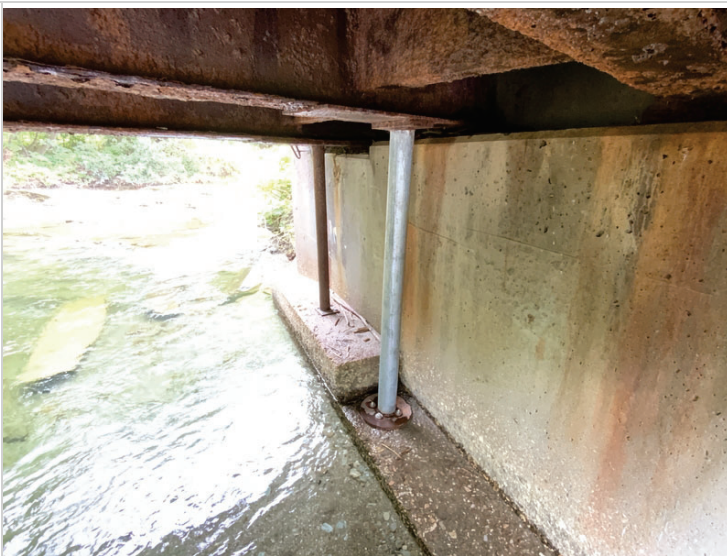
Beam 2 abutment 2 end
