# Draft Scoping Report Lower Cox Brook Covered Bridge Town Highway 3 Bridge 11 over Cox Brook

Northfield BO CVBR(8)

**January 24, 2026**

Prepared for:  
Vermont Agency of Transportation

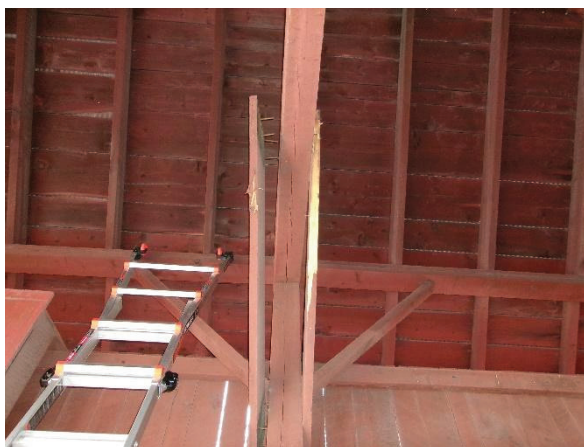
- The upper lateral bracing members exhibit splits, breaks, rot, and impact damage.
- The crossbeams have been hit by vehicles, causing impact damage and breaking the connection between the crossbeams and knee braces.
- The knee braces have been damaged from oversized vehicles, and some are not connected to the crossbeams or truss members.

Broken Connection at Crossbeam and Knee Brace

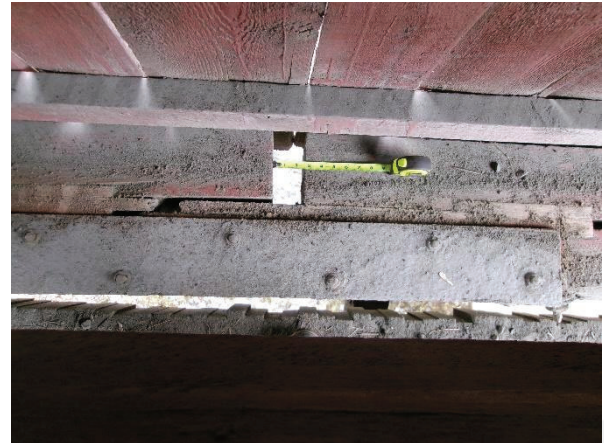
- There were no deficiencies noted at the time of inspection at bottom chord of the north truss.
- There is checking in the bottom chord of the south truss between nodes 5 and 6.
- There is a large gap of 2½" in Ply A of the bottom chord of the south truss at the splice location. Ply B is broken at the splice location, and the broken chord at Ply B has been repaired with an L-shaped steel plate and several bolts connecting both sides.

South Truss Splice at Bottom Chord

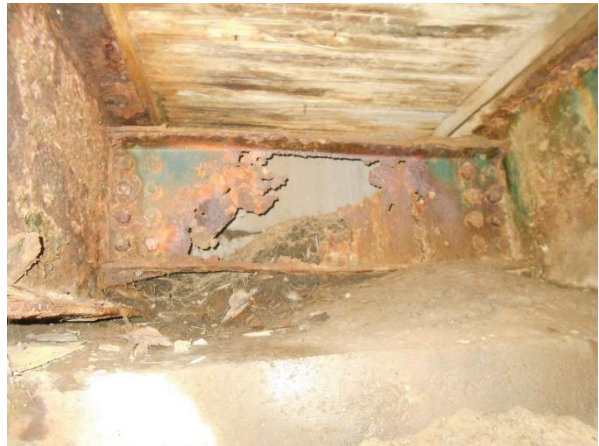
- The diaphragm between the northern interior and exterior beams (B3 and B4) at the east abutment has 100% section loss.
- The exterior beams had section loss that reduced flange thickness to  $\frac{7}{16}$ " typical, with isolated areas only  $\frac{3}{8}$ " thick. The top flange also had areas of section loss with a flange thickness of  $\frac{1}{2}$ " throughout. The webs were in fair condition with some areas of rust and section loss. By inspection, it appears the web had approximately  $\frac{1}{16}$ " section loss on both sides of the web.

100% Section Loss in Diaphragm

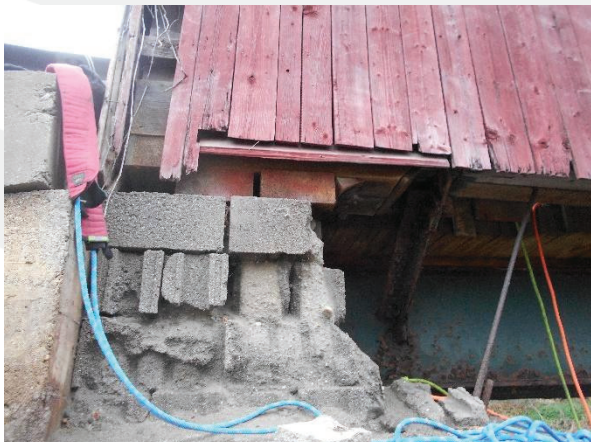
- The wooden bearing blocks exhibit heavy rot and decay at each end of the bridge.

- The wooden bearing blocks exhibit extensive rot and need to be replaced.
- The CMU blocks are in poor condition and need to be replaced.

Timber Bearing and CMU Blocks

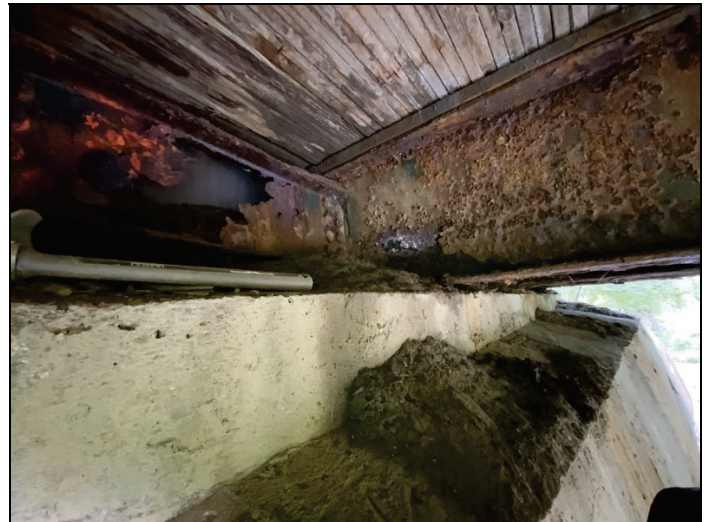
Steel repairs are needed

Abutment 2 beam ends

A project to clean and paint the beams should be considered as section loss in the beams continues increase.

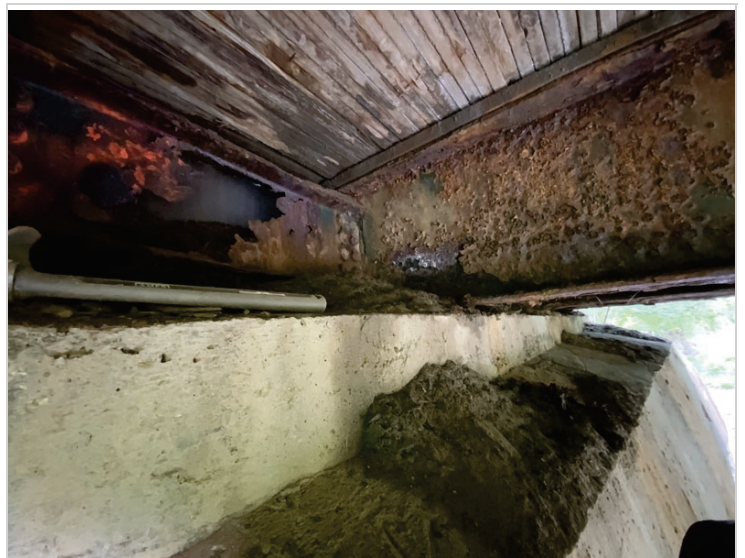
Rust scale throughout with moderate to heavy section loss. Areas of deep pitting in the surrounding area of the angled bracing support of the covered bridge in the fascia beams. The beam ends remain heavily saturated due to the gravel build up on the bridge seats resulting in heavy section loss. Typical section remaining in the beam ends (extending out beyond the bridge seat) along the flanges is 3/8" +/- and 1/4" +/- in the lower area of the web.

Abutment 2 beam ends

This structure should be considered for a paint project with extensive cleaning of the beams. Steel repairs are needed as well as channel beam diaphragms have extensive section loss and some members have failed. Further section loss in the abutment beam ends will result in more steel repairs or full replacement.

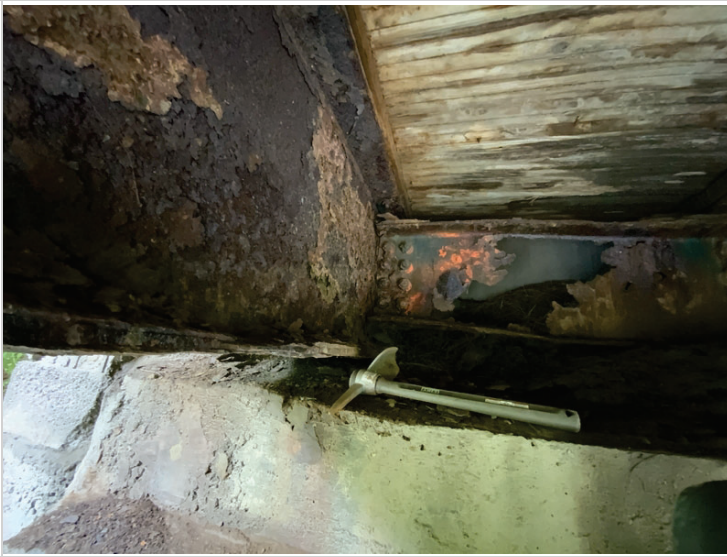
Beam 1 abutment 2 end

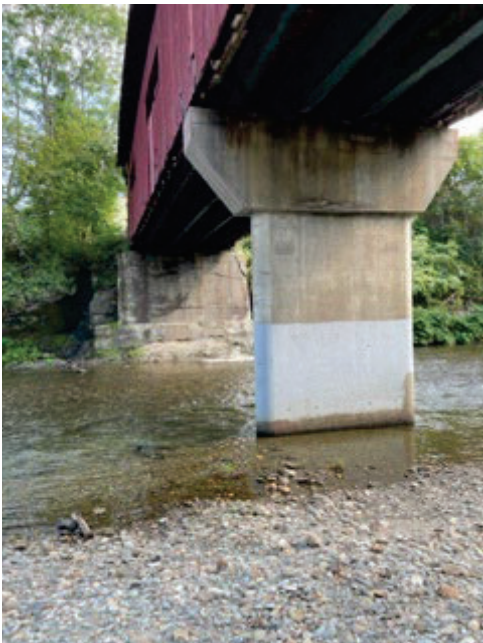
The underside of bridge 11. Taken 9/6/2023
