# Draft Scoping Report Northfield Falls Covered Bridge Town Highway 3 Bridge 15 over Dog River

Northfield BO CVBR(9)

**January 24, 2026**

Prepared for:  
Vermont Agency of Transportation

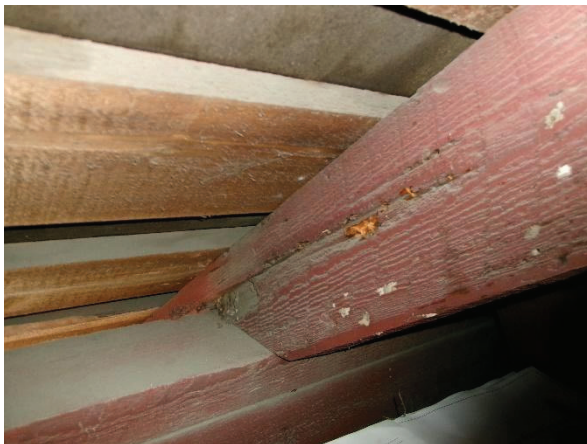
Split in Rafter

- The metal roof is in fair condition.
- The rafters exhibit spits, breakage, and dry rot throughout. Some split and broken members have been sistered to new members.
- The rafter support beam exhibits rotting in few locations.
- The roofboards are overall in satisfactory condition with some splits.
- The siding boards exhibit areas of faded paint. The siding is in good condition; however, removal and replacement will likely be required to provide access for the extensive truss member replacements.

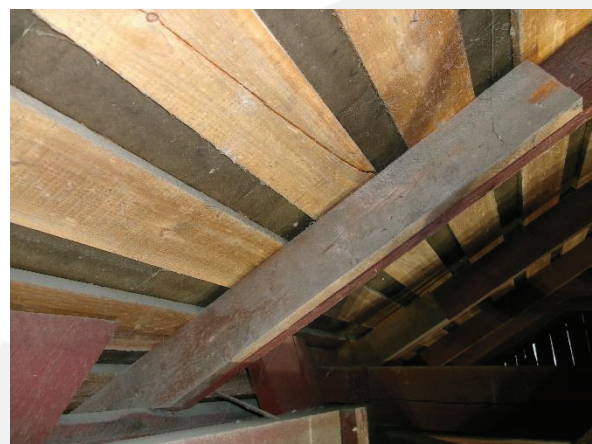
Split in Roofboard and Spliced Rafters

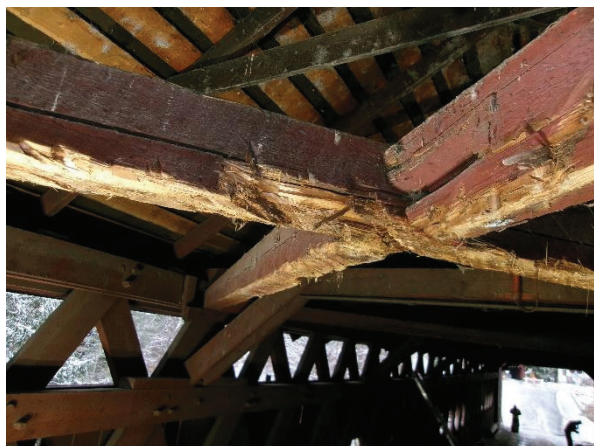
Impact Damage in Diagonal Bracing

- The cross beams exhibit significant impact damage from vehicles and dislodged and twisting in one location.
- Diagonal bracing members exhibit significant impact damage from vehicles, breakage, twisting and multiple are missing.
- Crossbeams have been previously damaged from oversized vehicles and are not well connected to the vertical truss members.
- The knee braces exhibit significant impact damage from vehicles and breakage.

- Replace all diagonal braces in-kind (PTN 2)
- Replace 1 crossbeams (11%) in-kind (PTN 2)
- Repair knee brace connections (PTN 1)

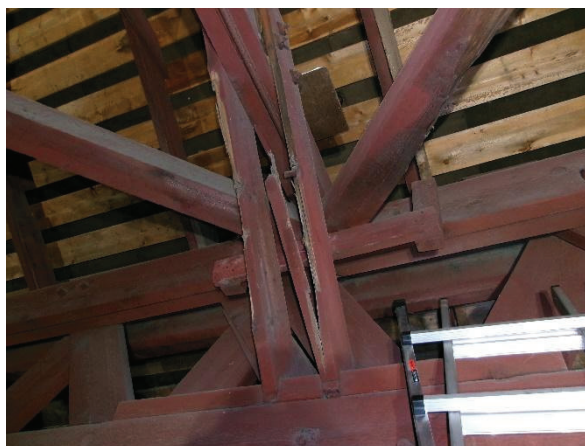
Broken Connection at Crossbeam and Knee Brace

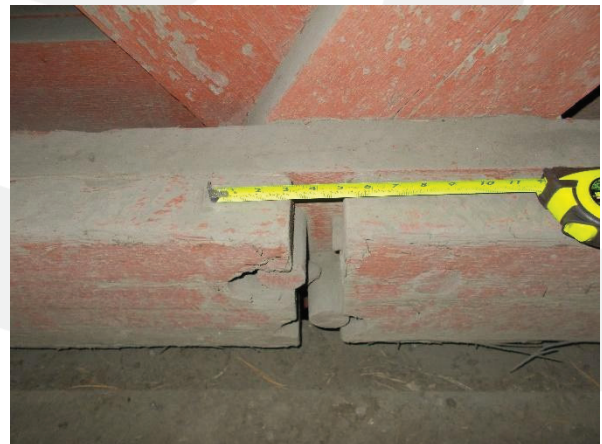
Gap in Chord 3 at Trunnels

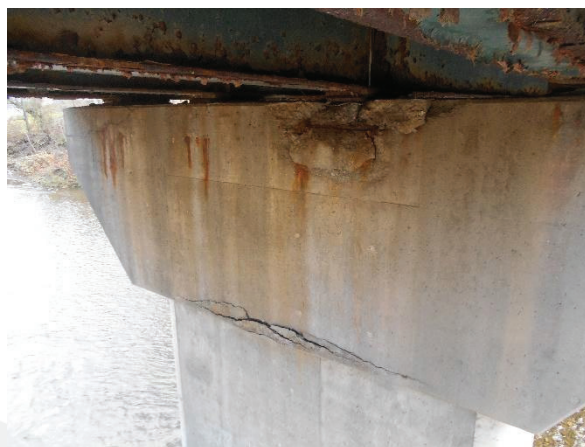
Concrete Spalling at Stringers Bearings

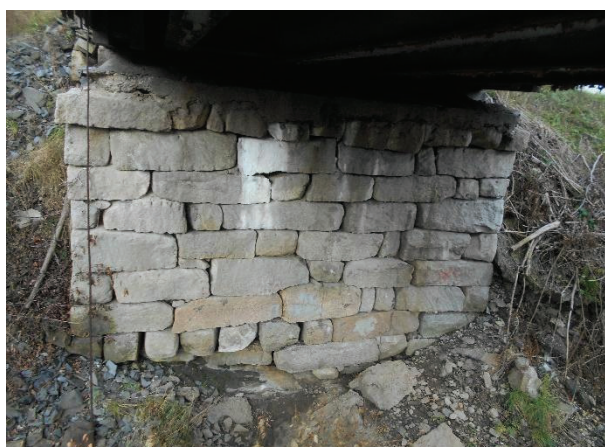
West Abutment Elevation

- The east abutment exhibits significant concrete spalling, efflorescence staining, delamination, and vertical, horizontal, and map cracking. The southeast beam seat corner has a large spall, and the concrete is coming loose from the structure. The concrete appears to be of poor quality with large round aggregates used.
- The west abutment masonry exhibits voids up to 5' deep. The concrete beam seat cap concrete has significantly deteriorated.
- The southwest wingwall is comprised of dry laid stacked stones which have failed, and the wall is no longer vertical.
- At the spalled areas, the concrete was observed to contain round river stones with no fractured faces, which significantly reduces the concrete strength and durability.
- The east abutment is in poor condition and needs to be replaced. The west abutment beam seat and backwall is in poor condition and needs to be replaced.

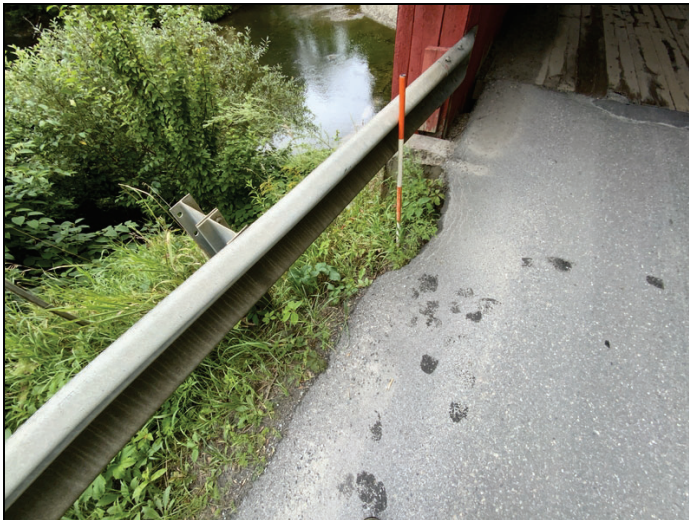
Upstream abutment 1 shoulder area

**Deficiency Description**

A means of retaining the approach roadway should be considered with added roadway fill.

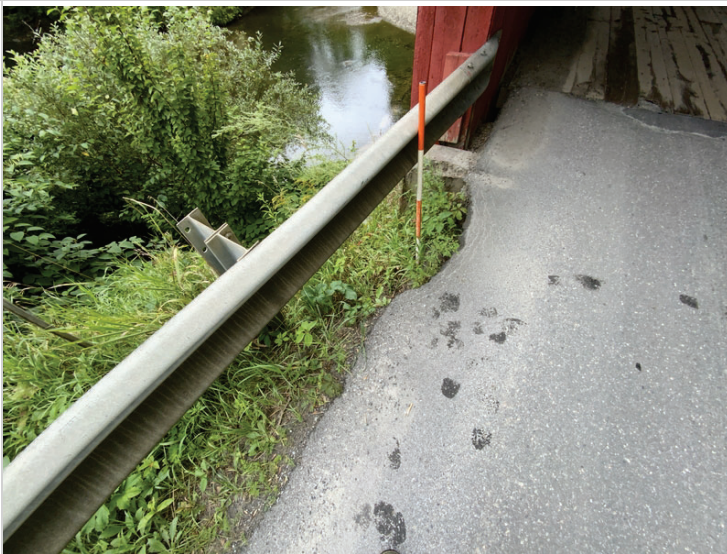
Upstream abutment 1 shoulder area

Abutment 1 Lineal cracking along the pour joints and scattered vertical shrinkage cracks with minor separation throughout. The ends have map cracking with minor efflorescence staining and minor to moderate spalling in the base. The upstream end has a segmented corner section that has failed revealing laid up granite block behind it.
