STATE OF VERMONT  
AGENCY OF TRANSPORTATION

**Scoping Report**

FOR  
**STATEWIDE NORTHWEST STP CULV(90):  
ESSEX VT ROUTE 2A BR #11**

**VT ROUTE 2A, BRIDGE 11 OVER UNNAMED BROOK**

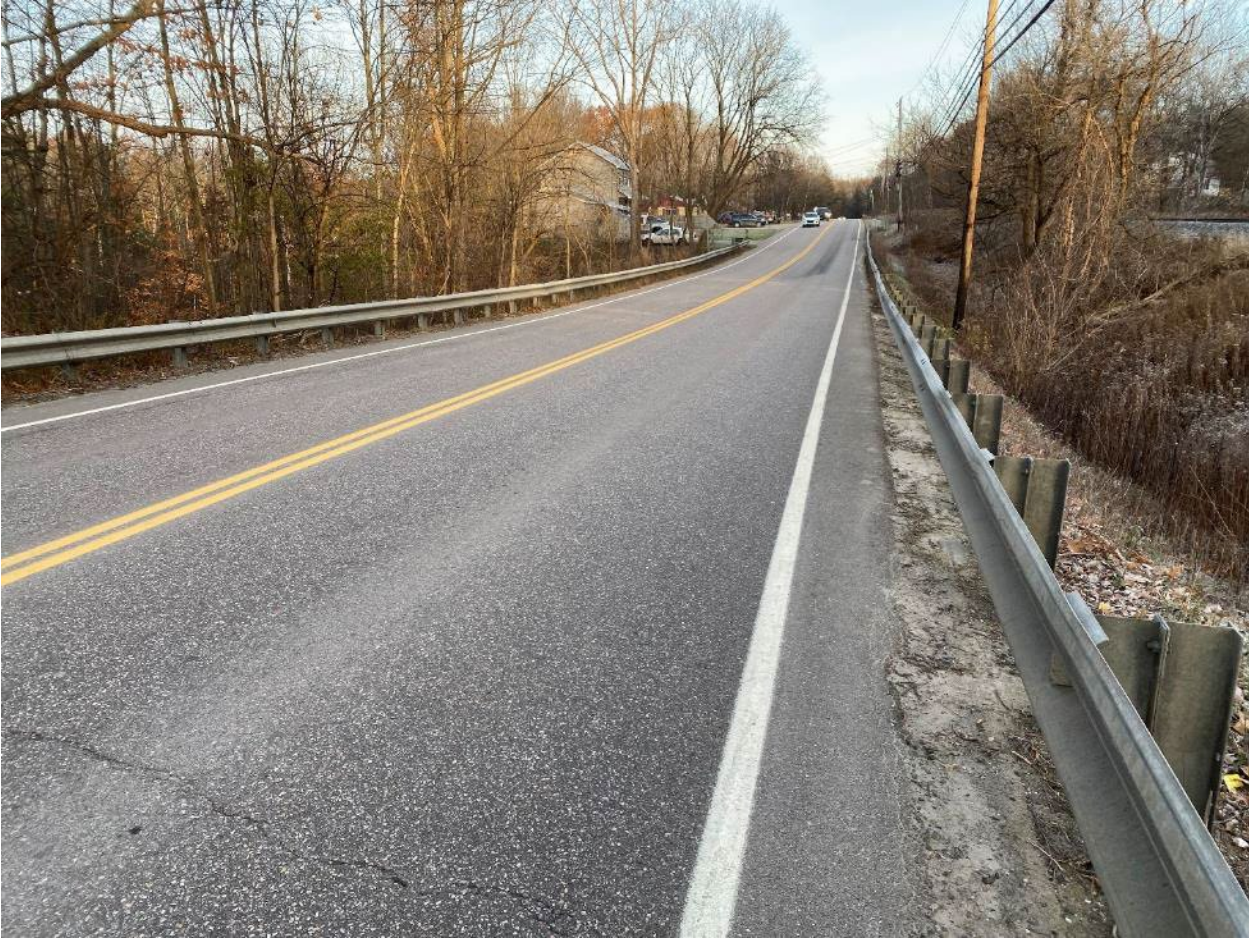
Looking North on VT Route 2A over Bridge 11 (Inspection photo 2021)

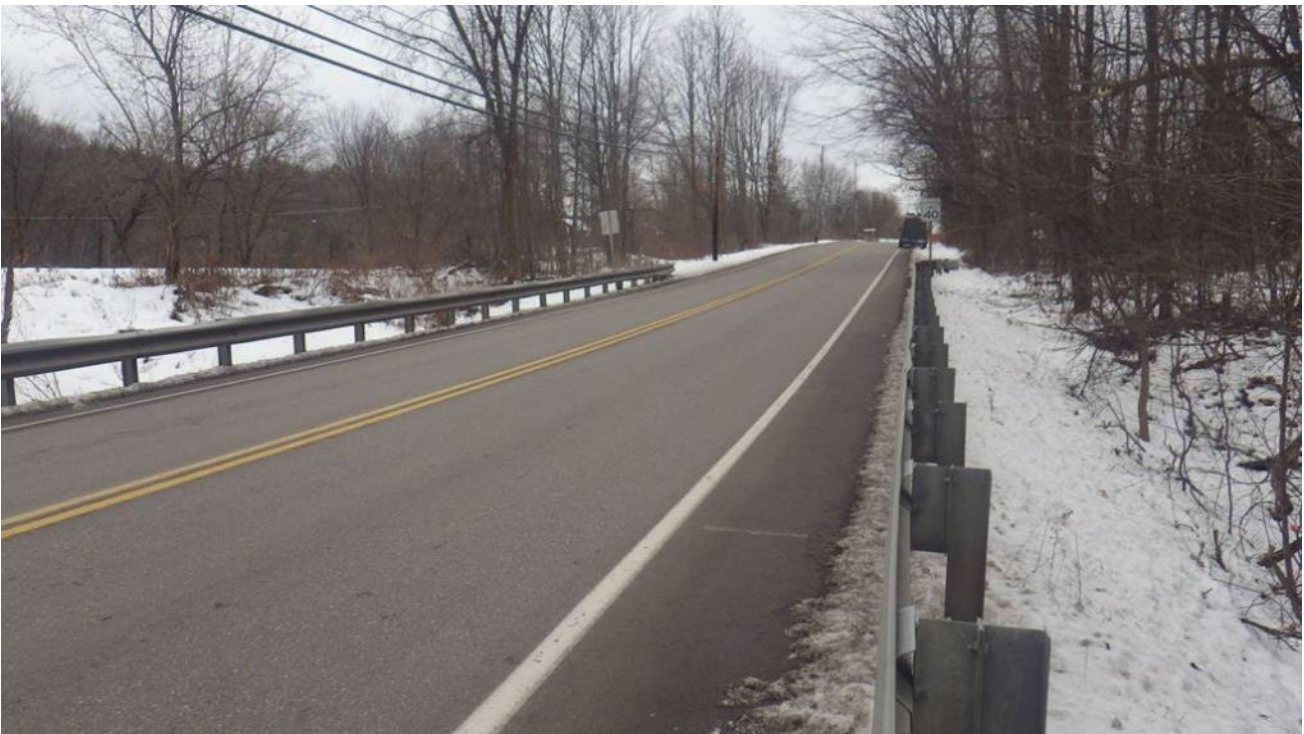
Looking South on VT Route 2A over Bridge 11 (Inspection photo 2021)

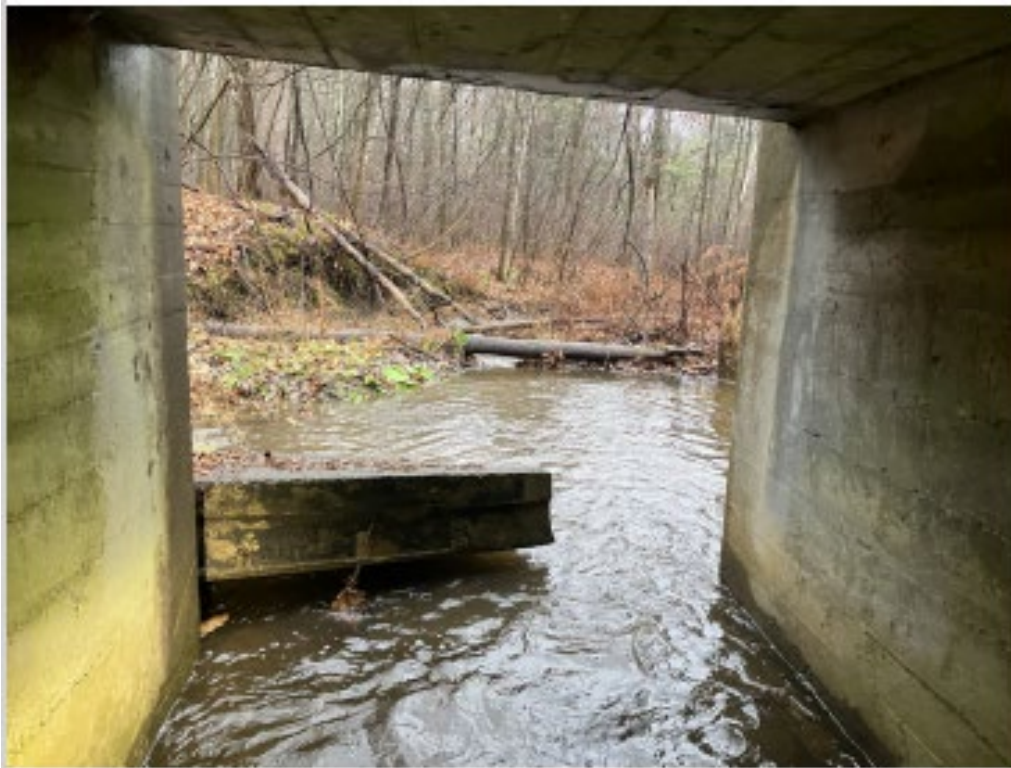
Downstream End of Culvert (Inspection photo 11/28/2022)

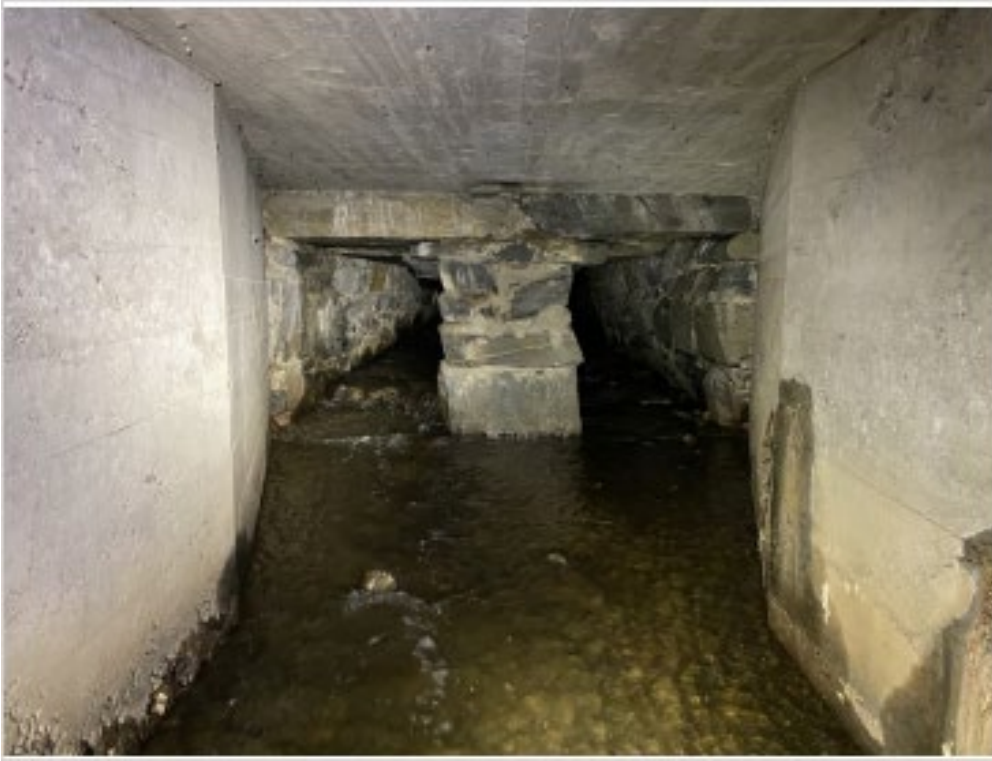
Upstream End of Box Culvert, connection point of laid up stone box culvert section underneath the New England Central Railroad (Inspection photo 11/28/2022)

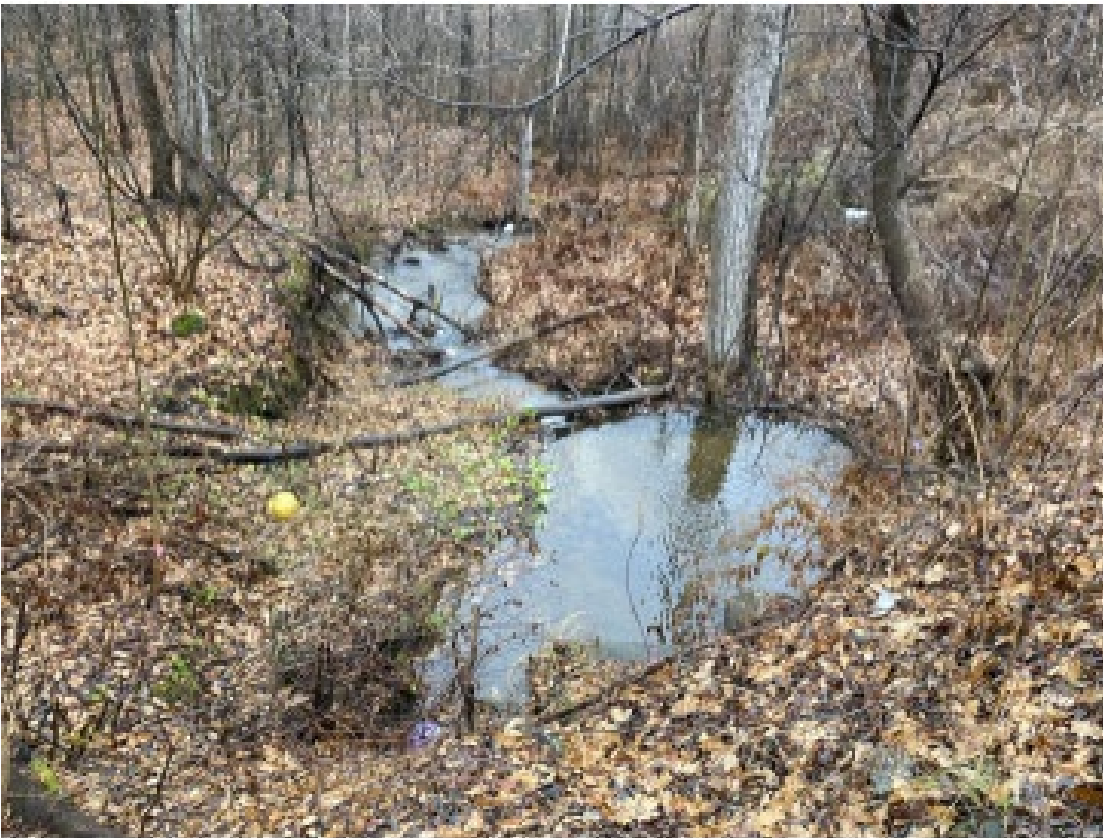
Downstream Channel (Inspection photo 11/28/2022)

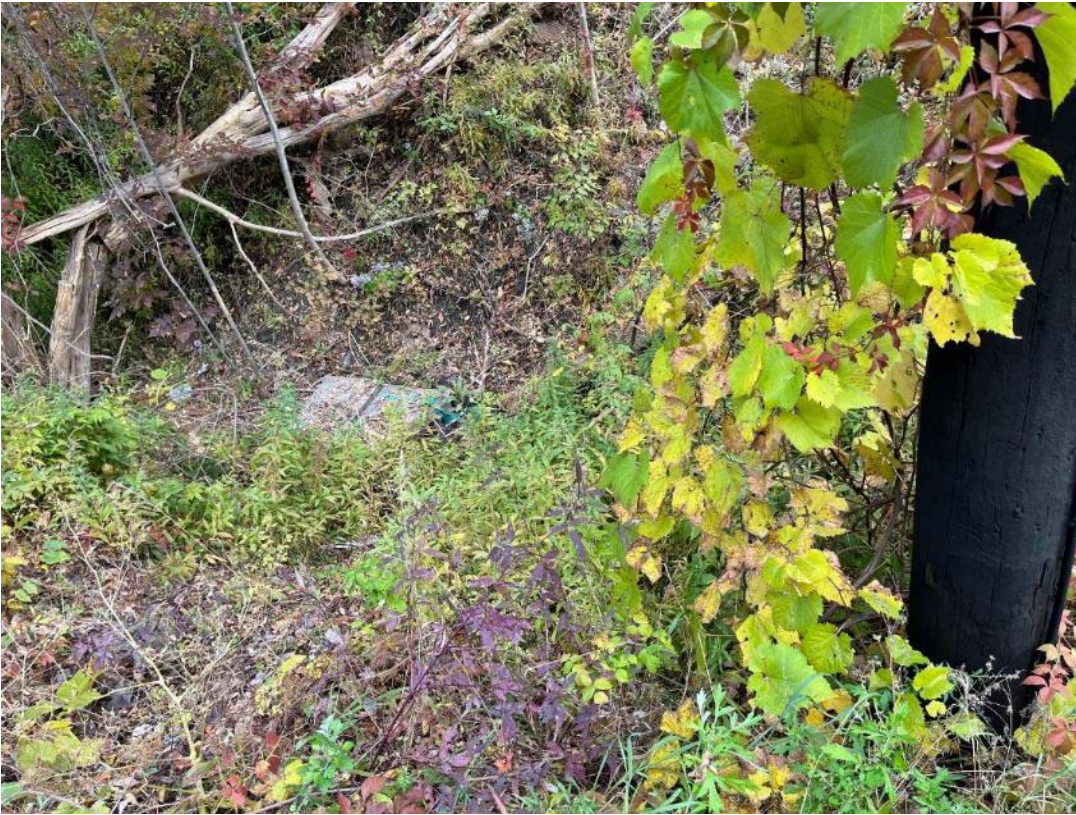
Drop Inlet into structure in median of VT Route 2A and NEC RR

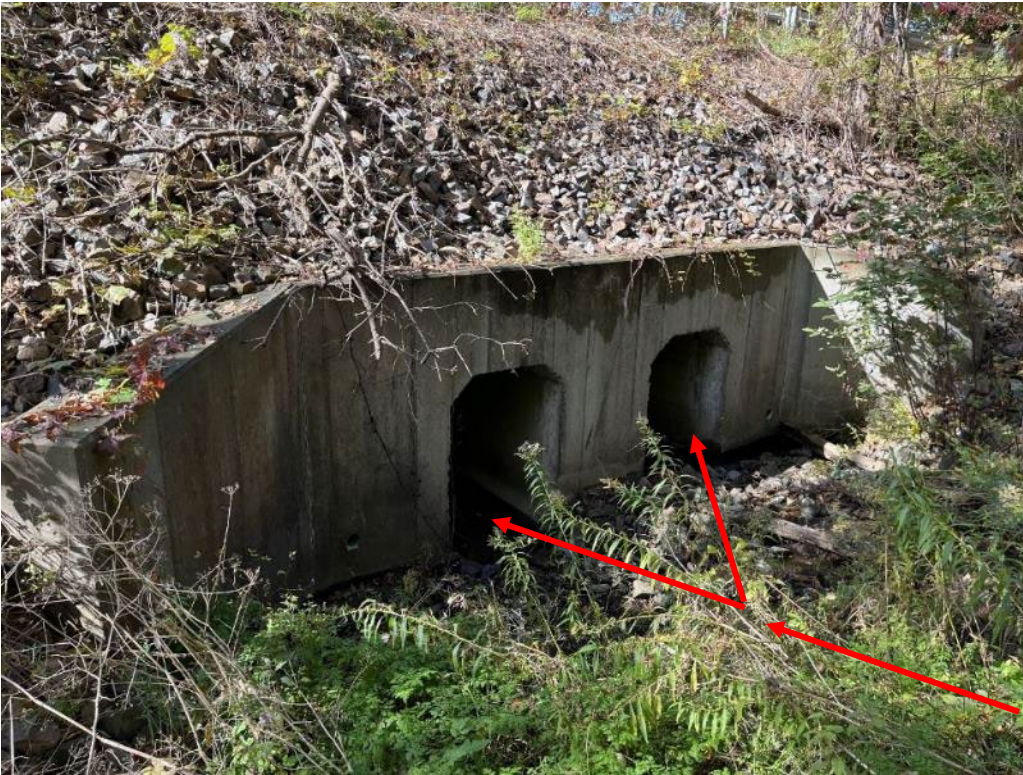
Frankenstein structure inlet from TH-24 (true inlet, first section, of 3-part structure) (red arrows show direction of flow)

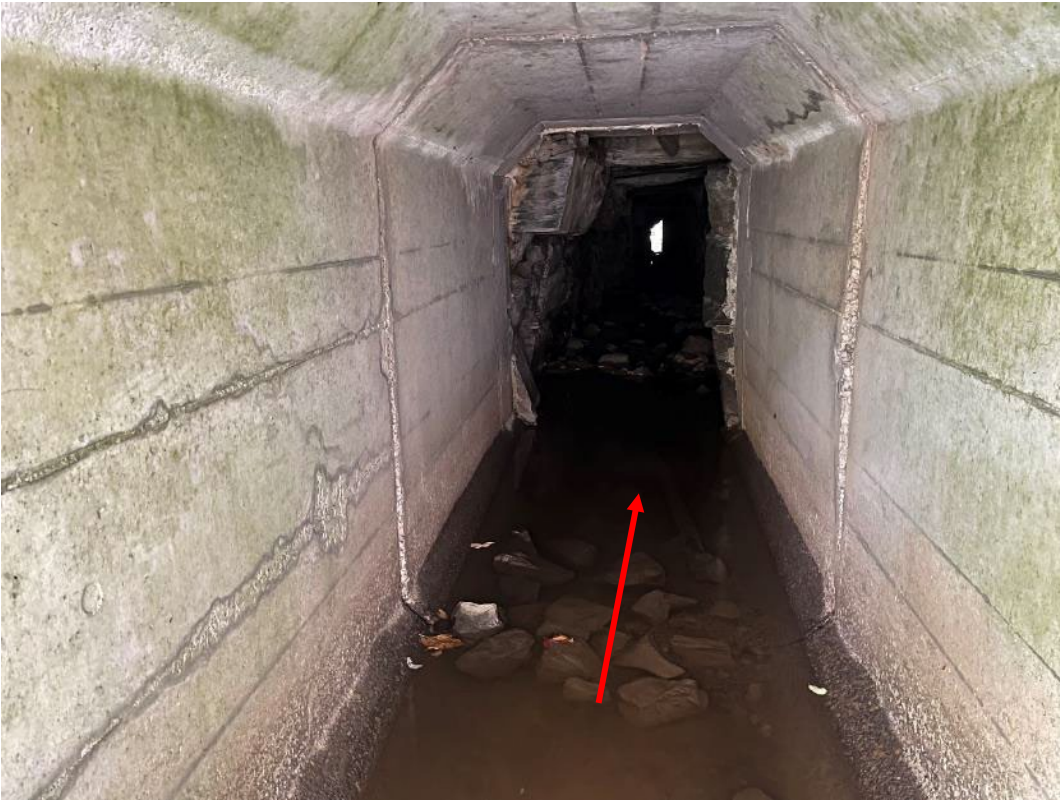
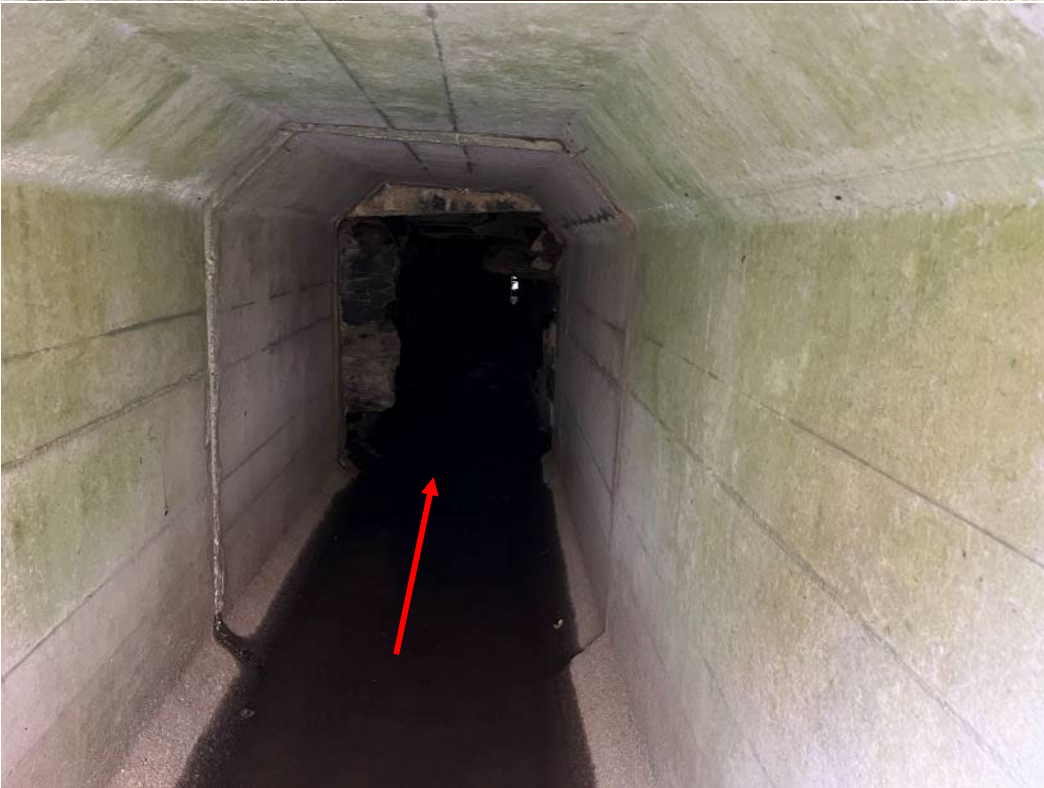
**SECTION 1 OF STRUCTURE**  
Looking downstream through  
first section of structure (TH-24)  
cast in place structure inlets

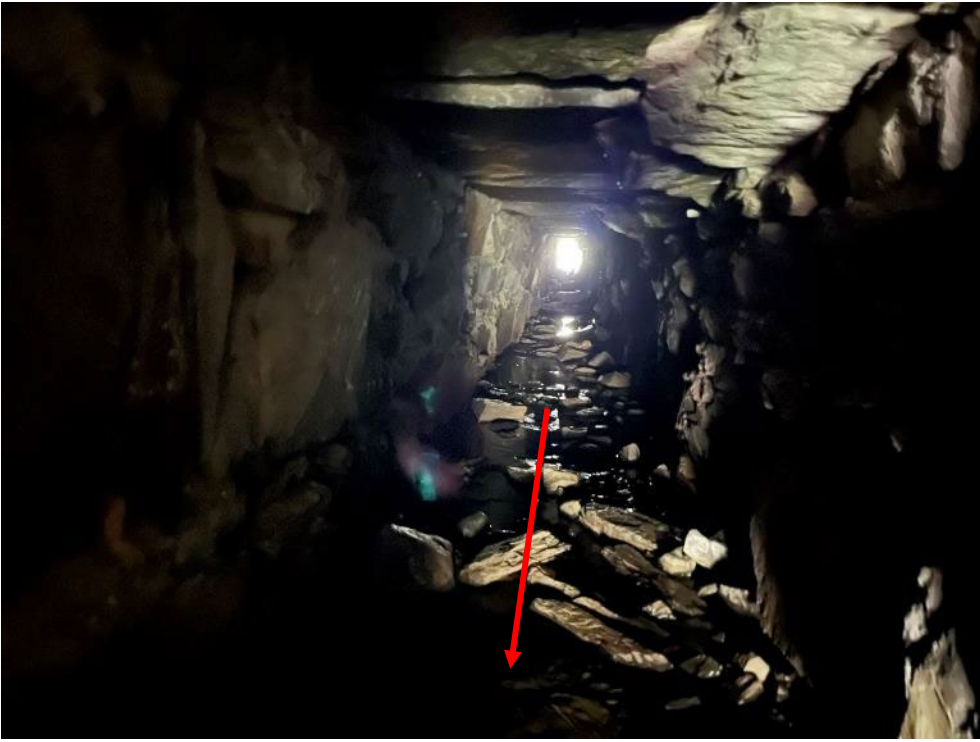
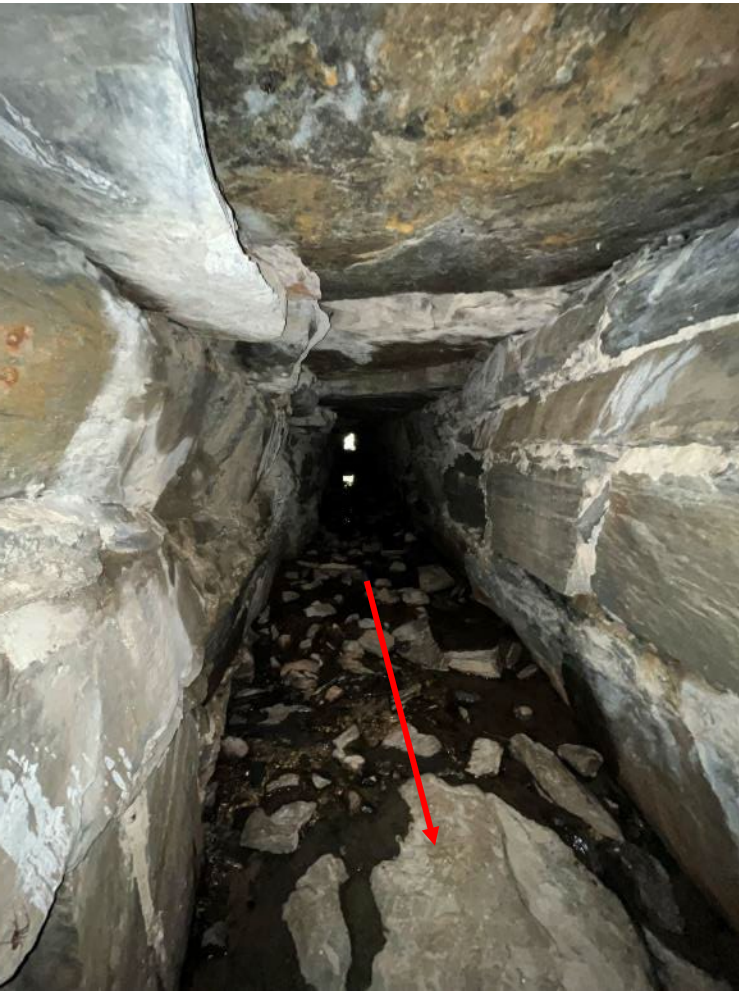
**SECTION 2 OF STRUCTURE**  
Looking upstream through  
second section of structures  
underneath NEC RR from the  
beginning of Br11 (third section,  
under VT Route 2A)

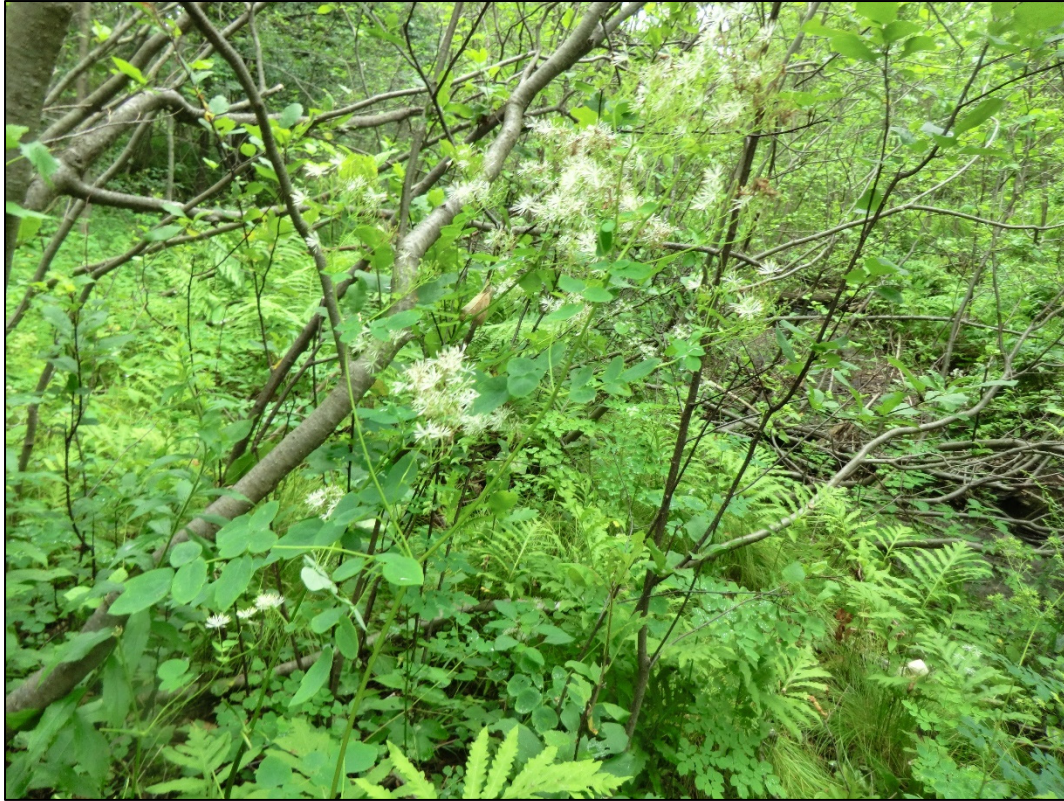
**Figure 1.** VT Route 2A BR II Wetland above box culvert

Wetland above the culvert is classified as Palustrine, dominantly Scrub-Shrub, broadleaved deciduous (PSS1C) and is seasonally flooded. This exhibited saturation and water-stained leaves as primary hydrology indicators and geomorphic position and FAC-neutral test as secondary indicators. Vegetation was dominated by American Elm, Box Elder, Speckled Alder, Sensitive Fern, and Tall Meadowrue (Figure 1).

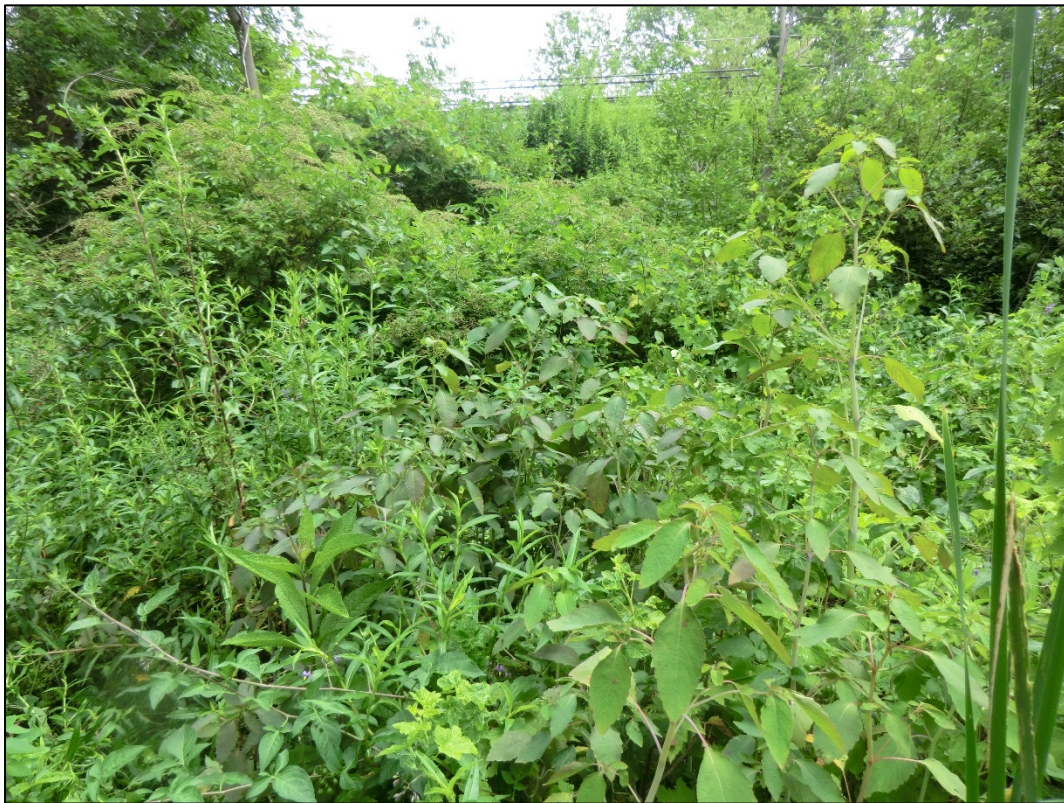
**Figure 2.** VT Route 2A BR II Wetland below box culvert

Wetland below the culvert is Palustrine, dominantly Scrub-Shrub, broadleaved deciduous, mixed with emergent, non-persistent and is seasonally flooded (PSS1/EM2C). Primary indicators of hydrology include: surface water, high water table, saturation, and water-stained leaves. Geomorphic position and FAC-neutral test are secondary hydrology indicators. The wetland below the culvert is dominated by herbaceous vegetation including: Sensitive Fern and Spotted Joe Pyeweed. Speckled Alder is present in the shrub layer (Figure 2).

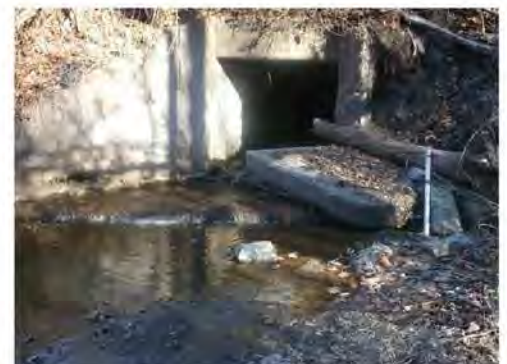
**Outlet**

**Comment:** Turns to Stone then concrete again. Goes under R.R tracks and VT-2A. DS wing wall has fallen over, obstructs DS opening along with debris.
