# Essex-Jericho Culvert Bundle Public Informational Meeting

March 21, 2024

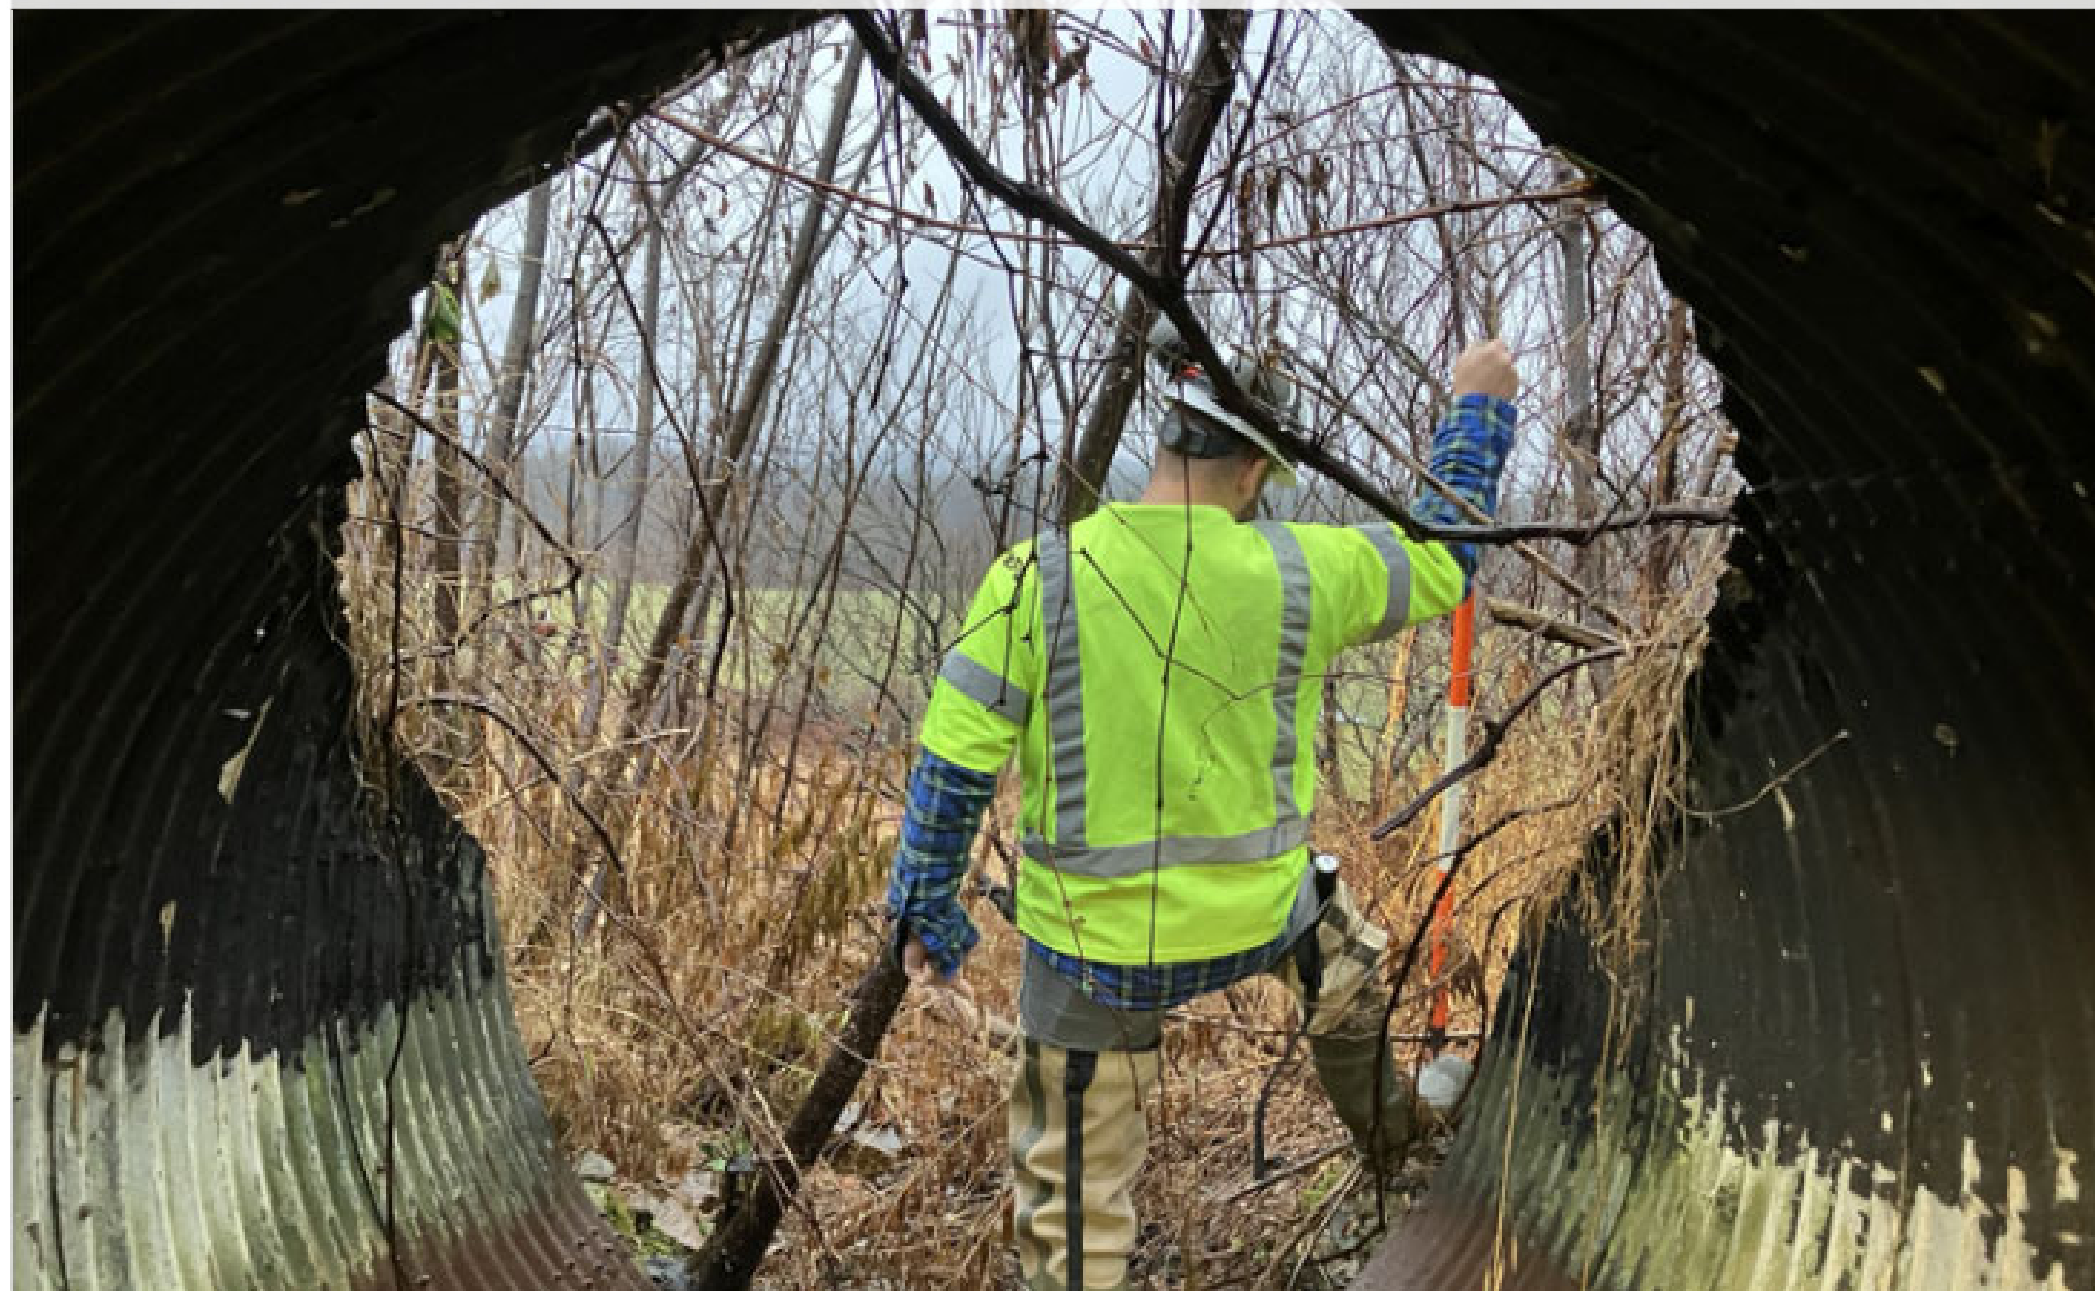
Culvert Barrel (Facing Upstream)

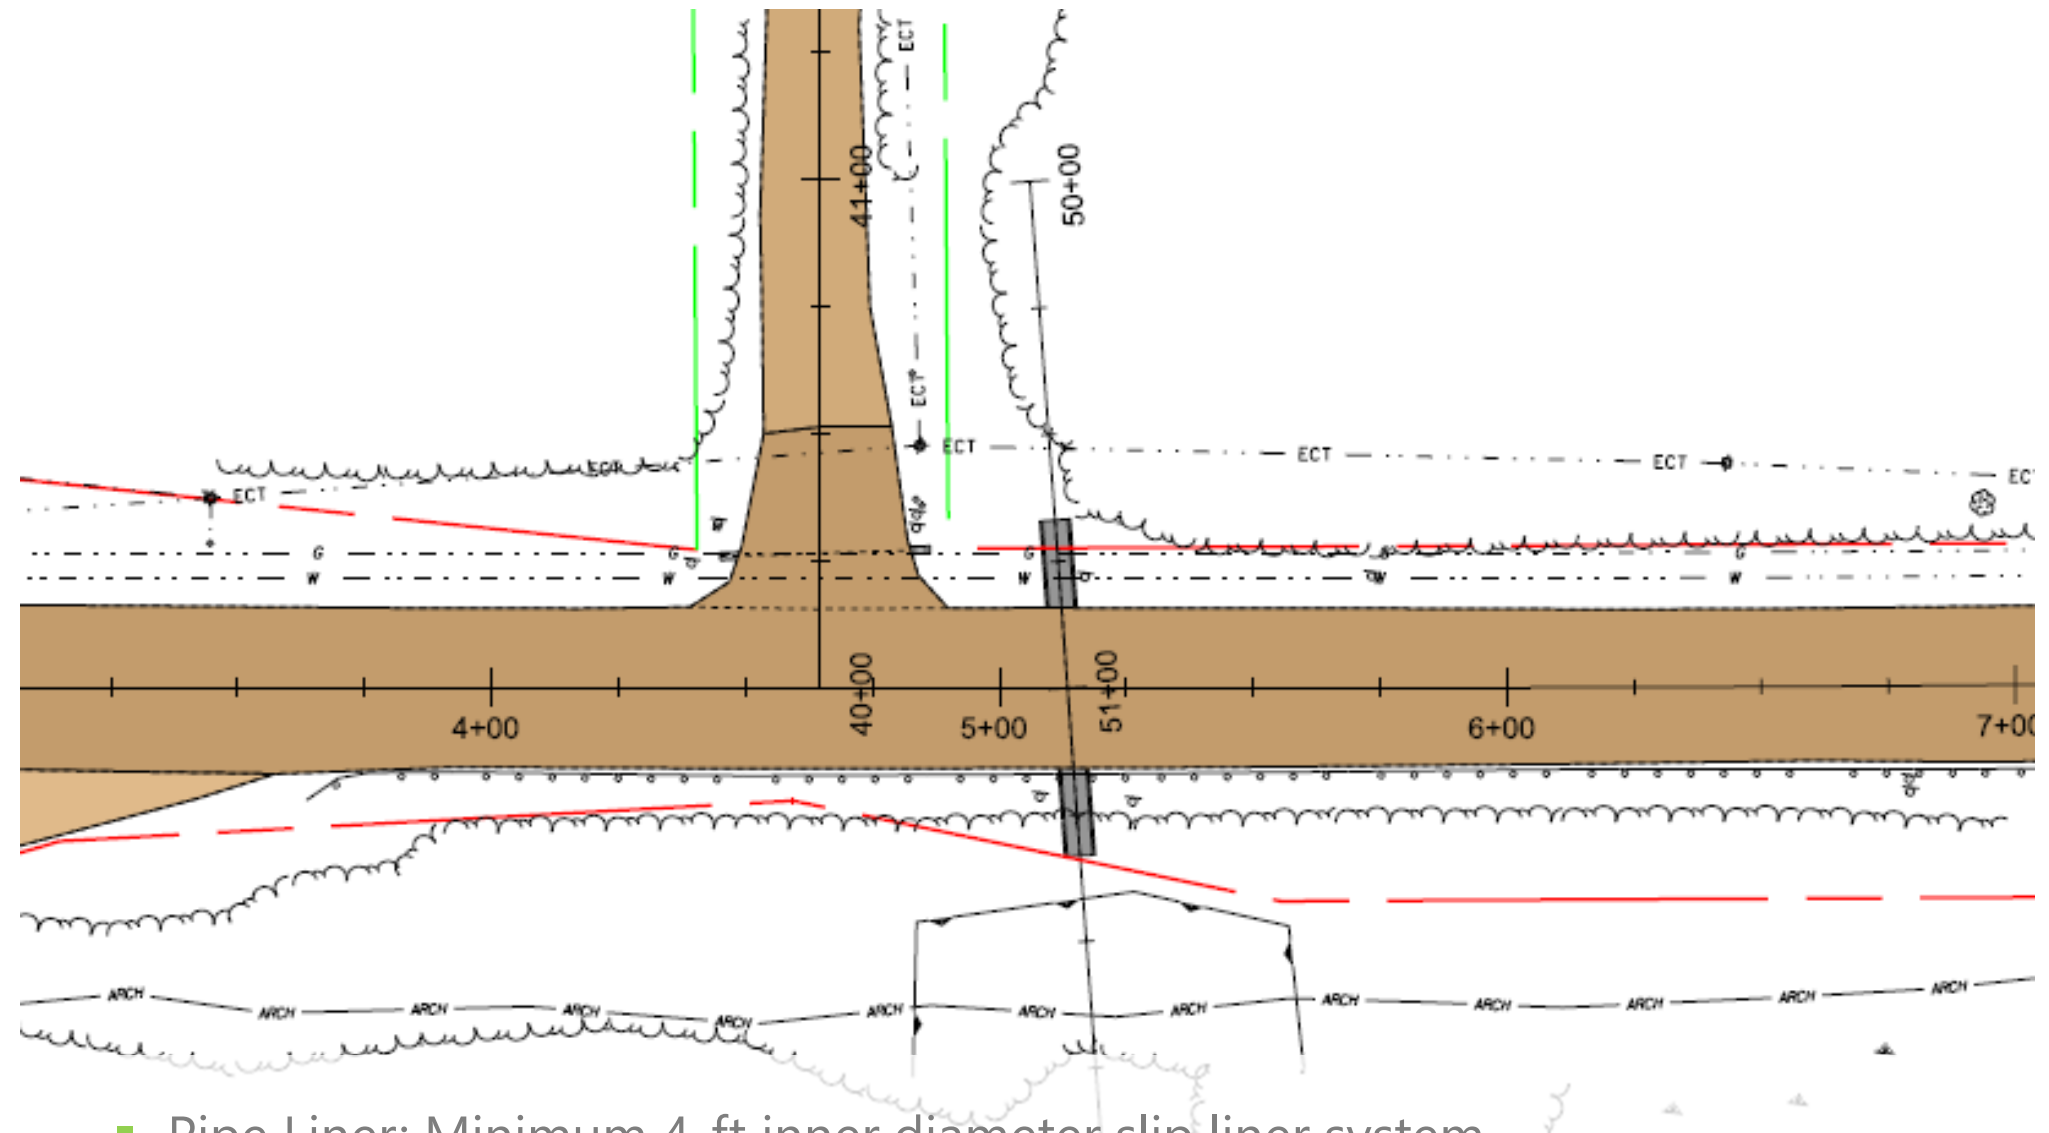
# Selected Alternative: Rehabilitation – Culvert Liner

- The culvert is in poor condition. There is heavy rust scaling and pitting which has led to small perforations along the haunches in the first half of the barrel. Moderate distortion throughout the pipe has allowed for small gaps along connection joints leading to minor piping. The invert is covered with gravel, and is in poor condition.
- The existing culvert meets VTrans hydraulics standards and meets bankfull width.
- VT Route 15 has substandard shoulder widths along the VT Route 15 corridor through the project area.

- Pipe Liner: Minimum 4-ft inner diameter slip liner system
- Spray-On Liner: polymer-enhanced cement mortar liner recommended
- Substandard shoulder widths through VT 15 corridor
- Meets minimum hydraulics standards
- Design Life; approx. 30 to 50 years

- Rehabilitate the existing culvert with a Round Pipe Slip Liner system while maintaining traffic on the existing culvert
  - Minimum 4-foot inside diameter slip liner system
  - Minimum hydraulic standards will be met
  - Substandard shoulder widths along the VT Route 15 corridor through the project area
  - Extends the life of the structure an additional 50 years
  - Possible temporary lane or shoulder closures for mobilizing construction equipment and managing truck traffic

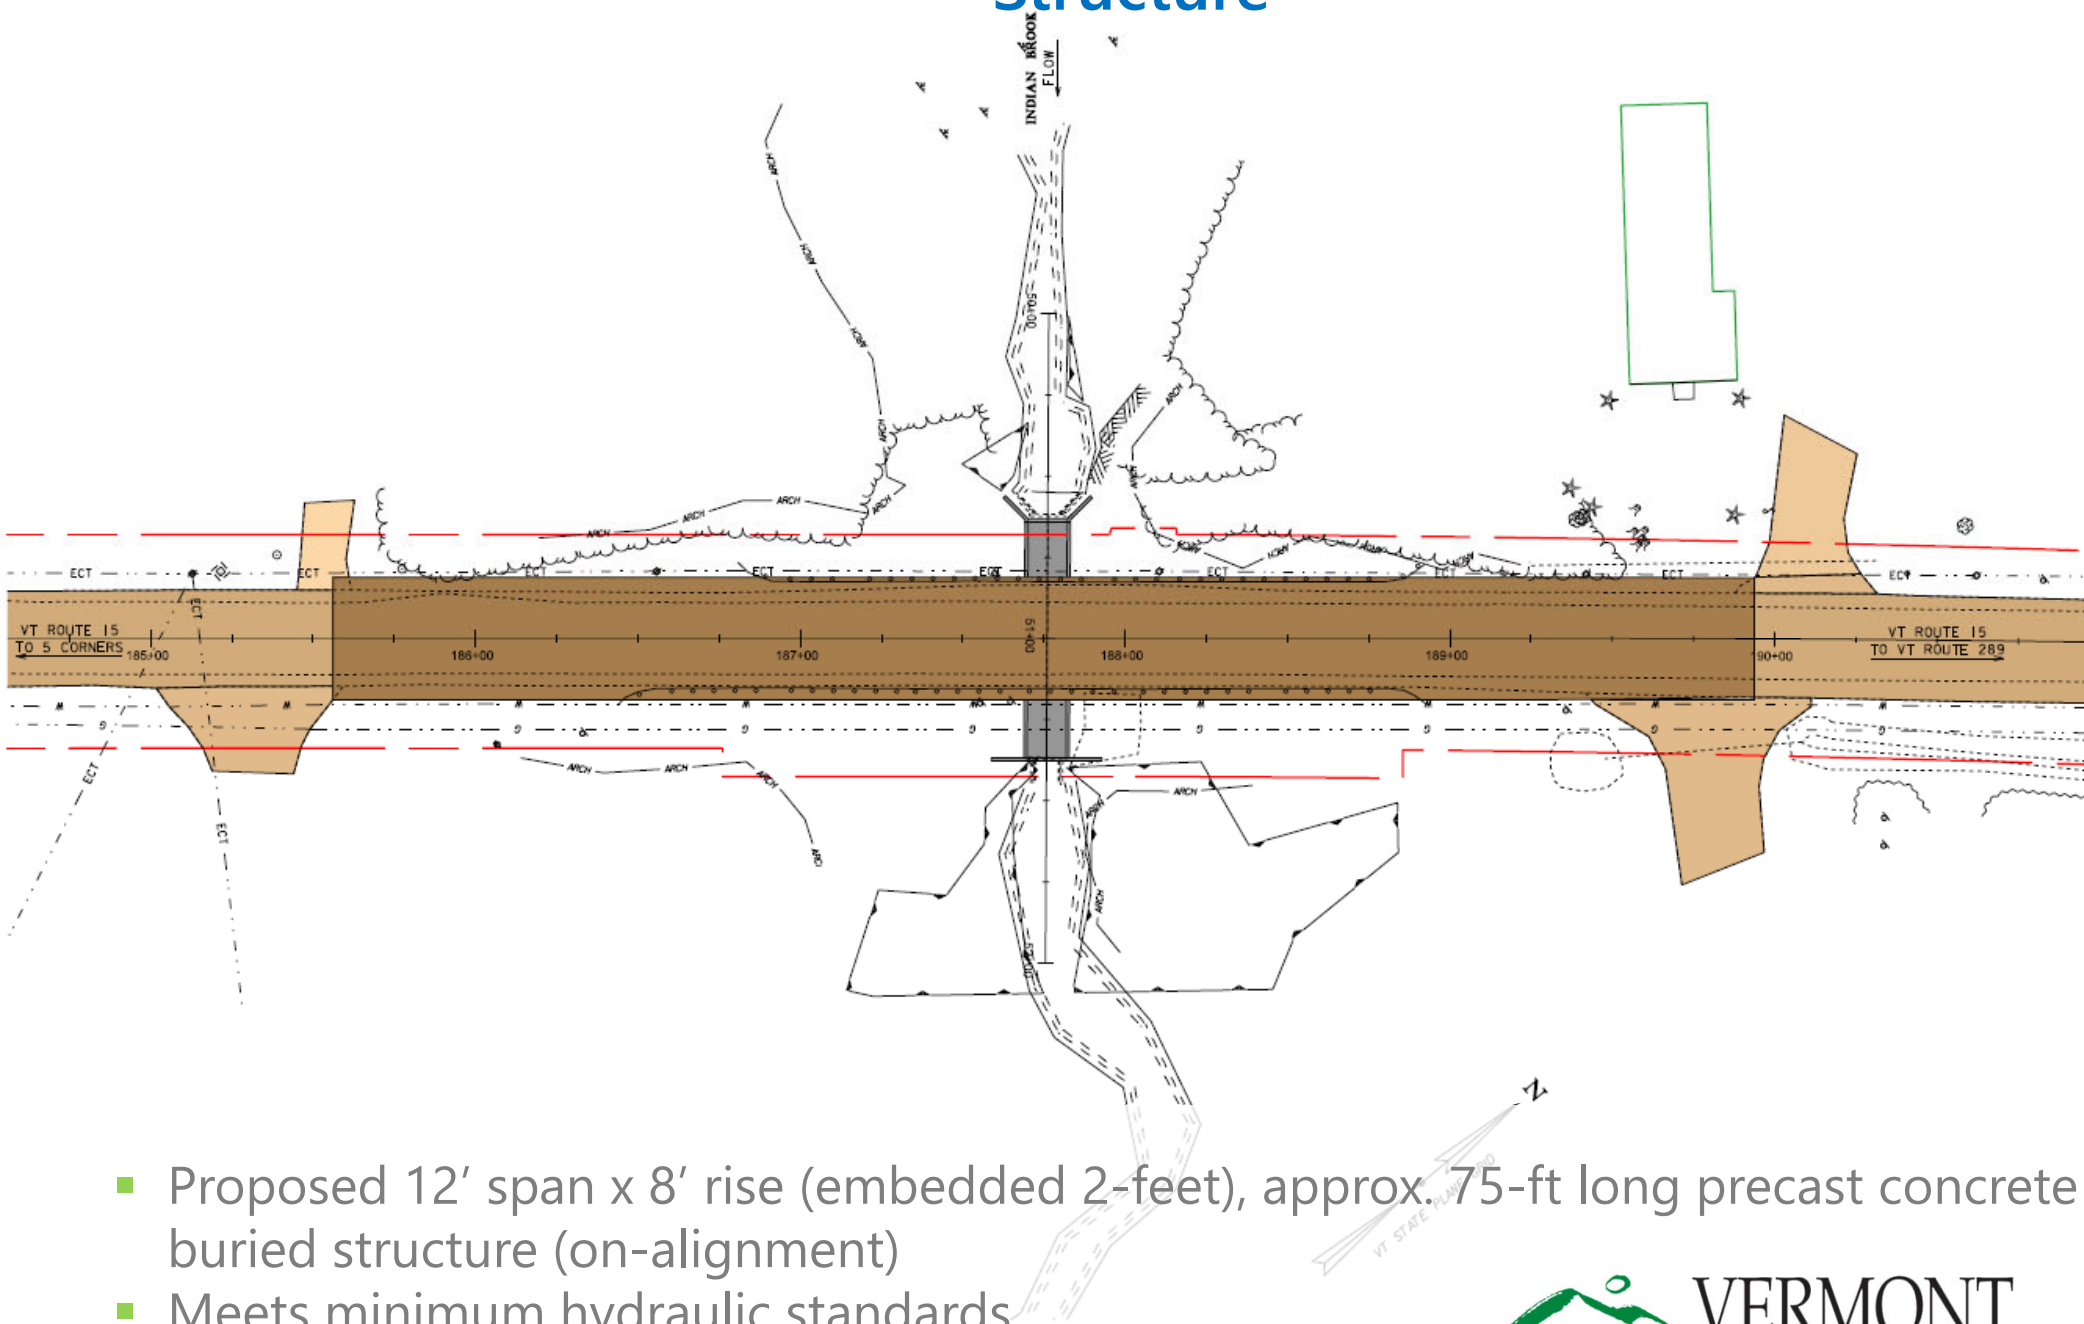
# Selected Alternative: Culvert Replacement with Buried Structure

- Culvert Rating 4 (Poor)
- Channel Rating 7 (Good)

- Proposed 12' span x 8' rise (embedded 2-feet), approx. 75-ft long precast concrete buried structure (on-alignment)
- Meets minimum hydraulic standards
- Design Life; 75 years

- Replace the existing culvert with a new 3-sided or 4-sided Precast Concrete Buried Structure
  - Traffic will be maintained via phased construction and/or an offsite detour, or a combination of the two in order to keep the corridor partially open during construction to be determined in design
  - Impacts to utilities, environmental resources and cultural resources will be minimized by not constructing a temporary bridge
  - Proposed 12' span, 75' long precast concrete box or frame (on-alignment)
  - Proposed 12' span meets the minimum hydraulic standards and bank full width conditions
  - New culvert length designed to meet minimum roadway width standards
  - 75-year Design life

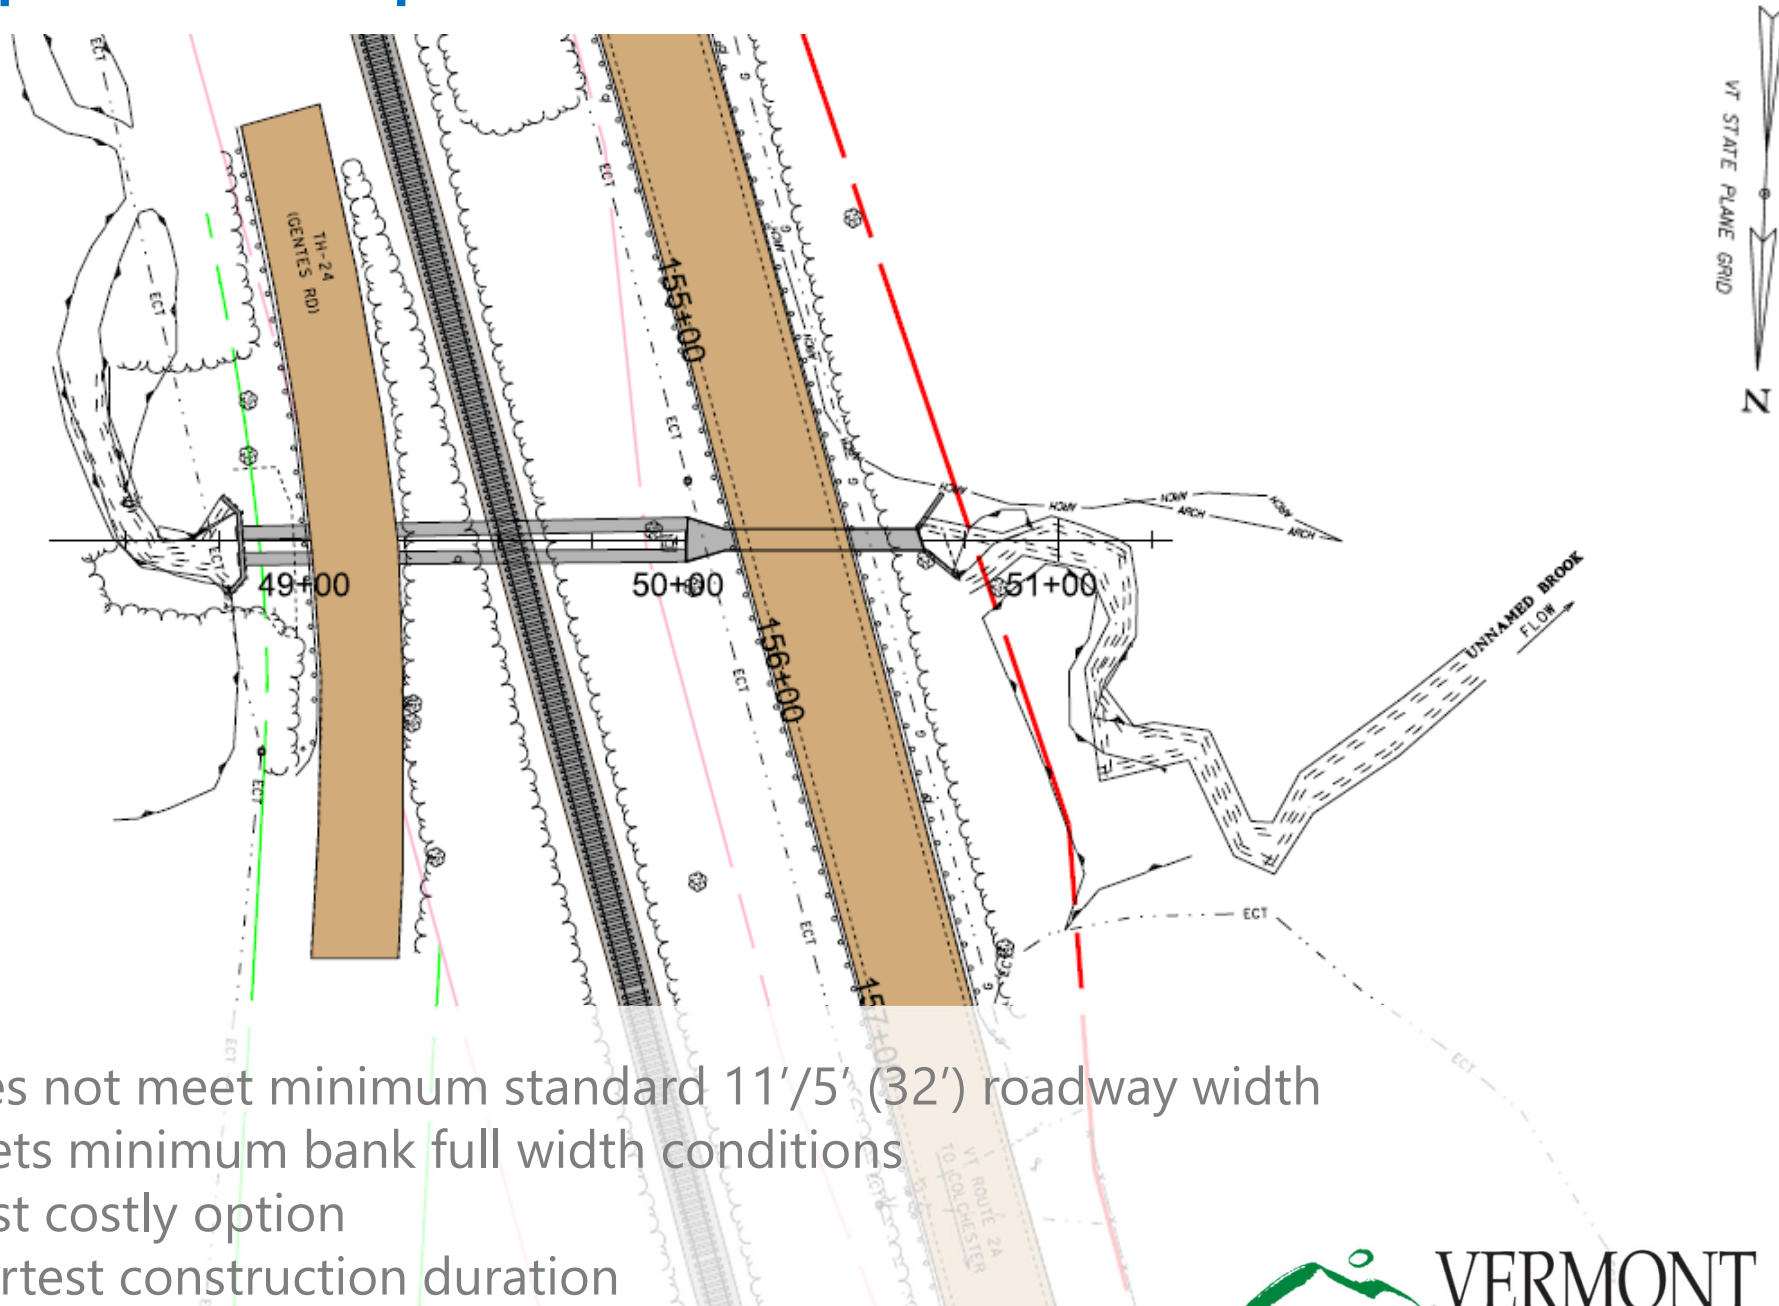
# Selected Alternative: Culvert Rehabilitation – Concrete Repair and Slope Work

- Culvert Rating 4 (Poor)
- Channel Rating 5 (Fair)

- Does not meet minimum standard 11'5' (32') roadway width
- Meets minimum bank full width conditions
- Least costly option
- Shortest construction duration
- Design Life; approx. 30 years

- Rehabilitate the existing culvert with Class III concrete repair and slope stabilization work while maintaining traffic on the existing culvert with temporary lane closures as needed.
  - Class III concrete repair and slope stabilization work including new wingwalls and headwall, and armoring side slopes
  - Minimum hydraulic standard and bank full width conditions will be met
  - Temporary lane or shoulder closures as needed in order to mobilize/demobilize construction equipment or manage truck traffic
  - Extends the life of the structure an additional 30 years

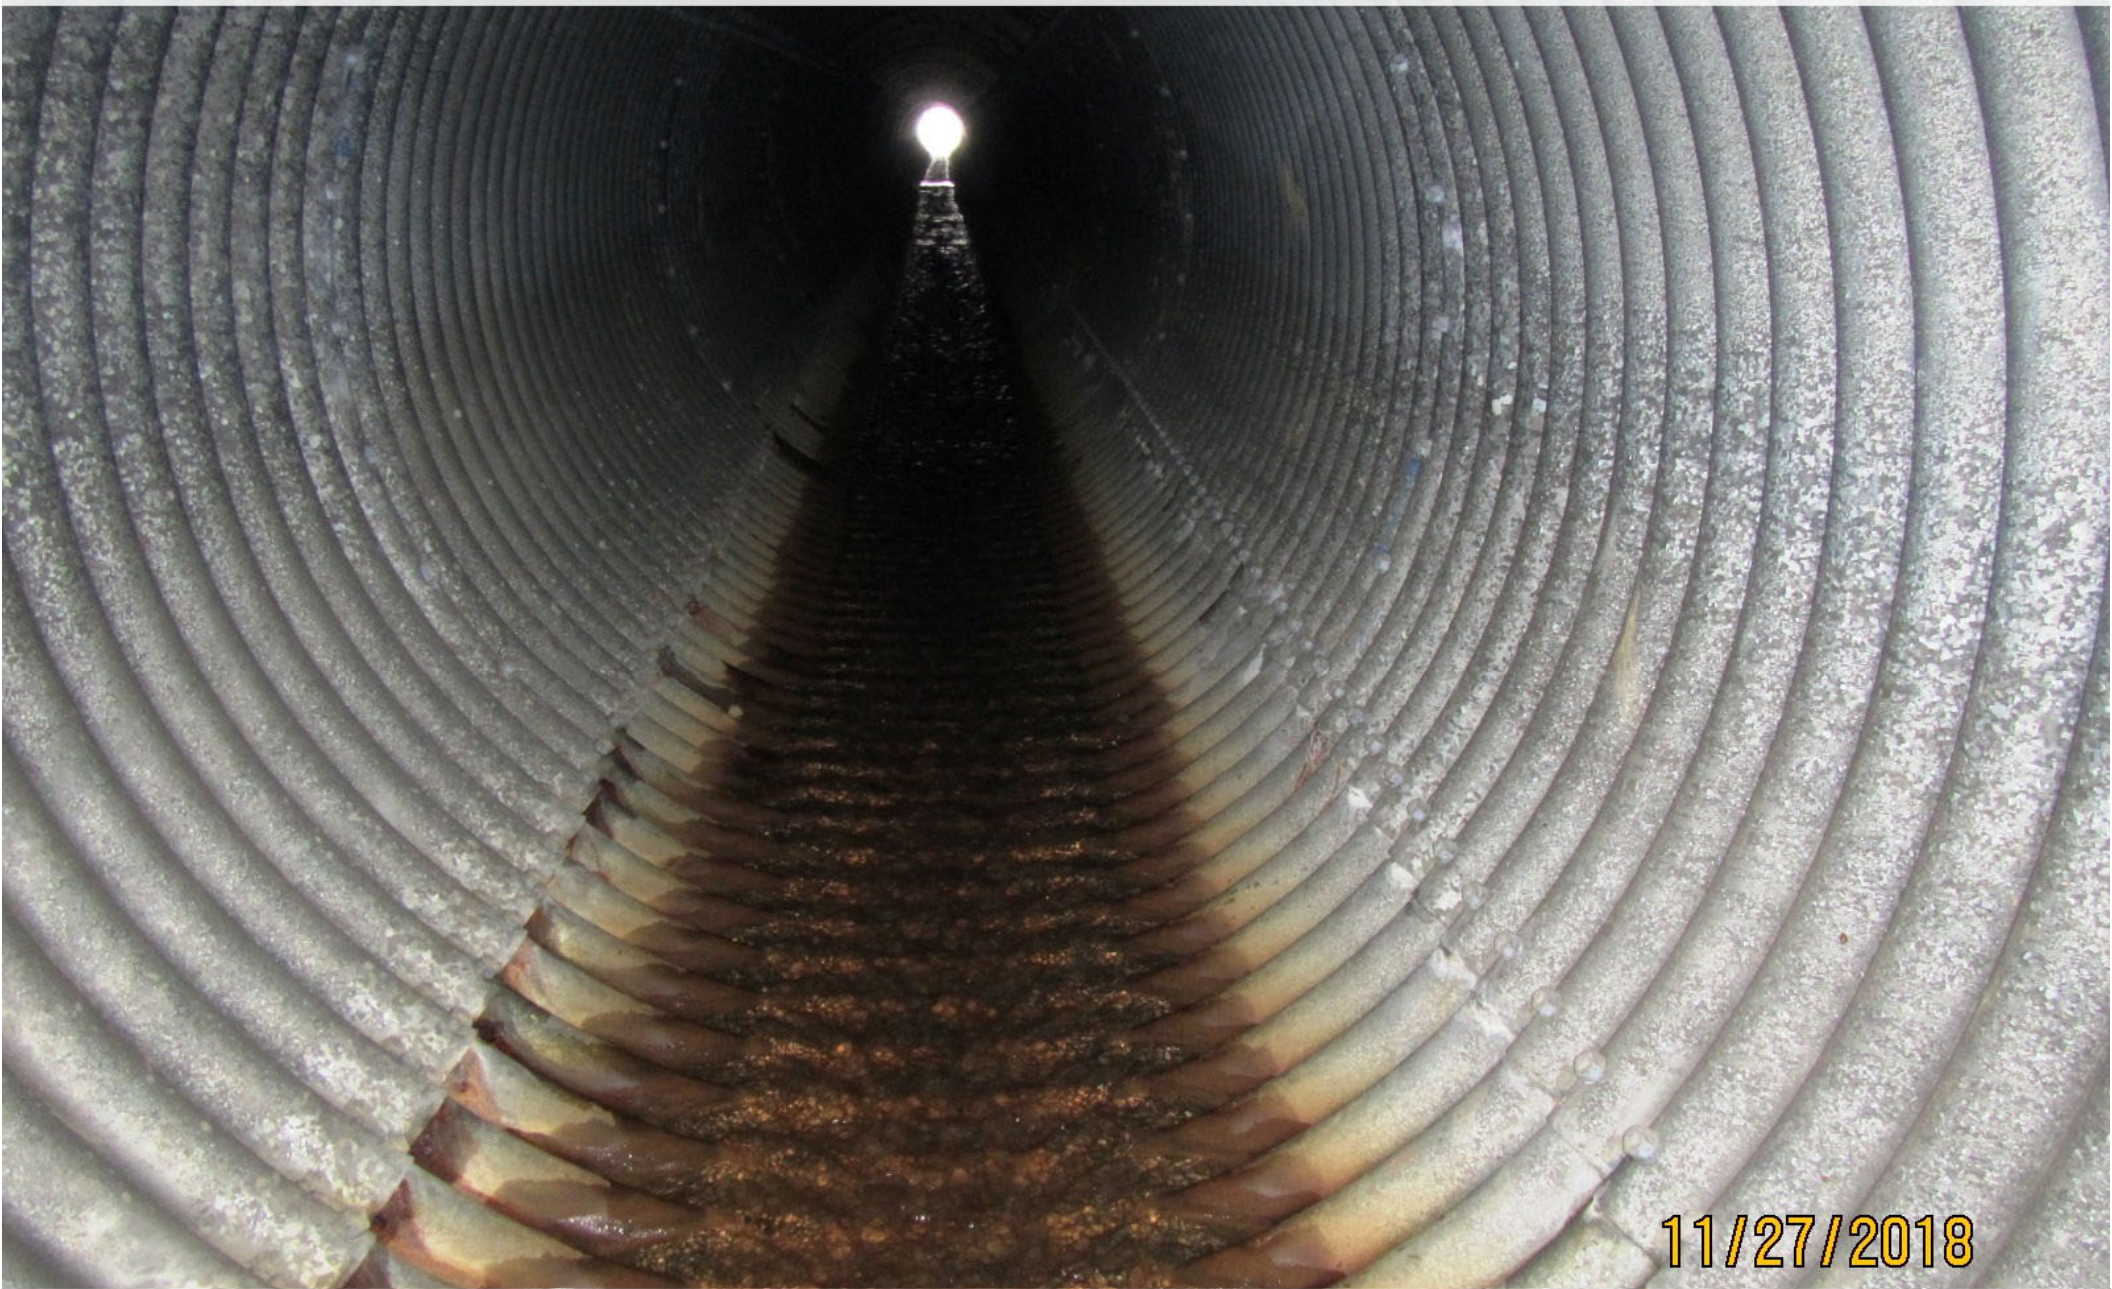
## Culvert Barrel

- Culvert Rating 5 (Fair)
- Channel Rating 7 (Good)
