# FACILITY CONDITION ASSESSMENT

FACILITY CONDITION ASSESSMENT  
OF  
BRADFORD INFORMATION CENTER  
I-91 NORTHBOUND, MILE MARKER 100  
BRADFORD, VT 05051

EMG  
10461 Mill Run Circle, Suite 1100  
Owings Mills, Maryland 21117  
800.733.0660  
[www.EMGcorp.com](http://www.EMGcorp.com)

June 19, 2017

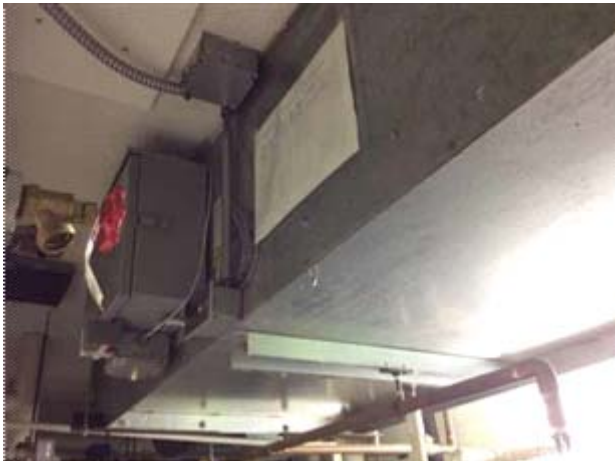
With integral heat exchanger.

Uniformat	Action Description	Quantity	Unit Cost	Plan Type	Priority	Year	Expenditure
<b>D3041</b>	Replace Air Handler, Single Zone	1 EA	\$7,798.74	BYL	Priority 3	2026	\$7,799

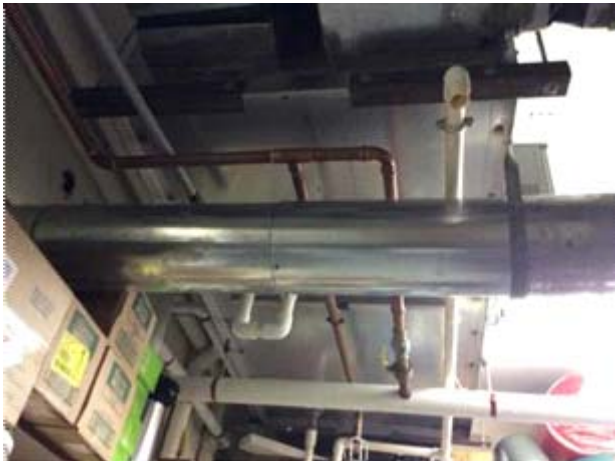
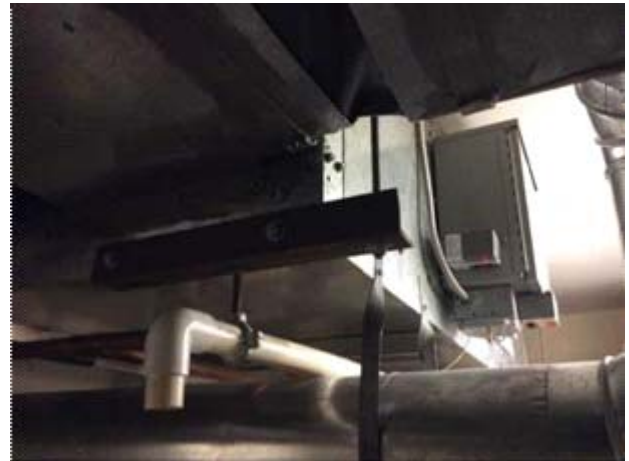
With integral heat exchanger.

Uniformat	Action Description	Quantity	Unit Cost	Plan Type	Priority	Year	Expenditure
<b>D3041</b>	Replace Air Handler, Single Zone	1 EA	\$7,798.74	BYL	Priority 3	2026	\$7,799
