FACILITY CONDITION ASSESSMENT

106686.17R000-087.305

July 03, 2017

FACILITY CONDITION ASSESSMENT
OF
HARTFORD SOUTH INFORMATION CENTER
I-91 SOUTHBOUND MILE MARKER 68.2
HARTFORD, VT 05047

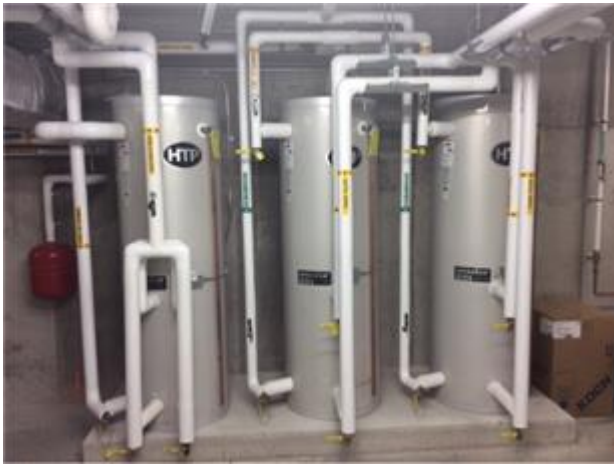
Coding / Field Name	Asset Description
D2023 Domestic Water Supply Equipment	Hot Water Storage Tank
Condition	Good
Qty / UOM	3 / EA
Unit Cost	\$2,140.56
Basis of Costing	Water Storage Tank, 80 to 150 GAL
Year in Service	2012
Expected Useful Life (EUL)	20 Year(s), Based on Industry Averages
Remaining Useful Life (RUL)	15 Year(s), Estimated, Based on Date of Observation
Location	Lower Level

Uniformat	Action Description	Quantity	Unit Cost	Plan Type	Priority	Year	Expenditure
D2023	Replace Hot Water Storage Tank	3 EA	\$2,140.56	BYL	Priority 3	2032	\$6,422

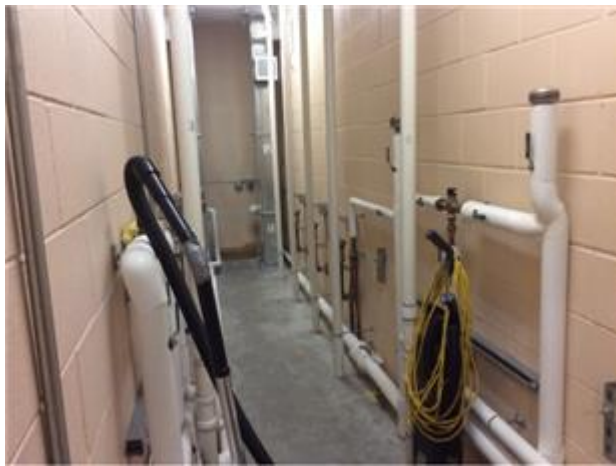
Coding / Field Name	Asset Description
D2029 Plumbing Systems	Plumbing System, Domestic Supply
Condition	Good
Qty / UOM	4718 / SF
Unit Cost	\$7.59
Basis of Costing	Plumbing System, Domestic Supply
Year in Service	2012
Expected Useful Life (EUL)	40 Year(s), Based on Industry Averages
Remaining Useful Life (RUL)	35 Year(s), Estimated, Based on Date of Observation
Location	Building Interior (General)

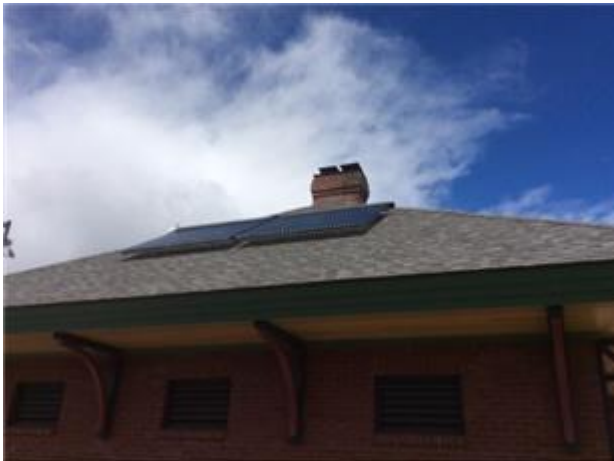
Coding / Field Name	Asset Description
D3016 Solar Energy System	Solar Panel, Vacuum Tube, Hot Water
Condition	Good
Qty / UOM	2 / EA
Cost Adjustment Factor/Reason	3 / Hot water not PV
Unit Cost (Adjusted)	\$4,902.22
Basis of Costing	Solar Panel, 24 SF
Year in Service	2012
Expected Useful Life (EUL)	15 Year(s), Based on Industry Averages
Remaining Useful Life (RUL)	10 Year(s), Estimated, Based on Date of Observation
Location	Roof

Uniformat	Action Description	Quantity	Unit Cost	Plan Type	Priority	Year	Expenditure
D3016	Replace Solar Panel, Vacuum Tube, Hot Water	2 EA	\$4,902.22	BYL	Priority 3	2027	\$9,804

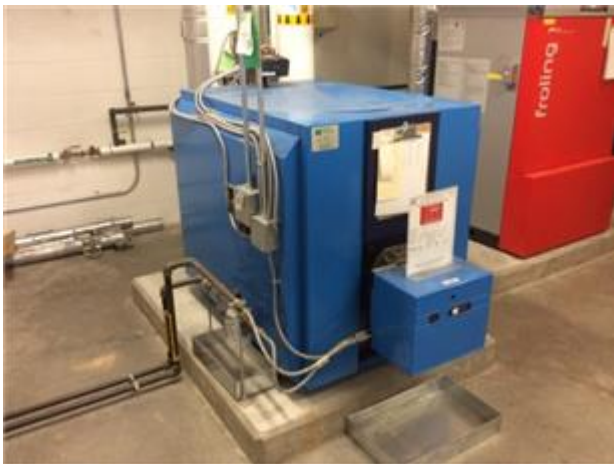
Coding / Field Name	Asset Description
D3021 Boilers	Boiler, Oil
Condition	Good
Qty / UOM	1 / EA
Unit Cost	\$23,762.28
Basis of Costing	Boiler, Oil, 401 to 750 MBH
Year in Service	2012
Expected Useful Life (EUL)	22 Year(s), Based on Industry Averages
Remaining Useful Life (RUL)	17 Year(s), Estimated, Based on Date of Observation
Location	Lower Level

Uniformat	Action Description	Quantity	Unit Cost	Plan Type	Priority	Year	Expenditure
D3021	Replace Boiler, Oil	1 EA	\$23,762.28	BYL	Priority 3	2034	\$23,762

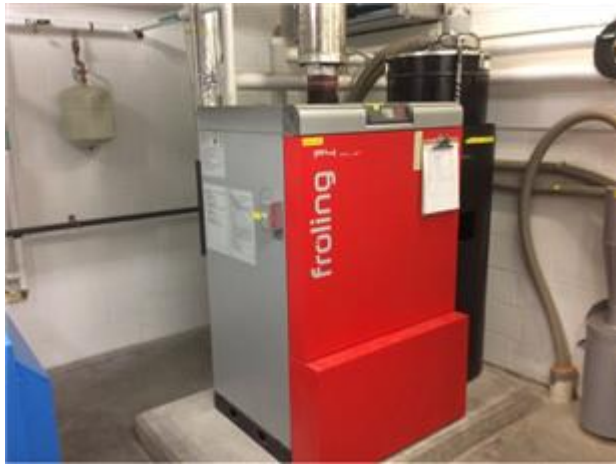
Coding / Field Name	Asset Description
D3021 Boilers	Boiler, Pellet
Condition	Good
Qty / UOM	1 / EA
Unit Cost	\$10,675.14
Basis of Costing	Boiler, Gas, 15 to 25 MBH
Year in Service	2012
Expected Useful Life (EUL)	25 Year(s), Based on Industry Averages
Remaining Useful Life (RUL)	20 Year(s), Estimated, Based on Date of Observation
Location	Lower Level

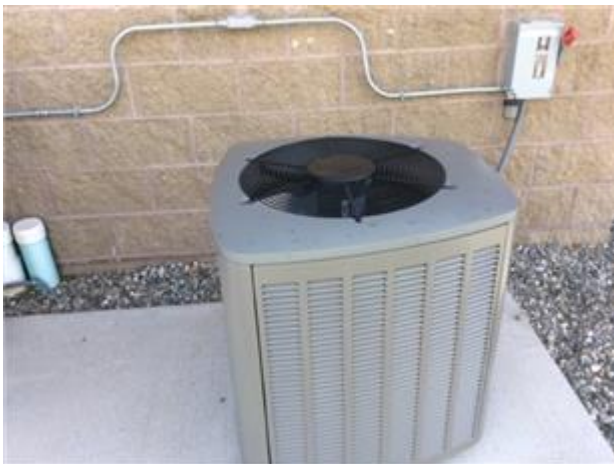
Coding / Field Name	Asset Description
D3032 Direct Expansion Systems	Condensing Unit, Split System
Condition	Good
Qty / UOM	1 / EA
Unit Cost	\$2,118.94
Basis of Costing	Condensing Unit, Split System DX, Air-Cooled, 1 Ton
Year in Service	2012
Expected Useful Life (EUL)	15 Year(s), Based on Industry Averages
Remaining Useful Life (RUL)	10 Year(s), Estimated, Based on Date of Observation
Location	Site

Uniformat	Action Description	Quantity	Unit Cost	Plan Type	Priority	Year	Expenditure
D3032	Replace Condensing Unit, Split System	1 EA	\$2,118.94	BYL	Priority 3	2027	\$2,119

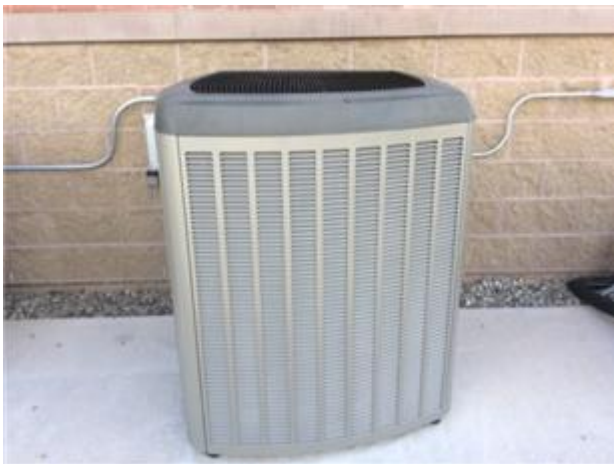
Coding / Field Name	Asset Description
D3032 Direct Expansion Systems	Condensing Unit, Split System - 2
Condition	Good
Qty / UOM	4 / EA
Unit Cost	\$3,122.18
Basis of Costing	Condensing Unit, Split System DX, Air-Cooled, 2 Ton
Year in Service	2012
Expected Useful Life (EUL)	15 Year(s), Based on Industry Averages
Remaining Useful Life (RUL)	10 Year(s), Estimated, Based on Date of Observation
Location	Site

Uniformat	Action Description	Quantity	Unit Cost	Plan Type	Priority	Year	Expenditure
D3032	Replace Condensing Unit, Split System - 2	4 EA	\$3,122.18	BYL	Priority 3	2027	\$12,489

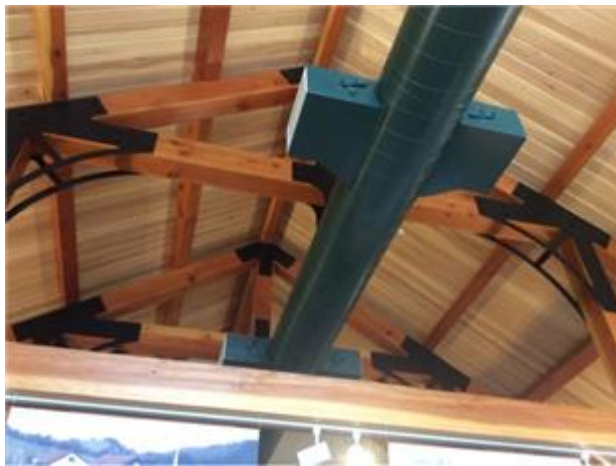
Coding / Field Name	Asset Description
D3041 Air Distribution Systems	HVAC System Ductwork, Sheet Metal
Condition	Good
Qty / UOM	4718 / SF
Unit Cost	\$19.50
Basis of Costing	HVAC System Ductwork, Sheet Metal
Year in Service	2012
Expected Useful Life (EUL)	30 Year(s), Based on Industry Averages
Remaining Useful Life (RUL)	25 Year(s), Estimated, Based on Date of Observation
Location	Lower Level

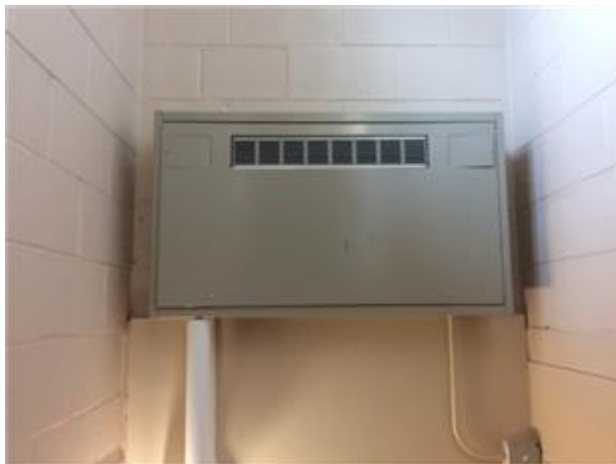
Coding / Field Name	Asset Description
D3041 Air Distribution Systems	Fan Coil Unit
Condition	Fair
Qty / UOM	5 / EA
Unit Cost	\$2,756.89
Basis of Costing	Fan Coil Unit, 2 to 2.5 Ton
Year in Service	2012
Expected Useful Life (EUL)	15 Year(s), Based on Industry Averages
Remaining Useful Life (RUL)	10 Year(s), Estimated, Based on Date of Observation
Location	Lower Level

Uniformat	Action Description	Quantity	Unit Cost	Plan Type	Priority	Year	Expenditure
D3041	Replace Fan Coil Unit	5 EA	\$2,756.89	BYL	Priority 3	2027	\$13,784

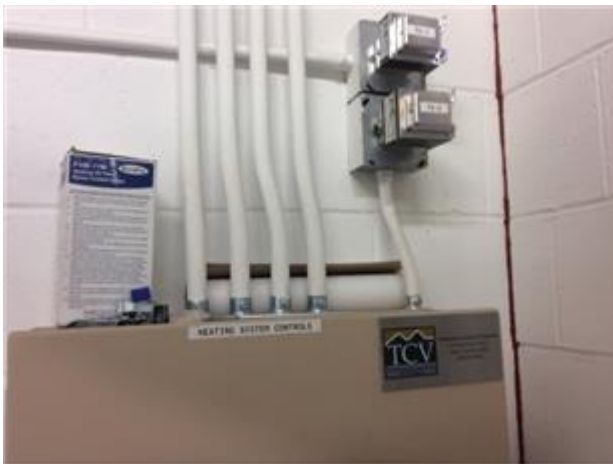
Coding / Field Name	Asset Description
D3068 Building Automation Systems	Direct Digital (DDC) HVAC Controls
Condition	Good
Qty / UOM	4718 / SF
Unit Cost	\$5.36
Basis of Costing	Building Automation System (HVAC Controls), Full Upgrade (per SF)
Year in Service	2012
Expected Useful Life (EUL)	20 Year(s), Based on Industry Averages
Remaining Useful Life (RUL)	15 Year(s), Estimated, Based on Date of Observation
Location	Lower Level

Uniformat	Action Description	Quantity	Unit Cost	Plan Type	Priority	Year	Expenditure
D3068	Replace Direct Digital (DDC) HVAC Controls	4,718 SF	\$5.36	BYL	Priority 3	2032	\$25,288

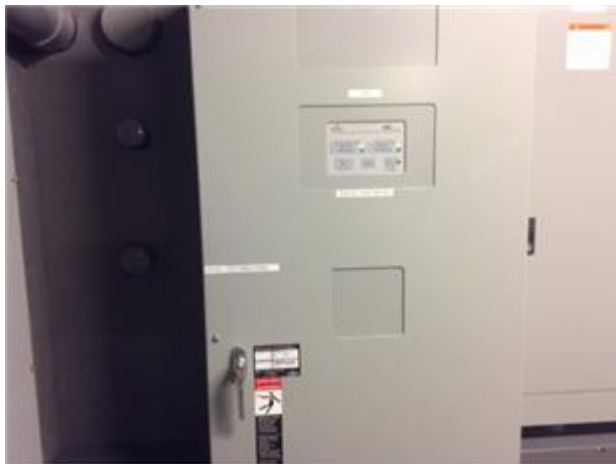
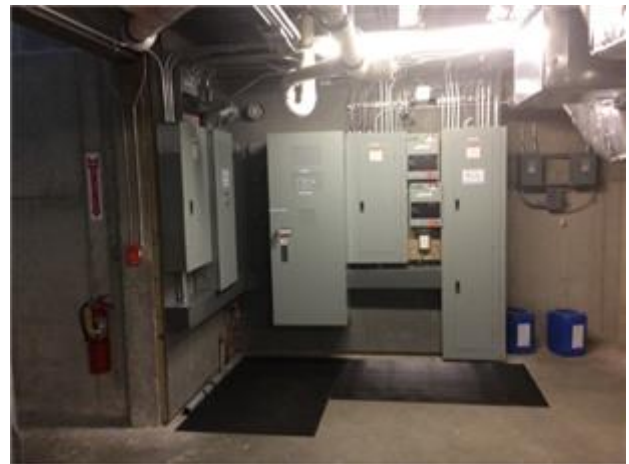
Coding / Field Name	Asset Description
D5012 Low Tension Service & Dist.	Transfer Switch, Auto
Condition	Good
Qty / UOM	1 / EA
Unit Cost	\$16,318.29
Basis of Costing	Transfer Switch, Auto, 600 V, 600 Amp
Year in Service	2012
Expected Useful Life (EUL)	18 Year(s), Based on Industry Averages
Remaining Useful Life (RUL)	13 Year(s), Estimated, Based on Date of Observation
Location	Lower Level

Uniformat	Action Description	Quantity	Unit Cost	Plan Type	Priority	Year	Expenditure
D5012	Replace Transfer Switch, Auto	1 EA	\$16,318.29	BYL	Priority 3	2030	\$16,318

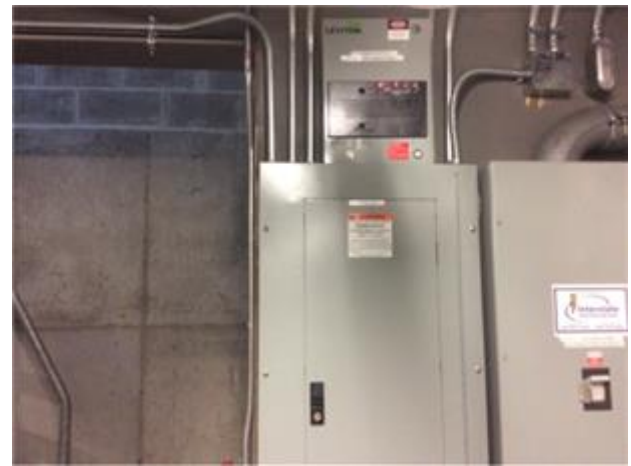
Coding / Field Name	Asset Description
D5012 Low Tension Service & Dist.	Distribution Panel - CU
Condition	Good
Qty / UOM	1 / EA
Unit Cost	\$7,906.20
Basis of Costing	Power Panel Board, 208 Y, 120 V, 200 Amp
Year in Service	2012
Expected Useful Life (EUL)	30 Year(s), Based on Industry Averages
Remaining Useful Life (RUL)	25 Year(s), Estimated, Based on Date of Observation
Location	Lower Level

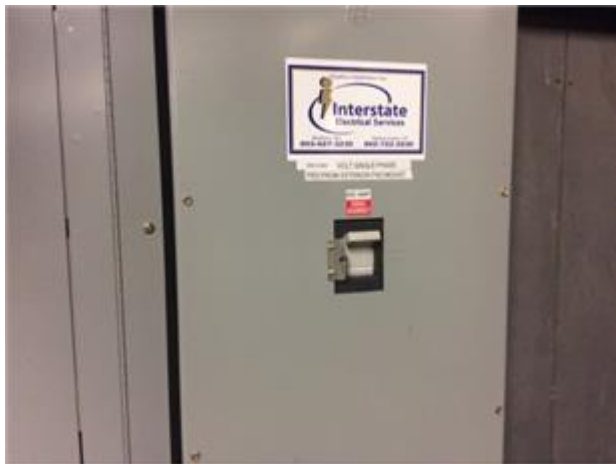
Coding / Field Name	Asset Description
D5012 Low Tension Service & Dist.	Disconnect Switch
Condition	Good
Qty / UOM	1 / EA
Unit Cost	\$7,287.20
Basis of Costing	Disconnect Switch, 600 Amp
Year in Service	2012
Expected Useful Life (EUL)	50 Year(s), Based on Industry Averages
Remaining Useful Life (RUL)	45 Year(s), Estimated, Based on Date of Observation
Location	Lower Level

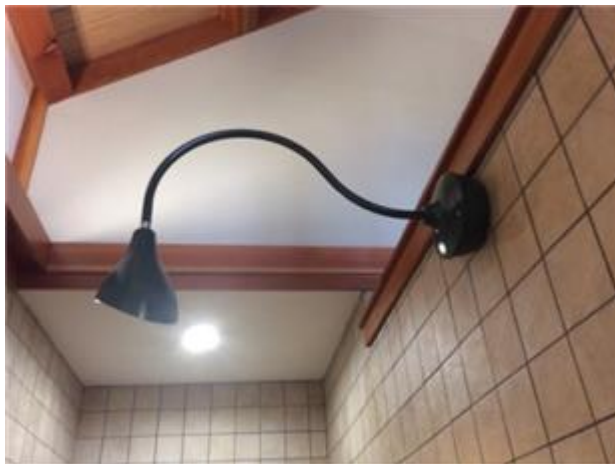
Coding / Field Name	Asset Description
D5029 Lighting Systems	Lighting System, Interior
Condition	Good
Qty / UOM	4718 / SF
Unit Cost	\$9.24
Basis of Costing	Lighting System, Full Upgrade, Office (per SF)
Year in Service	2012
Expected Useful Life (EUL)	25 Year(s), Based on Industry Averages
Remaining Useful Life (RUL)	20 Year(s), Estimated, Based on Date of Observation
Location	Building Interior (General)

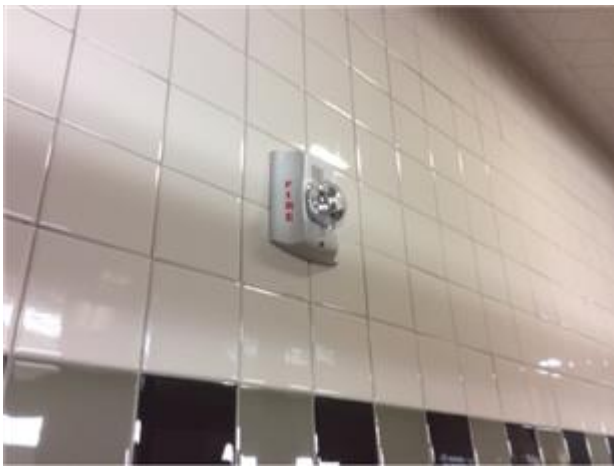
Coding / Field Name	Asset Description
D5037 Fire Alarm Systems	Fire Alarm System, Full Upgrade/Install
Condition	Good
Qty / UOM	4718 / SF
Unit Cost	\$4.25
Basis of Costing	Fire Alarm System, Full Upgrade/Install, Office (per SF)
Year in Service	2012
Expected Useful Life (EUL)	20 Year(s), Based on Industry Averages
Remaining Useful Life (RUL)	15 Year(s), Estimated, Based on Date of Observation
Location	Building Interior (General)

Uniformat	Action Description	Quantity	Unit Cost	Plan Type	Priority	Year	Expenditure
D5037	Replace Fire Alarm System, Full Upgrade/Install	4,718 SF	\$4.25	BYL	Priority 3	2032	\$20,052

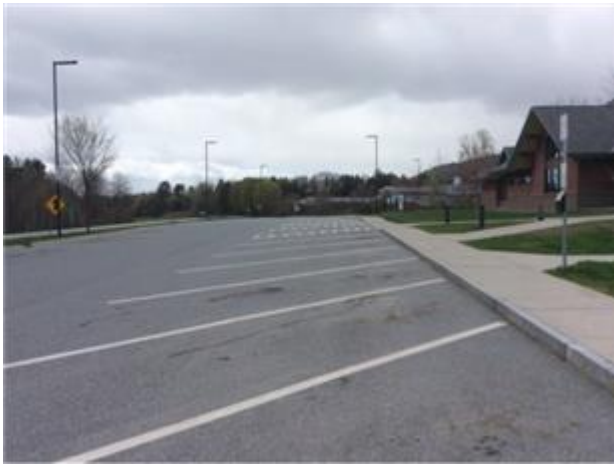
Coding / Field Name	Asset Description
G2022 Paving & Surfacing	Asphalt Pavement, Parking Lot
Condition	Good
Qty / UOM	100000 / SF
Unit Cost	\$5.90
Basis of Costing	Asphalt Pavement, Parking Lot
Year in Service	2012
Expected Useful Life (EUL)	25 Year(s), Based on Industry Averages
Remaining Useful Life (RUL)	20 Year(s), Estimated, Based on Date of Observation
Location	Site

Uniformat	Action Description	Quantity	Unit Cost	Plan Type	Priority	Year	Expenditure
G2022	Seal & Stripe Asphalt Pavement	100,000 SF	\$0.38	BYL	Priority 2	2020	\$38,000
G2022	Seal & Stripe Asphalt Pavement	100,000 SF	\$0.38	BYL	Priority 2	2025	\$38,000
G2022	Seal & Stripe Asphalt Pavement	100,000 SF	\$0.38	BYL	Priority 2	2030	\$38,000
G2022	Seal & Stripe Asphalt Pavement	100,000 SF	\$0.38	BYL	Priority 2	2035	\$38,000

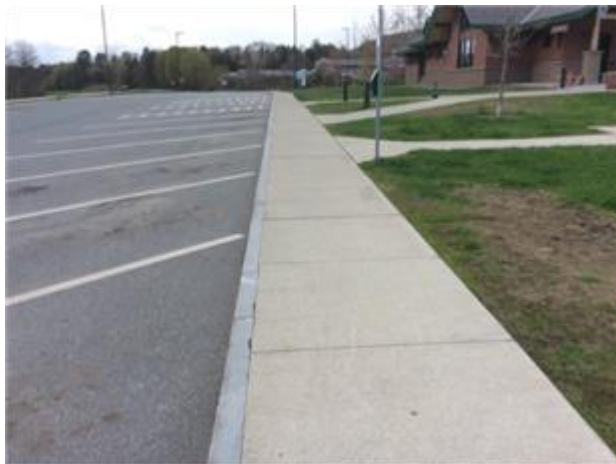
Coding / Field Name	Asset Description
G2031 Paving & Surfacing	Concrete Sidewalk
Condition	Good
Qty / UOM	3750 / SF
Unit Cost	\$19.82
Basis of Costing	Concrete Sidewalk
Year in Service	2012
Expected Useful Life (EUL)	30 Year(s), Based on Industry Averages
Remaining Useful Life (RUL)	25 Year(s), Estimated, Based on Date of Observation
Location	Site

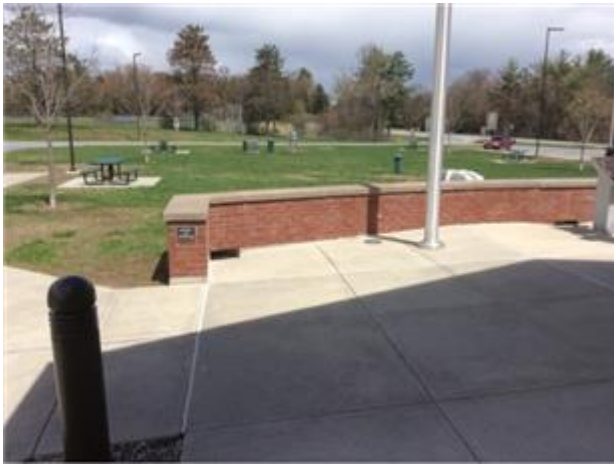
Coding / Field Name	Asset Description
G2042 Retaining Walls	Retaining Walls
Condition	Good
Qty / UOM	100 / SF
Unit Cost	\$130.61
Basis of Costing	Retaining Wall, Brick/Stone (per SF Face)
Year in Service	2012
Expected Useful Life (EUL)	40 Year(s), Based on Industry Averages
Remaining Useful Life (RUL)	35 Year(s), Estimated, Based on Date of Observation
Location	Site

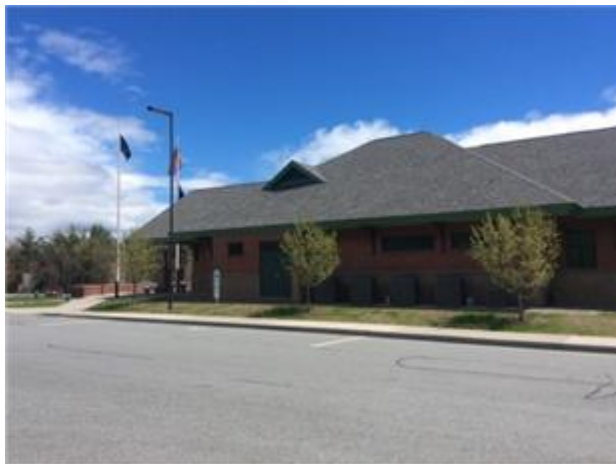
Coding / Field Name	Asset Description
G2048 Flagpoles	Flagpole, Metal
Condition	Good
Qty / UOM	2 / EA
Unit Cost	\$2,530.00
Basis of Costing	Flagpole, Metal, Internal or External Halyard, 30' to 40' High (Pole Only)
Year in Service	2012
Expected Useful Life (EUL)	20 Year(s), Based on Industry Averages
Remaining Useful Life (RUL)	15 Year(s), Estimated, Based on Date of Observation
Location	Site

Uniformat	Action Description	Quantity	Unit Cost	Plan Type	Priority	Year	Expenditure
G2048	Replace Flagpole, Metal	2 EA	\$2,530.00	BYL	Priority 3	2032	\$5,060

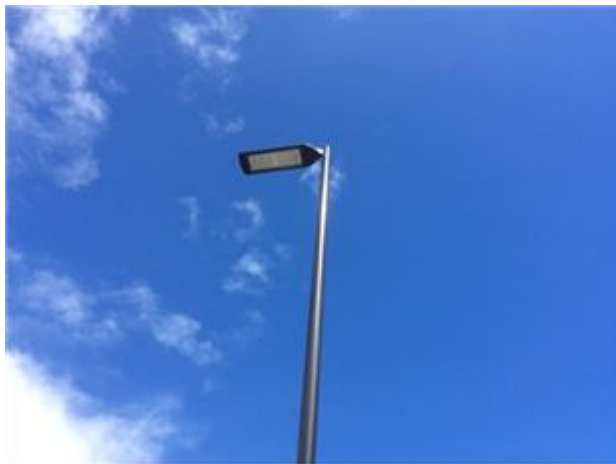
Coding / Field Name	Asset Description
G4021 Fixtures & Transformers	Site Lighting, Pole, LED
Condition	Good
Qty / UOM	18 / EA
Unit Cost	\$4,630.42
Basis of Costing	Pole Light, Exterior, 135 to 1000 W HID (Fixture Only)
Year in Service	2012
Expected Useful Life (EUL)	20 Year(s), Based on Industry Averages
Remaining Useful Life (RUL)	15 Year(s), Estimated, Based on Date of Observation
Location	Site

Uniformat	Action Description	Quantity	Unit Cost	Plan Type	Priority	Year	Expenditure
G4021	Replace Site Lighting, Pole, LED	18 EA	\$4,630.42	BYL	Priority 3	2032	\$83,347
