FACILITY CONDITION ASSESSMENT

106686.17R000-138.305

July 6, 2017

09437 RANDOLPH INFORMATION CENTER I89 SOUTH
I-89 SOUTHBOUND MILE MARKER 33.5
RANDOLPH, VT 05060

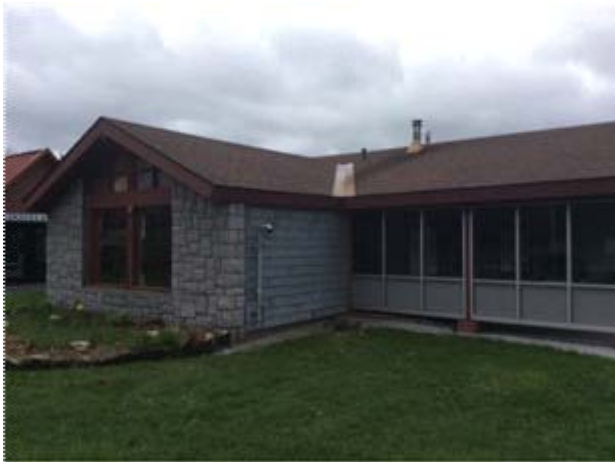
The Asset appears to have been well maintained, as such it is suggested it will exceed its EUL.

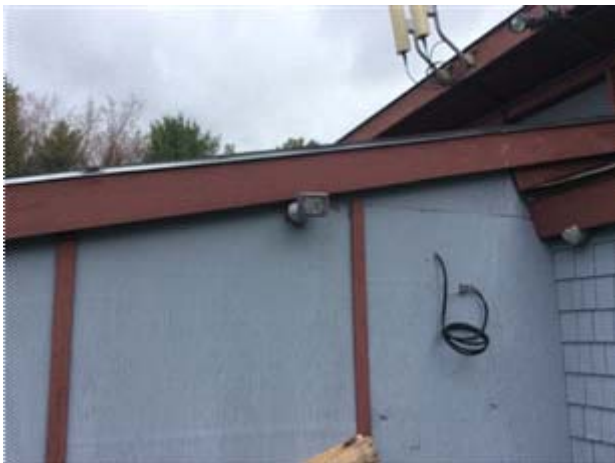
Asset age is unknown but estimated based on observed condition. The Condition and RUL are based on observation only. The Asset appears to be functioning as required.

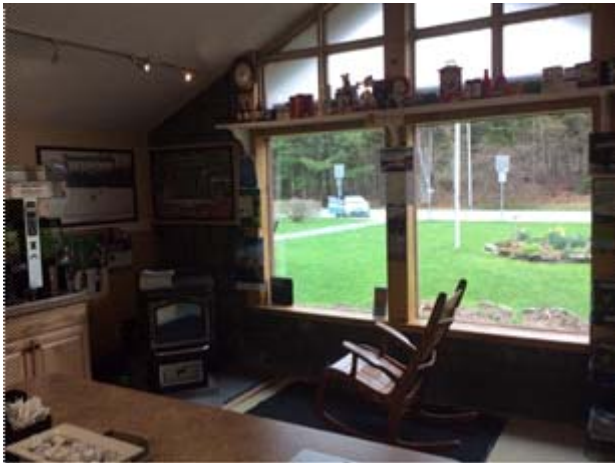
Asset age is unknown but estimated based on observed condition. The Condition and RUL are based on observation only. The Asset appears to be functioning as required.

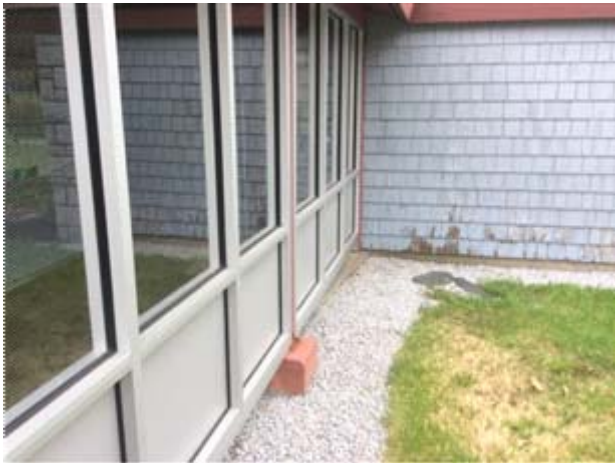
Asset age is unknown but estimated based on observed condition. The Condition and RUL are based on observation only. The Asset appears to be functioning as required.

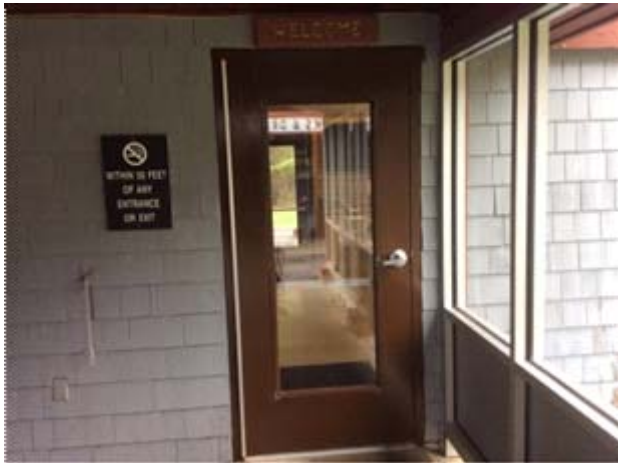
Asset age is unknown but estimated based on observed condition. The Condition and RUL are based on observation only. The Asset appears to be functioning as required.

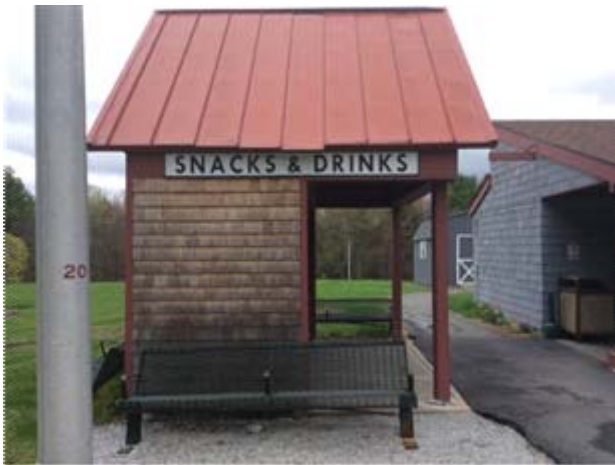
Asset age is unknown but estimated based on observed condition. The Condition and RUL are based on observation only. The Asset appears to be functioning as required.

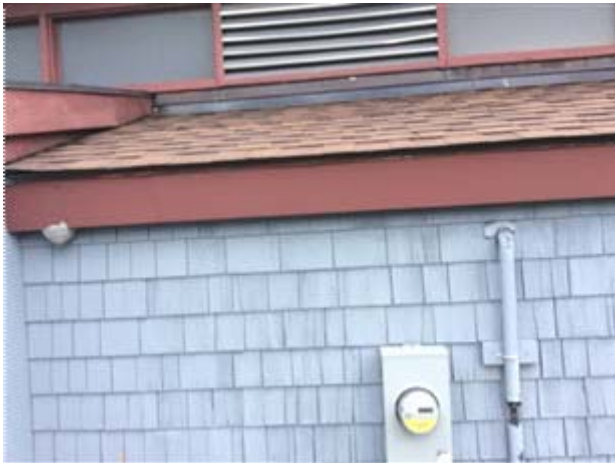
Asset age is unknown but estimated based on observed condition. The Condition and RUL are based on observation only. The Asset appears to be functioning as required.

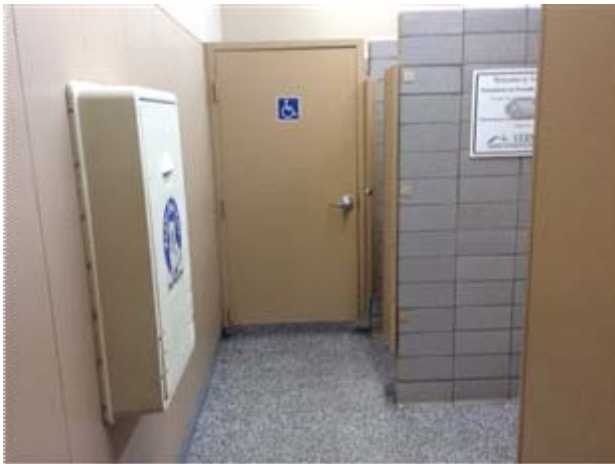
The Asset appears to have been well maintained, as such it is suggested it will exceed its EUL.

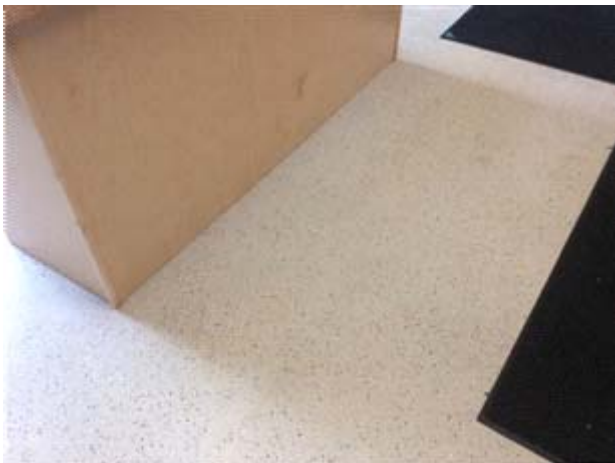
Asset age is unknown but estimated based on observed condition. The Condition and RUL are based on observation only. The Asset appears to be functioning as required.

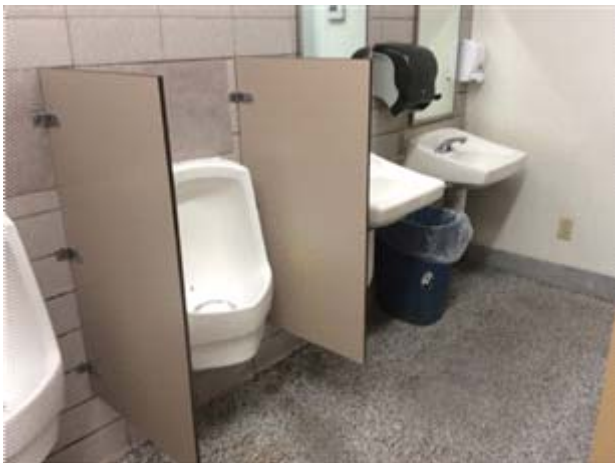
Asset age is unknown but estimated based on observed condition. The Condition and RUL are based on observation only. The Asset appears to be functioning as required.

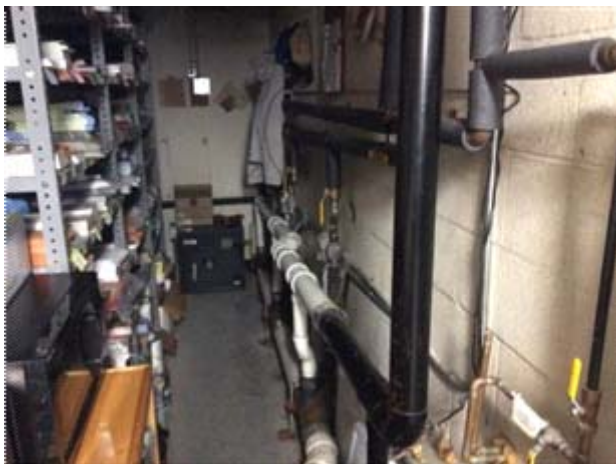
The Asset appears to have been well maintained, or repaired as needed, as such it is suggested it will exceed its EUL.

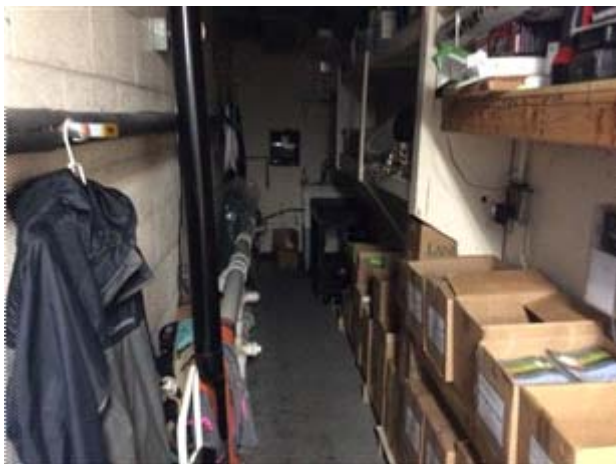
The Asset appears to have been well maintained, or repaired as needed, as such it is suggested it will exceed its EUL.

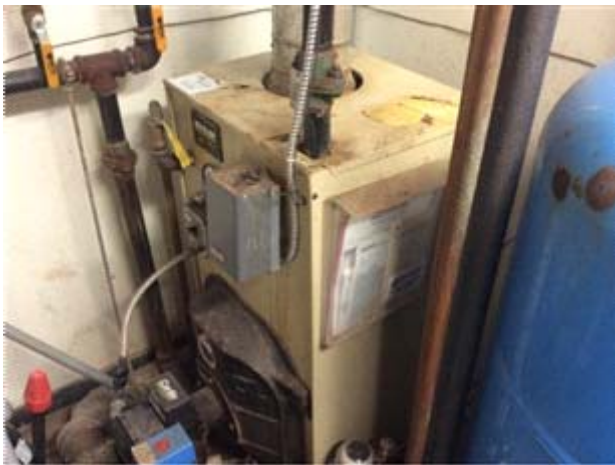
Asset age is unknown but estimated based on observed condition. The Condition and RUL are based on observation only. The Asset appears to be functioning as required.

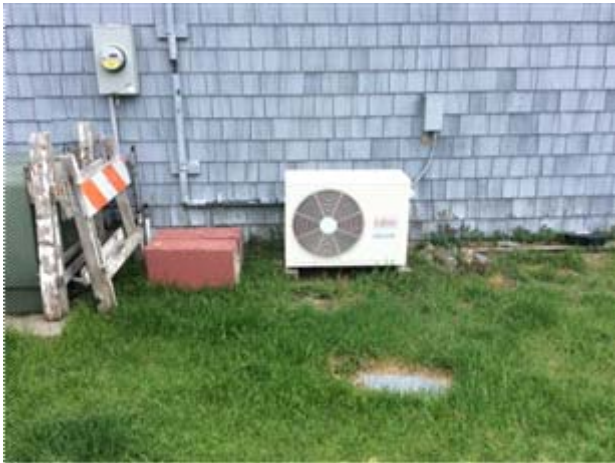
Asset age is unknown but estimated based on observed condition. The Condition and RUL are based on observation only. The Asset appears to be functioning as required.

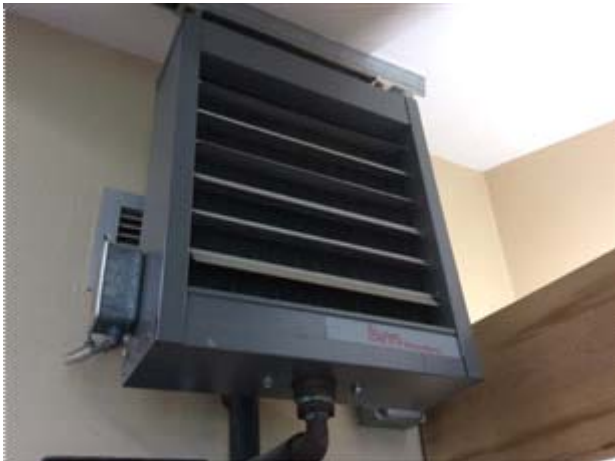
Asset age is unknown but estimated based on observed condition. The Condition and RUL are based on observation only. The Asset appears to be functioning as required.

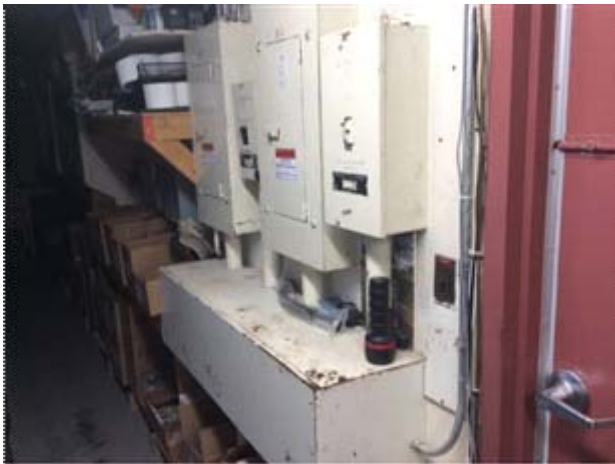
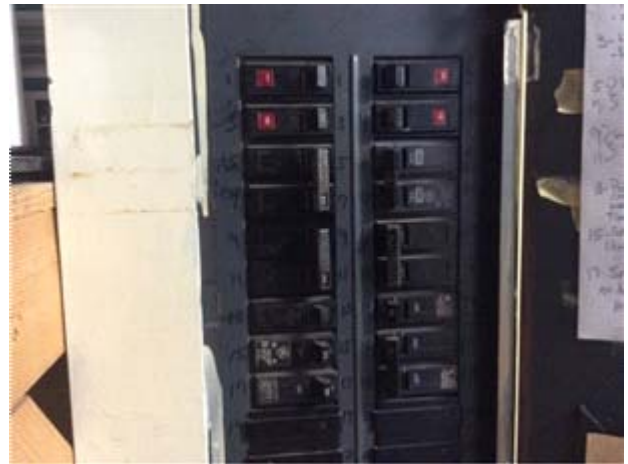
The Asset appears to have been well maintained, or repaired as needed, as such it is suggested it will exceed its EUL.

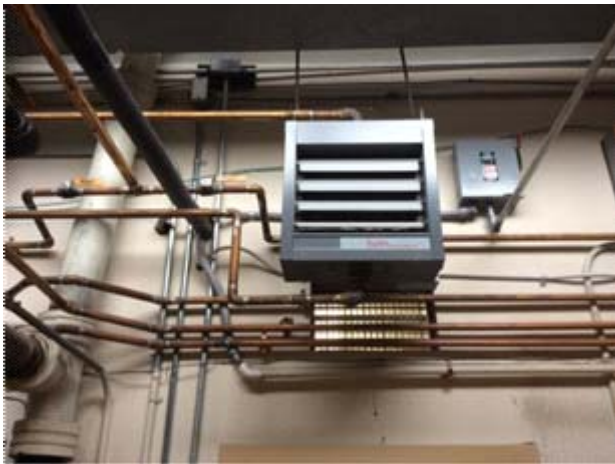
The Asset appears to have been well maintained, or repaired as needed, as such it is suggested it will exceed its EUL.

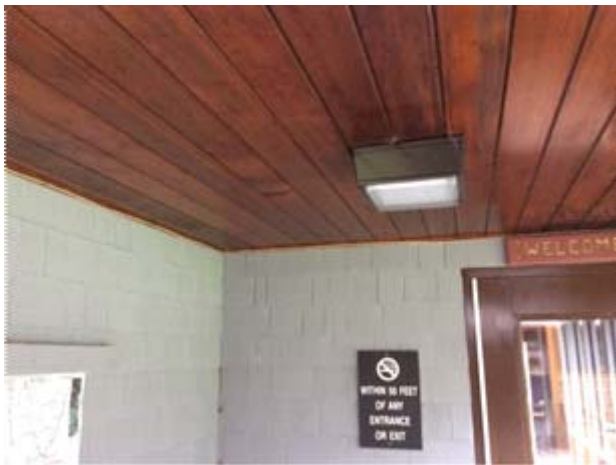
Asset age is unknown but estimated based on observed condition. The Condition and RUL are based on observation only. The Asset appears to be functioning as required.

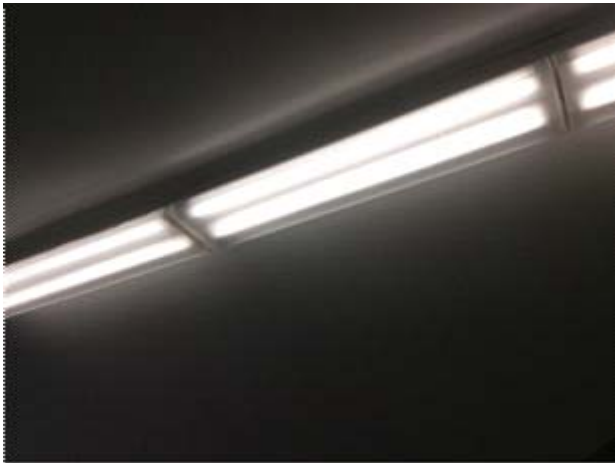
Asset age is unknown but estimated based on observed condition. The Condition and RUL are based on observation only. The Asset appears to be functioning as required.

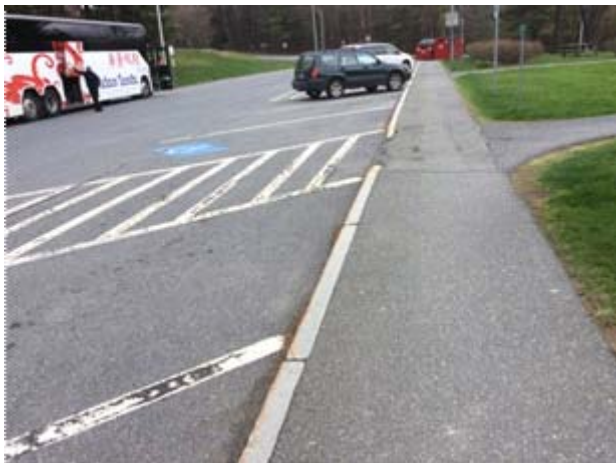
Asset age is unknown but estimated based on observed condition. The Condition and RUL are based on observation only. The Asset appears to be functioning as required.

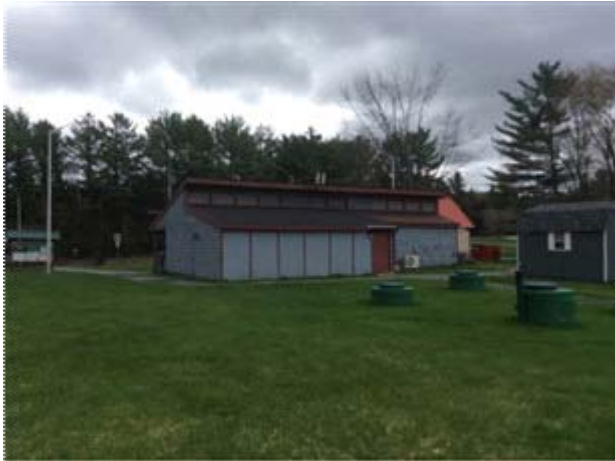
Asset age is unknown but estimated based on observed condition. The Condition and RUL are based on observation only. The Asset appears to be functioning as required.
