FACILITY CONDITION ASSESSMENT

FACILITY CONDITION ASSESSMENT
OF
ALBURGH WELCOME CENTER
70 ROUTE 2 NORTH MAIN STREET
ALBURGH, VT 05440

EMG
10461 Mill Run Circle, Suite 1100
Owings Mills, Maryland 21117
800.733.0660
www.EMGcorp.com

July 2, 2018

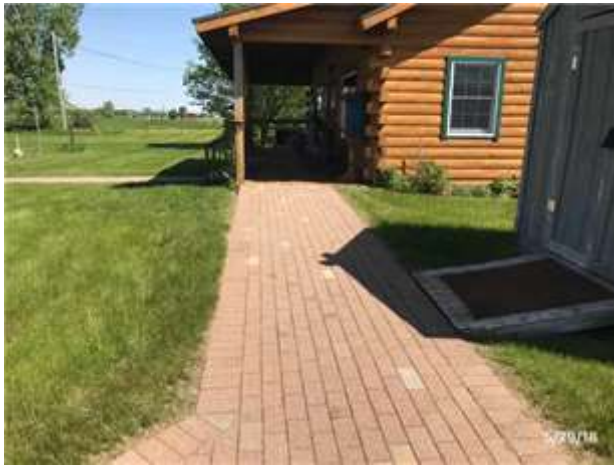
| Coding / Field Name | Asset Description |
|--|--|
| Remaining Useful Life (RUL) | 3 Year(s), Estimated, Based on Date of Observation |
| Location | Exterior Walls |

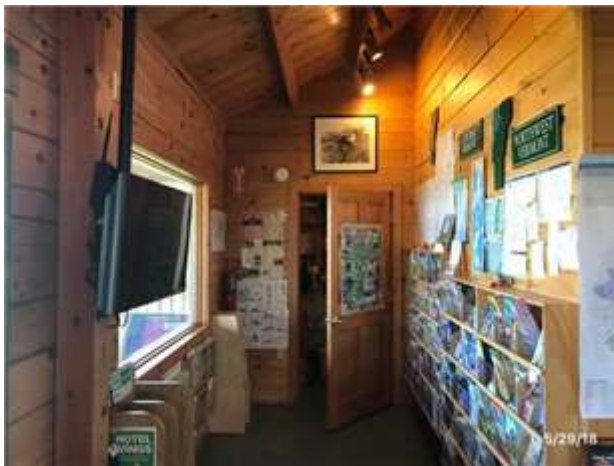
| Coding / Field Name | Asset Description |
|---|--|
| Remaining Useful Life (RUL) | 8 Year(s), Estimated, Based on Date of Observation |
| Location | Building Interior (General) |

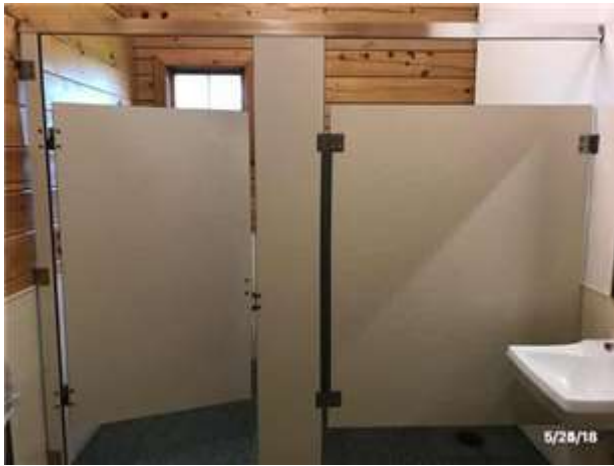
| Coding / Field Name | Asset Description |
|---|--|
| Remaining Useful Life (RUL) | 3 Year(s), Estimated, Based on Date of Observation |
| Location | Restrooms |

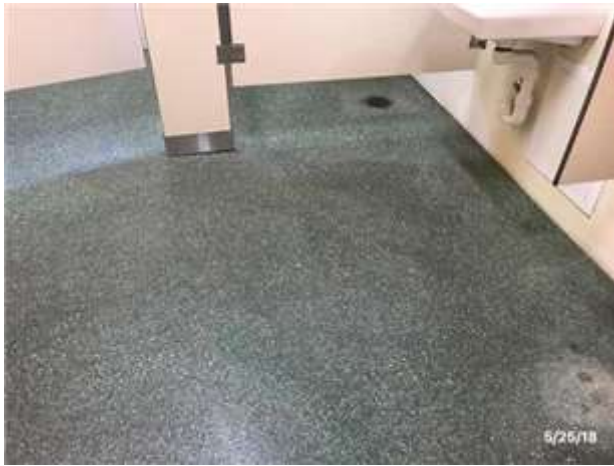
| Coding / Field Name | Asset Description |
|---|--|
| Remaining Useful Life (RUL) | 3 Year(s), Estimated, Based on Date of Observation |
| Location | Building Interior (General) |

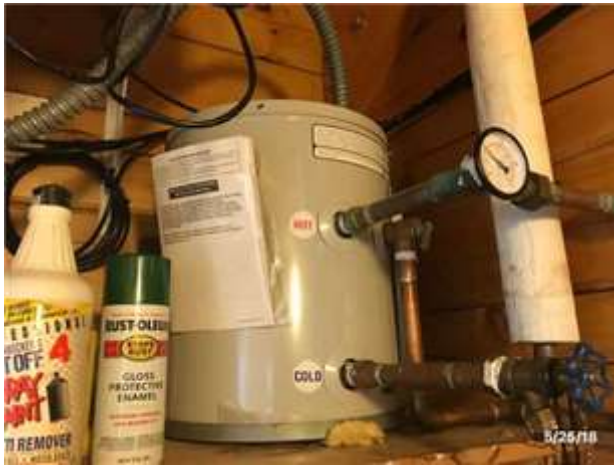
| Coding / Field Name | Asset Description |
|--|--|
| Remaining Useful Life (RUL) | 7 Year(s), Estimated, Based on Date of Observation |
| Location | MEP Closet |

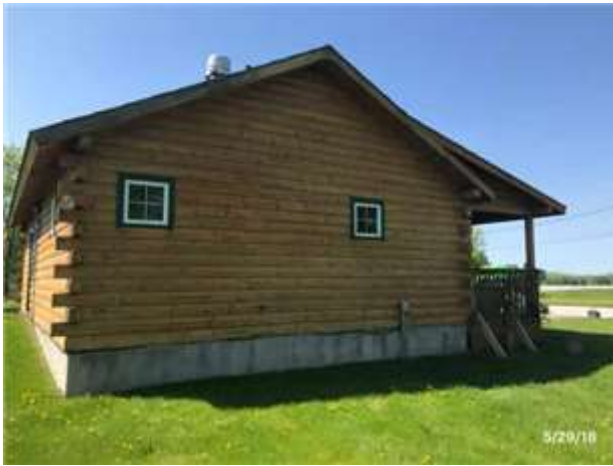
| Coding / Field Name | Asset Description |
|--|--|
| Remaining Useful Life (RUL) | 3 Year(s), Estimated, Based on Date of Observation |
| Location | Roof |

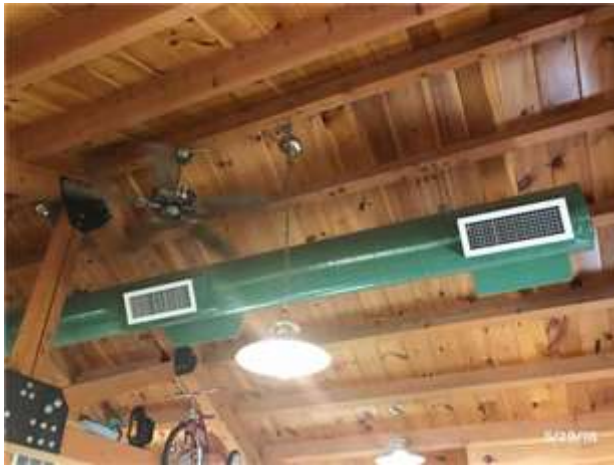
| Coding / Field Name | Asset Description |
|---|--|
| Remaining Useful Life (RUL) | 3 Year(s), Estimated, Based on Date of Observation |
| Location | Building Interior (General) |
