FACILITY CONDITION ASSESSMENT

FACILITY CONDITION ASSESSMENT
OF
WILLISTON NORTH INFORMATION CENTER
I-89 NORTHBOUND MILE MARKER 82
WILLISTON, VT 05495

106686.18R000-170.305

May 30, 2019

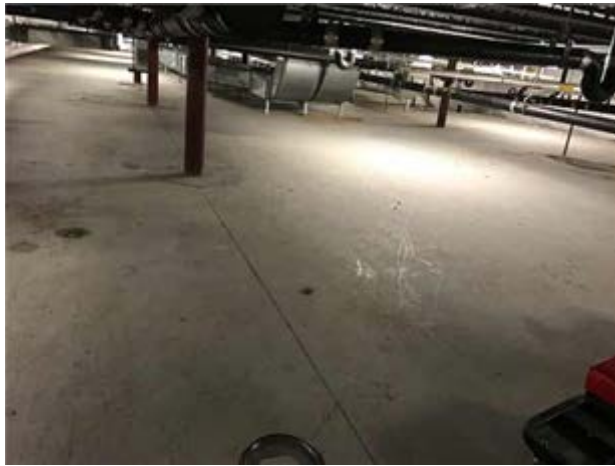
Coding / Field Name	Asset Description
A1011 Wall Foundations	Foundation, Perimeter Wall
Condition	Good
Qty / UOM	300 / LF
Unit Cost	\$105.56
Basis of Costing	Foundation Wall, Concrete or CMU w/ Continuous Footings, 1-2 Stories
Year in Service	2002
Expected Useful Life (EUL)	50 Year(s), Based on Industry Averages
Remaining Useful Life (RUL)	34 Year(s), Estimated, Based on Date of Observation
Location	Structure

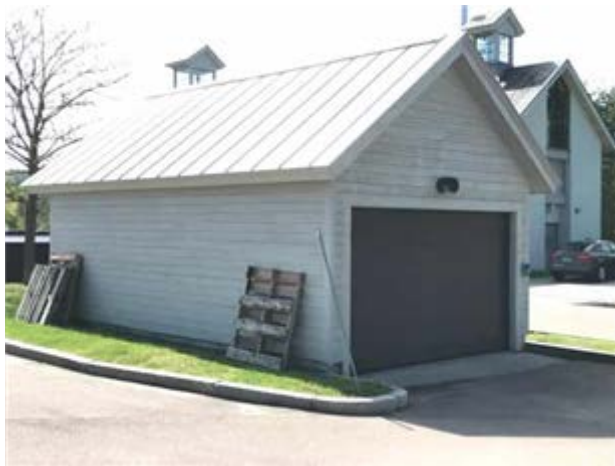
Coding / Field Name	Asset Description
A1031 Standard Slab on Grade	Concrete Slab-On-Grade
Condition	Fair
Qty / UOM	230 / SF
Unit Cost	\$10.44
Basis of Costing	Concrete Slab-On-Grade
Year in Service	2002
Expected Useful Life (EUL)	40 Year(s), Based on Industry Averages
Remaining Useful Life (RUL)	24 Year(s), Estimated, Based on Date of Observation
Location	Storage Building/Map Kiosk

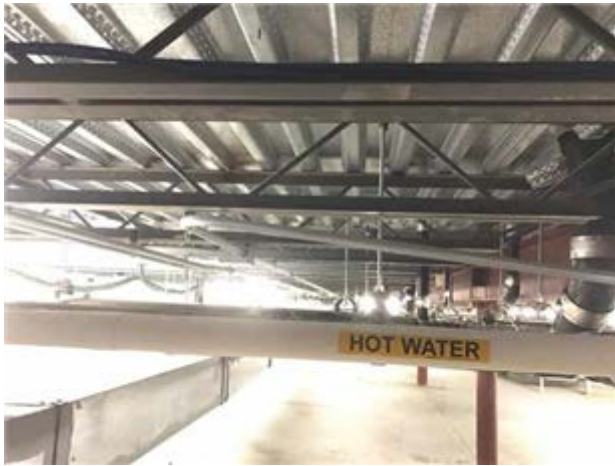
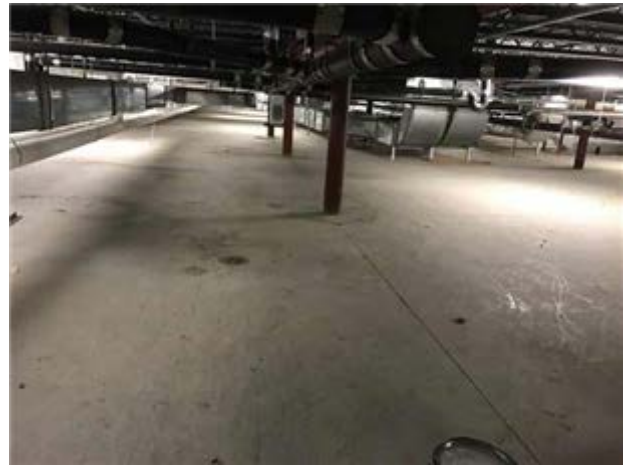
Coding / Field Name	Asset Description
B1012 Upper Floors Construction	Superstructure, Light Gauge Steel with Slab
Condition	Good
Qty / UOM	4588 / SF
Unit Cost	\$24.13
Basis of Costing	Superstructure, Structural Frame, Steel Light Gauge
Year in Service	2002
Expected Useful Life (EUL)	50 Year(s), Based on Industry Averages
Remaining Useful Life (RUL)	34 Year(s), Estimated, Based on Date of Observation
Location	Structure

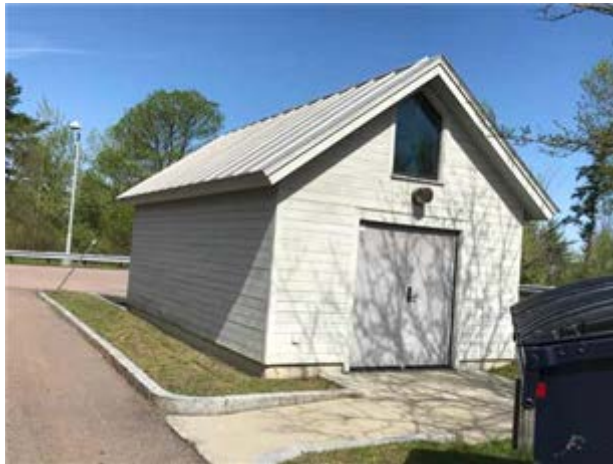
Coding / Field Name	Asset Description
B1022 Pitched Roof Construction	Roof Structure, Pitched, Wood Trusses
Condition	Good
Qty / UOM	230 / SF
Unit Cost	\$18.56
Basis of Costing	Roof Structure, Pitched, Wood Trusses
Year in Service	2002
Expected Useful Life (EUL)	50 Year(s), Based on Industry Averages
Remaining Useful Life (RUL)	34 Year(s), Estimated, Based on Date of Observation
Location	Storage Building/Map Kiosk

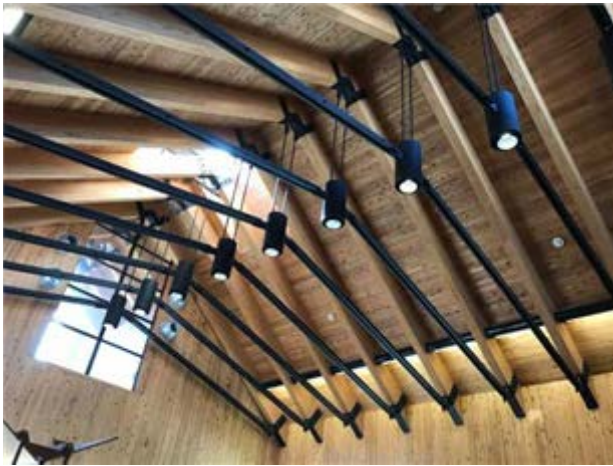
Coding / Field Name	Asset Description
B1022 Pitched Roof Construction	Pitched Roof Construction
Condition	Good
Qty / UOM	4588 / SF
Unit Cost	\$31.32
Basis of Costing	Roof Structure, Pitched, Heavy Timber Framing
Year in Service	2002
Expected Useful Life (EUL)	50 Year(s), Based on Industry Averages
Remaining Useful Life (RUL)	34 Year(s), Estimated, Based on Date of Observation
Location	Mechanical Room

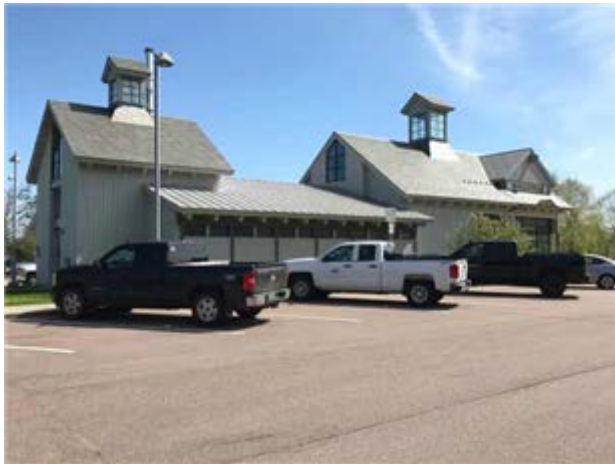
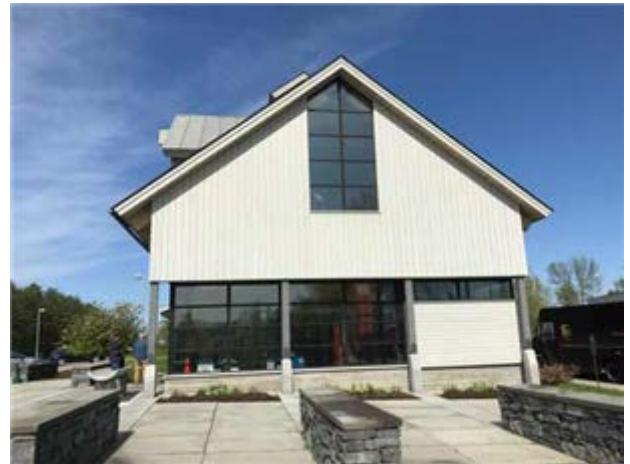
Coding / Field Name	Asset Description
B2011 Exterior Wall Construction	Wood Vertical Board, Exterior Siding
Condition	Fair
Qty / UOM	3200 / SF
Unit Cost	\$28.04
Basis of Costing	Wood Clapboard, Exterior, 3+ Stories
Year in Service	2002
Expected Useful Life (EUL)	20 Year(s), Based on Industry Averages
Remaining Useful Life (RUL)	15 Year(s), Estimated, Based on Date of Observation
Location	Exterior Walls

Uniformat	Action Description	Quantity	Unit Cost	Plan Type	Priority	Year	Expenditure
B2011	Prep & Paint Exterior Walls	3,200 SF	\$1.41	APP	Priority 3	2019	\$4,512
B2011	Prep & Paint Exterior Walls	3,200 SF	\$1.41	APP	Priority 3	2029	\$4,512
B2011	Replace Wood Vertical Board, Exterior Siding	3,200 SF	\$28.04	BYL	Priority 3	2034	\$89,719

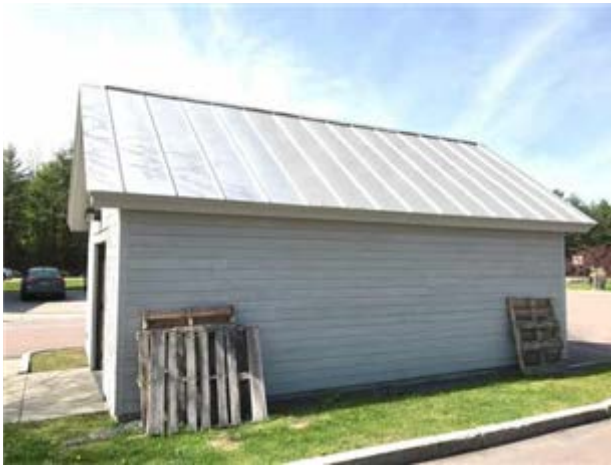
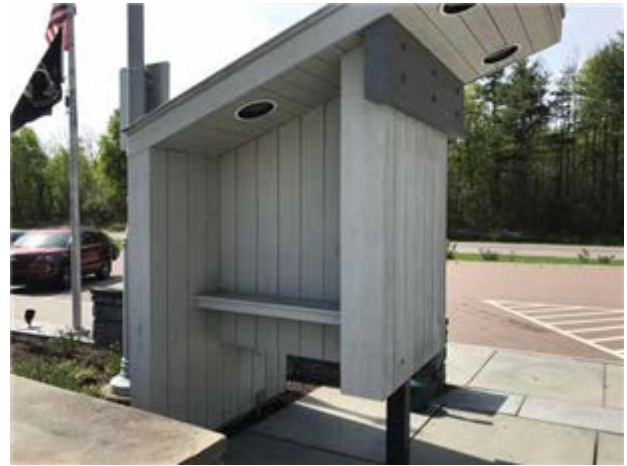
Coding / Field Name	Asset Description
B2011 Exterior Wall Construction	Wood Vertical Board, Exterior Siding
Condition	Fair
Qty / UOM	550 / SF
Unit Cost	\$28.04
Basis of Costing	Wood Clapboard, Exterior, 3+ Stories
Year in Service	2002
Expected Useful Life (EUL)	20 Year(s), Based on Industry Averages
Remaining Useful Life (RUL)	21 Year(s), Estimated, Based on Date of Observation
Location	Storage Building/Map Kiosk

Uniformat	Action Description	Quantity	Unit Cost	Plan Type	Priority	Year	Expenditure
B2011	Prep & Paint Exterior Walls	550 SF	\$1.24	APP	Priority 3	2023	\$682
B2011	Prep & Paint Exterior Walls	550 SF	\$1.24	APP	Priority 3	2033	\$682

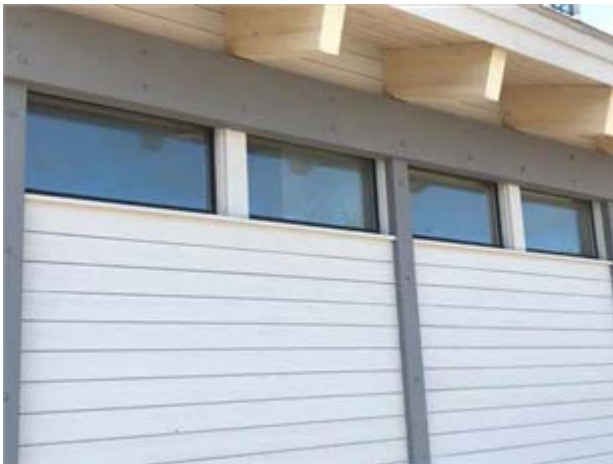
Coding / Field Name	Asset Description
B2021 Windows	Aluminum Window, Double Glazed, Fixed
Condition	Fair
Qty / UOM	14 / EA
Unit Cost	\$1,051.57
Basis of Costing	Aluminum Window, Double Glazed, 1-2 Stories, 12 SF
Year in Service	2002
Expected Useful Life (EUL)	30 Year(s), Based on Industry Averages
Remaining Useful Life (RUL)	14 Year(s), Estimated, Based on Date of Observation
Location	Exterior Walls
Windows Material	Aluminum
Windows Glazing	Double Glazed

Uniformat	Action Description	Quantity	Unit Cost	Plan Type	Priority	Year	Expenditure
B2021	Replace Aluminum Window, Double Glazed, Fixed	14 EA	\$1,051.57	BYL	Priority 3	2033	\$14,722

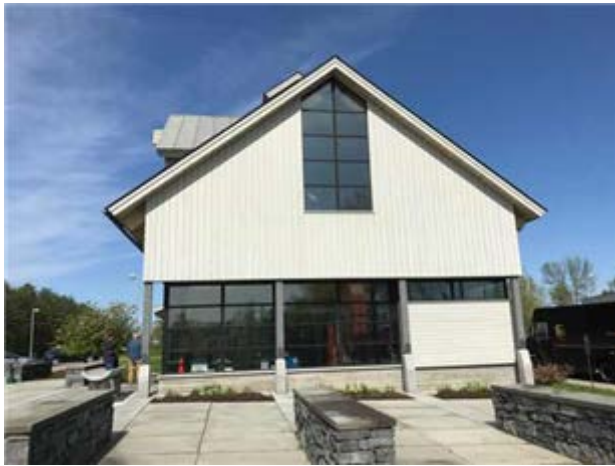
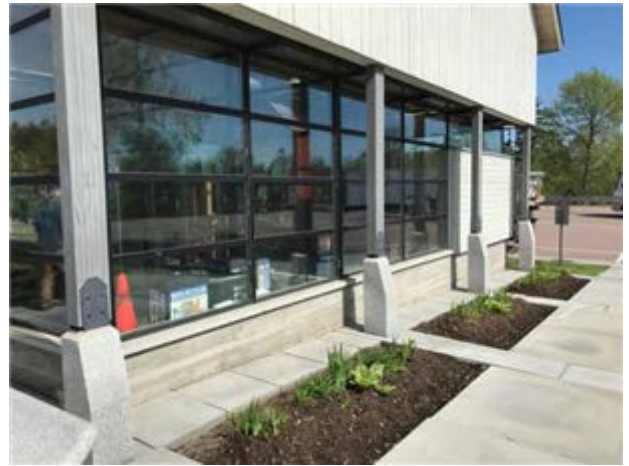
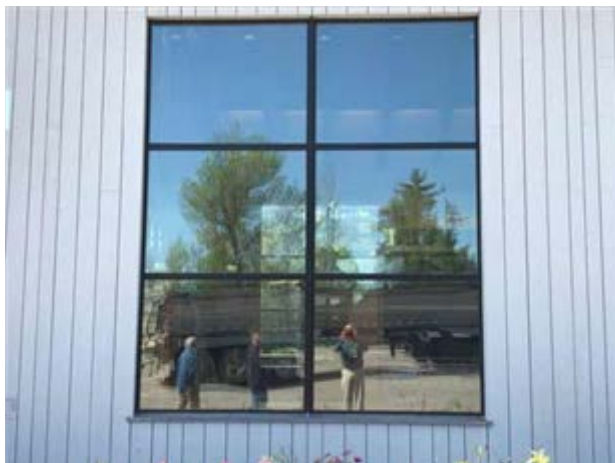
Coding / Field Name	Asset Description
B2022 Curtain Walls	Storefront Glazing & Framing
Condition	Fair
Qty / UOM	500 / SF
Unit Cost	\$87.21
Basis of Costing	Glass Curtain Wall
Year in Service	2002
Expected Useful Life (EUL)	30 Year(s), Based on Industry Averages
Remaining Useful Life (RUL)	14 Year(s), Estimated, Based on Date of Observation
Location	Exterior Walls
Window Type	Fixed
Windows Material	Aluminum
Windows Glazing	Double Glazed
Window Operation	Fixed

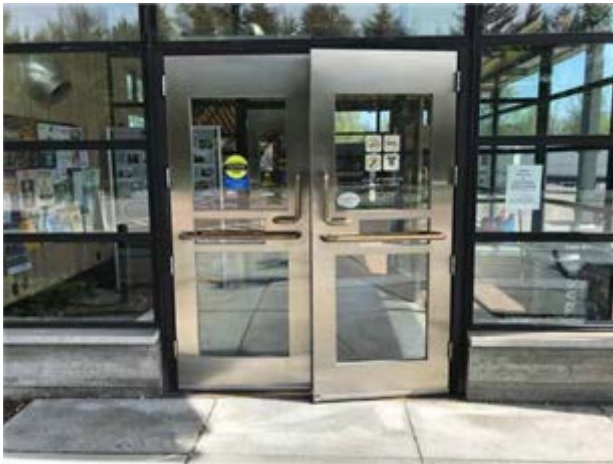
Coding / Field Name	Asset Description
B2031 Glazed Doors & Entrances	Glazed Entrance Doors
Condition	Fair
Qty / UOM	4 / EA
Unit Cost	\$10,194.36
Basis of Costing	Metal, Swinging Doors, Motor-Operated
Year in Service	2002
Expected Useful Life (EUL)	30 Year(s), Based on Industry Averages
Remaining Useful Life (RUL)	14 Year(s), Estimated, Based on Date of Observation
Location	Exterior Walls

Uniformat	Action Description	Quantity	Unit Cost	Plan Type	Priority	Year	Expenditure
B2031	Replace Glazed Entrance Doors	4 EA	\$10,194.36	BYL	Priority 3	2033	\$40,777

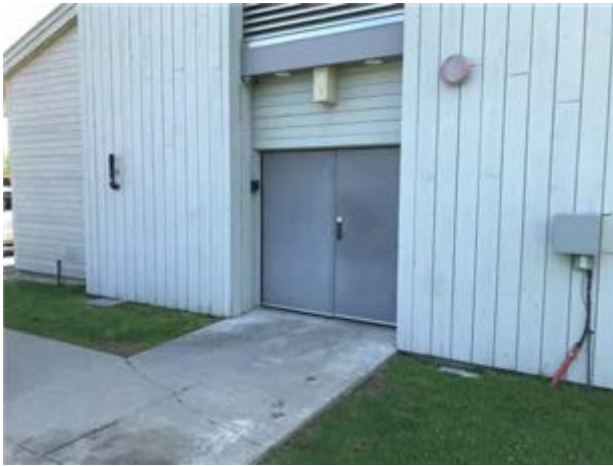
Coding / Field Name	Asset Description
B2032 Solid Exterior Doors	Steel, Exterior Door
Condition	Fair
Qty / UOM	2 / EA
Unit Cost	\$950.12
Basis of Costing	Steel, Exterior Door
Year in Service	2002
Expected Useful Life (EUL)	25 Year(s), Based on Industry Averages
Remaining Useful Life (RUL)	9 Year(s), Estimated, Based on Date of Observation
Location	Exterior Walls

Uniformat	Action Description	Quantity	Unit Cost	Plan Type	Priority	Year	Expenditure
B2032	Replace Steel, Exterior Door	2 EA	\$950.12	BYL	Priority 3	2028	\$1,900

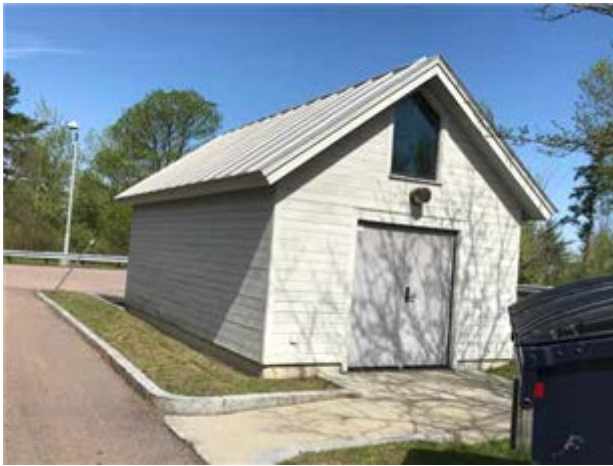
Coding / Field Name	Asset Description
B2032 Solid Exterior Doors	Steel, Exterior Door
Condition	Fair
Qty / UOM	2 / EA
Unit Cost	\$950.12
Basis of Costing	Steel, Exterior Door
Year in Service	2002
Expected Useful Life (EUL)	25 Year(s), Based on Industry Averages
Remaining Useful Life (RUL)	9 Year(s), Estimated, Based on Date of Observation
Location	Storage Building/Map Kiosk

Uniformat	Action Description	Quantity	Unit Cost	Plan Type	Priority	Year	Expenditure
B2032	Replace Steel, Exterior Door	2 EA	\$950.12	BYL	Priority 3	2028	\$1,900

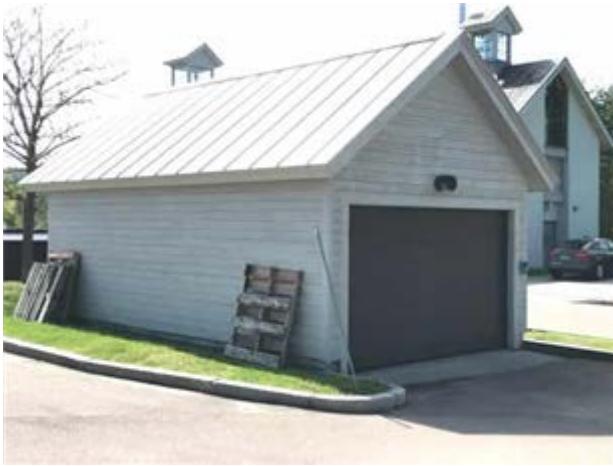
Coding / Field Name	Asset Description
B2034 Overhead Doors	Aluminum Roll-up Door
Condition	Fair
Qty / UOM	1 / EA
Unit Cost	\$4,025.54
Basis of Costing	Aluminum Roll-up Door, 144 SF
Year in Service	2002
Expected Useful Life (EUL)	35 Year(s), Based on Industry Averages
Remaining Useful Life (RUL)	19 Year(s), Estimated, Based on Date of Observation
Location	Storage Building/Map Kiosk

Uniformat	Action Description	Quantity	Unit Cost	Plan Type	Priority	Year	Expenditure
B2034	Replace Aluminum Roll-up Door	1 EA	\$4,025.54	BYL	Priority 3	2038	\$4,026

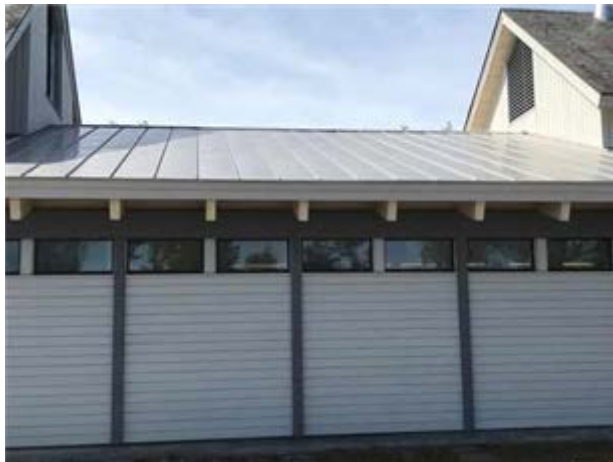
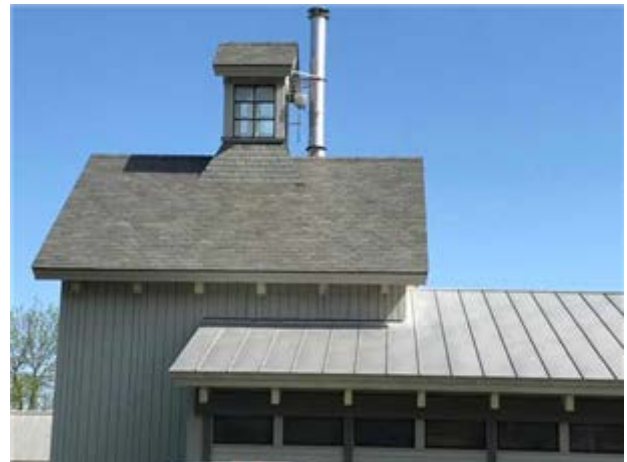
Coding / Field Name	Asset Description
B3011 Roof Finishes	Metal Roof
Condition	Fair
Qty / UOM	2400 / SF
Unit Cost	\$32.41
Basis of Costing	Metal Roof (Includes Tear-Off of Old)
Year in Service	2002
Expected Useful Life (EUL)	40 Year(s), Based on Industry Averages
Remaining Useful Life (RUL)	24 Year(s), Estimated, Based on Date of Observation
Location	Roof
Flashings and Trim	Metal
Roof Eaves and Soffits	Yes
Roof Drainage	Drains Over The Eaves
Roof Warranty	Unknown

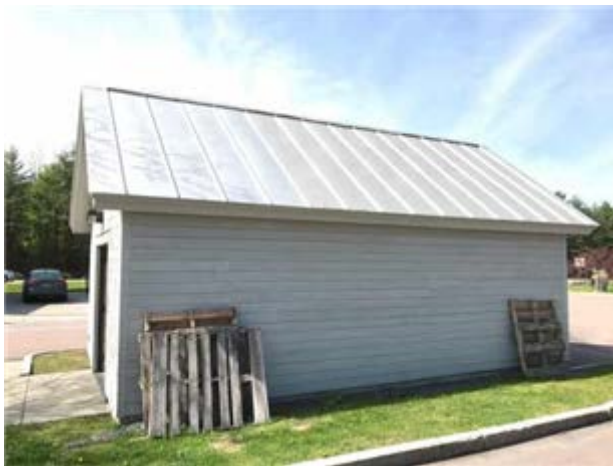
Coding / Field Name	Asset Description
B3011 Roof Finishes	Metal Roof
Condition	Fair
Qty / UOM	300 / SF
Unit Cost	\$32.41
Basis of Costing	Metal Roof (Includes Tear-Off of Old)
Year in Service	2002
Expected Useful Life (EUL)	40 Year(s), Based on Industry Averages
Remaining Useful Life (RUL)	24 Year(s), Estimated, Based on Date of Observation
Location	Storage Building/Map Kiosk
Flashings and Trim	Metal
Roof Eaves and Soffits	Yes
Roof Drainage	Drains Over The Eaves
Roof Warranty	Unknown

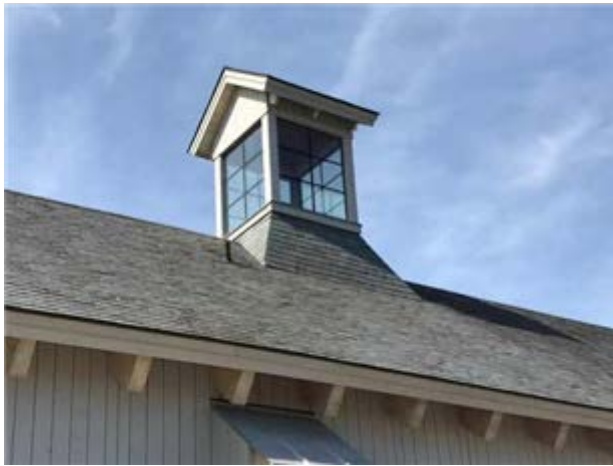
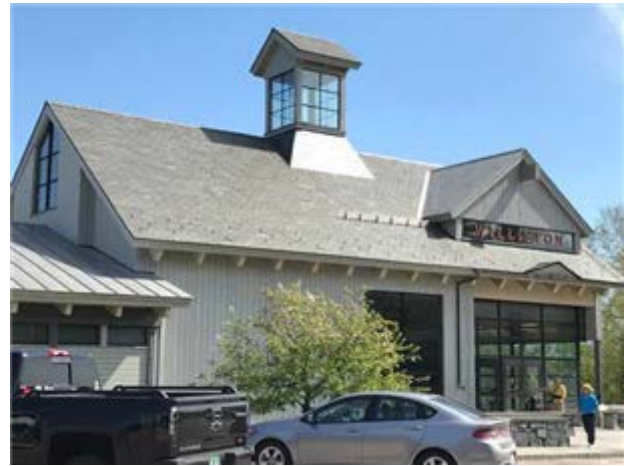
Coding / Field Name	Asset Description
B3011 Roof Finishes	Roof, Slate
Condition	Fair
Qty / UOM	2200 / SF
Unit Cost	\$29.80
Basis of Costing	Slate Steep Roof (Includes Tear-Off of Old)
Year in Service	2002
Expected Useful Life (EUL)	40 Year(s), Based on Industry Averages
Remaining Useful Life (RUL)	24 Year(s), Estimated, Based on Date of Observation
Location	Roof
Flashings and Trim	Metal
Roof Eaves and Soffits	Yes
Roof Drainage	Drains Over The Eaves
Roof Warranty	Unknown

Uniformat	Action Description	Quantity	Unit Cost	Plan Type	Priority	Year	Expenditure
B3011	Slate Steep Roofing, Minor Tile - (2.5% of Roof Area)	60 SF	\$56.36	MNT	Priority 2	2019	\$3,382
B3011	Slate Steep Roofing, Minor Tile - (2.5% of Roof Area)	60 SF	\$56.36	MNT	Priority 2	2024	\$3,382
B3011	Slate Steep Roofing, Minor Tile - (2.5% of Roof Area)	60 SF	\$56.36	MNT	Priority 2	2029	\$3,382
B3011	Slate Steep Roofing, Minor Tile - (2.5% of Roof Area)	60 SF	\$56.36	MNT	Priority 2	2034	\$3,382

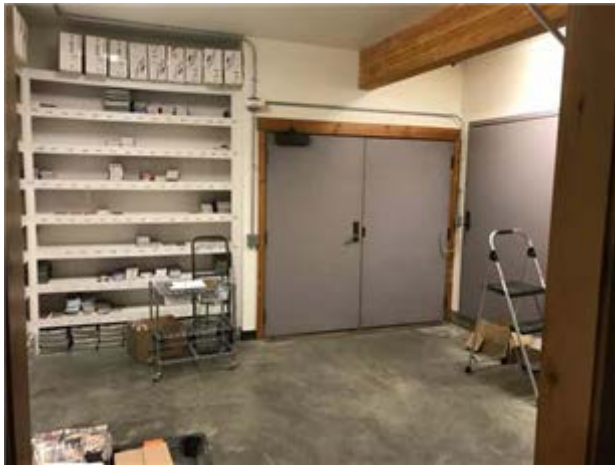
Coding / Field Name	Asset Description
C1021 Interior Doors	Interior Door, Steel
Condition	Fair
Qty / UOM	3 / EA
Unit Cost	\$950.12
Basis of Costing	Steel, Interior Door
Year in Service	2002
Expected Useful Life (EUL)	25 Year(s), Based on Industry Averages
Remaining Useful Life (RUL)	9 Year(s), Estimated, Based on Date of Observation
Location	Building Interior (General)

Uniformat	Action Description	Quantity	Unit Cost	Plan Type	Priority	Year	Expenditure
C1021	Replace Interior Door, Steel	3 EA	\$950.12	BYL	Priority 3	2028	\$2,850

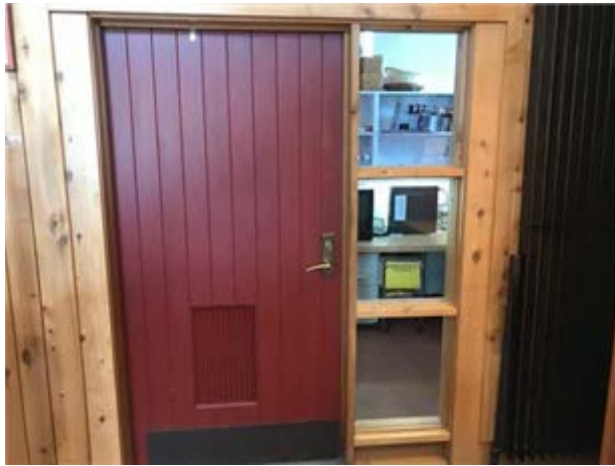
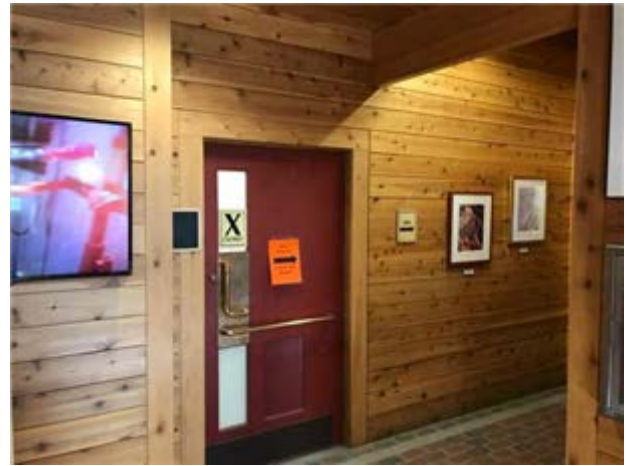
Coding / Field Name	Asset Description
C1021 Interior Doors	Interior Doors, Wood
Condition	Fair
Qty / UOM	8 / EA
Unit Cost	\$1,423.11
Basis of Costing	Wood, Solid Core, Painted/Stained, Interior Door
Year in Service	2002
Expected Useful Life (EUL)	20 Year(s), Based on Industry Averages
Remaining Useful Life (RUL)	10 Year(s), Estimated, Based on Date of Observation
Location	Building Interior (General)

Uniformat	Action Description	Quantity	Unit Cost	Plan Type	Priority	Year	Expenditure
C1021	Replace Interior Doors, Wood	8 EA	\$1,423.11	BYL	Priority 3	2029	\$11,385

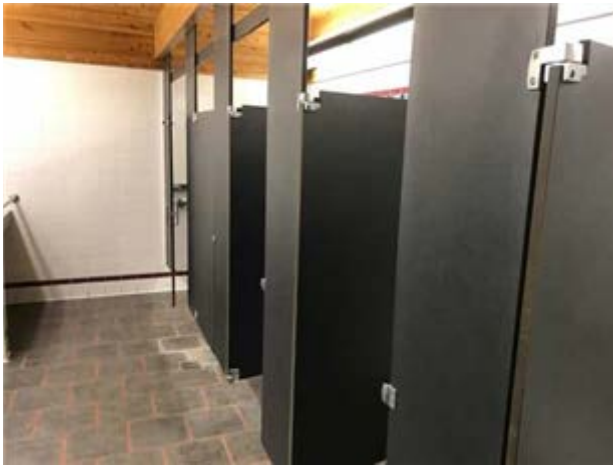
Coding / Field Name	Asset Description
C1031 Fabricated Toilet Partitions	Toilet Partitions, Laminated Wood
Condition	Fair
Qty / UOM	18 / EA
Unit Cost	\$465.02
Basis of Costing	Toilet Partitions, Wood
Year in Service	2002
Expected Useful Life (EUL)	20 Year(s), Based on Industry Averages
Remaining Useful Life (RUL)	7 Year(s), Estimated, Based on Date of Observation
Location	Restrooms

Uniformat	Action Description	Quantity	Unit Cost	Plan Type	Priority	Year	Expenditure
C1031	Replace Toilet Partitions, Laminated Wood	18 EA	\$465.02	BYL	Priority 3	2026	\$8,370

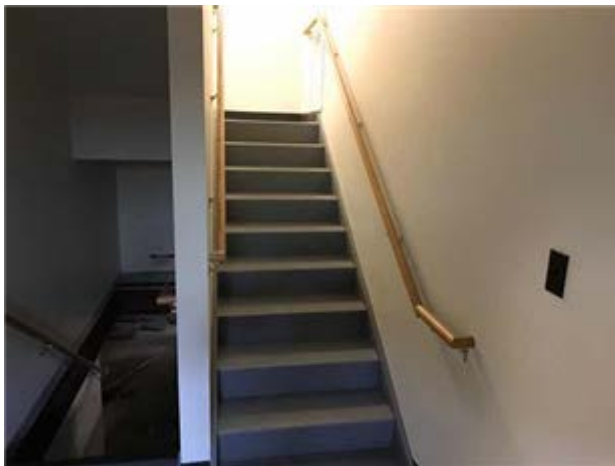
Coding / Field Name	Asset Description
C2011 Regular Stairs	Stairs, Wood
Condition	Fair
Qty / UOM	100 / SF
Unit Cost	\$45.09
Basis of Costing	Wood, Interior Stairs
Year in Service	2002
Expected Useful Life (EUL)	30 Year(s), Based on Industry Averages
Remaining Useful Life (RUL)	21 Year(s), Estimated, Based on Date of Observation
Location	Crawlspace

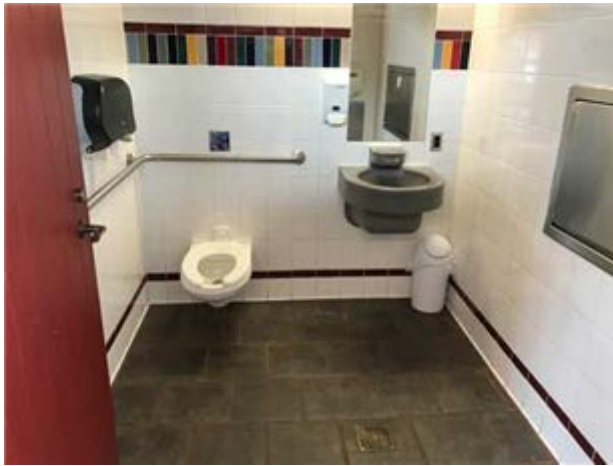
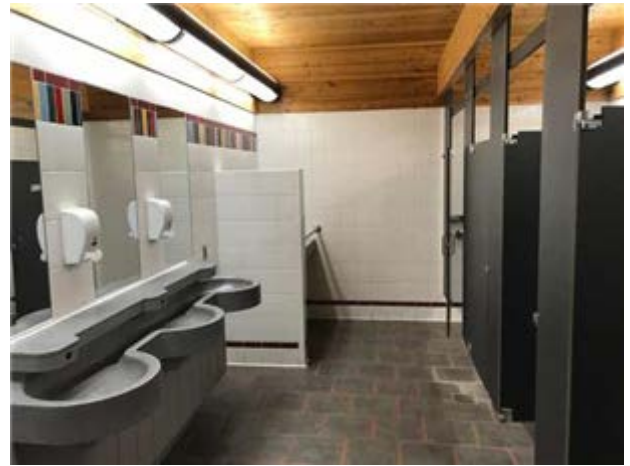
Coding / Field Name	Asset Description
C3012 Wall Finishes to Interior Walls	Ceramic Tile, Interior Wall Finish
Condition	Fair
Qty / UOM	1850 / SF
Unit Cost	\$16.55
Basis of Costing	Ceramic Tile, Interior Wall Finish
Year in Service	2002
Expected Useful Life (EUL)	25 Year(s), Based on Industry Averages
Remaining Useful Life (RUL)	15 Year(s), Estimated, Based on Date of Observation
Location	Restrooms

Uniformat	Action Description	Quantity	Unit Cost	Plan Type	Priority	Year	Expenditure
C3012	Replace Ceramic Tile, Interior Wall Finish	1,850 SF	\$16.55	BYL	Priority 4	2034	\$30,625

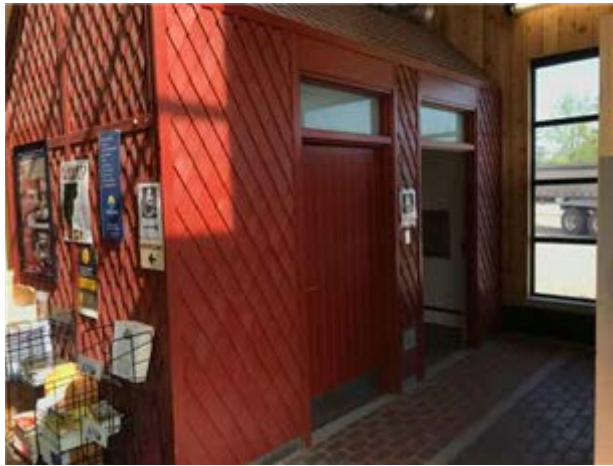
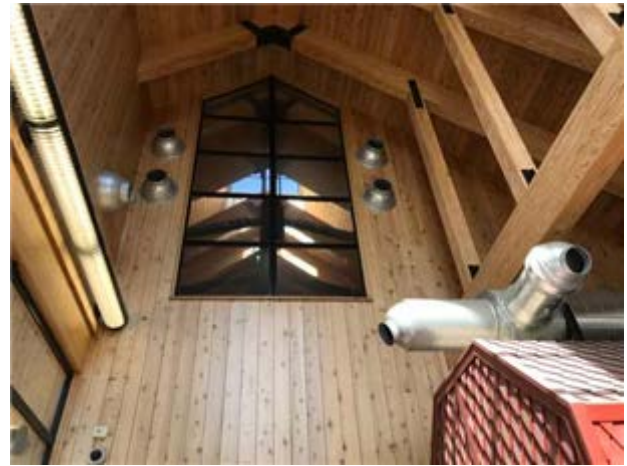
Coding / Field Name	Asset Description
C3012 Wall Finishes to Interior Walls	Interior Wall, Wood, Shiplap
Condition	Fair
Qty / UOM	2400 / SF
Unit Cost	\$23.73
Basis of Costing	Wood, Finished, Interior Paneling
Year in Service	2002
Expected Useful Life (EUL)	20 Year(s), Based on Industry Averages
Remaining Useful Life (RUL)	4 Year(s), Estimated, Based on Date of Observation
Location	Building Interior (General)

Uniformat	Action Description	Quantity	Unit Cost	Plan Type	Priority	Year	Expenditure
C3012	Paint wood walls	200 SF	\$1.24	APP	Priority 4	2023	\$248
C3012	Refinish natural wood walls	2,000 SF	\$1.24	APP	Priority 4	2027	\$2,480
C3012	Paint wood walls	200 SF	\$1.24	APP	Priority 4	2033	\$248

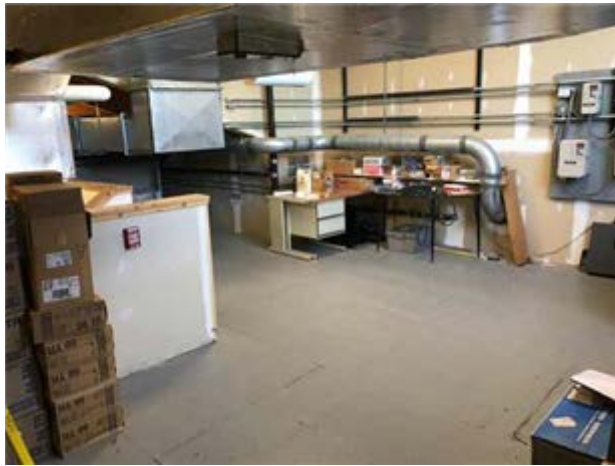
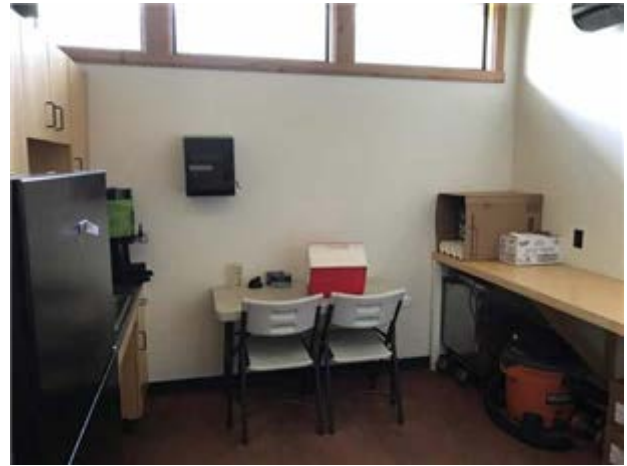
Coding / Field Name	Asset Description
C3012 Wall Finishes to Interior Walls	Gypsum Board, Wall
Condition	Fair
Qty / UOM	1800 / SF
Unit Cost	\$3.38
Basis of Costing	Gypsum Board/Plaster, Interior Wall
Year in Service	2002
Expected Useful Life (EUL)	40 Year(s), Based on Industry Averages
Remaining Useful Life (RUL)	24 Year(s), Estimated, Based on Date of Observation
Location	Building Interior (General)

Uniformat	Action Description	Quantity	Unit Cost	Plan Type	Priority	Year	Expenditure
C3012	Paint Interior Walls	1,800 SF	\$1.42	APP	Priority 4	2023	\$2,556
C3012	Paint Interior Walls	1,800 SF	\$1.42	APP	Priority 4	2031	\$2,556

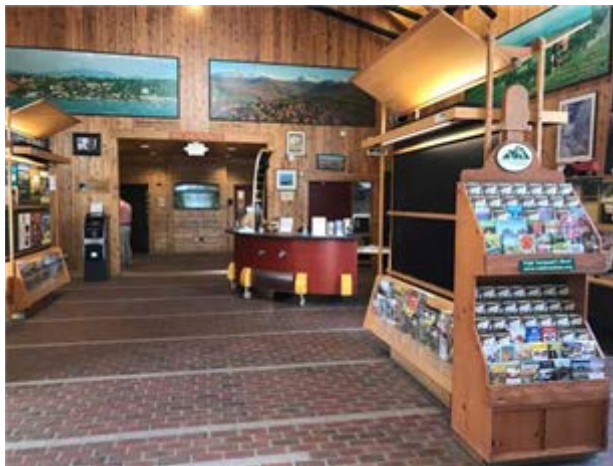
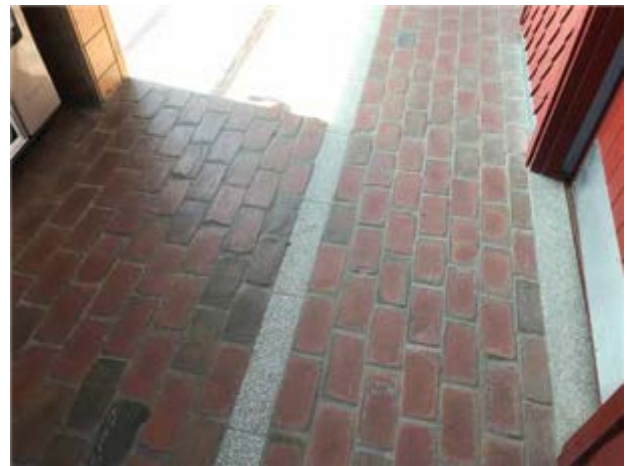
Coding / Field Name	Asset Description
C3024 Flooring	Clay Brick Flooring
Condition	Fair
Qty / UOM	1130 / SF
Unit Cost	\$42.65
Basis of Costing	Clay Brick Flooring
Year in Service	2002
Expected Useful Life (EUL)	50 Year(s), Based on Industry Averages
Remaining Useful Life (RUL)	34 Year(s), Estimated, Based on Date of Observation
Location	Building Interior (General)

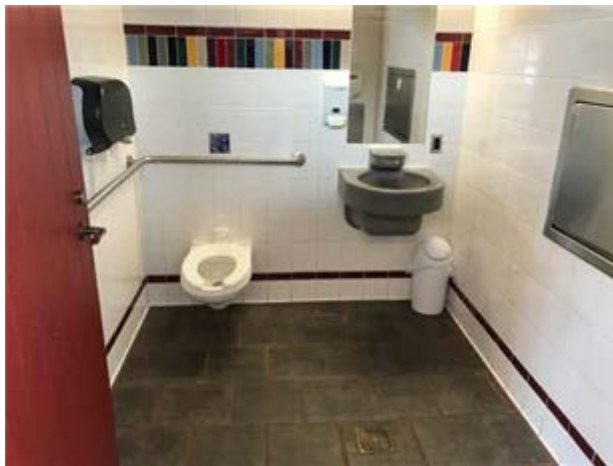
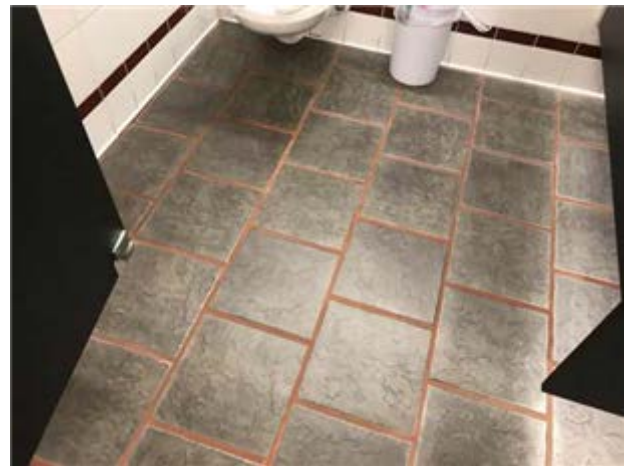
Coding / Field Name	Asset Description
C3024 Flooring	Quarry Tile Flooring
Condition	Fair
Qty / UOM	650 / SF
Unit Cost	\$15.19
Basis of Costing	Quarry Tile Flooring
Year in Service	2002
Expected Useful Life (EUL)	50 Year(s), Based on Industry Averages
Remaining Useful Life (RUL)	34 Year(s), Estimated, Based on Date of Observation
Location	Restrooms

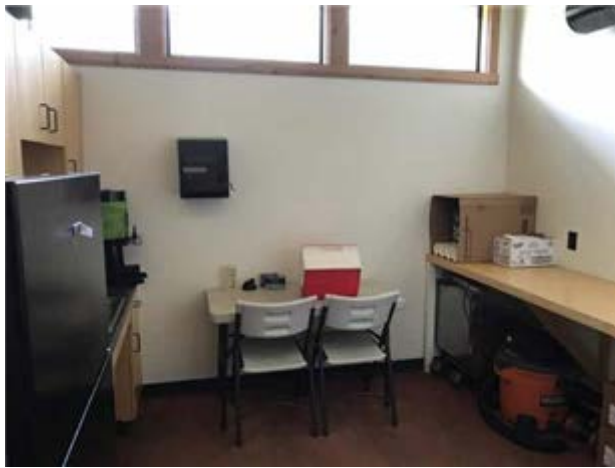
Coding / Field Name	Asset Description
C3024 Flooring	Vinyl Sheet Flooring
Condition	Fair
Qty / UOM	320 / SF
Unit Cost	\$7.01
Basis of Costing	Vinyl Sheet Flooring
Year in Service	2002
Expected Useful Life (EUL)	15 Year(s), Based on Industry Averages
Remaining Useful Life (RUL)	3 Year(s), Estimated, Based on Date of Observation
Location	Building Interior (General)

Uniformat	Action Description	Quantity	Unit Cost	Plan Type	Priority	Year	Expenditure
C3024	Replace Vinyl Sheet Flooring	320 SF	\$7.01	BYL	Priority 3	2022	\$2,243
C3024	Replace Vinyl Sheet Flooring	320 SF	\$7.01	BYL	Priority 3	2037	\$2,243

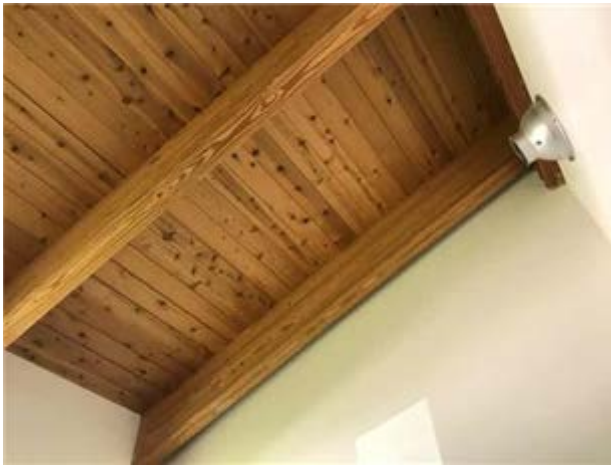
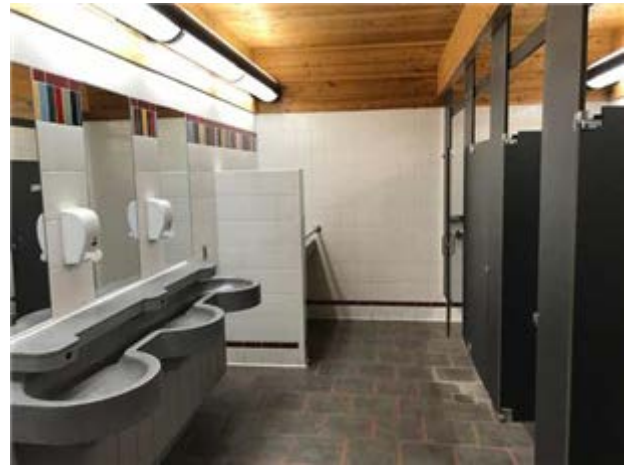
Coding / Field Name	Asset Description
C3031 Ceiling Finishes	Wood Ceiling
Condition	Fair
Qty / UOM	4100 / SF
Unit Cost	\$9.22
Basis of Costing	Wood Ceiling
Year in Service	2002
Expected Useful Life (EUL)	30 Year(s), Based on Industry Averages
Remaining Useful Life (RUL)	14 Year(s), Estimated, Based on Date of Observation
Location	Building Interior (General)

Uniformat	Action Description	Quantity	Unit Cost	Plan Type	Priority	Year	Expenditure
C3031	Refinish wood ceilings	4,100 SF	\$1.24	APP	Priority 4	2027	\$5,084

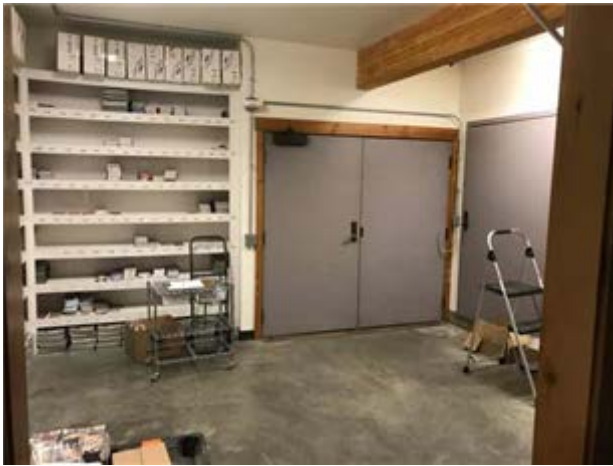
Coding / Field Name	Asset Description
C3031 Ceiling Finishes	Gypsum Board Ceiling
Condition	Fair
Qty / UOM	325 / SF
Unit Cost	\$7.13
Basis of Costing	Gypsum Board/Plaster, Ceiling
Year in Service	2002
Expected Useful Life (EUL)	50 Year(s), Based on Industry Averages
Remaining Useful Life (RUL)	34 Year(s), Estimated, Based on Date of Observation
Location	Building Interior (General)

Uniformat	Action Description	Quantity	Unit Cost	Plan Type	Priority	Year	Expenditure
C3031	Paint Interior Ceilings	325 SF	\$1.94	APP	Priority 4	2023	\$631
C3031	Paint Interior Ceilings	325 SF	\$1.94	APP	Priority 4	2033	\$631

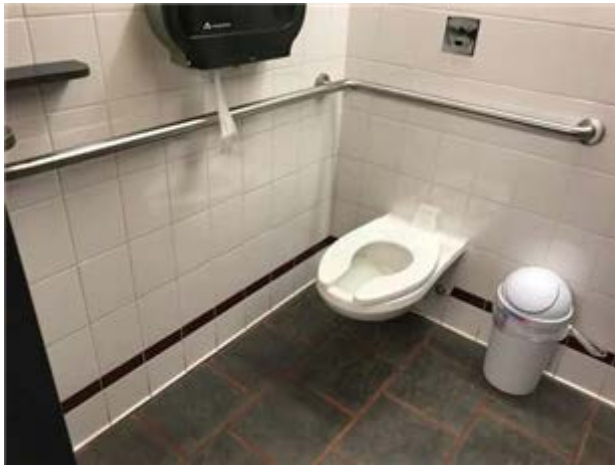
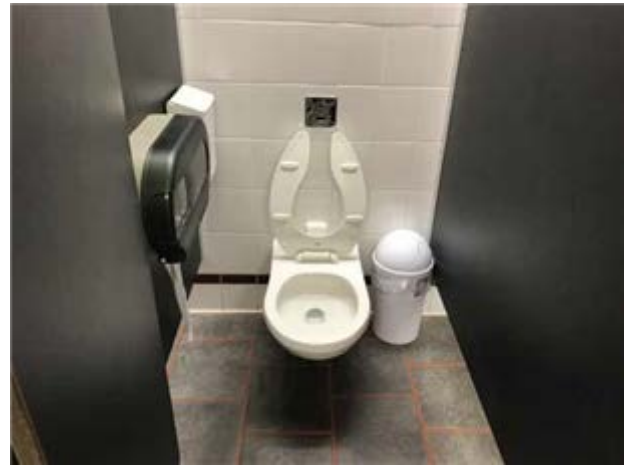
Coding / Field Name	Asset Description
D2011 Water Closets	Toilets (Water Closets)
Condition	Fair
Qty / UOM	20 / EA
Unit Cost	\$842.97
Basis of Costing	Tankless Water Closet
Year in Service	2002
Expected Useful Life (EUL)	20 Year(s), Based on Industry Averages
Remaining Useful Life (RUL)	4 Year(s), Estimated, Based on Date of Observation
Location	Restrooms

Uniformat	Action Description	Quantity	Unit Cost	Plan Type	Priority	Year	Expenditure
D2011	Replace Toilets (Water Closets)	20 EA	\$842.97	BYL	Priority 2	2023	\$16,859

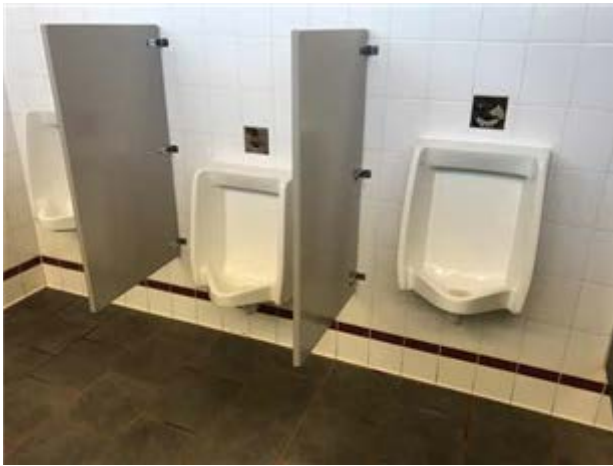
Coding / Field Name	Asset Description
D2012 Urinals	Urinals
Condition	Fair
Qty / UOM	3 / EA
Unit Cost	\$1,193.44
Basis of Costing	Urinal, Vitreous China
Year in Service	2002
Expected Useful Life (EUL)	20 Year(s), Based on Industry Averages
Remaining Useful Life (RUL)	4 Year(s), Estimated, Based on Date of Observation
Location	Restrooms

Uniformat	Action Description	Quantity	Unit Cost	Plan Type	Priority	Year	Expenditure
D2012	Replace Urinals	3 EA	\$1,193.44	BYL	Priority 2	2023	\$3,580

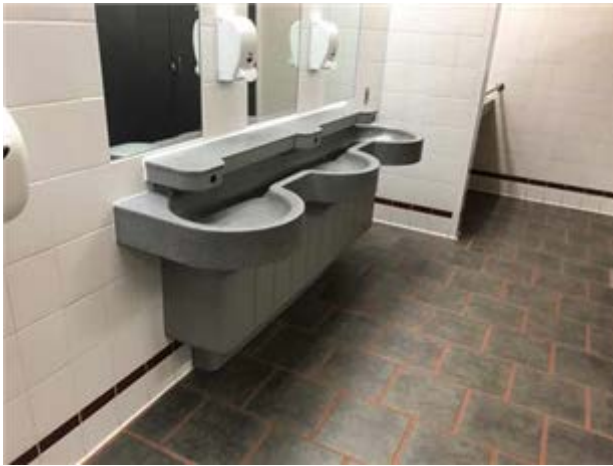
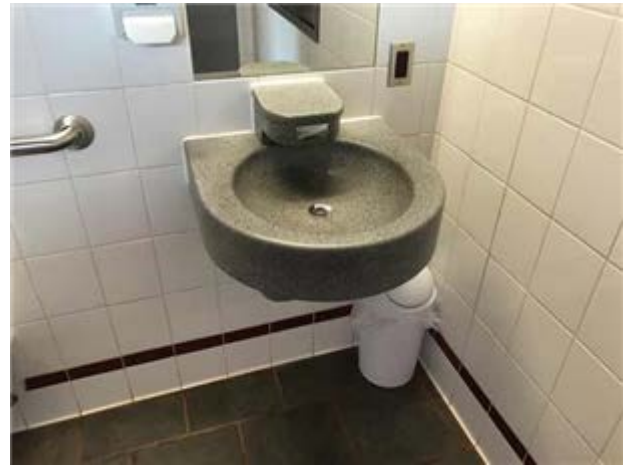
Coding / Field Name	Asset Description
D2013 Lavatories	Lavatories
Condition	Fair
Qty / UOM	5 / EA
Unit Cost	\$1,891.78
Basis of Costing	Lavatory, Cultured Marble
Year in Service	2002
Expected Useful Life (EUL)	20 Year(s), Based on Industry Averages
Remaining Useful Life (RUL)	10 Year(s), Estimated, Based on Date of Observation
Location	Restrooms

Uniformat	Action Description	Quantity	Unit Cost	Plan Type	Priority	Year	Expenditure
D2013	Replace Lavatories	5 EA	\$1,891.78	BYL	Priority 3	2029	\$9,459

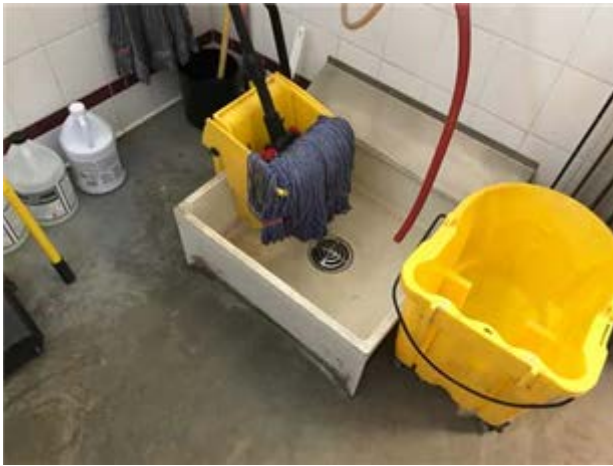
Coding / Field Name	Asset Description
D2014 Sinks	Service Sink, Floor
Condition	Fair
Qty / UOM	1 / EA
Unit Cost	\$1,599.51
Basis of Costing	Service Sink, Floor
Year in Service	2002
Expected Useful Life (EUL)	35 Year(s), Based on Industry Averages
Remaining Useful Life (RUL)	19 Year(s), Estimated, Based on Date of Observation
Location	Restrooms

Uniformat	Action Description	Quantity	Unit Cost	Plan Type	Priority	Year	Expenditure
D2014	Replace Service Sink, Floor	1 EA	\$1,599.51	BYL	Priority 3	2038	\$1,600

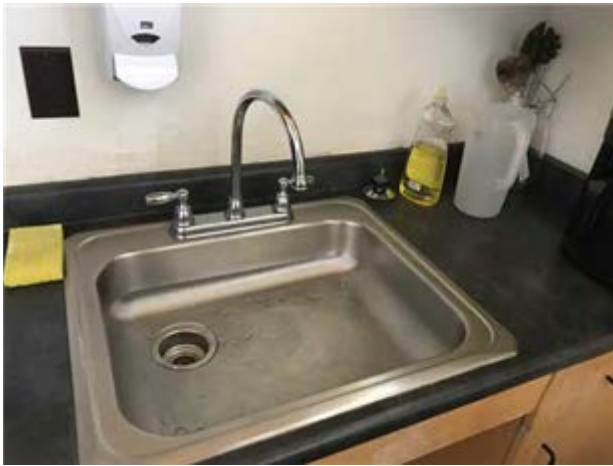
Coding / Field Name	Asset Description
D2014 Sinks	Sink, Stainless Steel
Condition	Fair
Qty / UOM	2 / EA
Unit Cost	\$1,054.05
Basis of Costing	Sink, Stainless Steel
Year in Service	2002
Expected Useful Life (EUL)	20 Year(s), Based on Industry Averages
Remaining Useful Life (RUL)	6 Year(s), Estimated, Based on Date of Observation
Location	Building Interior (General)

Uniformat	Action Description	Quantity	Unit Cost	Plan Type	Priority	Year	Expenditure
D2014	Replace Sink, Stainless Steel	2 EA	\$1,054.05	BYL	Priority 3	2025	\$2,108

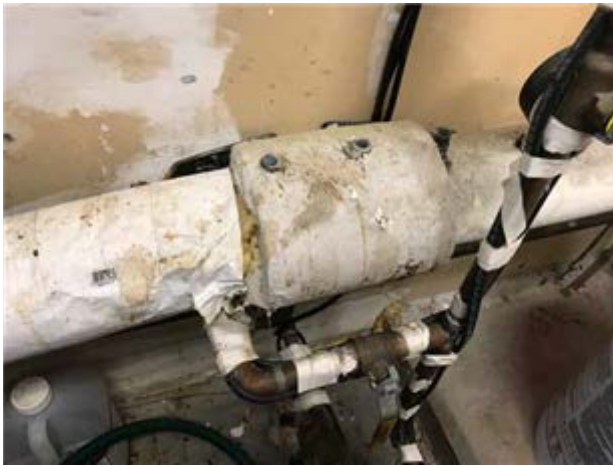
Coding / Field Name	Asset Description
D2021 Cold Water Service	Backflow Preventer, 2" Domestic
Condition	Fair
Qty / UOM	1 / EA
Unit Cost	\$2,603.17
Basis of Costing	Backflow Preventer, 2"
Year in Service	2002
Expected Useful Life (EUL)	15 Year(s), Based on Industry Averages
Remaining Useful Life (RUL)	3 Year(s), Estimated, Based on Date of Observation
Location	Mechanical Room

Uniformat	Action Description	Quantity	Unit Cost	Plan Type	Priority	Year	Expenditure
D2021	Replace Backflow Preventer, 2" Domestic	1 EA	\$2,603.17	BYL	Priority 1	2022	\$2,603
D2021	Replace Backflow Preventer, 2" Domestic	1 EA	\$2,603.17	BYL	Priority 1	2037	\$2,603

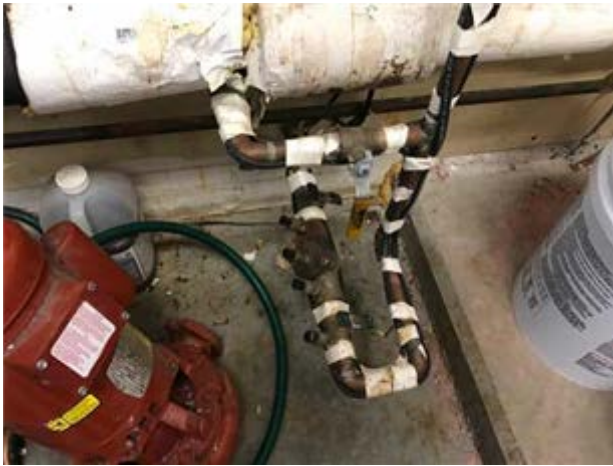
Coding / Field Name	Asset Description
D2021 Cold Water Service	Backflow Preventer, 1", Irrigation
Condition	Fair
Qty / UOM	1 / EA
Unit Cost	\$1,276.01
Basis of Costing	Backflow Preventer, 1"
Year in Service	2002
Expected Useful Life (EUL)	15 Year(s), Based on Industry Averages
Remaining Useful Life (RUL)	3 Year(s), Estimated, Based on Date of Observation
Location	Mechanical Room

Uniformat	Action Description	Quantity	Unit Cost	Plan Type	Priority	Year	Expenditure
D2021	Replace Backflow Preventer, 1", Irrigation	1 EA	\$1,276.01	BYL	Priority 1	2022	\$1,276
D2021	Replace Backflow Preventer, 1", Irrigation	1 EA	\$1,276.01	BYL	Priority 1	2037	\$1,276

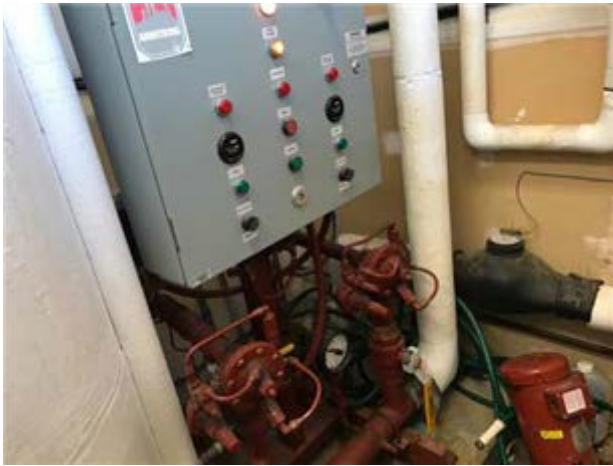
Coding / Field Name	Asset Description
D2023 Domestic Water Supply Equipment	Booster Domestic BoosterPump w/ Surge Tank
Condition	Fair
Qty / UOM	1 / EA
Unit Cost	\$11,887.30
Basis of Costing	Booster Pump w/ Surge Tank, High Efficiency, 7.5 HP
Year in Service	2002
Expected Useful Life (EUL)	20 Year(s), Based on Industry Averages
Remaining Useful Life (RUL)	4 Year(s), Estimated, Based on Date of Observation
Location	Mechanical Room

Uniformat	Action Description	Quantity	Unit Cost	Plan Type	Priority	Year	Expenditure
D2023	Replace Booster Domestic BoosterPump w/ Surge Tank	1 EA	\$11,887.30	BYL	Priority 2	2023	\$11,887

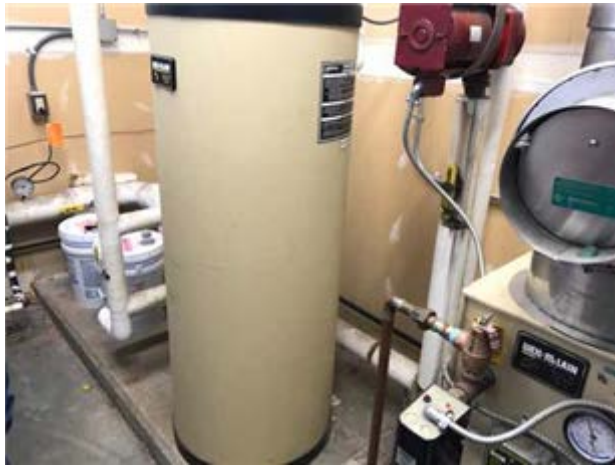
Coding / Field Name	Asset Description
D2023 Domestic Water Supply Equipment	Water Heater, Indirect, 46 GAL
Condition	Fair
Qty / UOM	1 / EA
Unit Cost	\$2,817.38
Basis of Costing	Water Heater, Indirect, 40 to 79 GAL
Year in Service	2002
Expected Useful Life (EUL)	15 Year(s), Based on Industry Averages
Remaining Useful Life (RUL)	3 Year(s), Estimated, Based on Date of Observation
Location	Mechanical Room

Uniformat	Action Description	Quantity	Unit Cost	Plan Type	Priority	Year	Expenditure
D2023	Replace Water Heater, Indirect, 46 GAL	1 EA	\$2,817.38	BYL	Priority 1	2022	\$2,817
D2023	Replace Water Heater, Indirect, 46 GAL	1 EA	\$2,817.38	BYL	Priority 1	2037	\$2,817

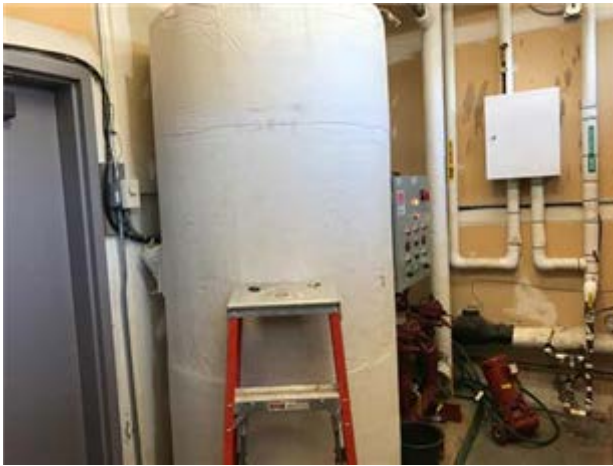
Coding / Field Name	Asset Description
D2023 Domestic Water Supply Equipment	Domestic Water Storage Tank, 300 GAL
Condition	Fair
Qty / UOM	1 / EA
Unit Cost	\$4,446.52
Basis of Costing	Water Storage Tank, 251 to 500 GAL
Year in Service	2002
Expected Useful Life (EUL)	20 Year(s), Based on Industry Averages
Remaining Useful Life (RUL)	9 Year(s), Estimated, Based on Date of Observation
Location	Mechanical Room

Uniformat	Action Description	Quantity	Unit Cost	Plan Type	Priority	Year	Expenditure
D2023	Replace Domestic Water Storage Tank, 300 GAL	1 EA	\$4,446.52	BYL	Priority 3	2028	\$4,447

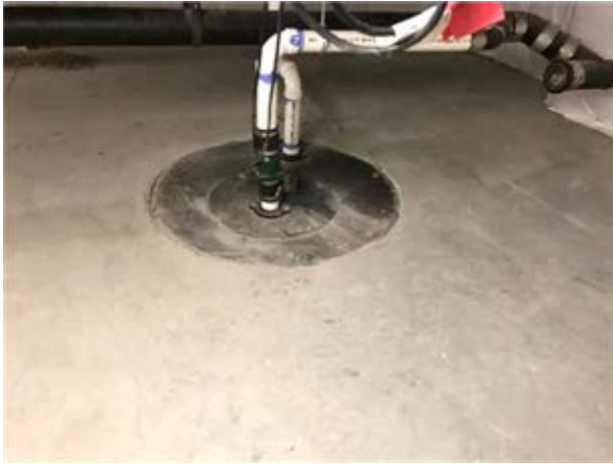
Coding / Field Name	Asset Description
D2043 Rainwater Drainage Equipment	Sump Pump
Condition	Fair
Qty / UOM	1 / EA
Unit Cost	\$2,062.81
Basis of Costing	Sump Pump, 3 HP
Year in Service	2002
Expected Useful Life (EUL)	15 Year(s), Based on Industry Averages
Remaining Useful Life (RUL)	4 Year(s), Estimated, Based on Date of Observation
Location	Crawlspace

Uniformat	Action Description	Quantity	Unit Cost	Plan Type	Priority	Year	Expenditure
D2043	Replace Sump Pump	1 EA	\$2,062.81	BYL	Priority 2	2023	\$2,063
D2043	Replace Sump Pump	1 EA	\$2,062.81	BYL	Priority 2	2038	\$2,063

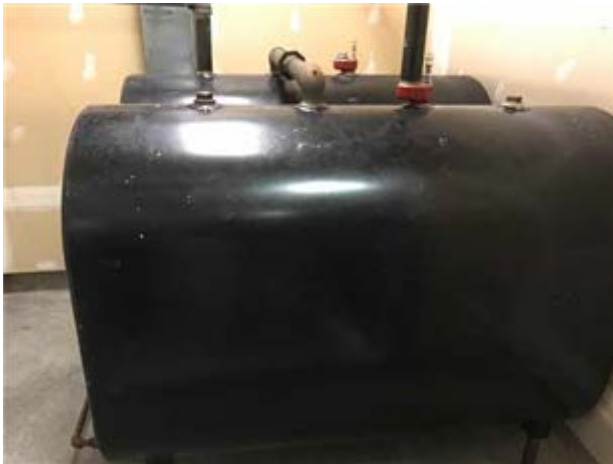
Coding / Field Name	Asset Description
D3011 Oil Supply System	Oil Storage Tank, 275 GAL
Condition	Fair
Qty / UOM	2 / EA
Unit Cost	\$935.73
Basis of Costing	Oil Storage Tank, 31 to 275 GAL
Year in Service	2002
Expected Useful Life (EUL)	25 Year(s), Based on Industry Averages
Remaining Useful Life (RUL)	14 Year(s), Estimated, Based on Date of Observation
Location	Oil Tank Closet
Fuel Tank Type	Ast

Uniformat	Action Description	Quantity	Unit Cost	Plan Type	Priority	Year	Expenditure
D3011	Replace Oil Storage Tank, 275 GAL	2 EA	\$935.73	BYL	Priority 3	2033	\$1,871

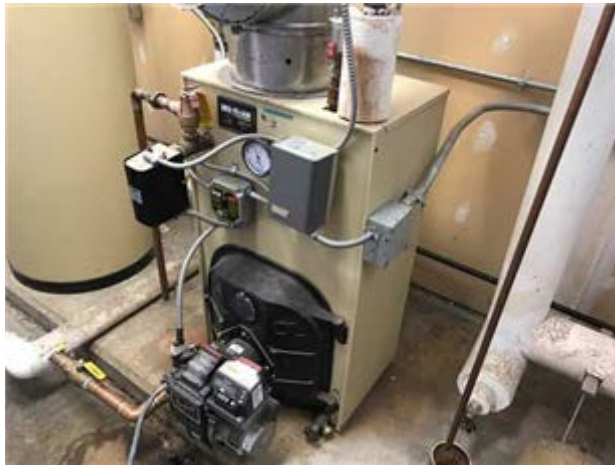
Coding / Field Name	Asset Description
D3021 Boilers	Domestic Boiler, Oil, 88 MBH
Condition	Fair
Qty / UOM	1 / EA
Unit Cost	\$12,832.31
Basis of Costing	Boiler, Oil, 76 to 100 MBH
Year in Service	2002
Expected Useful Life (EUL)	22 Year(s), Based on Industry Averages
Remaining Useful Life (RUL)	6 Year(s), Estimated, Based on Date of Observation
Location	Mechanical Room

Uniformat	Action Description	Quantity	Unit Cost	Plan Type	Priority	Year	Expenditure
D3021	Replace Domestic Boiler, Oil, 88 MBH	1 EA	\$12,832.31	BYL	Priority 2	2025	\$12,832
