FACILITY CONDITION ASSESSMENT

FACILITY CONDITION ASSESSMENT
OF
WILLISTON NORTH INFORMATION CENTER
I-89 NORTHBOUND MILE MARKER 82
WILLISTON, VT 05495

106686.18R000-170.305

May 30, 2019

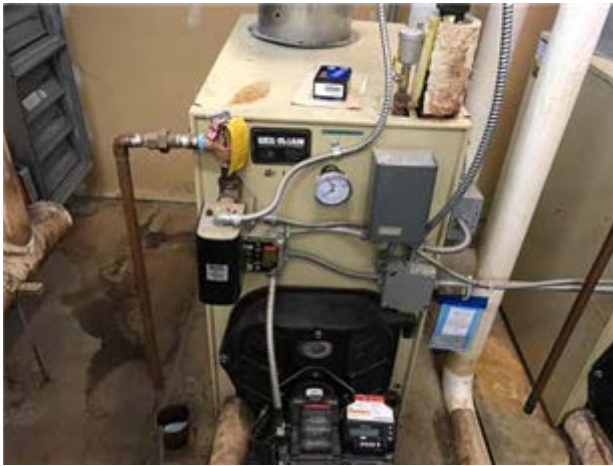
Coding / Field Name	Asset Description
D3021 Boilers	Boiler, Oil, 295 MBH
Condition	Fair
Qty / UOM	1 / EA
Unit Cost	\$18,107.75
Basis of Costing	Boiler, Oil, 251 to 300 MBH
Year in Service	2002
Expected Useful Life (EUL)	22 Year(s), Based on Industry Averages
Remaining Useful Life (RUL)	6 Year(s), Estimated, Based on Date of Observation
Location	Mechanical Room

Uniformat	Action Description	Quantity	Unit Cost	Plan Type	Priority	Year	Expenditure
D3021	Replace Boiler, Oil, 295 MBH	1 EA	\$18,107.75	BYL	Priority 2	2025	\$18,108

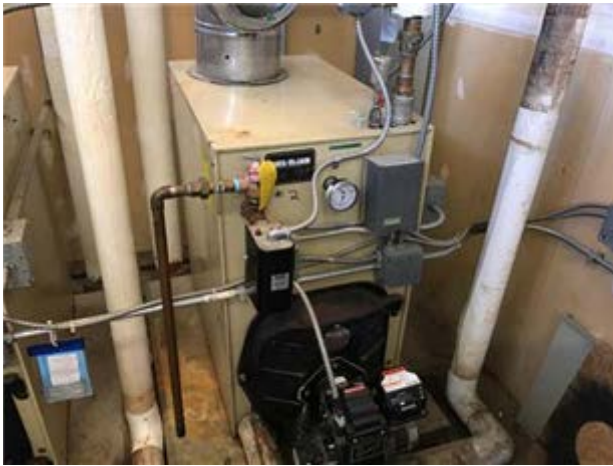
Coding / Field Name	Asset Description
D3021 Boilers	Boiler, Oil, 295 MBH
Condition	Fair
Qty / UOM	1 / EA
Unit Cost	\$18,107.75
Basis of Costing	Boiler, Oil, 251 to 300 MBH
Year in Service	2002
Expected Useful Life (EUL)	22 Year(s), Based on Industry Averages
Remaining Useful Life (RUL)	6 Year(s), Estimated, Based on Date of Observation
Location	Mechanical Room

Uniformat	Action Description	Quantity	Unit Cost	Plan Type	Priority	Year	Expenditure
D3021	Replace Boiler, Oil, 295 MBH	1 EA	\$18,107.75	BYL	Priority 2	2025	\$18,108

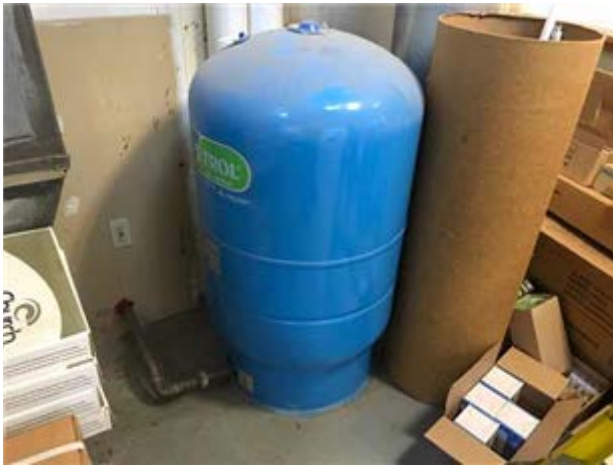
Coding / Field Name	Asset Description
D3022 Boiler Room Piping & Specialties	Expansion Tank, Domestic Water
Condition	Fair
Qty / UOM	1 / EA
Unit Cost	\$1,999.43
Basis of Costing	Expansion Tank, 11 to 30 GAL
Year in Service	2004
Expected Useful Life (EUL)	25 Year(s), Based on Industry Averages
Remaining Useful Life (RUL)	11 Year(s), Estimated, Based on Date of Observation
Location	Loft Equipment Room

Uniformat	Action Description	Quantity	Unit Cost	Plan Type	Priority	Year	Expenditure
D3022	Replace Expansion Tank, Domestic Water	1 EA	\$1,999.43	BYL	Priority 3	2030	\$1,999

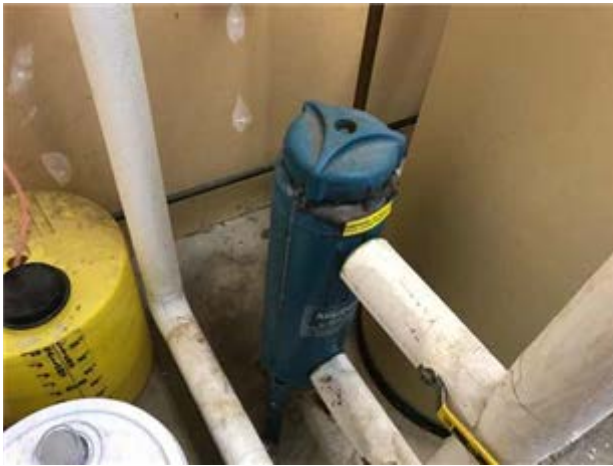
Coding / Field Name	Asset Description
D3022 Boiler Room Piping & Specialties	Shot Feed Tank, 2 GAL
Condition	Fair
Qty / UOM	1 / EA
Unit Cost	\$1,600.59
Basis of Costing	Shot Feed Tank, 5 GAL
Year in Service	2002
Expected Useful Life (EUL)	25 Year(s), Based on Industry Averages
Remaining Useful Life (RUL)	9 Year(s), Estimated, Based on Date of Observation
Location	Mechanical Room

Uniformat	Action Description	Quantity	Unit Cost	Plan Type	Priority	Year	Expenditure
D3022	Replace Shot Feed Tank, 2 GAL	1 EA	\$1,600.59	BYL	Priority 3	2028	\$1,601

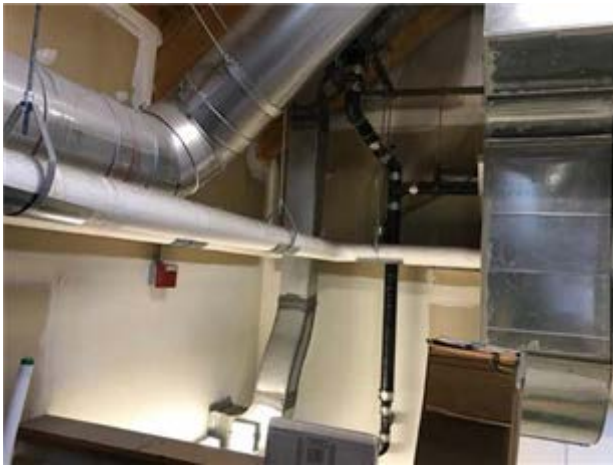
Coding / Field Name	Asset Description
D3041 Air Distribution Systems	HVAC System Ductwork, Sheet Metal
Condition	Fair
Qty / UOM	4588 / SF
Unit Cost	\$19.50
Basis of Costing	HVAC System Ductwork, Sheet Metal
Year in Service	2002
Expected Useful Life (EUL)	30 Year(s), Based on Industry Averages
Remaining Useful Life (RUL)	14 Year(s), Estimated, Based on Date of Observation
Location	Building Interior (General)

Uniformat	Action Description	Quantity	Unit Cost	Plan Type	Priority	Year	Expenditure
D3041	Replace HVAC System Ductwork, Sheet Metal	4,588 SF	\$19.50	BYL	Priority 4	2033	\$89,466

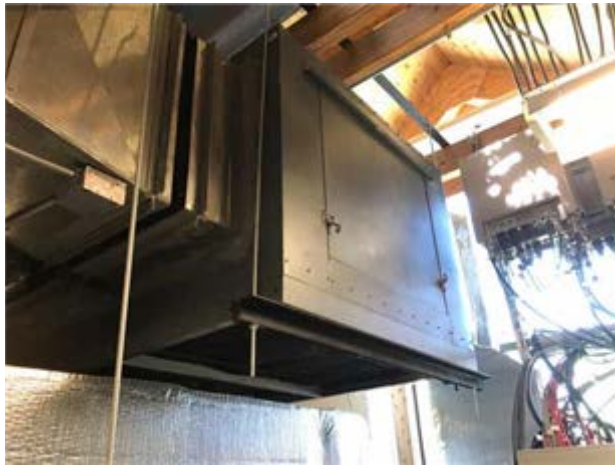
Coding / Field Name	Asset Description
D3041 Air Distribution Systems	Air Handler, Heat Exchanger
Condition	Fair
Qty / UOM	1 / EA
Unit Cost	\$14,597.03
Basis of Costing	Air Handler, Single Zone, 2,501 to 5,000 CFM
Year in Service	2002
Expected Useful Life (EUL)	15 Year(s), Based on Industry Averages
Remaining Useful Life (RUL)	7 Year(s), Estimated, Based on Date of Observation
Location	Loft Equipment Room

Uniformat	Action Description	Quantity	Unit Cost	Plan Type	Priority	Year	Expenditure
D3041	Replace Air Handler, Heat Exchanger	1 EA	\$14,597.03	BYL	Priority 2	2026	\$14,597

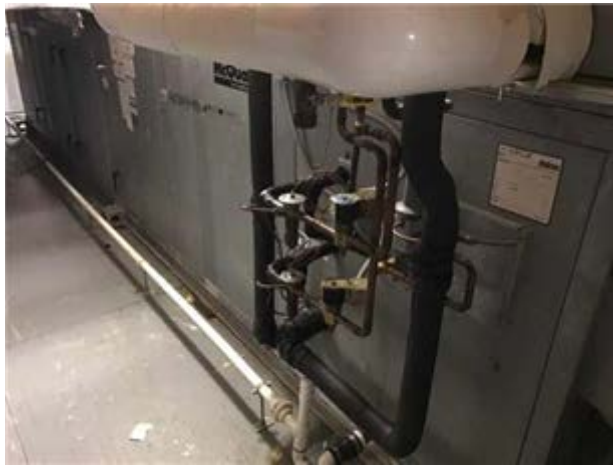
Coding / Field Name	Asset Description
D3041 Air Distribution Systems	Air Handler, Multizone, 7,000 cfm
Condition	Fair
Qty / UOM	1 / EA
Unit Cost	\$26,016.62
Basis of Costing	Air Handler, Multizone, 6,501 to 8,000 CFM
Year in Service	2002
Expected Useful Life (EUL)	15 Year(s), Based on Industry Averages
Remaining Useful Life (RUL)	5 Year(s), Estimated, Based on Date of Observation
Location	Loft Equipment Room

Uniformat	Action Description	Quantity	Unit Cost	Plan Type	Priority	Year	Expenditure
D3041	Replace Air Handler, Multizone, 7,000 cfm	1 EA	\$26,016.62	BYL	Priority 2	2024	\$26,017

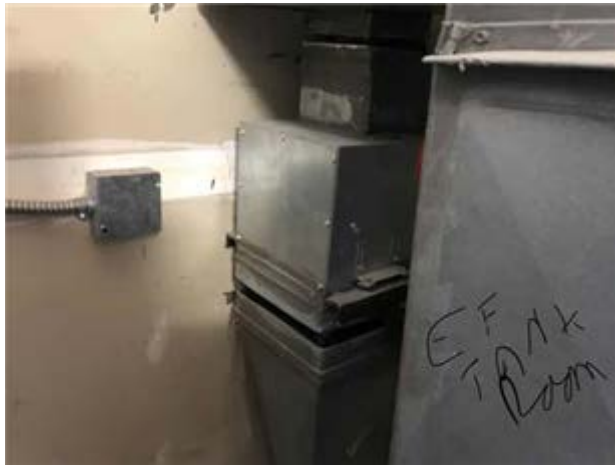
Coding / Field Name	Asset Description
D3042 Exhaust Ventilation Systems	Exhaust Fan, Centrifugal, EF-3
Condition	Fair
Qty / UOM	1 / EA
Unit Cost	\$889.90
Basis of Costing	Exhaust Fan, Centrifugal, 100 to 250 CFM
Year in Service	2002
Expected Useful Life (EUL)	15 Year(s), Based on Industry Averages
Remaining Useful Life (RUL)	3 Year(s), Estimated, Based on Date of Observation
Location	Loft Equipment Room

Uniformat	Action Description	Quantity	Unit Cost	Plan Type	Priority	Year	Expenditure
D3042	Replace Exhaust Fan, Centrifugal, EF-3	1 EA	\$889.90	BYL	Priority 1	2022	\$890
D3042	Replace Exhaust Fan, Centrifugal, EF-3	1 EA	\$889.90	BYL	Priority 1	2037	\$890

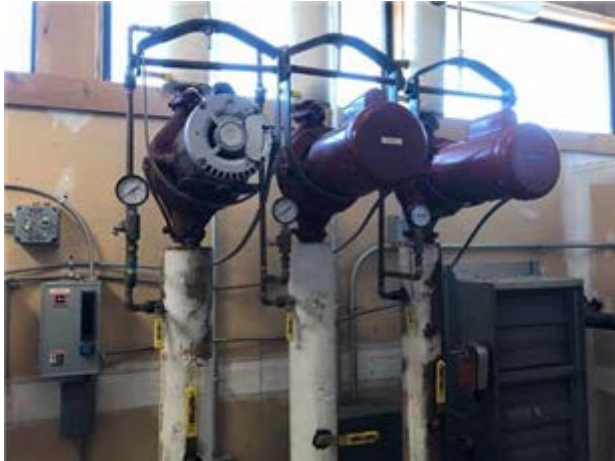
Coding / Field Name	Asset Description
D3044 Hot Water Distribution	Circulation Pumps, Heating Water
Condition	Fair
Qty / UOM	3 / EA
Cost Adjustment Factor/Reason	0.5 / 1 hp
Unit Cost (Adjusted)	\$2,326.15
Basis of Costing	Circulation Pump, Hot Water, 3 HP
Year in Service	2012
Expected Useful Life (EUL)	20 Year(s), Based on Industry Averages
Remaining Useful Life (RUL)	14 Year(s), Estimated, Based on Date of Observation
Location	Mechanical Room

Uniformat	Action Description	Quantity	Unit Cost	Plan Type	Priority	Year	Expenditure
D3044	Replace Circulation Pumps, Heating Water	3 EA	\$2,326.15	BYL	Priority 3	2033	\$6,978

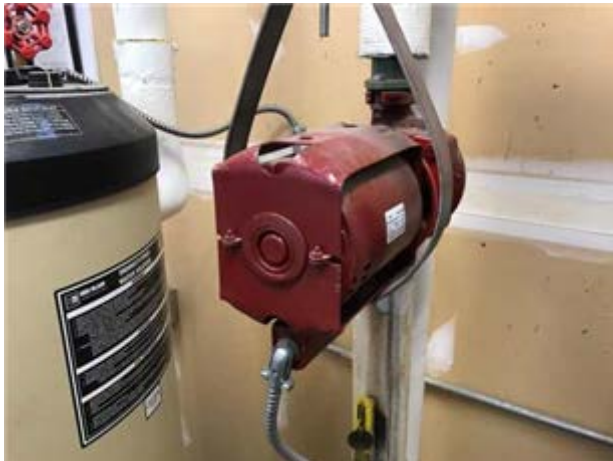
Coding / Field Name	Asset Description
D3044 Hot Water Distribution	Circulation Pumps, Heating Water
Condition	Fair
Qty / UOM	3 / EA
Cost Adjustment Factor/Reason	0.25 / Fractional hp
Unit Cost (Adjusted)	\$1,163.07
Basis of Costing	Circulation Pump, Hot Water, 3 HP
Year in Service	2012
Expected Useful Life (EUL)	20 Year(s), Based on Industry Averages
Remaining Useful Life (RUL)	14 Year(s), Estimated, Based on Date of Observation
Location	Mechanical Room

Uniformat	Action Description	Quantity	Unit Cost	Plan Type	Priority	Year	Expenditure
D3044	Replace Circulation Pumps, Heating Water	3 EA	\$1,163.07	BYL	Priority 3	2033	\$3,489

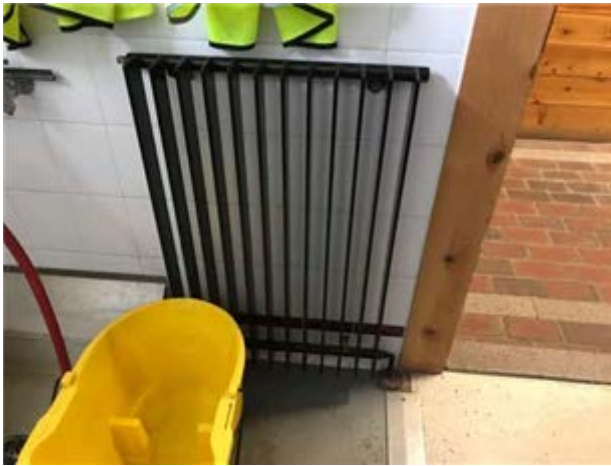
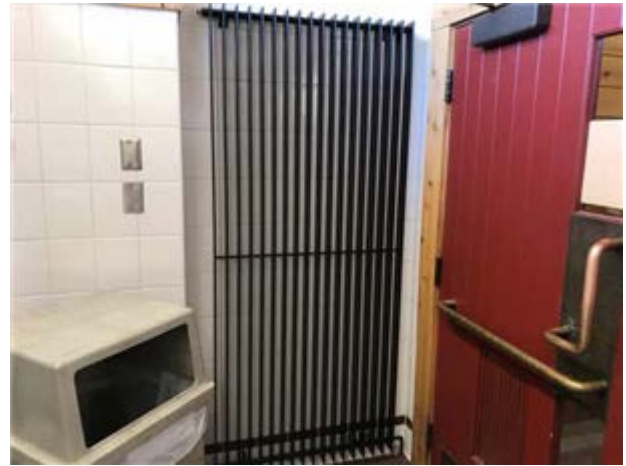
Coding / Field Name	Asset Description
D3051 Terminal Self-Contained Units	Radiator, Hydronic, Wall
Condition	Fair
Qty / UOM	17 / EA
Unit Cost	\$1,487.37
Basis of Costing	Radiator, Electric, Finned, Wall, 4 to 5 kW
Year in Service	2002
Expected Useful Life (EUL)	25 Year(s), Based on Industry Averages
Remaining Useful Life (RUL)	9 Year(s), Estimated, Based on Date of Observation
Location	Building Interior (General)

Uniformat	Action Description	Quantity	Unit Cost	Plan Type	Priority	Year	Expenditure
D3051	Replace Radiator, Hydronic, Wall	17 EA	\$1,487.37	BYL	Priority 3	2028	\$25,285

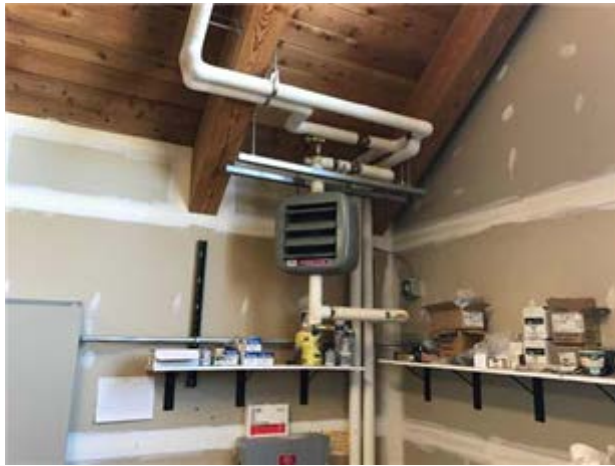
Coding / Field Name	Asset Description
D3051 Terminal Self-Contained Units	Unit Heater, Hydronic
Condition	Fair
Qty / UOM	8 / EA
Unit Cost	\$1,516.80
Basis of Costing	Unit Heater, Hydronic, 13 to 36 MBH
Year in Service	2002
Expected Useful Life (EUL)	20 Year(s), Based on Industry Averages
Remaining Useful Life (RUL)	10 Year(s), Estimated, Based on Date of Observation
Location	Building Interior (General)

Uniformat	Action Description	Quantity	Unit Cost	Plan Type	Priority	Year	Expenditure
D3051	Replace Unit Heater, Hydronic	8 EA	\$1,516.80	BYL	Priority 3	2029	\$12,134

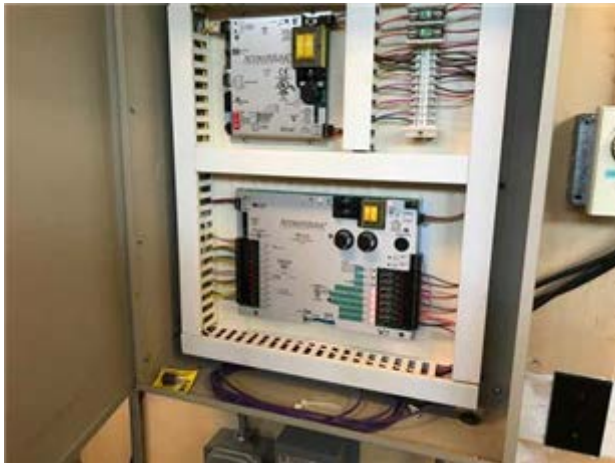
Coding / Field Name	Asset Description
D3068 Building Automation Systems	DDC HVAC Controls
Condition	Fair
Qty / UOM	4588 / SF
Cost Adjustment Factor/Reason	0.5 / Small system
Unit Cost (Adjusted)	\$4.83
Basis of Costing	Building Automation System (HVAC Controls), Full Upgrade (per SF)
Year in Service	2002
Expected Useful Life (EUL)	20 Year(s), Based on Industry Averages
Remaining Useful Life (RUL)	4 Year(s), Estimated, Based on Date of Observation
Location	Building Interior (General)

Uniformat	Action Description	Quantity	Unit Cost	Plan Type	Priority	Year	Expenditure
D3068	Replace DDC HVAC Controls	4,588 SF	\$4.83	MOD	Priority 3	2023	\$22,137

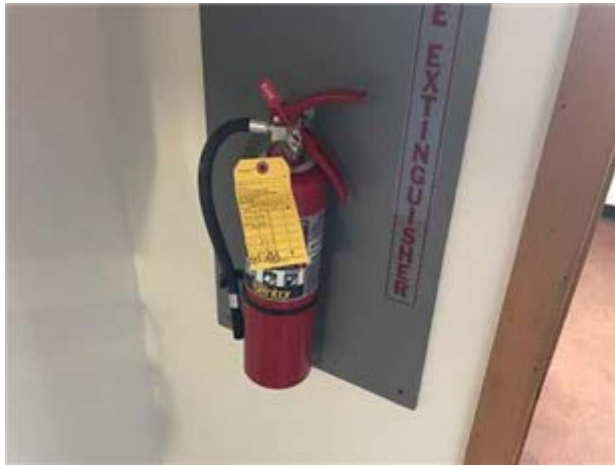
Coding / Field Name	Asset Description
D4031 Fire Extinguishers	Fire Extinguisher, Type ABC
Condition	Fair
Qty / UOM	4 / EA
Unit Cost	\$314.93
Basis of Costing	Fire Extinguisher - Type ABC
Year in Service	2010
Expected Useful Life (EUL)	15 Year(s), Based on Industry Averages
Remaining Useful Life (RUL)	7 Year(s), Estimated, Based on Date of Observation
Location	Building Interior (General)

Uniformat	Action Description	Quantity	Unit Cost	Plan Type	Priority	Year	Expenditure
D4031	Replace Fire Extinguisher, Type ABC	4 EA	\$314.93	BYL	Priority 2	2026	\$1,260

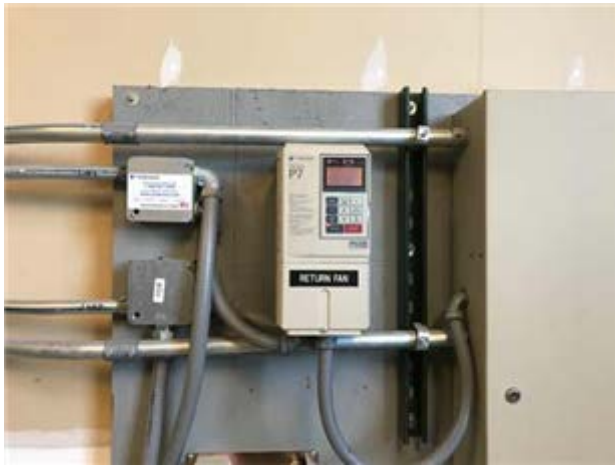
Coding / Field Name	Asset Description
D5012 Low Tension Service & Dist.	Variable Frequency Drive, RF-1
Condition	Fair
Qty / UOM	1 / EA
Unit Cost	\$4,748.96
Basis of Costing	Variable Frequency Drive, 5 HP Motor
Year in Service	2002
Expected Useful Life (EUL)	20 Year(s), Based on Industry Averages
Remaining Useful Life (RUL)	4 Year(s), Estimated, Based on Date of Observation
Location	Loft Equipment Room

Uniformat	Action Description	Quantity	Unit Cost	Plan Type	Priority	Year	Expenditure
D5012	Replace Variable Frequency Drive, RF-1	1 EA	\$4,748.96	BYL	Priority 2	2023	\$4,749

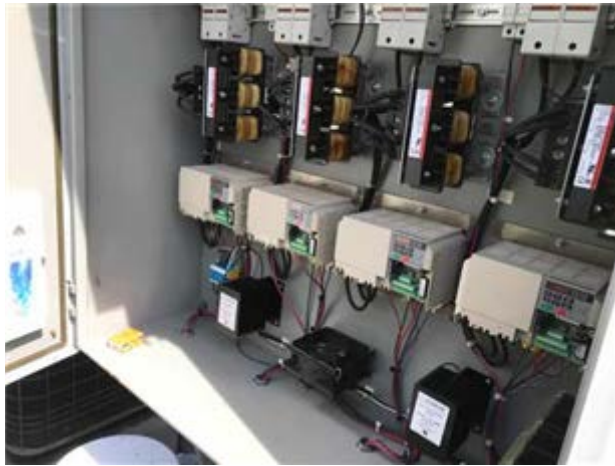
Coding / Field Name	Asset Description
D5012 Low Tension Service & Dist.	Variable Frequency Drive, AC Condensing Units
Condition	Fair
Qty / UOM	4 / EA
Unit Cost	\$4,748.96
Basis of Costing	Variable Frequency Drive, 5 HP Motor
Year in Service	2008
Expected Useful Life (EUL)	20 Year(s), Based on Industry Averages
Remaining Useful Life (RUL)	10 Year(s), Estimated, Based on Date of Observation
Location	Site

Uniformat	Action Description	Quantity	Unit Cost	Plan Type	Priority	Year	Expenditure
D5012	Replace Variable Frequency Drive, AC Condensing Units	4 EA	\$4,748.96	BYL	Priority 3	2029	\$18,996

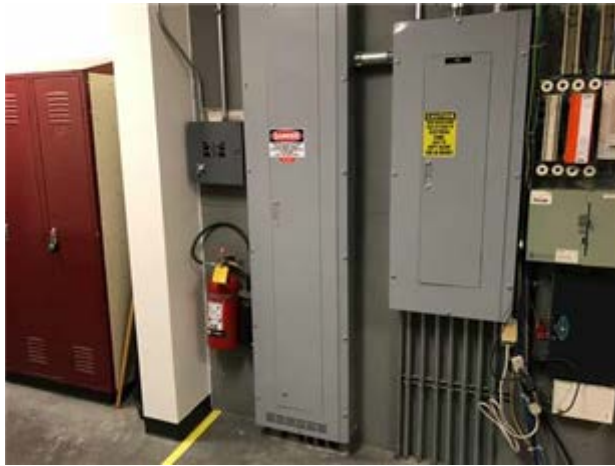
Coding / Field Name	Asset Description
D5012 Low Tension Service & Dist.	Main Distribution Panel
Condition	Fair
Qty / UOM	1 / EA
Unit Cost	\$9,487.85
Basis of Costing	Power Panel Board, 208 Y, 120 V, 400 Amp
Year in Service	2002
Expected Useful Life (EUL)	30 Year(s), Based on Industry Averages
Remaining Useful Life (RUL)	14 Year(s), Estimated, Based on Date of Observation
Location	Electrical Room (Primary)

Uniformat	Action Description	Quantity	Unit Cost	Plan Type	Priority	Year	Expenditure
D5012	Replace Main Distribution Panel	1 EA	\$9,487.85	BYL	Priority 3	2033	\$9,488

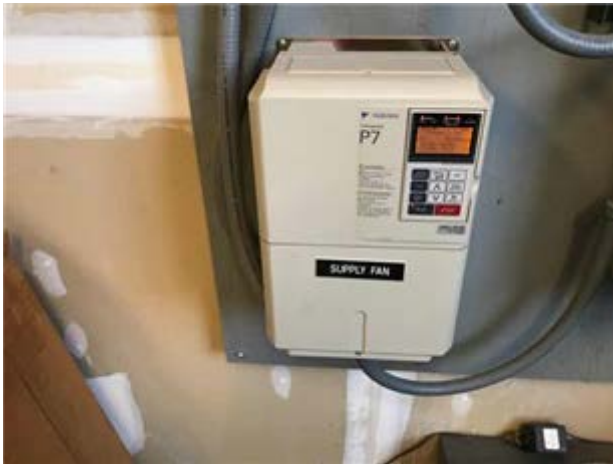
Coding / Field Name	Asset Description
D5012 Low Tension Service & Dist.	Variable Frequency Drive, SF-1
Condition	Fair
Qty / UOM	1 / EA
Unit Cost	\$6,304.96
Basis of Costing	Variable Frequency Drive, 10 HP Motor
Year in Service	2002
Expected Useful Life (EUL)	20 Year(s), Based on Industry Averages
Remaining Useful Life (RUL)	4 Year(s), Estimated, Based on Date of Observation
Location	Loft Equipment Room

Uniformat	Action Description	Quantity	Unit Cost	Plan Type	Priority	Year	Expenditure
D5012	Replace Variable Frequency Drive, SF-1	1 EA	\$6,304.96	BYL	Priority 2	2023	\$6,305

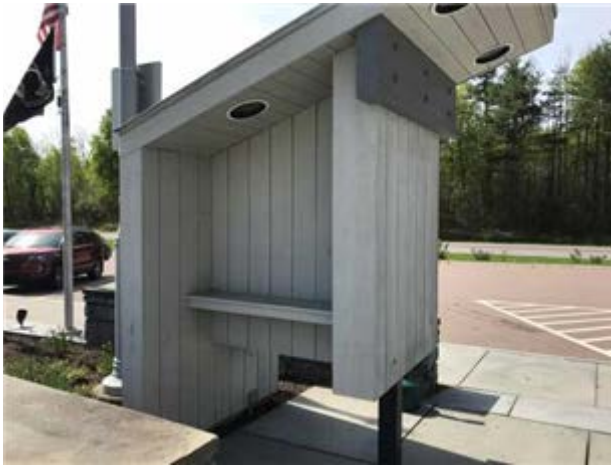
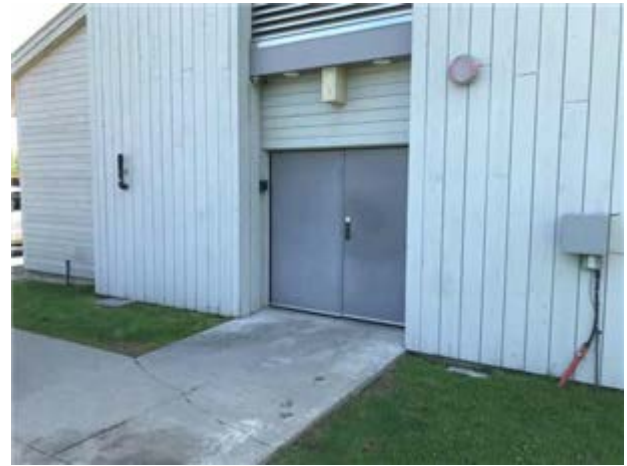
Coding / Field Name	Asset Description
D5022 Lighting Equipment	LED Lighting Fixture, Soffit
Condition	Good
Qty / UOM	6 / EA
Unit Cost	\$180.19
Basis of Costing	LED Lighting Fixture, Basic, 15 W
Year in Service	2014
Expected Useful Life (EUL)	20 Year(s), Based on Industry Averages
Remaining Useful Life (RUL)	16 Year(s), Estimated, Based on Date of Observation
Location	Exterior Walls

Uniformat	Action Description	Quantity	Unit Cost	Plan Type	Priority	Year	Expenditure
D5022	Replace LED Lighting Fixture, Soffit	6 EA	\$180.19	BYL	Priority 3	2035	\$1,081

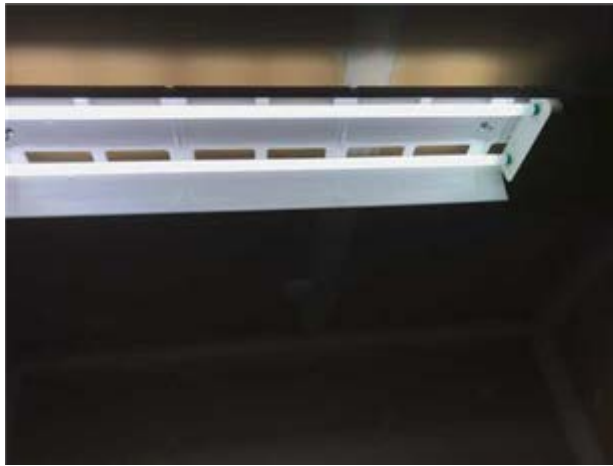
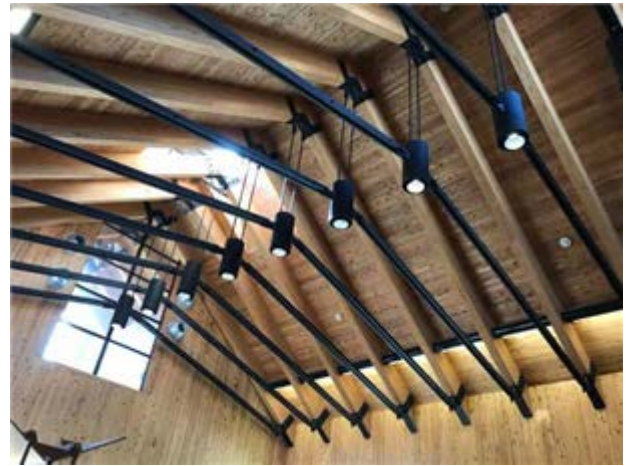
Coding / Field Name	Asset Description
D5029 Lighting Systems	Lighting System, Interior
Condition	Fair
Qty / UOM	4588 / SF
Unit Cost	\$9.24
Basis of Costing	Lighting System, Full Upgrade, Office (per SF)
Year in Service	2002
Expected Useful Life (EUL)	25 Year(s), Based on Industry Averages
Remaining Useful Life (RUL)	9 Year(s), Estimated, Based on Date of Observation
Location	Building Interior (General)

Uniformat	Action Description	Quantity	Unit Cost	Plan Type	Priority	Year	Expenditure
D5029	Replace Lighting System, Interior	4,588 SF	\$9.24	BYL	Priority 3	2028	\$42,393

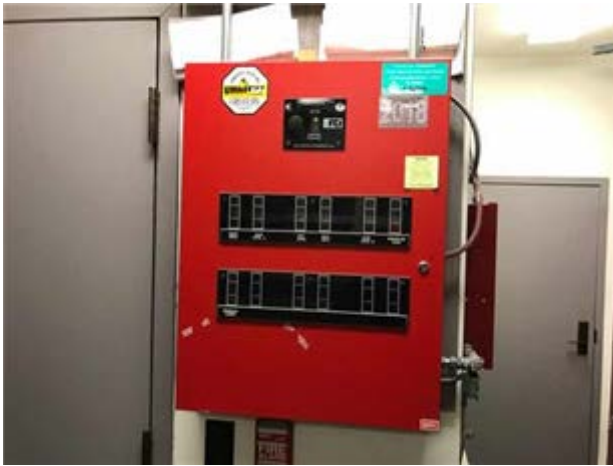
Coding / Field Name	Asset Description
D5037 Fire Alarm Systems	Fire Alarm System
Condition	Fair
Qty / UOM	4588 / SF
Unit Cost	\$2.36
Basis of Costing	Fire Alarm System, Full Upgrade/Install, Office (per SF)
Year in Service	2002
Expected Useful Life (EUL)	20 Year(s), Based on Industry Averages
Remaining Useful Life (RUL)	4 Year(s), Estimated, Based on Date of Observation
Location	Building Interior (General)

Uniformat	Action Description	Quantity	Unit Cost	Plan Type	Priority	Year	Expenditure
D5037	Replace Fire Alarm System	4,588 SF	\$2.36	BYL	Priority 2	2023	\$10,828

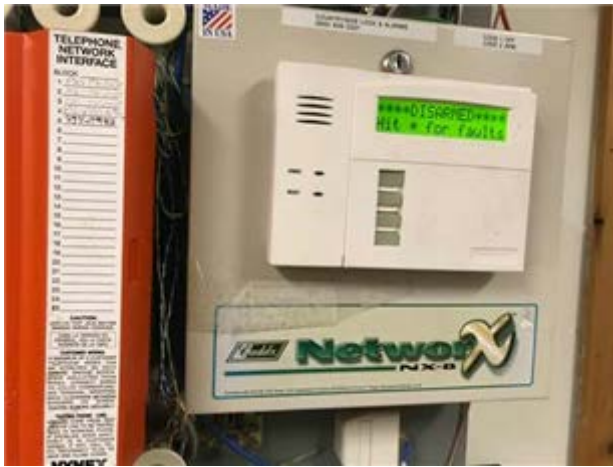
Coding / Field Name	Asset Description
D5038 Security and Detection Systems	Security System
Condition	Fair
Qty / UOM	4588 / GSF
Unit Cost	\$4.35
Year in Service	2002
Expected Useful Life (EUL)	25 Year(s), Based on Industry Averages
Remaining Useful Life (RUL)	9 Year(s), Estimated, Based on Date of Observation
Location	Building Interior (General)

Uniformat	Action Description	Quantity	Unit Cost	Plan Type	Priority	Year	Expenditure
D5038	Replace Security System	4,588 GSF	\$4.35	BYL	Priority 3	2028	\$19,958

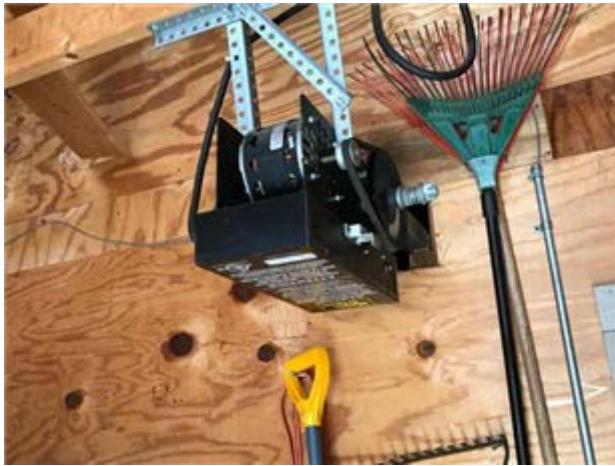
Coding / Field Name	Asset Description
E1031 Vehicular Service Equipment	Garage Door Opener, Belt Drive
Condition	Fair
Qty / UOM	1 / EA
Unit Cost	\$519.03
Basis of Costing	Garage Door Opener, Belt Drive, 0.5 HP
Year in Service	2002
Expected Useful Life (EUL)	15 Year(s), Based on Industry Averages
Remaining Useful Life (RUL)	4 Year(s), Estimated, Based on Date of Observation
Location	Storage Building/Map Kiosk

Uniformat	Action Description	Quantity	Unit Cost	Plan Type	Priority	Year	Expenditure
E1031	Replace Garage Door Opener, Belt Drive	1 EA	\$519.03	BYL	Priority 3	2023	\$519
E1031	Replace Garage Door Opener, Belt Drive	1 EA	\$519.03	BYL	Priority 3	2038	\$519

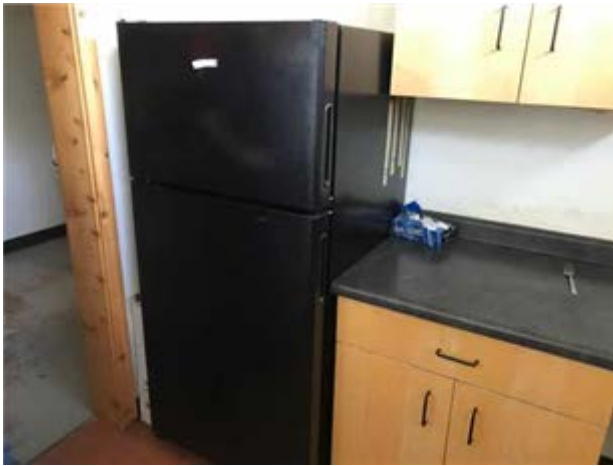
Coding / Field Name	Asset Description
E1094 Residential Equipment	Refrigerator, Residential
Condition	Good
Qty / UOM	1 / EA
Unit Cost	\$956.04
Basis of Costing	Refrigerator, Residential, 14-18 CF
Year in Service	2016
Expected Useful Life (EUL)	15 Year(s), Based on Industry Averages
Remaining Useful Life (RUL)	13 Year(s), Estimated, Based on Date of Observation
Location	Building Interior (General)

Uniformat	Action Description	Quantity	Unit Cost	Plan Type	Priority	Year	Expenditure
E1094	Replace Refrigerator, Residential	1 EA	\$956.04	BYL	Priority 3	2032	\$956

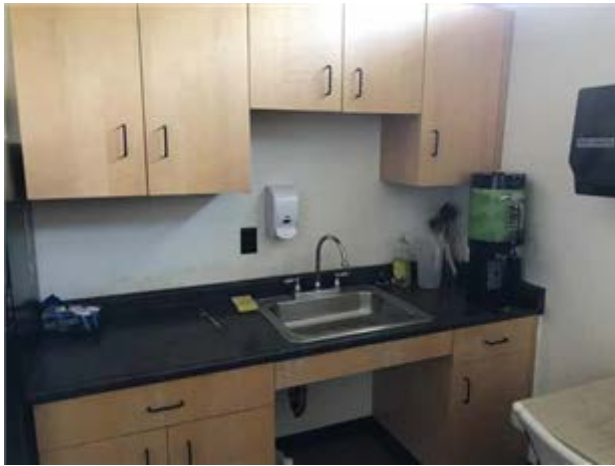
Coding / Field Name	Asset Description
E2012 Fixed Casework	Kitchen Cabinet, Base and Wall Section, Wood with counter
Condition	Fair
Qty / UOM	12 / LF
Unit Cost	\$467.63
Basis of Costing	Kitchen Cabinet, Base and Wall Section, Wood
Year in Service	2002
Expected Useful Life (EUL)	20 Year(s), Based on Industry Averages
Remaining Useful Life (RUL)	3 Year(s), Estimated, Based on Date of Observation
Location	Building Interior (General)

Uniformat	Action Description	Quantity	Unit Cost	Plan Type	Priority	Year	Expenditure
E2012	Replace Kitchen Cabinet, Base and Wall Section, Wood with counter	12 LF	\$467.63	BYL	Priority 3	2022	\$5,612

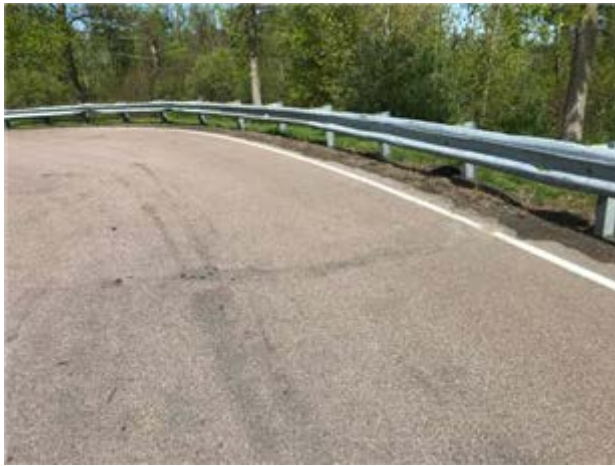
Coding / Field Name	Asset Description
G2012 Paving & Surfacing	Steel Guard Rail
Condition	Fair
Qty / UOM	550 / LF
Unit Cost	\$45.42
Basis of Costing	Steel Guard Rail
Year in Service	2002
Expected Useful Life (EUL)	25 Year(s), Based on Industry Averages
Remaining Useful Life (RUL)	9 Year(s), Estimated, Based on Date of Observation
Location	Site

Uniformat	Action Description	Quantity	Unit Cost	Plan Type	Priority	Year	Expenditure
G2012	Replace Steel Guard Rail	550 LF	\$45.42	BYL	Priority 3	2028	\$24,979

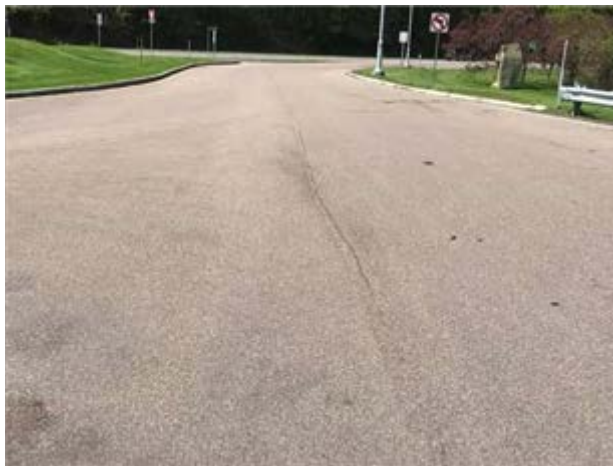
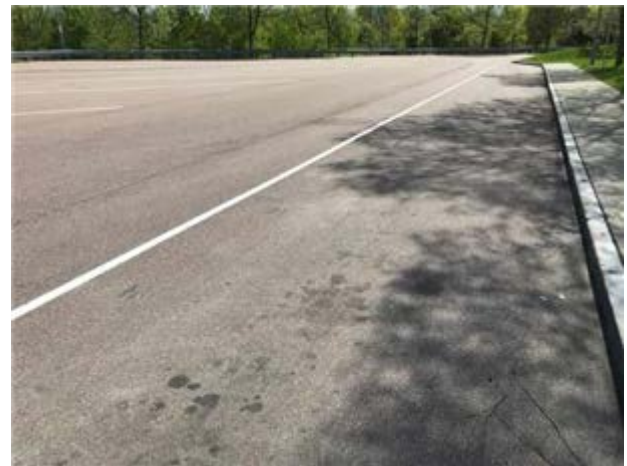
Coding / Field Name	Asset Description
G2022 Paving & Surfacing	Asphalt Pavement, Parking Lot
Condition	Fair
Qty / UOM	43000 / SF
Unit Cost	\$5.90
Basis of Costing	Asphalt Pavement, Parking Lot
Year in Service	2001
Expected Useful Life (EUL)	25 Year(s), Based on Industry Averages
Remaining Useful Life (RUL)	8 Year(s), Estimated, Based on Date of Observation
Location	Site

Uniformat	Action Description	Quantity	Unit Cost	Plan Type	Priority	Year	Expenditure
G2022	Seal & Stripe Asphalt Pavement	43,000 SF	\$0.38	BYL	Priority 2	2022	\$16,340
G2022	Seal & Stripe Asphalt Pavement	43,000 SF	\$0.38	BYL	Priority 2	2027	\$16,340
G2022	Mill & Overlay Asphalt Pavement	43,000 SF	\$3.28	BYL	Priority 3	2027	\$141,040
G2022	Seal & Stripe Asphalt Pavement	43,000 SF	\$0.38	BYL	Priority 2	2032	\$16,340
G2022	Seal & Stripe Asphalt Pavement	43,000 SF	\$0.38	BYL	Priority 2	2037	\$16,340

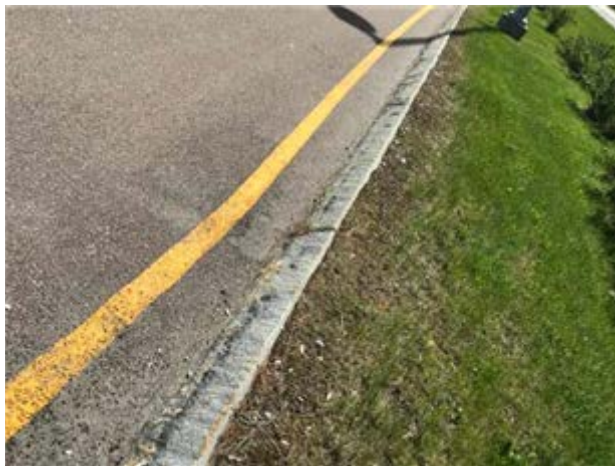
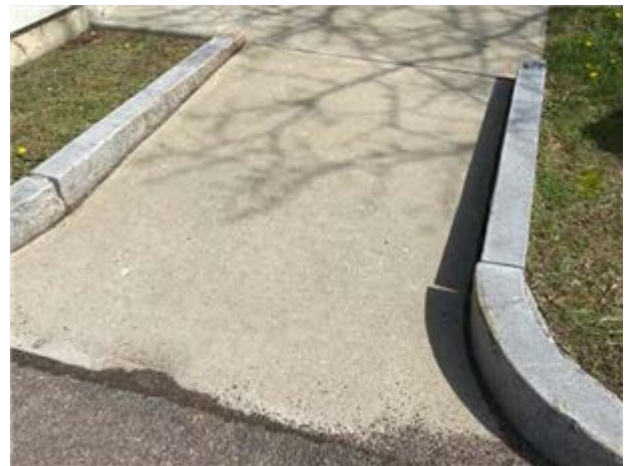
Coding / Field Name	Asset Description
G2022 Paving & Surfacing	Curb, Granite
Condition	Fair
Qty / UOM	1100 / LF
Unit Cost	\$40.08
Basis of Costing	Curb & Gutter, Concrete, 24" by 6" straight (per LF)
Year in Service	2002
Expected Useful Life (EUL)	40 Year(s), Based on Industry Averages
Remaining Useful Life (RUL)	24 Year(s), Estimated, Based on Date of Observation
Location	Site

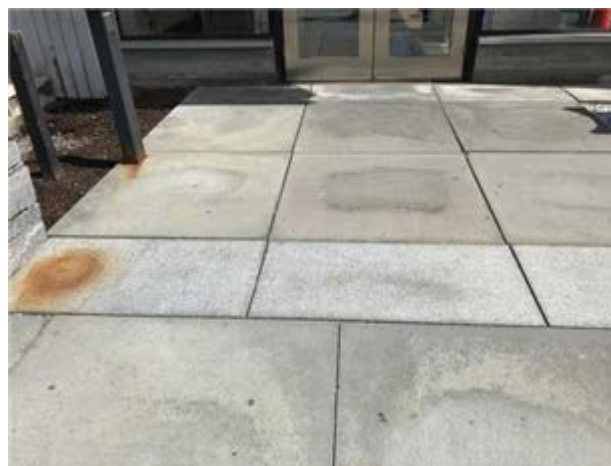
Coding / Field Name	Asset Description
G2031 Paving & Surfacing	Bluestone / Granite Paver Sidewalk, Exterior
Condition	Fair
Qty / UOM	1700 / SF
Unit Cost	\$34.11
Basis of Costing	Clay Brick/Masonry Paver Sidewalk, Exterior
Year in Service	2000
Expected Useful Life (EUL)	30 Year(s), Based on Industry Averages
Remaining Useful Life (RUL)	12 Year(s), Estimated, Based on Date of Observation
Location	Site

Some areas deteriorating.

Deteriorating paver

Uniformat	Action Description	Quantity	Unit Cost	Plan Type	Priority	Year	Expenditure
G2031	1" Pavers with 2" Sand Bedding	400 SF	\$34.02	REL	Priority 1	2019	\$13,608
G2031	Replace Bluestone / Granite Paver Sidewalk, Exterior	1,700 SF	\$34.11	BYL	Priority 3	2031	\$57,985

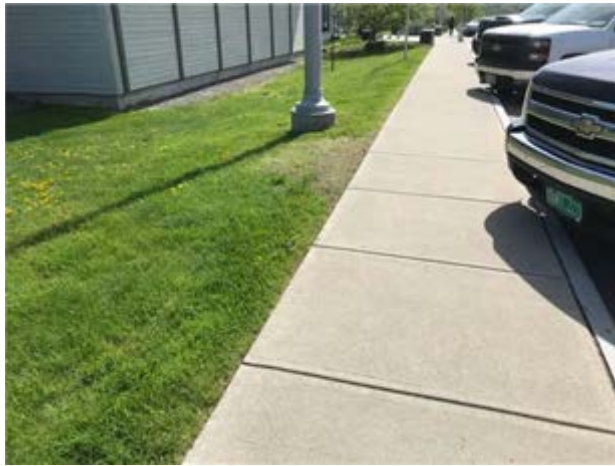
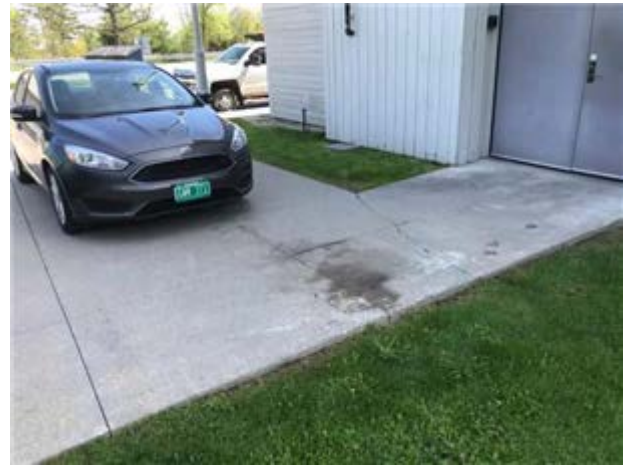
Coding / Field Name	Asset Description
G2031 Paving & Surfacing	Concrete Sidewalk
Condition	Fair
Qty / UOM	2100 / SF
Unit Cost	\$19.82
Basis of Costing	Concrete Sidewalk
Year in Service	2002
Expected Useful Life (EUL)	30 Year(s), Based on Industry Averages
Remaining Useful Life (RUL)	14 Year(s), Estimated, Based on Date of Observation
Location	Site

Uniformat	Action Description	Quantity	Unit Cost	Plan Type	Priority	Year	Expenditure
G2031	Replace Concrete Sidewalk	2,100 SF	\$19.82	BYL	Priority 3	2033	\$41,626

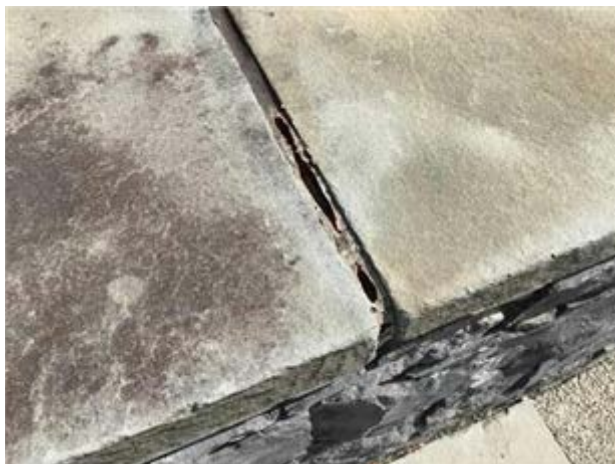
Coding / Field Name	Asset Description
G2042 Retaining Walls	Landscape Wall, Brick/Stone
Condition	Fair
Qty / UOM	100 / SF
Unit Cost	\$130.61
Basis of Costing	Retaining Wall, Brick/Stone (per SF Face)
Year in Service	2002
Expected Useful Life (EUL)	40 Year(s), Based on Industry Averages
Remaining Useful Life (RUL)	24 Year(s), Estimated, Based on Date of Observation
Location	Site

The joints along the tops of the landscape walls need sealer replacement.

Failed sealant

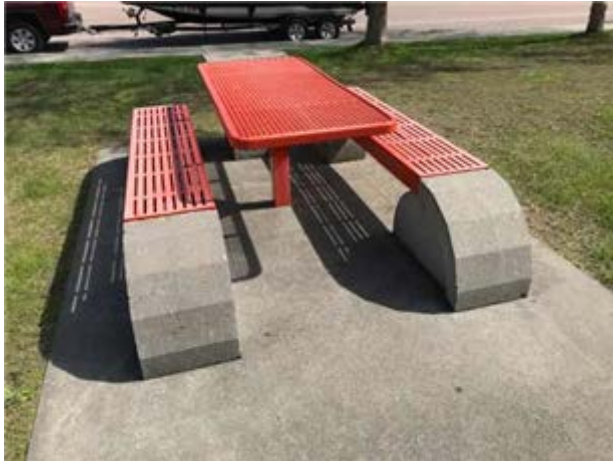
Coding / Field Name	Asset Description
G2045 SITE GATES	Picnic Table Concrete and Coated Steel
Condition	Fair
Qty / UOM	5 / EA
Cost Adjustment Factor/Reason	1.5 / Concrete portions
Unit Cost (Adjusted)	\$2,087.25
Basis of Costing	Picnic Table, Expanded Metal, Plastic Coated
Year in Service	2002
Expected Useful Life (EUL)	30 Year(s), Based on Industry Averages
Remaining Useful Life (RUL)	14 Year(s), Estimated, Based on Date of Observation
Location	Site

Uniformat	Action Description	Quantity	Unit Cost	Plan Type	Priority	Year	Expenditure
G2045	Replace Picnic Table Concrete and Coated Steel	5 EA	\$2,087.25	BYL	Priority 3	2033	\$10,436

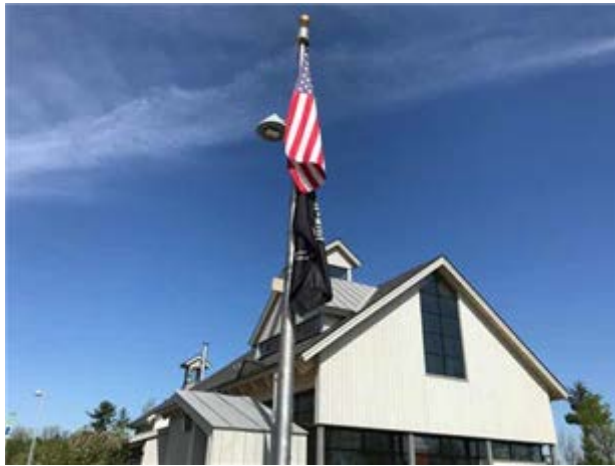
Coding / Field Name	Asset Description
G2048 Flagpoles	Flagpole, Metal, Internal or External Halyard
Condition	Fair
Qty / UOM	2 / EA
Unit Cost	\$2,530.00
Basis of Costing	Flagpole, Metal, Internal or External Halyard, 30' to 40' High (Pole Only)
Year in Service	2002
Expected Useful Life (EUL)	20 Year(s), Based on Industry Averages
Remaining Useful Life (RUL)	4 Year(s), Estimated, Based on Date of Observation
Location	Site

Uniformat	Action Description	Quantity	Unit Cost	Plan Type	Priority	Year	Expenditure
G2048	Replace Flagpole, Metal, Internal or External Halyard	2 EA	\$2,530.00	BYL	Priority 2	2023	\$5,060

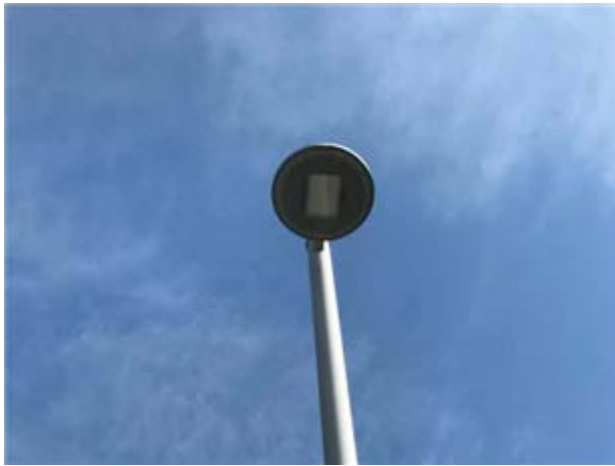
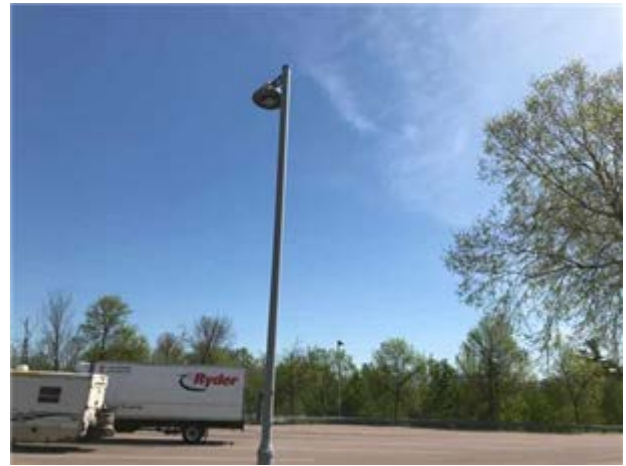
Coding / Field Name	Asset Description
G4021 Fixtures & Transformers	Pole Light, Exterior, LED Flood
Condition	Good
Qty / UOM	19 / EA
Unit Cost	\$4,630.42
Basis of Costing	Pole Light, Exterior, 135 to 1000 W HID (Fixture Only)
Year in Service	2015
Expected Useful Life (EUL)	20 Year(s), Based on Industry Averages
Remaining Useful Life (RUL)	17 Year(s), Estimated, Based on Date of Observation
Location	Site

Uniformat	Action Description	Quantity	Unit Cost	Plan Type	Priority	Year	Expenditure
G4021	Replace Pole Light, Exterior, LED Flood	19 EA	\$4,630.42	BYL	Priority 3	2036	\$87,978
