FACILITY CONDITION ASSESSMENT

FACILITY CONDITION ASSESSMENT
OF
BENNINGTON WELCOME CENTER
100 VT RT. 279
BENNINGTON, VT 05201

106686.17R000-068.305

June 23, 2017

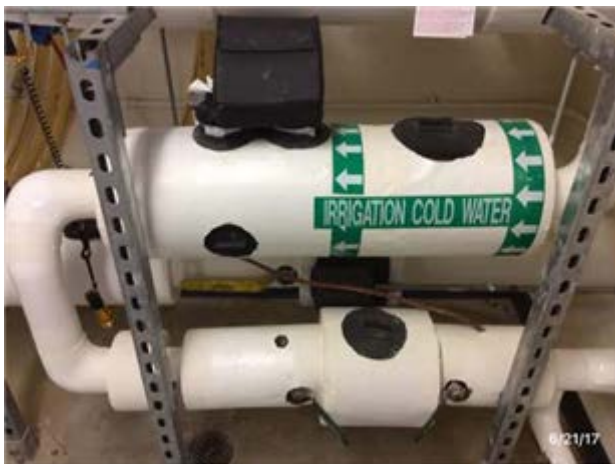
Nameplate Inaccessible.

Uniformat	Action Description	Quantity	Unit Cost	Plan Type	Priority	Year	Expenditure
D2021	Replace Backflow Preventer, 2"	1 EA	\$2,603.17	BYL	Priority 3	2028	\$2,603

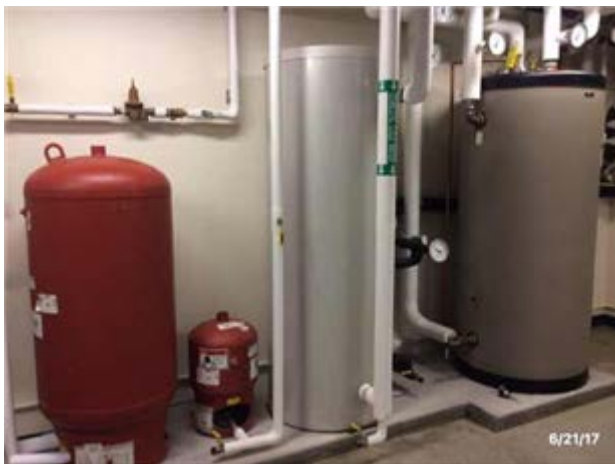
Solar hot water storage tank

Uniformat	Action Description	Quantity	Unit Cost	Plan Type	Priority	Year	Expenditure
D2023	Replace Water Storage Tank, 80 to 150 GAL	1 EA	\$2,140.56	BYL	Priority 3	2033	\$2,141

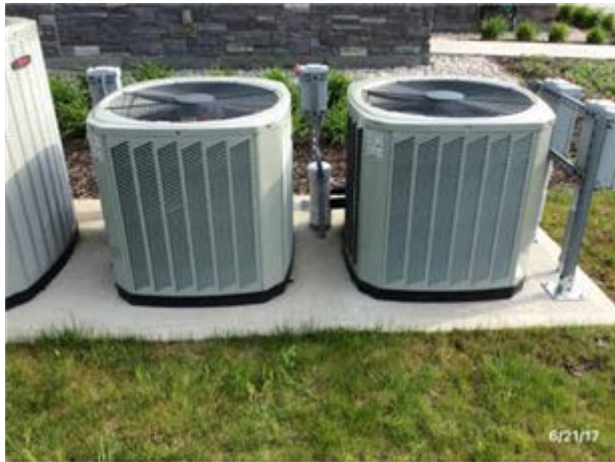
Coding / Field Name	Asset Description
D3032 Direct Expansion Systems	Condensing Unit, Small
Condition	Good
Qty / UOM	2 / EA
Unit Cost	\$2,755.13
Basis of Costing	Condenser, Air-Cooled, 3 Ton
Year in Service	2013
Expected Useful Life (EUL)	15 Year(s), Based on Industry Averages
Remaining Useful Life (RUL)	11 Year(s), Estimated, Based on Date of Observation
Location	Site

Uniformat	Action Description	Quantity	Unit Cost	Plan Type	Priority	Year	Expenditure
D3032	Replace Condensing Unit, Small	2 EA	\$2,755.13	BYL	Priority 3	2028	\$5,510

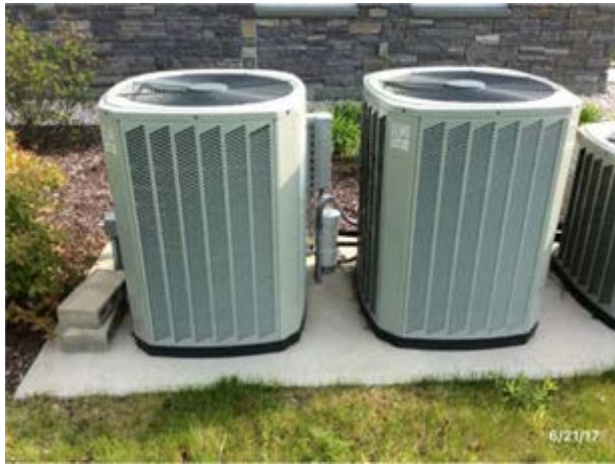
Coding / Field Name	Asset Description
D3032 Direct Expansion Systems	Condensing Unit, Large
Condition	Good
Qty / UOM	2 / EA
Unit Cost	\$6,439.81
Basis of Costing	Condensing Unit, Split System DX, Air-Cooled, 5 Ton
Year in Service	2013
Expected Useful Life (EUL)	15 Year(s), Based on Industry Averages
Remaining Useful Life (RUL)	11 Year(s), Estimated, Based on Date of Observation
Location	Site

Uniformat	Action Description	Quantity	Unit Cost	Plan Type	Priority	Year	Expenditure
D3032	Replace Condensing Unit, Large	2 EA	\$6,439.81	BYL	Priority 3	2028	\$12,880

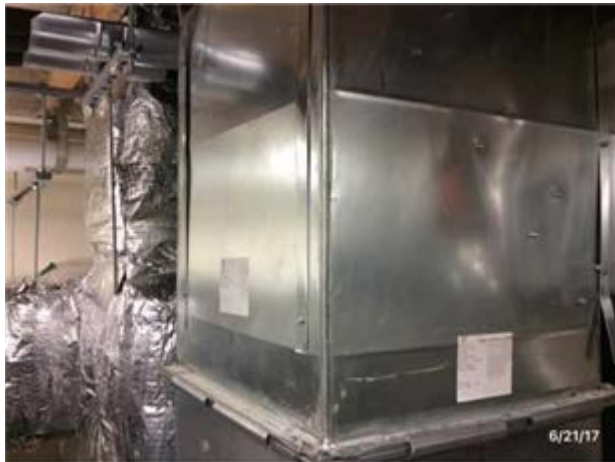
Coding / Field Name	Asset Description
D3041 Air Distribution Systems	HVAC System Ductwork, Sheet Metal
Condition	Good
Qty / UOM	1 / SF
Unit Cost	\$19.50
Basis of Costing	HVAC System Ductwork, Sheet Metal
Year in Service	2013
Expected Useful Life (EUL)	30 Year(s), Based on Industry Averages
Remaining Useful Life (RUL)	26 Year(s), Estimated, Based on Date of Observation
Location	Building Interior (General)

Uniformat	Action Description	Quantity	Unit Cost	Plan Type	Priority	Year	Expenditure
D3041	Clean Ductwork	6,181 SF	\$0.25	MNT	Priority 4	2023	\$1,545

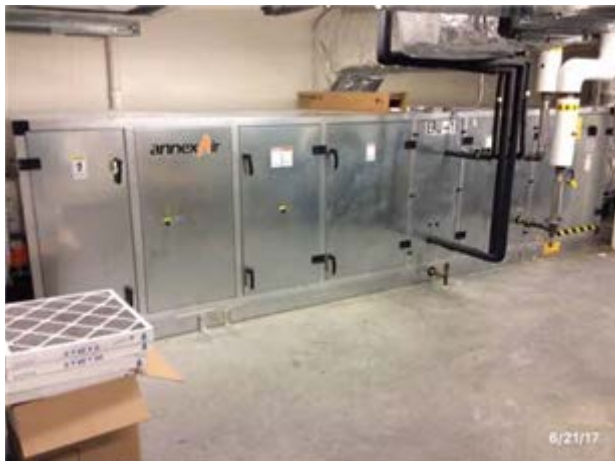
Estimated 5000 CFM airflow

Uniformat	Action Description	Quantity	Unit Cost	Plan Type	Priority	Year	Expenditure
D3041	Replace Air Handler, ERU-1	1 EA	\$29,194.07	BYL	Priority 3	2028	\$29,194

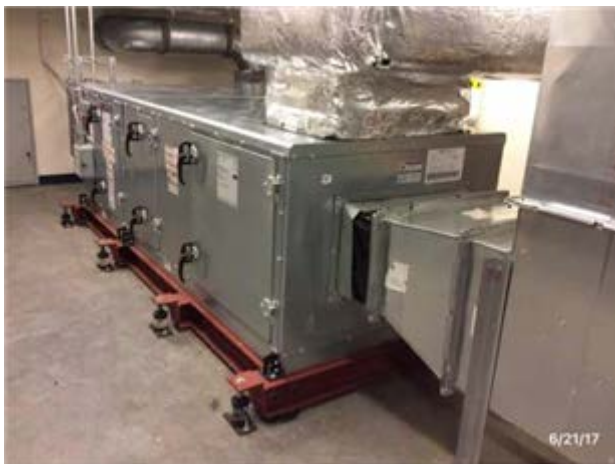
Estimated 3000 CFM airflow

Uniformat	Action Description	Quantity	Unit Cost	Plan Type	Priority	Year	Expenditure
D3041	Replace Air Handler, Single Zone	1 EA	\$14,597.03	BYL	Priority 3	2028	\$14,597

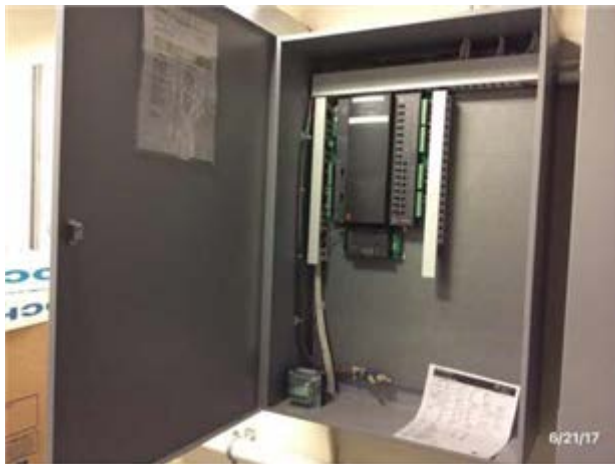
Coding / Field Name	Asset Description
D3068 Building Automation Systems	Direct Digital (DDC) HVAC Controls
Condition	Good
Qty / UOM	6861 / SF
Unit Cost	\$5.36
Basis of Costing	Building Automation System (HVAC Controls), Full Upgrade (per SF)
Year in Service	2013
Expected Useful Life (EUL)	20 Year(s), Based on Industry Averages
Remaining Useful Life (RUL)	16 Year(s), Estimated, Based on Date of Observation
Location	Building Interior (General)

Uniformat	Action Description	Quantity	Unit Cost	Plan Type	Priority	Year	Expenditure
D3068	Replace Direct Digital (DDC) HVAC Controls	6,861 SF	\$5.36	BYL	Priority 3	2033	\$36,775

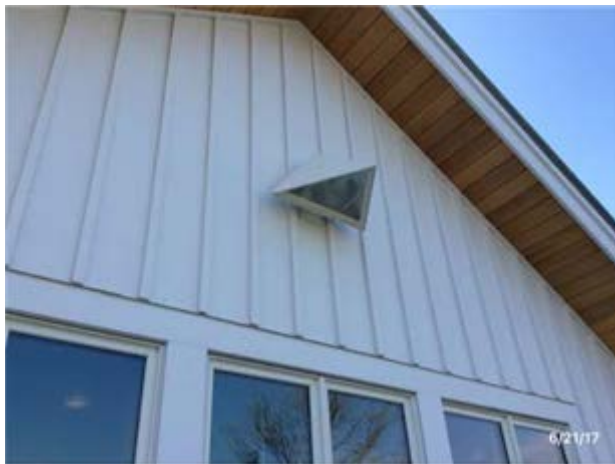
Coding / Field Name	Asset Description
D5022 Lighting Equipment	Light Fixture, Exterior, LED
Condition	Good
Qty / UOM	5 / EA
Unit Cost	\$180.19
Basis of Costing	LED Lighting Fixture, Basic, 20 W
Year in Service	2013
Expected Useful Life (EUL)	20 Year(s), Based on Industry Averages
Remaining Useful Life (RUL)	16 Year(s), Estimated, Based on Date of Observation
Location	Exterior Walls

Uniformat	Action Description	Quantity	Unit Cost	Plan Type	Priority	Year	Expenditure
D5022	Replace Light Fixture, Exterior, LED	5 EA	\$180.19	BYL	Priority 3	2033	\$901

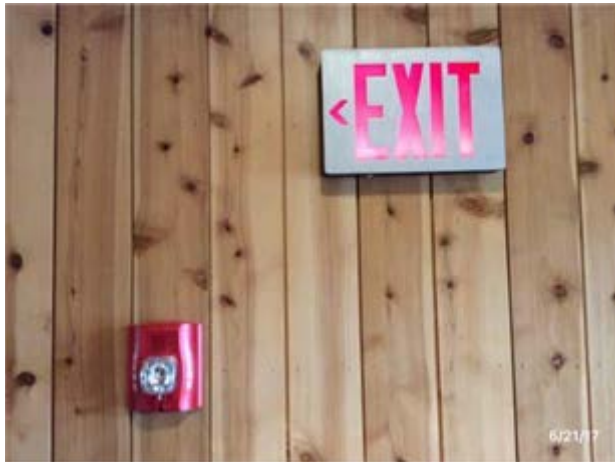
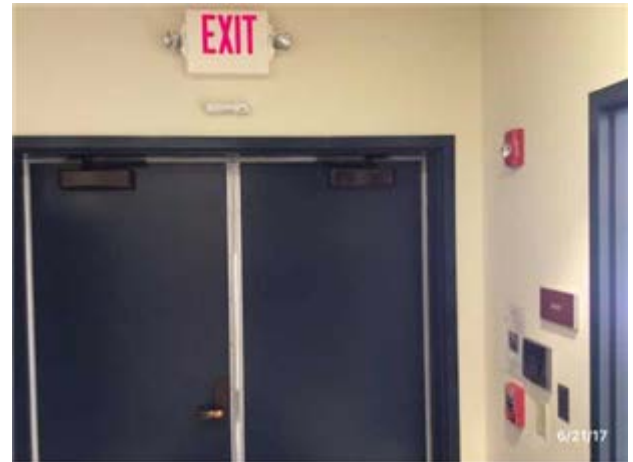
Coding / Field Name	Asset Description
D5037 Fire Alarm Systems	Fire Alarm System
Condition	Good
Qty / UOM	6861 / SF
Unit Cost	\$2.36
Basis of Costing	Fire Alarm System, Full Upgrade/Install, Office (per SF)
Year in Service	2013
Expected Useful Life (EUL)	20 Year(s), Based on Industry Averages
Remaining Useful Life (RUL)	16 Year(s), Estimated, Based on Date of Observation
Location	Building Interior (General)

Uniformat	Action Description	Quantity	Unit Cost	Plan Type	Priority	Year	Expenditure
D5037	Replace Fire Alarm System	6,861 SF	\$2.36	BYL	Priority 3	2033	\$16,192

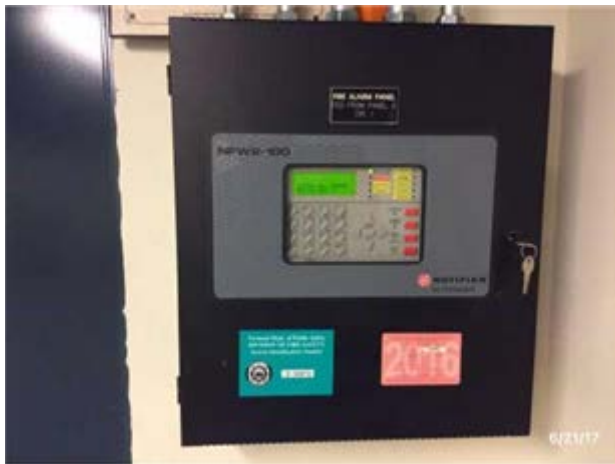
Coding / Field Name	Asset Description
D5037 Fire Alarm Systems	Fire Alarm Control Panel
Condition	Good
Qty / UOM	1 / EA
Unit Cost	\$20,297.59
Basis of Costing	Fire Alarm Control Panel, Addressable
Year in Service	2013
Expected Useful Life (EUL)	15 Year(s), Based on Industry Averages
Remaining Useful Life (RUL)	11 Year(s), Estimated, Based on Date of Observation
Location	Mechanical Room (Primary)

Uniformat	Action Description	Quantity	Unit Cost	Plan Type	Priority	Year	Expenditure
D5037	Replace Fire Alarm Control Panel	1 EA	\$20,297.59	BYL	Priority 3	2028	\$20,298

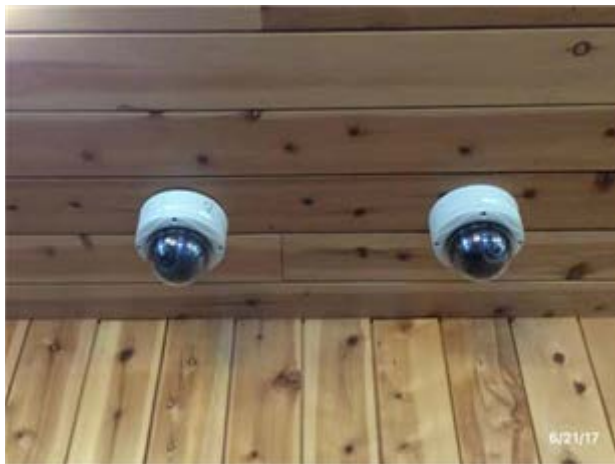
Coding / Field Name	Asset Description
D5038 Security and Detection Systems	Camera, Security System
Condition	Fair
Qty / UOM	6 / EA
Unit Cost	\$2,158.37
Basis of Costing	Camera, Security System
Year in Service	2013
Expected Useful Life (EUL)	10 Year(s), Based on Industry Averages
Remaining Useful Life (RUL)	6 Year(s), Estimated, Based on Date of Observation
Location	Building Interior (General)

Uniformat	Action Description	Quantity	Unit Cost	Plan Type	Priority	Year	Expenditure
D5038	Replace Camera, Security System	6 EA	\$2,158.37	BYL	Priority 2	2023	\$12,950
D5038	Replace Camera, Security System	6 EA	\$2,158.37	BYL	Priority 2	2033	\$12,950

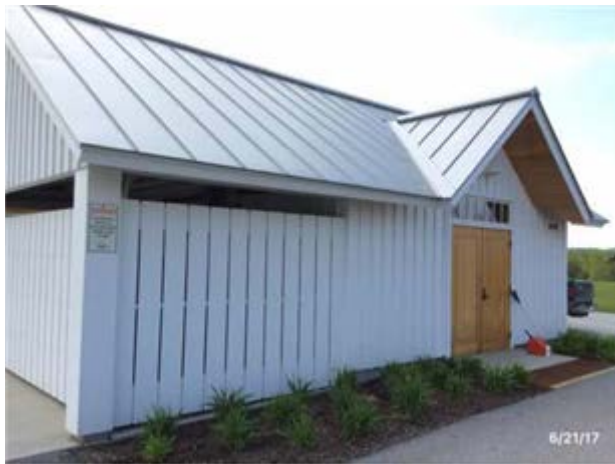
Coding / Field Name	Asset Description
F1013 Other Special Structures	Generator Shed
Condition	Good
Qty / UOM	1 / SF
Unit Cost	\$125.19
Basis of Costing	Prefabricated Temporary Building, All Components
Year in Service	2000
Expected Useful Life (EUL)	30 Year(s), Based on Industry Averages
Remaining Useful Life (RUL)	13 Year(s), Estimated, Based on Date of Observation
Location	Site

Uniformat	Action Description	Quantity	Unit Cost	Plan Type	Priority	Year	Expenditure
F1013	Paint Existing Wood Siding, One Coat, Spray with Medium Prep and Clean Up	100 SF	\$1.24	BYL	Priority 3	2022	\$124
F1013	Replace Generator Shed	1 SF	\$125.19	BYL	Priority 4	2030	\$125
F1013	Paint Existing Wood Siding, One Coat, Spray with Medium Prep and Clean Up	100 SF	\$1.24	BYL	Priority 3	2032	\$124

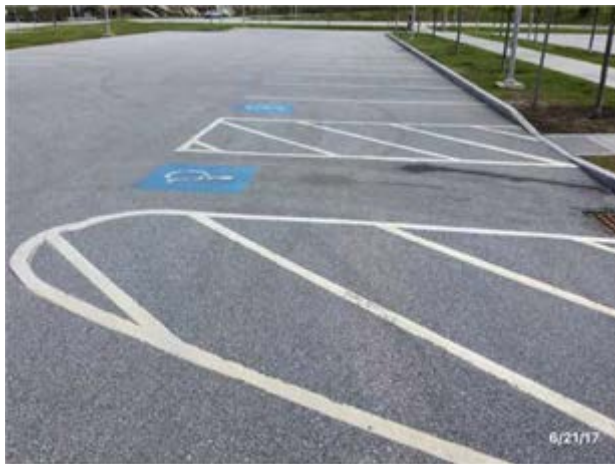
Coding / Field Name	Asset Description
G2022 Paving & Surfacing	Asphalt Pavement, Parking Lot
Condition	Good
Qty / UOM	100000 / SF
Unit Cost	\$4.96
Basis of Costing	Asphalt Pavement, Parking Lot
Year in Service	2013
Expected Useful Life (EUL)	25 Year(s), Based on Industry Averages
Remaining Useful Life (RUL)	21 Year(s), Estimated, Based on Date of Observation
Location	Site

Uniformat	Action Description	Quantity	Unit Cost	Plan Type	Priority	Year	Expenditure
G2022	Seal & Stripe Asphalt Pavement	100,000 SY	\$0.38	BYL	Priority 2	2020	\$38,000
G2022	Seal & Stripe Asphalt Pavement	100,000 SY	\$0.38	BYL	Priority 2	2025	\$38,000
G2022	Seal & Stripe Asphalt Pavement	100,000 SY	\$0.38	BYL	Priority 2	2030	\$38,000
G2022	Seal & Stripe Asphalt Pavement	100,000 SY	\$0.38	BYL	Priority 2	2035	\$38,000

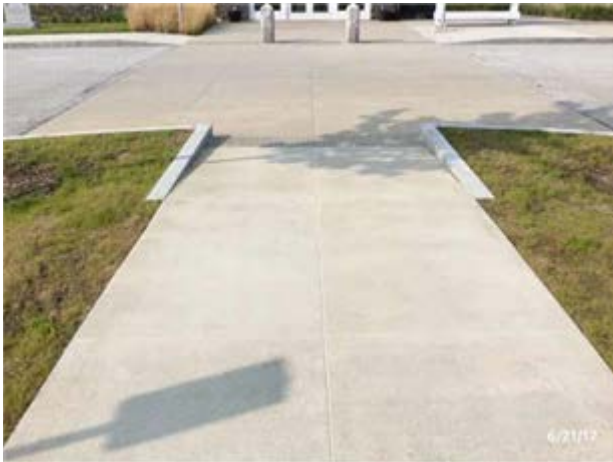
Coding / Field Name	Asset Description
G2031 Paving & Surfacing	Concrete Sidewalk
Condition	Good
Qty / UOM	11000 / SF
Unit Cost	\$19.82
Basis of Costing	Concrete Sidewalk
Year in Service	2013
Expected Useful Life (EUL)	30 Year(s), Based on Industry Averages
Remaining Useful Life (RUL)	26 Year(s), Estimated, Based on Date of Observation
Location	Site

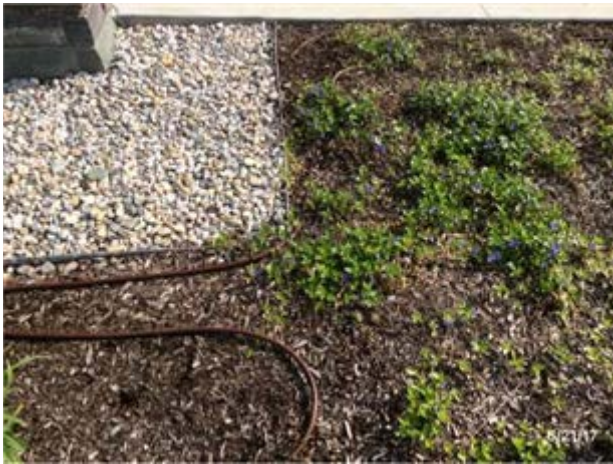
Coding / Field Name	Asset Description
G2057 Irrigation Systems	Irrigation System
Condition	Good
Qty / UOM	10000 / SF
Unit Cost	\$3.16
Basis of Costing	Irrigation System
Year in Service	2013
Expected Useful Life (EUL)	25 Year(s), Based on Industry Averages
Remaining Useful Life (RUL)	21 Year(s), Estimated, Based on Date of Observation
Location	Site

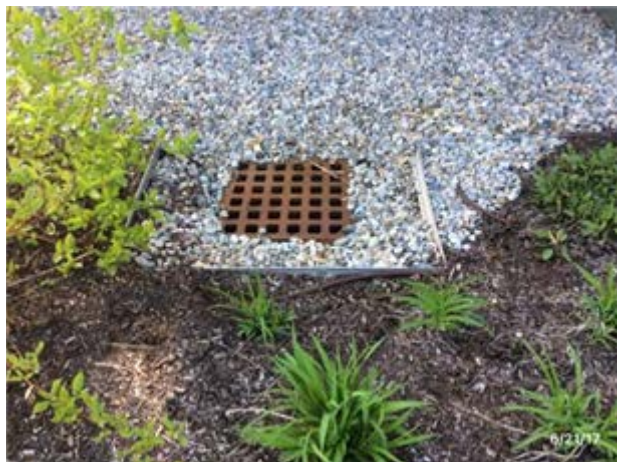
Coding / Field Name	Asset Description
G3030 Storm Sewer	Site Drainage
Condition	Good
Qty / UOM	400000 /
Unit Cost	\$1.00
Year in Service	2013
Expected Useful Life (EUL)	50 Year(s), Based on Industry Averages
Remaining Useful Life (RUL)	46 Year(s), Estimated, Based on Date of Observation
Location	Site
