FACILITY CONDITION ASSESSMENT

FACILITY CONDITION ASSESSMENT
OF
09916 DERBY WELCOME CENTER
1076 RT. I-91 SOUTHBOUND
DERBY, VT 05855

June 19, 2017

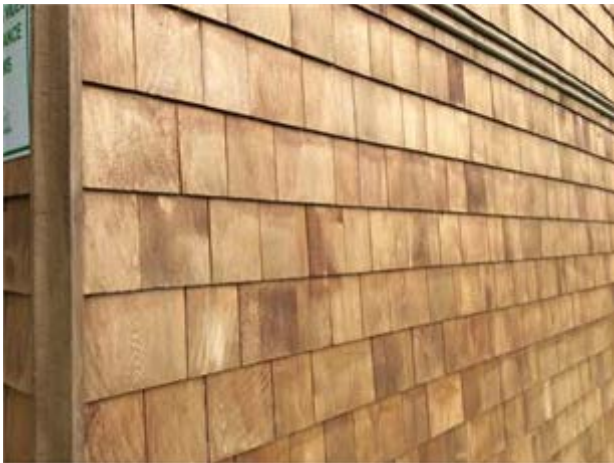
Coding / Field Name	Asset Description
B2011 Exterior Wall Construction	Wood Shingles
Condition	Good
Qty / UOM	2000 / SF
Unit Cost	\$6.69
Basis of Costing	Wood Shingles, 1-2 Stories
Year in Service	2012
Expected Useful Life (EUL)	20 Year(s), Based on Industry Averages
Remaining Useful Life (RUL)	15 Year(s), Estimated, Based on Date of Observation
Location	Exterior Walls
Exterior Wall Construction	Wood Shake Siding
Parapets	No
Exterior Soffits	Exposed

Uniformat	Action Description	Quantity	Unit Cost	Plan Type	Priority	Year	Expenditure
B2011	Prep & Paint/Stain Exterior Walls, up to 4-Story Building	2,000 SF	\$1.41	BYL	Priority 2	2022	\$2,820
B2011	Prep & Paint/Stain Exterior Walls, up to 4-Story Building	2,000 SF	\$1.41	BYL	Priority 2	2032	\$2,820
B2011	Replace Wood Shingles	2,000 SF	\$6.69	BYL	Priority 3	2032	\$13,378

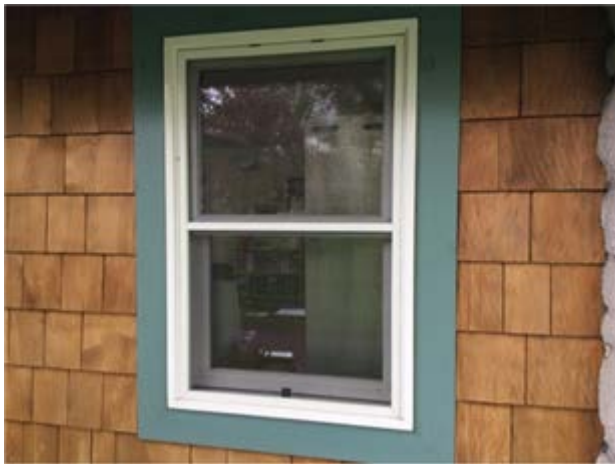
Coding / Field Name	Asset Description
B2021 Windows	Wood Window, Double-Hung
Condition	Fair
Qty / UOM	1 / EA
Unit Cost	\$1,295.75
Basis of Costing	Wood Window, 1-2 Stories, 12 SF
Year in Service	1988
Expected Useful Life (EUL)	30 Year(s), Based on Industry Averages
Remaining Useful Life (RUL)	7 Year(s), Estimated, Based on Date of Observation
Location	Exterior Walls
Window Type	Double Hung
Windows Material	Wood
Windows Glazing	Double Glazed
Window Operation	Manual

Uniformat	Action Description	Quantity	Unit Cost	Plan Type	Priority	Year	Expenditure
B2021	Replace Wood Window, Double-Hung	1 EA	\$1,295.75	BYL	Priority 3	2024	\$1,296

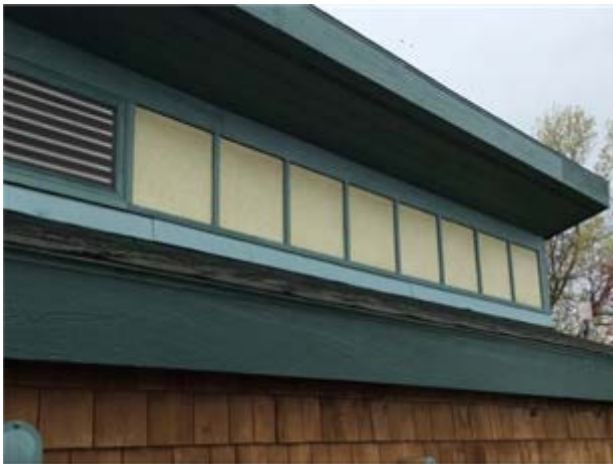
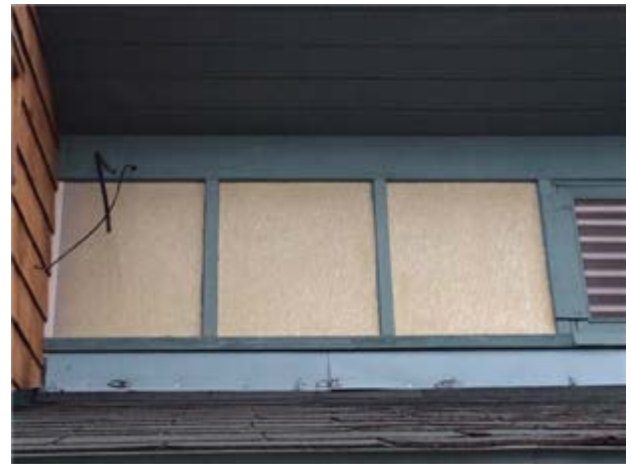
Coding / Field Name	Asset Description
B2021 Windows	Wood Window, Translucent
Condition	Fair
Qty / UOM	19 / EA
Cost Adjustment Factor/Reason	0.5 / Translucent, Small
Unit Cost (Adjusted)	\$647.88
Basis of Costing	Wood Window, 1-2 Stories, 12 SF
Year in Service	1988
Expected Useful Life (EUL)	30 Year(s), Based on Industry Averages
Remaining Useful Life (RUL)	12 Year(s), Estimated, Based on Date of Observation
Location	Exterior Walls
Window Type	Fixed
Windows Material	Wood
Windows Glazing	Double Glazed
Window Operation	Fixed

Uniformat	Action Description	Quantity	Unit Cost	Plan Type	Priority	Year	Expenditure
B2021	Replace Wood Window, Translucent	19 EA	\$647.88	BYL	Priority 3	2029	\$12,310

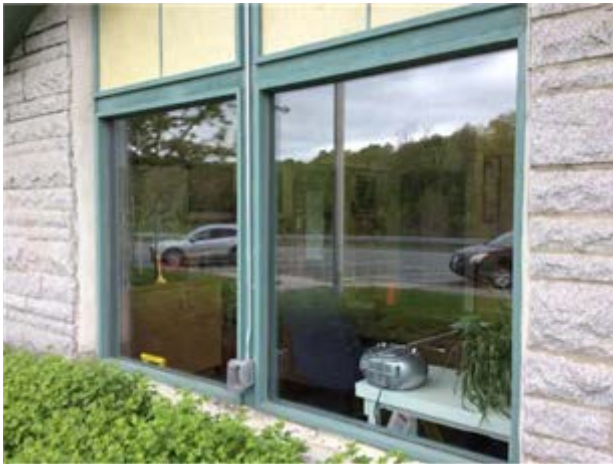
Coding / Field Name	Asset Description
B2021 Windows	Wood Window, Fixed
Condition	Fair
Qty / UOM	2 / EA
Unit Cost	\$1,974.60
Basis of Costing	Wood Window, 1-2 Stories, 24 SF
Year in Service	1988
Expected Useful Life (EUL)	30 Year(s), Based on Industry Averages
Remaining Useful Life (RUL)	10 Year(s), Estimated, Based on Date of Observation
Location	Exterior Walls

Uniformat	Action Description	Quantity	Unit Cost	Plan Type	Priority	Year	Expenditure
B2021	Replace Wood Window, Fixed	2 EA	\$1,974.60	BYL	Priority 3	2027	\$3,949

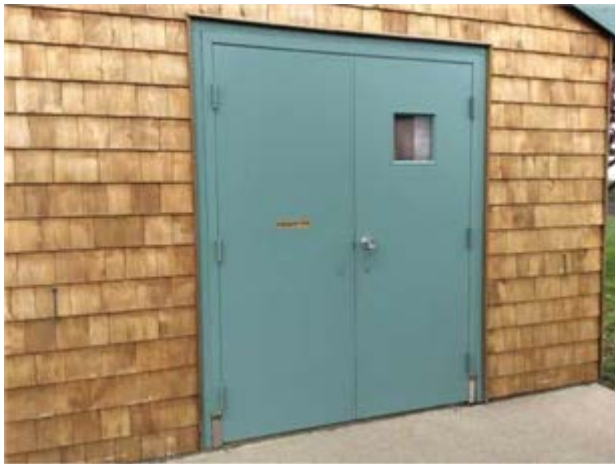
Coding / Field Name	Asset Description
B2032 Solid Exterior Doors	Steel, Insulated, Exterior Door
Condition	Fair
Qty / UOM	3 / EA
Unit Cost	\$1,577.53
Basis of Costing	Steel, Insulated, Exterior Door
Year in Service	1995
Expected Useful Life (EUL)	25 Year(s), Based on Industry Averages
Remaining Useful Life (RUL)	8 Year(s), Estimated, Based on Date of Observation
Location	Exterior Walls
Door Hardware	Knob
Door Operation	Manual
Core Type	Hollow Core
Door Frame	Metal Framed

Uniformat	Action Description	Quantity	Unit Cost	Plan Type	Priority	Year	Expenditure
B2032	Replace Steel, Insulated, Exterior Door	3 EA	\$1,577.53	BYL	Priority 3	2025	\$4,733

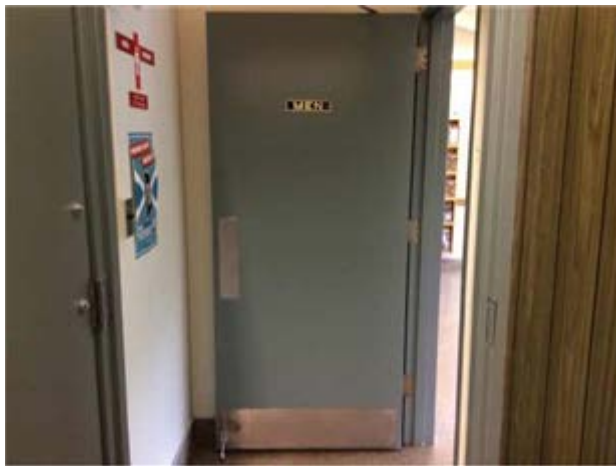
Coding / Field Name	Asset Description
C1021 Interior Doors	Steel, Interior Door
Condition	Fair
Qty / UOM	9 / EA
Unit Cost	\$950.12
Basis of Costing	Steel, Interior Door
Year in Service	1988
Expected Useful Life (EUL)	25 Year(s), Based on Industry Averages
Remaining Useful Life (RUL)	12 Year(s), Estimated, Based on Date of Observation
Location	Building Interior (General)

Uniformat	Action Description	Quantity	Unit Cost	Plan Type	Priority	Year	Expenditure
C1021	Replace Steel, Interior Door	9 EA	\$950.12	BYL	Priority 3	2029	\$8,551

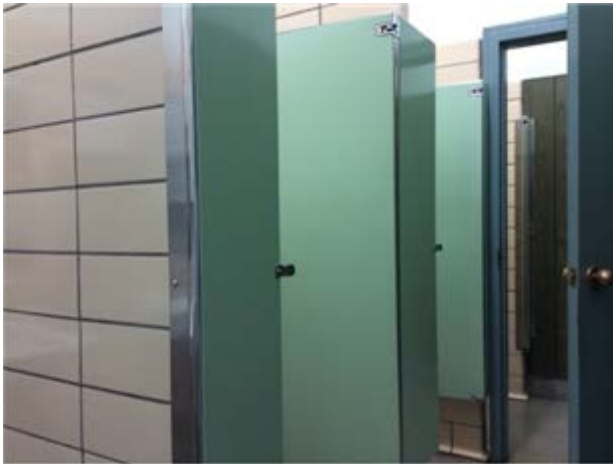
Coding / Field Name	Asset Description
C1031 Fabricated Toilet Partitions	Toilet Partitions, Metal, Overhead Braced
Condition	Fair
Qty / UOM	3 / EA
Unit Cost	\$850.00
Basis of Costing	Toilet Partitions, Metal, Overhead Braced
Year in Service	1968
Expected Useful Life (EUL)	20 Year(s), Based on Industry Averages
Remaining Useful Life (RUL)	6 Year(s), Estimated, Based on Date of Observation
Location	Restrooms

Uniformat	Action Description	Quantity	Unit Cost	Plan Type	Priority	Year	Expenditure
C1031	Replace Toilet Partitions, Metal, Overhead Braced	3 EA	\$850.00	BYL	Priority 3	2023	\$2,550

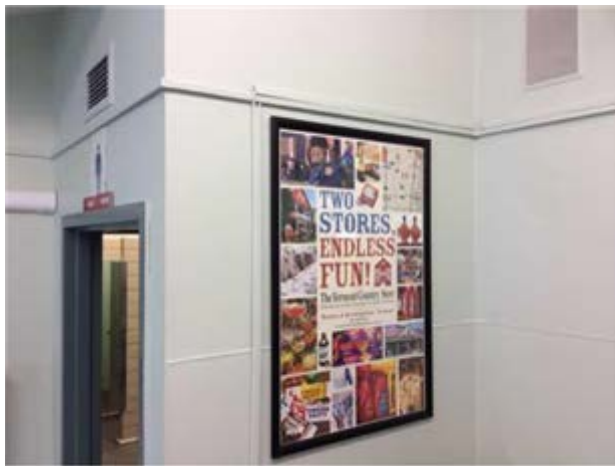
Coding / Field Name	Asset Description
C3012 Wall Finishes to Interior Walls	Gypsum Board/Plaster, Interior Wall
Condition	Fair
Qty / UOM	2000 / SF
Unit Cost	\$3.38
Basis of Costing	Gypsum Board/Plaster, Interior Wall
Year in Service	1968
Expected Useful Life (EUL)	40 Year(s), Based on Industry Averages
Remaining Useful Life (RUL)	25 Year(s), Estimated, Based on Date of Observation
Location	Building Interior (General)

Uniformat	Action Description	Quantity	Unit Cost	Plan Type	Priority	Year	Expenditure
C3012	Paint Interior Walls	2,000 SF	\$1.42	BYL	Priority 3	2022	\$2,840
C3012	Paint Interior Walls	2,000 SF	\$1.42	BYL	Priority 3	2030	\$2,840

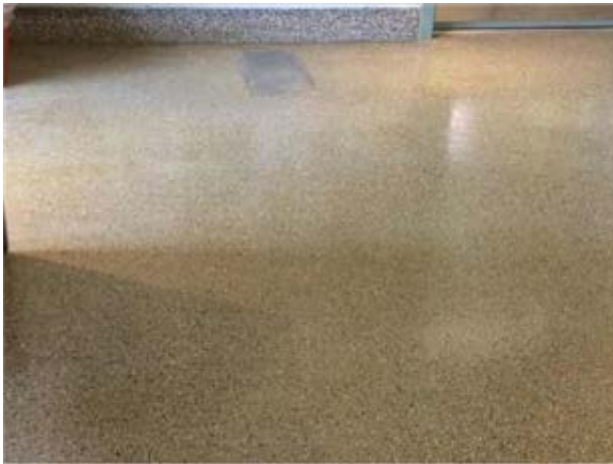
Coding / Field Name	Asset Description
C3021 Floor Toppings	Epoxy Floor Finish
Condition	Fair
Qty / UOM	1000 / SF
Unit Cost	\$8.74
Basis of Costing	Epoxy Floor Finish
Year in Service	1988
Expected Useful Life (EUL)	10 Year(s), Based on Industry Averages
Remaining Useful Life (RUL)	3 Year(s), Estimated, Based on Date of Observation
Location	Building Interior (General)

Uniformat	Action Description	Quantity	Unit Cost	Plan Type	Priority	Year	Expenditure
C3021	Replace Epoxy Floor Finish	1,000 SF	\$8.74	BYL	Priority 3	2020	\$8,740
C3021	Replace Epoxy Floor Finish	1,000 SF	\$8.74	BYL	Priority 3	2030	\$8,740

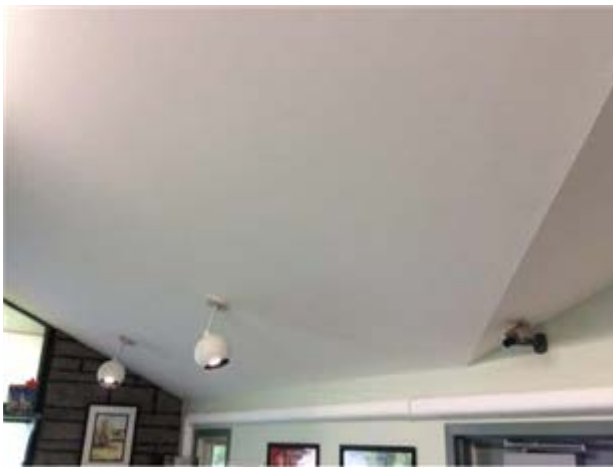
Coding / Field Name	Asset Description
C3031 Ceiling Finishes	Gypsum Board/Plaster, Ceiling
Condition	Fair
Qty / UOM	1300 / SF
Unit Cost	\$7.13
Basis of Costing	Gypsum Board/Plaster, Ceiling
Year in Service	1988
Expected Useful Life (EUL)	50 Year(s), Based on Industry Averages
Remaining Useful Life (RUL)	25 Year(s), Estimated, Based on Date of Observation
Location	Building Interior (General)

Uniformat	Action Description	Quantity	Unit Cost	Plan Type	Priority	Year	Expenditure
C3031	Paint Interior Ceilings	1,300 SF	\$1.94	BYL	Priority 3	2022	\$2,522
C3031	Paint Interior Ceilings	1,300 SF	\$1.94	BYL	Priority 3	2032	\$2,522

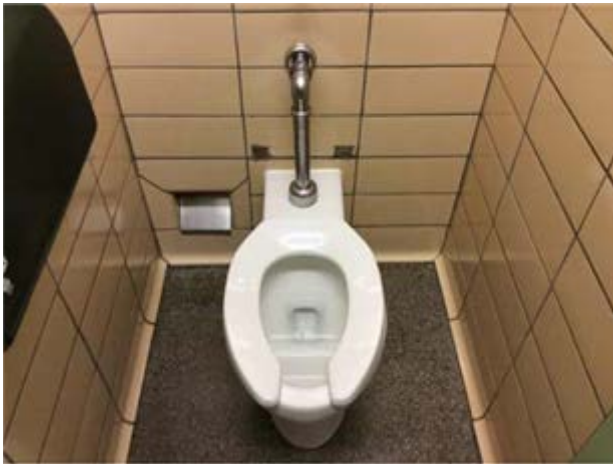
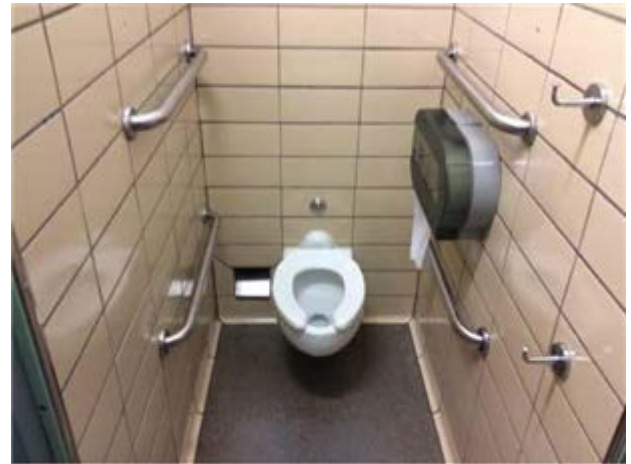
Coding / Field Name	Asset Description
D2011 Water Closets	Tankless Water Closet
Condition	Fair
Qty / UOM	5 / EA
Unit Cost	\$842.97
Basis of Costing	Tankless Water Closet
Year in Service	1988
Expected Useful Life (EUL)	20 Year(s), Based on Industry Averages
Remaining Useful Life (RUL)	7 Year(s), Estimated, Based on Date of Observation
Location	Restrooms

Uniformat	Action Description	Quantity	Unit Cost	Plan Type	Priority	Year	Expenditure
D2011	Replace Tankless Water Closet	5 EA	\$842.97	BYL	Priority 3	2024	\$4,215

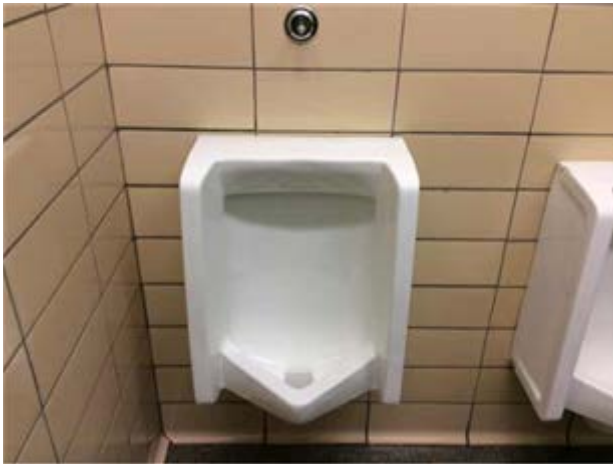
Coding / Field Name	Asset Description
D2012 Urinals	Urinal, Vitreous China
Condition	Fair
Qty / UOM	2 / EA
Unit Cost	\$1,193.44
Basis of Costing	Urinal, Vitreous China
Year in Service	2000
Expected Useful Life (EUL)	20 Year(s), Based on Industry Averages
Remaining Useful Life (RUL)	5 Year(s), Estimated, Based on Date of Observation
Location	Restrooms

Uniformat	Action Description	Quantity	Unit Cost	Plan Type	Priority	Year	Expenditure
D2012	Replace Urinal, Vitreous China	2 EA	\$1,193.44	BYL	Priority 2	2022	\$2,387

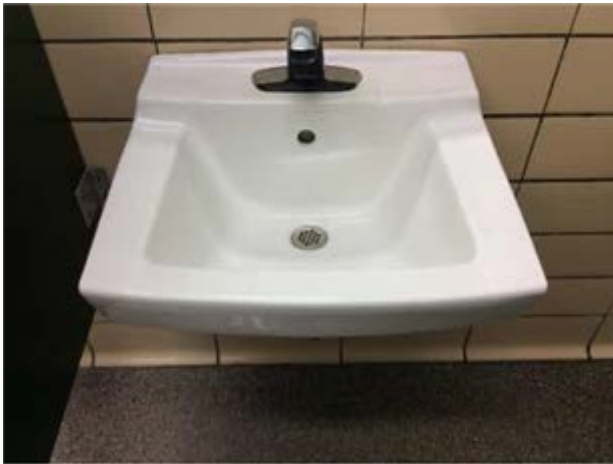
Coding / Field Name	Asset Description
D2013 Lavatories	Lavatory, Enameled Steel
Condition	Fair
Qty / UOM	4 / EA
Unit Cost	\$353.05
Basis of Costing	Lavatory, Enameled Steel
Year in Service	1988
Expected Useful Life (EUL)	20 Year(s), Based on Industry Averages
Remaining Useful Life (RUL)	8 Year(s), Estimated, Based on Date of Observation
Location	Restrooms

Uniformat	Action Description	Quantity	Unit Cost	Plan Type	Priority	Year	Expenditure
D2013	Replace Lavatory, Enameled Steel	4 EA	\$353.05	BYL	Priority 3	2025	\$1,412

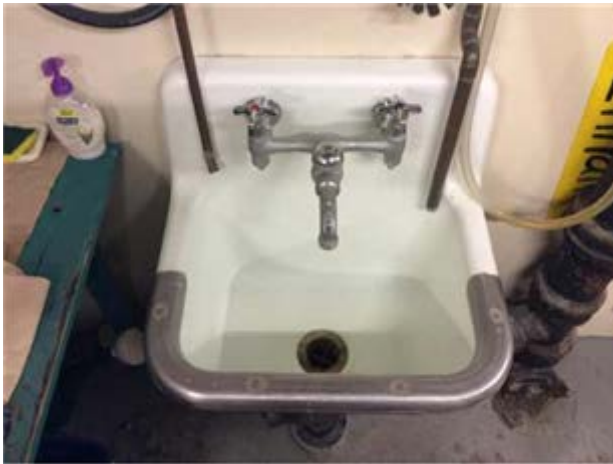
Coding / Field Name	Asset Description
D2014 Sinks	Service Sink, Porcelain Enamel, Cast Iron
Condition	Fair
Qty / UOM	1 / EA
Unit Cost	\$1,360.33
Basis of Costing	Service Sink, Porcelain Enamel, Cast Iron
Year in Service	1988
Expected Useful Life (EUL)	20 Year(s), Based on Industry Averages
Remaining Useful Life (RUL)	7 Year(s), Estimated, Based on Date of Observation
Location	Utility Area

Uniformat	Action Description	Quantity	Unit Cost	Plan Type	Priority	Year	Expenditure
D2014	Replace Service Sink, Porcelain Enamel, Cast Iron	1 EA	\$1,360.33	BYL	Priority 3	2024	\$1,360

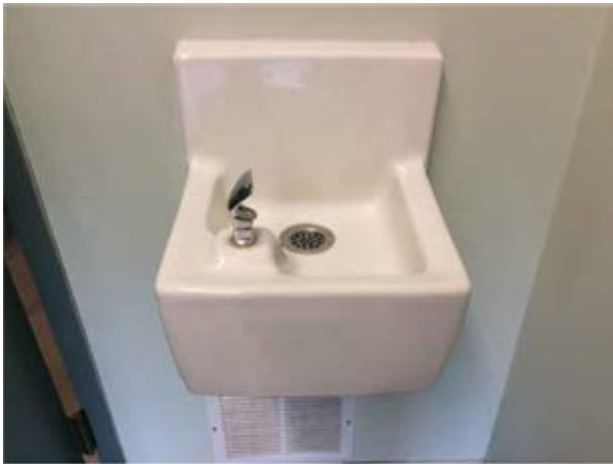
Coding / Field Name	Asset Description
D2018 Drinking Fountains and Coolers	Drinking Fountain, Vitreous China
Condition	Fair
Qty / UOM	1 / EA
Unit Cost	\$1,938.99
Basis of Costing	Drinking Fountain, Vitreous China
Year in Service	1968
Expected Useful Life (EUL)	15 Year(s), Based on Industry Averages
Remaining Useful Life (RUL)	3 Year(s), Estimated, Based on Date of Observation
Location	Building Interior (General)

Uniformat	Action Description	Quantity	Unit Cost	Plan Type	Priority	Year	Expenditure
D2018	Replace Drinking Fountain, Vitreous China	1 EA	\$1,938.99	BYL	Priority 2	2020	\$1,939
D2018	Replace Drinking Fountain, Vitreous China	1 EA	\$1,938.99	BYL	Priority 2	2035	\$1,939

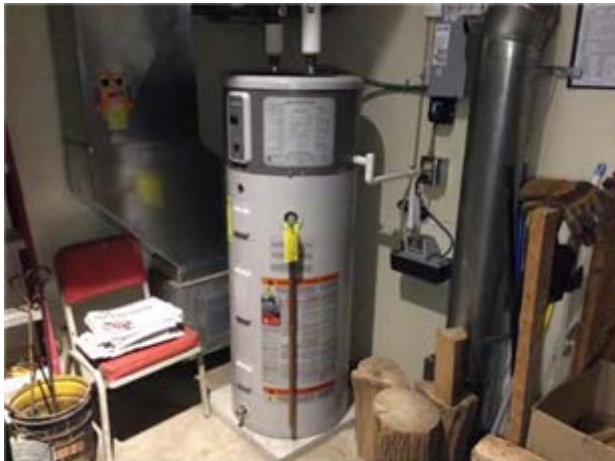
Coding / Field Name	Asset Description
D2023 Domestic Water Supply Equipment	Water Heater, Electric, Hybrid
Condition	Good
Qty / UOM	1 / EA
Cost Adjustment Factor/Reason	1.5 / Integral heat pump
Unit Cost (Adjusted)	\$4,406.10
Basis of Costing	Water Heater, Electric, Residential, 53 to 120 GAL
Year in Service	2015
Expected Useful Life (EUL)	15 Year(s), Based on Industry Averages
Remaining Useful Life (RUL)	13 Year(s), Estimated, Based on Date of Observation
Location	Utility Area

Uniformat	Action Description	Quantity	Unit Cost	Plan Type	Priority	Year	Expenditure
D2023	Replace Water Heater, Electric, Hybrid	1 EA	\$4,406.10	BYL	Priority 3	2030	\$4,406

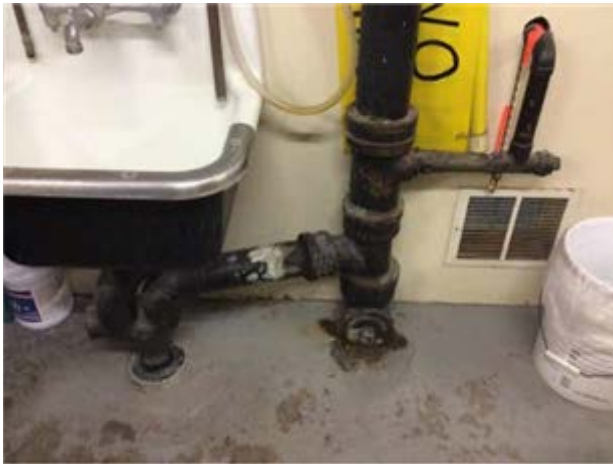
Coding / Field Name	Asset Description
D2034 Sanitary Waste Equipment	Plumbing System, Sanitary Waste
Condition	Fair
Qty / UOM	1300 / SF
Unit Cost	\$5.06
Basis of Costing	Plumbing System, Sanitary Waste
Year in Service	1968
Expected Useful Life (EUL)	40 Year(s), Based on Industry Averages
Remaining Useful Life (RUL)	8 Year(s), Estimated, Based on Date of Observation
Location	Building Interior (General)

Uniformat	Action Description	Quantity	Unit Cost	Plan Type	Priority	Year	Expenditure
D2034	Replace Plumbing System, Sanitary Waste	1,300 SF	\$5.06	BYL	Priority 3	2025	\$6,578

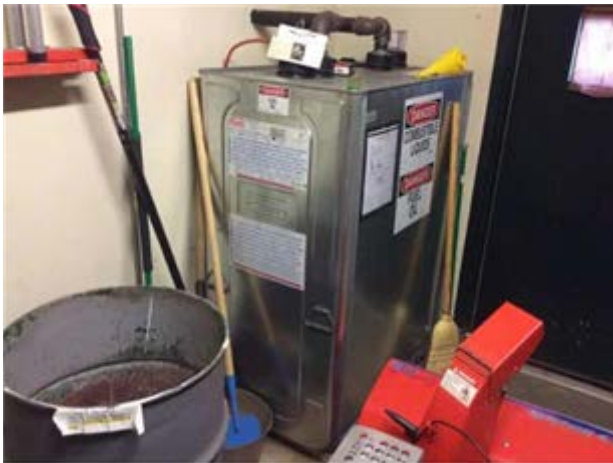
Coding / Field Name	Asset Description
D3011 Oil Supply System	Oil Storage Tank, 275 GAL
Condition	Good
Qty / UOM	1 / EA
Unit Cost	\$935.73
Basis of Costing	Oil Storage Tank, 31 to 275 GAL
Year in Service	2006
Expected Useful Life (EUL)	25 Year(s), Based on Industry Averages
Remaining Useful Life (RUL)	19 Year(s), Estimated, Based on Date of Observation
Location	Mechanical Room (Primary)
Manufacturer	Roth
Model	DWT
Fuel Tank Type	Ast

Uniformat	Action Description	Quantity	Unit Cost	Plan Type	Priority	Year	Expenditure
D3011	Replace Oil Storage Tank, 275 GAL	1 EA	\$935.73	BYL	Priority 3	2036	\$936

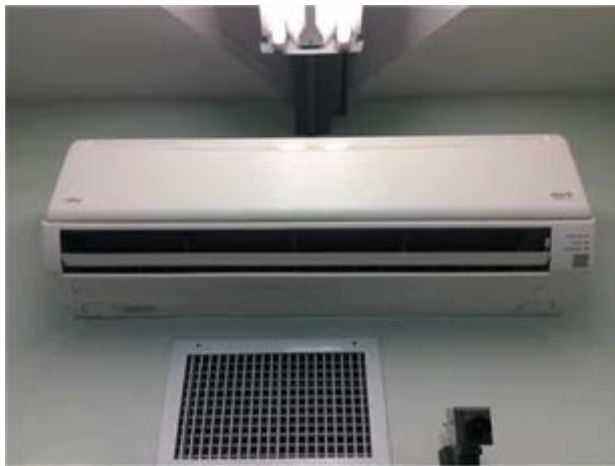
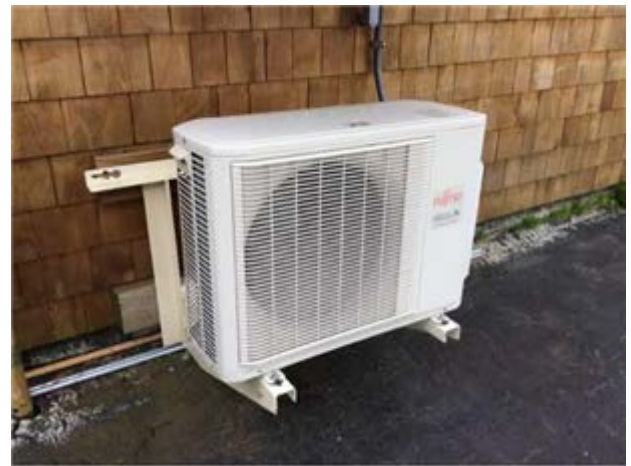
Coding / Field Name	Asset Description
D3032 Direct Expansion Systems	Ductless Split System, Single Zone, 2 Ton
Condition	Good
Qty / UOM	1 / EA
Unit Cost	\$4,473.11
Basis of Costing	Ductless Split System, Single Zone, 1.5 to 2 Ton
Year in Service	2012
Expected Useful Life (EUL)	15 Year(s), Based on Industry Averages
Remaining Useful Life (RUL)	10 Year(s), Estimated, Based on Date of Observation
Location	Building Interior (General)

Uniformat	Action Description	Quantity	Unit Cost	Plan Type	Priority	Year	Expenditure
D3032	Replace Ductless Split System, Single Zone, 2 Ton	1 EA	\$4,473.11	BYL	Priority 3	2027	\$4,473

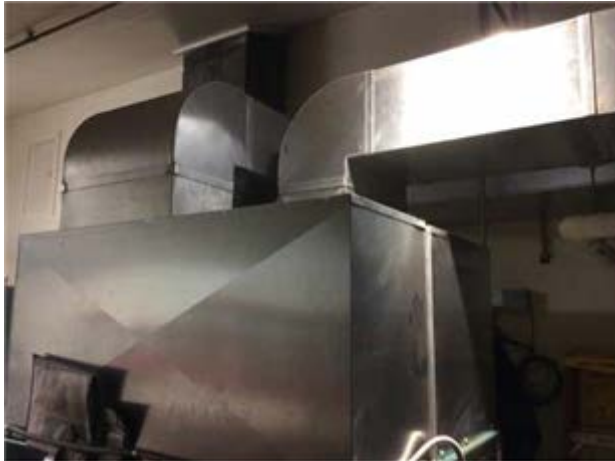
Coding / Field Name	Asset Description
D3041 Air Distribution Systems	HVAC System Ductwork, Sheetmetal
Condition	Good
Qty / UOM	1300 / SF
Cost Adjustment Factor/Reason	0.7 / Basic System
Unit Cost (Adjusted)	\$13.65
Basis of Costing	HVAC System Ductwork, Sheet Metal
Year in Service	2013
Expected Useful Life (EUL)	30 Year(s), Based on Industry Averages
Remaining Useful Life (RUL)	26 Year(s), Estimated, Based on Date of Observation
Location	Building Interior (General)

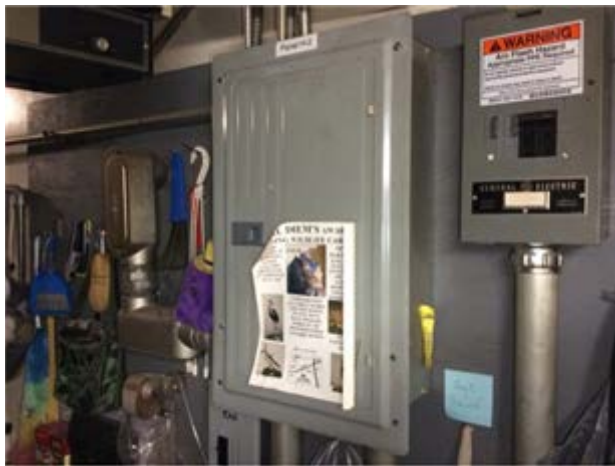
Coding / Field Name	Asset Description
D5012 Low Tension Service & Dist.	Power Panel Board, 208 Y, 120 V, 100 Amp, Left
Condition	Fair
Qty / UOM	1 / EA
Unit Cost	\$5,079.93
Basis of Costing	Power Panel Board, 208 Y, 120 V, 100 Amp
Year in Service	1996
Expected Useful Life (EUL)	30 Year(s), Based on Industry Averages
Remaining Useful Life (RUL)	12 Year(s), Estimated, Based on Date of Observation
Location	Electrical Room (Primary)

Uniformat	Action Description	Quantity	Unit Cost	Plan Type	Priority	Year	Expenditure
D5012	Replace Power Panel Board, 208 Y, 120 V, 100 Amp, Left	1 EA	\$5,079.93	BYL	Priority 3	2029	\$5,080

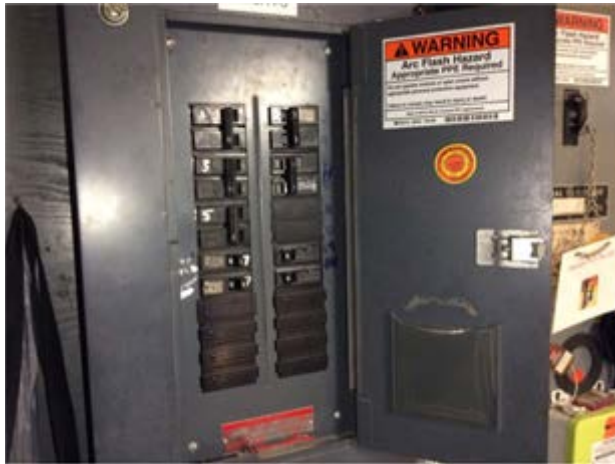
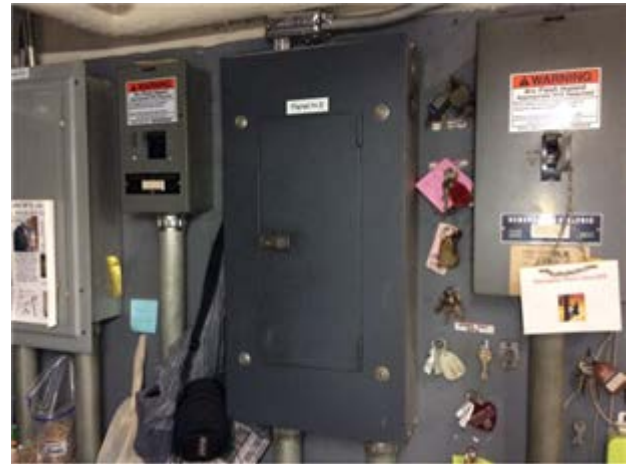
Coding / Field Name	Asset Description
D5012 Low Tension Service & Dist.	Power Panel Board, 208 Y, 120 V, 100 Amp, Right
Condition	Fair
Qty / UOM	1 / EA
Unit Cost	\$5,079.93
Basis of Costing	Power Panel Board, 208 Y, 120 V, 100 Amp
Year in Service	1968
Expected Useful Life (EUL)	30 Year(s), Based on Industry Averages
Remaining Useful Life (RUL)	3 Year(s), Estimated, Based on Date of Observation
Location	Electrical Room (Primary)

Uniformat	Action Description	Quantity	Unit Cost	Plan Type	Priority	Year	Expenditure
D5012	Replace Power Panel Board, 208 Y, 120 V, 100 Amp, Right	1 EA	\$5,079.93	BYL	Priority 1	2020	\$5,080

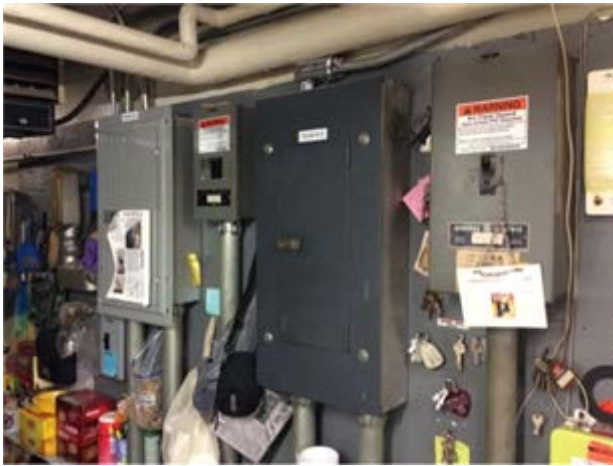
Coding / Field Name	Asset Description
D5019 Electrical Systems	Electrical System, Distribution
Condition	Fair
Qty / UOM	1300 / SF
Unit Cost	\$27.25
Basis of Costing	Electrical System, Full Upgrade, Office (per SF)
Year in Service	1963
Expected Useful Life (EUL)	40 Year(s), Based on Industry Averages
Remaining Useful Life (RUL)	5 Year(s), Estimated, Based on Date of Observation
Location	Building Interior (General)

Uniformat	Action Description	Quantity	Unit Cost	Plan Type	Priority	Year	Expenditure
D5019	Replace Electrical System, Distribution	1,300 SF	\$27.25	BYL	Priority 2	2022	\$35,430

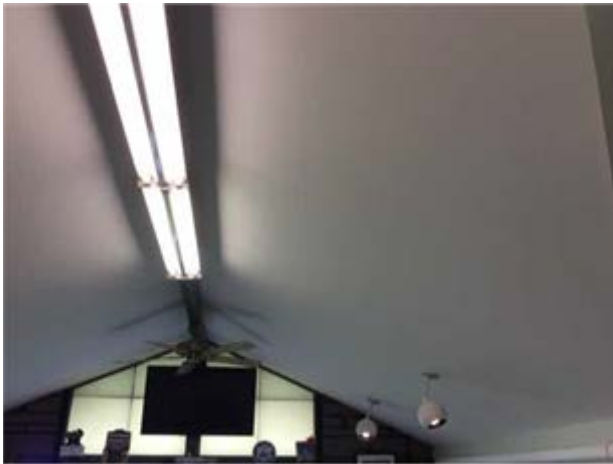
Coding / Field Name	Asset Description
D5029 Lighting Systems	Lighting System, Interior
Condition	Fair
Qty / UOM	1300 / SF
Unit Cost	\$9.24
Basis of Costing	Lighting System, Full Upgrade, Office (per SF)
Year in Service	1988
Expected Useful Life (EUL)	25 Year(s), Based on Industry Averages
Remaining Useful Life (RUL)	4 Year(s), Estimated, Based on Date of Observation
Location	Building Interior (General)

Uniformat	Action Description	Quantity	Unit Cost	Plan Type	Priority	Year	Expenditure
D5029	Replace Lighting System, Interior	1,300 SF	\$9.24	BYL	Priority 2	2021	\$12,012

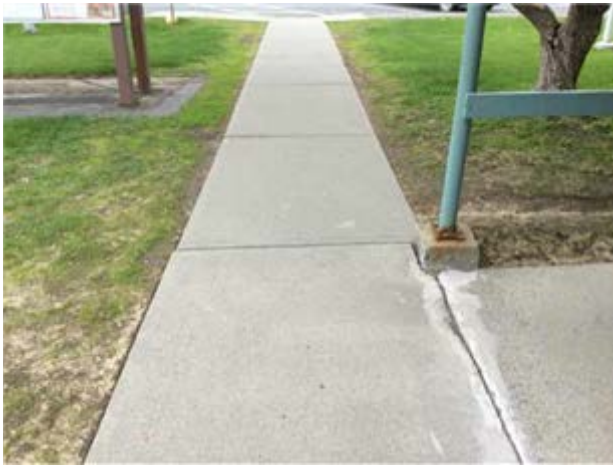
Coding / Field Name	Asset Description
G2031 Paving & Surfacing	Concrete Sidewalk
Condition	Fair
Qty / UOM	500 / SF
Unit Cost	\$19.82
Basis of Costing	Concrete Sidewalk
Year in Service	2000
Expected Useful Life (EUL)	30 Year(s), Based on Industry Averages
Remaining Useful Life (RUL)	13 Year(s), Estimated, Based on Date of Observation
Location	Site

Uniformat	Action Description	Quantity	Unit Cost	Plan Type	Priority	Year	Expenditure
G2031	Replace Concrete Sidewalk	500 SF	\$19.82	BYL	Priority 3	2030	\$9,911

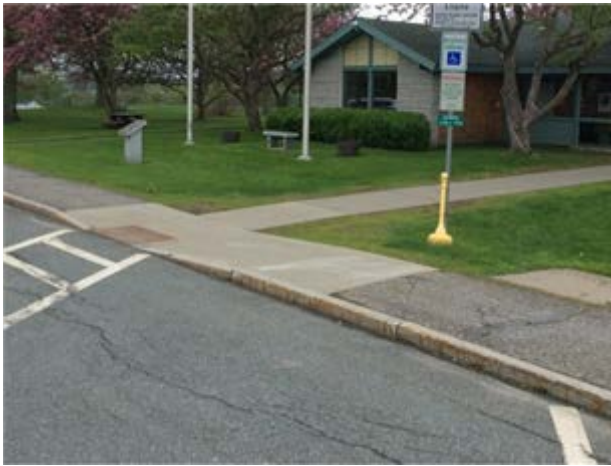
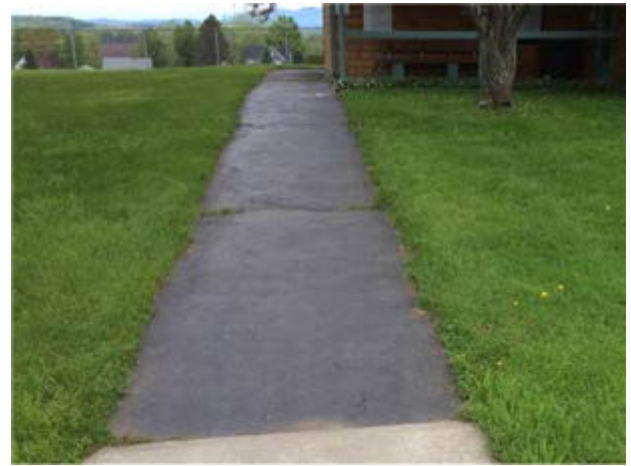
Coding / Field Name	Asset Description
G2031 Paving & Surfacing	Asphalt Sidewalk
Condition	Fair
Qty / UOM	1200 / SF
Unit Cost	\$0.75
Basis of Costing	Asphalt Sidewalk
Year in Service	1995
Expected Useful Life (EUL)	25 Year(s), Based on Industry Averages
Remaining Useful Life (RUL)	3 Year(s), Estimated, Based on Date of Observation
Location	Site

Uniformat	Action Description	Quantity	Unit Cost	Plan Type	Priority	Year	Expenditure
G2031	Mill & Overlay Asphalt Pavement	1,200 SF	\$3.28	BYL	Priority 2	2020	\$3,936
G2031	Asphalt Walk- Seal	1,200 SF	\$0.50	BYL	Priority 3	2025	\$600
G2031	Asphalt Walk- Seal	1,200 SF	\$0.50	BYL	Priority 3	2030	\$600
G2031	Asphalt Walk- Seal	1,200 SF	\$0.50	BYL	Priority 3	2035	\$600

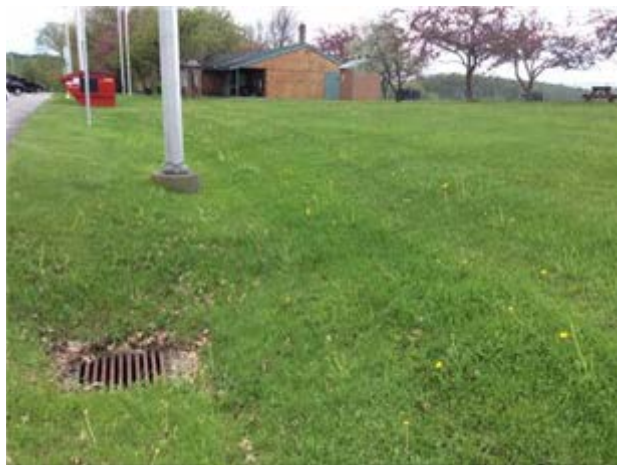
Coding / Field Name	Asset Description
G3030 Storm Sewer	Site Drainage
Condition	Fair
Qty / UOM	45000 /
Unit Cost	\$1.00
Year in Service	1968
Expected Useful Life (EUL)	50 Year(s), Based on Industry Averages
Remaining Useful Life (RUL)	25 Year(s), Estimated, Based on Date of Observation
Location	Site
