FACILITY CONDITION ASSESSMENT

106686.17R000-086.305

June 19, 2017

FACILITY CONDITION ASSESSMENT
OF
GUILFORD WELCOME CENTER
91 NORTH
GUILFORD, VT 05602

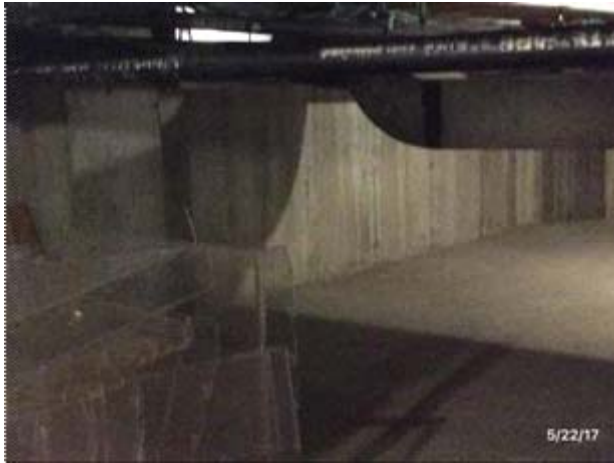
Coding / Field Name	Asset Description
A1011 Wall Foundations	Basement Wall, Concrete
Condition	Good
Qty / UOM	312 / LF
Unit Cost	\$110.00
Year in Service	1999
Expected Useful Life (EUL)	75 Year(s), Based on Industry Averages
Remaining Useful Life (RUL)	57 Year(s), Estimated, Based on Date of Observation
Location	Structure

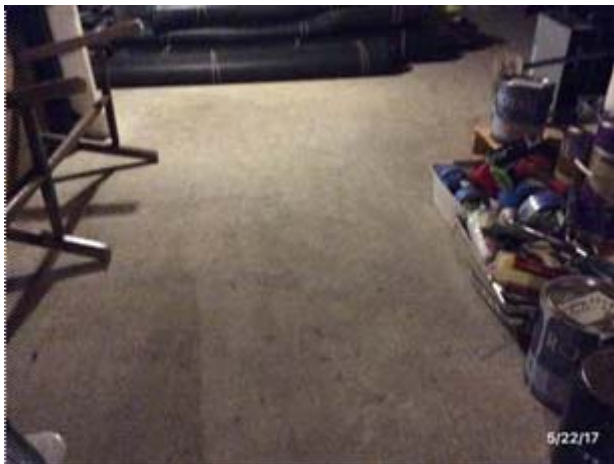
Coding / Field Name	Asset Description
A1031 Standard Slab on Grade	Concrete Slab
Condition	Good
Qty / UOM	7138 / SF
Unit Cost	\$10.03
Basis of Costing	Concrete Slab-On-Grade
Year in Service	1999
Expected Useful Life (EUL)	50 Year(s), Based on Industry Averages
Remaining Useful Life (RUL)	40 Year(s), Estimated, Based on Date of Observation
Location	Structure

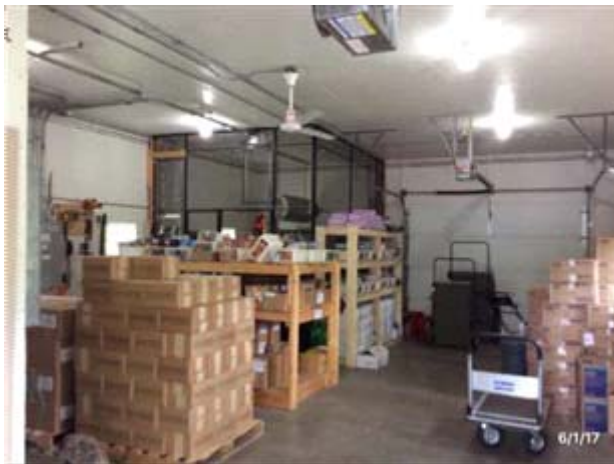
Coding / Field Name	Asset Description
A1031 Standard Slab on Grade	Concrete Slab, Garage
Condition	Good
Qty / UOM	1100 / SF
Unit Cost	\$10.03
Basis of Costing	Concrete Slab-On-Grade
Year in Service	1999
Expected Useful Life (EUL)	50 Year(s), Based on Industry Averages
Remaining Useful Life (RUL)	40 Year(s), Estimated, Based on Date of Observation
Location	Garage

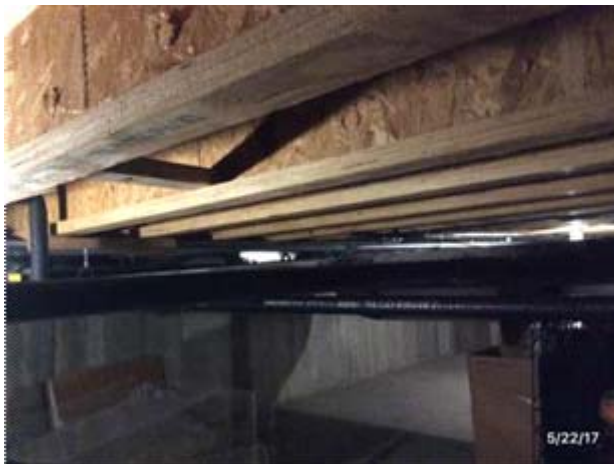
Coding / Field Name	Asset Description
B1012 Upper Floors Construction	Wood Frame and decking
Condition	Good
Qty / UOM	6130 / SF
Unit Cost	\$10.13
Basis of Costing	Wood Decking
Year in Service	1999
Expected Useful Life (EUL)	50 Year(s), Based on Industry Averages
Remaining Useful Life (RUL)	40 Year(s), Estimated, Based on Date of Observation
Location	Structure

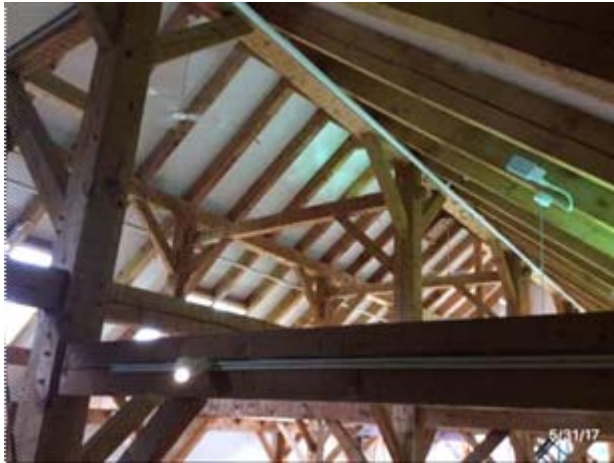
Coding / Field Name	Asset Description
B1022 Pitched Roof Construction	Timber Frame Roof with Panel Skin
Condition	Good
Qty / UOM	7138 / SF
Unit Cost	\$85.00
Year in Service	1999
Expected Useful Life (EUL)	75 Year(s), Based on Industry Averages
Remaining Useful Life (RUL)	57 Year(s), Estimated, Based on Date of Observation
Location	Roof

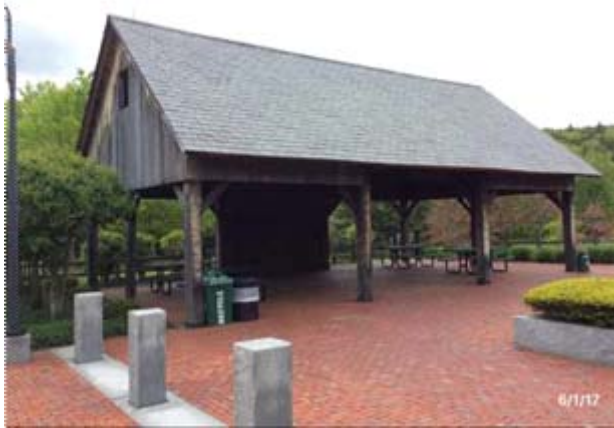
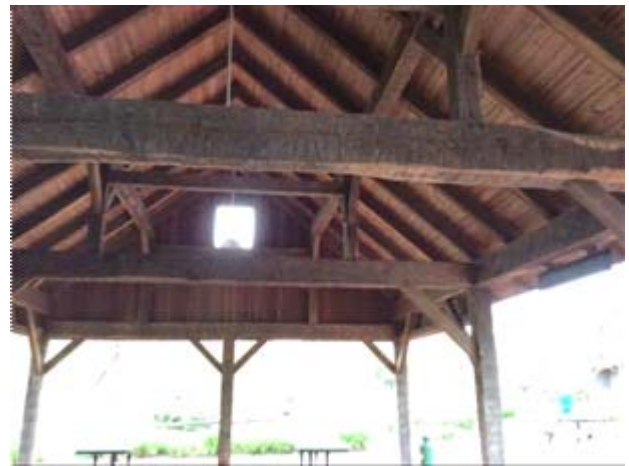
Coding / Field Name	Asset Description
B1033 Wood Frame Structure	Wood Frame Structure, Picnic Canopy
Condition	Good
Qty / UOM	920 / SF
Cost Adjustment Factor/Reason	1.2 / Timber Frame
Unit Cost (Adjusted)	\$33.60
Year in Service	1999
Expected Useful Life (EUL)	75 Year(s), Based on Industry Averages
Remaining Useful Life (RUL)	57 Year(s), Estimated, Based on Date of Observation
Location	Picnic Canopy

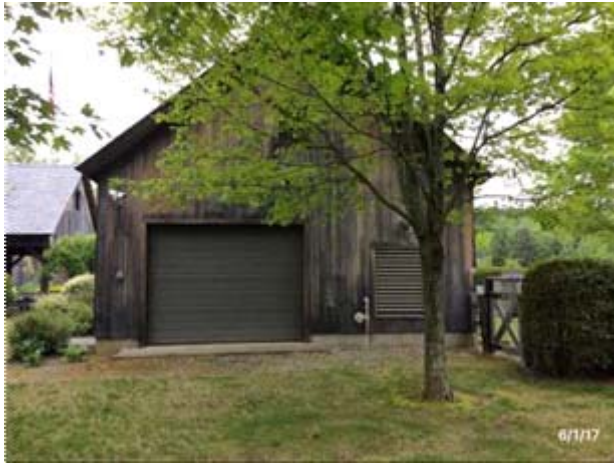
Coding / Field Name	Asset Description
B1033 Wood Frame Structure	Wood Frame Structure, Garage
Condition	Good
Qty / UOM	1100 / SF
Unit Cost	\$28.00
Year in Service	1999
Expected Useful Life (EUL)	75 Year(s), Based on Industry Averages
Remaining Useful Life (RUL)	57 Year(s), Estimated, Based on Date of Observation
Location	Garage

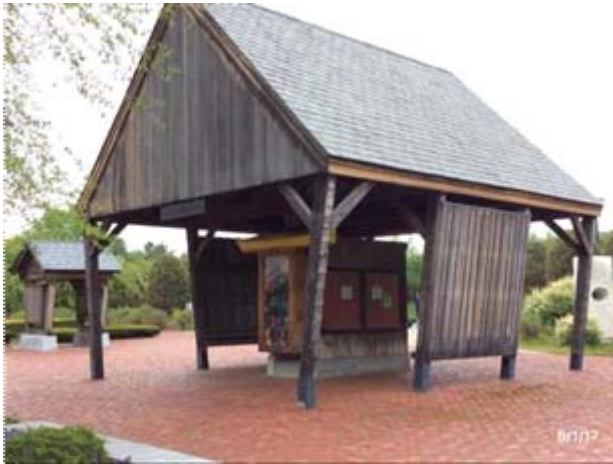
Coding / Field Name	Asset Description
B1033 Wood Frame Structure	Wood Frame Structure, Information Canopy
Condition	Good
Qty / UOM	480 / SF
Cost Adjustment Factor/Reason	1.2 / Timber Frame
Unit Cost (Adjusted)	\$33.60
Year in Service	1999
Expected Useful Life (EUL)	75 Year(s), Based on Industry Averages
Remaining Useful Life (RUL)	57 Year(s), Estimated, Based on Date of Observation
Location	Information Canopy

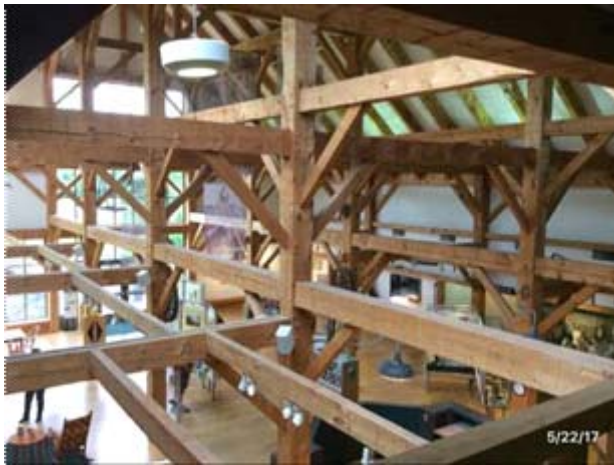
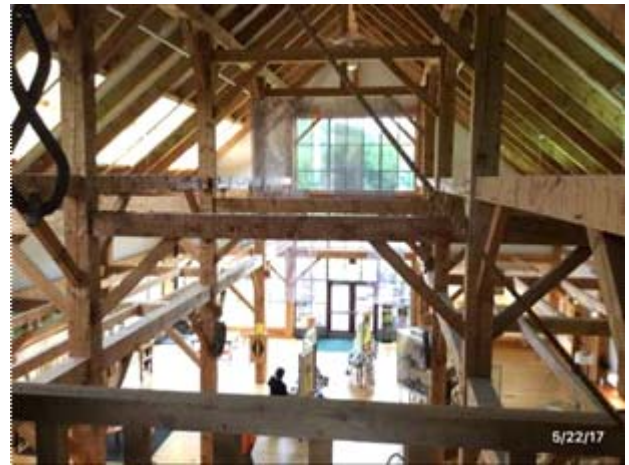
Coding / Field Name	Asset Description
B1033 Wood Frame Structure	Timber Frame with panelized walls
Condition	Good
Qty / UOM	7138 / SF
Unit Cost	\$105.00
Year in Service	1999
Expected Useful Life (EUL)	75 Year(s), Based on Industry Averages
Remaining Useful Life (RUL)	60 Year(s), Estimated, Based on Date of Observation
Location	Structure

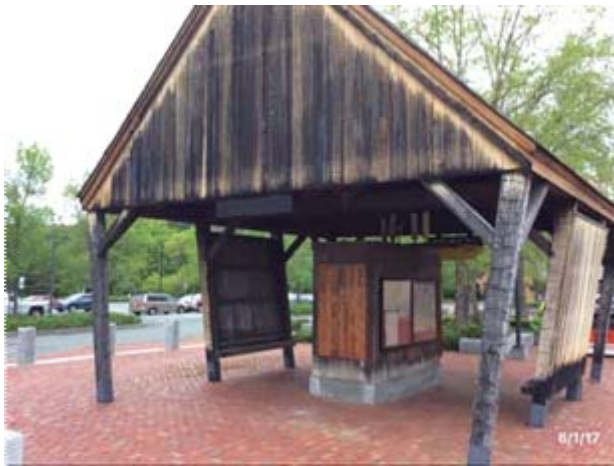
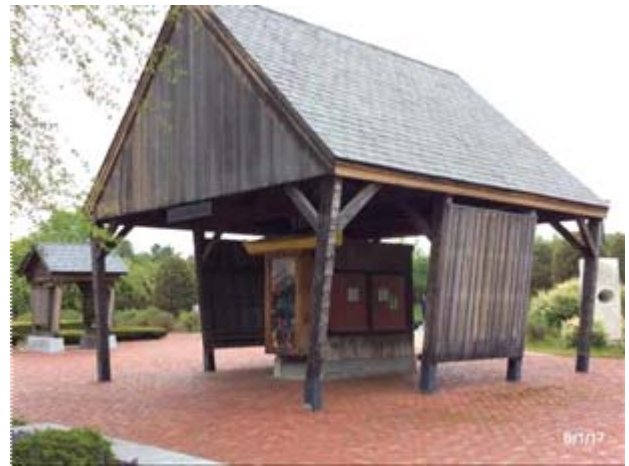
Coding / Field Name	Asset Description
B2011 Exterior Wall Construction	Wood Barn Siding, Information Canopy
Condition	Good
Qty / UOM	340 / SF
Unit Cost	\$7.90
Basis of Costing	Wood Shingles, 3+ Stories
Year in Service	1999
Expected Useful Life (EUL)	20 Year(s), Based on Industry Averages
Remaining Useful Life (RUL)	17 Year(s), Estimated, Based on Date of Observation
Location	Information Canopy

Uniformat	Action Description	Quantity	Unit Cost	Plan Type	Priority	Year	Expenditure
B2011	Prep and Stain Wood Siding	340 SF	\$1.41	MNT	Priority 3	2020	\$479
B2011	Prep and Stain Wood Siding	340 SF	\$1.41	MNT	Priority 3	2030	\$479

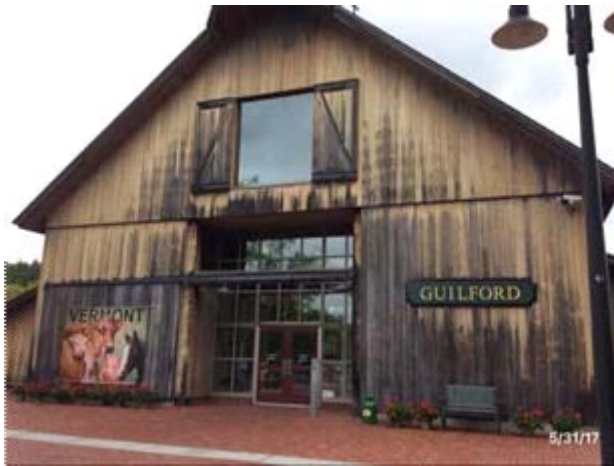
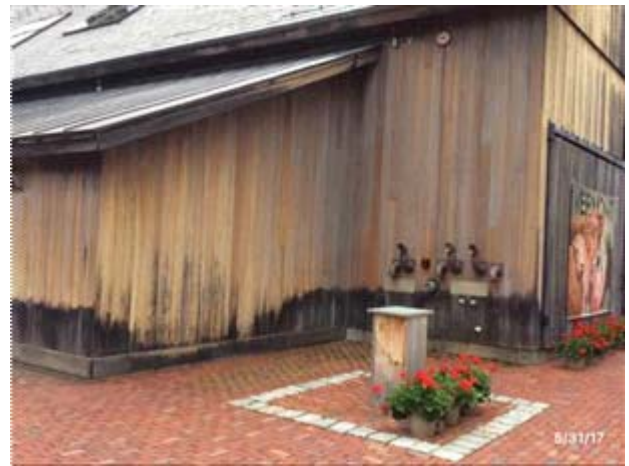
Coding / Field Name	Asset Description
B2011 Exterior Wall Construction	Wood Barn Siding
Condition	Good
Qty / UOM	8000 / SF
Unit Cost	\$7.90
Basis of Costing	Wood Shingles, 3+ Stories
Year in Service	1999
Expected Useful Life (EUL)	20 Year(s), Based on Industry Averages
Remaining Useful Life (RUL)	17 Year(s), Estimated, Based on Date of Observation
Location	Exterior Walls

Unifomat	Action Description	Quantity	Unit Cost	Plan Type	Priority	Year	Expenditure
B2011	Prep & Stain Exterior Walls	8,000 SF	\$1.41	APP	Priority 3	2019	\$11,280
B2011	Prep & Stain Exterior Walls	8,000 SF	\$1.41	APP	Priority 3	2029	\$11,280
B2011	Replace Wood Barn Siding	8,000 SF	\$7.90	BYL	Priority 3	2034	\$63,225

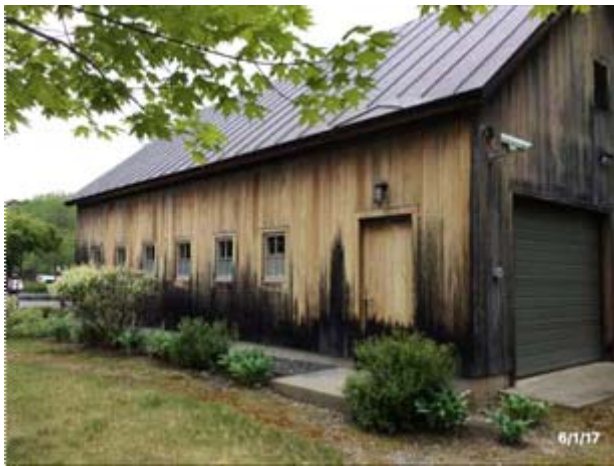
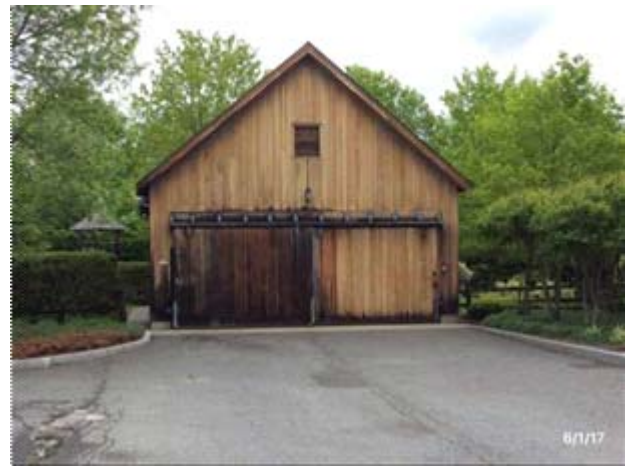
Coding / Field Name	Asset Description
B2011 Exterior Wall Construction	Wood Barn Siding, Garage
Condition	Good
Qty / UOM	1400 / SF
Unit Cost	\$7.90
Basis of Costing	Wood Shingles, 3+ Stories
Year in Service	1999
Expected Useful Life (EUL)	20 Year(s), Based on Industry Averages
Remaining Useful Life (RUL)	17 Year(s), Estimated, Based on Date of Observation
Location	Garage

Uniformat	Action Description	Quantity	Unit Cost	Plan Type	Priority	Year	Expenditure
B2011	Stain Existing Wood Siding	1,400 SF	\$1.41	MNT	Priority 2	2018	\$1,974
B2011	Stain Existing Wood Siding	1,400 SF	\$1.41	MNT	Priority 2	2028	\$1,974
B2011	Replace Wood Barn Siding, Garage	1,400 SF	\$7.90	BYL	Priority 3	2034	\$11,064

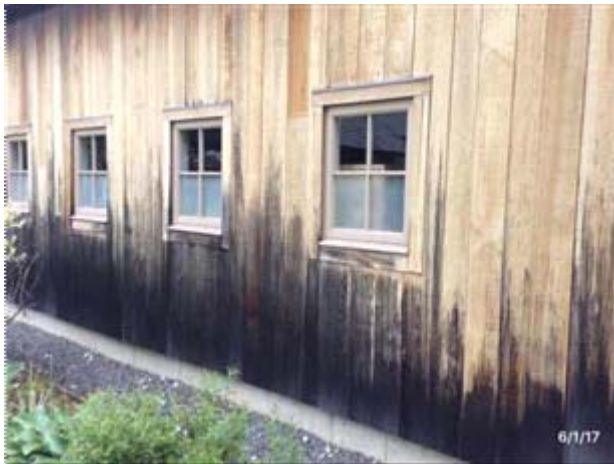
Coding / Field Name	Asset Description
B2021 Windows	Vinyl Window, Double Glazed, Garage
Condition	Fair
Qty / UOM	9 / EA
Unit Cost	\$1,000.05
Basis of Costing	Vinyl Window, Double Glazed, 1-2 Stories, 12 SF
Year in Service	1999
Expected Useful Life (EUL)	30 Year(s), Based on Industry Averages
Remaining Useful Life (RUL)	12 Year(s), Estimated, Based on Date of Observation
Location	Garage
Window Type	Double Hung
Windows Material	Vinyl
Windows Glazing	Double Glazed
Window Operation	Manual

Unifomat	Action Description	Quantity	Unit Cost	Plan Type	Priority	Year	Expenditure
B2021	Replace Vinyl Window, Double Glazed, Garage	9 EA	\$1,000.05	BYL	Priority 3	2029	\$9,000

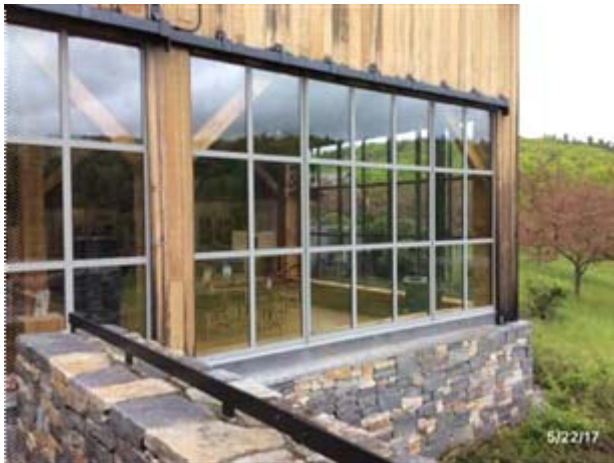
Coding / Field Name	Asset Description
B2023 Storefronts	Storefront Glazing & Framing
Condition	Fair
Qty / UOM	1985 / SF
Unit Cost	\$48.00
Year in Service	1999
Expected Useful Life (EUL)	30 Year(s), Based on Industry Averages
Remaining Useful Life (RUL)	12 Year(s), Estimated, Based on Date of Observation
Location	Exterior Walls
Window Type	Fixed
Windows Material	Aluminum
Windows Glazing	Double Glazed
Window Operation	Fixed

Unifomat	Action Description	Quantity	Unit Cost	Plan Type	Priority	Year	Expenditure
B2023	Replace Storefront Glazing & Framing	1,985 SF	\$48.00	BYL	Priority 3	2029	\$95,280

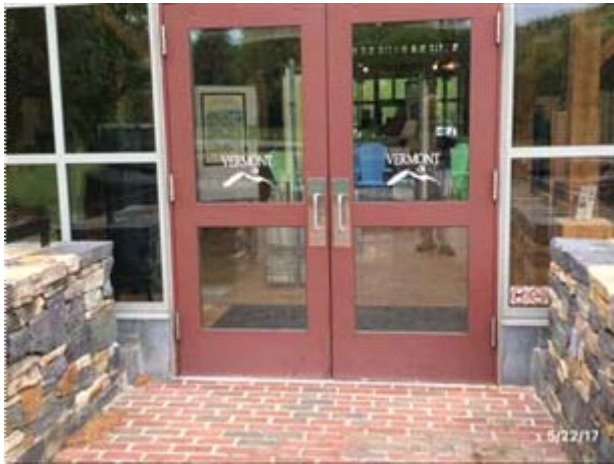
Coding / Field Name	Asset Description
B2031 Glazed Doors & Entrances	Glazed Entrance Doors
Condition	Fair
Qty / UOM	4 / EA
Unit Cost	\$1,368.37
Basis of Costing	Aluminum Frame, Fully Glazed, Exterior Door
Year in Service	1999
Expected Useful Life (EUL)	30 Year(s), Based on Industry Averages
Remaining Useful Life (RUL)	12 Year(s), Estimated, Based on Date of Observation
Location	Exterior Walls

Uniformat	Action Description	Quantity	Unit Cost	Plan Type	Priority	Year	Expenditure
B2031	Replace Glazed Entrance Doors	4 EA	\$1,368.37	BYL	Priority 3	2029	\$5,473

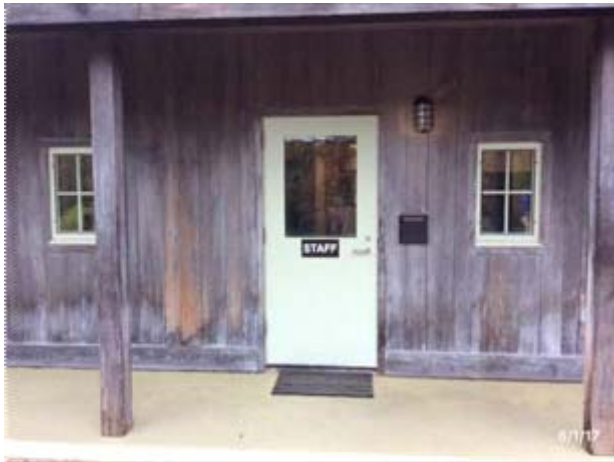
Coding / Field Name	Asset Description
B2032 Solid Exterior Doors	Steel, Insulated, Exterior Door
Condition	Fair
Qty / UOM	2 / EA
Unit Cost	\$1,577.53
Basis of Costing	Steel, Insulated, Exterior Door
Year in Service	1999
Expected Useful Life (EUL)	25 Year(s), Based on Industry Averages
Remaining Useful Life (RUL)	7 Year(s), Estimated, Based on Date of Observation
Location	Exterior Walls

Uniformat	Action Description	Quantity	Unit Cost	Plan Type	Priority	Year	Expenditure
B2032	Replace Steel, Insulated, Exterior Door	2 EA	\$1,577.53	BYL	Priority 3	2024	\$3,155

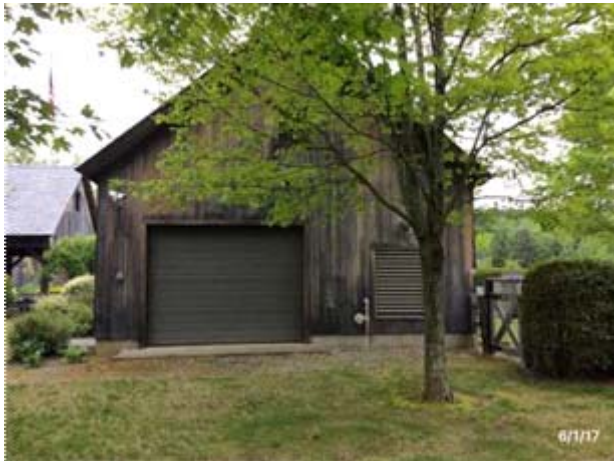
Coding / Field Name	Asset Description
B2034 Overhead Doors	Steel, Insulated Roll-up Door, Garage
Condition	Fair
Qty / UOM	2 / EA
Cost Adjustment Factor/Reason	1.1 / With Opener
Unit Cost (Adjusted)	\$3,197.82
Basis of Costing	Steel, Insulated Roll-up Door, 144 SF
Year in Service	1999
Expected Useful Life (EUL)	35 Year(s), Based on Industry Averages
Remaining Useful Life (RUL)	17 Year(s), Estimated, Based on Date of Observation
Location	Garage

Uniformat	Action Description	Quantity	Unit Cost	Plan Type	Priority	Year	Expenditure
B2034	Replace Steel, Insulated Roll-up Door, Garage	2 EA	\$3,197.82	BYL	Priority 3	2034	\$6,396

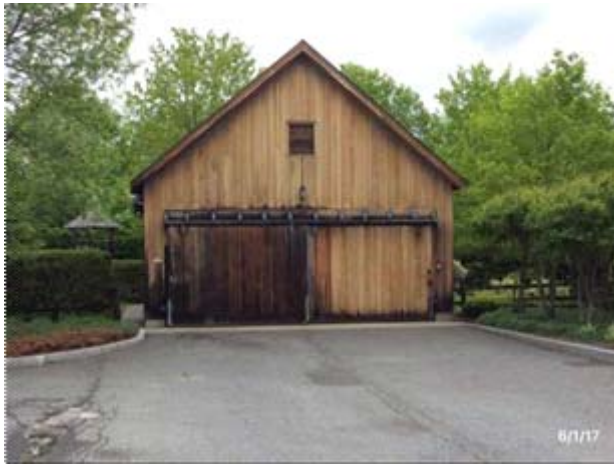
Coding / Field Name	Asset Description
B2034 Overhead Doors	Wood Sliding Door, Garage
Condition	Fair
Qty / UOM	1 / EA
Unit Cost	\$7,987.36
Basis of Costing	Wood Roll-up Door, 288 SF
Year in Service	1999
Expected Useful Life (EUL)	35 Year(s), Based on Industry Averages
Remaining Useful Life (RUL)	17 Year(s), Estimated, Based on Date of Observation
Location	Garage

Uniformat	Action Description	Quantity	Unit Cost	Plan Type	Priority	Year	Expenditure
B2034	Replace Wood Sliding Door, Garage	1 EA	\$7,987.36	BYL	Priority 3	2034	\$7,987

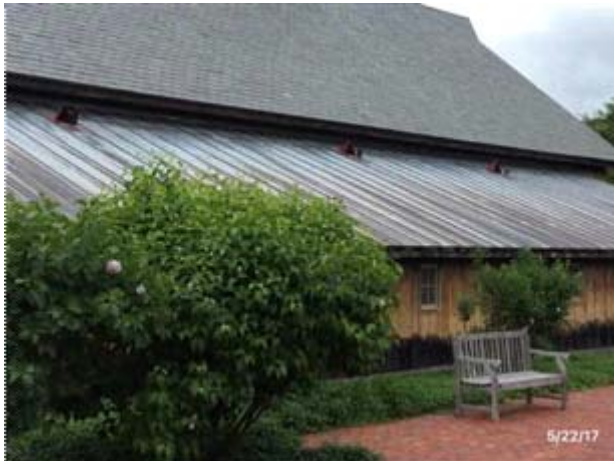
Coding / Field Name	Asset Description
B3011 Roof Finishes	Metal Roof, Copper
Condition	Good
Qty / UOM	2630 / SF
Cost Adjustment Factor/Reason	1.3 / Copper
Unit Cost (Adjusted)	\$42.13
Basis of Costing	Metal Roof (Includes Tear-Off of Old)
Year in Service	1999
Expected Useful Life (EUL)	40 Year(s), Based on Industry Averages
Remaining Useful Life (RUL)	25 Year(s), Estimated, Based on Date of Observation
Location	Roof

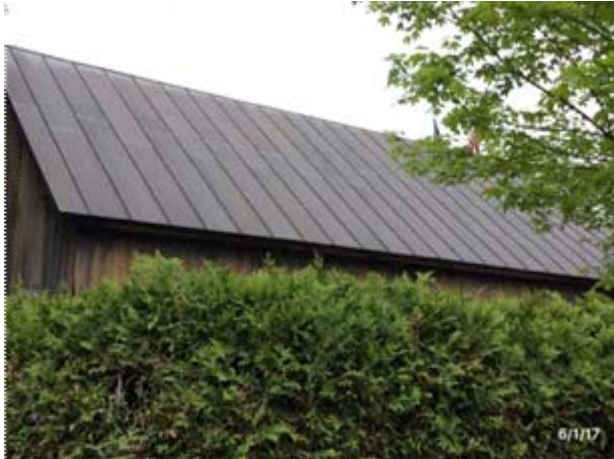
Coding / Field Name	Asset Description
B3011 Roof Finishes	Metal Roof, Copper, Garage
Condition	Good
Qty / UOM	1100 / SF
Cost Adjustment Factor/Reason	1.3 / Copper
Unit Cost (Adjusted)	\$42.13
Basis of Costing	Metal Roof (Includes Tear-Off of Old)
Year in Service	1999
Expected Useful Life (EUL)	40 Year(s), Based on Industry Averages
Remaining Useful Life (RUL)	25 Year(s), Estimated, Based on Date of Observation
Location	Garage

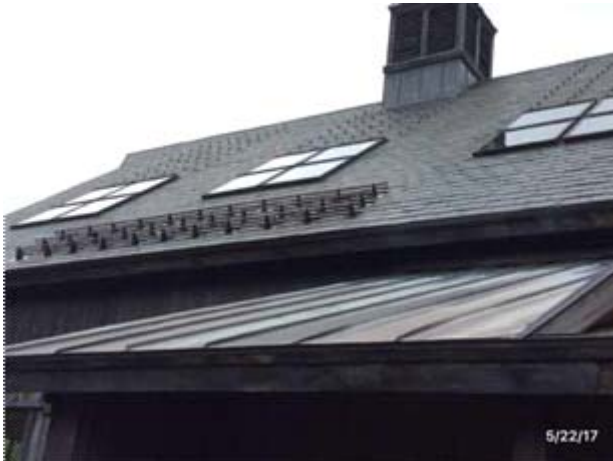
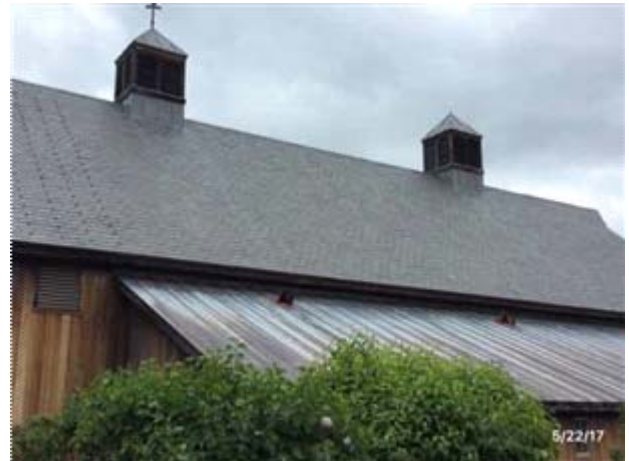
Coding / Field Name	Asset Description
B3011 Roof Finishes	Slate Steep Roof
Condition	Good
Qty / UOM	4540 / SF
Cost Adjustment Factor/Reason	1.4 / Snow guards
Unit Cost (Adjusted)	\$41.72
Basis of Costing	Slate Steep Roof (Includes Tear-Off of Old)
Year in Service	1999
Expected Useful Life (EUL)	40 Year(s), Based on Industry Averages
Remaining Useful Life (RUL)	25 Year(s), Estimated, Based on Date of Observation
Location	Roof

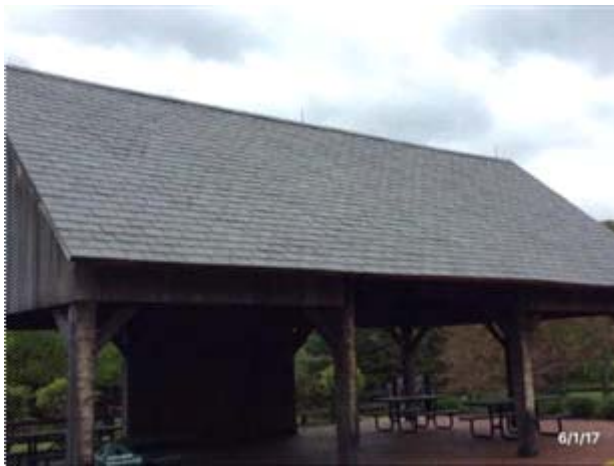
Coding / Field Name	Asset Description
B3011 Roof Finishes	Slate Steep Roof, Picnic Canopy
Condition	Good
Qty / UOM	920 / SF
Unit Cost	\$29.80
Basis of Costing	Slate Steep Roof (Includes Tear-Off of Old)
Year in Service	1999
Expected Useful Life (EUL)	40 Year(s), Based on Industry Averages
Remaining Useful Life (RUL)	25 Year(s), Estimated, Based on Date of Observation
Location	Picnic Canopy

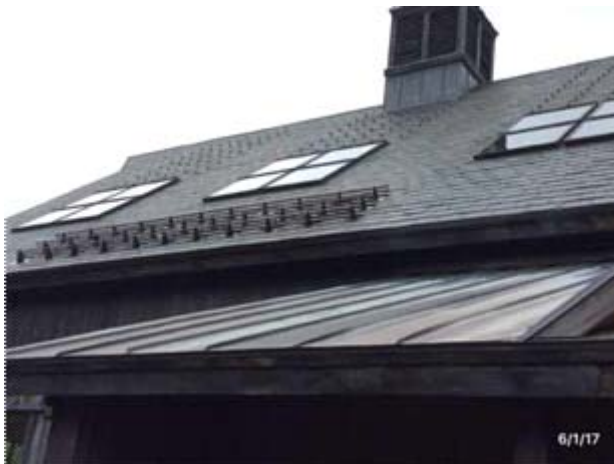
Coding / Field Name	Asset Description
B3021 Glazed Roof Openings	Single Unit Glass Skylight
Condition	Fair
Qty / UOM	130 / SF
Cost Adjustment Factor/Reason	2 / Segmented units
Unit Cost (Adjusted)	\$167.64
Basis of Costing	Single Unit Glass Skylight
Year in Service	1999
Expected Useful Life (EUL)	30 Year(s), Based on Industry Averages
Remaining Useful Life (RUL)	12 Year(s), Estimated, Based on Date of Observation
Location	Roof

Unifomat	Action Description	Quantity	Unit Cost	Plan Type	Priority	Year	Expenditure
B3021	Replace Single Unit Glass Skylight	130 SF	\$167.64	BYL	Priority 3	2029	\$21,793

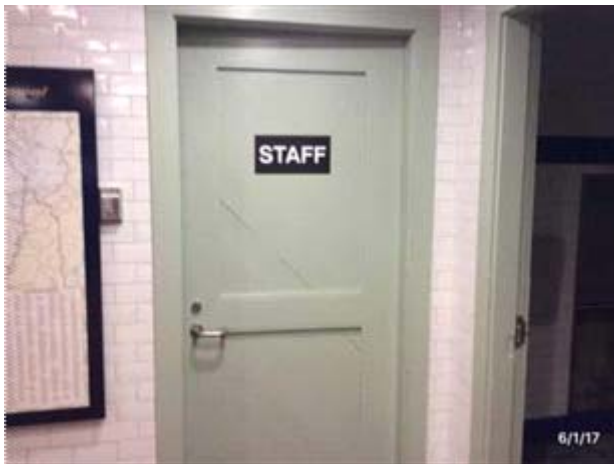
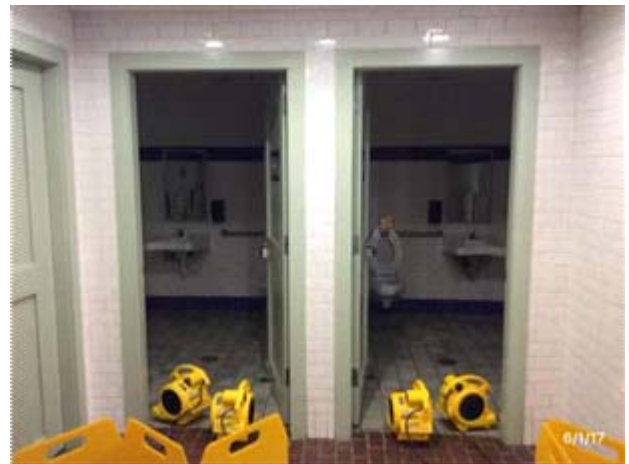
Coding / Field Name	Asset Description
C1021 Interior Doors	Wood, Solid Core, Painted/Stained, Interior Door
Condition	Fair
Qty / UOM	14 / EA
Unit Cost	\$1,423.11
Basis of Costing	Wood, Solid Core, Painted/Stained, Interior Door
Year in Service	1999
Expected Useful Life (EUL)	20 Year(s), Based on Industry Averages
Remaining Useful Life (RUL)	10 Year(s), Estimated, Based on Date of Observation
Location	Building Interior (General)

Uniformat	Action Description	Quantity	Unit Cost	Plan Type	Priority	Year	Expenditure
C1021	Replace Wood, Solid Core, Painted/Stained, Interior Door	14 EA	\$1,423.11	BYL	Priority 3	2027	\$19,924

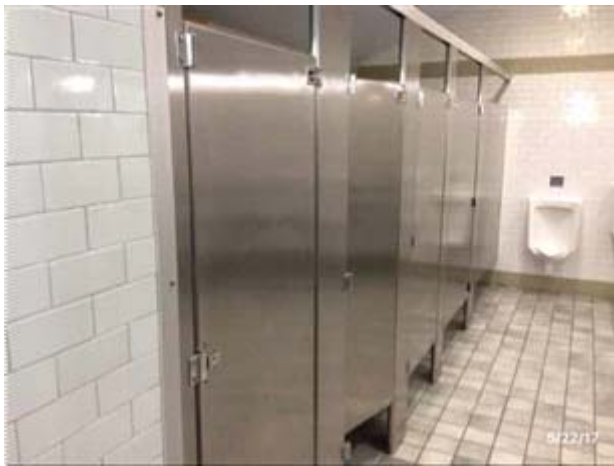
Coding / Field Name	Asset Description
C1031 Fabricated Toilet Partitions	Toilet Partitions, Metal
Condition	Fair
Qty / UOM	21 / EA
Unit Cost	\$850.00
Basis of Costing	Toilet Partitions, Metal, Overhead Braced
Year in Service	1999
Expected Useful Life (EUL)	20 Year(s), Based on Industry Averages
Remaining Useful Life (RUL)	7 Year(s), Estimated, Based on Date of Observation
Location	Restrooms

Uniformat	Action Description	Quantity	Unit Cost	Plan Type	Priority	Year	Expenditure
C1031	Replace Toilet Partitions, Metal	21 EA	\$850.00	BYL	Priority 3	2024	\$17,850

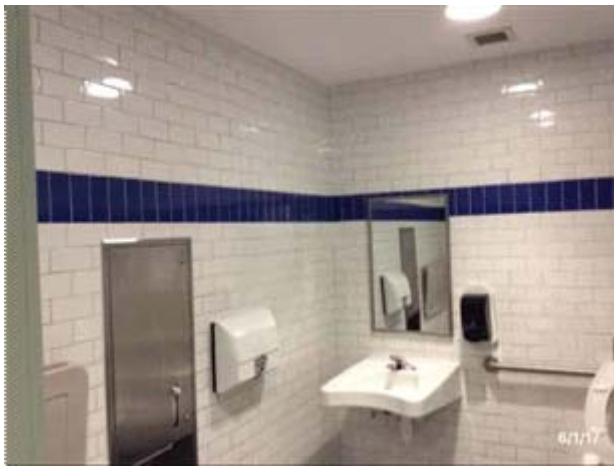
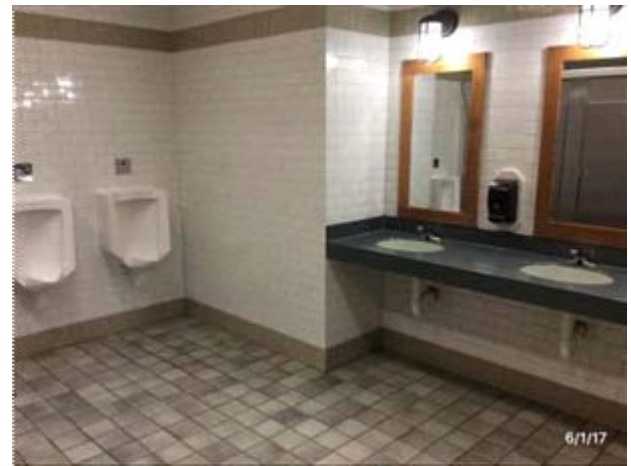
Coding / Field Name	Asset Description
C3012 Wall Finishes to Interior Walls	Ceramic Tile, Interior Wall Finish
Condition	Fair
Qty / UOM	3000 / SF
Unit Cost	\$16.55
Basis of Costing	Ceramic Tile, Interior Wall Finish
Year in Service	1999
Expected Useful Life (EUL)	25 Year(s), Based on Industry Averages
Remaining Useful Life (RUL)	12 Year(s), Estimated, Based on Date of Observation
Location	Restrooms

Uniformat	Action Description	Quantity	Unit Cost	Plan Type	Priority	Year	Expenditure
C3012	Replace Ceramic Tile, Interior Wall Finish	3,000 SF	\$16.55	BYL	Priority 4	2029	\$49,662

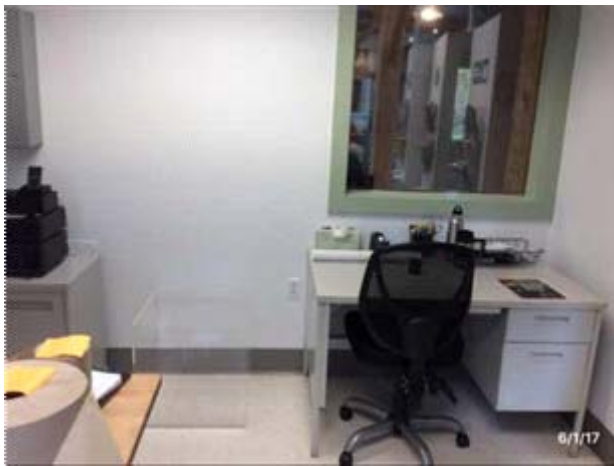
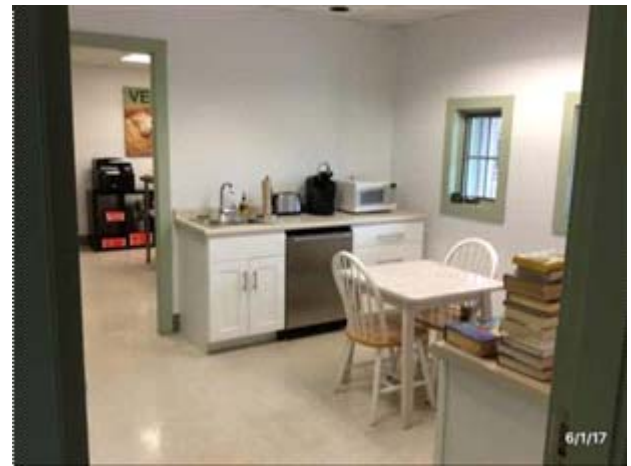
Coding / Field Name	Asset Description
C3012 Wall Finishes to Interior Walls	Gypsum Board, Wall
Condition	Good
Qty / UOM	1800 / SF
Unit Cost	\$3.38
Basis of Costing	Gypsum Board/Plaster, Interior Wall
Year in Service	1999
Expected Useful Life (EUL)	40 Year(s), Based on Industry Averages
Remaining Useful Life (RUL)	22 Year(s), Estimated, Based on Date of Observation
Location	Building Interior (General)

Uniformat	Action Description	Quantity	Unit Cost	Plan Type	Priority	Year	Expenditure
C3012	Paint Interior Walls	1,800 SF	\$1.42	MNT	Priority 4	2023	\$2,556
C3012	Paint Interior Walls	1,800 SF	\$1.42	MNT	Priority 4	2031	\$2,556

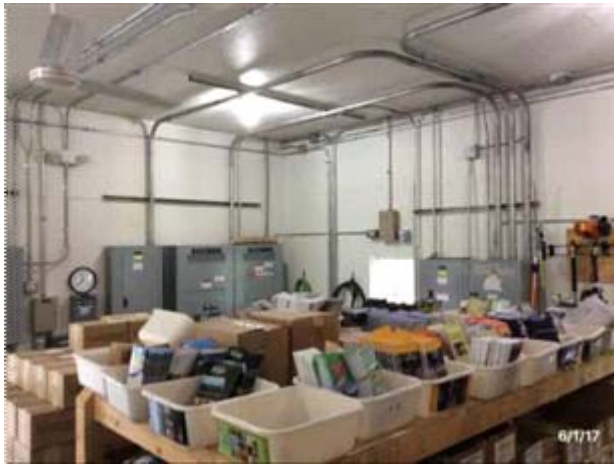
Coding / Field Name	Asset Description
C3012 Wall Finishes to Interior Walls	Gypsum Board, Wall, Garage
Condition	Good
Qty / UOM	1200 / SF
Unit Cost	\$3.38
Basis of Costing	Gypsum Board/Plaster, Interior Wall
Year in Service	1999
Expected Useful Life (EUL)	40 Year(s), Based on Industry Averages
Remaining Useful Life (RUL)	22 Year(s), Estimated, Based on Date of Observation
Location	Garage

Uniformat	Action Description	Quantity	Unit Cost	Plan Type	Priority	Year	Expenditure
C3012	Paint Interior Gypsum Board walls	1,200 SF	\$1.24	MNT	Priority 3	2020	\$1,488
C3012	Paint Interior Gypsum Board walls	1,200 SF	\$1.24	MNT	Priority 3	2030	\$1,488

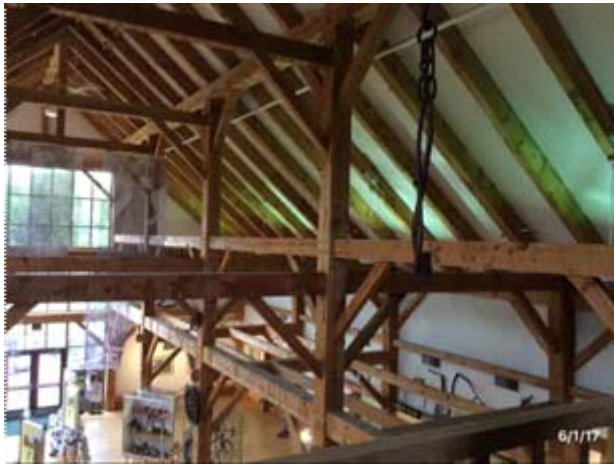
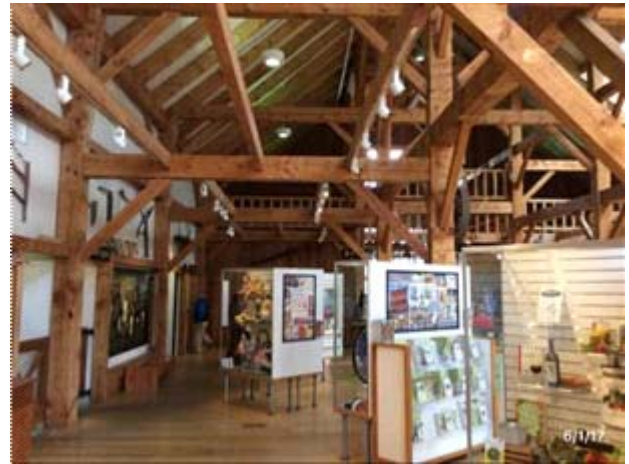
Coding / Field Name	Asset Description
C3012 Wall Finishes to Interior Walls	Gypsum Panel, Wall and Ceiling
Condition	Good
Qty / UOM	9300 / SF
Unit Cost	\$3.38
Basis of Costing	Gypsum Board/Plaster, Interior Wall
Year in Service	1999
Expected Useful Life (EUL)	40 Year(s), Based on Industry Averages
Remaining Useful Life (RUL)	22 Year(s), Estimated, Based on Date of Observation
Location	Building Interior (General)

Uniformat	Action Description	Quantity	Unit Cost	Plan Type	Priority	Year	Expenditure
C3012	General Painting Cost Per SF, Minor Prep Work	9,300 SF	\$2.25	MNT	Priority 4	2029	\$20,925

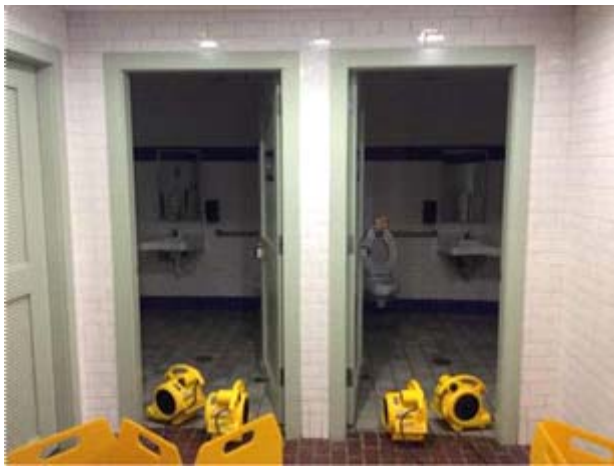
Coding / Field Name	Asset Description
C3024 Flooring	Clay Brick Flooring
Condition	Fair
Qty / UOM	1200 / SF
Unit Cost	\$42.65
Basis of Costing	Clay Brick Flooring
Year in Service	1999
Expected Useful Life (EUL)	50 Year(s), Based on Industry Averages
Remaining Useful Life (RUL)	32 Year(s), Estimated, Based on Date of Observation
Location	Building Interior (General)

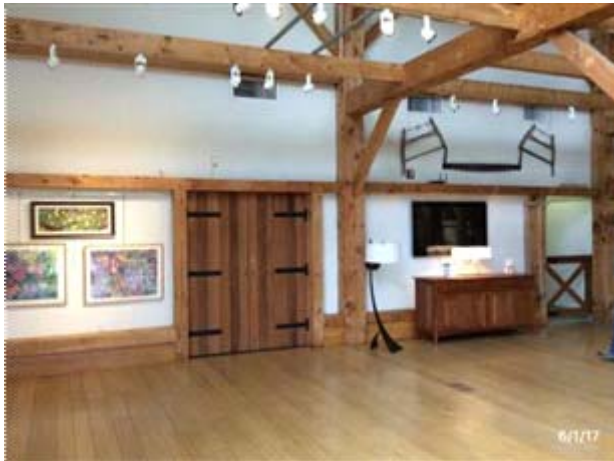
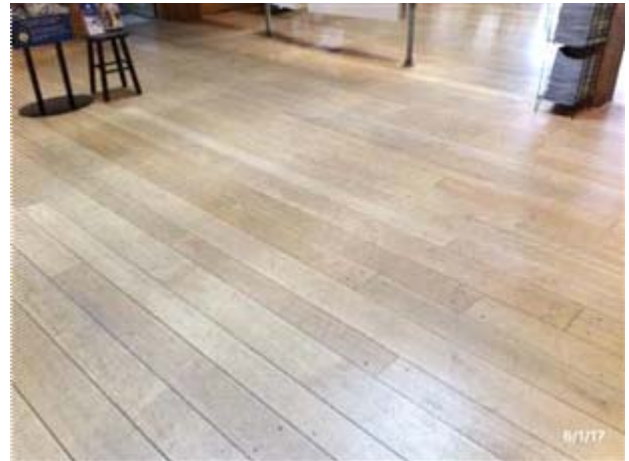
Coding / Field Name	Asset Description
C3024 Flooring	Wood Strip Flooring
Condition	Fair
Qty / UOM	3120 / SF
Cost Adjustment Factor/Reason	1.3 / Wide boards
Unit Cost (Adjusted)	\$17.58
Basis of Costing	Wood Strip Flooring
Year in Service	1999
Expected Useful Life (EUL)	30 Year(s), Based on Industry Averages
Remaining Useful Life (RUL)	12 Year(s), Estimated, Based on Date of Observation
Location	Building Interior (General)

Unifomat	Action Description	Quantity	Unit Cost	Plan Type	Priority	Year	Expenditure
C3024	Replace Wood Strip Flooring	3,120 SF	\$17.58	BYL	Priority 4	2029	\$54,854

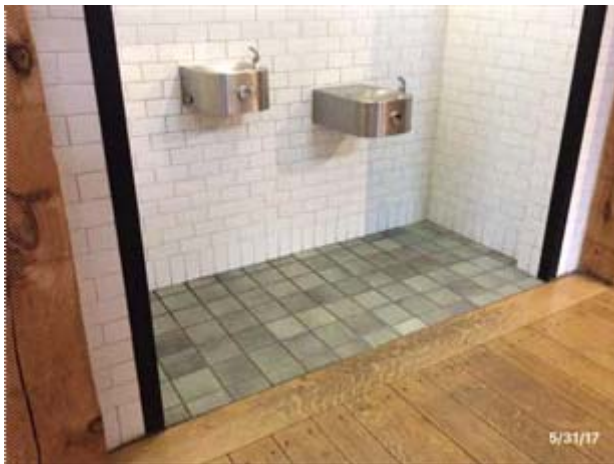
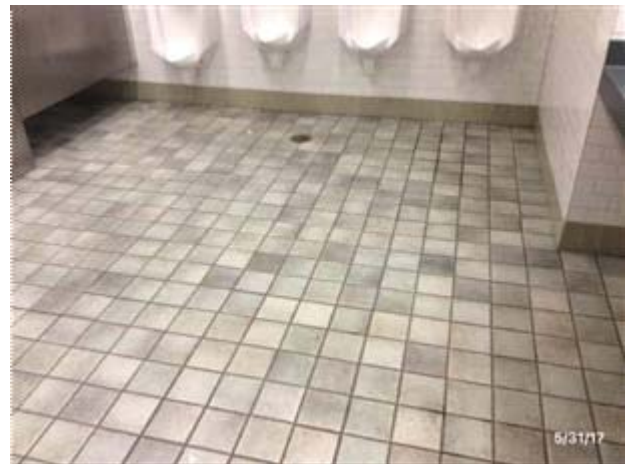
Coding / Field Name	Asset Description
C3024 Flooring	Ceramic Tile Flooring
Condition	Fair
Qty / UOM	1500 / SF
Unit Cost	\$15.75
Basis of Costing	Ceramic Tile Flooring
Year in Service	1999
Expected Useful Life (EUL)	50 Year(s), Based on Industry Averages
Remaining Useful Life (RUL)	32 Year(s), Estimated, Based on Date of Observation
Location	Restrooms

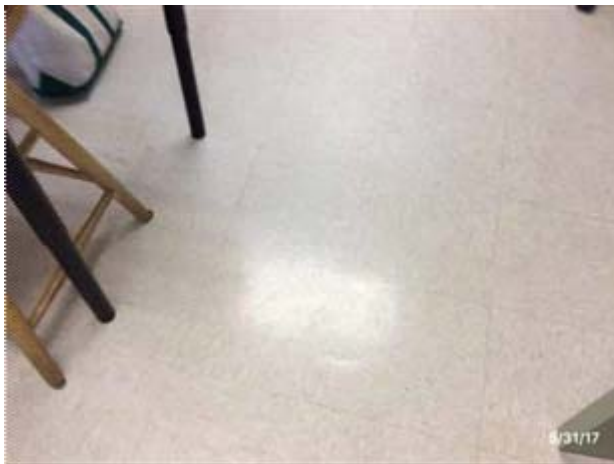
Coding / Field Name	Asset Description
C3024 Flooring	Vinyl Tile Flooring
Condition	Fair
Qty / UOM	900 / SF
Unit Cost	\$4.80
Basis of Costing	Vinyl Tile Flooring
Year in Service	1999
Expected Useful Life (EUL)	15 Year(s), Based on Industry Averages
Remaining Useful Life (RUL)	3 Year(s), Estimated, Based on Date of Observation
Location	Building Interior (General)

Uniformat	Action Description	Quantity	Unit Cost	Plan Type	Priority	Year	Expenditure
C3024	Replace Vinyl Tile Flooring	900 SF	\$4.80	BYL	Priority 3	2020	\$4,321
C3024	Replace Vinyl Tile Flooring	900 SF	\$4.80	BYL	Priority 3	2035	\$4,321

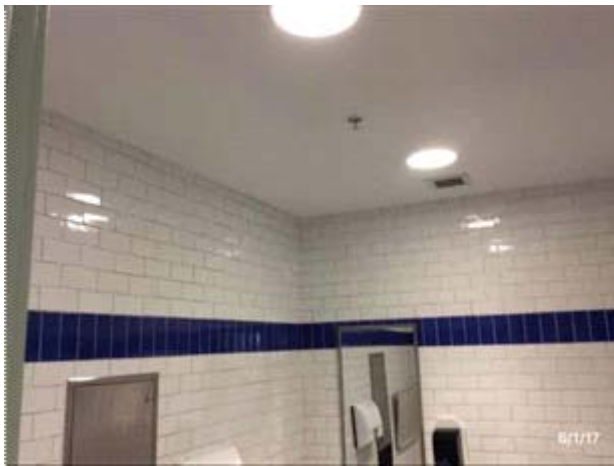
Coding / Field Name	Asset Description
C3031 Ceiling Finishes	Gypsum Board Ceiling
Condition	Good
Qty / UOM	1500 / SF
Unit Cost	\$7.13
Basis of Costing	Gypsum Board/Plaster, Ceiling
Year in Service	1999
Expected Useful Life (EUL)	50 Year(s), Based on Industry Averages
Remaining Useful Life (RUL)	32 Year(s), Estimated, Based on Date of Observation
Location	Restrooms

Uniformat	Action Description	Quantity	Unit Cost	Plan Type	Priority	Year	Expenditure
C3031	Paint Interior Ceilings	1,500 SF	\$1.94	APP	Priority 4	2023	\$2,910
C3031	Paint Interior Ceilings	1,500 SF	\$1.94	APP	Priority 4	2033	\$2,910

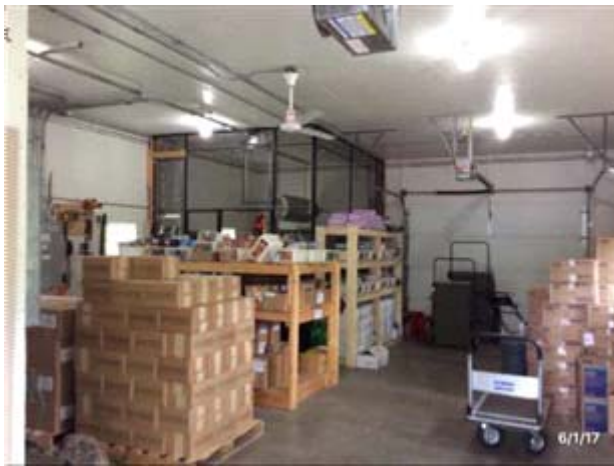
Coding / Field Name	Asset Description
C3031 Ceiling Finishes	Gypsum Board Ceiling, Garage
Condition	Good
Qty / UOM	1100 / SF
Unit Cost	\$7.13
Basis of Costing	Gypsum Board/Plaster, Ceiling
Year in Service	1999
Expected Useful Life (EUL)	50 Year(s), Based on Industry Averages
Remaining Useful Life (RUL)	32 Year(s), Estimated, Based on Date of Observation
Location	Garage

Uniformat	Action Description	Quantity	Unit Cost	Plan Type	Priority	Year	Expenditure
C3031	Paint Gypsum Board Ceiling	1,100 SF	\$0.00	MNT	Priority 3	2020	\$
C3031	Paint Gypsum Board Ceiling	1,100 SF	\$0.00	MNT	Priority 3	2030	\$

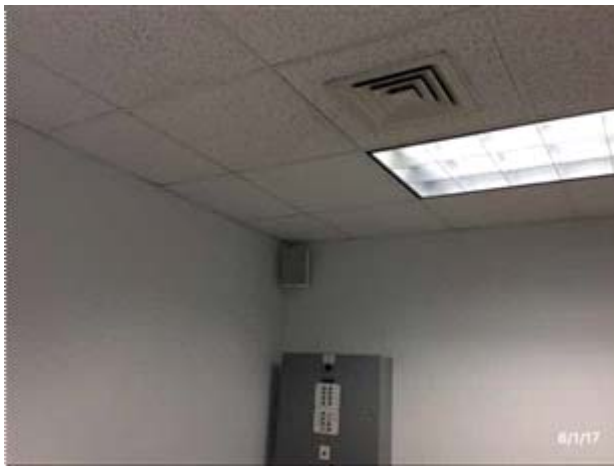
Coding / Field Name	Asset Description
C3032 Suspended Ceilings	Acoustical Tile Ceiling
Condition	Fair
Qty / UOM	900 / SF
Unit Cost	\$3.11
Basis of Costing	Acoustical Tile Ceiling
Year in Service	1999
Expected Useful Life (EUL)	20 Year(s), Based on Industry Averages
Remaining Useful Life (RUL)	7 Year(s), Estimated, Based on Date of Observation
Location	Building Interior (General)

Uniformat	Action Description	Quantity	Unit Cost	Plan Type	Priority	Year	Expenditure
C3032	Replace Acoustical Tile Ceiling	900 SF	\$3.11	BYL	Priority 3	2024	\$2,799

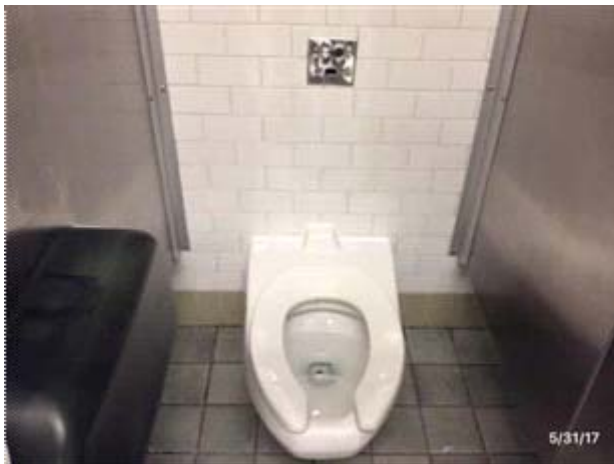
Coding / Field Name	Asset Description
D2011 Water Closets	Toilets (Water Closets)
Condition	Fair
Qty / UOM	20 / EA
Unit Cost	\$842.97
Basis of Costing	Tankless Water Closet
Year in Service	1999
Expected Useful Life (EUL)	20 Year(s), Based on Industry Averages
Remaining Useful Life (RUL)	10 Year(s), Estimated, Based on Date of Observation
Location	Restrooms

Uniformat	Action Description	Quantity	Unit Cost	Plan Type	Priority	Year	Expenditure
D2011	Replace Toilets (Water Closets)	20 EA	\$842.97	BYL	Priority 3	2027	\$16,859

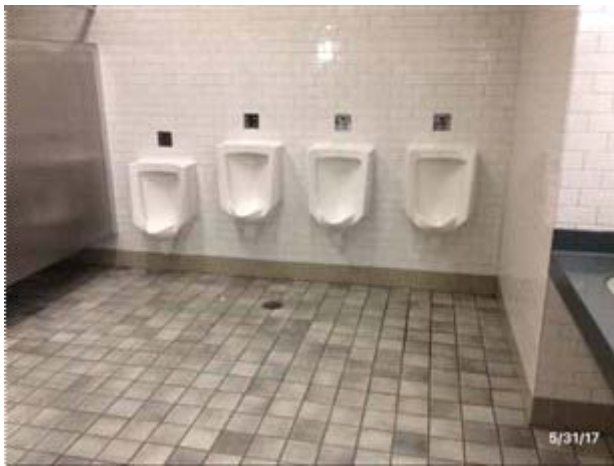
Coding / Field Name	Asset Description
D2012 Urinals	Urinals
Condition	Fair
Qty / UOM	4 / EA
Unit Cost	\$1,193.44
Basis of Costing	Urinal, Vitreous China
Year in Service	1999
Expected Useful Life (EUL)	20 Year(s), Based on Industry Averages
Remaining Useful Life (RUL)	10 Year(s), Estimated, Based on Date of Observation
Location	Restrooms

Uniformat	Action Description	Quantity	Unit Cost	Plan Type	Priority	Year	Expenditure
D2012	Replace Urinals	4 EA	\$1,193.44	BYL	Priority 3	2027	\$4,774

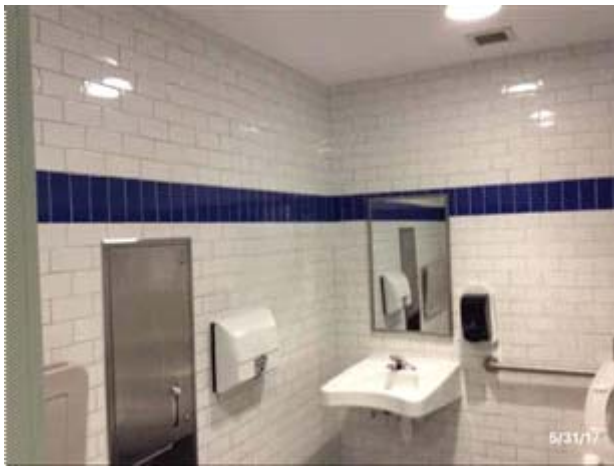
Coding / Field Name	Asset Description
D2013 Lavatories	Lavatory, Vitreous China
Condition	Fair
Qty / UOM	2 / EA
Unit Cost	\$572.66
Basis of Costing	Lavatory, Vitreous China
Year in Service	1999
Expected Useful Life (EUL)	20 Year(s), Based on Industry Averages
Remaining Useful Life (RUL)	10 Year(s), Estimated, Based on Date of Observation
Location	Restrooms

Uniformat	Action Description	Quantity	Unit Cost	Plan Type	Priority	Year	Expenditure
D2013	Replace Lavatory, Vitreous China	2 EA	\$572.66	BYL	Priority 3	2027	\$1,145

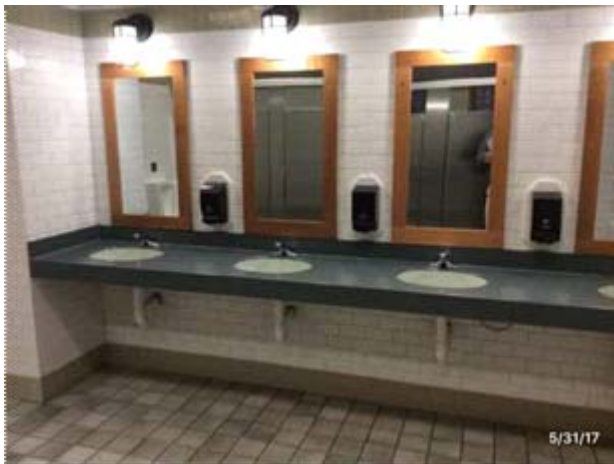
Coding / Field Name	Asset Description
D2013 Lavatories	Lavatory, Cultured Marble
Condition	Fair
Qty / UOM	12 / EA
Unit Cost	\$1,891.78
Basis of Costing	Lavatory, Cultured Marble
Year in Service	1999
Expected Useful Life (EUL)	20 Year(s), Based on Industry Averages
Remaining Useful Life (RUL)	10 Year(s), Estimated, Based on Date of Observation
Location	Restrooms

Uniformat	Action Description	Quantity	Unit Cost	Plan Type	Priority	Year	Expenditure
D2013	Replace Lavatory, Cultured Marble	12 EA	\$1,891.78	BYL	Priority 3	2027	\$22,701

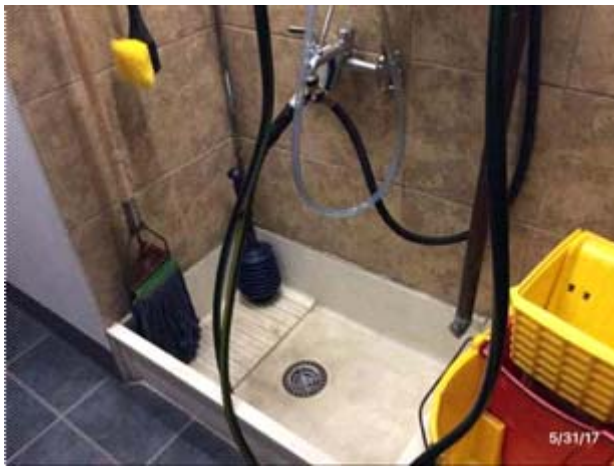
Coding / Field Name	Asset Description
D2014 Sinks	Service Sink, Floor
Condition	Fair
Qty / UOM	1 / EA
Unit Cost	\$1,599.51
Basis of Costing	Service Sink, Floor
Year in Service	1999
Expected Useful Life (EUL)	35 Year(s), Based on Industry Averages
Remaining Useful Life (RUL)	17 Year(s), Estimated, Based on Date of Observation
Location	Restrooms

Uniformat	Action Description	Quantity	Unit Cost	Plan Type	Priority	Year	Expenditure
D2014	Replace Service Sink, Floor	1 EA	\$1,599.51	BYL	Priority 3	2034	\$1,600

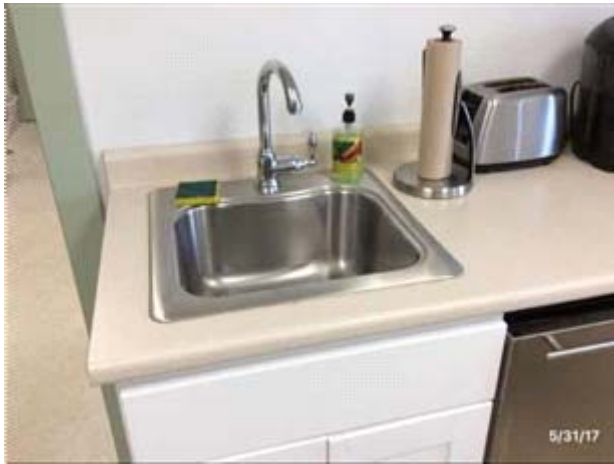
Coding / Field Name	Asset Description
D2014 Sinks	Sink, Stainless Steel
Condition	Fair
Qty / UOM	1 / EA
Unit Cost	\$1,054.05
Basis of Costing	Sink, Stainless Steel
Year in Service	1999
Expected Useful Life (EUL)	20 Year(s), Based on Industry Averages
Remaining Useful Life (RUL)	10 Year(s), Estimated, Based on Date of Observation
Location	Building Interior (General)

Uniformat	Action Description	Quantity	Unit Cost	Plan Type	Priority	Year	Expenditure
D2014	Replace Sink, Stainless Steel	1 EA	\$1,054.05	BYL	Priority 3	2027	\$1,054

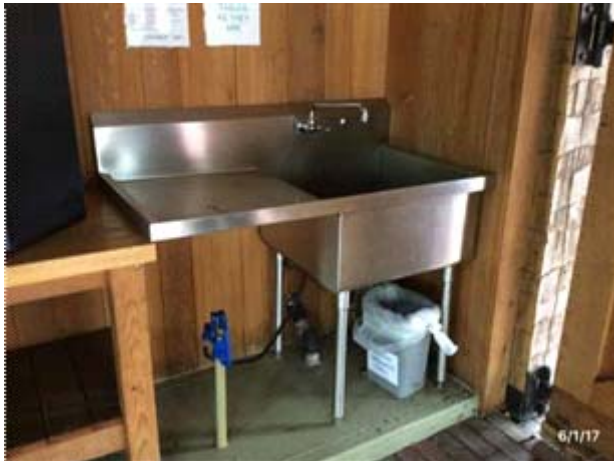
Coding / Field Name	Asset Description
D2014 Sinks	Sink, Stainless Steel, Picnic Canopy
Condition	Fair
Qty / UOM	1 / EA
Cost Adjustment Factor/Reason	1.4 / With side counter
Unit Cost (Adjusted)	\$1,475.67
Basis of Costing	Sink, Stainless Steel
Year in Service	1999
Expected Useful Life (EUL)	20 Year(s), Based on Industry Averages
Remaining Useful Life (RUL)	20 Year(s), Estimated, Based on Date of Observation
Location	Picnic Canopy

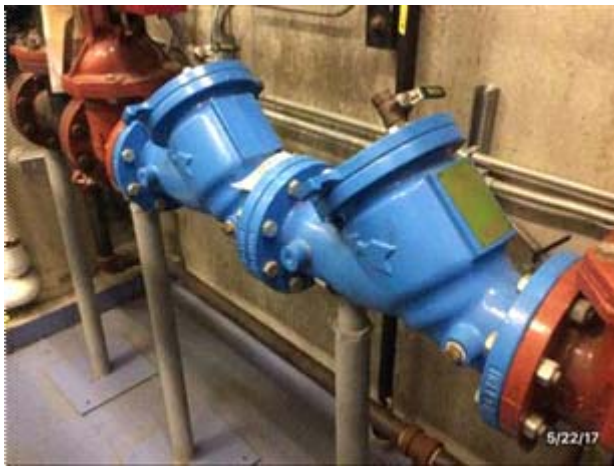
Coding / Field Name	Asset Description
D2021 Cold Water Service	Backflow Preventer, Fire Service
Condition	Good
Qty / UOM	1 / EA
Unit Cost	\$6,001.42
Basis of Costing	Backflow Preventer, 4"
Year in Service	2005
Expected Useful Life (EUL)	15 Year(s), Based on Industry Averages
Remaining Useful Life (RUL)	3 Year(s), Estimated, Based on Date of Observation
Location	Mechanical Room

Uniformat	Action Description	Quantity	Unit Cost	Plan Type	Priority	Year	Expenditure
D2021	Replace Backflow Preventer, Fire Service	1 EA	\$6,001.42	BYL	Priority 1	2020	\$6,001
D2021	Replace Backflow Preventer, Fire Service	1 EA	\$6,001.42	BYL	Priority 1	2035	\$6,001
