FACILITY CONDITION ASSESSMENT

106686.17R000-086.305

June 19, 2017

FACILITY CONDITION ASSESSMENT
OF
GUILFORD WELCOME CENTER
91 NORTH
GUILFORD, VT 05602

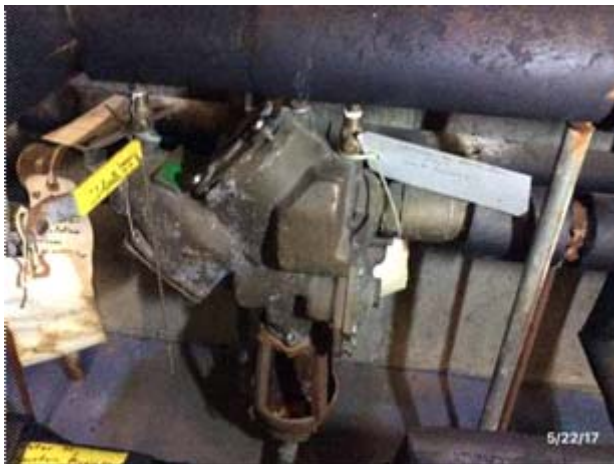
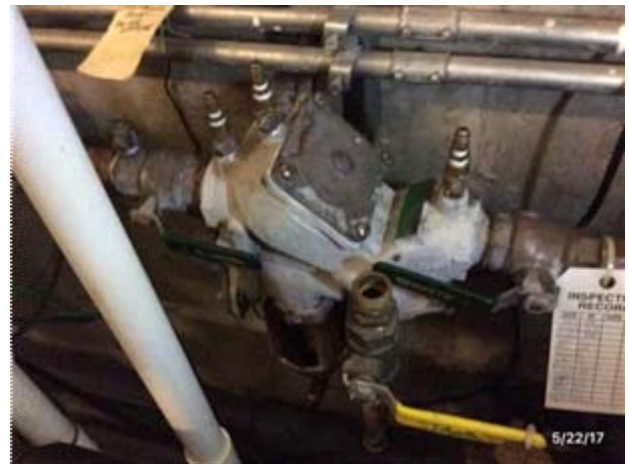
Coding / Field Name	Asset Description
D2021 Cold Water Service	Backflow Preventer
Condition	Good
Qty / UOM	2 / EA
Unit Cost	\$2,603.17
Basis of Costing	Backflow Preventer, 2"
Year in Service	2005
Expected Useful Life (EUL)	15 Year(s), Based on Industry Averages
Remaining Useful Life (RUL)	3 Year(s), Estimated, Based on Date of Observation
Location	Mechanical Room

Uniformat	Action Description	Quantity	Unit Cost	Plan Type	Priority	Year	Expenditure
D2021	Replace Backflow Preventer	2 EA	\$2,603.17	BYL	Priority 1	2020	\$5,206
D2021	Replace Backflow Preventer	2 EA	\$2,603.17	BYL	Priority 1	2035	\$5,206

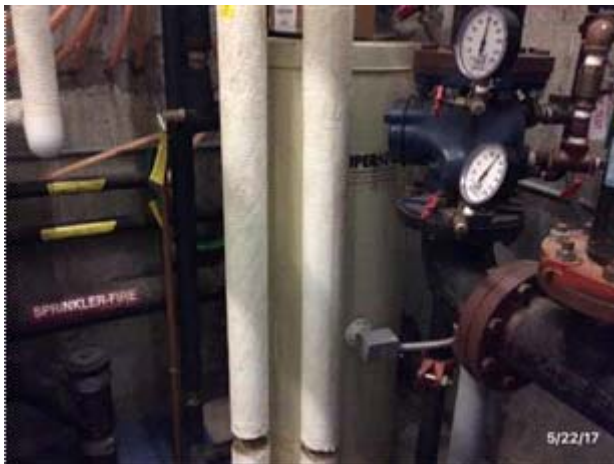
Coding / Field Name	Asset Description
D2023 Domestic Water Supply Equipment	Water Heater, Indirect
Condition	Fair
Qty / UOM	1 / EA
Unit Cost	\$2,817.38
Basis of Costing	Water Heater, Indirect, 40 to 79 GAL
Year in Service	1999
Expected Useful Life (EUL)	15 Year(s), Based on Industry Averages
Remaining Useful Life (RUL)	3 Year(s), Estimated, Based on Date of Observation
Location	Mechanical Room

Uniformat	Action Description	Quantity	Unit Cost	Plan Type	Priority	Year	Expenditure
D2023	Replace Water Heater, Indirect	1 EA	\$2,817.38	BYL	Priority 1	2020	\$2,817
D2023	Replace Water Heater, Indirect	1 EA	\$2,817.38	BYL	Priority 1	2035	\$2,817

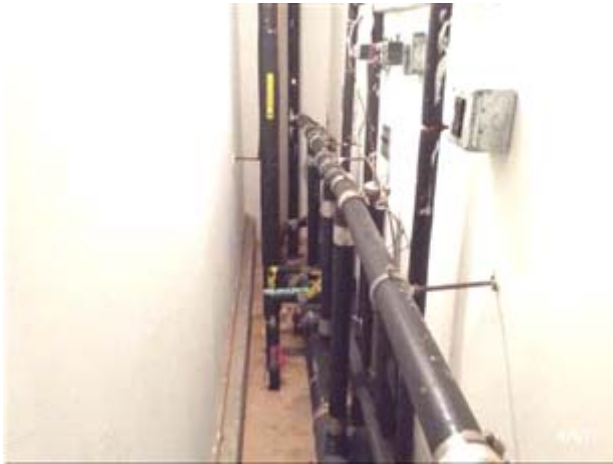
Coding / Field Name	Asset Description
D2029 Plumbing Systems	Plumbing System
Condition	Good
Qty / UOM	7138 / SF
Unit Cost	\$13.91
Basis of Costing	Plumbing System, Full Upgrade, Office (per SF)
Year in Service	1999
Expected Useful Life (EUL)	40 Year(s), Based on Industry Averages
Remaining Useful Life (RUL)	30 Year(s), Estimated, Based on Date of Observation
Location	Building Interior (General)

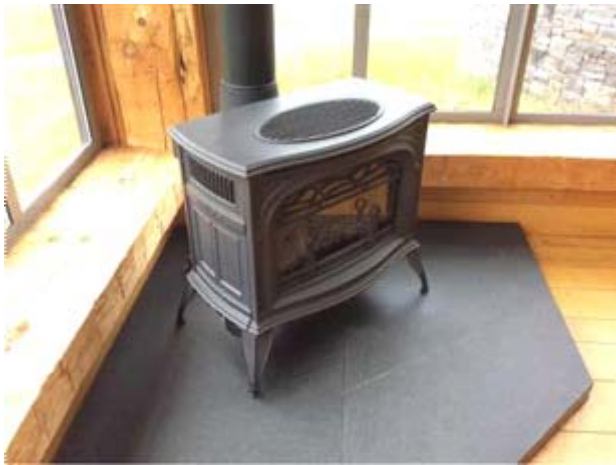
Coding / Field Name	Asset Description
D3020 Heat Generation Systems	Gas Stove
Condition	Good
Qty / UOM	1 /
Unit Cost	\$5,000.00
Year in Service	2015
Expected Useful Life (EUL)	30 Year(s), Based on Industry Averages
Remaining Useful Life (RUL)	26 Year(s), Estimated, Based on Date of Observation
Location	Building Interior (General)

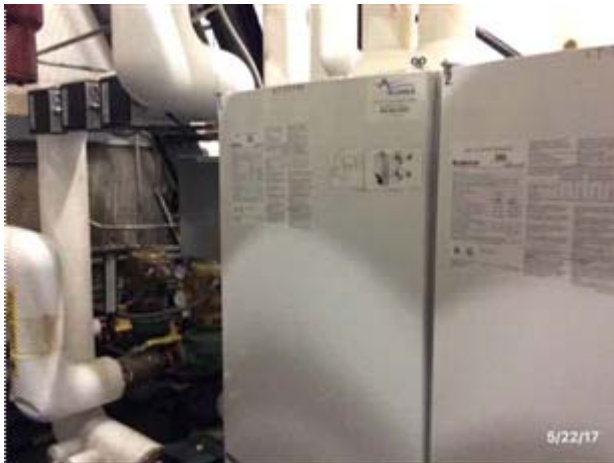
Coding / Field Name	Asset Description
D3021 Boilers	Boiler #1
Condition	Good
Qty / UOM	1 / EA
Unit Cost	\$50,249.07
Basis of Costing	Boiler, Gas, Condensing Style, High Efficiency, 126 to 750 MBH
Year in Service	2014
Expected Useful Life (EUL)	25 Year(s), Based on Industry Averages
Remaining Useful Life (RUL)	22 Year(s), Estimated, Based on Date of Observation
Location	Mechanical Room
Boiler Draft Type	Forced Draft
Boiler Manufacturer	Buderus
Boiler Model	GB-162-89

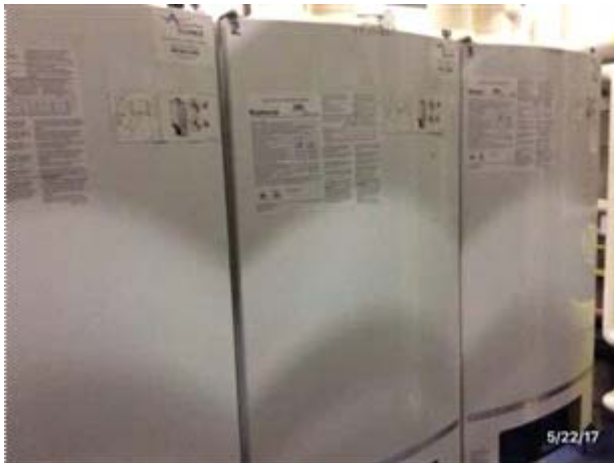
Coding / Field Name	Asset Description
D3021 Boilers	Boiler #2
Condition	Good
Qty / UOM	1 / EA
Unit Cost	\$50,249.07
Basis of Costing	Boiler, Gas, Condensing Style, High Efficiency, 126 to 750 MBH
Year in Service	2014
Expected Useful Life (EUL)	25 Year(s), Based on Industry Averages
Remaining Useful Life (RUL)	22 Year(s), Estimated, Based on Date of Observation
Location	Mechanical Room
Boiler Draft Type	Forced Draft
Boiler Manufacturer	Buderus
Boiler Model	GB-162-89

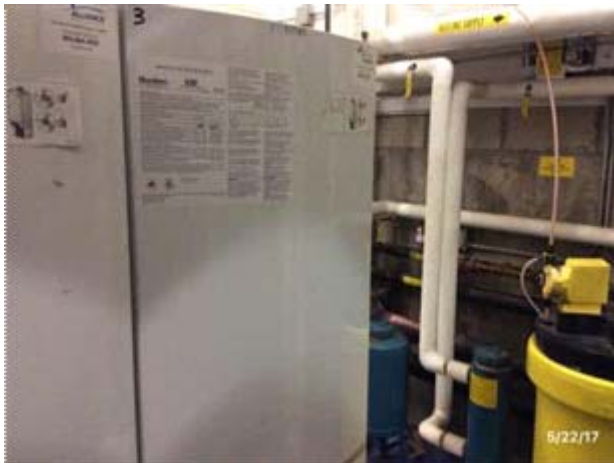
Coding / Field Name	Asset Description
D3021 Boilers	Boiler #3
Condition	Good
Qty / UOM	1 / EA
Unit Cost	\$50,249.07
Basis of Costing	Boiler, Gas, Condensing Style, High Efficiency, 126 to 750 MBH
Year in Service	2014
Expected Useful Life (EUL)	25 Year(s), Based on Industry Averages
Remaining Useful Life (RUL)	22 Year(s), Estimated, Based on Date of Observation
Location	Mechanical Room
Boiler Draft Type	Forced Draft
Boiler Manufacturer	Buderus
Boiler Model	GB-162-89

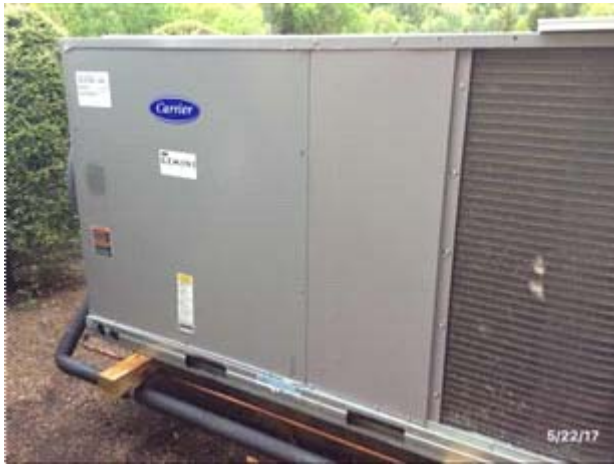
Coding / Field Name	Asset Description
D3032 Direct Expansion Systems	Condensing Unit, Split System DX, Air-Cooled, #1
Condition	Good
Qty / UOM	1 / EA
Unit Cost	\$34,327.51
Basis of Costing	Condensing Unit, Split System DX, Air-Cooled, 16 to 20 Ton
Year in Service	2017
Expected Useful Life (EUL)	15 Year(s), Based on Industry Averages
Remaining Useful Life (RUL)	15 Year(s), Estimated, Based on Date of Observation
Location	Site

Uniformat	Action Description	Quantity	Unit Cost	Plan Type	Priority	Year	Expenditure
D3032	Replace Condensing Unit, Split System DX, Air-Cooled, #1	1 EA	\$34,327.51	BYL	Priority 3	2032	\$34,328

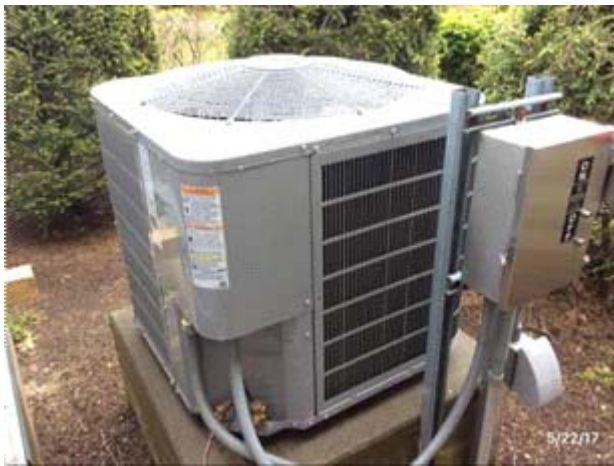
Coding / Field Name	Asset Description
D3032 Direct Expansion Systems	Condensing Unit, Split System DX, Air-Cooled, #2
Condition	Good
Qty / UOM	1 / EA
Unit Cost	\$6,439.81
Basis of Costing	Condensing Unit, Split System DX, Air-Cooled, 5 Ton
Year in Service	2017
Expected Useful Life (EUL)	15 Year(s), Based on Industry Averages
Remaining Useful Life (RUL)	15 Year(s), Estimated, Based on Date of Observation
Location	Site

Uniformat	Action Description	Quantity	Unit Cost	Plan Type	Priority	Year	Expenditure
D3032	Replace Condensing Unit, Split System DX, Air-Cooled, #2	1 EA	\$6,439.81	BYL	Priority 3	2032	\$6,440

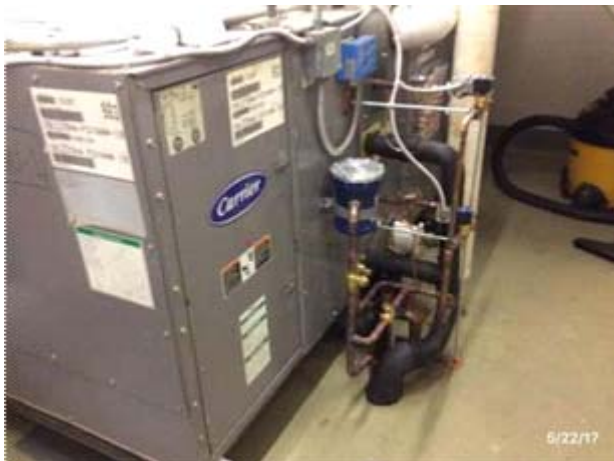
Coding / Field Name	Asset Description
D3041 Air Distribution Systems	Air Handler, AHU-1
Condition	Fair
Qty / UOM	1 / EA
Cost Adjustment Factor/Reason	1.5 / Add ductwork
Unit Cost (Adjusted)	\$21,895.55
Basis of Costing	Air Handler, Single Zone, 2,501 to 5,000 CFM
Year in Service	1999
Expected Useful Life (EUL)	15 Year(s), Based on Industry Averages
Remaining Useful Life (RUL)	5 Year(s), Estimated, Based on Date of Observation
Location	Mezzanine

6623 cfm per dwg schedule

Unifomat	Action Description	Quantity	Unit Cost	Plan Type	Priority	Year	Expenditure
D3041	Replace Air Handler, AHU-1	1 EA	\$21,895.55	BYL	Priority 2	2022	\$21,896

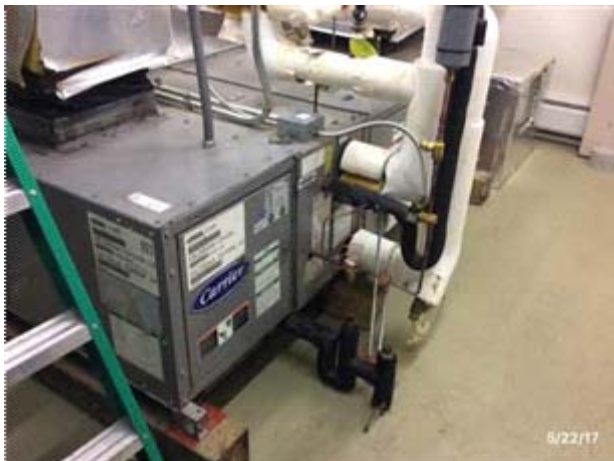
Coding / Field Name	Asset Description
D3041 Air Distribution Systems	Air Handler, AHU-2
Condition	Fair
Qty / UOM	1 / EA
Cost Adjustment Factor/Reason	1.5 / Add ductwork
Unit Cost (Adjusted)	\$9,526.75
Basis of Costing	Air Handler, Single Zone, 801 to 1,300 CFM
Year in Service	1999
Expected Useful Life (EUL)	15 Year(s), Based on Industry Averages
Remaining Useful Life (RUL)	5 Year(s), Estimated, Based on Date of Observation
Location	Mezzanine

1019 cfm per dwg schedule

Unifomat	Action Description	Quantity	Unit Cost	Plan Type	Priority	Year	Expenditure
D3041	Replace Air Handler, AHU-2	1 EA	\$9,526.75	BYL	Priority 2	2022	\$9,527

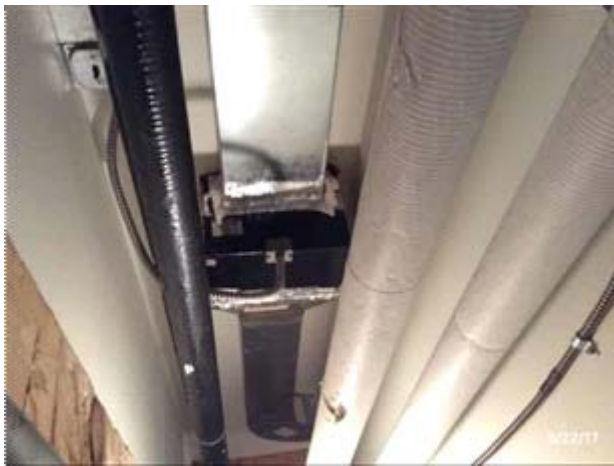
Coding / Field Name	Asset Description
D3042 Exhaust Ventilation Systems	Exhaust Fan
Condition	Fair
Qty / UOM	3 / EA
Unit Cost	\$889.90
Basis of Costing	Exhaust Fan, Centrifugal, 100 to 250 CFM
Year in Service	1999
Expected Useful Life (EUL)	15 Year(s), Based on Industry Averages
Remaining Useful Life (RUL)	3 Year(s), Estimated, Based on Date of Observation
Location	Building Interior (General)

Uniformat	Action Description	Quantity	Unit Cost	Plan Type	Priority	Year	Expenditure
D3042	Replace Exhaust Fan	3 EA	\$889.90	BYL	Priority 1	2020	\$2,670
D3042	Replace Exhaust Fan	3 EA	\$889.90	BYL	Priority 1	2035	\$2,670

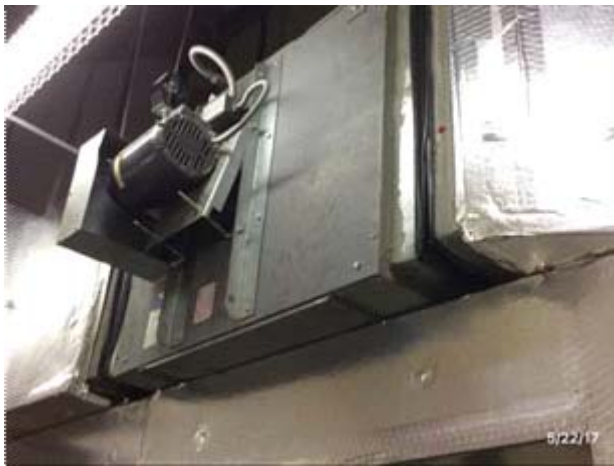
Coding / Field Name	Asset Description
D3042 Exhaust Ventilation Systems	Return Fan, #1
Condition	Fair
Qty / UOM	1 / EA
Unit Cost	\$3,072.78
Basis of Costing	Exhaust Fan, Centrifugal, 2,001 to 3,500 CFM
Year in Service	1999
Expected Useful Life (EUL)	15 Year(s), Based on Industry Averages
Remaining Useful Life (RUL)	5 Year(s), Estimated, Based on Date of Observation
Location	Roof

Uniformat	Action Description	Quantity	Unit Cost	Plan Type	Priority	Year	Expenditure
D3042	Replace Return Fan, #1	1 EA	\$3,072.78	BYL	Priority 2	2022	\$3,073

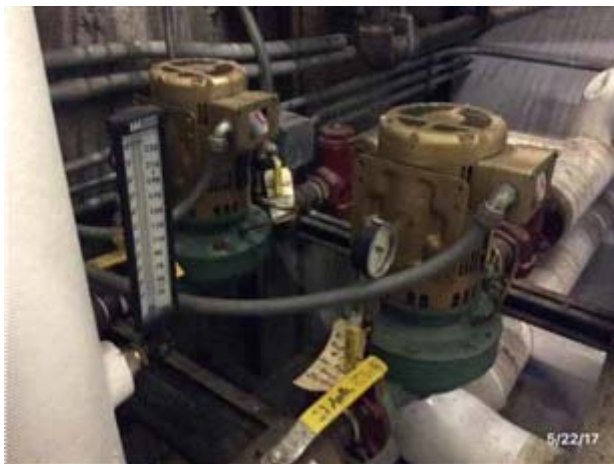
Coding / Field Name	Asset Description
D3044 Hot Water Distribution	Circulation Pump, Hot Water
Condition	Good
Qty / UOM	2 / EA
Unit Cost	\$4,652.29
Basis of Costing	Circulation Pump, Hot Water, 3 HP
Year in Service	2014
Expected Useful Life (EUL)	20 Year(s), Based on Industry Averages
Remaining Useful Life (RUL)	17 Year(s), Estimated, Based on Date of Observation
Location	Mechanical Room
Distribution Piping Diameter	2
Distribution Piping Insulation	Fiberglass
Pump Manufacturer	Taco
Pump Model	NV
Pump HP	3

Uniformat	Action Description	Quantity	Unit Cost	Plan Type	Priority	Year	Expenditure
D3044	Replace Circulation Pump, Hot Water	2 EA	\$4,652.29	BYL	Priority 3	2034	\$9,305

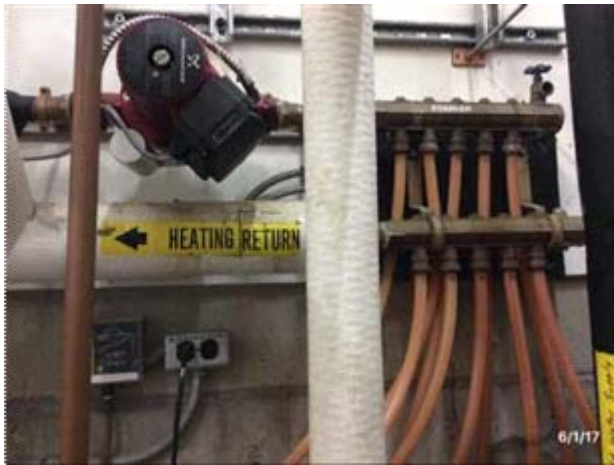
Coding / Field Name	Asset Description
D3047 Glycol Distribution Systems	Glycol Snowmelt System
Condition	Fair
Qty / UOM	1 / EA
Unit Cost	\$8,000.00
Year in Service	1999
Expected Useful Life (EUL)	30 Year(s), Based on Industry Averages
Remaining Useful Life (RUL)	12 Year(s), Estimated, Based on Date of Observation
Location	Site

Uniformat	Action Description	Quantity	Unit Cost	Plan Type	Priority	Year	Expenditure
D3047	Replace Glycol Snowmelt System	1 EA	\$8,000.00	BYL	Priority 3	2029	\$8,000

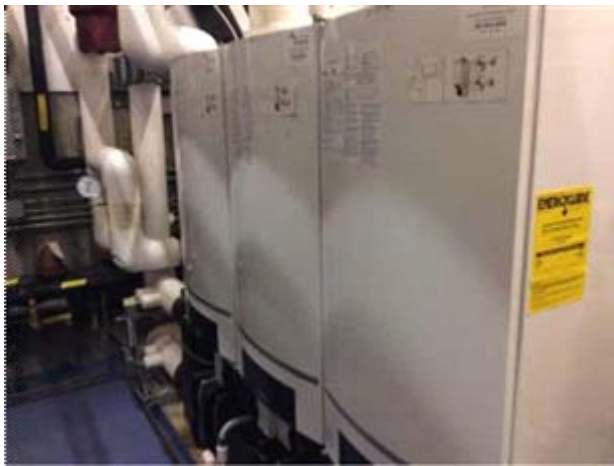
Coding / Field Name	Asset Description
D3049 HVAC Systems	HVAC System, 2-Pipe
Condition	Good
Qty / UOM	7138 / SF
Unit Cost	\$37.86
Basis of Costing	HVAC System, Full Upgrade, Office (per SF)
Year in Service	1999
Expected Useful Life (EUL)	40 Year(s), Based on Industry Averages
Remaining Useful Life (RUL)	25 Year(s), Estimated, Based on Date of Observation
Location	Building Interior (General)

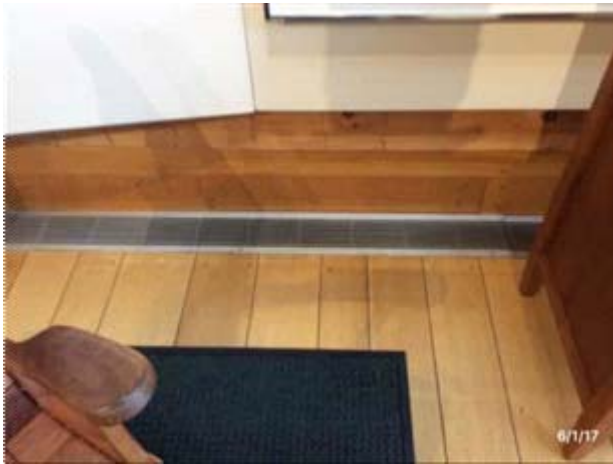
Coding / Field Name	Asset Description
D3051 Terminal Self-Contained Units	Radiator, Hydronic Baseboard
Condition	Good
Qty / UOM	200 / LF
Unit Cost	\$132.77
Basis of Costing	Radiator, Hydronic Baseboard (per LF)
Year in Service	1999
Expected Useful Life (EUL)	50 Year(s), Based on Industry Averages
Remaining Useful Life (RUL)	32 Year(s), Estimated, Based on Date of Observation
Location	Building Interior (General)

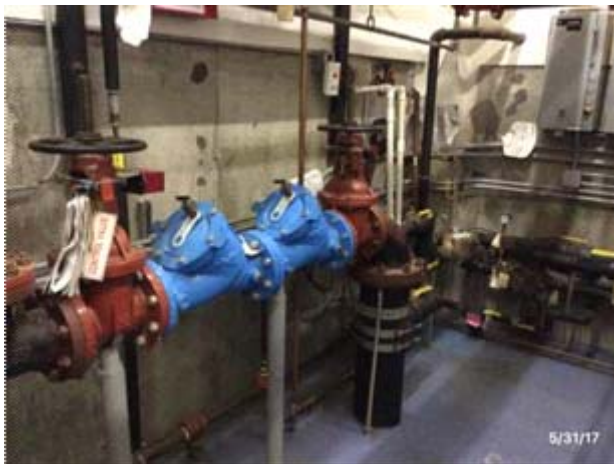
Coding / Field Name	Asset Description
D4019 Sprinkler Systems	Sprinkler Heads, Existing
Condition	Fair
Qty / UOM	7138 / SF
Unit Cost	\$1.33
Basis of Costing	Sprinkler Heads, Existing (per SF)
Year in Service	1999
Expected Useful Life (EUL)	20 Year(s), Based on Industry Averages
Remaining Useful Life (RUL)	12 Year(s), Estimated, Based on Date of Observation
Location	Building Interior (General)

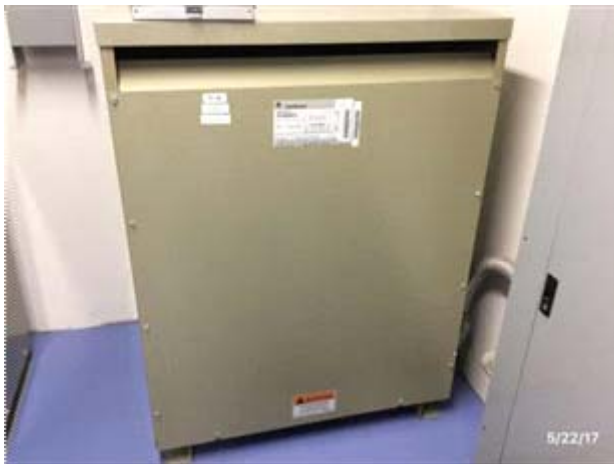
Coding / Field Name	Asset Description
D5012 Low Tension Service & Dist.	Secondary Transformer, Dry, T-4
Condition	Good
Qty / UOM	1 / EA
Unit Cost	\$11,920.05
Basis of Costing	Secondary Transformer, Dry, 113 kVA
Year in Service	1999
Expected Useful Life (EUL)	30 Year(s), Based on Industry Averages
Remaining Useful Life (RUL)	17 Year(s), Estimated, Based on Date of Observation
Location	Electrical Room (Primary)

Uniformat	Action Description	Quantity	Unit Cost	Plan Type	Priority	Year	Expenditure
D5012	Replace Secondary Transformer, Dry, T-4	1 EA	\$11,920.05	BYL	Priority 3	2034	\$11,920

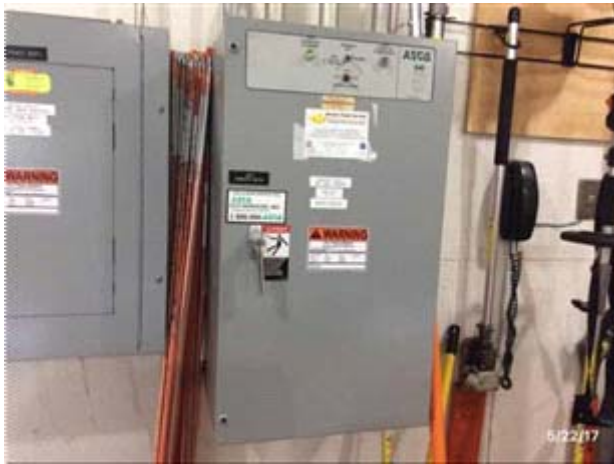
Coding / Field Name	Asset Description
D5012 Low Tension Service & Dist.	Transfer Switch
Condition	Fair
Qty / UOM	1 / EA
Unit Cost	\$7,671.31
Basis of Costing	Transfer Switch, Auto, 600 V, 100 Amp
Year in Service	1999
Expected Useful Life (EUL)	18 Year(s), Based on Industry Averages
Remaining Useful Life (RUL)	3 Year(s), Estimated, Based on Date of Observation
Location	Garage

Uniformat	Action Description	Quantity	Unit Cost	Plan Type	Priority	Year	Expenditure
D5012	Replace Transfer Switch	1 EA	\$7,671.31	BYL	Priority 1	2020	\$7,671

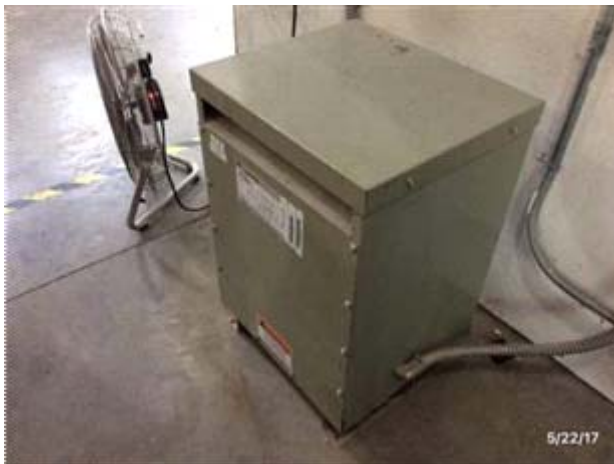
Coding / Field Name	Asset Description
D5012 Low Tension Service & Dist.	Secondary Transformer, Dry, T-2
Condition	Good
Qty / UOM	1 / EA
Unit Cost	\$5,454.95
Basis of Costing	Secondary Transformer, Dry, 15 kVA
Year in Service	1999
Expected Useful Life (EUL)	30 Year(s), Based on Industry Averages
Remaining Useful Life (RUL)	17 Year(s), Estimated, Based on Date of Observation
Location	Garage

Uniformat	Action Description	Quantity	Unit Cost	Plan Type	Priority	Year	Expenditure
D5012	Replace Secondary Transformer, Dry, T-2	1 EA	\$5,454.95	BYL	Priority 3	2034	\$5,455

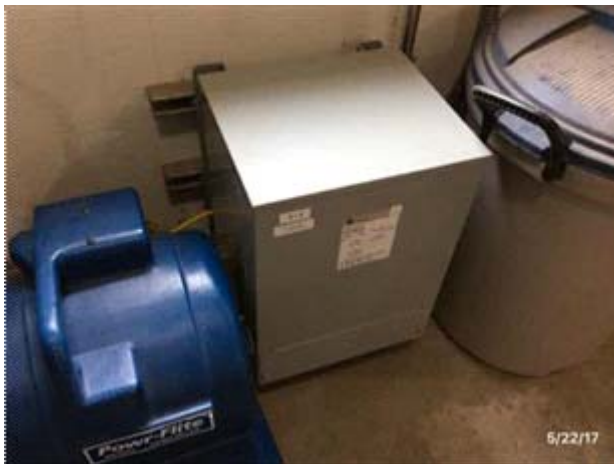
Coding / Field Name	Asset Description
D5012 Low Tension Service & Dist.	Secondary Transformer, Dry, T-1
Condition	Good
Qty / UOM	1 / EA
Unit Cost	\$5,454.95
Basis of Costing	Secondary Transformer, Dry, 15 kVA
Year in Service	1999
Expected Useful Life (EUL)	30 Year(s), Based on Industry Averages
Remaining Useful Life (RUL)	17 Year(s), Estimated, Based on Date of Observation
Location	Garage

Uniformat	Action Description	Quantity	Unit Cost	Plan Type	Priority	Year	Expenditure
D5012	Replace Secondary Transformer, Dry, T-1	1 EA	\$5,454.95	BYL	Priority 3	2034	\$5,455

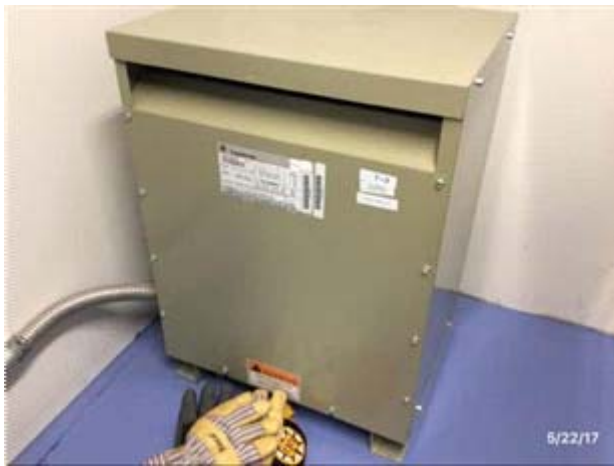
Coding / Field Name	Asset Description
D5012 Low Tension Service & Dist.	Secondary Transformer, Dry, T-3
Condition	Good
Qty / UOM	1 / EA
Unit Cost	\$6,086.36
Basis of Costing	Secondary Transformer, Dry, 30 kVA
Year in Service	1999
Expected Useful Life (EUL)	30 Year(s), Based on Industry Averages
Remaining Useful Life (RUL)	12 Year(s), Estimated, Based on Date of Observation
Location	Electrical Room (Primary)

Uniformat	Action Description	Quantity	Unit Cost	Plan Type	Priority	Year	Expenditure
D5012	Replace Secondary Transformer, Dry, T-3	1 EA	\$6,086.36	BYL	Priority 3	2029	\$6,086

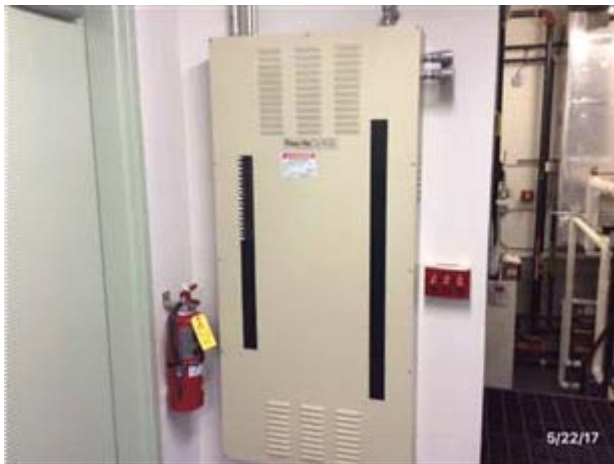
Coding / Field Name	Asset Description
D5022 Lighting Equipment	Light Dimming Panel
Condition	Fair
Qty / UOM	1 / EA
Unit Cost	\$4,261.42
Basis of Costing	Light Dimming Panel, Digital Multi-Purpose Time Control Clock & Photosensor
Year in Service	1999
Expected Useful Life (EUL)	15 Year(s), Based on Industry Averages
Remaining Useful Life (RUL)	3 Year(s), Estimated, Based on Date of Observation
Location	Electrical Room (Primary)

Uniformat	Action Description	Quantity	Unit Cost	Plan Type	Priority	Year	Expenditure
D5022	Replace Light Dimming Panel	1 EA	\$4,261.42	BYL	Priority 1	2020	\$4,261
D5022	Replace Light Dimming Panel	1 EA	\$4,261.42	BYL	Priority 1	2035	\$4,261

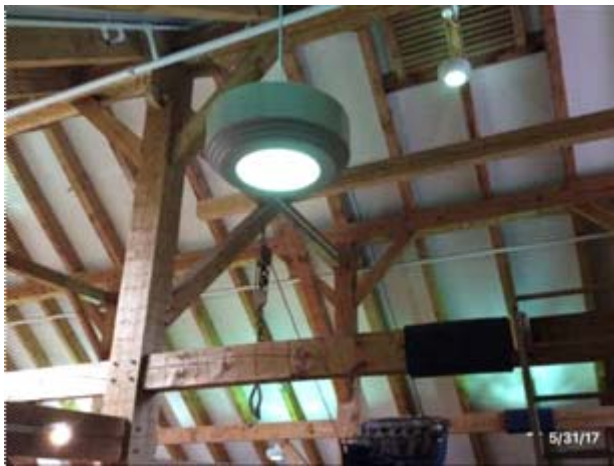
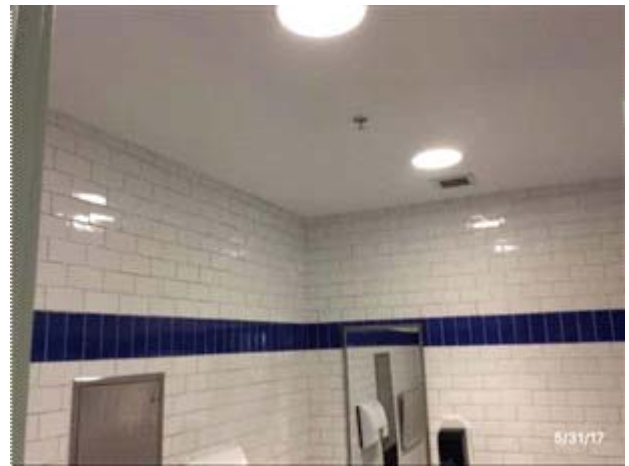
Coding / Field Name	Asset Description
D5029 Lighting Systems	Lighting System, Interior
Condition	Fair
Qty / UOM	7138 / SF
Unit Cost	\$6.76
Basis of Costing	Lighting System, Full Upgrade, Multi-Family (per SF)
Year in Service	1999
Expected Useful Life (EUL)	25 Year(s), Based on Industry Averages
Remaining Useful Life (RUL)	7 Year(s), Estimated, Based on Date of Observation
Location	Building Interior (General)

Uniformat	Action Description	Quantity	Unit Cost	Plan Type	Priority	Year	Expenditure
D5029	Replace Lighting System, Interior	7,138 SF	\$6.76	BYL	Priority 2	2024	\$48,240

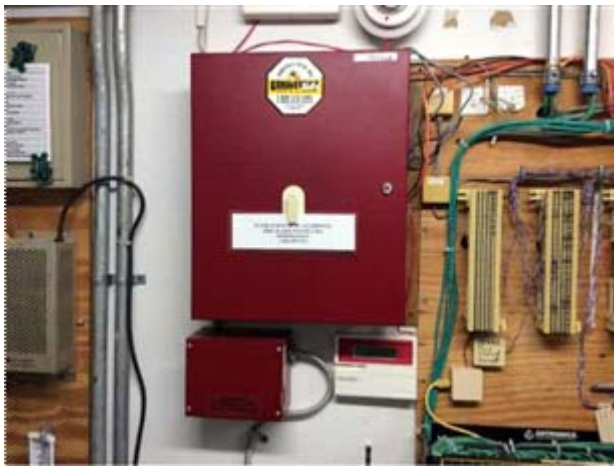
Coding / Field Name	Asset Description
D5037 Fire Alarm Systems	Fire Alarm System
Condition	Fair
Qty / UOM	7138 / SF
Unit Cost	\$2.36
Basis of Costing	Fire Alarm System, Full Upgrade/Install, Office (per SF)
Year in Service	1999
Expected Useful Life (EUL)	20 Year(s), Based on Industry Averages
Remaining Useful Life (RUL)	3 Year(s), Estimated, Based on Date of Observation
Location	Building Interior (General)

Uniformat	Action Description	Quantity	Unit Cost	Plan Type	Priority	Year	Expenditure
D5037	Replace Fire Alarm System	7,138 SF	\$2.36	BYL	Priority 1	2020	\$16,846

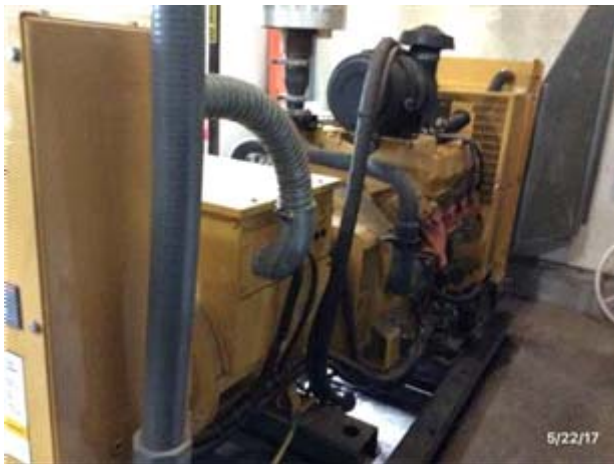
Coding / Field Name	Asset Description
D5092 Emergency Light & Power Systems	Generator, Gas
Condition	Fair
Qty / UOM	1 / EA
Unit Cost	\$71,929.70
Basis of Costing	Generator, Gas or Gasoline, 65 kW to 125 kW
Year in Service	1999
Expected Useful Life (EUL)	25 Year(s), Based on Industry Averages
Remaining Useful Life (RUL)	7 Year(s), Estimated, Based on Date of Observation
Location	Garage

Uniformat	Action Description	Quantity	Unit Cost	Plan Type	Priority	Year	Expenditure
D5092	Replace Generator, Gas	1 EA	\$71,929.70	BYL	Priority 3	2024	\$71,930

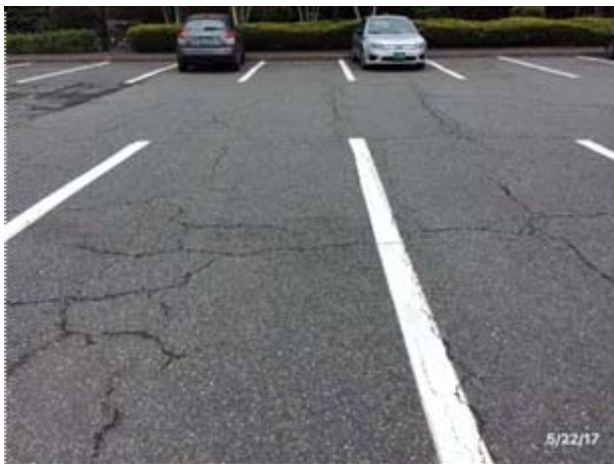
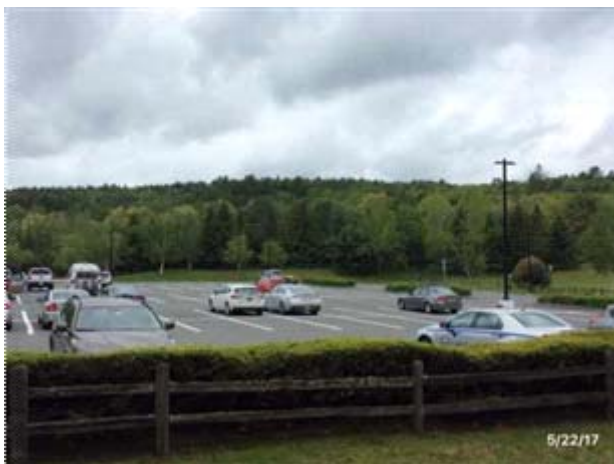
Coding / Field Name	Asset Description
G2022 Paving & Surfacing	Asphalt Pavement, Parking Lot
Condition	Fair
Qty / UOM	140000 / SF
Unit Cost	\$5.90
Basis of Costing	Asphalt Pavement, Parking Lot
Year in Service	1999
Expected Useful Life (EUL)	25 Year(s), Based on Industry Averages
Remaining Useful Life (RUL)	7 Year(s), Estimated, Based on Date of Observation
Location	Site

Isolated patching needed. Crack sealing and seal coat needed. Striping is recent.

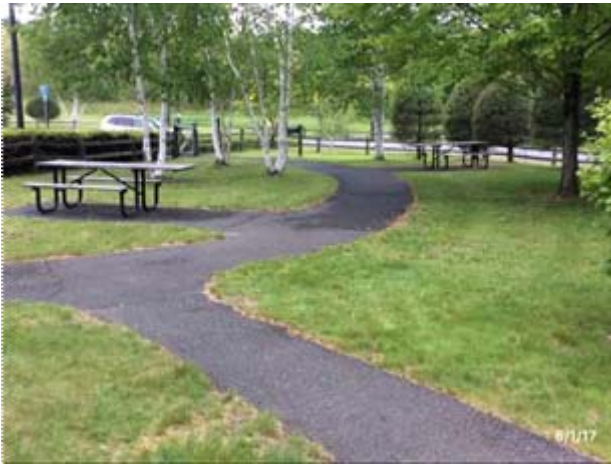
Coding / Field Name	Asset Description
G2031 Paving & Surfacing	Asphalt Sidewalk
Condition	Fair
Qty / UOM	500 / SF
Unit Cost	\$0.75
Basis of Costing	Asphalt Sidewalk
Year in Service	1999
Expected Useful Life (EUL)	25 Year(s), Based on Industry Averages
Remaining Useful Life (RUL)	7 Year(s), Estimated, Based on Date of Observation
Location	Site

Uniformat	Action Description	Quantity	Unit Cost	Plan Type	Priority	Year	Expenditure
G2031	Replace Asphalt Sidewalk	500 SF	\$0.75	BYL	Priority 3	2024	\$373

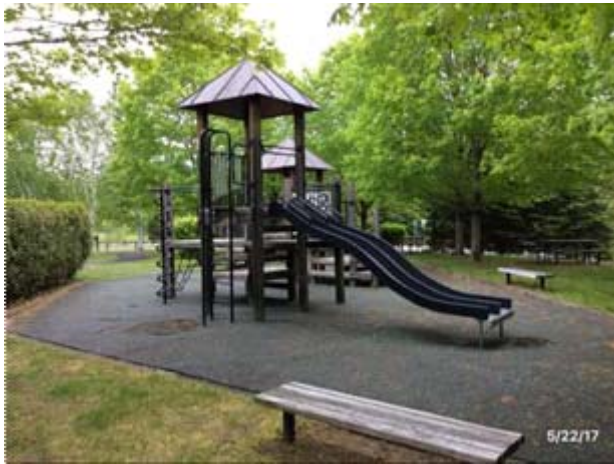
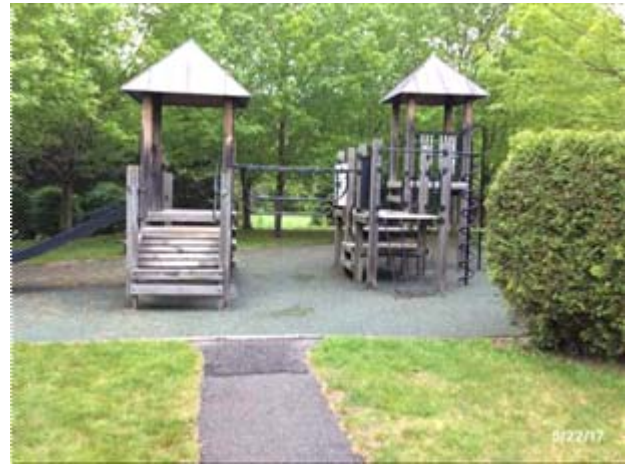
Coding / Field Name	Asset Description
G2047 Playing Fields	Play Structure, Large
Condition	Fair
Qty / UOM	1 / EA
Unit Cost	\$53,130.00
Basis of Costing	Play Structure, Large
Year in Service	1999
Expected Useful Life (EUL)	20 Year(s), Based on Industry Averages
Remaining Useful Life (RUL)	5 Year(s), Estimated, Based on Date of Observation
Location	Site

Uniformat	Action Description	Quantity	Unit Cost	Plan Type	Priority	Year	Expenditure
G2047	Replace Play Structure, Large	1 EA	\$53,130.00	BYL	Priority 3	2022	\$53,130

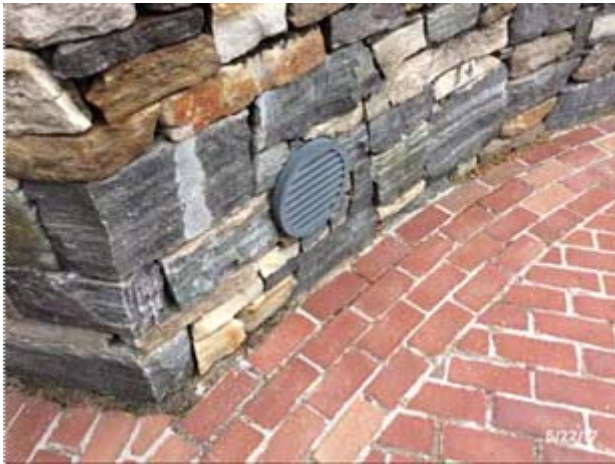
Coding / Field Name	Asset Description
G4021 Fixtures & Transformers	Walkway Luminaire
Condition	Fair
Qty / UOM	6 / EA
Unit Cost	\$1,894.72
Basis of Costing	Walkway Luminaire, 70 to 250 W HID (Fixture Only)
Year in Service	2012
Expected Useful Life (EUL)	20 Year(s), Based on Industry Averages
Remaining Useful Life (RUL)	15 Year(s), Estimated, Based on Date of Observation
Location	Site

Uniformat	Action Description	Quantity	Unit Cost	Plan Type	Priority	Year	Expenditure
G4021	Replace Walkway Luminaire	6 EA	\$1,894.72	BYL	Priority 3	2032	\$11,368

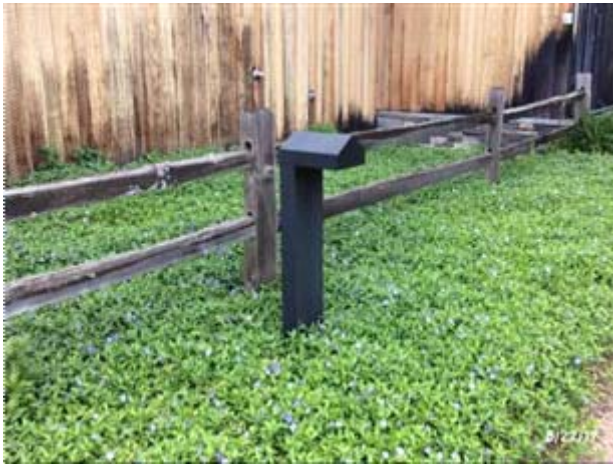
Coding / Field Name	Asset Description
G4021 Fixtures & Transformers	Walkway Bollard Light
Condition	Fair
Qty / UOM	3 / EA
Unit Cost	\$1,494.12
Basis of Costing	Walkway Bollard Light, 70 to 150 W HID
Year in Service	2012
Expected Useful Life (EUL)	20 Year(s), Based on Industry Averages
Remaining Useful Life (RUL)	15 Year(s), Estimated, Based on Date of Observation
Location	Site

Uniformat	Action Description	Quantity	Unit Cost	Plan Type	Priority	Year	Expenditure
G4021	Replace Walkway Bollard Light	3 EA	\$1,494.12	BYL	Priority 3	2032	\$4,482

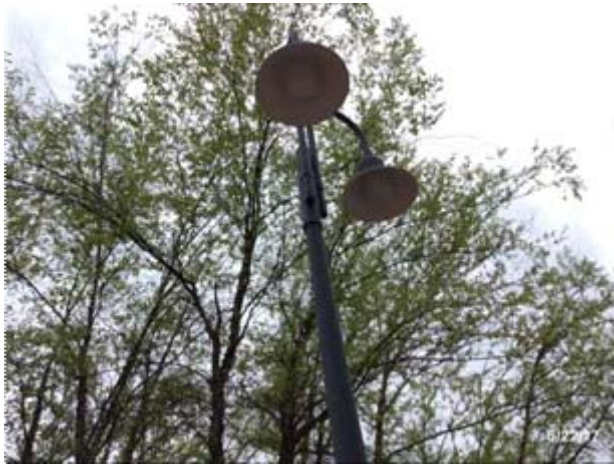
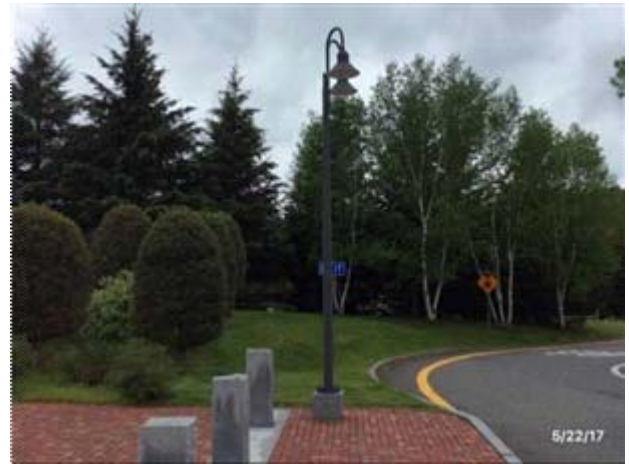
Coding / Field Name	Asset Description
G4021 Fixtures & Transformers	Pole Light, Exterior, Plaza
Condition	Good
Qty / UOM	19 / EA
Unit Cost	\$2,246.90
Basis of Costing	Pole Light, Exterior, 135 to 1000 W HID (Fixture, Ballast, & Lamp)
Year in Service	2012
Expected Useful Life (EUL)	10 Year(s), Based on Industry Averages
Remaining Useful Life (RUL)	5 Year(s), Estimated, Based on Date of Observation
Location	Site

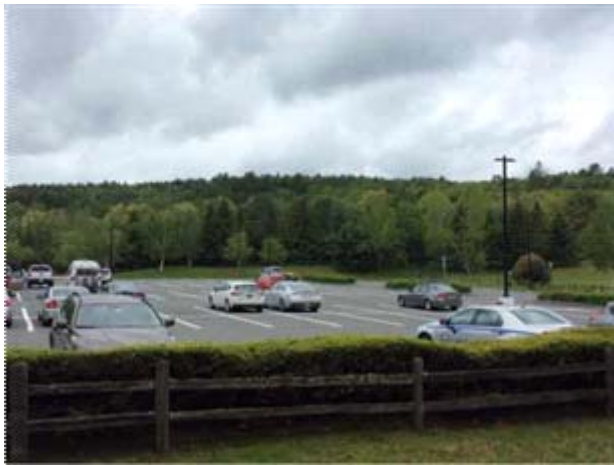
Coding / Field Name	Asset Description
G4023 Wiring Conduits & Ductbanks	Site Electrical Wiring
Condition	Fair
Qty / UOM	250000 / SF
Unit Cost	\$0.25
Year in Service	1999
Expected Useful Life (EUL)	40 Year(s), Based on Industry Averages
Remaining Useful Life (RUL)	22 Year(s), Estimated, Based on Date of Observation
Location	Site
