FACILITY CONDITION ASSESSMENT

FACILITY CONDITION ASSESSMENT
OF
09731 WATERFORD WELCOME CENTER
1270 I-93 NORTHBOUND
WATERFORD, VT 05819

106686.17R000-152.305

June 21, 2017

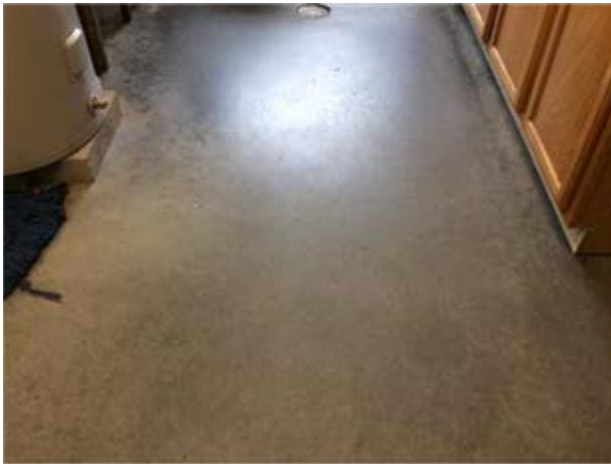
Coding / Field Name	Asset Description
A1031 Standard Slab on Grade	Concrete Slab-On-Grade
Condition	Good
Qty / UOM	2340 / SF
Unit Cost	\$10.44
Basis of Costing	Concrete Slab-On-Grade
Year in Service	1982
Expected Useful Life (EUL)	40 Year(s), Based on Industry Averages
Remaining Useful Life (RUL)	35 Year(s), Estimated, Based on Date of Observation
Location	Structure

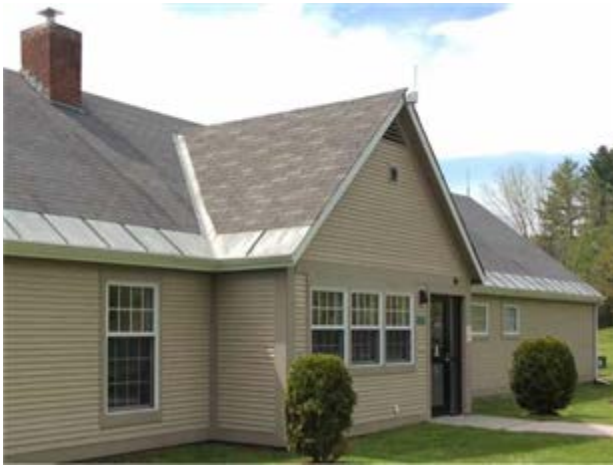
Coding / Field Name	Asset Description
B1012 Upper Floors Construction	Superstructure, Structural Frame, Wood Conventional Stud
Condition	Fair
Qty / UOM	2340 / SF
Unit Cost	\$18.10
Basis of Costing	Superstructure, Structural Frame, Wood Conventional Stud
Year in Service	1982
Expected Useful Life (EUL)	50 Year(s), Based on Industry Averages
Remaining Useful Life (RUL)	35 Year(s), Estimated, Based on Date of Observation
Location	Structure

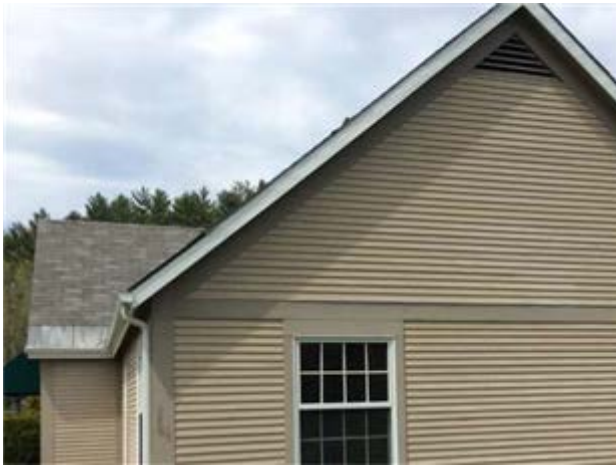
Coding / Field Name	Asset Description
B1022 Pitched Roof Construction	Roof Structure, Pitched, Wood Rafters
Condition	Fair
Qty / UOM	2340 / SF
Unit Cost	\$19.72
Basis of Costing	Roof Structure, Pitched, Wood Rafters
Year in Service	1982
Expected Useful Life (EUL)	50 Year(s), Based on Industry Averages
Remaining Useful Life (RUL)	35 Year(s), Estimated, Based on Date of Observation
Location	Structure

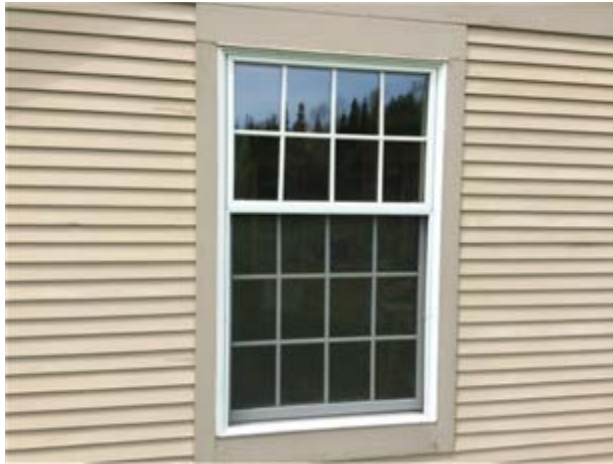
Coding / Field Name	Asset Description
B2021 Windows	Wood Window, Single-Pane
Condition	Fair
Qty / UOM	13 / EA
Unit Cost	\$1,295.75
Basis of Costing	Wood Window, 1-2 Stories, 12 SF
Year in Service	1982
Expected Useful Life (EUL)	30 Year(s), Based on Industry Averages
Remaining Useful Life (RUL)	3 Year(s), Estimated, Based on Date of Observation
Location	Exterior Walls
Window Type	Double Hung
Windows Material	Wood
Windows Glazing	Single Glazed
Window Operation	Manual

Uniformat	Action Description	Quantity	Unit Cost	Plan Type	Priority	Year	Expenditure
B2021	Replace Wood Window, Single-Pane	13 EA	\$1,295.75	BYL	Priority 2	2020	\$16,845

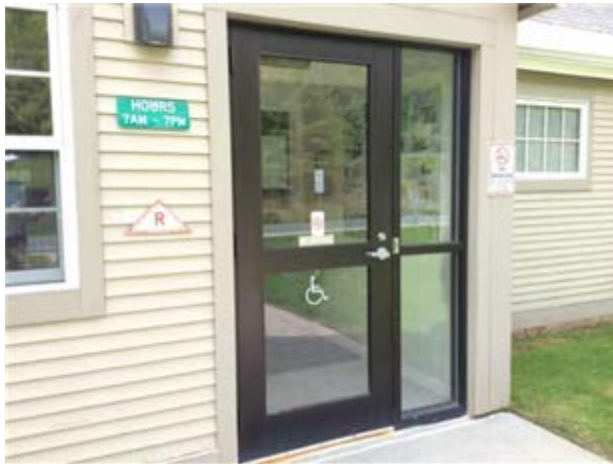
Coding / Field Name	Asset Description
B2031 Glazed Doors & Entrances	Aluminum Frame, Fully Glazed, Exterior Door
Condition	Fair
Qty / UOM	2 / EA
Unit Cost	\$1,368.37
Basis of Costing	Aluminum Frame, Fully Glazed, Exterior Door
Year in Service	1997
Expected Useful Life (EUL)	30 Year(s), Based on Industry Averages
Remaining Useful Life (RUL)	14 Year(s), Estimated, Based on Date of Observation
Location	Exterior Walls

Uniformat	Action Description	Quantity	Unit Cost	Plan Type	Priority	Year	Expenditure
B2031	Replace Aluminum Frame, Fully Glazed, Exterior Door	2 EA	\$1,368.37	BYL	Priority 3	2031	\$2,737

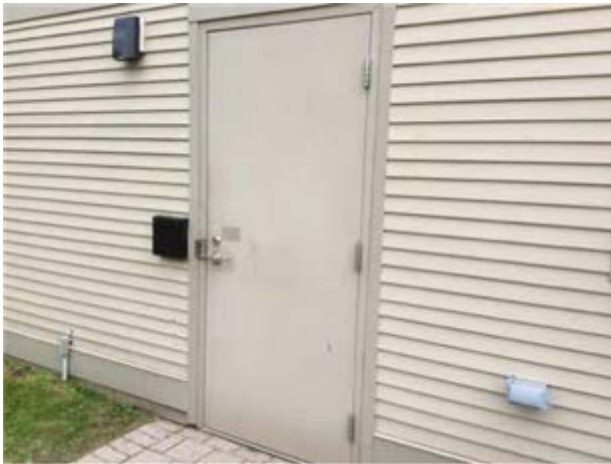
Coding / Field Name	Asset Description
B2032 Solid Exterior Doors	Steel, Insulated, Exterior Door
Condition	Fair
Qty / UOM	1 / EA
Unit Cost	\$1,577.53
Basis of Costing	Steel, Insulated, Exterior Door
Year in Service	1997
Expected Useful Life (EUL)	25 Year(s), Based on Industry Averages
Remaining Useful Life (RUL)	12 Year(s), Estimated, Based on Date of Observation
Location	Exterior Walls

Uniformat	Action Description	Quantity	Unit Cost	Plan Type	Priority	Year	Expenditure
B2032	Replace Steel, Insulated, Exterior Door	1 EA	\$1,577.53	BYL	Priority 3	2029	\$1,578

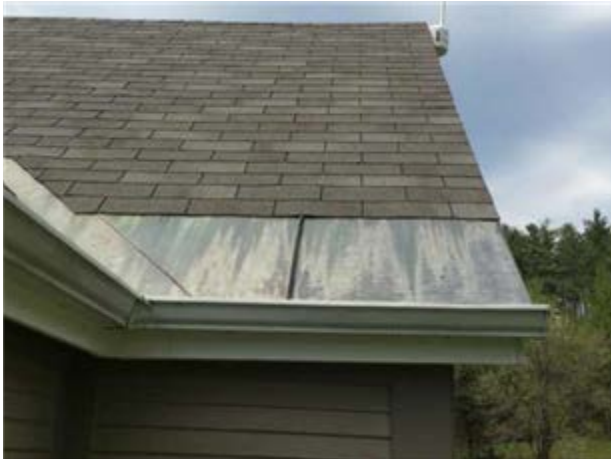
Coding / Field Name	Asset Description
B3011 Roof Finishes	Asphalt Shingle Roof (Includes Tear-Off of Old)
Condition	Fair
Qty / UOM	3500 / SF
Cost Adjustment Factor/Reason	1.3 / Gable
Unit Cost (Adjusted)	\$21.01
Basis of Costing	Asphalt Shingle Roof (Includes Tear-Off of Old)
Year in Service	1997
Expected Useful Life (EUL)	20 Year(s), Based on Industry Averages
Remaining Useful Life (RUL)	7 Year(s), Estimated, Based on Date of Observation
Location	Roof

Uniformat	Action Description	Quantity	Unit Cost	Plan Type	Priority	Year	Expenditure
B3011	Replace Asphalt Shingle Roof (Includes Tear-Off of Old)	3,500 SF	\$21.01	BYL	Priority 3	2024	\$73,528

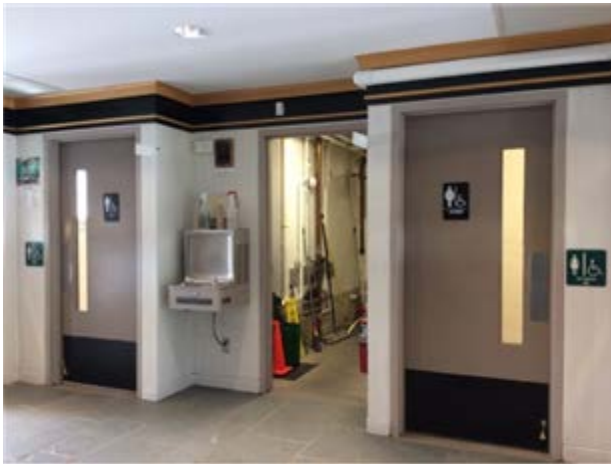
Coding / Field Name	Asset Description
C1021 Interior Doors	Steel, Interior Door
Condition	Fair
Qty / UOM	9 / EA
Unit Cost	\$950.12
Basis of Costing	Steel, Interior Door
Year in Service	1997
Expected Useful Life (EUL)	25 Year(s), Based on Industry Averages
Remaining Useful Life (RUL)	8 Year(s), Estimated, Based on Date of Observation
Location	Building Interior (General)

Uniformat	Action Description	Quantity	Unit Cost	Plan Type	Priority	Year	Expenditure
C1021	Replace Steel, Interior Door	9 EA	\$950.12	BYL	Priority 3	2025	\$8,551

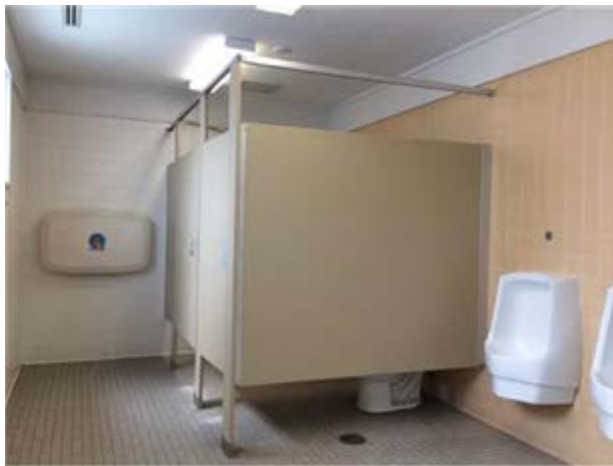
Coding / Field Name	Asset Description
C1031 Fabricated Toilet Partitions	Toilet Partitions, Metal, Overhead Braced
Condition	Fair
Qty / UOM	5 / EA
Unit Cost	\$850.00
Basis of Costing	Toilet Partitions, Metal, Overhead Braced
Year in Service	2010
Expected Useful Life (EUL)	20 Year(s), Based on Industry Averages
Remaining Useful Life (RUL)	13 Year(s), Estimated, Based on Date of Observation
Location	Restrooms

Uniformat	Action Description	Quantity	Unit Cost	Plan Type	Priority	Year	Expenditure
C1031	Replace Toilet Partitions, Metal, Overhead Braced	5 EA	\$850.00	BYL	Priority 3	2030	\$4,250

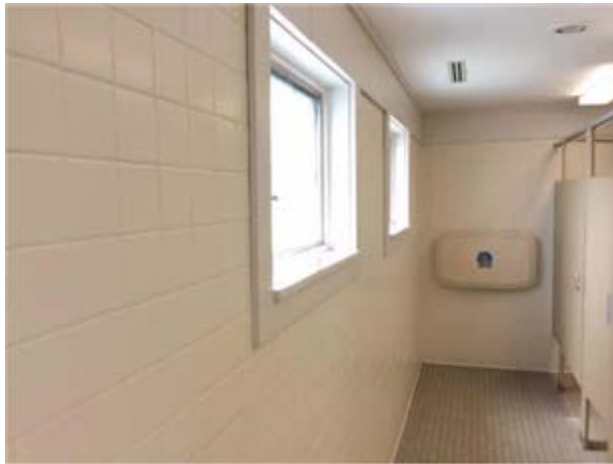
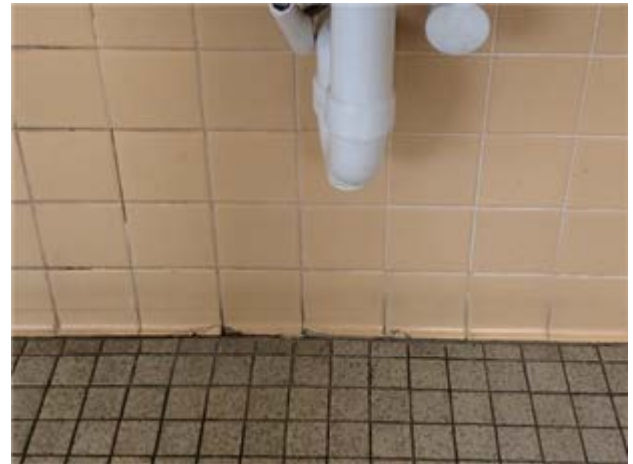
Coding / Field Name	Asset Description
C3012 Wall Finishes to Interior Walls	Ceramic Tile, Interior Wall Finish
Condition	Fair
Qty / UOM	1000 / SF
Unit Cost	\$16.55
Basis of Costing	Ceramic Tile, Interior Wall Finish
Year in Service	1982
Expected Useful Life (EUL)	25 Year(s), Based on Industry Averages
Remaining Useful Life (RUL)	4 Year(s), Estimated, Based on Date of Observation
Location	Restrooms

Uniformat	Action Description	Quantity	Unit Cost	Plan Type	Priority	Year	Expenditure
C3012	Replace Ceramic Tile, Interior Wall Finish	1,000 SF	\$16.55	BYL	Priority 3	2021	\$16,554

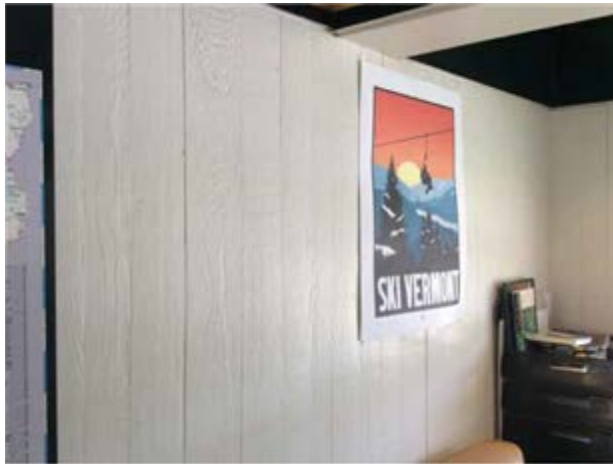
Coding / Field Name	Asset Description
C3012 Wall Finishes to Interior Walls	Interior Wall Finish, Wood, Painted
Condition	Fair
Qty / UOM	2000 / SF
Unit Cost	\$23.73
Basis of Costing	Wood, Finished, Interior Paneling
Year in Service	1997
Expected Useful Life (EUL)	20 Year(s), Based on Industry Averages
Remaining Useful Life (RUL)	12 Year(s), Estimated, Based on Date of Observation
Location	Building Interior (General)

Uniformat	Action Description	Quantity	Unit Cost	Plan Type	Priority	Year	Expenditure
C3012	Paint Interior Walls	2,000 SF	\$1.42	BYL	Priority 3	2022	\$2,840
C3012	Paint Interior Walls	2,000 SF	\$1.42	BYL	Priority 3	2030	\$2,840

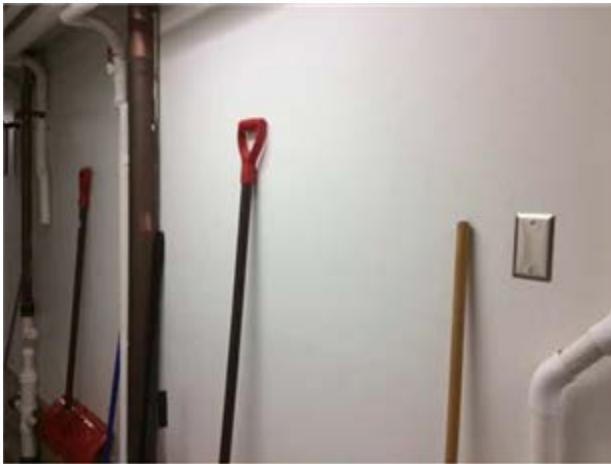
Coding / Field Name	Asset Description
C3012 Wall Finishes to Interior Walls	Gypsum Board, Wall
Condition	Fair
Qty / UOM	2000 / SF
Unit Cost	\$3.38
Basis of Costing	Gypsum Board/Plaster, Interior Wall
Year in Service	1982
Expected Useful Life (EUL)	40 Year(s), Based on Industry Averages
Remaining Useful Life (RUL)	25 Year(s), Estimated, Based on Date of Observation
Location	Building Interior (General)

Uniformat	Action Description	Quantity	Unit Cost	Plan Type	Priority	Year	Expenditure
C3012	Paint Interior Walls	2,000 SF	\$1.42	BYL	Priority 3	2022	\$2,840
C3012	Paint Interior Walls	2,000 SF	\$1.42	BYL	Priority 3	2030	\$2,840

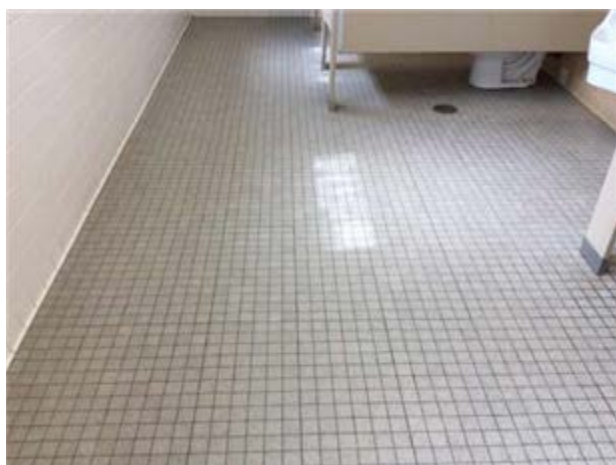
Coding / Field Name	Asset Description
C3024 Flooring	Ceramic Tile Flooring
Condition	Fair
Qty / UOM	500 / SF
Unit Cost	\$15.75
Basis of Costing	Ceramic Tile Flooring
Year in Service	1997
Expected Useful Life (EUL)	50 Year(s), Based on Industry Averages
Remaining Useful Life (RUL)	30 Year(s), Estimated, Based on Date of Observation
Location	Restrooms

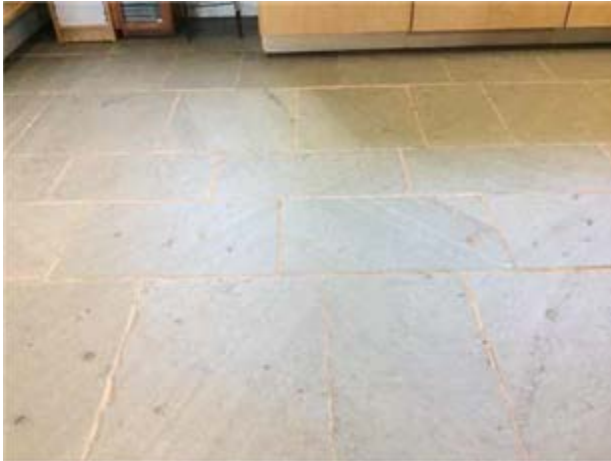
Coding / Field Name	Asset Description
C3024 Flooring	Tile, Slate
Condition	Fair
Qty / UOM	1000 / SF
Cost Adjustment Factor/Reason	0.5 / Slate tile
Unit Cost (Adjusted)	\$34.78
Basis of Costing	Marble Flooring
Year in Service	1982
Expected Useful Life (EUL)	50 Year(s), Based on Industry Averages
Remaining Useful Life (RUL)	25 Year(s), Estimated, Based on Date of Observation
Location	Building Interior (General)

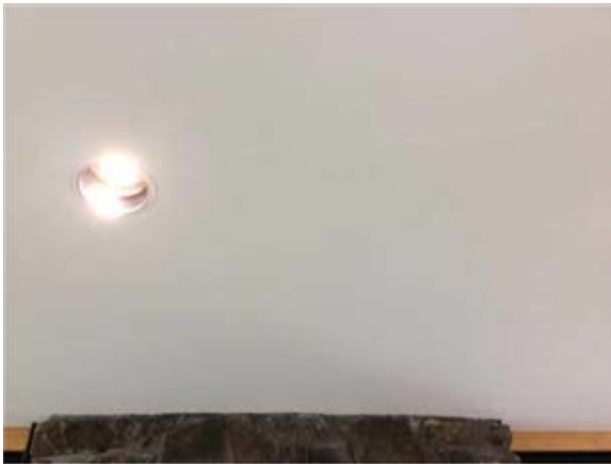
Coding / Field Name	Asset Description
C3031 Ceiling Finishes	Gypsum Board Ceiling
Condition	Fair
Qty / UOM	2500 / SF
Unit Cost	\$7.13
Basis of Costing	Gypsum Board/Plaster, Ceiling
Year in Service	1982
Expected Useful Life (EUL)	50 Year(s), Based on Industry Averages
Remaining Useful Life (RUL)	25 Year(s), Estimated, Based on Date of Observation
Location	Building Interior (General)

Uniformat	Action Description	Quantity	Unit Cost	Plan Type	Priority	Year	Expenditure
C3031	Paint Interior Ceilings	2,500 SF	\$1.94	BYL	Priority 3	2022	\$4,850
C3031	Paint Interior Ceilings	2,500 SF	\$1.94	BYL	Priority 3	2032	\$4,850

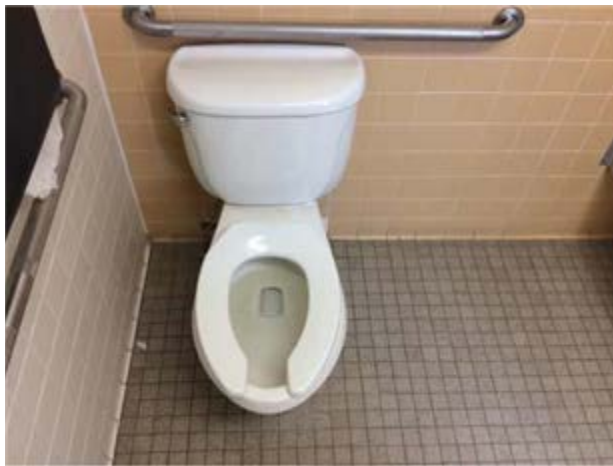
Coding / Field Name	Asset Description
D2011 Water Closets	Flush Tank Water Closet, One Piece
Condition	Good
Qty / UOM	5 / EA
Unit Cost	\$1,055.15
Basis of Costing	Flush Tank Water Closet, One Piece
Year in Service	2010
Expected Useful Life (EUL)	20 Year(s), Based on Industry Averages
Remaining Useful Life (RUL)	13 Year(s), Estimated, Based on Date of Observation
Location	Restrooms

Uniformat	Action Description	Quantity	Unit Cost	Plan Type	Priority	Year	Expenditure
D2011	Replace Flush Tank Water Closet, One Piece	5 EA	\$1,055.15	BYL	Priority 3	2030	\$5,276

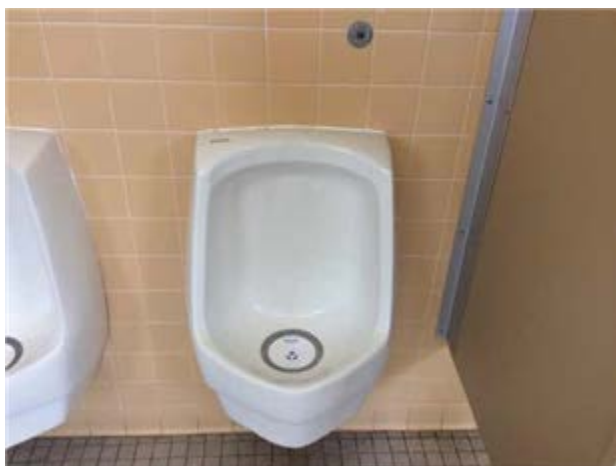
Waterless

Uniformat	Action Description	Quantity	Unit Cost	Plan Type	Priority	Year	Expenditure
D2012	Replace Urinal, Vitreous China	2 EA	\$1,193.44	BYL	Priority 3	2033	\$2,387

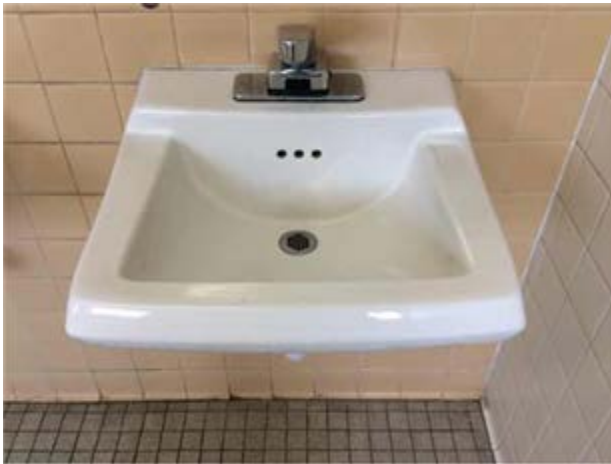
Coding / Field Name	Asset Description
D2013 Lavatories	Lavatory, Enameled Steel
Condition	Fair
Qty / UOM	4 / EA
Unit Cost	\$353.05
Basis of Costing	Lavatory, Enameled Steel
Year in Service	1997
Expected Useful Life (EUL)	20 Year(s), Based on Industry Averages
Remaining Useful Life (RUL)	5 Year(s), Estimated, Based on Date of Observation
Location	Restrooms

Uniformat	Action Description	Quantity	Unit Cost	Plan Type	Priority	Year	Expenditure
D2013	Replace Lavatory, Enameled Steel	4 EA	\$353.05	BYL	Priority 2	2022	\$1,412

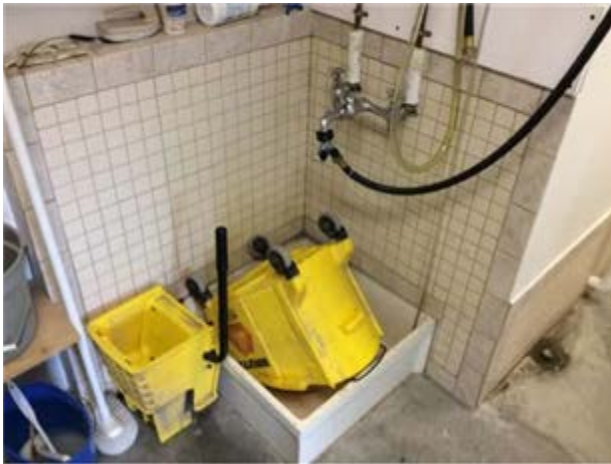
Coding / Field Name	Asset Description
D2014 Sinks	Service Sink, Floor
Condition	Fair
Qty / UOM	1 / EA
Unit Cost	\$1,599.51
Basis of Costing	Service Sink, Floor
Year in Service	1997
Expected Useful Life (EUL)	35 Year(s), Based on Industry Averages
Remaining Useful Life (RUL)	15 Year(s), Estimated, Based on Date of Observation
Location	Utility Area

Uniformat	Action Description	Quantity	Unit Cost	Plan Type	Priority	Year	Expenditure
D2014	Replace Service Sink, Floor	1 EA	\$1,599.51	BYL	Priority 3	2032	\$1,600

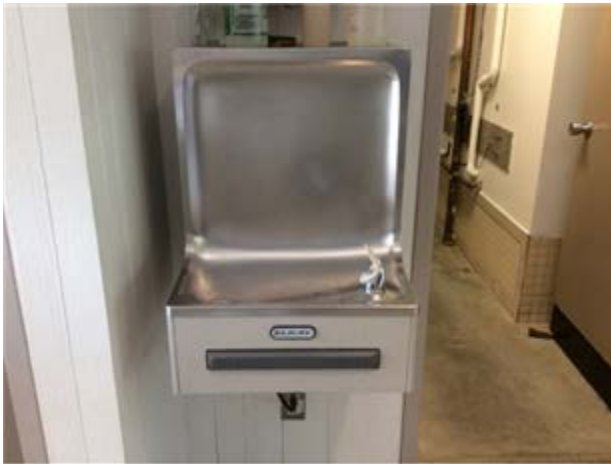
Coding / Field Name	Asset Description
D2018 Drinking Fountains and Coolers	Drinking Fountain, Refrigerated
Condition	Good
Qty / UOM	1 / EA
Unit Cost	\$1,257.51
Basis of Costing	Drinking Fountain, Refrigerated
Year in Service	2013
Expected Useful Life (EUL)	10 Year(s), Based on Industry Averages
Remaining Useful Life (RUL)	7 Year(s), Estimated, Based on Date of Observation
Location	Building Interior (General)

Uniformat	Action Description	Quantity	Unit Cost	Plan Type	Priority	Year	Expenditure
D2018	Replace Drinking Fountain, Refrigerated	1 EA	\$1,257.51	BYL	Priority 3	2024	\$1,258
D2018	Replace Drinking Fountain, Refrigerated	1 EA	\$1,257.51	BYL	Priority 3	2034	\$1,258

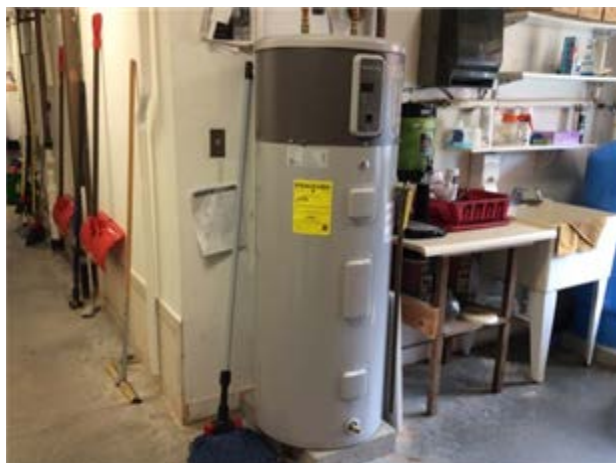
Coding / Field Name	Asset Description
D2023 Domestic Water Supply Equipment	Water Heater, Electric, Commercial, 50 GAL
Condition	Good
Qty / UOM	1 / EA
Cost Adjustment Factor/Reason	1.5 / Integral heat pump
Unit Cost (Adjusted)	\$4,406.10
Basis of Costing	Water Heater, Electric, Residential, 53 to 120 GAL
Year in Service	2016
Expected Useful Life (EUL)	15 Year(s), Based on Industry Averages
Remaining Useful Life (RUL)	14 Year(s), Estimated, Based on Date of Observation
Location	Utility Area

Hybrid heat pump system.

Uniformat	Action Description	Quantity	Unit Cost	Plan Type	Priority	Year	Expenditure
D2023	Replace Water Heater, Electric, Commercial, 50 GAL	1 EA	\$4,406.10	BYL	Priority 3	2031	\$4,406

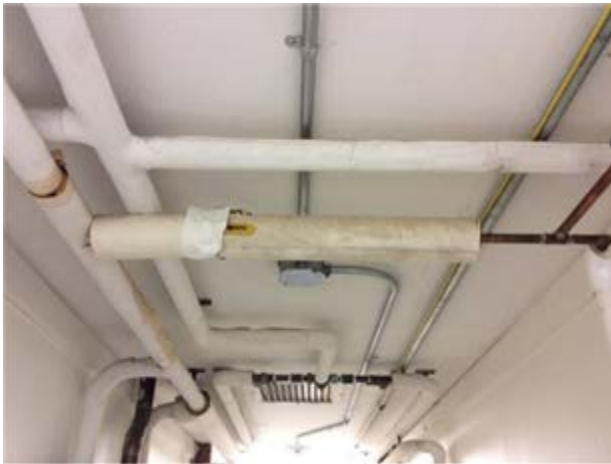
Coding / Field Name	Asset Description
D2029 Plumbing Systems	Domestic Water Distribution
Condition	Fair
Qty / UOM	2340 / SF
Unit Cost	\$7.59
Basis of Costing	Plumbing System, Domestic Supply
Year in Service	1982
Expected Useful Life (EUL)	40 Year(s), Based on Industry Averages
Remaining Useful Life (RUL)	15 Year(s), Estimated, Based on Date of Observation
Location	Building Interior (General)

Uniformat	Action Description	Quantity	Unit Cost	Plan Type	Priority	Year	Expenditure
D2029	Replace Domestic Water Distribution	2,340 SF	\$7.59	BYL	Priority 4	2032	\$17,761

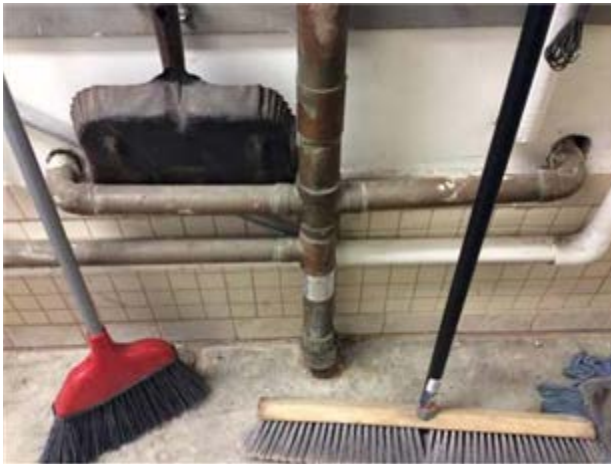
Coding / Field Name	Asset Description
D2034 Sanitary Waste Equipment	Plumbing System, Sanitary Waste
Condition	Fair
Qty / UOM	2340 / SF
Unit Cost	\$5.06
Basis of Costing	Plumbing System, Sanitary Waste
Year in Service	1982
Expected Useful Life (EUL)	40 Year(s), Based on Industry Averages
Remaining Useful Life (RUL)	15 Year(s), Estimated, Based on Date of Observation
Location	Building Interior (General)

Uniformat	Action Description	Quantity	Unit Cost	Plan Type	Priority	Year	Expenditure
D2034	Replace Plumbing System, Sanitary Waste	2,340 SF	\$5.06	BYL	Priority 4	2032	\$11,840

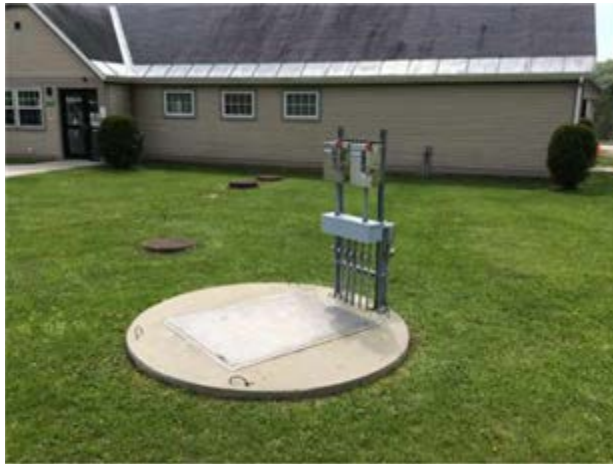
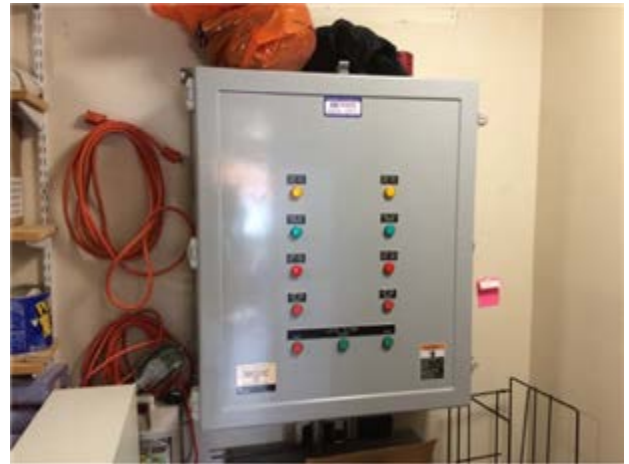
Coding / Field Name	Asset Description
D2034 Sanitary Waste Equipment	Sewage Ejector Pump, 3 HP
Condition	Good
Qty / UOM	2 / EA
Unit Cost	\$2,993.56
Basis of Costing	Sewage Ejector Pump, 1 to 3 HP
Year in Service	2012
Expected Useful Life (EUL)	15 Year(s), Based on Industry Averages
Remaining Useful Life (RUL)	10 Year(s), Estimated, Based on Date of Observation
Location	Site

Uniformat	Action Description	Quantity	Unit Cost	Plan Type	Priority	Year	Expenditure
D2034	Replace Sewage Ejector Pump, 3 HP	2 EA	\$2,993.56	BYL	Priority 3	2027	\$5,987

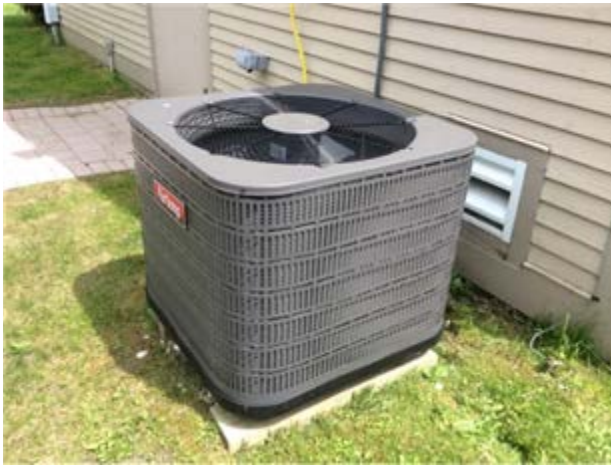
Coding / Field Name	Asset Description
D3032 Direct Expansion Systems	Condensing Unit, Split System DX, Air-Cooled, 4 Ton
Condition	Good
Qty / UOM	1 / EA
Unit Cost	\$4,619.82
Basis of Costing	Condensing Unit, Split System DX, Air-Cooled, 4 Ton
Year in Service	2012
Expected Useful Life (EUL)	15 Year(s), Based on Industry Averages
Remaining Useful Life (RUL)	10 Year(s), Estimated, Based on Date of Observation
Location	Site

Uniformat	Action Description	Quantity	Unit Cost	Plan Type	Priority	Year	Expenditure
D3032	Replace Condensing Unit, Split System DX, Air-Cooled, 4 Ton	1 EA	\$4,619.82	BYL	Priority 3	2027	\$4,620

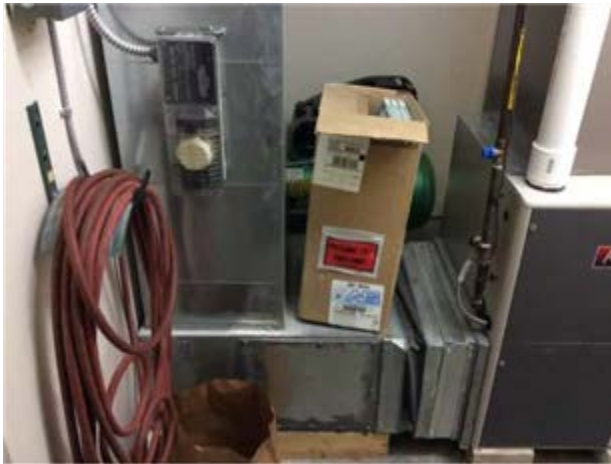
Coding / Field Name	Asset Description
D3041 Air Distribution Systems	HVAC System Ductwork, Sheetmetal
Condition	Fair
Qty / UOM	2340 / SF
Unit Cost	\$19.50
Basis of Costing	HVAC System Ductwork, Sheet Metal
Year in Service	1997
Expected Useful Life (EUL)	30 Year(s), Based on Industry Averages
Remaining Useful Life (RUL)	18 Year(s), Estimated, Based on Date of Observation
Location	Building Interior (General)

Uniformat	Action Description	Quantity	Unit Cost	Plan Type	Priority	Year	Expenditure
D3041	Replace HVAC System Ductwork, Sheetmetal	2,340 SF	\$19.50	BYL	Priority 4	2035	\$45,630

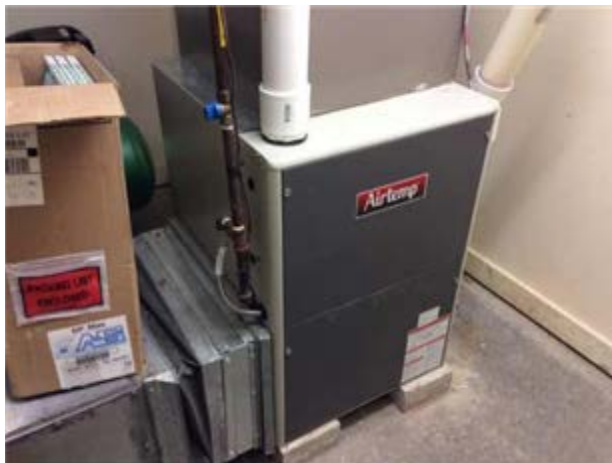
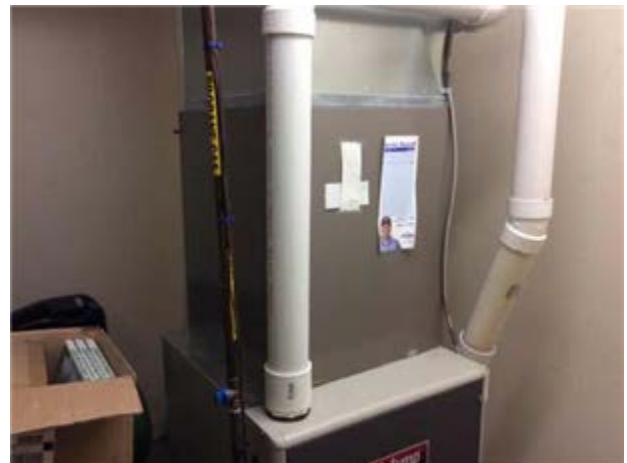
Coding / Field Name	Asset Description
D3051 Terminal Self-Contained Units	Furnace, Propane, 120 MBH
Condition	Good
Qty / UOM	1 / EA
Cost Adjustment Factor/Reason	1.3 / Cooling coil accessory
Unit Cost (Adjusted)	\$7,337.55
Basis of Costing	Furnace, Gas, 101 to 150 MBH
Year in Service	2011
Expected Useful Life (EUL)	20 Year(s), Based on Industry Averages
Remaining Useful Life (RUL)	14 Year(s), Estimated, Based on Date of Observation
Location	Mechanical Room (Primary)

With accessory cooling coil section.

Uniformat	Action Description	Quantity	Unit Cost	Plan Type	Priority	Year	Expenditure
D3051	Replace Furnace, Propane, 120 MBH	1 EA	\$7,337.55	BYL	Priority 3	2031	\$7,338

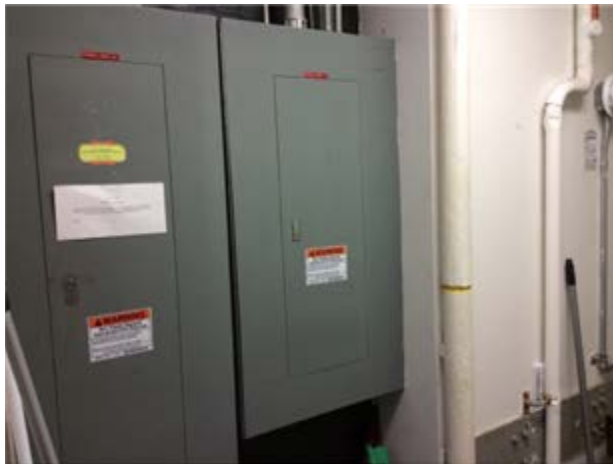
Coding / Field Name	Asset Description
D5012 Low Tension Service & Dist.	Power Panel Board, 208 Y, 120 V, 150 Amp, Right
Condition	Fair
Qty / UOM	1 / EA
Unit Cost	\$7,906.20
Basis of Costing	Power Panel Board, 208 Y, 120 V, 200 Amp
Year in Service	1982
Expected Useful Life (EUL)	30 Year(s), Based on Industry Averages
Remaining Useful Life (RUL)	5 Year(s), Estimated, Based on Date of Observation
Location	Utility Area
Service Size (Amperage)	150
Service Voltage	120/240
Service Voltage Type	Single-Phase Three-Wire Alternating Current (Ac)
Step Down Transformers	No
Electrical Distribution Panel Type	Circuit Breakers
Main Electrical Distribution Lines	Overhead
Site Electrical Transformer Location	Pad-Mounted
Electrical Wiring in Metal Conduit	Yes
Electrical Wiring in Non-Metal (NM) Conduit	No
Electrical Wiring in Non- Metal Sheathing (Romex)	No
Electrical Wiring in Metal Sheathing (BX)	Yes

Uniformat	Action Description	Quantity	Unit Cost	Plan Type	Priority	Year	Expenditure
D5012	Replace Power Panel Board, 208 Y, 120 V, 150 Amp, Right	1 EA	\$7,906.20	BYL	Priority 2	2022	\$7,906

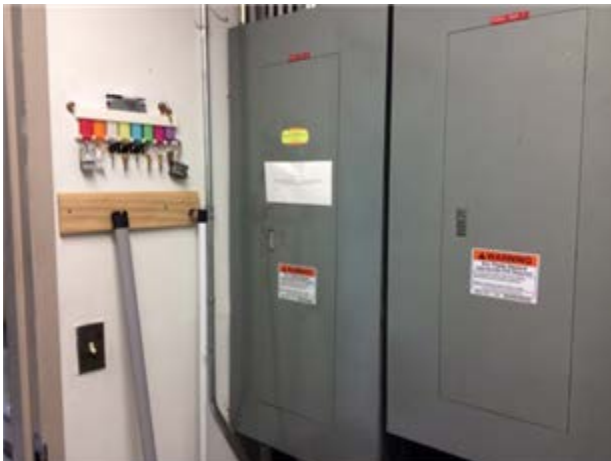
Coding / Field Name	Asset Description
D5012 Low Tension Service & Dist.	Power Panel Board, 208 Y, 120 V, 150 Amp, Left
Condition	Fair
Qty / UOM	1 / EA
Unit Cost	\$7,906.20
Basis of Costing	Power Panel Board, 208 Y, 120 V, 200 Amp
Year in Service	1982
Expected Useful Life (EUL)	30 Year(s), Based on Industry Averages
Remaining Useful Life (RUL)	5 Year(s), Estimated, Based on Date of Observation
Location	Utility Area
Service Size (Amperage)	150
Service Voltage	120/240
Service Voltage Type	Single-Phase Three-Wire Alternating Current (Ac)
Step Down Transformers	No
Electrical Distribution Panel Type	Circuit Breakers
Main Electrical Distribution Lines	Overhead
Site Electrical Transformer Location	Pad-Mounted
Electrical Wiring in Metal Conduit	Yes
Electrical Wiring in Non-Metal (NM) Conduit	No
Electrical Wiring in Non- Metal Sheathing (Romex)	No
Electrical Wiring in Metal Sheathing (BX)	Yes

Uniformat	Action Description	Quantity	Unit Cost	Plan Type	Priority	Year	Expenditure
D5012	Replace Power Panel Board, 208 Y, 120 V, 150 Amp, Left	1 EA	\$7,906.20	BYL	Priority 2	2022	\$7,906

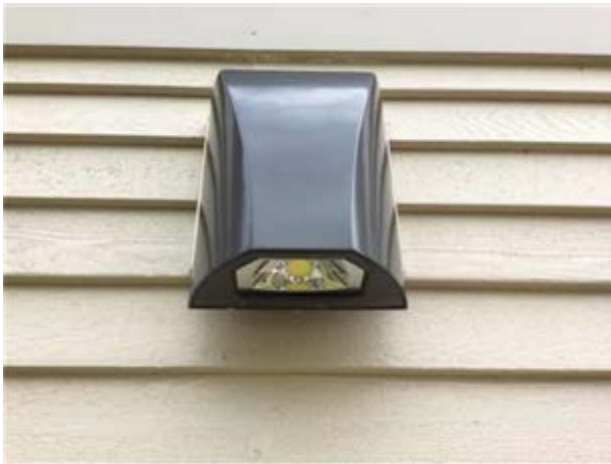
Coding / Field Name	Asset Description
D5022 Lighting Equipment	LED Lighting Fixture, Basic
Condition	Good
Qty / UOM	12 / EA
Unit Cost	\$180.19
Basis of Costing	LED Lighting Fixture, Basic, 20 W
Year in Service	2013
Expected Useful Life (EUL)	20 Year(s), Based on Industry Averages
Remaining Useful Life (RUL)	16 Year(s), Estimated, Based on Date of Observation
Location	Exterior Walls

Uniformat	Action Description	Quantity	Unit Cost	Plan Type	Priority	Year	Expenditure
D5022	Replace LED Lighting Fixture, Basic	12 EA	\$180.19	BYL	Priority 3	2033	\$2,162

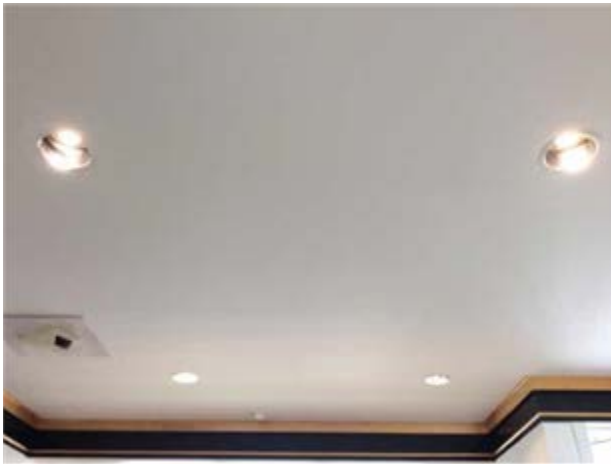
Coding / Field Name	Asset Description
D5029 Lighting Systems	Lighting System, Interior
Condition	Fair
Qty / UOM	2340 / SF
Unit Cost	\$9.24
Basis of Costing	Lighting System, Full Upgrade, Office (per SF)
Year in Service	1997
Expected Useful Life (EUL)	25 Year(s), Based on Industry Averages
Remaining Useful Life (RUL)	8 Year(s), Estimated, Based on Date of Observation
Location	Building Interior (General)

Uniformat	Action Description	Quantity	Unit Cost	Plan Type	Priority	Year	Expenditure
D5029	Replace Lighting System, Interior	2,340 SF	\$9.24	BYL	Priority 3	2025	\$21,622

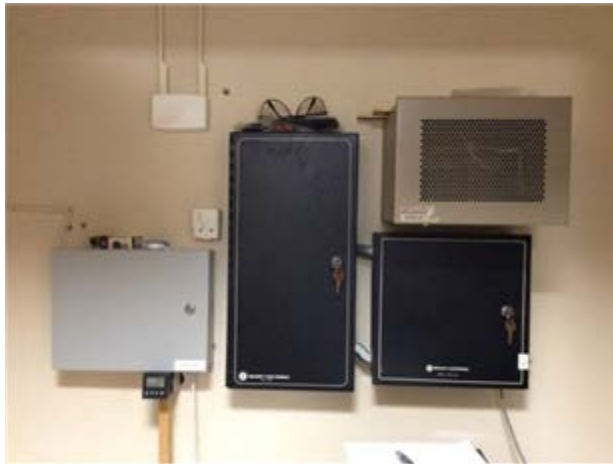
Coding / Field Name	Asset Description
D5039 Local Area Networks	Security System, Full Upgrade/Install, Cameras and CCTV (per SF)
Condition	Fair
Qty / UOM	2340 / SF
Unit Cost	\$4.35
Basis of Costing	Security System, Full Upgrade/Install, Cameras and CCTV (per SF)
Year in Service	2010
Expected Useful Life (EUL)	10 Year(s), Based on Industry Averages
Remaining Useful Life (RUL)	3 Year(s), Estimated, Based on Date of Observation
Location	Building Interior (General)

Uniformat	Action Description	Quantity	Unit Cost	Plan Type	Priority	Year	Expenditure
D5039	Replace Security System, Full Upgrade/Install, Cameras and CCTV (per SF)	2,340 SF	\$4.35	BYL	Priority 1	2020	\$10,172
D5039	Replace Security System, Full Upgrade/Install, Cameras and CCTV (per SF)	2,340 SF	\$4.35	BYL	Priority 1	2030	\$10,172

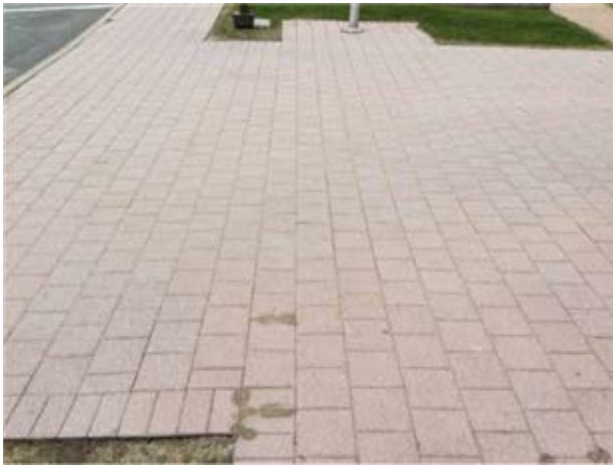
Coding / Field Name	Asset Description
G2031 Paving & Surfacing	Clay Brick/Masonry Paver Sidewalk, Exterior
Condition	Fair
Qty / UOM	4000 / SF
Unit Cost	\$34.11
Basis of Costing	Clay Brick/Masonry Paver Sidewalk, Exterior
Year in Service	1997
Expected Useful Life (EUL)	30 Year(s), Based on Industry Averages
Remaining Useful Life (RUL)	10 Year(s), Estimated, Based on Date of Observation
Location	Site

Uniformat	Action Description	Quantity	Unit Cost	Plan Type	Priority	Year	Expenditure
G2031	Replace Clay Brick/Masonry Paver Sidewalk, Exterior	4,000 SF	\$34.11	BYL	Priority 3	2027	\$136,435

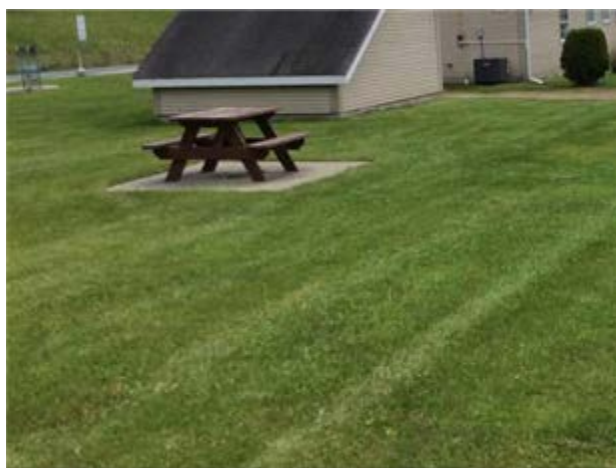
Coding / Field Name	Asset Description
G3030 Storm Sewer	Site Drainage
Condition	Fair
Qty / UOM	75000 /
Unit Cost	\$1.00
Year in Service	1983
Expected Useful Life (EUL)	50 Year(s), Based on Industry Averages
Remaining Useful Life (RUL)	25 Year(s), Estimated, Based on Date of Observation
Location	Site

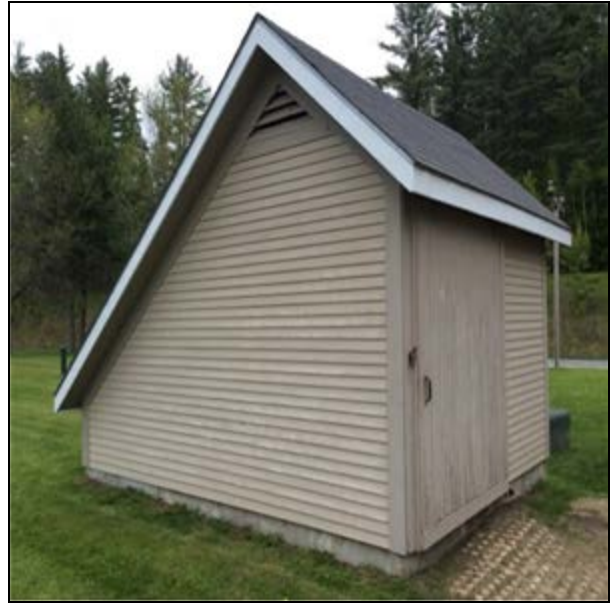
Shed

Paint is peeling and cracking

Uniformat	Action Description	Quantity	Unit Cost	Plan Type	Priority	Year	Expenditure
F1013	Prep & Paint Exterior Walls, up to 4-Story Building	1 EA	\$1,000.00	APP	Priority 3	2017	\$1,000
F1013	Prep & Paint Exterior Walls, up to 4-Story Building	1 EA	\$1,000.00	APP	Priority 3	2027	\$1,000
F1013	Replace Ancillary Structure, Shed, All Components	200 SF	\$125.19	BYL	Priority 4	2032	\$25,039

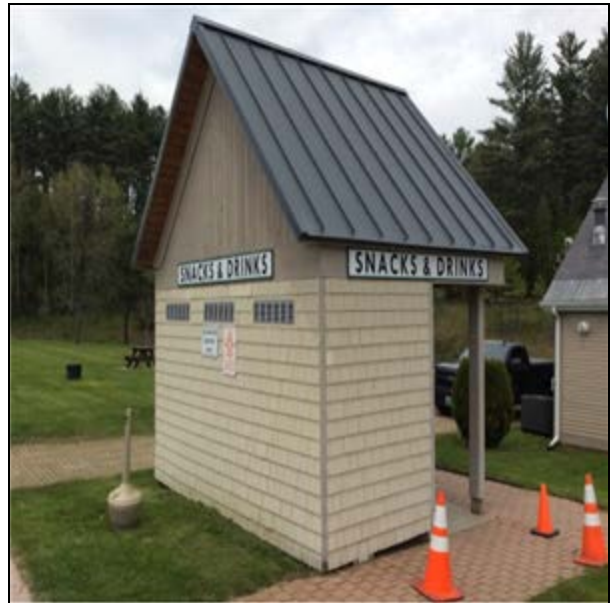
Vending Stand

Glazed doors and frames are rusting

Uniformat	Action Description	Quantity	Unit Cost	Plan Type	Priority	Year	Expenditure
F1013	Refinish/repair glazed doors/frames	1 EA	\$1,000.00	BYL	Priority 2	2018	\$1,000
F1013	Prep & Paint Exterior Walls, up to 4-Story Building	1 EA	\$1,000.00	BYL	Priority 3	2023	\$1,000
F1013	Replace Ancillary Structure, Vending Stand, All Components	250 SF	\$125.19	BYL	Priority 4	2027	\$31,298
F1013	Prep & Paint Exterior Walls, up to 4-Story Building	1 EA	\$1,000.00	BYL	Priority 3	2033	\$1,000
