FACILITY CONDITION ASSESSMENT

FACILITY CONDITION ASSESSMENT
OF
SHARON NORTH INFORMATION CENTER
I-89 NORTHBOUND MILE MARKER 10
SHARON, VT 05065

December 17, 2018

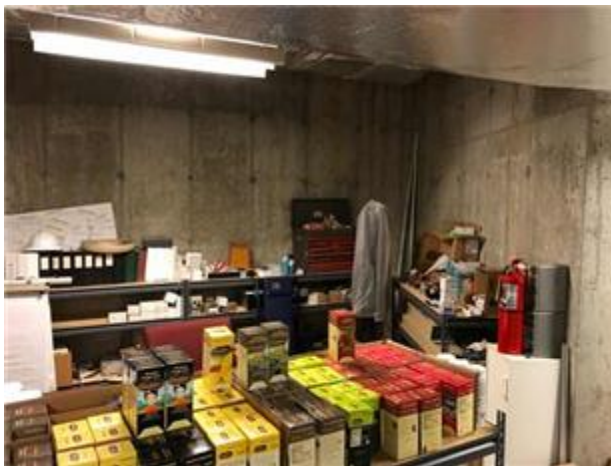
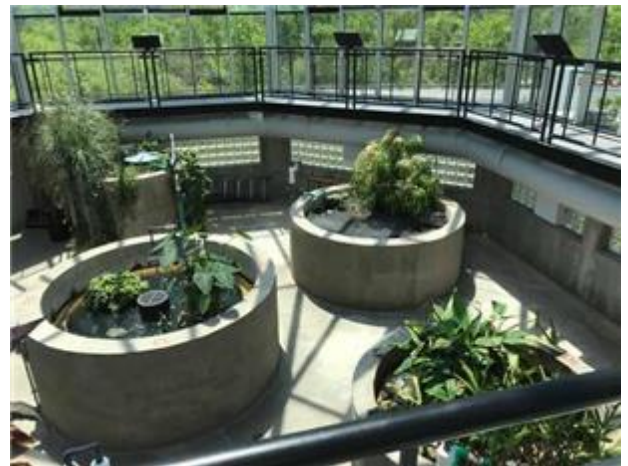
Coding / Field Name	Asset Description
A1011 Wall Foundations	Concrete Basement Wall
Condition	Good
Qty / UOM	320 / LF
Unit Cost	\$105.56
Basis of Costing	Foundation Wall, Concrete or CMU w/ Continuous Footings, 1-2 Stories
Year in Service	2005
Expected Useful Life (EUL)	50 Year(s), Based on Industry Averages
Remaining Useful Life (RUL)	37 Year(s), Estimated, Based on Date of Observation
Location	Structure

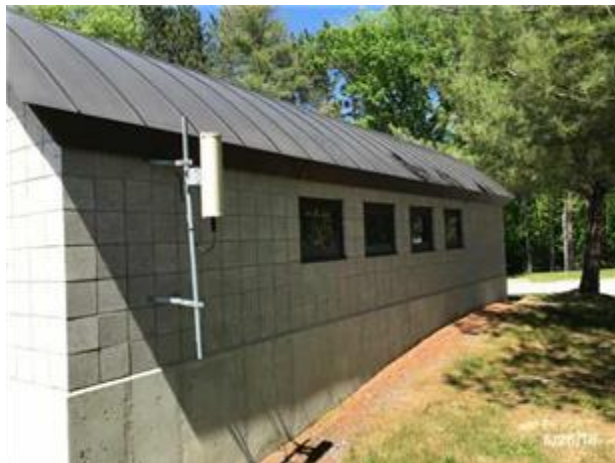
Coding / Field Name	Asset Description
A1011 Wall Foundations	Foundation Wall, Concrete w/ Continuous Footings
Condition	Good
Qty / UOM	100 / LF
Unit Cost	\$105.56
Basis of Costing	Foundation Wall, Concrete or CMU w/ Continuous Footings, 1-2 Stories
Year in Service	2005
Expected Useful Life (EUL)	50 Year(s), Based on Industry Averages
Remaining Useful Life (RUL)	37 Year(s), Estimated, Based on Date of Observation
Location	Storage Building
Foundation Type	Reinforced Concrete Spread Footing
Perimeter Drainage	Yes
Insulation	No

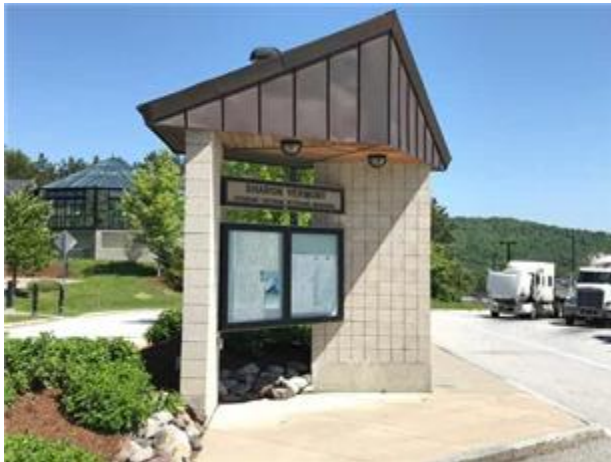
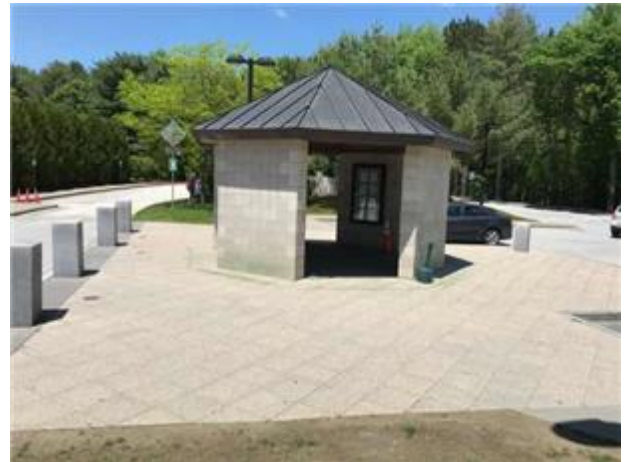
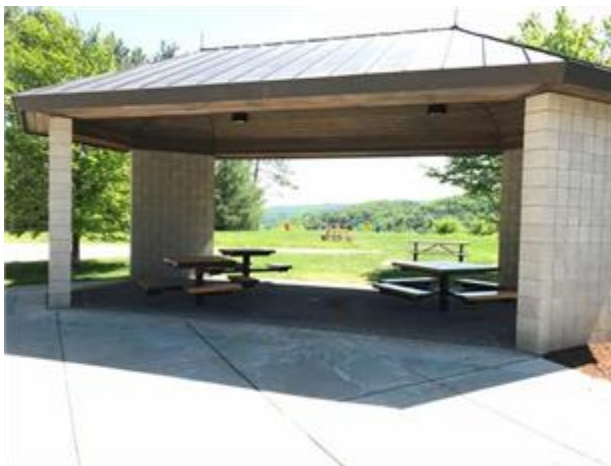
Coding / Field Name	Asset Description
A1032 Structural Slab on Grade	Foundations, Concrete Slab-on-Grade Structural w/ Integral Perimeter Footings
Condition	Good
Qty / UOM	540 / SF
Unit Cost	\$14.85
Basis of Costing	Foundations, Concrete Slab-on-Grade Structural w/ Integral Perimeter Footings
Year in Service	2005
Expected Useful Life (EUL)	60 Year(s), Based on Industry Averages
Remaining Useful Life (RUL)	47 Year(s), Estimated, Based on Date of Observation
Location	Kiosks, Picnic Shelter

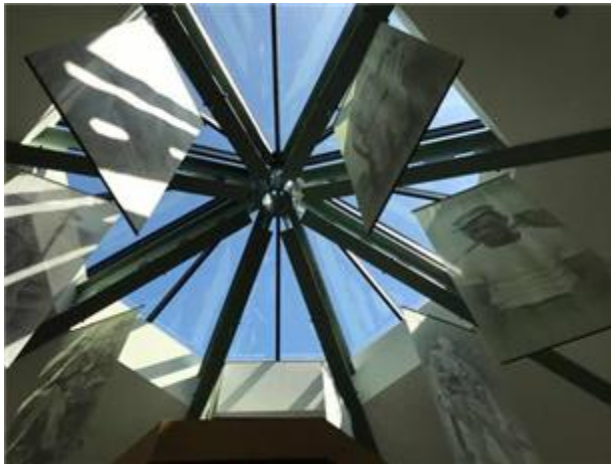
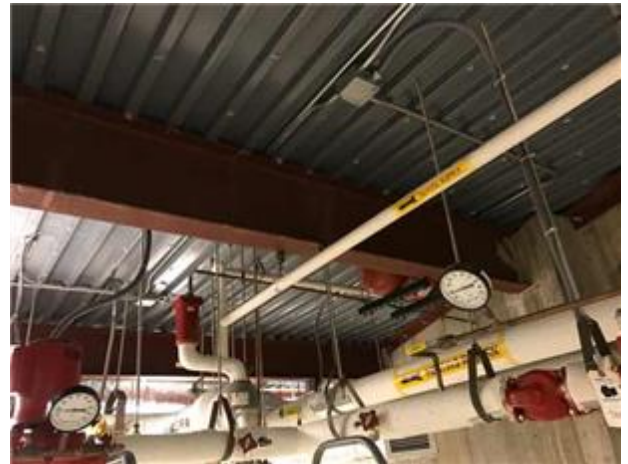
Coding / Field Name	Asset Description
B1012 Upper Floors Construction	Superstructure, Structural Frame, Steel Columns & Beams
Condition	Good
Qty / UOM	7732 / SF
Unit Cost	\$32.16
Basis of Costing	Superstructure, Structural Frame, Steel Columns & Beams, 1-2 Stories
Year in Service	2005
Expected Useful Life (EUL)	50 Year(s), Based on Industry Averages
Remaining Useful Life (RUL)	37 Year(s), Estimated, Based on Date of Observation
Location	Structure

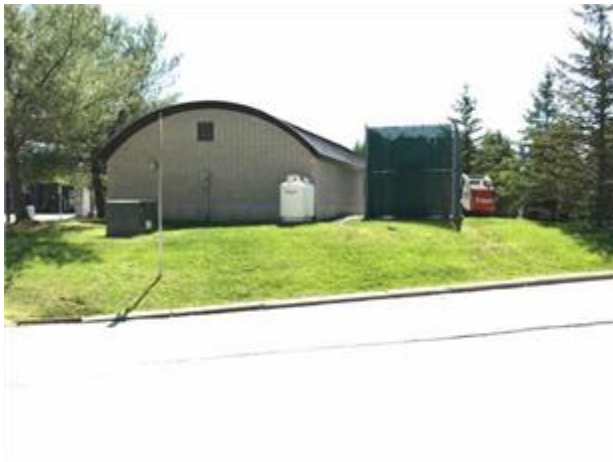
Coding / Field Name	Asset Description
B1022 Pitched Roof Construction	Roof Structure, Wood Trusses
Condition	Good
Qty / UOM	500 / SF
Unit Cost	\$18.56
Basis of Costing	Roof Structure, Pitched, Wood Trusses
Year in Service	2005
Expected Useful Life (EUL)	50 Year(s), Based on Industry Averages
Remaining Useful Life (RUL)	37 Year(s), Estimated, Based on Date of Observation
Location	Storage Building
Roofing Type	Barrel
Roof Access	None

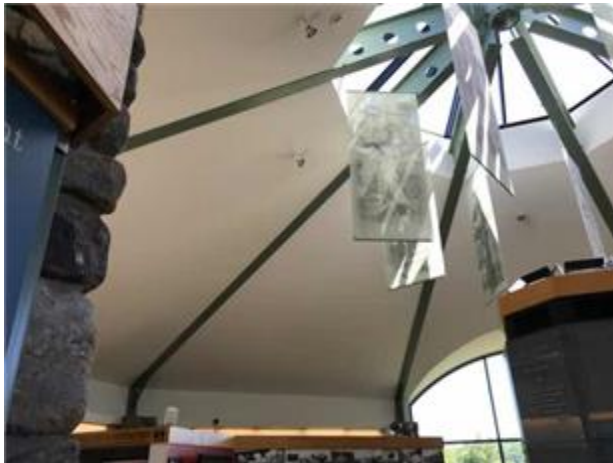
Coding / Field Name	Asset Description
B1022 Pitched Roof Construction	Roof Structure, Steel Framing
Condition	Good
Qty / UOM	3400 / SF
Unit Cost	\$27.84
Basis of Costing	Roof Structure, Pitched, Steel Framing
Year in Service	2005
Expected Useful Life (EUL)	50 Year(s), Based on Industry Averages
Remaining Useful Life (RUL)	37 Year(s), Estimated, Based on Date of Observation
Location	Structure
Roofing Type	Hexagonal
Attic	No
Roof Access	None

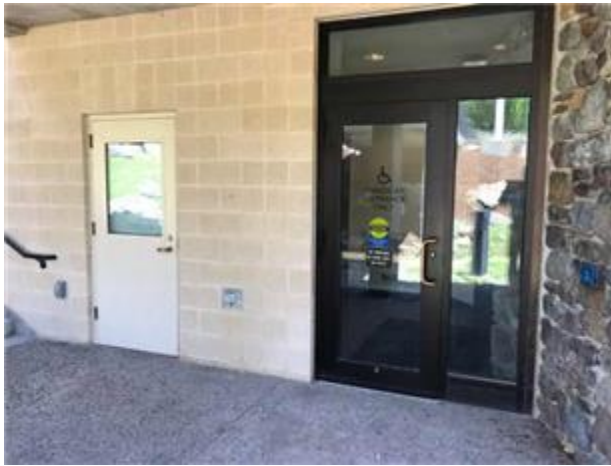
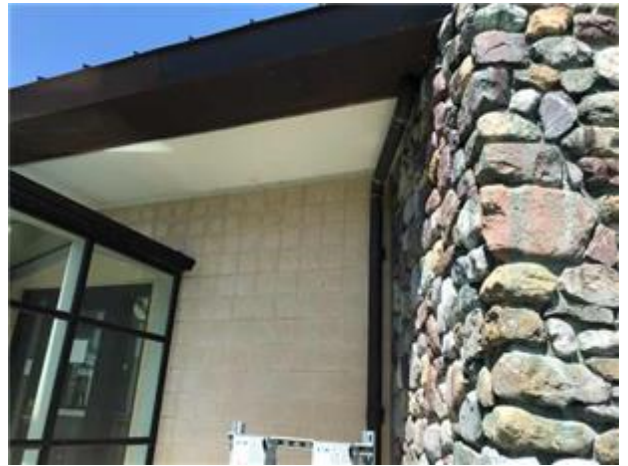
Coding / Field Name	Asset Description
B2011 Exterior Wall Construction	Concrete Block, Exterior
Condition	Fair
Qty / UOM	1200 / SF
Unit Cost	\$17.16
Basis of Costing	Concrete Block, Exterior, 1-2 Stories
Year in Service	2005
Expected Useful Life (EUL)	40 Year(s), Based on Industry Averages
Remaining Useful Life (RUL)	27 Year(s), Estimated, Based on Date of Observation
Location	Exterior Walls

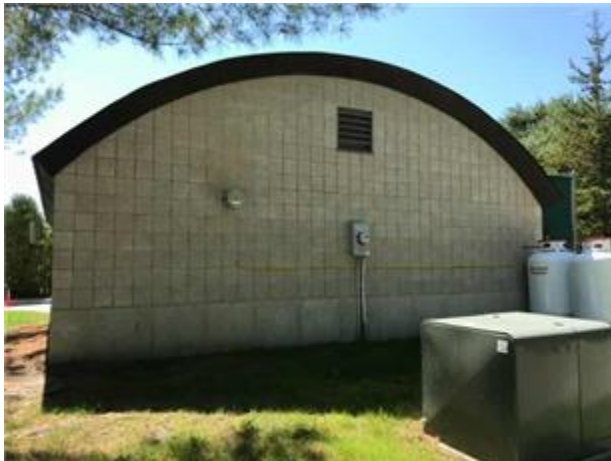
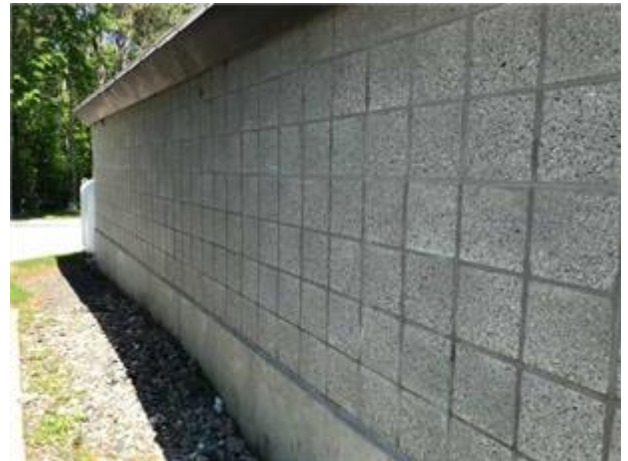
Coding / Field Name	Asset Description
B2011 Exterior Wall Construction	Concrete Block, Exterior
Condition	Fair
Qty / UOM	600 / SF
Unit Cost	\$17.16
Basis of Costing	Concrete Block, Exterior, 1-2 Stories
Year in Service	2005
Expected Useful Life (EUL)	40 Year(s), Based on Industry Averages
Remaining Useful Life (RUL)	27 Year(s), Estimated, Based on Date of Observation
Location	Storage Building
Exterior Wall Construction	Concrete Block Masonry

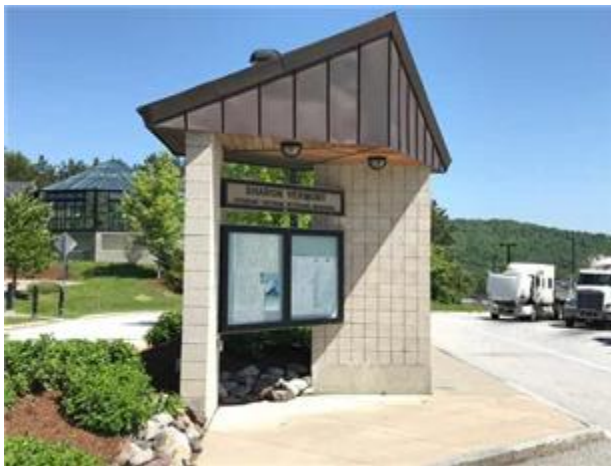
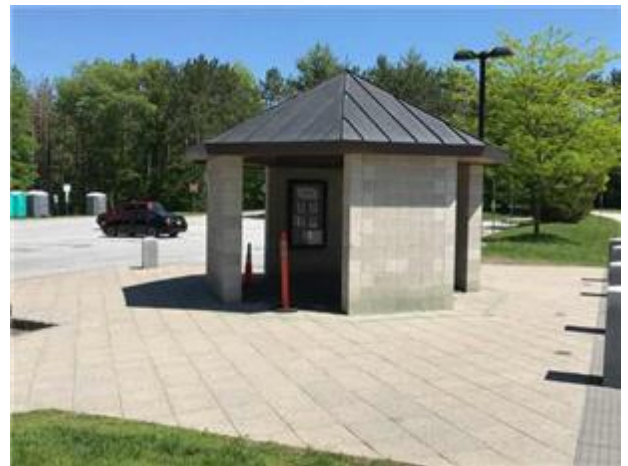
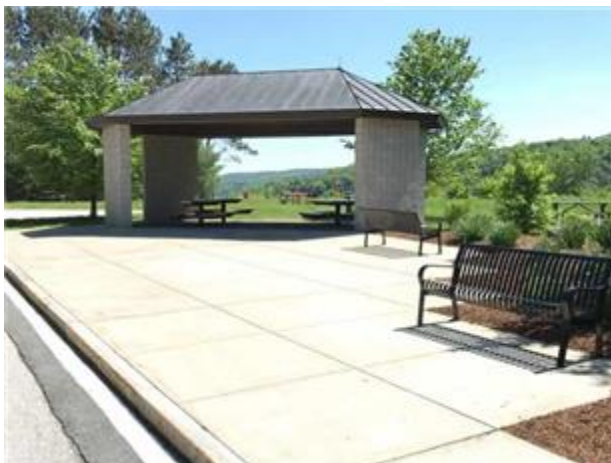
Coding / Field Name	Asset Description
B2011 Exterior Wall Construction	Concrete Block, Exterior
Condition	Fair
Qty / UOM	500 / SF
Unit Cost	\$17.16
Basis of Costing	Concrete Block, Exterior, 1-2 Stories
Year in Service	2005
Expected Useful Life (EUL)	40 Year(s), Based on Industry Averages
Remaining Useful Life (RUL)	27 Year(s), Estimated, Based on Date of Observation
Location	Kiosks, Picnic Shelter

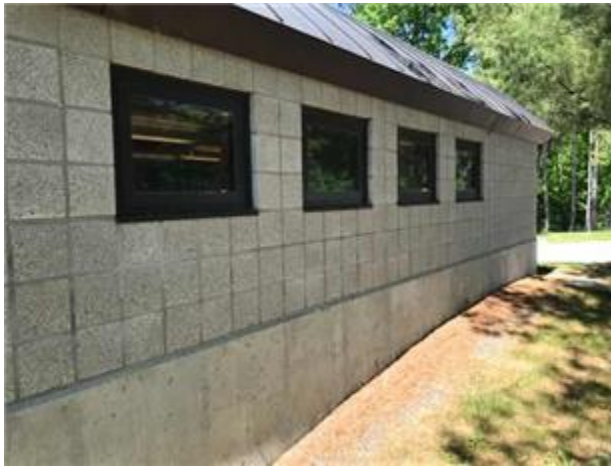
Coding / Field Name	Asset Description
B2021 Windows	Aluminum Window, Double Glazed
Condition	Fair
Qty / UOM	4 / EA
Unit Cost	\$1,051.57
Basis of Costing	Aluminum Window, Double Glazed, 1-2 Stories, 12 SF
Year in Service	2005
Expected Useful Life (EUL)	30 Year(s), Based on Industry Averages
Remaining Useful Life (RUL)	17 Year(s), Estimated, Based on Date of Observation
Location	Storage Building
Window Type	Fixed
Windows Material	Aluminum
Windows Glazing	Double Glazed
Window Operation	Fixed

Unifomat	Action Description	Quantity	Unit Cost	Plan Type	Priority	Year	Expenditure
B2021	Replace Aluminum Window, Double Glazed	4 EA	\$1,051.57	BYL	Priority 3	2035	\$4,206

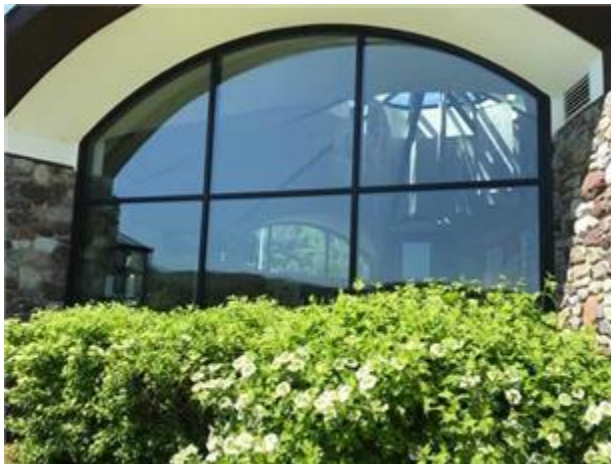
Coding / Field Name	Asset Description
B2022 Curtain Walls	Storefront Glass Wall
Condition	Fair
Qty / UOM	400 / SF
Unit Cost	\$87.21
Basis of Costing	Glass Curtain Wall
Year in Service	2005
Expected Useful Life (EUL)	30 Year(s), Based on Industry Averages
Remaining Useful Life (RUL)	17 Year(s), Estimated, Based on Date of Observation
Location	Exterior Walls
Window Type	Fixed
Windows Material	Aluminum

Unifomat	Action Description	Quantity	Unit Cost	Plan Type	Priority	Year	Expenditure
B2022	Replace Storefront Glass Wall	400 SF	\$87.21	BYL	Priority 3	2035	\$34,884

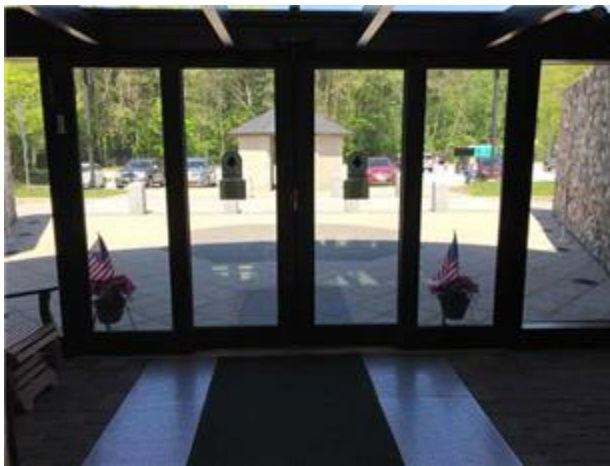
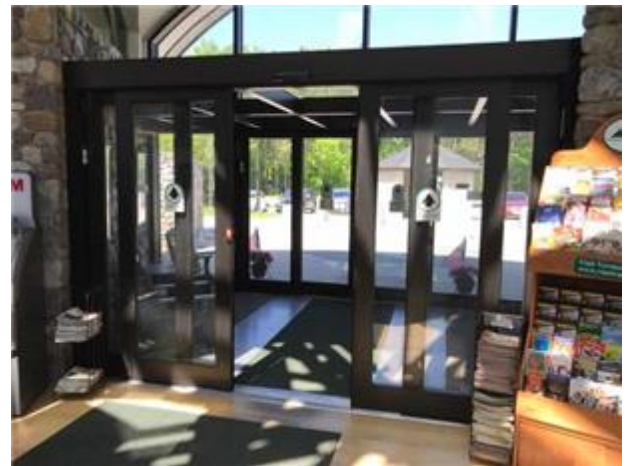
Coding / Field Name	Asset Description
B2031 Glazed Doors & Entrances	Aluminum Frame, Fully Glazed, Sliding Exterior Door
Condition	Fair
Qty / UOM	4 / EA
Unit Cost	\$2,334.31
Basis of Costing	Aluminum/Vinyl Frame, Fully Glazed, Sliding Exterior Door
Year in Service	2005
Expected Useful Life (EUL)	25 Year(s), Based on Industry Averages
Remaining Useful Life (RUL)	12 Year(s), Estimated, Based on Date of Observation
Location	Exterior Walls

Uniformat	Action Description	Quantity	Unit Cost	Plan Type	Priority	Year	Expenditure
B2031	Replace Aluminum Frame, Fully Glazed, Sliding Exterior Door	4 EA	\$2,334.31	BYL	Priority 3	2030	\$9,337

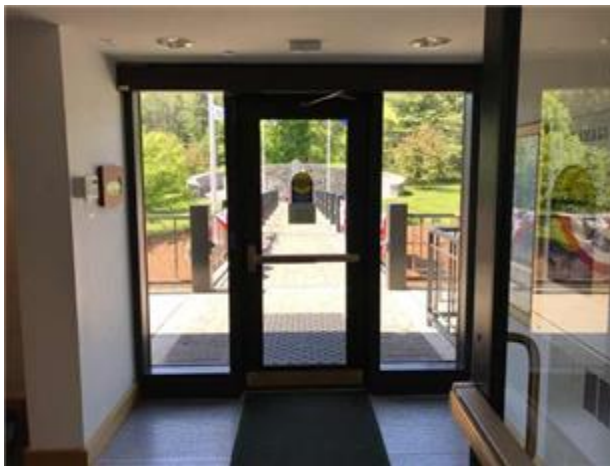
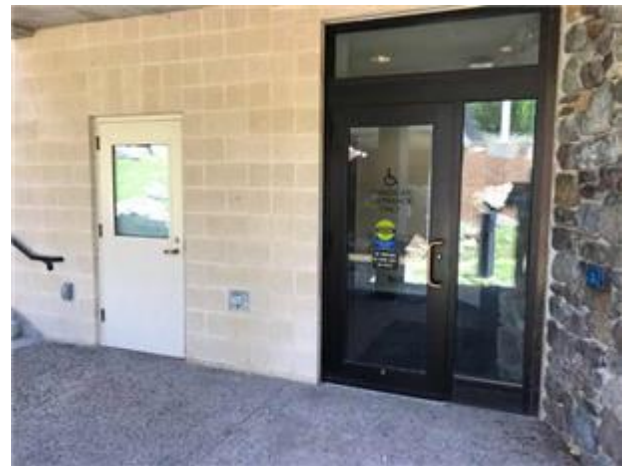
Coding / Field Name	Asset Description
B2031 Glazed Doors & Entrances	Aluminum Frame, Fully Glazed, Exterior Door
Condition	Fair
Qty / UOM	3 / EA
Unit Cost	\$1,368.37
Basis of Costing	Aluminum Frame, Fully Glazed, Exterior Door
Year in Service	2005
Expected Useful Life (EUL)	30 Year(s), Based on Industry Averages
Remaining Useful Life (RUL)	17 Year(s), Estimated, Based on Date of Observation
Location	Exterior Walls

Uniformat	Action Description	Quantity	Unit Cost	Plan Type	Priority	Year	Expenditure
B2031	Replace Aluminum Frame, Fully Glazed, Exterior Door	3 EA	\$1,368.37	BYL	Priority 3	2035	\$4,105

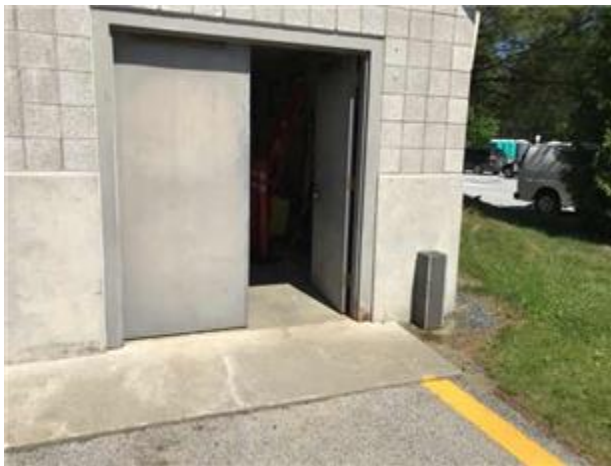
Coding / Field Name	Asset Description
B2032 Solid Exterior Doors	Steel, Exterior Double Door
Condition	Fair
Qty / UOM	1 / EA
Unit Cost	\$2,154.43
Basis of Costing	Steel, Exterior Double Door
Year in Service	2005
Expected Useful Life (EUL)	25 Year(s), Based on Industry Averages
Remaining Useful Life (RUL)	12 Year(s), Estimated, Based on Date of Observation
Location	Storage Building

Uniformat	Action Description	Quantity	Unit Cost	Plan Type	Priority	Year	Expenditure
B2032	Replace Steel, Exterior Double Door	1 EA	\$2,154.43	BYL	Priority 3	2030	\$2,154

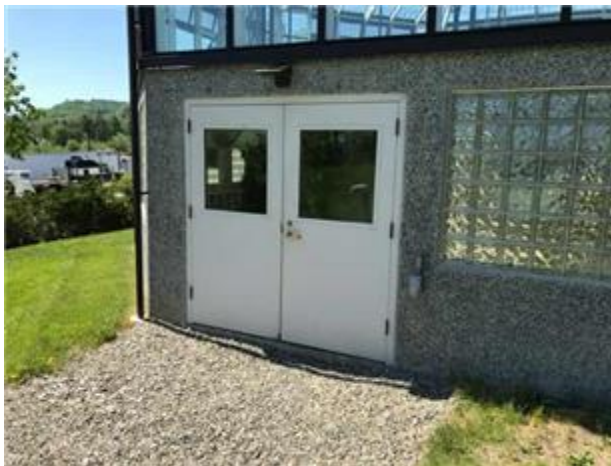
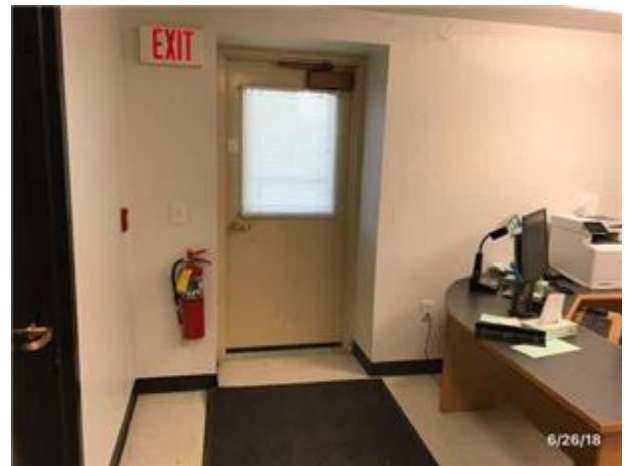
Coding / Field Name	Asset Description
B2032 Solid Exterior Doors	Steel w/ Safety Glass, Exterior Door
Condition	Fair
Qty / UOM	3 / EA
Unit Cost	\$1,352.72
Basis of Costing	Steel w/ Safety Glass, Exterior Door
Year in Service	2005
Expected Useful Life (EUL)	25 Year(s), Based on Industry Averages
Remaining Useful Life (RUL)	12 Year(s), Estimated, Based on Date of Observation
Location	Exterior Walls
Door Hardware	Lever
Door Operation	Manual
Core Type	Solid Core
Door Frame	Metal Framed

Unifomat	Action Description	Quantity	Unit Cost	Plan Type	Priority	Year	Expenditure
B2032	Replace Steel w/ Safety Glass, Exterior Door	3 EA	\$1,352.72	BYL	Priority 3	2030	\$4,058

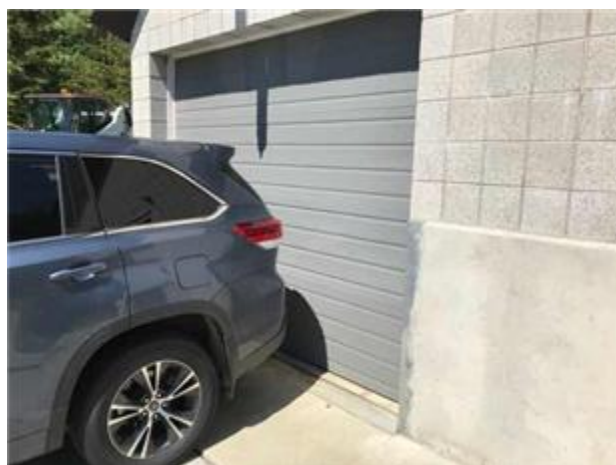
Coding / Field Name	Asset Description
B2034 Overhead Doors	Steel, Residential Garage Door
Condition	Fair
Qty / UOM	1 / EA
Unit Cost	\$865.50
Basis of Costing	Steel, Residential Garage Door, 56 SF
Year in Service	2005
Expected Useful Life (EUL)	35 Year(s), Based on Industry Averages
Remaining Useful Life (RUL)	22 Year(s), Estimated, Based on Date of Observation
Location	Storage Building

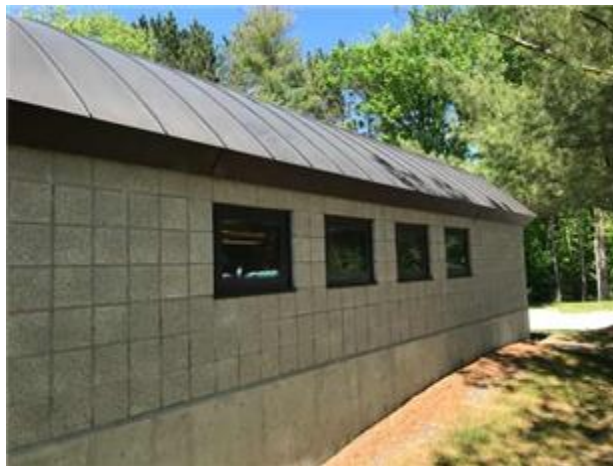
Coding / Field Name	Asset Description
B3011 Roof Finishes	Metal Roof
Condition	Fair
Qty / UOM	500 / SF
Unit Cost	\$32.41
Basis of Costing	Metal Roof (Includes Tear-Off of Old)
Year in Service	2005
Expected Useful Life (EUL)	40 Year(s), Based on Industry Averages
Remaining Useful Life (RUL)	27 Year(s), Estimated, Based on Date of Observation
Location	Storage Building
Flashings and Trim	Metal
Roof Eaves and Soffits	Yes
Roof Drainage	Drains Over The Eaves
Roof Warranty	Unknown

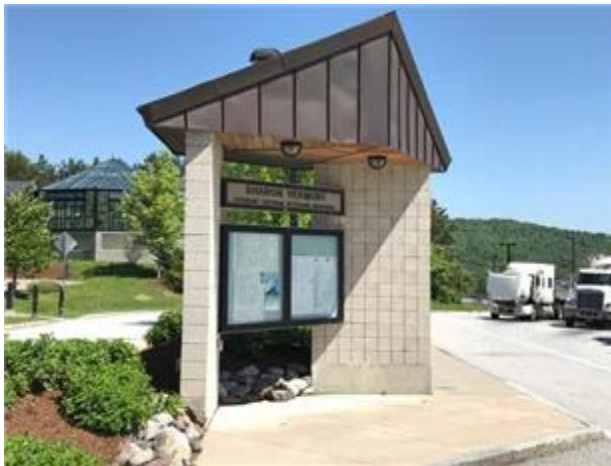
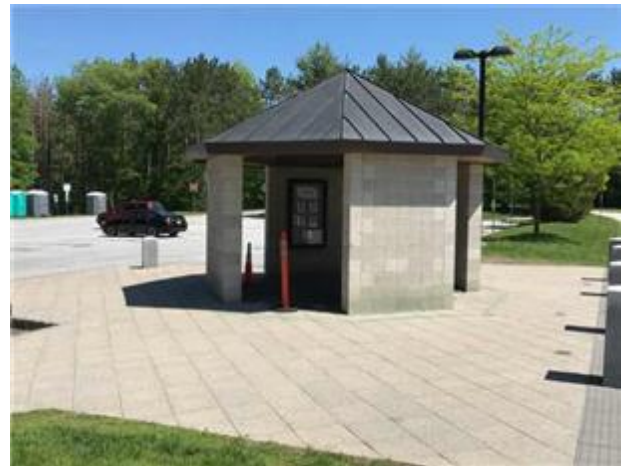
Coding / Field Name	Asset Description
B3011 Roof Finishes	Metal Roof
Condition	Fair
Qty / UOM	500 / SF
Unit Cost	\$32.41
Basis of Costing	Metal Roof (Includes Tear-Off of Old)
Year in Service	2005
Expected Useful Life (EUL)	40 Year(s), Based on Industry Averages
Remaining Useful Life (RUL)	27 Year(s), Estimated, Based on Date of Observation
Location	Kiosks, Picnic Shelter
Insulation	None
Flashings and Trim	Metal
Roof Eaves and Soffits	Yes
Roof Drainage	Drains Over The Eaves
Roof Warranty	Unknown

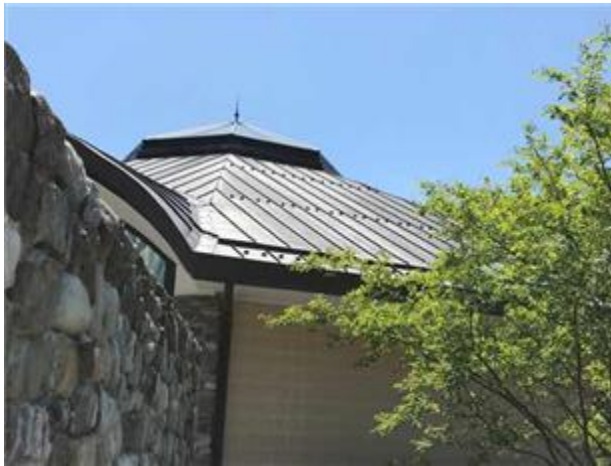
Coding / Field Name	Asset Description
B3011 Roof Finishes	Metal Roof
Condition	Fair
Qty / UOM	2900 / SF
Unit Cost	\$32.41
Basis of Costing	Metal Roof (Includes Tear-Off of Old)
Year in Service	2005
Expected Useful Life (EUL)	40 Year(s), Based on Industry Averages
Remaining Useful Life (RUL)	27 Year(s), Estimated, Based on Date of Observation
Location	Roof
Flashings and Trim	Metal
Roof Eaves and Soffits	Yes
Roof Drainage	Metal Gutter And Down Spouts
Roof Warranty	Unknown

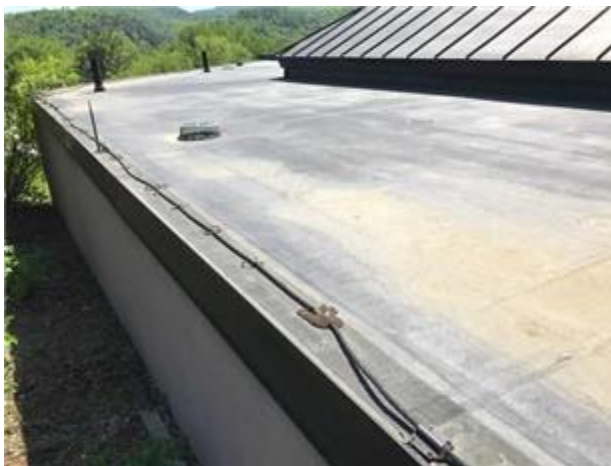
Coding / Field Name	Asset Description
B3011 Roof Finishes	Single-Ply EPDM Membrane Roof
Condition	Fair
Qty / UOM	420 / SF
Unit Cost	\$28.94
Basis of Costing	Single-Ply EPDM Membrane Roof (Includes Tear-Off of Old)
Year in Service	2005
Expected Useful Life (EUL)	20 Year(s), Based on Industry Averages
Remaining Useful Life (RUL)	7 Year(s), Estimated, Based on Date of Observation
Location	Roof
Insulation	Rigid
Flashings and Trim	Metal
Roof Eaves and Soffits	No
Roof Drainage	Internal Building Piping
Roof Warranty	Unknown

Unifomat	Action Description	Quantity	Unit Cost	Plan Type	Priority	Year	Expenditure
B3011	Replace Single-Ply EPDM Membrane Roof	420 SF	\$28.94	BYL	Priority 3	2025	\$12,155

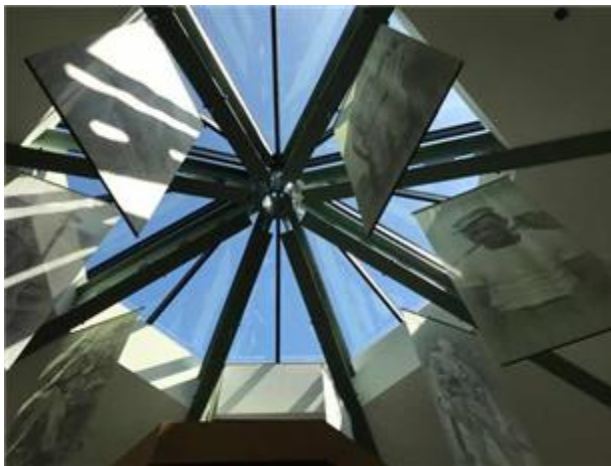
Coding / Field Name	Asset Description
B3021 Glazed Roof Openings	Single Unit Glass Skylight
Condition	Fair
Qty / UOM	320 / SF
Unit Cost	\$83.82
Basis of Costing	Single Unit Glass Skylight
Year in Service	2005
Expected Useful Life (EUL)	30 Year(s), Based on Industry Averages
Remaining Useful Life (RUL)	17 Year(s), Estimated, Based on Date of Observation
Location	Roof

Uniformat	Action Description	Quantity	Unit Cost	Plan Type	Priority	Year	Expenditure
B3021	Replace Single Unit Glass Skylight	320 SF	\$83.82	BYL	Priority 3	2035	\$26,822

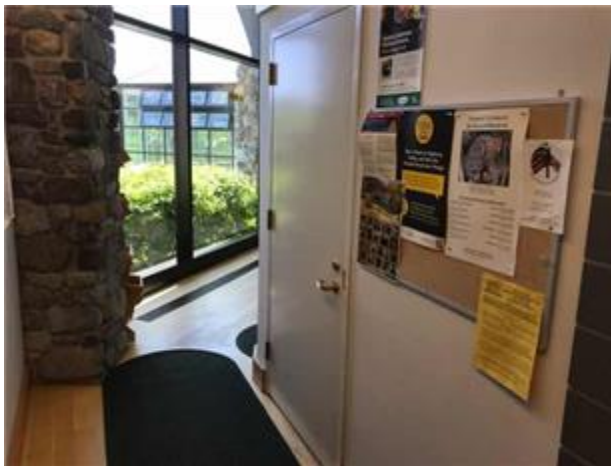
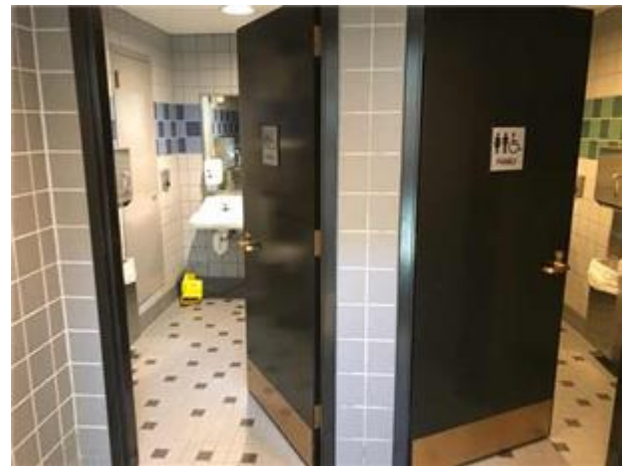
Coding / Field Name	Asset Description
C1021 Interior Doors	Wood, Solid Core, Painted/Stained, Interior Door
Condition	Fair
Qty / UOM	12 / EA
Unit Cost	\$1,423.11
Basis of Costing	Wood, Solid Core, Painted/Stained, Interior Door
Year in Service	2005
Expected Useful Life (EUL)	20 Year(s), Based on Industry Averages
Remaining Useful Life (RUL)	7 Year(s), Estimated, Based on Date of Observation
Location	Building Interior (General)

Uniformat	Action Description	Quantity	Unit Cost	Plan Type	Priority	Year	Expenditure
C1021	Replace Wood, Solid Core, Painted/Stained, Interior Door	12 EA	\$1,423.11	BYL	Priority 3	2025	\$17,077

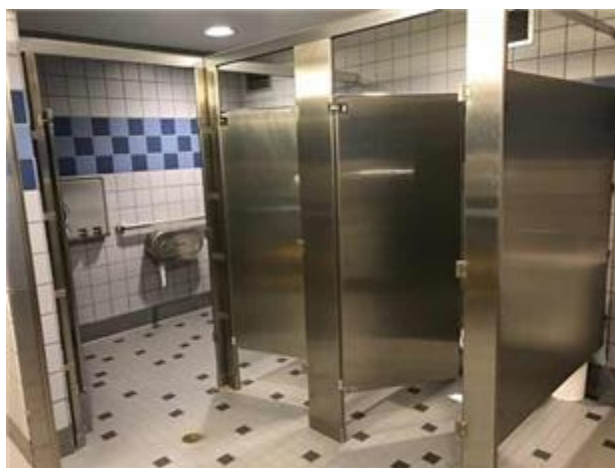
Coding / Field Name	Asset Description
C1031 Fabricated Toilet Partitions	Toilet Partitions, Metal
Condition	Fair
Qty / UOM	8 / EA
Unit Cost	\$850.00
Basis of Costing	Toilet Partitions, Metal, Overhead Braced
Year in Service	2005
Expected Useful Life (EUL)	20 Year(s), Based on Industry Averages
Remaining Useful Life (RUL)	7 Year(s), Estimated, Based on Date of Observation
Location	Restrooms

Uniformat	Action Description	Quantity	Unit Cost	Plan Type	Priority	Year	Expenditure
C1031	Replace Toilet Partitions, Metal	8 EA	\$850.00	BYL	Priority 3	2025	\$6,800

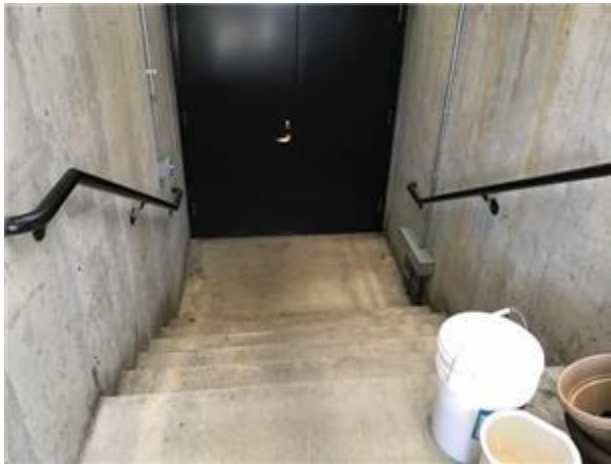
Coding / Field Name	Asset Description
C2011 Regular Stairs	Concrete, Interior Stairs
Condition	Good
Qty / UOM	25 / SF
Unit Cost	\$44.14
Basis of Costing	Concrete, Interior Stairs
Year in Service	2005
Expected Useful Life (EUL)	50 Year(s), Based on Industry Averages
Remaining Useful Life (RUL)	37 Year(s), Estimated, Based on Date of Observation
Location	Treatment Room

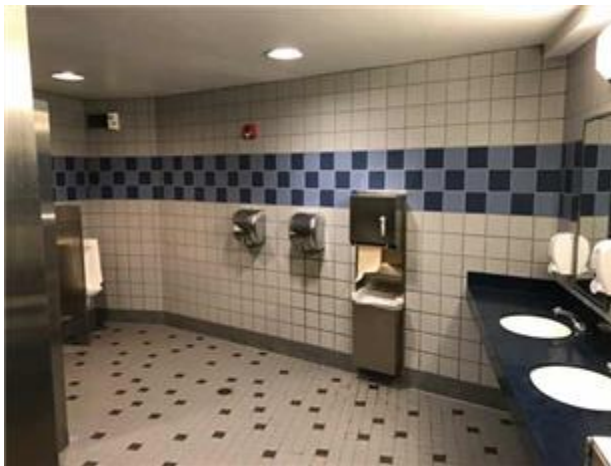
Coding / Field Name	Asset Description
C3012 Wall Finishes to Interior Walls	Ceramic Tile, Interior Wall Finish
Condition	Good
Qty / UOM	1250 / SF
Unit Cost	\$16.55
Basis of Costing	Ceramic Tile, Interior Wall Finish
Year in Service	2005
Expected Useful Life (EUL)	25 Year(s), Based on Industry Averages
Remaining Useful Life (RUL)	18 Year(s), Estimated, Based on Date of Observation
Location	Restrooms

Uniformat	Action Description	Quantity	Unit Cost	Plan Type	Priority	Year	Expenditure
C3012	Replace Ceramic Tile, Interior Wall Finish	1,250 SF	\$16.55	BYL	Priority 4	2036	\$20,693

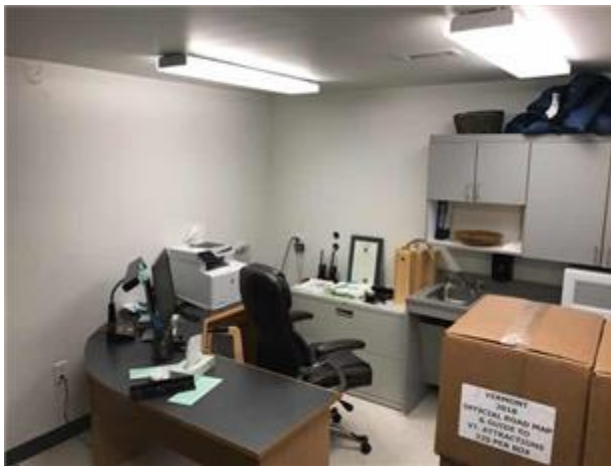
Coding / Field Name	Asset Description
C3012 Wall Finishes to Interior Walls	Gypsum Board, Wall
Condition	Fair
Qty / UOM	1200 / SF
Unit Cost	\$3.38
Basis of Costing	Gypsum Board/Plaster, Interior Wall
Year in Service	2005
Expected Useful Life (EUL)	40 Year(s), Based on Industry Averages
Remaining Useful Life (RUL)	27 Year(s), Estimated, Based on Date of Observation
Location	Building Interior (General)

Uniformat	Action Description	Quantity	Unit Cost	Plan Type	Priority	Year	Expenditure
C3012	Paint Interior Walls	1,200 SF	\$1.42	APP	Priority 4	2020	\$1,704
C3012	Paint Interior Walls	1,200 SF	\$1.42	APP	Priority 4	2028	\$1,704
C3012	Paint Interior Walls	1,200 SF	\$1.42	APP	Priority 4	2036	\$1,704

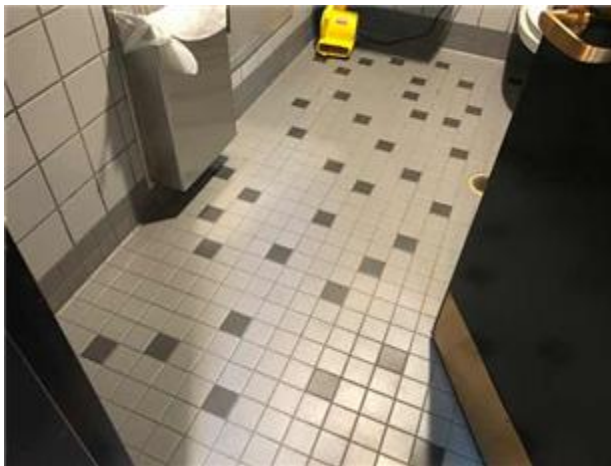
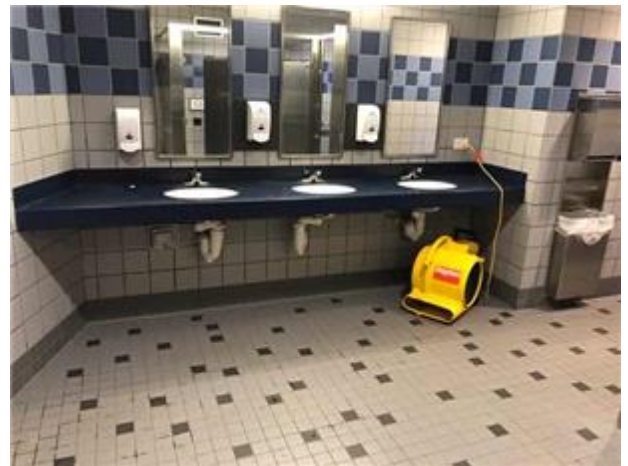
Coding / Field Name	Asset Description
C3024 Flooring	Ceramic Tile Flooring
Condition	Good
Qty / UOM	850 / SF
Unit Cost	\$15.75
Basis of Costing	Ceramic Tile Flooring
Year in Service	2005
Expected Useful Life (EUL)	50 Year(s), Based on Industry Averages
Remaining Useful Life (RUL)	37 Year(s), Estimated, Based on Date of Observation
Location	Restrooms

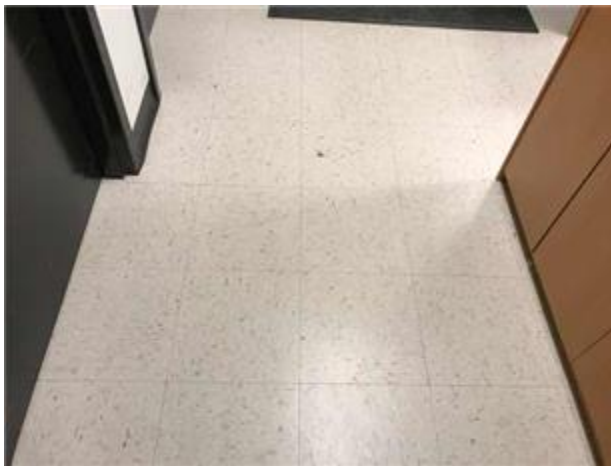
Coding / Field Name	Asset Description
C3024 Flooring	Vinyl Tile Flooring
Condition	Fair
Qty / UOM	250 / SF
Unit Cost	\$4.80
Basis of Costing	Vinyl Tile Flooring
Year in Service	2005
Expected Useful Life (EUL)	15 Year(s), Based on Industry Averages
Remaining Useful Life (RUL)	6 Year(s), Estimated, Based on Date of Observation
Location	Basement

Uniformat	Action Description	Quantity	Unit Cost	Plan Type	Priority	Year	Expenditure
C3024	Replace Vinyl Tile Flooring	250 SF	\$4.80	BYL	Priority 3	2024	\$1,200

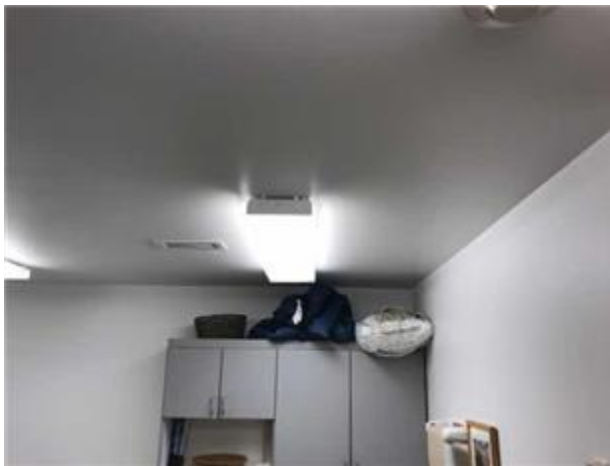
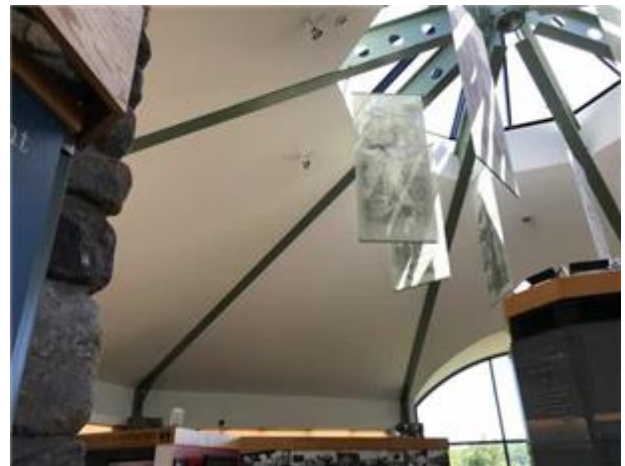
Coding / Field Name	Asset Description
C3031 Ceiling Finishes	Gypsum Board, Ceiling
Condition	Good
Qty / UOM	3500 / SF
Unit Cost	\$7.13
Basis of Costing	Gypsum Board/Plaster, Ceiling
Year in Service	2005
Expected Useful Life (EUL)	50 Year(s), Based on Industry Averages
Remaining Useful Life (RUL)	37 Year(s), Estimated, Based on Date of Observation
Location	Building Interior (General)

Uniformat	Action Description	Quantity	Unit Cost	Plan Type	Priority	Year	Expenditure
C3031	Paint Interior Ceilings	3,500 SF	\$1.24	APP	Priority 4	2020	\$4,340
C3031	Paint Interior Ceilings	3,500 SF	\$1.24	APP	Priority 4	2030	\$4,340

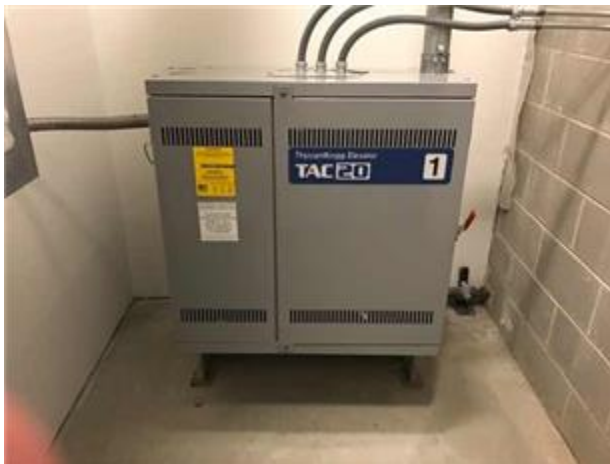
Coding / Field Name	Asset Description
D1011 Passenger Elevators	Elevator Controls, Automatic
Condition	Fair
Qty / UOM	1 / EA
Unit Cost	\$11,547.25
Basis of Costing	Elevator Controls, Automatic, 2 Car Cluster
Year in Service	2005
Expected Useful Life (EUL)	20 Year(s), Based on Industry Averages
Remaining Useful Life (RUL)	7 Year(s), Estimated, Based on Date of Observation
Location	Basement
Elevator Style	Passenger
Elevator Type	Hydraulic
Machinery Location	Room Adjacent To The Shaft
Elevator Cab Finishes	Plastic-Laminated Wood
Elevator Doors	Electronic Safety Stops
Elevator Light Fixtures	Recessed Ceiling
Certificate of Inspection Location	Elevator Cab
Certificate of Inspection Expired	No

Uniformat	Action Description	Quantity	Unit Cost	Plan Type	Priority	Year	Expenditure
D1011	Replace Elevator Controls, Automatic	1 EA	\$11,547.25	BYL	Priority 3	2025	\$11,547

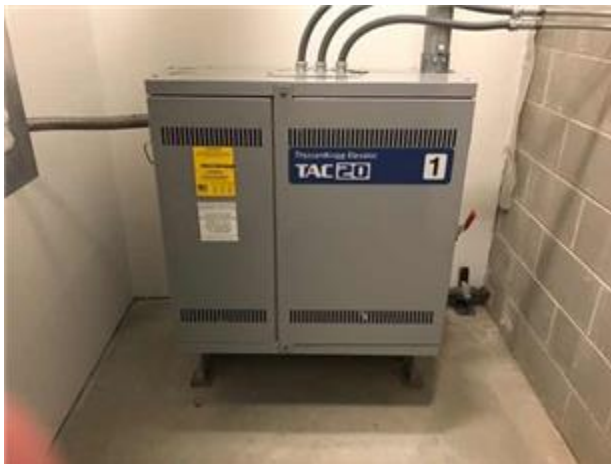
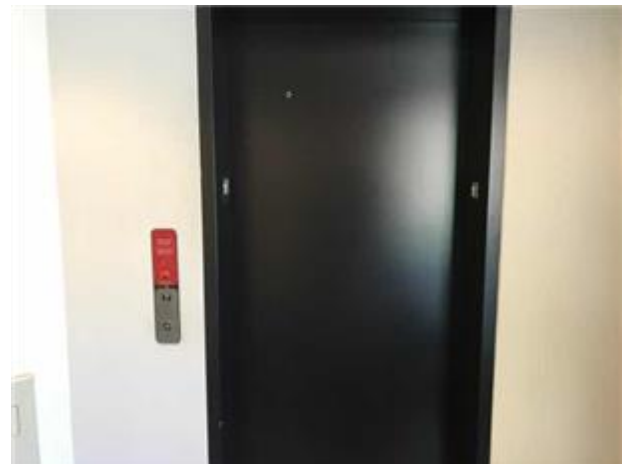
Coding / Field Name	Asset Description
D1011 Passenger Elevators	Elevator Equipment
Condition	Fair
Qty / UOM	1 / EA
Unit Cost	\$108,794.40
Basis of Costing	Elevator, Hydraulic, 1500 to 2500 LB, 2 Floors
Year in Service	2005
Expected Useful Life (EUL)	30 Year(s), Based on Industry Averages
Remaining Useful Life (RUL)	17 Year(s), Estimated, Based on Date of Observation
Location	Basement
Elevator Style	Passenger
Elevator Type	Hydraulic
Machinery Location	Room Adjacent To The Shaft
Elevator Cab Finishes	Plastic-Laminated Wood
Elevator Doors	Electronic Safety Stops
Elevator Light Fixtures	Recessed Ceiling
Certificate of Inspection Location	Elevator Cab
Certificate of Inspection Expired	No

Unifomat	Action Description	Quantity	Unit Cost	Plan Type	Priority	Year	Expenditure
D1011	Remove & Replace Elevator Cab Finishes	1 EA	\$2,000.00	APP	Priority 3	2020	\$2,000
D1011	Remove & Replace Elevator Cab Finishes	1 EA	\$2,000.00	APP	Priority 3	2030	\$2,000
D1011	Replace Elevator Equipment	1 EA	\$108,794.40	BYL	Priority 3	2035	\$108,794

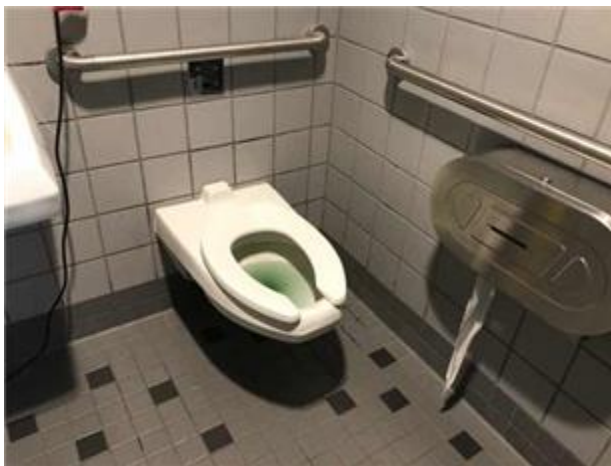
Coding / Field Name	Asset Description
D2011 Water Closets	Toilets (Water Closets)
Condition	Fair
Qty / UOM	10 / EA
Unit Cost	\$842.97
Basis of Costing	Tankless Water Closet
Year in Service	2005
Expected Useful Life (EUL)	20 Year(s), Based on Industry Averages
Remaining Useful Life (RUL)	7 Year(s), Estimated, Based on Date of Observation
Location	Restrooms
Low Flow Toilet	Yes
System Grade	Commercial Grade

Unifomat	Action Description	Quantity	Unit Cost	Plan Type	Priority	Year	Expenditure
D2011	Replace Toilets (Water Closets)	10 EA	\$842.97	BYL	Priority 3	2025	\$8,430

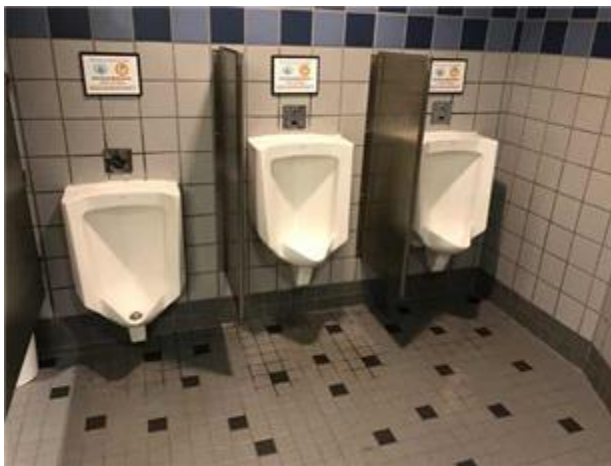
Coding / Field Name	Asset Description
D2012 Urinals	Urinals
Condition	Fair
Qty / UOM	3 / EA
Unit Cost	\$1,193.44
Basis of Costing	Urinal, Vitreous China
Year in Service	2005
Expected Useful Life (EUL)	20 Year(s), Based on Industry Averages
Remaining Useful Life (RUL)	7 Year(s), Estimated, Based on Date of Observation
Location	Restrooms
Low Flow Toilet	Yes
System Grade	Commercial Grade

Uniformat	Action Description	Quantity	Unit Cost	Plan Type	Priority	Year	Expenditure
D2012	Replace Urinals	3 EA	\$1,193.44	BYL	Priority 3	2025	\$3,580

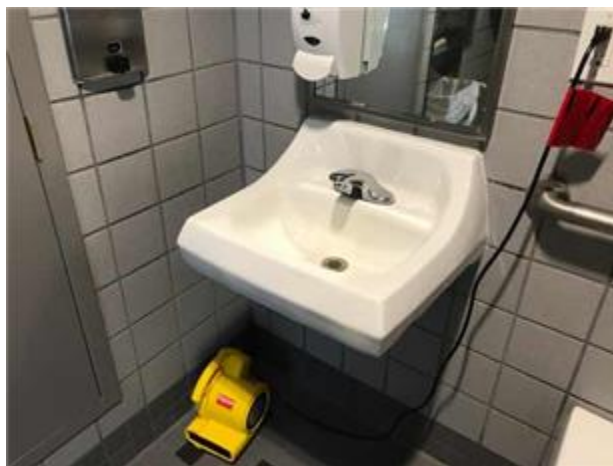
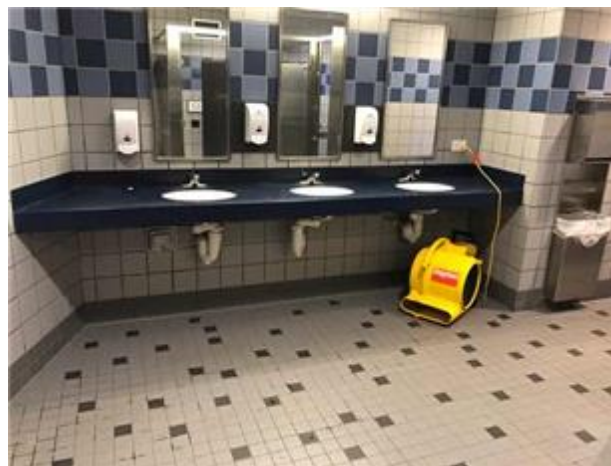
Coding / Field Name	Asset Description
D2013 Lavatories	Lavatory, Vitreous China
Condition	Fair
Qty / UOM	8 / EA
Unit Cost	\$572.66
Basis of Costing	Lavatory, Vitreous China
Year in Service	2005
Expected Useful Life (EUL)	20 Year(s), Based on Industry Averages
Remaining Useful Life (RUL)	7 Year(s), Estimated, Based on Date of Observation
Location	Restrooms

Uniformat	Action Description	Quantity	Unit Cost	Plan Type	Priority	Year	Expenditure
D2013	Replace Lavatory, Vitreous China	8 EA	\$572.66	BYL	Priority 3	2025	\$4,581

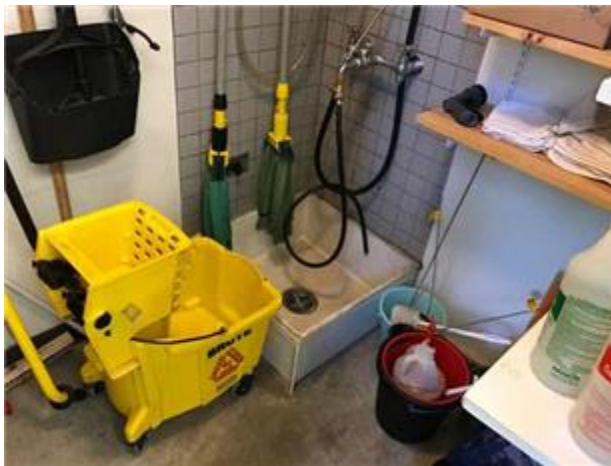
Coding / Field Name	Asset Description
D2014 Sinks	Service Sink, Floor
Condition	Fair
Qty / UOM	2 / EA
Unit Cost	\$1,599.51
Basis of Costing	Service Sink, Floor
Year in Service	2005
Expected Useful Life (EUL)	35 Year(s), Based on Industry Averages
Remaining Useful Life (RUL)	22 Year(s), Estimated, Based on Date of Observation
Location	Building Interior (General)

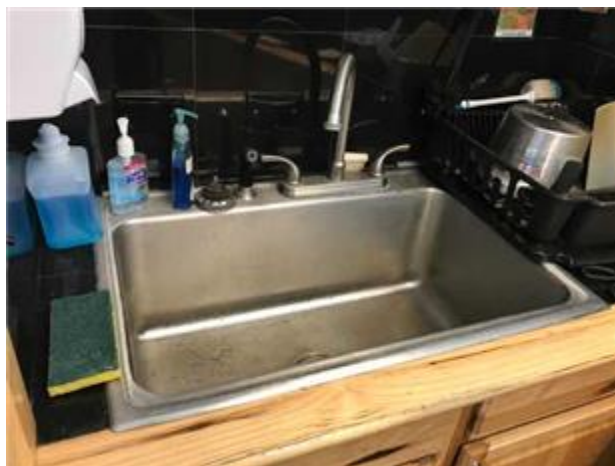
Coding / Field Name	Asset Description
D2014 Sinks	Sink, Stainless Steel
Condition	Fair
Qty / UOM	3 / EA
Unit Cost	\$1,054.05
Basis of Costing	Sink, Stainless Steel
Year in Service	2005
Expected Useful Life (EUL)	20 Year(s), Based on Industry Averages
Remaining Useful Life (RUL)	7 Year(s), Estimated, Based on Date of Observation
Location	Building Interior (General)

Uniformat	Action Description	Quantity	Unit Cost	Plan Type	Priority	Year	Expenditure
D2014	Replace Sink, Stainless Steel	3 EA	\$1,054.05	BYL	Priority 3	2025	\$3,162

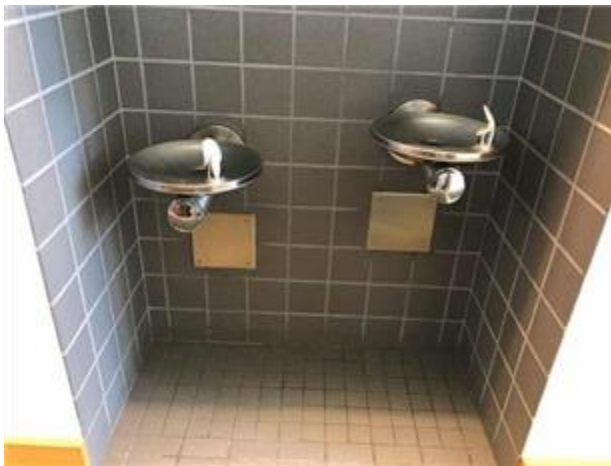
Coding / Field Name	Asset Description
D2018 Drinking Fountains and Coolers	Drinking Fountains
Condition	Fair
Qty / UOM	2 / EA
Unit Cost	\$1,257.51
Basis of Costing	Drinking Fountain, Refrigerated
Year in Service	2005
Expected Useful Life (EUL)	10 Year(s), Based on Industry Averages
Remaining Useful Life (RUL)	3 Year(s), Estimated, Based on Date of Observation
Location	Main lobby

Uniformat	Action Description	Quantity	Unit Cost	Plan Type	Priority	Year	Expenditure
D2018	Replace Drinking Fountains	2 EA	\$1,257.51	BYL	Priority 2	2021	\$2,515
D2018	Replace Drinking Fountains	2 EA	\$1,257.51	BYL	Priority 2	2031	\$2,515

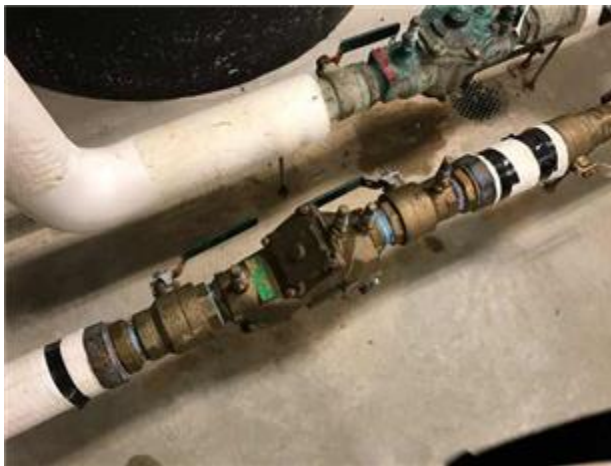
Coding / Field Name	Asset Description
D2021 Cold Water Service	Backflow Preventer, 2", Non-Potable System
Condition	Fair
Qty / UOM	1 / EA
Unit Cost	\$2,603.17
Basis of Costing	Backflow Preventer, 2"
Year in Service	2010
Expected Useful Life (EUL)	15 Year(s), Based on Industry Averages
Remaining Useful Life (RUL)	7 Year(s), Estimated, Based on Date of Observation
Location	Basement

Uniformat	Action Description	Quantity	Unit Cost	Plan Type	Priority	Year	Expenditure
D2021	Replace Backflow Preventer, 2", Non-Potable System	1 EA	\$2,603.17	BYL	Priority 2	2025	\$2,603

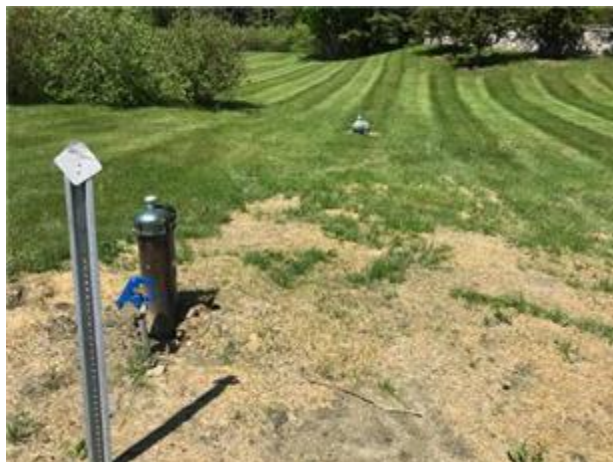
Coding / Field Name	Asset Description
D2023 Domestic Water Supply Equipment	Water Storage Tank and Well Equipment
Condition	Good
Qty / UOM	1 / EA
Cost Adjustment Factor/Reason	2 / Entire system
Unit Cost (Adjusted)	\$21,295.41
Basis of Costing	Water Storage Tank, 2,501 to 5,000 GAL
Year in Service	2005
Expected Useful Life (EUL)	50 Year(s), Based on Industry Averages
Remaining Useful Life (RUL)	37 Year(s), Estimated, Based on Date of Observation
Location	Site

Uniformat	Action Description	Quantity	Unit Cost	Plan Type	Priority	Year	Expenditure
D2023	Replace well pump	1 EA	\$5,500.00	BYL	Priority 2	2025	\$5,500

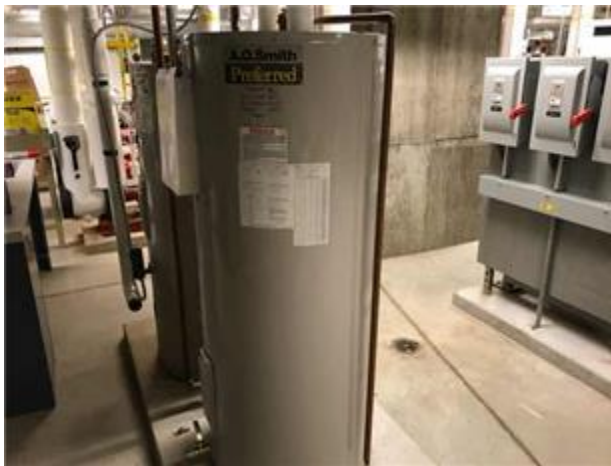
Coding / Field Name	Asset Description
D2023 Domestic Water Supply Equipment	Water Heater, Electric, Commercial, 80 GAL
Condition	Fair
Qty / UOM	1 / EA
Unit Cost	\$6,963.24
Basis of Costing	Water Heater, Electric, Commercial, 30 to 80 GAL
Year in Service	2005
Expected Useful Life (EUL)	15 Year(s), Based on Industry Averages
Remaining Useful Life (RUL)	3 Year(s), Estimated, Based on Date of Observation
Location	Basement

Uniformat	Action Description	Quantity	Unit Cost	Plan Type	Priority	Year	Expenditure
D2023	Replace Water Heater, Electric, Commercial, 80 GAL	1 EA	\$6,963.24	BYL	Priority 1	2021	\$6,963
D2023	Replace Water Heater, Electric, Commercial, 80 GAL	1 EA	\$6,963.24	BYL	Priority 1	2036	\$6,963
