FACILITY CONDITION ASSESSMENT

FACILITY CONDITION ASSESSMENT
OF
SHARON NORTH INFORMATION CENTER
I-89 NORTHBOUND MILE MARKER 10
SHARON, VT 05065

December 17, 2018

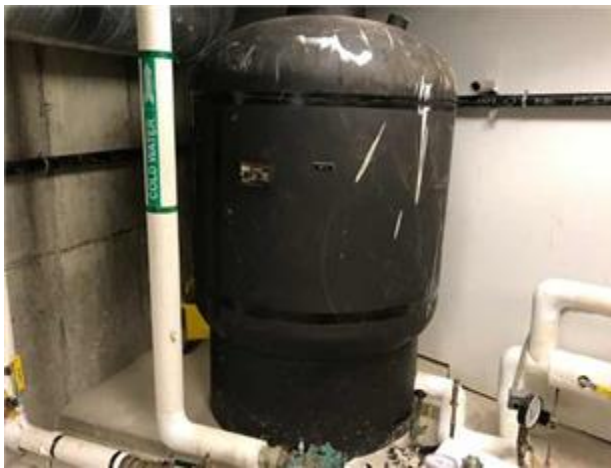
Coding / Field Name	Asset Description
D2023 Domestic Water Supply Equipment	Water Storage Tank, 500 GAL
Condition	Fair
Qty / UOM	1 / EA
Unit Cost	\$4,446.52
Basis of Costing	Water Storage Tank, 251 to 500 GAL
Year in Service	2005
Expected Useful Life (EUL)	20 Year(s), Based on Industry Averages
Remaining Useful Life (RUL)	7 Year(s), Estimated, Based on Date of Observation
Location	Basement

Pressure tank for reuse water.

Unifomat	Action Description	Quantity	Unit Cost	Plan Type	Priority	Year	Expenditure
D2023	Replace Water Storage Tank, 500 GAL	1 EA	\$4,446.52	BYL	Priority 2	2025	\$4,447

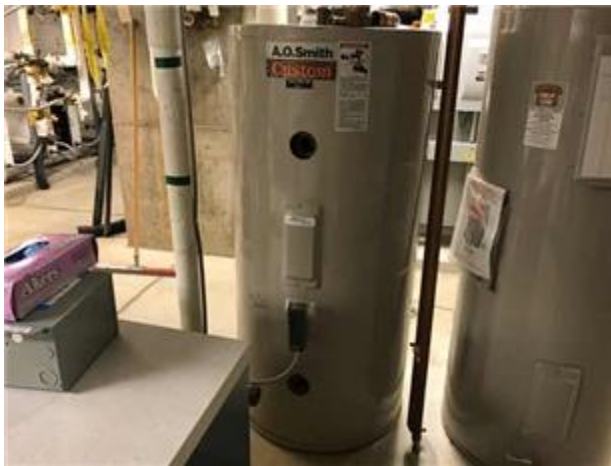
Coding / Field Name	Asset Description
D2023 Domestic Water Supply Equipment	Water Storage Tank, DHW
Condition	Fair
Qty / UOM	1 / EA
Unit Cost	\$2,140.56
Basis of Costing	Water Storage Tank, 80 to 150 GAL
Year in Service	2005
Expected Useful Life (EUL)	20 Year(s), Based on Industry Averages
Remaining Useful Life (RUL)	7 Year(s), Estimated, Based on Date of Observation
Location	Basement

Uniformat	Action Description	Quantity	Unit Cost	Plan Type	Priority	Year	Expenditure
D2023	Replace Water Storage Tank, DHW	1 EA	\$2,140.56	BYL	Priority 2	2025	\$2,141

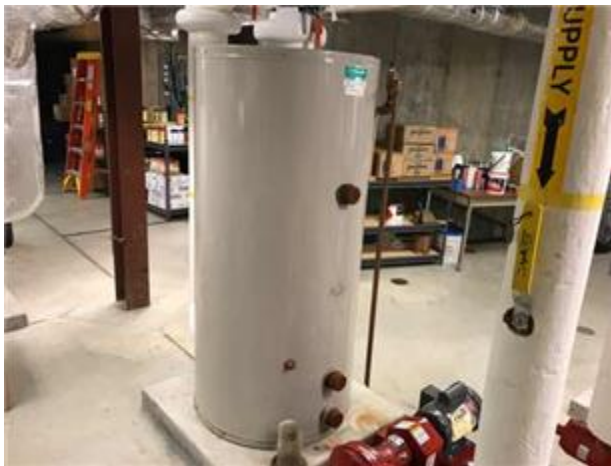
Coding / Field Name	Asset Description
D2023 Domestic Water Supply Equipment	Heating Water Buffer Tank
Condition	Fair
Qty / UOM	1 / EA
Unit Cost	\$2,140.56
Basis of Costing	Water Storage Tank, 80 to 150 GAL
Year in Service	2005
Expected Useful Life (EUL)	20 Year(s), Based on Industry Averages
Remaining Useful Life (RUL)	7 Year(s), Estimated, Based on Date of Observation
Location	Basement

Uniformat	Action Description	Quantity	Unit Cost	Plan Type	Priority	Year	Expenditure
D2023	Replace Heating Water Buffer Tank	1 EA	\$2,140.56	BYL	Priority 2	2025	\$2,141

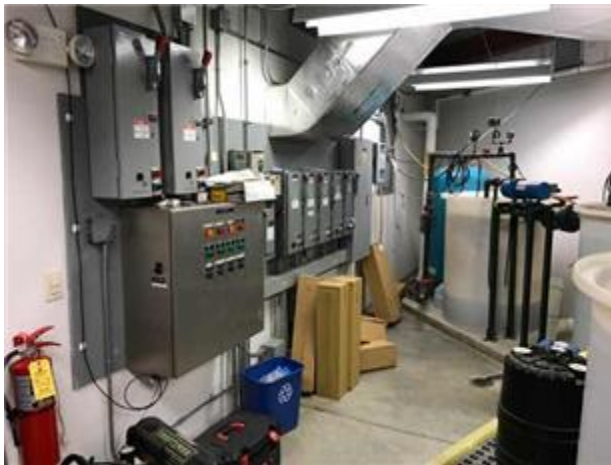
Coding / Field Name	Asset Description
D2034 Sanitary Waste Equipment	Living Machine Control System
Condition	Fair
Qty / UOM	1 / EA
Unit Cost	\$75,000.00
Year in Service	2005
Expected Useful Life (EUL)	25 Year(s), Based on Industry Averages
Remaining Useful Life (RUL)	12 Year(s), Estimated, Based on Date of Observation
Location	Basement

Unifomat	Action Description	Quantity	Unit Cost	Plan Type	Priority	Year	Expenditure
D2034	Replace Living Machine Control System	1 EA	\$75,000.00	BYL	Priority 3	2030	\$75,000

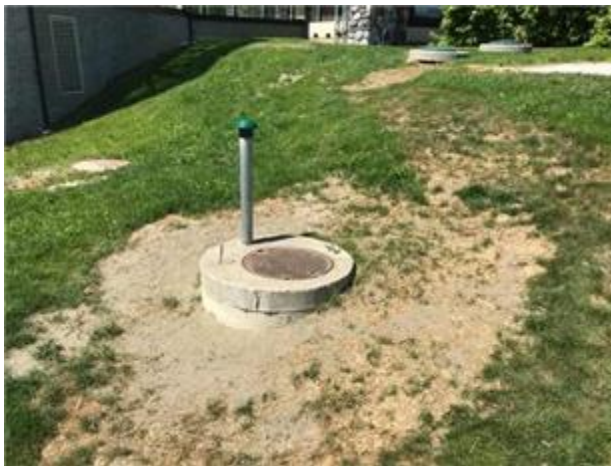
Coding / Field Name	Asset Description
D2034 Sanitary Waste Equipment	Sewage Grinder Pump
Condition	Good
Qty / UOM	2 / EA
Unit Cost	\$2,993.56
Basis of Costing	Sewage Ejector Pump, 1 to 3 HP
Year in Service	2017
Expected Useful Life (EUL)	15 Year(s), Based on Industry Averages
Remaining Useful Life (RUL)	14 Year(s), Estimated, Based on Date of Observation
Location	Site

Uniformat	Action Description	Quantity	Unit Cost	Plan Type	Priority	Year	Expenditure
D2034	Replace Sewage Grinder Pump	2 EA	\$2,993.56	BYL	Priority 3	2032	\$5,987

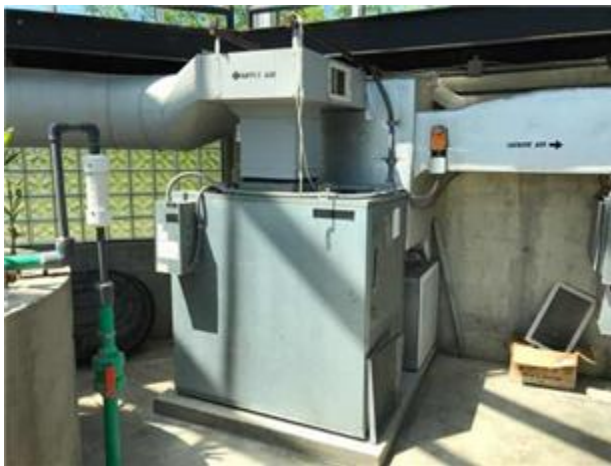
Coding / Field Name	Asset Description
D3041 Air Distribution Systems	Air Handler, Single Zone, AHU-1
Condition	Fair
Qty / UOM	1 / EA
Unit Cost	\$14,597.03
Basis of Costing	Air Handler, Single Zone, 2,501 to 5,000 CFM
Year in Service	2005
Expected Useful Life (EUL)	15 Year(s), Based on Industry Averages
Remaining Useful Life (RUL)	4 Year(s), Estimated, Based on Date of Observation
Location	Treatment Room

Uniformat	Action Description	Quantity	Unit Cost	Plan Type	Priority	Year	Expenditure
D3041	Replace Air Handler, Single Zone, AHU-1	1 EA	\$14,597.03	BYL	Priority 2	2022	\$14,597
D3041	Replace Air Handler, Single Zone, AHU-1	1 EA	\$14,597.03	BYL	Priority 2	2037	\$14,597

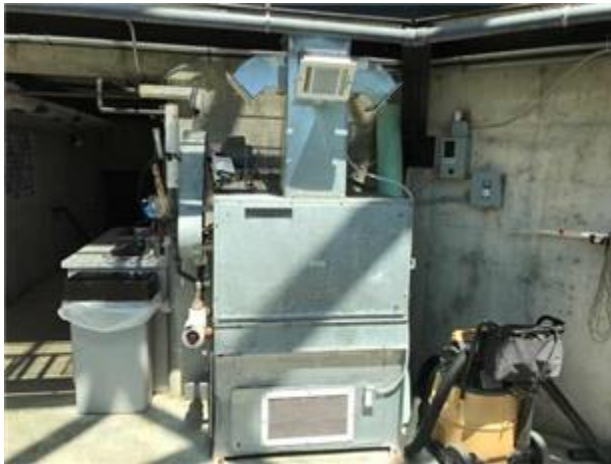
Coding / Field Name	Asset Description
D3041 Air Distribution Systems	Air Handler, Single Zone, AHU-2
Condition	Fair
Qty / UOM	1 / EA
Unit Cost	\$14,597.03
Basis of Costing	Air Handler, Single Zone, 2,501 to 5,000 CFM
Year in Service	2006
Expected Useful Life (EUL)	15 Year(s), Based on Industry Averages
Remaining Useful Life (RUL)	5 Year(s), Estimated, Based on Date of Observation
Location	Treatment Room

Uniformat	Action Description	Quantity	Unit Cost	Plan Type	Priority	Year	Expenditure
D3041	Replace Air Handler, Single Zone, AHU-2	1 EA	\$14,597.03	BYL	Priority 2	2023	\$14,597

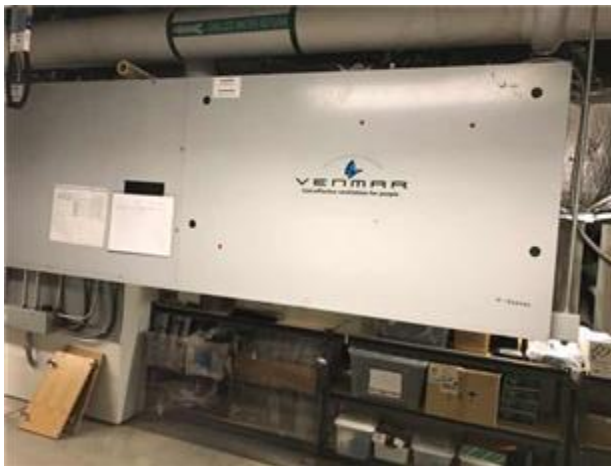
Coding / Field Name	Asset Description
D3041 Air Distribution Systems	Air Handler, Energy Recovery Ventilator
Condition	Fair
Qty / UOM	1 / EA
Unit Cost	\$16,110.04
Basis of Costing	Air Handler, Multizone, Variable Volume w/ Exhaust Recovery Wheel, 2,500 CFM
Year in Service	2005
Expected Useful Life (EUL)	25 Year(s), Based on Industry Averages
Remaining Useful Life (RUL)	12 Year(s), Estimated, Based on Date of Observation
Location	Basement

Uniformat	Action Description	Quantity	Unit Cost	Plan Type	Priority	Year	Expenditure
D3041	Replace Air Handler, Energy Recovery Ventilator	1 EA	\$16,110.04	BYL	Priority 3	2030	\$16,110

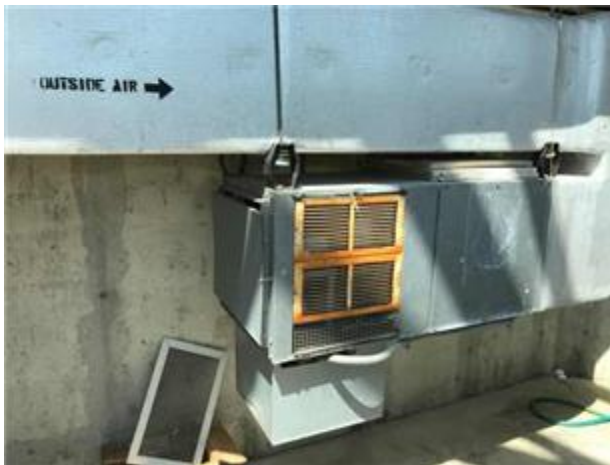
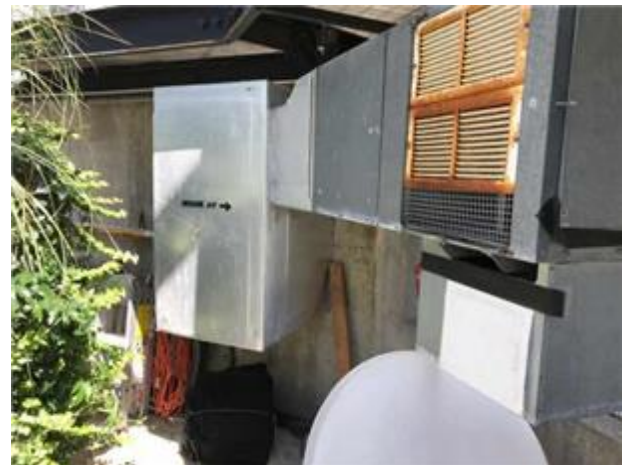
Coding / Field Name	Asset Description
D3042 Exhaust Ventilation Systems	Supply Fans
Condition	Fair
Qty / UOM	2 / EA
Unit Cost	\$2,664.18
Basis of Costing	Exhaust Fan, Centrifugal, 801 to 2,000 CFM
Year in Service	2005
Expected Useful Life (EUL)	15 Year(s), Based on Industry Averages
Remaining Useful Life (RUL)	5 Year(s), Estimated, Based on Date of Observation
Location	Treatment Room
Ventilation System	Central Exhaust Duct Network
Ventilation Fan Manufacturer	NV
Ventilation Fan Model	NV

Unifomat	Action Description	Quantity	Unit Cost	Plan Type	Priority	Year	Expenditure
D3042	Replace Supply Fans	2 EA	\$2,664.18	BYL	Priority 2	2023	\$5,328

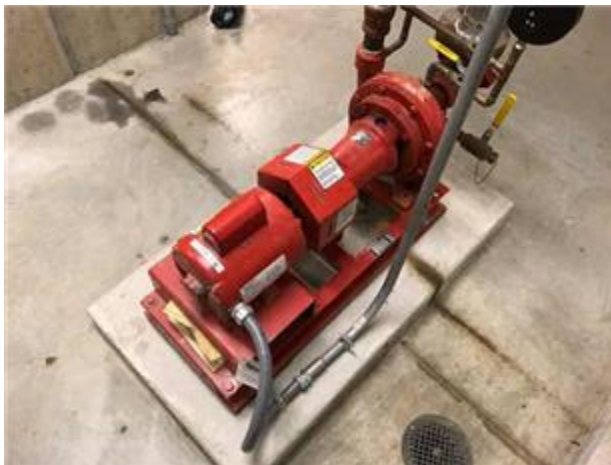
Coding / Field Name	Asset Description
D3044 Hot Water Distribution	Circulation Pump, Hot Water, P-3
Condition	Fair
Qty / UOM	1 / EA
Cost Adjustment Factor/Reason	0.55 / Smaller hp
Unit Cost (Adjusted)	\$2,558.76
Basis of Costing	Circulation Pump, Hot Water, 3 HP
Year in Service	2005
Expected Useful Life (EUL)	20 Year(s), Based on Industry Averages
Remaining Useful Life (RUL)	7 Year(s), Estimated, Based on Date of Observation
Location	Basement
Pump Manufacturer	Bell & Gossett
Pump Model	1510

Unifomat	Action Description	Quantity	Unit Cost	Plan Type	Priority	Year	Expenditure
D3044	Replace Circulation Pump, Hot Water, P-3	1 EA	\$2,558.76	BYL	Priority 2	2025	\$2,559

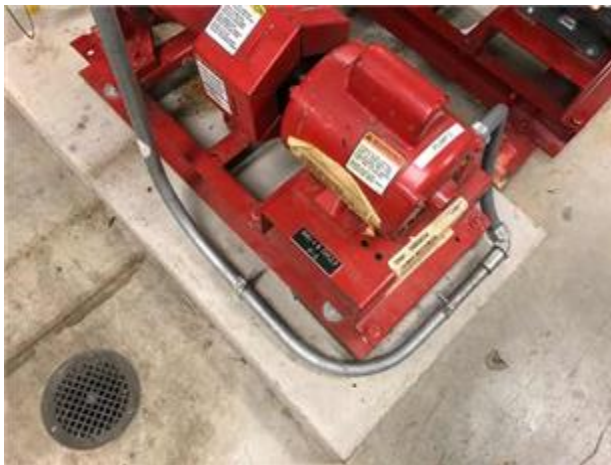
Coding / Field Name	Asset Description
D3044 Hot Water Distribution	Circulation Pump, Hot Water, P-5
Condition	Fair
Qty / UOM	1 / EA
Cost Adjustment Factor/Reason	0.55 / Smaller hp
Unit Cost (Adjusted)	\$2,558.76
Basis of Costing	Circulation Pump, Hot Water, 3 HP
Year in Service	2005
Expected Useful Life (EUL)	20 Year(s), Based on Industry Averages
Remaining Useful Life (RUL)	7 Year(s), Estimated, Based on Date of Observation
Location	Basement
Pump Manufacturer	Bell & Gosset
Pump Model	1510

Unifomat	Action Description	Quantity	Unit Cost	Plan Type	Priority	Year	Expenditure
D3044	Replace Circulation Pump, Hot Water, P-5	1 EA	\$2,558.76	BYL	Priority 2	2025	\$2,559

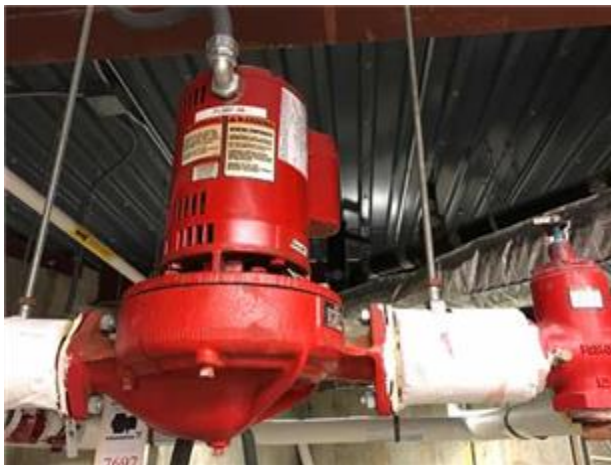
Coding / Field Name	Asset Description
D3044 Hot Water Distribution	Circulation Pump, Snow Melt, P-4A
Condition	Fair
Qty / UOM	1 / EA
Cost Adjustment Factor/Reason	0.6 / Smaller hp
Unit Cost (Adjusted)	\$2,791.37
Basis of Costing	Circulation Pump, Hot Water, 3 HP
Year in Service	2005
Expected Useful Life (EUL)	20 Year(s), Based on Industry Averages
Remaining Useful Life (RUL)	7 Year(s), Estimated, Based on Date of Observation
Location	Basement
Pump Manufacturer	Bell & Gossett
Pump Model	90

Unformat	Action Description	Quantity	Unit Cost	Plan Type	Priority	Year	Expenditure
D3044	Replace Circulation Pump, Snow Melt, P-4A	1 EA	\$2,791.37	BYL	Priority 2	2025	\$2,791

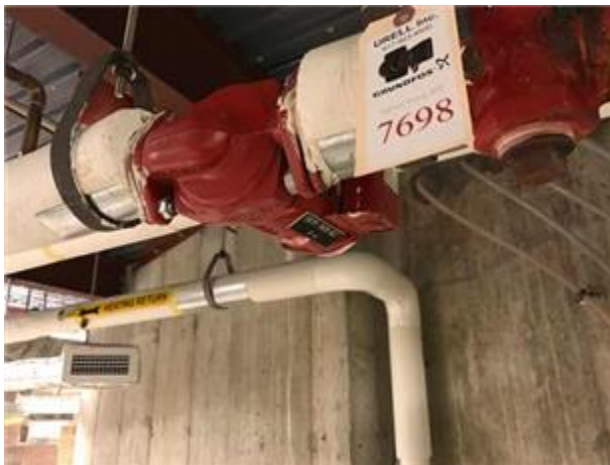
Coding / Field Name	Asset Description
D3044 Hot Water Distribution	Circulation Pump, Snow Melt, P-4
Condition	Fair
Qty / UOM	1 / EA
Cost Adjustment Factor/Reason	0.5 / Fractional HP
Unit Cost (Adjusted)	\$2,326.15
Basis of Costing	Circulation Pump, Hot Water, 3 HP
Year in Service	2005
Expected Useful Life (EUL)	20 Year(s), Based on Industry Averages
Remaining Useful Life (RUL)	7 Year(s), Estimated, Based on Date of Observation
Location	Basement
Pump Manufacturer	Bell & Gossett
Pump Model	PL-55

Unifomat	Action Description	Quantity	Unit Cost	Plan Type	Priority	Year	Expenditure
D3044	Replace Circulation Pump, Snow Melt, P-4	1 EA	\$2,326.15	BYL	Priority 2	2025	\$2,326

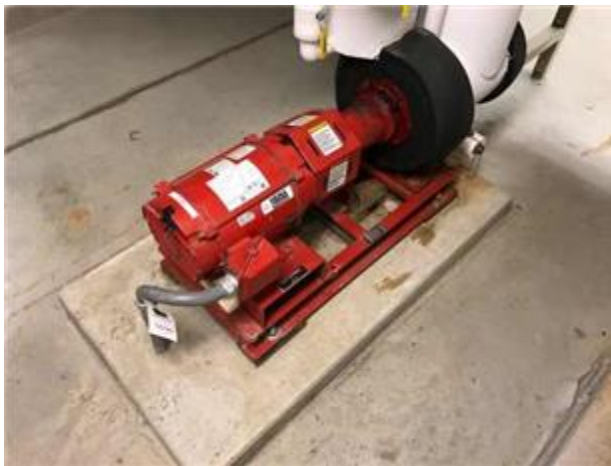
Coding / Field Name	Asset Description
D3045 Chilled Water Distribution	Circulation Pump, Geothermal Well Water, P-1
Condition	Fair
Qty / UOM	1 / EA
Unit Cost	\$5,518.88
Basis of Costing	Circulation Pump, Chiller & Condenser Water, 5 HP
Year in Service	2005
Expected Useful Life (EUL)	20 Year(s), Based on Industry Averages
Remaining Useful Life (RUL)	7 Year(s), Estimated, Based on Date of Observation
Location	Basement

Uniformat	Action Description	Quantity	Unit Cost	Plan Type	Priority	Year	Expenditure
D3045	Replace Circulation Pump, Geothermal Well Water, P-1	1 EA	\$5,518.88	BYL	Priority 2	2025	\$5,519

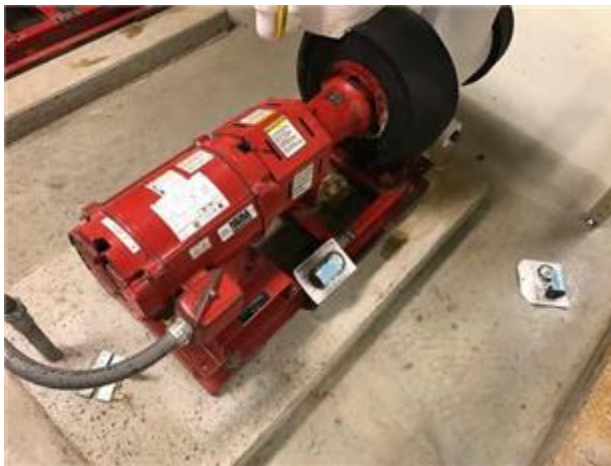
Coding / Field Name	Asset Description
D3045 Chilled Water Distribution	Circulation Pump, Geothermal Well Water, P-2
Condition	Fair
Qty / UOM	1 / EA
Unit Cost	\$5,518.88
Basis of Costing	Circulation Pump, Chiller & Condenser Water, 5 HP
Year in Service	2005
Expected Useful Life (EUL)	20 Year(s), Based on Industry Averages
Remaining Useful Life (RUL)	7 Year(s), Estimated, Based on Date of Observation
Location	Basement

Uniformat	Action Description	Quantity	Unit Cost	Plan Type	Priority	Year	Expenditure
D3045	Replace Circulation Pump, Geothermal Well Water, P-2	1 EA	\$5,518.88	BYL	Priority 2	2025	\$5,519

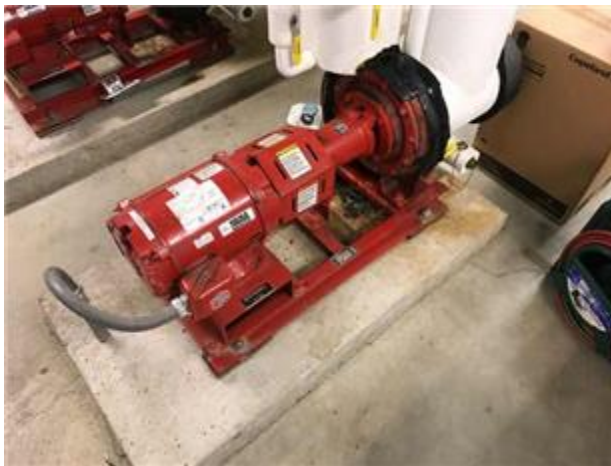
Coding / Field Name	Asset Description
D3045 Chilled Water Distribution	Circulation Pump, Geothermal Well Water, P-2A
Condition	Fair
Qty / UOM	1 / EA
Unit Cost	\$5,518.88
Basis of Costing	Circulation Pump, Chiller & Condenser Water, 5 HP
Year in Service	2005
Expected Useful Life (EUL)	20 Year(s), Based on Industry Averages
Remaining Useful Life (RUL)	7 Year(s), Estimated, Based on Date of Observation
Location	Basement

Uniformat	Action Description	Quantity	Unit Cost	Plan Type	Priority	Year	Expenditure
D3045	Replace Circulation Pump, Geothermal Well Water, P-2A	1 EA	\$5,518.88	BYL	Priority 2	2025	\$5,519

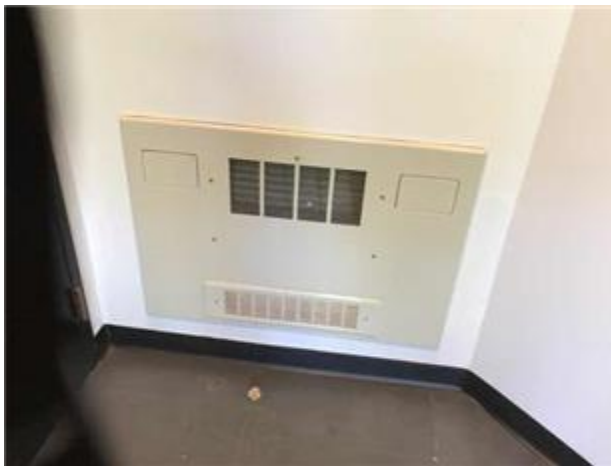
Coding / Field Name	Asset Description
D3051 Terminal Self-Contained Units	Cabinet Heater, Hydronic
Condition	Fair
Qty / UOM	3 / EA
Unit Cost	\$3,179.94
Basis of Costing	Cabinet Heater, Electric
Year in Service	2005
Expected Useful Life (EUL)	20 Year(s), Based on Industry Averages
Remaining Useful Life (RUL)	7 Year(s), Estimated, Based on Date of Observation
Location	Building Interior (General)

Uniformat	Action Description	Quantity	Unit Cost	Plan Type	Priority	Year	Expenditure
D3051	Replace Cabinet Heater, Hydronic	3 EA	\$3,179.94	BYL	Priority 2	2025	\$9,540

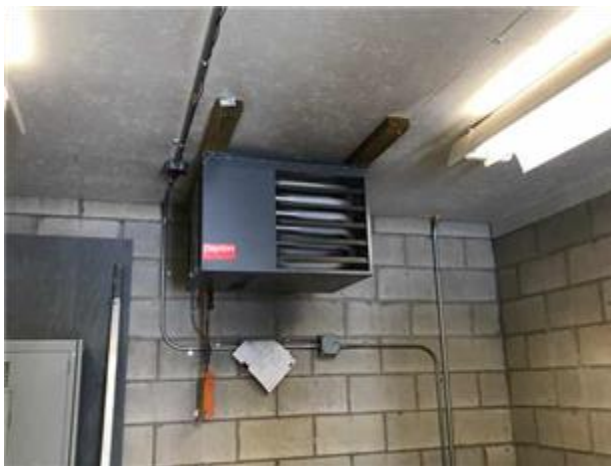
Coding / Field Name	Asset Description
D3051 Terminal Self-Contained Units	Suspended Heater, Natural Gas
Condition	Fair
Qty / UOM	1 / EA
Unit Cost	\$4,467.67
Basis of Costing	Suspended Heater, Natural Gas, 56 to 75 MBH
Year in Service	2005
Expected Useful Life (EUL)	20 Year(s), Based on Industry Averages
Remaining Useful Life (RUL)	7 Year(s), Estimated, Based on Date of Observation
Location	Storage Building
PTAC Manufacturer	Dayton
PTAC Model	NV

Uniformat	Action Description	Quantity	Unit Cost	Plan Type	Priority	Year	Expenditure
D3051	Replace Suspended Heater, Natural Gas	1 EA	\$4,467.67	BYL	Priority 2	2025	\$4,468

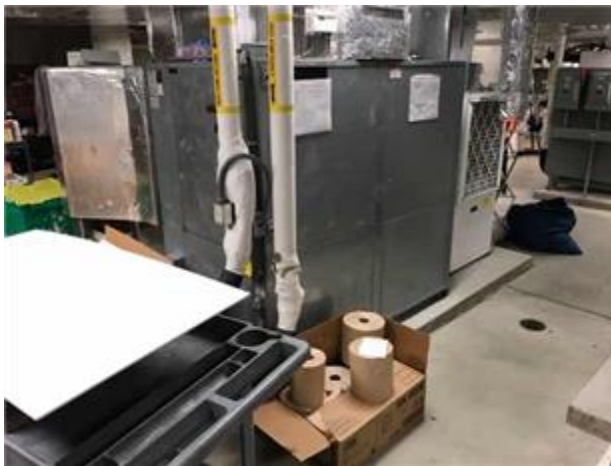
Coding / Field Name	Asset Description
D3052 Package Units	Water-to-Air Heat Pump, HP-2
Condition	Fair
Qty / UOM	1 / EA
Unit Cost	\$15,325.27
Basis of Costing	Heat Pump, 6 to 10 Ton
Year in Service	2005
Expected Useful Life (EUL)	15 Year(s), Based on Industry Averages
Remaining Useful Life (RUL)	4 Year(s), Estimated, Based on Date of Observation
Location	Basement

Uniformat	Action Description	Quantity	Unit Cost	Plan Type	Priority	Year	Expenditure
D3052	Replace Water-to-Air Heat Pump, HP-2	1 EA	\$15,325.27	BYL	Priority 2	2022	\$15,325
D3052	Replace Water-to-Air Heat Pump, HP-2	1 EA	\$15,325.27	BYL	Priority 2	2037	\$15,325

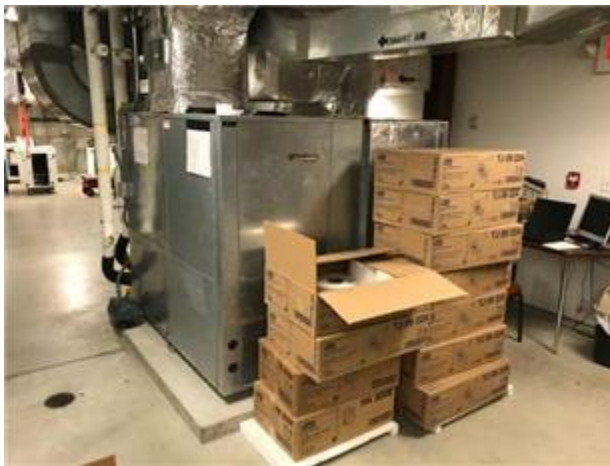
Coding / Field Name	Asset Description
D3052 Package Units	Water-to-Air Heat Pump, HP-1
Condition	Fair
Qty / UOM	1 / EA
Unit Cost	\$15,325.27
Basis of Costing	Heat Pump, 6 to 10 Ton
Year in Service	2005
Expected Useful Life (EUL)	15 Year(s), Based on Industry Averages
Remaining Useful Life (RUL)	4 Year(s), Estimated, Based on Date of Observation
Location	Basement

Uniformat	Action Description	Quantity	Unit Cost	Plan Type	Priority	Year	Expenditure
D3052	Replace Water-to-Air Heat Pump, HP-1	1 EA	\$15,325.27	BYL	Priority 2	2022	\$15,325
D3052	Replace Water-to-Air Heat Pump, HP-1	1 EA	\$15,325.27	BYL	Priority 2	2037	\$15,325

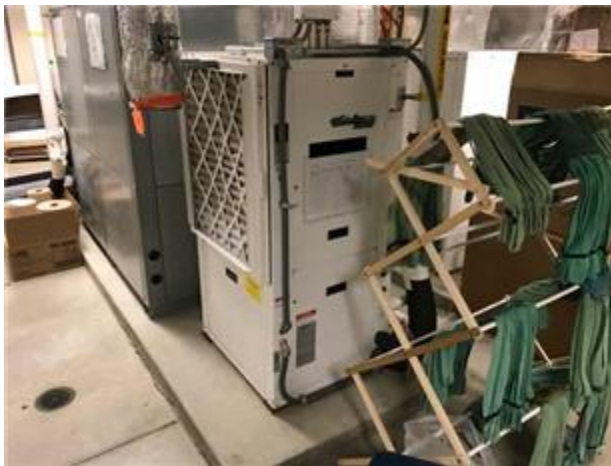
Coding / Field Name	Asset Description
D3052 Package Units	Water-to-Air Heat Pump, HP-3
Condition	Fair
Qty / UOM	1 / EA
Unit Cost	\$5,030.68
Basis of Costing	Heat Pump, 1.5 to 2 Ton
Year in Service	2005
Expected Useful Life (EUL)	15 Year(s), Based on Industry Averages
Remaining Useful Life (RUL)	4 Year(s), Estimated, Based on Date of Observation
Location	Basement

Uniformat	Action Description	Quantity	Unit Cost	Plan Type	Priority	Year	Expenditure
D3052	Replace Water-to-Air Heat Pump, HP-3	1 EA	\$5,030.68	BYL	Priority 2	2022	\$5,031
D3052	Replace Water-to-Air Heat Pump, HP-3	1 EA	\$5,030.68	BYL	Priority 2	2037	\$5,031

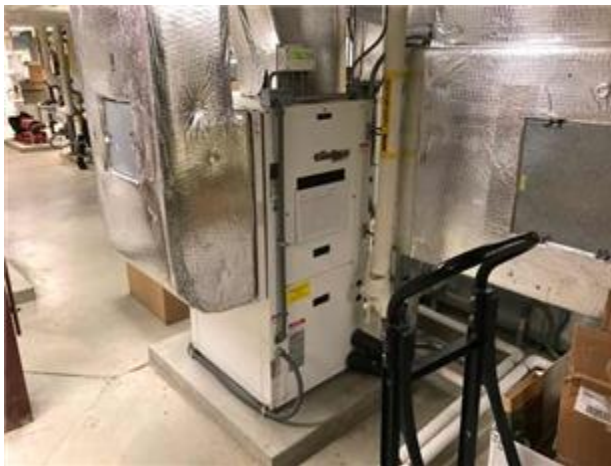
Coding / Field Name	Asset Description
D3052 Package Units	Water-to-Air Heat Pump, HP-4
Condition	Fair
Qty / UOM	1 / EA
Unit Cost	\$5,030.68
Basis of Costing	Heat Pump, 1.5 to 2 Ton
Year in Service	2005
Expected Useful Life (EUL)	15 Year(s), Based on Industry Averages
Remaining Useful Life (RUL)	4 Year(s), Estimated, Based on Date of Observation
Location	Basement

Uniformat	Action Description	Quantity	Unit Cost	Plan Type	Priority	Year	Expenditure
D3052	Replace Water-to-Air Heat Pump, HP-4	1 EA	\$5,030.68	BYL	Priority 2	2022	\$5,031
D3052	Replace Water-to-Air Heat Pump, HP-4	1 EA	\$5,030.68	BYL	Priority 2	2037	\$5,031

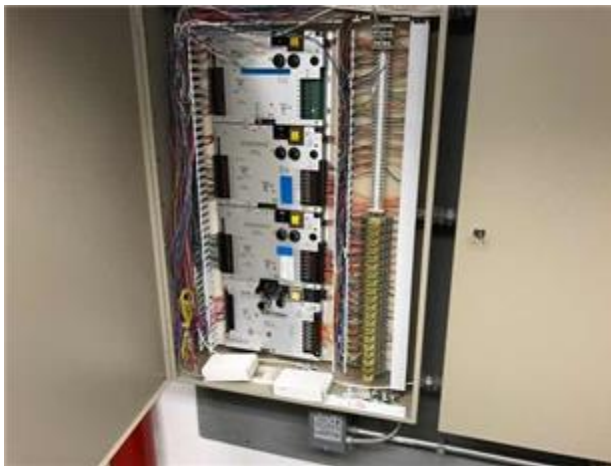
Coding / Field Name	Asset Description
D3068 Building Automation Systems	Direct Digital (DDC) HVAC Controls
Condition	Fair
Qty / UOM	7732 / SF
Unit Cost	\$5.36
Basis of Costing	Building Automation System (HVAC Controls), Full Upgrade (per SF)
Year in Service	2005
Expected Useful Life (EUL)	20 Year(s), Based on Industry Averages
Remaining Useful Life (RUL)	7 Year(s), Estimated, Based on Date of Observation
Location	Building Interior (General)

Uniformat	Action Description	Quantity	Unit Cost	Plan Type	Priority	Year	Expenditure
D3068	Replace Direct Digital (DDC) HVAC Controls	7,732 SF	\$5.36	BYL	Priority 2	2025	\$41,444

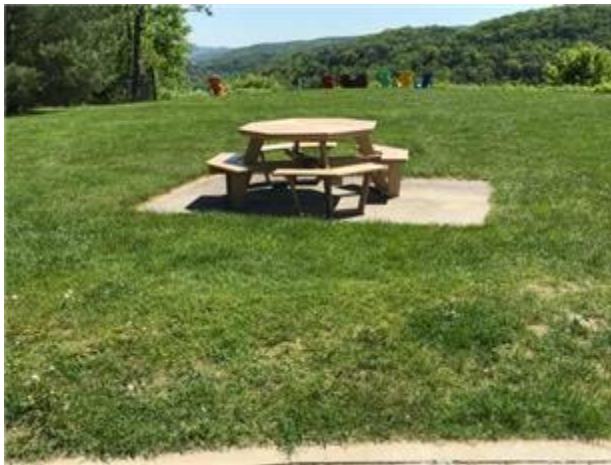
Coding / Field Name	Asset Description
D3091 Special Cooling Systems & Devices	Geothermal Wellfield
Condition	Good
Qty / UOM	1 / EA
Unit Cost	\$75,000.00
Year in Service	2005
Expected Useful Life (EUL)	50 Year(s), Based on Industry Averages
Remaining Useful Life (RUL)	37 Year(s), Estimated, Based on Date of Observation
Location	Site

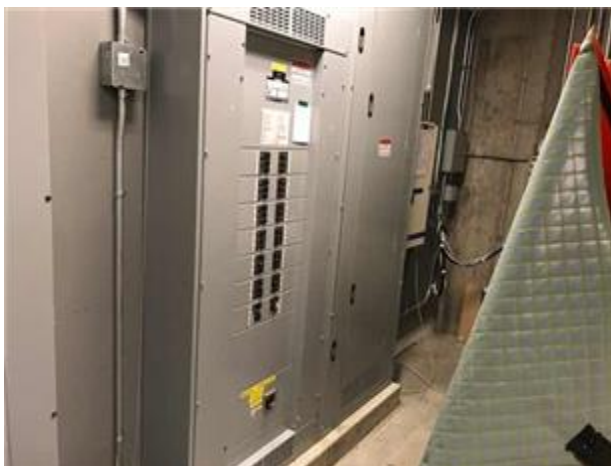
Coding / Field Name	Asset Description
D5012 Low Tension Service & Dist.	Distribution Panel, PPN-1
Condition	Fair
Qty / UOM	1 / EA
Unit Cost	\$13,423.81
Basis of Costing	Power Panel Board, 208 Y, 120 V, 800 Amp
Year in Service	2005
Expected Useful Life (EUL)	30 Year(s), Based on Industry Averages
Remaining Useful Life (RUL)	17 Year(s), Estimated, Based on Date of Observation
Location	Basement
Service Size (Amperage)	600
Service Voltage	120/240
Service Voltage Type	Single-Phase Three-Wire Alternating Current (Ac)
Step Down Transformers	No
Electrical Distribution Panel Type	Circuit Breakers
Main Electrical Distribution Lines	Underground
Site Electrical Transformer Location	Pad-Mounted
Electrical Wiring Material	Solid Copper
Electrical Wiring in Metal Conduit	Yes
Electrical Wiring in Non-Metal (NM) Conduit	No
Electrical Wiring in Non- Metal Sheathing (Romex)	No
Electrical Wiring in Metal Sheathing (BX)	Yes

Unifomat	Action Description	Quantity	Unit Cost	Plan Type	Priority	Year	Expenditure
D5012	Replace Distribution Panel, PPN-1	1 EA	\$13,423.81	BYL	Priority 3	2035	\$13,424

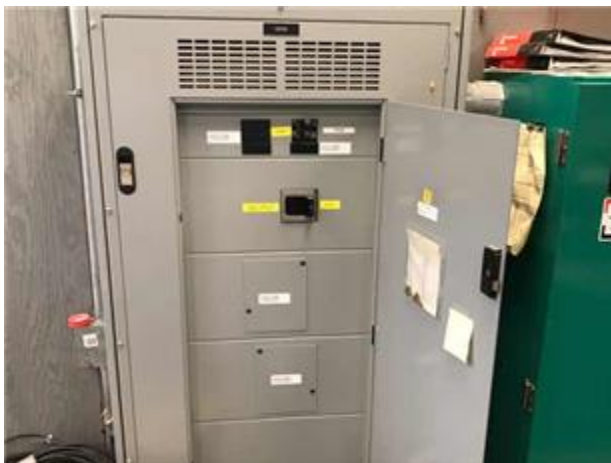
Coding / Field Name	Asset Description
D5012 Low Tension Service & Dist.	Distribution Panel, DPEM
Condition	Fair
Qty / UOM	1 / EA
Unit Cost	\$9,487.85
Basis of Costing	Power Panel Board, 208 Y, 120 V, 400 Amp
Year in Service	2005
Expected Useful Life (EUL)	30 Year(s), Based on Industry Averages
Remaining Useful Life (RUL)	17 Year(s), Estimated, Based on Date of Observation
Location	Storage Building
Service Voltage	120/240
Service Voltage Type	Single-Phase Three-Wire Alternating Current (Ac)
Step Down Transformers	No
Electrical Distribution Panel Type	Circuit Breakers
Main Electrical Distribution Lines	Underground
Site Electrical Transformer Location	Pad-Mounted
Electrical Wiring Material	Solid Copper
Electrical Wiring in Metal Conduit	Yes
Electrical Wiring in Non-Metal (NM) Conduit	No
Electrical Wiring in Non- Metal Sheathing (Romex)	No
Electrical Wiring in Metal Sheathing (BX)	Yes

Unifomat	Action Description	Quantity	Unit Cost	Plan Type	Priority	Year	Expenditure
D5012	Replace Distribution Panel, DPEM	1 EA	\$9,487.85	BYL	Priority 3	2035	\$9,488

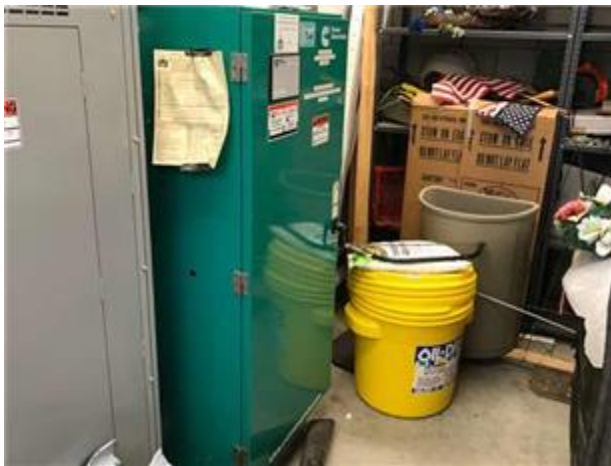
Coding / Field Name	Asset Description
D5012 Low Tension Service & Dist.	Transfer Switch, Auto, 600 V, 400 Amp
Condition	Fair
Qty / UOM	1 / EA
Unit Cost	\$12,045.75
Basis of Costing	Transfer Switch, Auto, 600 V, 400 Amp
Year in Service	2005
Expected Useful Life (EUL)	18 Year(s), Based on Industry Averages
Remaining Useful Life (RUL)	5 Year(s), Estimated, Based on Date of Observation
Location	Storage Building

Unifomat	Action Description	Quantity	Unit Cost	Plan Type	Priority	Year	Expenditure
D5012	Replace Transfer Switch, Auto, 600 V, 400 Amp	1 EA	\$12,045.75	BYL	Priority 2	2023	\$12,046

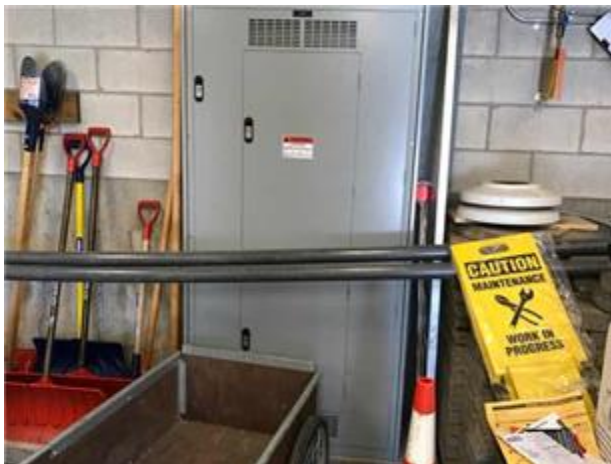
Coding / Field Name	Asset Description
D5012 Low Tension Service & Dist.	Main Distribution Panel, DPN
Condition	Fair
Qty / UOM	1 / EA
Unit Cost	\$14,791.28
Basis of Costing	Power Panel Board, 208 Y, 120 V, 1,200 Amp
Year in Service	2005
Expected Useful Life (EUL)	30 Year(s), Based on Industry Averages
Remaining Useful Life (RUL)	17 Year(s), Estimated, Based on Date of Observation
Location	Storage Building
Service Size (Amperage)	1200
Service Voltage	120/240
Service Voltage Type	Single-Phase Three-Wire Alternating Current (Ac)
Step Down Transformers	No
Electrical Distribution Panel Type	Circuit Breakers
Main Electrical Distribution Lines	Underground
Site Electrical Transformer Location	Pad-Mounted
Electrical Wiring Material	Solid Copper
Electrical Wiring in Metal Conduit	Yes
Electrical Wiring in Non-Metal (NM) Conduit	No
Electrical Wiring in Non- Metal Sheathing (Romex)	No
Electrical Wiring in Metal Sheathing (BX)	Yes

Unifomat	Action Description	Quantity	Unit Cost	Plan Type	Priority	Year	Expenditure
D5012	Replace Main Distribution Panel, DPN	1 EA	\$14,791.28	BYL	Priority 3	2035	\$14,791

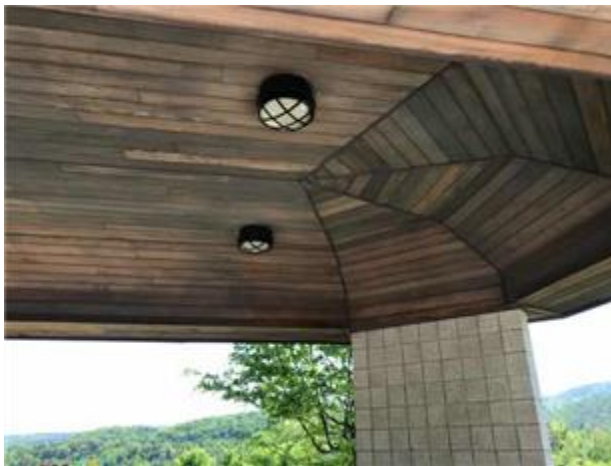
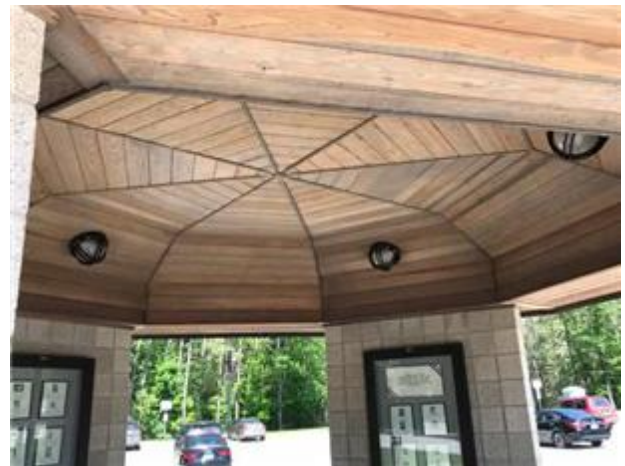
Coding / Field Name	Asset Description
D5022 Lighting Equipment	Soffit Lighting Fixture
Condition	Fair
Qty / UOM	10 / EA
Unit Cost	\$259.09
Basis of Costing	Halogen Lighting Fixture, 100 W
Year in Service	2005
Expected Useful Life (EUL)	20 Year(s), Based on Industry Averages
Remaining Useful Life (RUL)	7 Year(s), Estimated, Based on Date of Observation
Location	Kiosks, Picnic Shelter

Uniformat	Action Description	Quantity	Unit Cost	Plan Type	Priority	Year	Expenditure
D5022	Replace Soffit Lighting Fixture	10 EA	\$259.09	BYL	Priority 2	2025	\$2,591

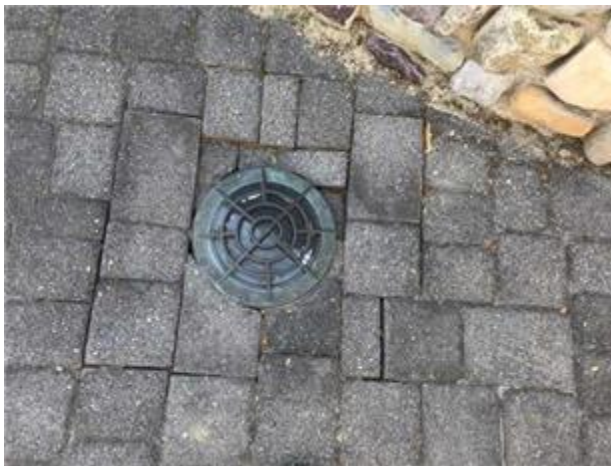
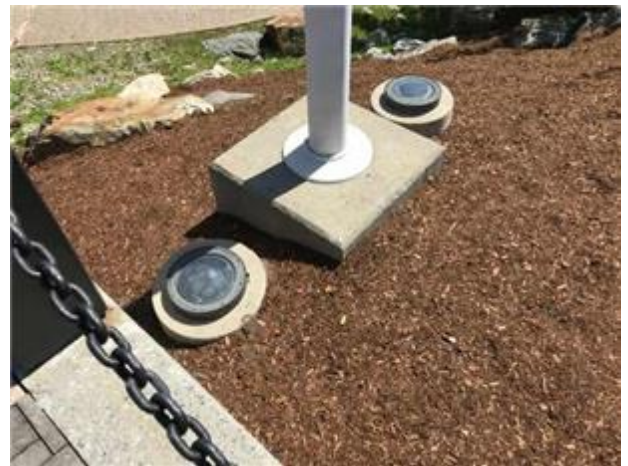
Coding / Field Name	Asset Description
D5022 Lighting Equipment	Metal Halide Lighting Fixture, Flush Walkway Mount
Condition	Fair
Qty / UOM	19 / EA
Unit Cost	\$678.47
Basis of Costing	Metal Halide Lighting Fixture, Wall Mount, 150 W
Year in Service	2005
Expected Useful Life (EUL)	20 Year(s), Based on Industry Averages
Remaining Useful Life (RUL)	7 Year(s), Estimated, Based on Date of Observation
Location	Site

Uniformat	Action Description	Quantity	Unit Cost	Plan Type	Priority	Year	Expenditure
D5022	Replace Metal Halide Lighting Fixture, Flush Walkway Mount	19 EA	\$678.47	BYL	Priority 2	2025	\$12,891

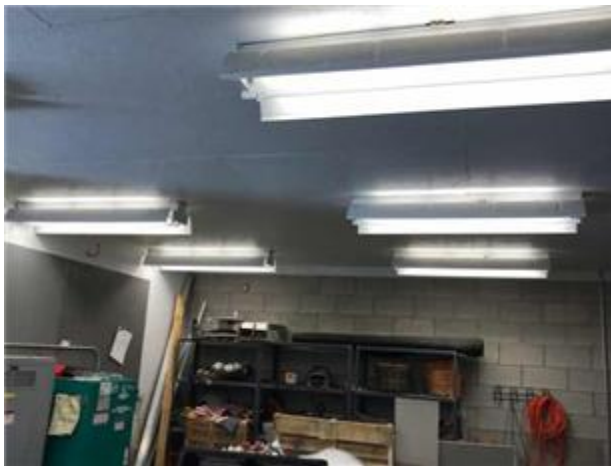
Coding / Field Name	Asset Description
D5022 Lighting Equipment	Fluorescent Lighting Fixture, T8, 32 W
Condition	Fair
Qty / UOM	12 / EA
Unit Cost	\$213.86
Basis of Costing	Fluorescent Lighting Fixture, T8, 32 W
Year in Service	2005
Expected Useful Life (EUL)	20 Year(s), Based on Industry Averages
Remaining Useful Life (RUL)	7 Year(s), Estimated, Based on Date of Observation
Location	Storage Building

Uniformat	Action Description	Quantity	Unit Cost	Plan Type	Priority	Year	Expenditure
D5022	Replace Fluorescent Lighting Fixture, T8, 32 W	12 EA	\$213.86	BYL	Priority 2	2025	\$2,566

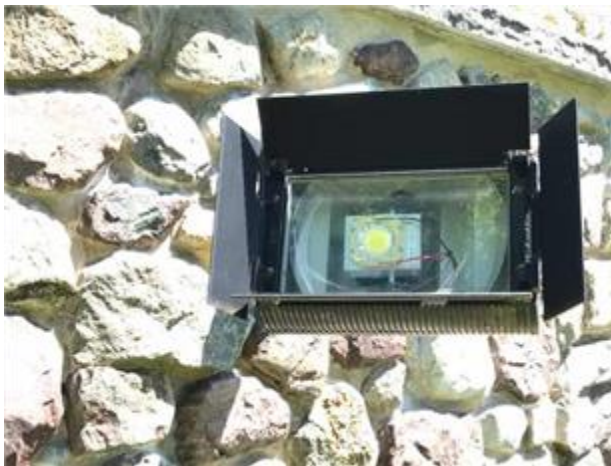
Coding / Field Name	Asset Description
D5022 Lighting Equipment	Flood Light, Exterior, LED
Condition	Good
Qty / UOM	2 / EA
Unit Cost	\$995.47
Basis of Costing	Flood Light, Exterior, 100 W
Year in Service	2014
Expected Useful Life (EUL)	20 Year(s), Based on Industry Averages
Remaining Useful Life (RUL)	16 Year(s), Estimated, Based on Date of Observation
Location	Site

Uniformat	Action Description	Quantity	Unit Cost	Plan Type	Priority	Year	Expenditure
D5022	Replace Flood Light, Exterior, LED	2 EA	\$995.47	BYL	Priority 3	2034	\$1,991

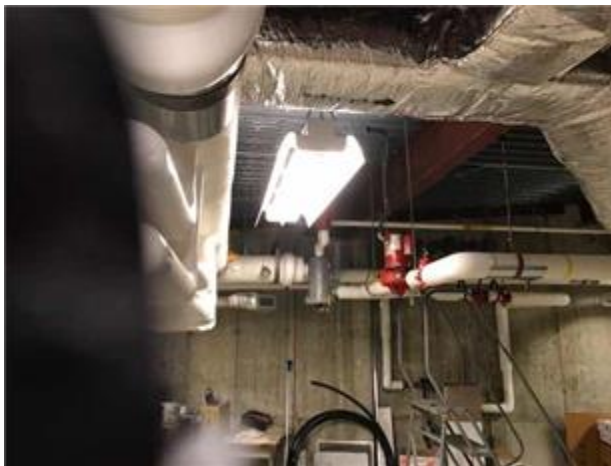
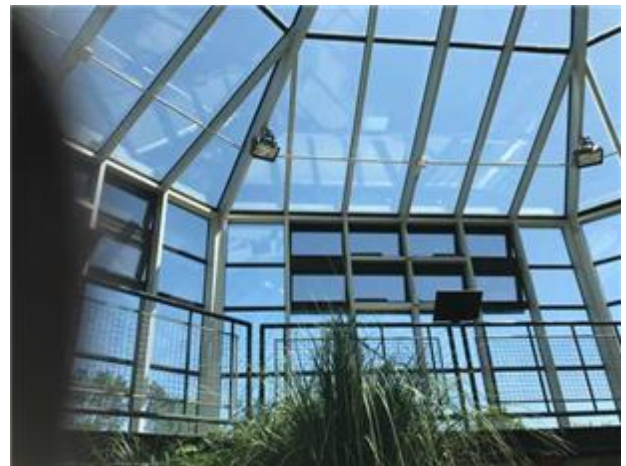
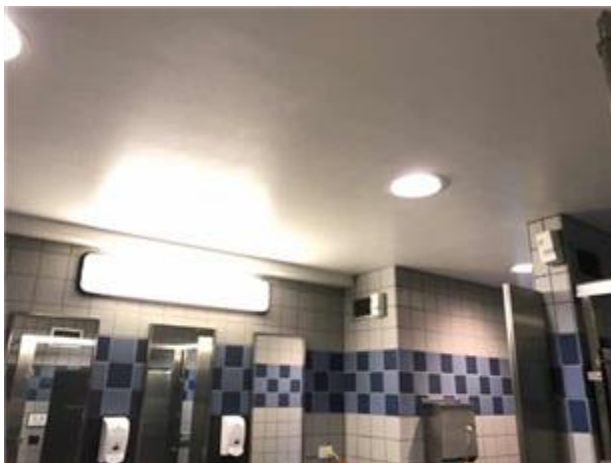
Coding / Field Name	Asset Description
D5029 Lighting Systems	Lighting System, Interior
Condition	Fair
Qty / UOM	7732 / SF
Unit Cost	\$6.76
Basis of Costing	Lighting System, Full Upgrade, Multi-Family (per SF)
Year in Service	2005
Expected Useful Life (EUL)	25 Year(s), Based on Industry Averages
Remaining Useful Life (RUL)	12 Year(s), Estimated, Based on Date of Observation
Location	Building Interior (General)

Uniformat	Action Description	Quantity	Unit Cost	Plan Type	Priority	Year	Expenditure
D5029	Replace Lighting System, Interior	7,732 SF	\$6.76	BYL	Priority 3	2030	\$52,254

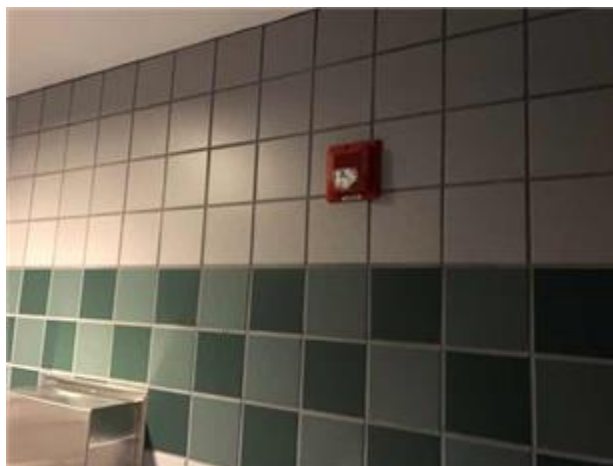
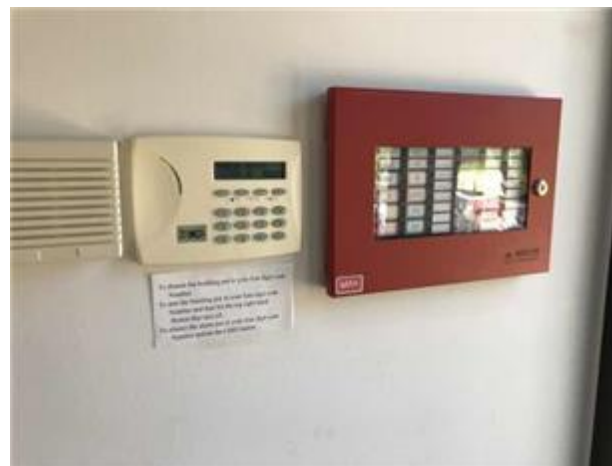
Coding / Field Name	Asset Description
D5037 Fire Alarm Systems	Fire Alarm System
Condition	Fair
Qty / UOM	7732 / SF
Unit Cost	\$2.36
Basis of Costing	Fire Alarm System, Full Upgrade/Install, Office (per SF)
Year in Service	2005
Expected Useful Life (EUL)	20 Year(s), Based on Industry Averages
Remaining Useful Life (RUL)	7 Year(s), Estimated, Based on Date of Observation
Location	Building Interior (General)

Uniformat	Action Description	Quantity	Unit Cost	Plan Type	Priority	Year	Expenditure
D5037	Replace Fire Alarm System	7,732 SF	\$2.36	BYL	Priority 2	2025	\$18,248

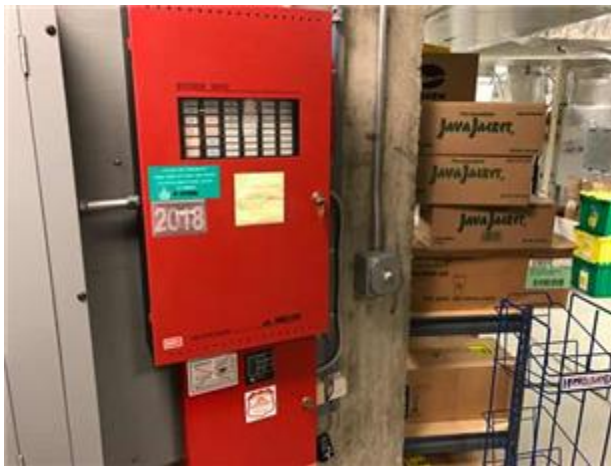
Coding / Field Name	Asset Description
D5037 Fire Alarm Systems	Fire Alarm Control Panel
Condition	Fair
Qty / UOM	1 / EA
Unit Cost	\$20,297.59
Basis of Costing	Fire Alarm Control Panel, Addressable
Year in Service	2005
Expected Useful Life (EUL)	15 Year(s), Based on Industry Averages
Remaining Useful Life (RUL)	4 Year(s), Estimated, Based on Date of Observation
Location	Basement

Unifomat	Action Description	Quantity	Unit Cost	Plan Type	Priority	Year	Expenditure
D5037	Replace Fire Alarm Control Panel	1 EA	\$20,297.59	BYL	Priority 2	2022	\$20,298
D5037	Replace Fire Alarm Control Panel	1 EA	\$20,297.59	BYL	Priority 2	2037	\$20,298

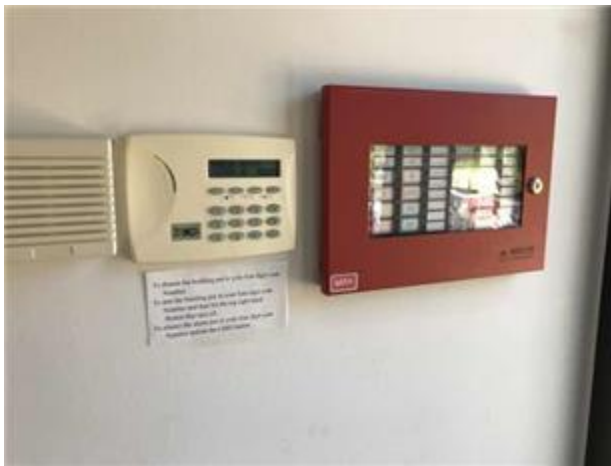
Coding / Field Name	Asset Description
D5038 Security and Detection Systems	Security System
Condition	Fair
Qty / UOM	1 / EA
Unit Cost	\$6,594.69
Basis of Costing	Security Control Panel
Year in Service	2005
Expected Useful Life (EUL)	15 Year(s), Based on Industry Averages
Remaining Useful Life (RUL)	3 Year(s), Estimated, Based on Date of Observation
Location	Building Interior (General)

Uniformat	Action Description	Quantity	Unit Cost	Plan Type	Priority	Year	Expenditure
D5038	Replace Security System	1 EA	\$6,594.69	BYL	Priority 1	2021	\$6,595
D5038	Replace Security System	1 EA	\$6,594.69	BYL	Priority 1	2036	\$6,595

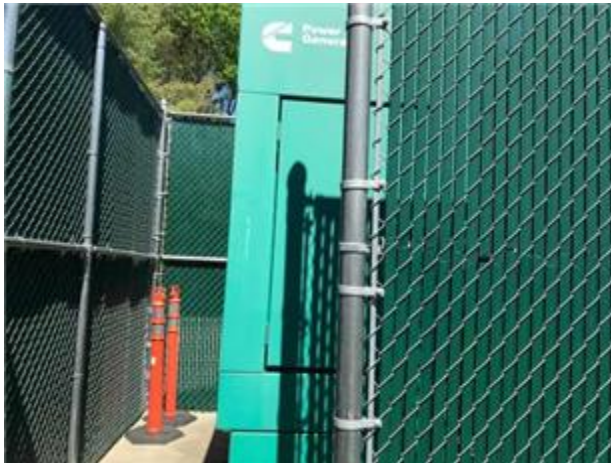
Coding / Field Name	Asset Description
D5092 Emergency Light & Power Systems	Generator, Diesel
Condition	Fair
Qty / UOM	1 / EA
Unit Cost	\$113,996.22
Basis of Costing	Generator, Diesel, 65 to 125 kW
Year in Service	2005
Expected Useful Life (EUL)	25 Year(s), Based on Industry Averages
Remaining Useful Life (RUL)	12 Year(s), Estimated, Based on Date of Observation
Location	Storage Building
Generator Fuel	Diesel
Power Rating kVA	67
Generator Serves	Fire And Life Safety Systems

Unformat	Action Description	Quantity	Unit Cost	Plan Type	Priority	Year	Expenditure
D5092	Replace Generator, Diesel	1 EA	\$113,996.22	BYL	Priority 3	2030	\$113,996

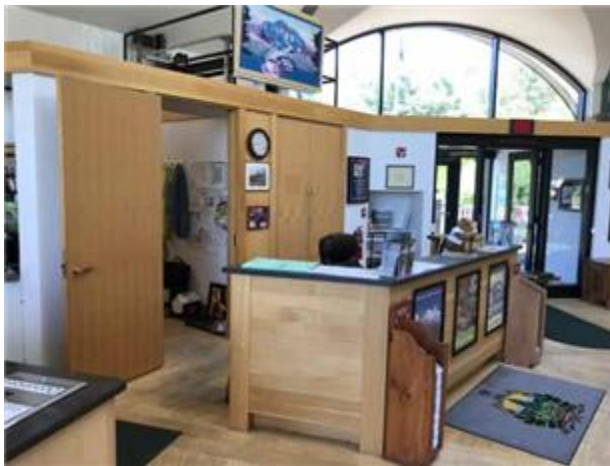
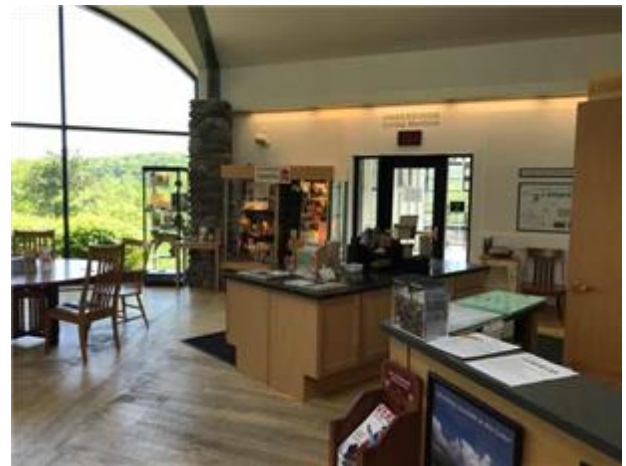
Coding / Field Name	Asset Description
E2012 Fixed Casework	Cabinet, Base Section and Counter, Wood
Condition	Fair
Qty / UOM	20 / LF
Unit Cost	\$467.63
Basis of Costing	Kitchen Cabinet, Base and Wall Section, Wood
Year in Service	2005
Expected Useful Life (EUL)	20 Year(s), Based on Industry Averages
Remaining Useful Life (RUL)	7 Year(s), Estimated, Based on Date of Observation
Location	Main lobby

Uniformat	Action Description	Quantity	Unit Cost	Plan Type	Priority	Year	Expenditure
E2012	Replace Cabinet, Base Section and Counter, Wood	20 LF	\$467.63	BYL	Priority 3	2025	\$9,353

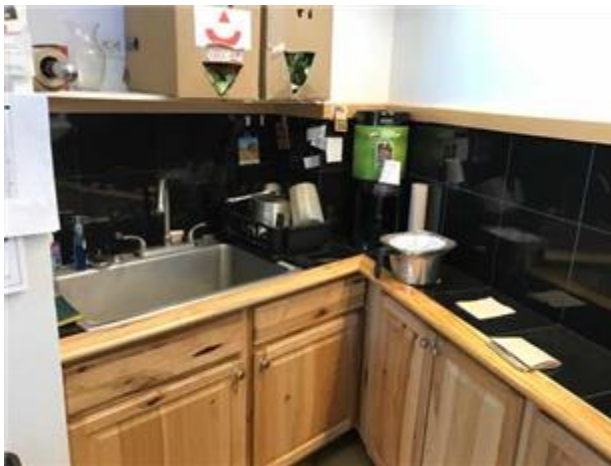
Coding / Field Name	Asset Description
E2012 Fixed Casework	Kitchen Cabinet, Base Section and Counter Wood
Condition	Fair
Qty / UOM	10 / LF
Unit Cost	\$467.63
Basis of Costing	Kitchen Cabinet, Base and Wall Section, Wood
Year in Service	2005
Expected Useful Life (EUL)	20 Year(s), Based on Industry Averages
Remaining Useful Life (RUL)	7 Year(s), Estimated, Based on Date of Observation
Location	Building Interior (General)

Uniformat	Action Description	Quantity	Unit Cost	Plan Type	Priority	Year	Expenditure
E2012	Replace Kitchen Cabinet, Base Section and Counter Wood	10 LF	\$467.63	BYL	Priority 3	2025	\$4,676

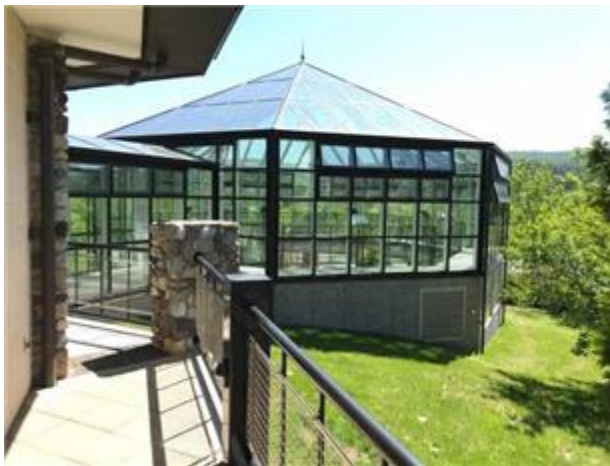
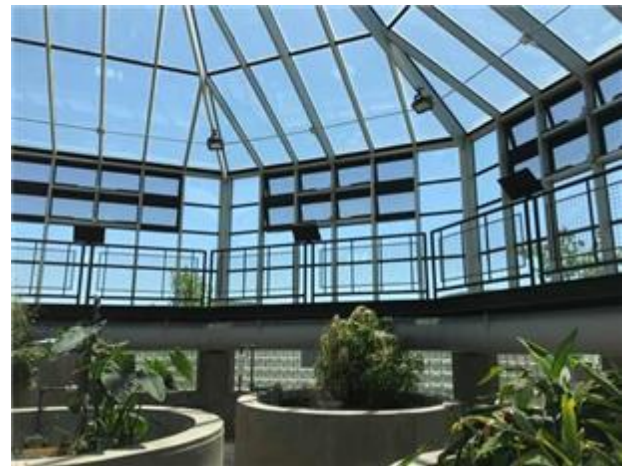
Coding / Field Name	Asset Description
F1049 Other Special Facilities	Greenhouse Structure, Glazing & Accessories
Condition	Fair
Qty / UOM	2500 / SF
Unit Cost	\$69.59
Basis of Costing	Greenhouse Structure, Glazing & Accessories
Year in Service	2005
Expected Useful Life (EUL)	30 Year(s), Based on Industry Averages
Remaining Useful Life (RUL)	17 Year(s), Estimated, Based on Date of Observation
Location	Exterior Walls

Uniformat	Action Description	Quantity	Unit Cost	Plan Type	Priority	Year	Expenditure
F1049	Replace Greenhouse Structure, Glazing & Accessories	2,500 SF	\$69.59	BYL	Priority 3	2035	\$173,969

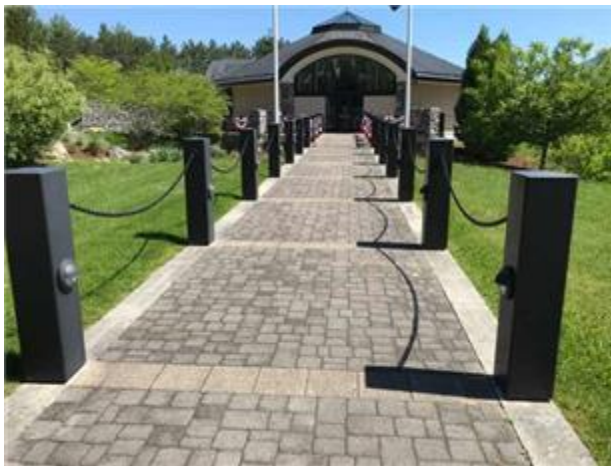
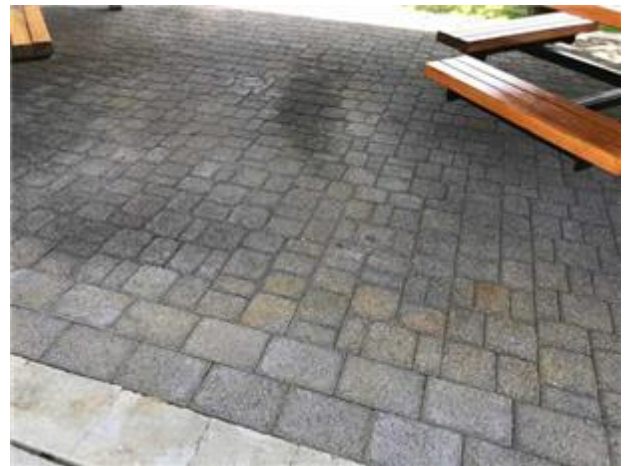
Coding / Field Name	Asset Description
G2031 Paving & Surfacing	Masonry Paver Sidewalk, Exterior
Condition	Fair
Qty / UOM	5000 / SF
Unit Cost	\$34.11
Basis of Costing	Clay Brick/Masonry Paver Sidewalk, Exterior
Year in Service	2005
Expected Useful Life (EUL)	30 Year(s), Based on Industry Averages
Remaining Useful Life (RUL)	17 Year(s), Estimated, Based on Date of Observation
Location	Site

Uniformat	Action Description	Quantity	Unit Cost	Plan Type	Priority	Year	Expenditure
G2031	Replace Masonry Paver Sidewalk, Exterior	5,000 SF	\$34.11	BYL	Priority 3	2035	\$170,544

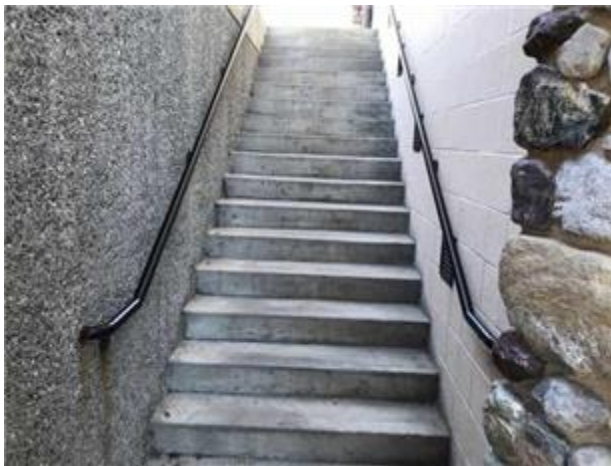
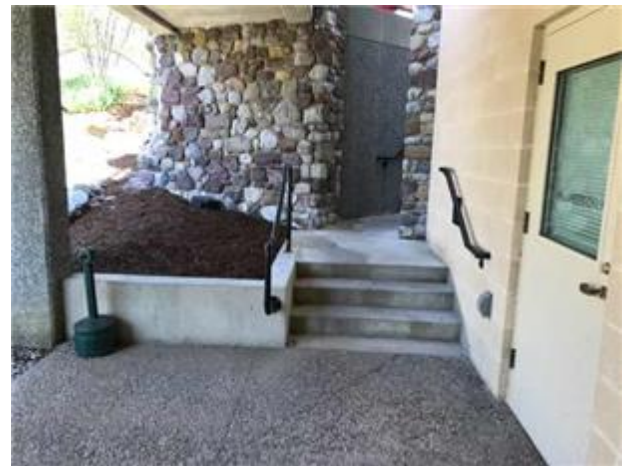
Coding / Field Name	Asset Description
G2035 Exterior Steps & Ramps	Concrete, Exterior Stairs
Condition	Fair
Qty / UOM	100 / LF
Unit Cost	\$38.43
Basis of Costing	Concrete Stairs (per LF of Nosing)
Year in Service	2005
Expected Useful Life (EUL)	25 Year(s), Based on Industry Averages
Remaining Useful Life (RUL)	12 Year(s), Estimated, Based on Date of Observation
Location	Exterior Walls

Unifomat	Action Description	Quantity	Unit Cost	Plan Type	Priority	Year	Expenditure
G2035	Replace Concrete, Exterior Stairs	100 LF	\$38.43	BYL	Priority 3	2030	\$3,843
