FACILITY CONDITION ASSESSMENT

FACILITY CONDITION ASSESSMENT
OF
SHARON NORTH INFORMATION CENTER
I-89 NORTHBOUND MILE MARKER 10
SHARON, VT 05065

December 17, 2018

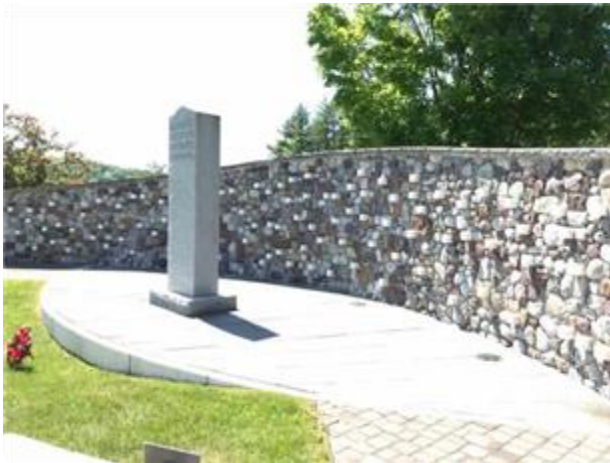
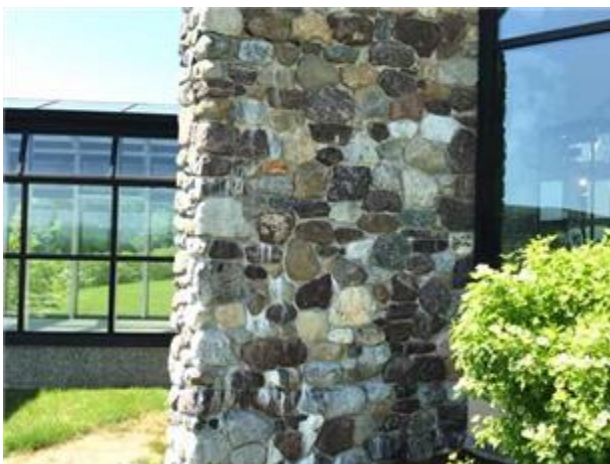
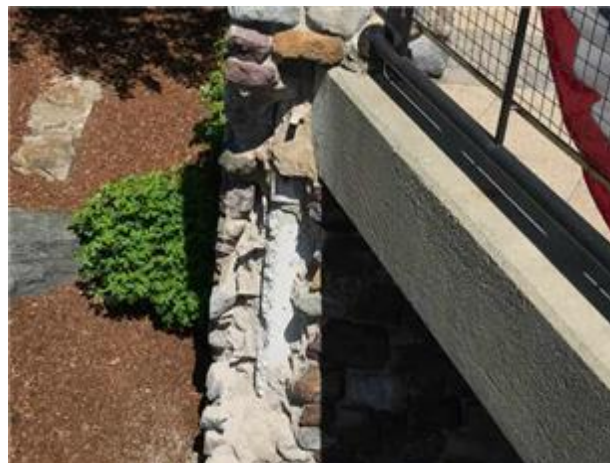
Coding / Field Name	Asset Description
G2042 Retaining Walls	Retaining and Garden Walls, Stone Faced
Condition	Good
Qty / UOM	250 / LF
Unit Cost	\$118.49
Basis of Costing	Retaining Wall, Cast-in-place Concrete (per SF Face)
Year in Service	2005
Expected Useful Life (EUL)	50 Year(s), Based on Industry Averages
Remaining Useful Life (RUL)	37 Year(s), Estimated, Based on Date of Observation
Location	Site

Portions of the stone veneer have failed and several areas are cracked. Immediate repairs are needed. Most of the mortar joints need repointing around the building. The memorial walls were capped and patched within the last 5 years.

Unifomat	Action Description	Quantity	Unit Cost	Plan Type	Priority	Year	Expenditure
G2042	Stone Masonry Wall - Joint Pointing	500 SF	\$5.31	MNT	Priority 3	2018	\$2,655
G2042	Stone Masonry Veneer Repair	200 SF	\$25.00	REL	Priority 2	2018	\$5,000

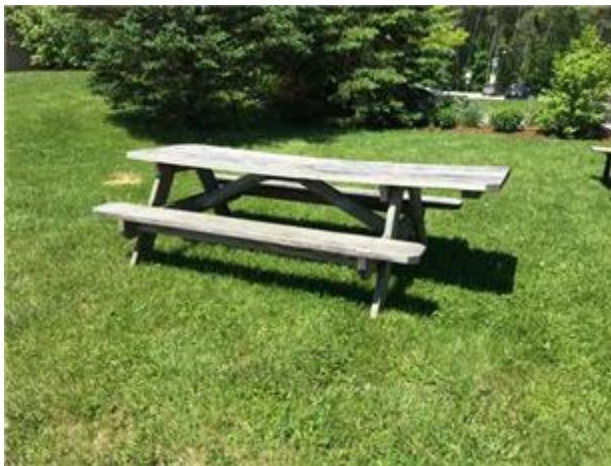
Coding / Field Name	Asset Description
G2045 SITE GATES	Picnic Table, Wood
Condition	Fair
Qty / UOM	4 / EA
Unit Cost	\$689.43
Basis of Costing	Picnic Table, Wood or Composite
Year in Service	2000
Expected Useful Life (EUL)	20 Year(s), Based on Industry Averages
Remaining Useful Life (RUL)	3 Year(s), Estimated, Based on Date of Observation
Location	Site

Uniformat	Action Description	Quantity	Unit Cost	Plan Type	Priority	Year	Expenditure
G2045	Replace Picnic Table, Wood	4 EA	\$689.43	BYL	Priority 2	2021	\$2,758

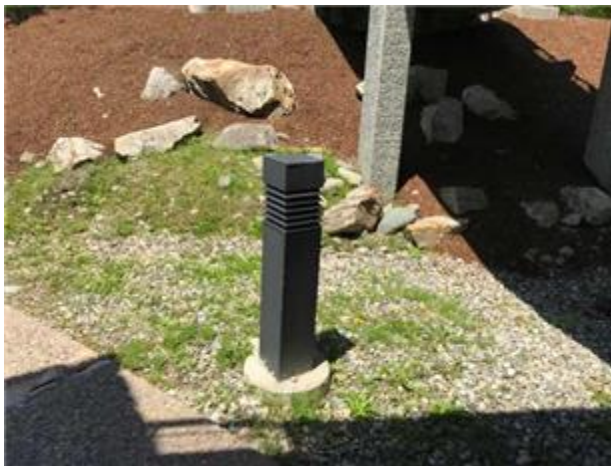
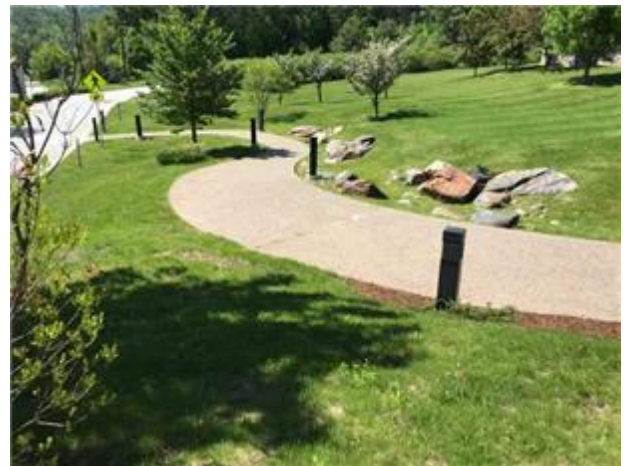
Coding / Field Name	Asset Description
G4021 Fixtures & Transformers	Walkway Bollard Light
Condition	Fair
Qty / UOM	13 / EA
Unit Cost	\$1,494.12
Basis of Costing	Walkway Bollard Light, 70 to 150 W HID
Year in Service	2005
Expected Useful Life (EUL)	20 Year(s), Based on Industry Averages
Remaining Useful Life (RUL)	7 Year(s), Estimated, Based on Date of Observation
Location	Site

Uniformat	Action Description	Quantity	Unit Cost	Plan Type	Priority	Year	Expenditure
G4021	Replace Walkway Bollard Light	13 EA	\$1,494.12	BYL	Priority 3	2025	\$19,424
