# FACILITY CONDITION ASSESSMENT

FACILITY CONDITION ASSESSMENT  
OF  
WILLISTON SOUTH INFORMATION CENTER  
I-89 SOUTHBOUND MILE MARKER 83  
WILLISTON, VT 05495

December 17, 2018

May 16, 2018

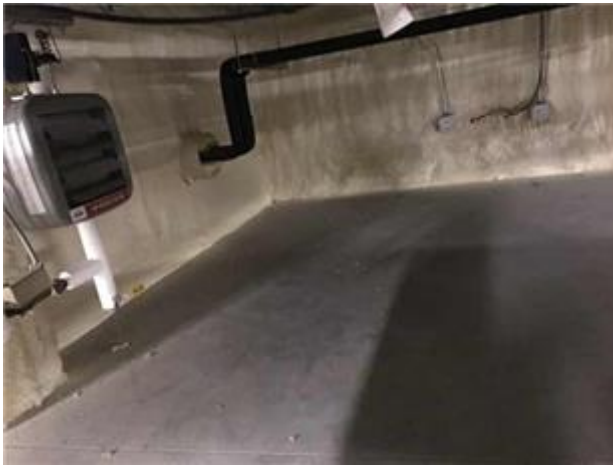
Coding / Field Name	Asset Description
<b>A1011 Wall Foundations</b>	Foundation, Perimeter Wall
<b>Condition</b>	Fair
<b>Qty / UOM</b>	300 / LF
<b>Unit Cost</b>	\$105.56
<b>Basis of Costing</b>	Foundation Wall, Concrete or CMU w/ Continuous Footings, 1-2 Stories
<b>Year in Service</b>	2002
<b>Expected Useful Life (EUL)</b>	50 Year(s), Based on Industry Averages
<b>Remaining Useful Life (RUL)</b>	34 Year(s), Estimated, Based on Date of Observation
<b>Location</b>	Structure

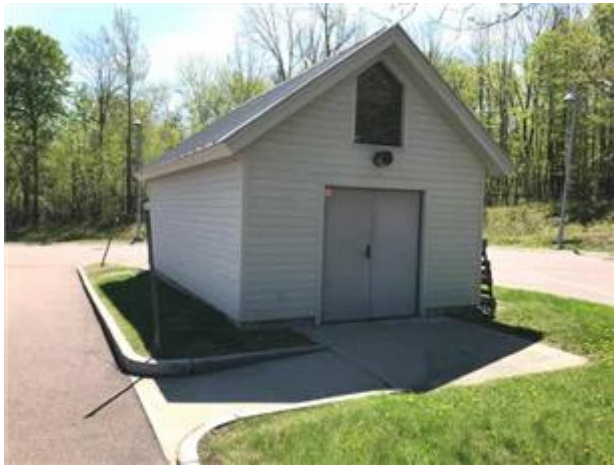
Coding / Field Name	Asset Description
<b>A1031 Standard Slab on Grade</b>	Concrete Slab-On-Grade
<b>Condition</b>	Fair
<b>Qty / UOM</b>	230 / SF
<b>Unit Cost</b>	\$10.44
<b>Basis of Costing</b>	Concrete Slab-On-Grade
<b>Year in Service</b>	2002
<b>Expected Useful Life (EUL)</b>	40 Year(s), Based on Industry Averages
<b>Remaining Useful Life (RUL)</b>	24 Year(s), Estimated, Based on Date of Observation
<b>Location</b>	Storage Building/Map Kiosk

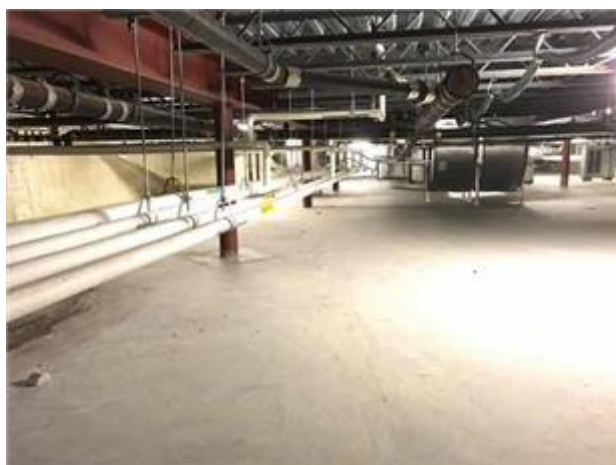
Coding / Field Name	Asset Description
<b>B1012 Upper Floors Construction</b>	Superstructure, Light Gauge Steel with Slab
<b>Condition</b>	Good
<b>Qty / UOM</b>	4600 / SF
<b>Unit Cost</b>	\$24.13
<b>Basis of Costing</b>	Superstructure, Structural Frame, Steel Light Gauge
<b>Year in Service</b>	2002
<b>Expected Useful Life (EUL)</b>	50 Year(s), Based on Industry Averages
<b>Remaining Useful Life (RUL)</b>	34 Year(s), Estimated, Based on Date of Observation
<b>Location</b>	Structure

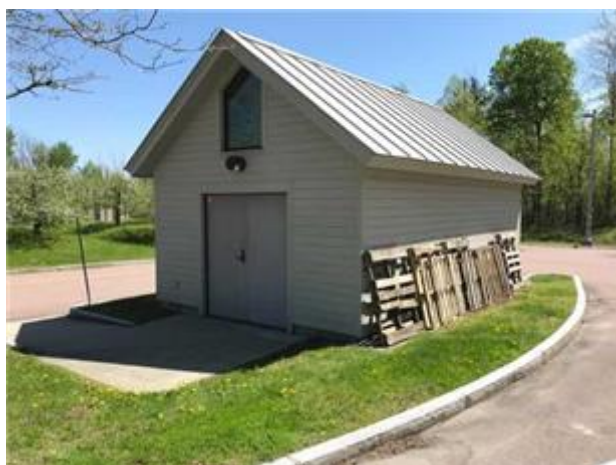
Coding / Field Name	Asset Description
<b>B1022 Pitched Roof Construction</b>	Roof Structure, Pitched, Wood Trusses
<b>Condition</b>	Good
<b>Qty / UOM</b>	230 / SF
<b>Unit Cost</b>	\$18.56
<b>Basis of Costing</b>	Roof Structure, Pitched, Wood Trusses
<b>Year in Service</b>	2002
<b>Expected Useful Life (EUL)</b>	50 Year(s), Based on Industry Averages
<b>Remaining Useful Life (RUL)</b>	34 Year(s), Estimated, Based on Date of Observation
<b>Location</b>	Storage Building/Map Kiosk

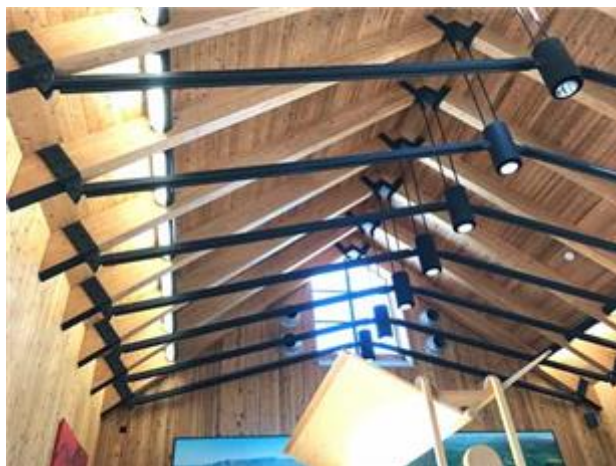
Coding / Field Name	Asset Description
<b>B1022 Pitched Roof Construction</b>	Pitched Roof Construction
<b>Condition</b>	Good
<b>Qty / UOM</b>	4588 / SF
<b>Unit Cost</b>	\$31.32
<b>Basis of Costing</b>	Roof Structure, Pitched, Heavy Timber Framing
<b>Year in Service</b>	2002
<b>Expected Useful Life (EUL)</b>	50 Year(s), Based on Industry Averages
<b>Remaining Useful Life (RUL)</b>	34 Year(s), Estimated, Based on Date of Observation
<b>Location</b>	Building Interior (General)

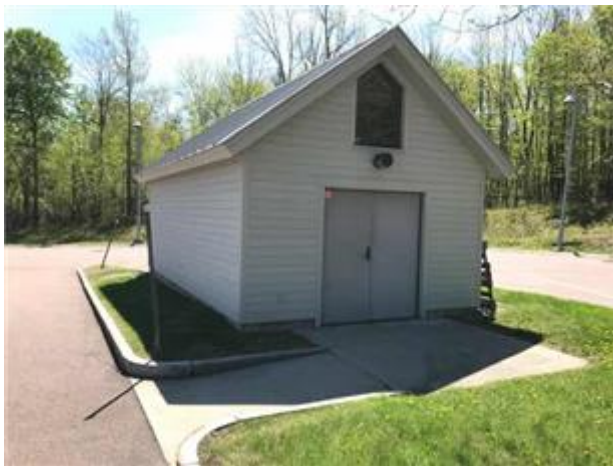
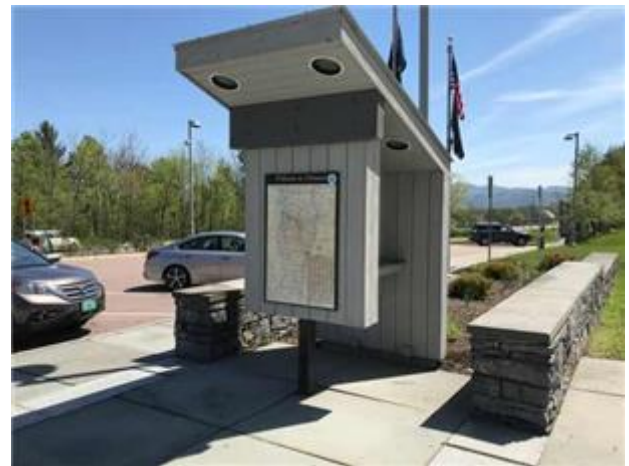
Coding / Field Name	Asset Description
<b>B2011 Exterior Wall Construction</b>	Wood Vertical Board, Exterior Siding
<b>Condition</b>	Good
<b>Qty / UOM</b>	550 / SF
<b>Unit Cost</b>	\$28.04
<b>Basis of Costing</b>	Wood Clapboard, Exterior, 3+ Stories
<b>Year in Service</b>	2002
<b>Expected Useful Life (EUL)</b>	20 Year(s), Based on Industry Averages
<b>Remaining Useful Life (RUL)</b>	15 Year(s), Estimated, Based on Date of Observation
<b>Location</b>	Storage Building/Map Kiosk

Uniformat	Action Description	Quantity	Unit Cost	Plan Type	Priority	Year	Expenditure
<b>B2011</b>	Prep & Paint Exterior Walls	550 SF	\$1.24	APP	Priority 3	2023	\$682
<b>B2011</b>	Prep & Paint Exterior Walls	550 SF	\$1.24	APP	Priority 3	2033	\$682
<b>B2011</b>	Replace Wood Vertical Board, Exterior Siding	550 SF	\$28.04	BYL	Priority 3	2033	\$15,421

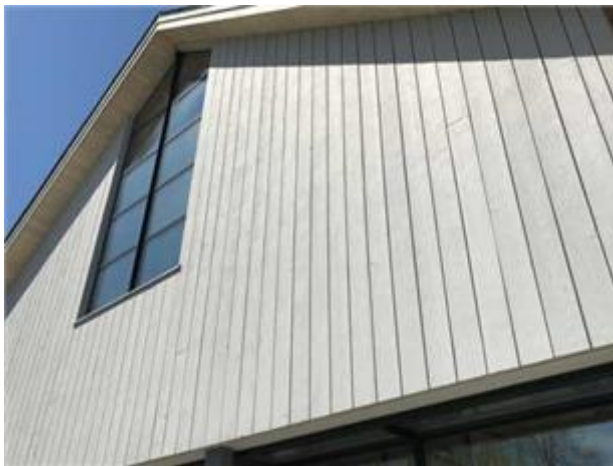
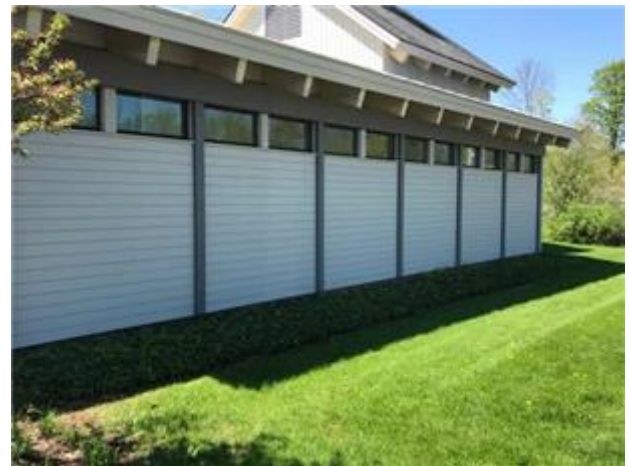
Coding / Field Name	Asset Description
<b>B2011 Exterior Wall Construction</b>	Wood Vertical Board, Exterior Siding
<b>Condition</b>	Good
<b>Qty / UOM</b>	3200 / SF
<b>Unit Cost</b>	\$28.04
<b>Basis of Costing</b>	Wood Clapboard, Exterior, 3+ Stories
<b>Year in Service</b>	2002
<b>Expected Useful Life (EUL)</b>	20 Year(s), Based on Industry Averages
<b>Remaining Useful Life (RUL)</b>	15 Year(s), Estimated, Based on Date of Observation
<b>Location</b>	Exterior Walls

Uniformat	Action Description	Quantity	Unit Cost	Plan Type	Priority	Year	Expenditure
<b>B2011</b>	Prep & Paint Exterior Walls	3,200 SF	\$1.41	APP	Priority 3	2019	\$4,512
<b>B2011</b>	Prep & Paint Exterior Walls	3,200 SF	\$1.41	APP	Priority 3	2029	\$4,512
<b>B2011</b>	Replace Wood Vertical Board, Exterior Siding	3,200 SF	\$28.04	BYL	Priority 3	2033	\$89,719

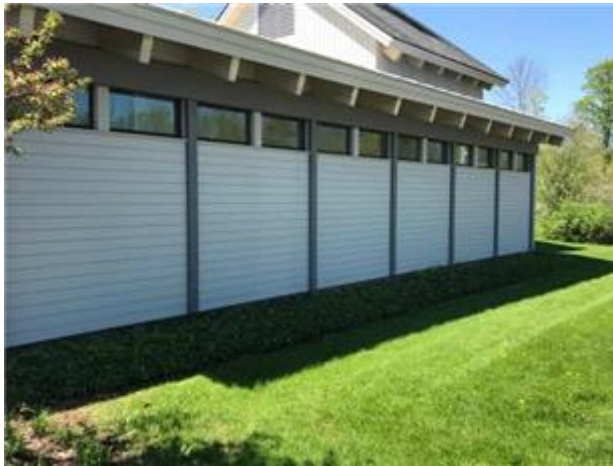
Coding / Field Name	Asset Description
<b>B2021 Windows</b>	Aluminum Window, Double Glazed, Fixed
<b>Condition</b>	Fair
<b>Qty / UOM</b>	14 / EA
<b>Unit Cost</b>	\$1,051.57
<b>Basis of Costing</b>	Aluminum Window, Double Glazed, 1-2 Stories, 12 SF
<b>Year in Service</b>	2002
<b>Expected Useful Life (EUL)</b>	30 Year(s), Based on Industry Averages
<b>Remaining Useful Life (RUL)</b>	14 Year(s), Estimated, Based on Date of Observation
<b>Location</b>	Exterior Walls
<b>Window Type</b>	Fixed
<b>Windows Material</b>	Aluminum
<b>Windows Glazing</b>	Double Glazed
<b>Window Operation</b>	Fixed

Unifomat	Action Description	Quantity	Unit Cost	Plan Type	Priority	Year	Expenditure
<b>B2021</b>	Replace Aluminum Window, Double Glazed, Fixed	14 EA	\$1,051.57	BYL	Priority 3	2032	\$14,722

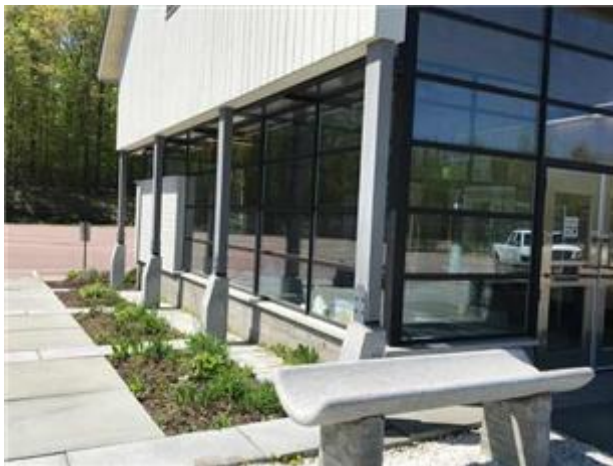
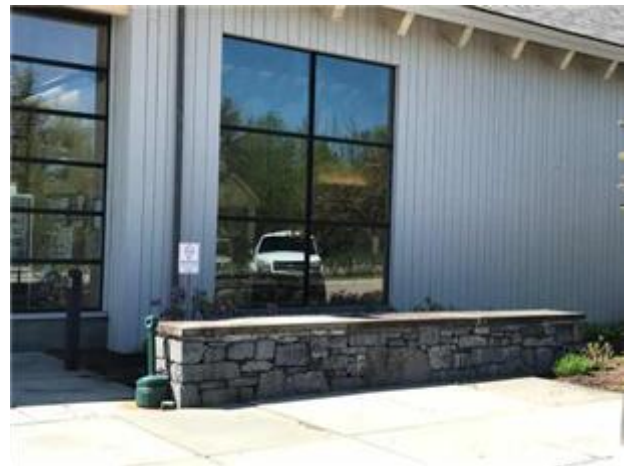
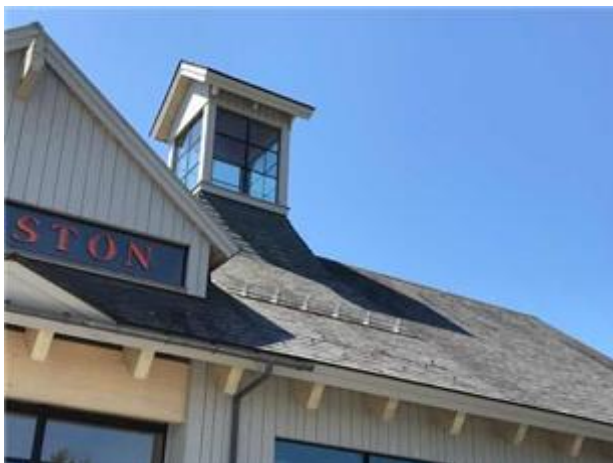
Coding / Field Name	Asset Description
<b>B2022 Curtain Walls</b>	Storefront Glazing & Framing
<b>Condition</b>	Fair
<b>Qty / UOM</b>	500 / SF
<b>Unit Cost</b>	\$87.21
<b>Basis of Costing</b>	Glass Curtain Wall
<b>Year in Service</b>	2002
<b>Expected Useful Life (EUL)</b>	30 Year(s), Based on Industry Averages
<b>Remaining Useful Life (RUL)</b>	14 Year(s), Estimated, Based on Date of Observation
<b>Location</b>	Exterior Walls
<b>Window Type</b>	Fixed
<b>Windows Material</b>	Aluminum
<b>Windows Glazing</b>	Double Glazed
<b>Window Operation</b>	Fixed

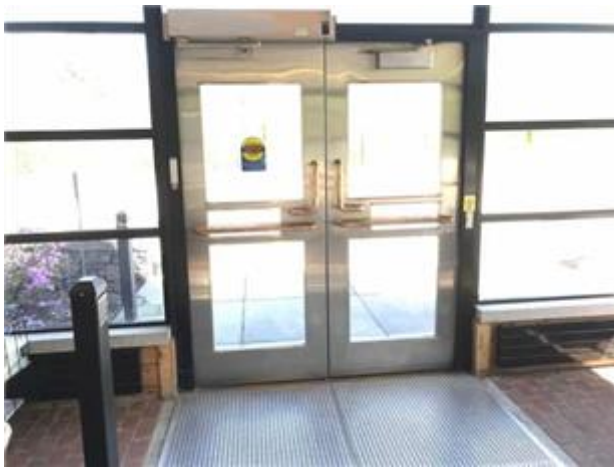
Coding / Field Name	Asset Description
<b>B2031 Glazed Doors &amp; Entrances</b>	Glazed Entrance Doors
<b>Condition</b>	Fair
<b>Qty / UOM</b>	4 / EA
<b>Unit Cost</b>	\$10,194.36
<b>Basis of Costing</b>	Metal, Swinging Doors, Motor-Operated
<b>Year in Service</b>	2002
<b>Expected Useful Life (EUL)</b>	30 Year(s), Based on Industry Averages
<b>Remaining Useful Life (RUL)</b>	14 Year(s), Estimated, Based on Date of Observation
<b>Location</b>	Exterior Walls

Uniformat	Action Description	Quantity	Unit Cost	Plan Type	Priority	Year	Expenditure
<b>B2031</b>	Replace Glazed Entrance Doors	4 EA	\$10,194.36	BYL	Priority 3	2032	\$40,777

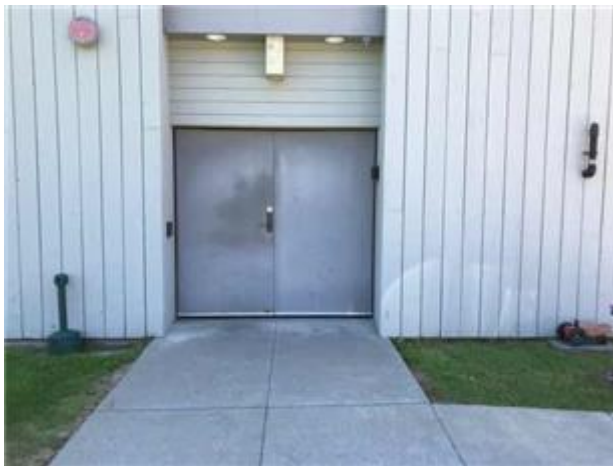
Coding / Field Name	Asset Description
<b>B2032 Solid Exterior Doors</b>	Steel, Exterior Door
<b>Condition</b>	Fair
<b>Qty / UOM</b>	2 / EA
<b>Unit Cost</b>	\$950.12
<b>Basis of Costing</b>	Steel, Exterior Door
<b>Year in Service</b>	2002
<b>Expected Useful Life (EUL)</b>	25 Year(s), Based on Industry Averages
<b>Remaining Useful Life (RUL)</b>	9 Year(s), Estimated, Based on Date of Observation
<b>Location</b>	Exterior Walls

Uniformat	Action Description	Quantity	Unit Cost	Plan Type	Priority	Year	Expenditure
<b>B2032</b>	Replace Steel, Exterior Door	2 EA	\$950.12	BYL	Priority 3	2027	\$1,900

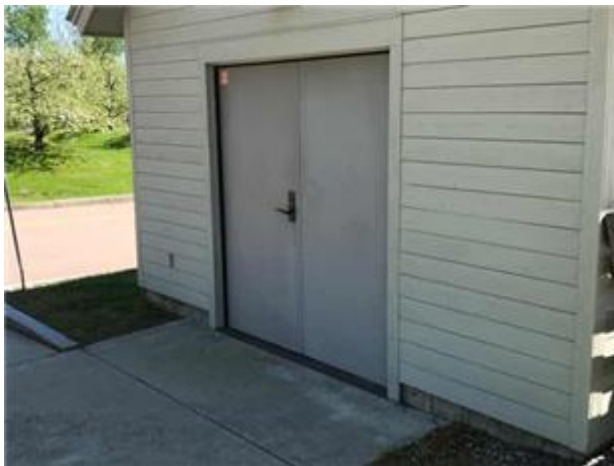
Coding / Field Name	Asset Description
<b>B2032 Solid Exterior Doors</b>	Steel, Exterior Door
<b>Condition</b>	Fair
<b>Qty / UOM</b>	2 / EA
<b>Unit Cost</b>	\$950.12
<b>Basis of Costing</b>	Steel, Exterior Door
<b>Year in Service</b>	2002
<b>Expected Useful Life (EUL)</b>	25 Year(s), Based on Industry Averages
<b>Remaining Useful Life (RUL)</b>	9 Year(s), Estimated, Based on Date of Observation
<b>Location</b>	Storage Building/Map Kiosk

Uniformat	Action Description	Quantity	Unit Cost	Plan Type	Priority	Year	Expenditure
<b>B2032</b>	Replace Steel, Exterior Door	2 EA	\$950.12	BYL	Priority 3	2027	\$1,900

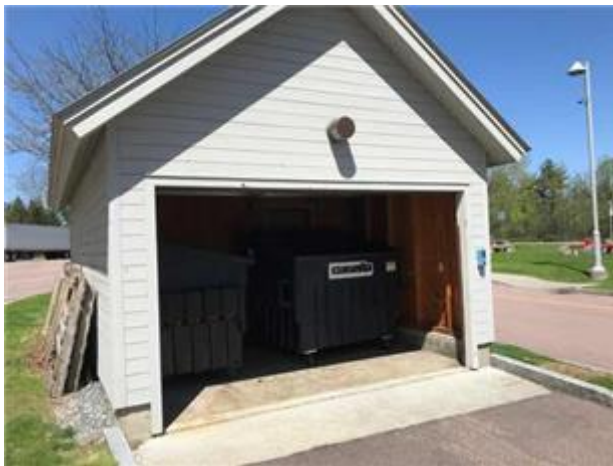
Coding / Field Name	Asset Description
<b>B2034 Overhead Doors</b>	Aluminum Roll-up Door
<b>Condition</b>	Fair
<b>Qty / UOM</b>	1 / EA
<b>Unit Cost</b>	\$4,025.54
<b>Basis of Costing</b>	Aluminum Roll-up Door, 144 SF
<b>Year in Service</b>	2002
<b>Expected Useful Life (EUL)</b>	35 Year(s), Based on Industry Averages
<b>Remaining Useful Life (RUL)</b>	19 Year(s), Estimated, Based on Date of Observation
<b>Location</b>	Storage Building/Map Kiosk

Uniformat	Action Description	Quantity	Unit Cost	Plan Type	Priority	Year	Expenditure
<b>B2034</b>	Replace Aluminum Roll-up Door	1 EA	\$4,025.54	BYL	Priority 3	2037	\$4,026

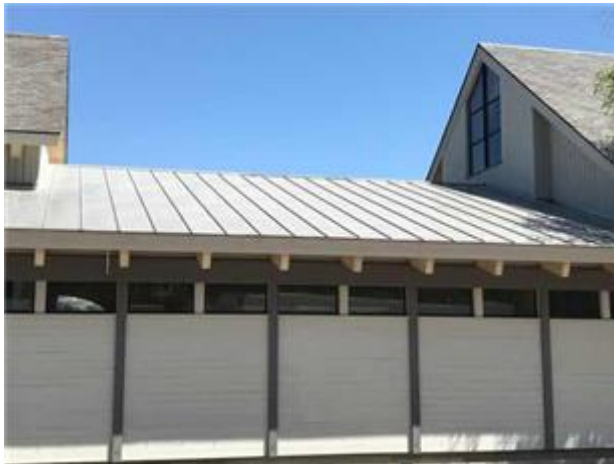
Coding / Field Name	Asset Description
<b>B3011 Roof Finishes</b>	Metal Roof
<b>Condition</b>	Fair
<b>Qty / UOM</b>	2400 / SF
<b>Unit Cost</b>	\$32.41
<b>Basis of Costing</b>	Metal Roof (Includes Tear-Off of Old)
<b>Year in Service</b>	2002
<b>Expected Useful Life (EUL)</b>	40 Year(s), Based on Industry Averages
<b>Remaining Useful Life (RUL)</b>	24 Year(s), Estimated, Based on Date of Observation
<b>Location</b>	Roof
<b>Flashings and Trim</b>	Metal
<b>Roof Eaves and Soffits</b>	Yes
<b>Roof Drainage</b>	Drains Over The Eaves
<b>Roof Warranty</b>	Unknown

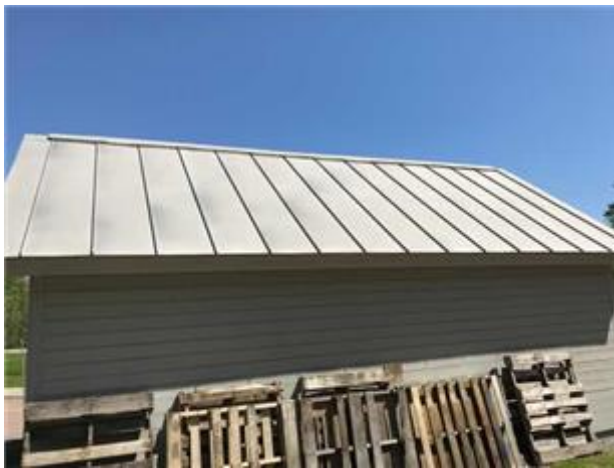
Coding / Field Name	Asset Description
<b>B3011 Roof Finishes</b>	Metal Roof
<b>Condition</b>	Fair
<b>Qty / UOM</b>	300 / SF
<b>Unit Cost</b>	\$32.41
<b>Basis of Costing</b>	Metal Roof (Includes Tear-Off of Old)
<b>Year in Service</b>	2002
<b>Expected Useful Life (EUL)</b>	40 Year(s), Based on Industry Averages
<b>Remaining Useful Life (RUL)</b>	24 Year(s), Estimated, Based on Date of Observation
<b>Location</b>	Storage Building/Map Kiosk
<b>Flashings and Trim</b>	Metal
<b>Roof Eaves and Soffits</b>	Yes
<b>Roof Drainage</b>	Drains Over The Eaves
<b>Roof Warranty</b>	Unknown

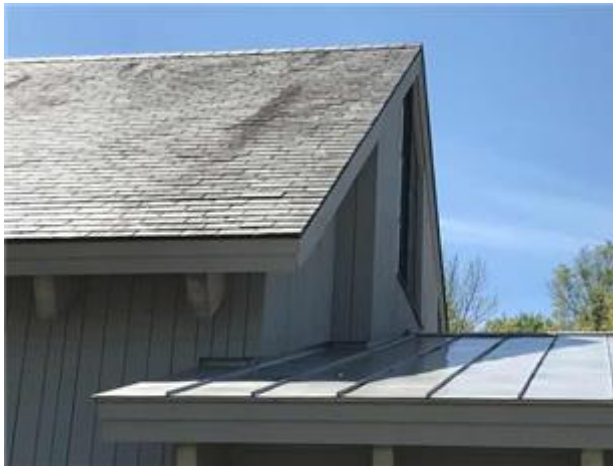
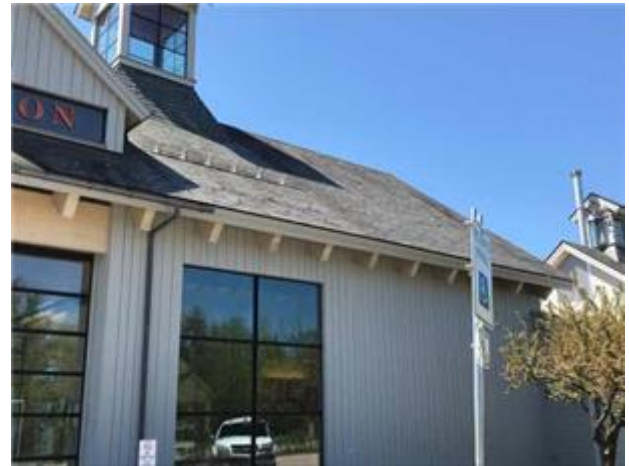
Coding / Field Name	Asset Description
<b>B3011 Roof Finishes</b>	Roof, Slate
<b>Condition</b>	Fair
<b>Qty / UOM</b>	2200 / SF
<b>Unit Cost</b>	\$29.80
<b>Basis of Costing</b>	Slate Steep Roof (Includes Tear-Off of Old)
<b>Year in Service</b>	2002
<b>Expected Useful Life (EUL)</b>	40 Year(s), Based on Industry Averages
<b>Remaining Useful Life (RUL)</b>	24 Year(s), Estimated, Based on Date of Observation
<b>Location</b>	Roof
<b>Flashings and Trim</b>	Metal
<b>Roof Eaves and Soffits</b>	Yes
<b>Roof Drainage</b>	Drains Over The Eaves
<b>Roof Warranty</b>	Unknown

Unifomat	Action Description	Quantity	Unit Cost	Plan Type	Priority	Year	Expenditure
<b>B3011</b>	Slate Steep Roofing, Minor Tile - (2.5% of Roof Area)	60 SF	\$56.36	MNT	Priority 2	2019	\$3,382
<b>B3011</b>	Slate Steep Roofing, Minor Tile - (2.5% of Roof Area)	60 SF	\$56.36	MNT	Priority 2	2024	\$3,382
<b>B3011</b>	Slate Steep Roofing, Minor Tile - (2.5% of Roof Area)	60 SF	\$56.36	MNT	Priority 2	2029	\$3,382
<b>B3011</b>	Slate Steep Roofing, Minor Tile - (2.5% of Roof Area)	60 SF	\$56.36	MNT	Priority 2	2034	\$3,382

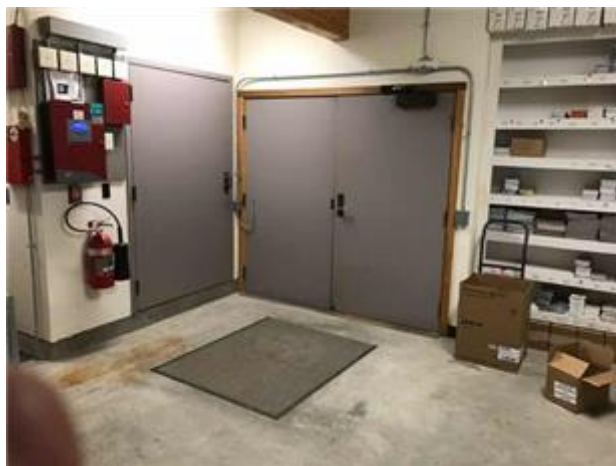
Coding / Field Name	Asset Description
<b>C1021 Interior Doors</b>	Interior Doors, Steel
<b>Condition</b>	Fair
<b>Qty / UOM</b>	3 / EA
<b>Unit Cost</b>	\$950.12
<b>Basis of Costing</b>	Steel, Interior Door
<b>Year in Service</b>	2002
<b>Expected Useful Life (EUL)</b>	25 Year(s), Based on Industry Averages
<b>Remaining Useful Life (RUL)</b>	9 Year(s), Estimated, Based on Date of Observation
<b>Location</b>	Building Interior (General)

Uniformat	Action Description	Quantity	Unit Cost	Plan Type	Priority	Year	Expenditure
<b>C1021</b>	Replace Interior Doors, Steel	3 EA	\$950.12	BYL	Priority 3	2027	\$2,850

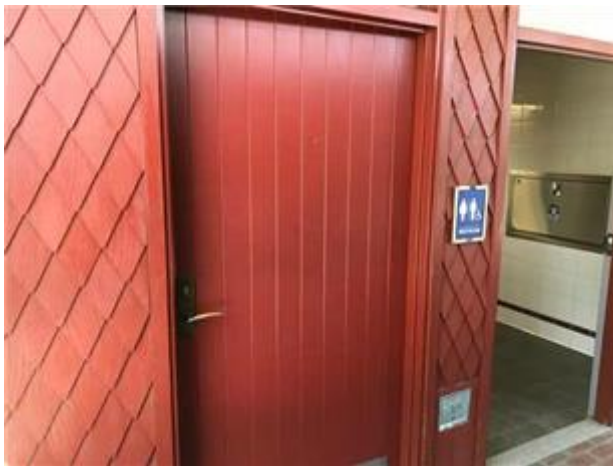
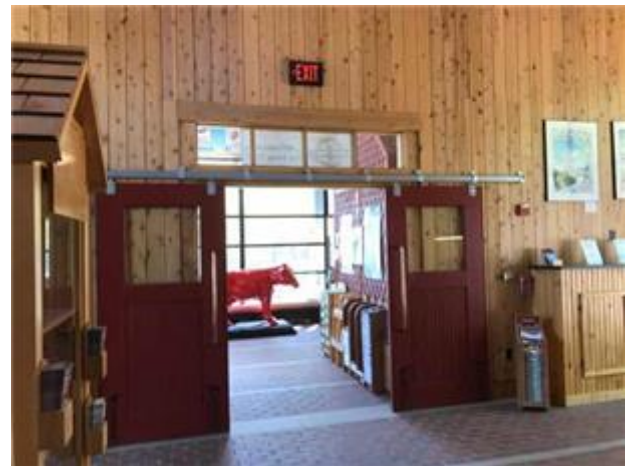
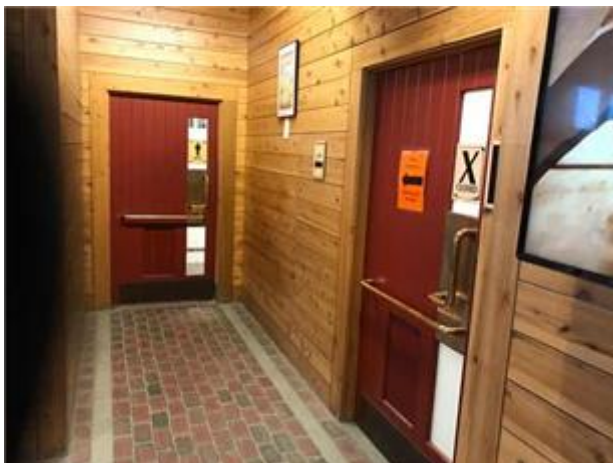
Coding / Field Name	Asset Description
<b>C1021 Interior Doors</b>	Interior Doors, Wood
<b>Condition</b>	Fair
<b>Qty / UOM</b>	8 / EA
<b>Unit Cost</b>	\$1,423.11
<b>Basis of Costing</b>	Wood, Solid Core, Painted/Stained, Interior Door
<b>Year in Service</b>	2002
<b>Expected Useful Life (EUL)</b>	20 Year(s), Based on Industry Averages
<b>Remaining Useful Life (RUL)</b>	10 Year(s), Estimated, Based on Date of Observation
<b>Location</b>	Building Interior (General)

Unimat	Action Description	Quantity	Unit Cost	Plan Type	Priority	Year	Expenditure
<b>C1021</b>	Replace Interior Doors, Wood	8 EA	\$1,423.11	BYL	Priority 3	2028	\$11,385

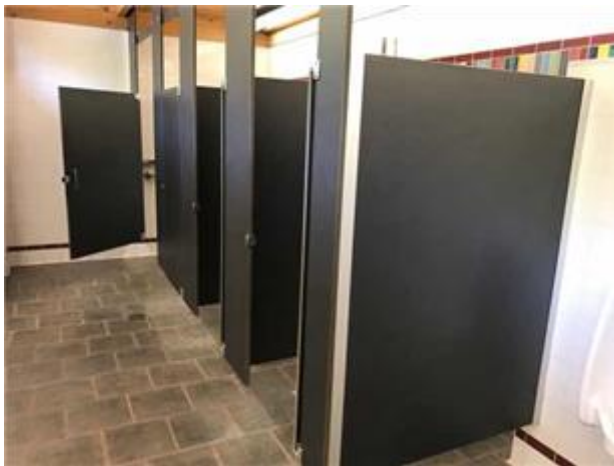
Coding / Field Name	Asset Description
<b>C1031 Fabricated Toilet Partitions</b>	Toilet Partitions, Laminated Wood
<b>Condition</b>	Fair
<b>Qty / UOM</b>	18 / EA
<b>Unit Cost</b>	\$465.02
<b>Basis of Costing</b>	Toilet Partitions, Wood
<b>Year in Service</b>	2002
<b>Expected Useful Life (EUL)</b>	20 Year(s), Based on Industry Averages
<b>Remaining Useful Life (RUL)</b>	7 Year(s), Estimated, Based on Date of Observation
<b>Location</b>	Restrooms

Uniformat	Action Description	Quantity	Unit Cost	Plan Type	Priority	Year	Expenditure
<b>C1031</b>	Replace Toilet Partitions, Laminated Wood	18 EA	\$465.02	BYL	Priority 3	2025	\$8,370

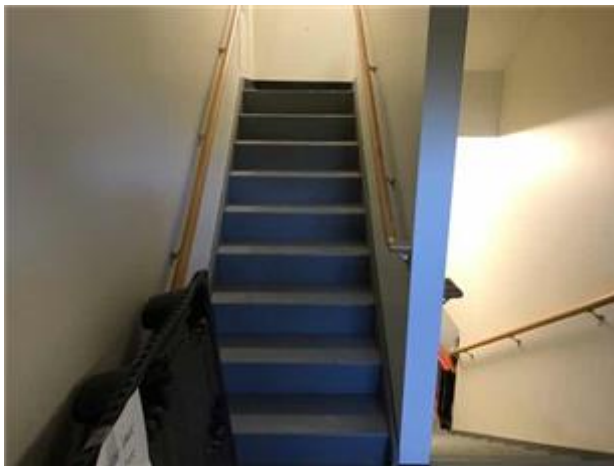
Coding / Field Name	Asset Description
<b>C2011 Regular Stairs</b>	Stairs, Wood
<b>Condition</b>	Fair
<b>Qty / UOM</b>	100 / SF
<b>Unit Cost</b>	\$45.09
<b>Basis of Costing</b>	Wood, Interior Stairs
<b>Year in Service</b>	2002
<b>Expected Useful Life (EUL)</b>	30 Year(s), Based on Industry Averages
<b>Remaining Useful Life (RUL)</b>	21 Year(s), Estimated, Based on Date of Observation
<b>Location</b>	Crawlspace

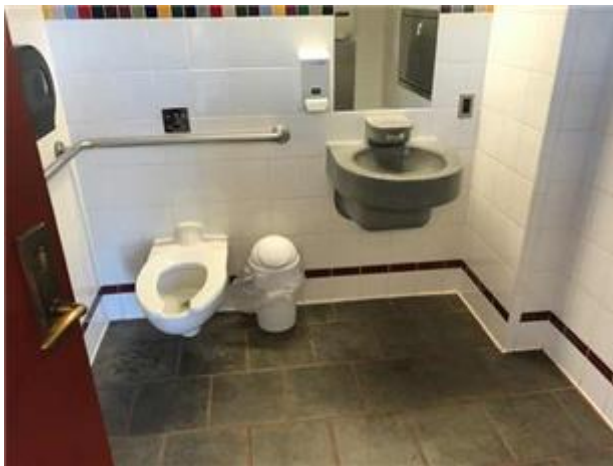
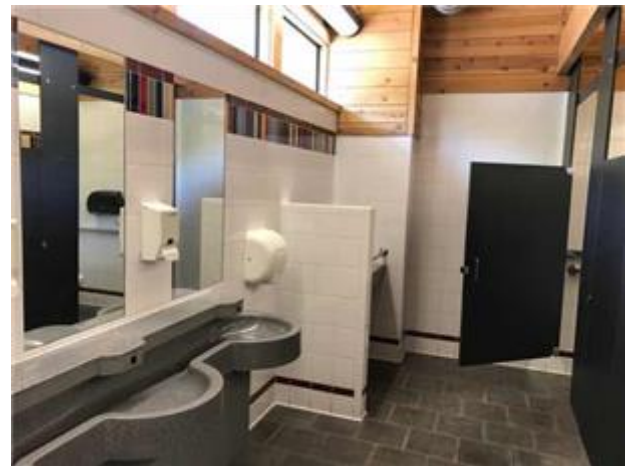
Coding / Field Name	Asset Description
<b>C3012 Wall Finishes to Interior Walls</b>	Ceramic Tile, Interior Wall Finish
<b>Condition</b>	Fair
<b>Qty / UOM</b>	1850 / SF
<b>Unit Cost</b>	\$16.55
<b>Basis of Costing</b>	Ceramic Tile, Interior Wall Finish
<b>Year in Service</b>	2002
<b>Expected Useful Life (EUL)</b>	25 Year(s), Based on Industry Averages
<b>Remaining Useful Life (RUL)</b>	15 Year(s), Estimated, Based on Date of Observation
<b>Location</b>	Restrooms

Uniformat	Action Description	Quantity	Unit Cost	Plan Type	Priority	Year	Expenditure
<b>C3012</b>	Replace Ceramic Tile, Interior Wall Finish	1,850 SF	\$16.55	BYL	Priority 4	2033	\$30,625

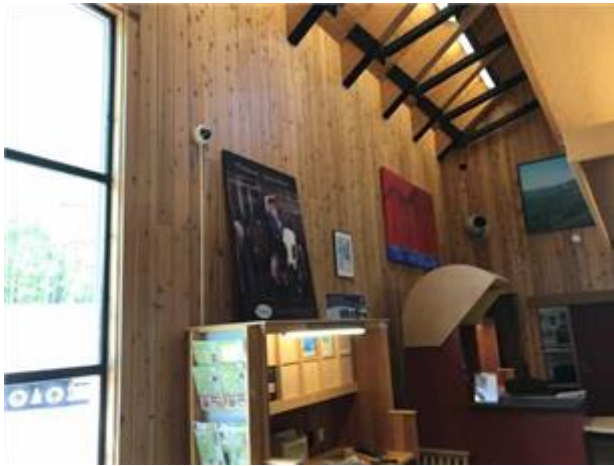
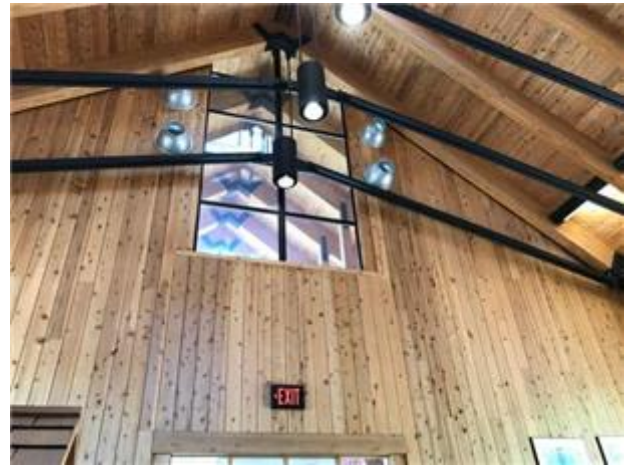
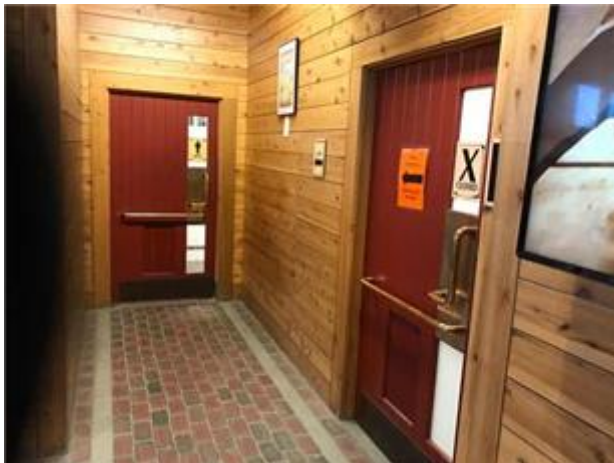
Coding / Field Name	Asset Description
<b>C3012 Wall Finishes to Interior Walls</b>	Interior Wall, Wood, Shiplap
<b>Condition</b>	Fair
<b>Qty / UOM</b>	2200 / SF
<b>Unit Cost</b>	\$23.73
<b>Basis of Costing</b>	Wood, Finished, Interior Paneling
<b>Year in Service</b>	2002
<b>Expected Useful Life (EUL)</b>	20 Year(s), Based on Industry Averages
<b>Remaining Useful Life (RUL)</b>	4 Year(s), Estimated, Based on Date of Observation
<b>Location</b>	Building Interior (General)

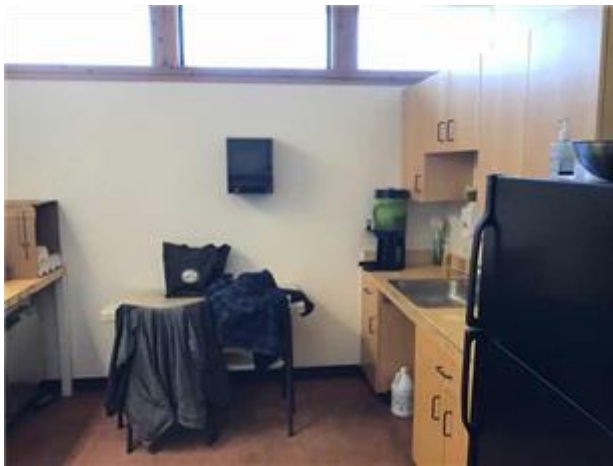
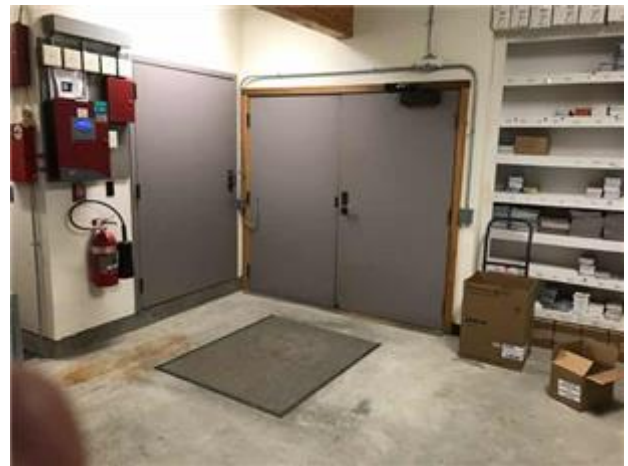
Coding / Field Name	Asset Description
<b>C3012 Wall Finishes to Interior Walls</b>	Gypsum Board, Wall
<b>Condition</b>	Fair
<b>Qty / UOM</b>	1800 / SF
<b>Unit Cost</b>	\$3.38
<b>Basis of Costing</b>	Gypsum Board/Plaster, Interior Wall
<b>Year in Service</b>	2002
<b>Expected Useful Life (EUL)</b>	40 Year(s), Based on Industry Averages
<b>Remaining Useful Life (RUL)</b>	24 Year(s), Estimated, Based on Date of Observation
<b>Location</b>	Building Interior (General)

Uniformat	Action Description	Quantity	Unit Cost	Plan Type	Priority	Year	Expenditure
<b>C3012</b>	Paint Interior Walls	1,800 SF	\$1.42	APP	Priority 4	2023	\$2,556
<b>C3012</b>	Paint Interior Walls	1,800 SF	\$1.42	APP	Priority 4	2031	\$2,556

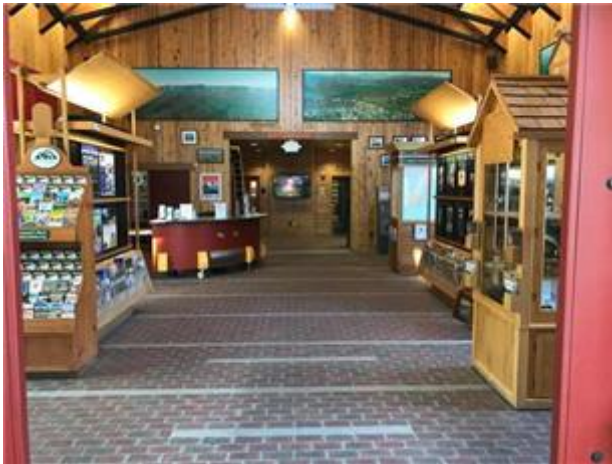
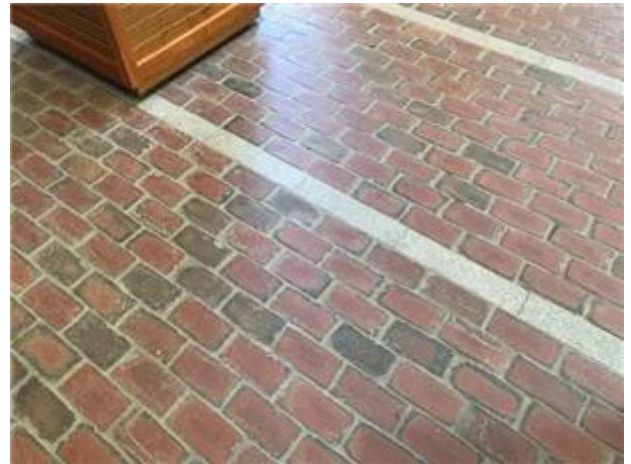
Coding / Field Name	Asset Description
<b>C3024 Flooring</b>	Clay Brick Flooring
<b>Condition</b>	Fair
<b>Qty / UOM</b>	1130 / SF
<b>Unit Cost</b>	\$42.65
<b>Basis of Costing</b>	Clay Brick Flooring
<b>Year in Service</b>	2002
<b>Expected Useful Life (EUL)</b>	50 Year(s), Based on Industry Averages
<b>Remaining Useful Life (RUL)</b>	34 Year(s), Estimated, Based on Date of Observation
<b>Location</b>	Building Interior (General)

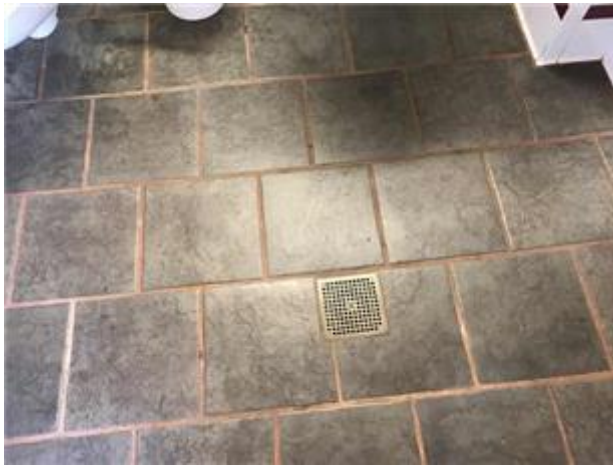
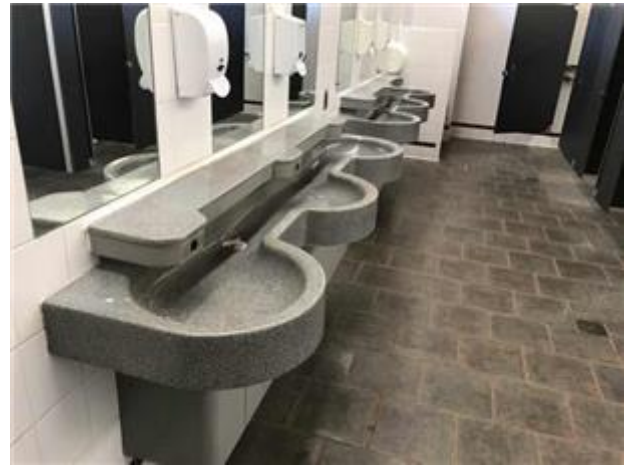
Coding / Field Name	Asset Description
<b>C3024 Flooring</b>	Quarry Tile Flooring
<b>Condition</b>	Fair
<b>Qty / UOM</b>	650 / SF
<b>Unit Cost</b>	\$15.19
<b>Basis of Costing</b>	Quarry Tile Flooring
<b>Year in Service</b>	2002
<b>Expected Useful Life (EUL)</b>	50 Year(s), Based on Industry Averages
<b>Remaining Useful Life (RUL)</b>	34 Year(s), Estimated, Based on Date of Observation
<b>Location</b>	Restrooms

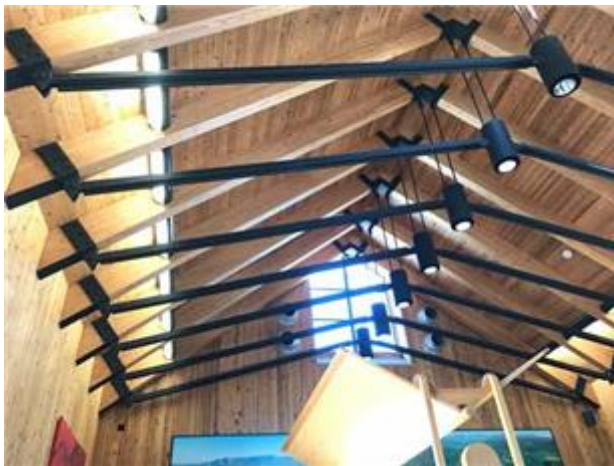
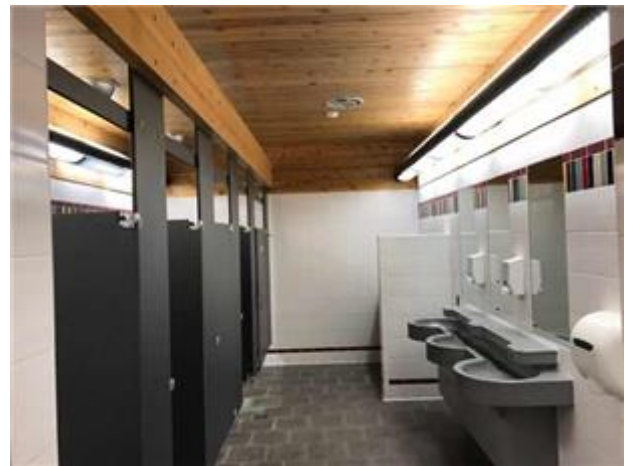
Coding / Field Name	Asset Description
<b>C3031 Ceiling Finishes</b>	Wood Ceiling
<b>Condition</b>	Fair
<b>Qty / UOM</b>	4100 / SF
<b>Unit Cost</b>	\$9.22
<b>Basis of Costing</b>	Wood Ceiling
<b>Year in Service</b>	2002
<b>Expected Useful Life (EUL)</b>	30 Year(s), Based on Industry Averages
<b>Remaining Useful Life (RUL)</b>	14 Year(s), Estimated, Based on Date of Observation
<b>Location</b>	Building Interior (General)

Uniformat	Action Description	Quantity	Unit Cost	Plan Type	Priority	Year	Expenditure
<b>C3031</b>	Refinish wood ceilings	4,100 SF	\$1.24	APP	Priority 4	2027	\$5,084

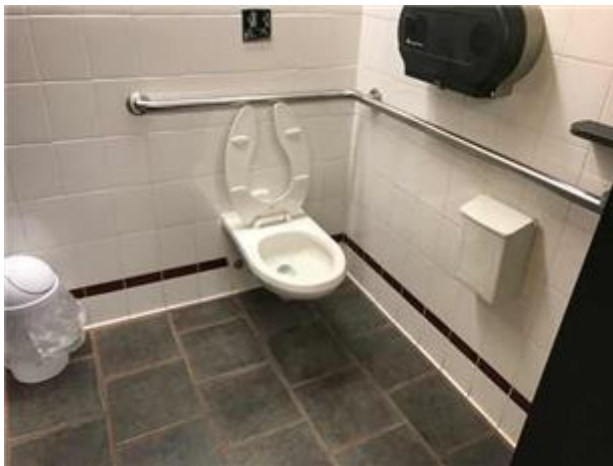
Coding / Field Name	Asset Description
<b>D2011 Water Closets</b>	Toilets (Water Closets)
<b>Condition</b>	Fair
<b>Qty / UOM</b>	20 / EA
<b>Unit Cost</b>	\$842.97
<b>Basis of Costing</b>	Tankless Water Closet
<b>Year in Service</b>	2002
<b>Expected Useful Life (EUL)</b>	20 Year(s), Based on Industry Averages
<b>Remaining Useful Life (RUL)</b>	4 Year(s), Estimated, Based on Date of Observation
<b>Location</b>	Restrooms

Uniformat	Action Description	Quantity	Unit Cost	Plan Type	Priority	Year	Expenditure
<b>D2011</b>	Replace Toilets (Water Closets)	20 EA	\$842.97	BYL	Priority 2	2022	\$16,859

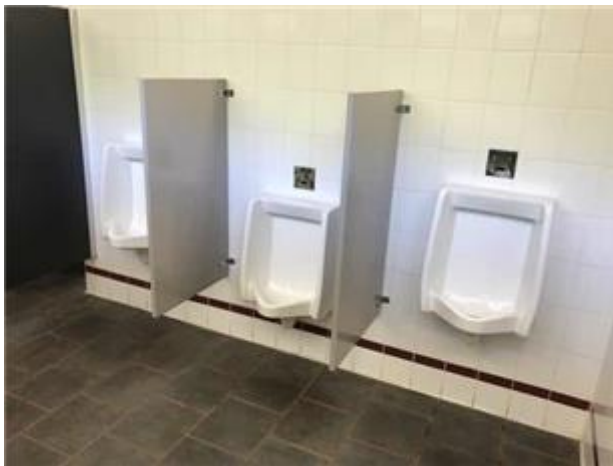
Coding / Field Name	Asset Description
D2012 Urinals	Urinals
Condition	Fair
Qty / UOM	3 / EA
Unit Cost	\$1,193.44
Basis of Costing	Urinal, Vitreous China
Year in Service	2002
Expected Useful Life (EUL)	20 Year(s), Based on Industry Averages
Remaining Useful Life (RUL)	4 Year(s), Estimated, Based on Date of Observation
Location	Restrooms

Uniformat	Action Description	Quantity	Unit Cost	Plan Type	Priority	Year	Expenditure
D2012	Replace Urinals	3 EA	\$1,193.44	BYL	Priority 2	2022	\$3,580

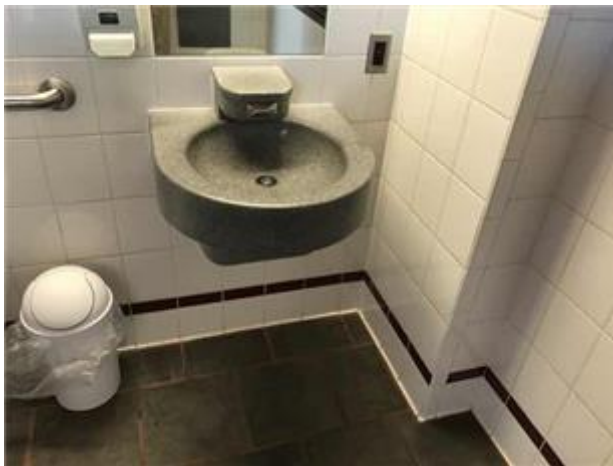
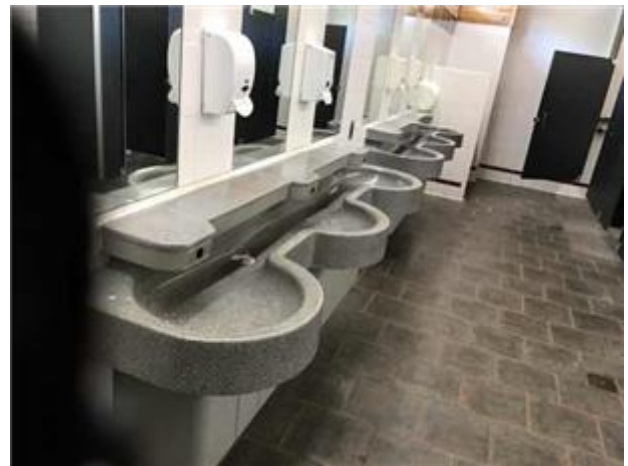
Coding / Field Name	Asset Description
<b>D2013 Lavatories</b>	Lavatories
<b>Condition</b>	Fair
<b>Qty / UOM</b>	5 / EA
<b>Unit Cost</b>	\$1,891.78
<b>Basis of Costing</b>	Lavatory, Cultured Marble
<b>Year in Service</b>	2002
<b>Expected Useful Life (EUL)</b>	20 Year(s), Based on Industry Averages
<b>Remaining Useful Life (RUL)</b>	10 Year(s), Estimated, Based on Date of Observation
<b>Location</b>	Restrooms

Uniformat	Action Description	Quantity	Unit Cost	Plan Type	Priority	Year	Expenditure
<b>D2013</b>	Replace Lavatories	5 EA	\$1,891.78	BYL	Priority 3	2028	\$9,459

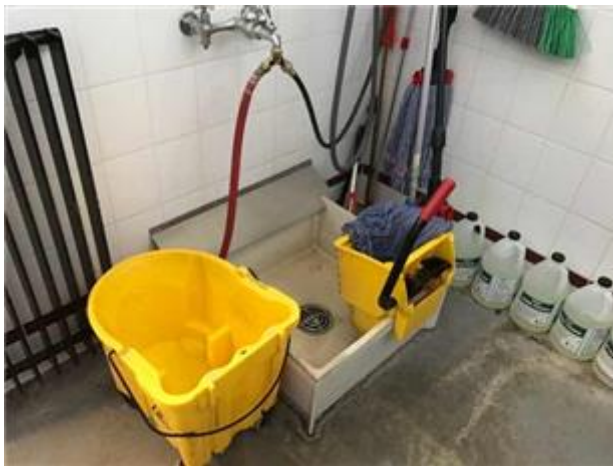
Coding / Field Name	Asset Description
<b>D2014 Sinks</b>	Service Sink, Floor
<b>Condition</b>	Fair
<b>Qty / UOM</b>	1 / EA
<b>Unit Cost</b>	\$1,599.51
<b>Basis of Costing</b>	Service Sink, Floor
<b>Year in Service</b>	2002
<b>Expected Useful Life (EUL)</b>	35 Year(s), Based on Industry Averages
<b>Remaining Useful Life (RUL)</b>	19 Year(s), Estimated, Based on Date of Observation
<b>Location</b>	Restrooms

Uniformat	Action Description	Quantity	Unit Cost	Plan Type	Priority	Year	Expenditure
<b>D2014</b>	Replace Service Sink, Floor	1 EA	\$1,599.51	BYL	Priority 3	2037	\$1,600

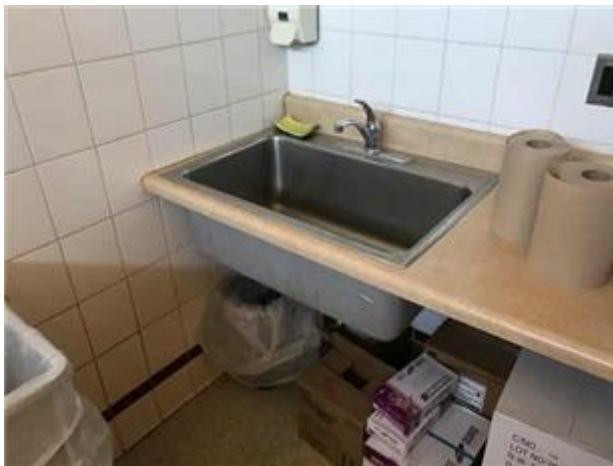
Coding / Field Name	Asset Description
<b>D2014 Sinks</b>	Sink, Stainless Steel
<b>Condition</b>	Fair
<b>Qty / UOM</b>	2 / EA
<b>Unit Cost</b>	\$1,054.05
<b>Basis of Costing</b>	Sink, Stainless Steel
<b>Year in Service</b>	2002
<b>Expected Useful Life (EUL)</b>	20 Year(s), Based on Industry Averages
<b>Remaining Useful Life (RUL)</b>	6 Year(s), Estimated, Based on Date of Observation
<b>Location</b>	Building Interior (General)

Uniformat	Action Description	Quantity	Unit Cost	Plan Type	Priority	Year	Expenditure
<b>D2014</b>	Replace Sink, Stainless Steel	2 EA	\$1,054.05	BYL	Priority 3	2024	\$2,108

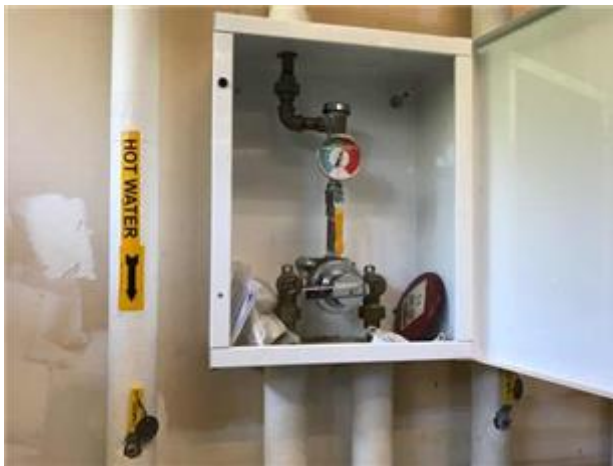
Coding / Field Name	Asset Description
D2021 Cold Water Service	Mixing Valve
Condition	Good
Qty / UOM	1 / EA
Unit Cost	\$1,163.74
Basis of Costing	Mixing Valve, 0.5"
Year in Service	2015
Expected Useful Life (EUL)	15 Year(s), Based on Industry Averages
Remaining Useful Life (RUL)	12 Year(s), Estimated, Based on Date of Observation
Location	Mechanical Room

Uniformat	Action Description	Quantity	Unit Cost	Plan Type	Priority	Year	Expenditure
D2021	Replace Mixing Valve	1 EA	\$1,163.74	BYL	Priority 3	2030	\$1,164

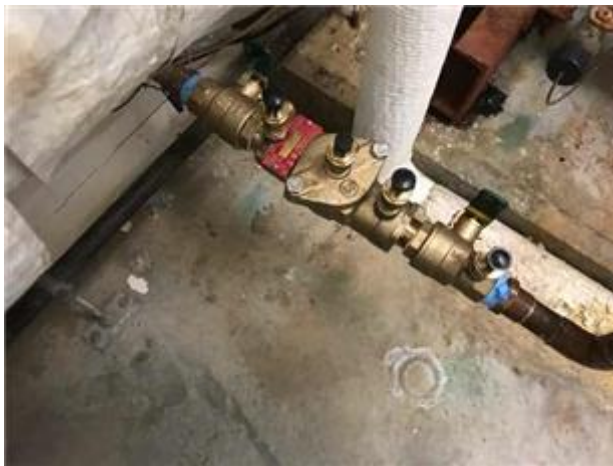
Coding / Field Name	Asset Description
<b>D2021 Cold Water Service</b>	Backflow Preventer, 0.75 Irrigation
<b>Condition</b>	Good
<b>Qty / UOM</b>	1 / EA
<b>Unit Cost</b>	\$1,276.01
<b>Basis of Costing</b>	Backflow Preventer, 1"
<b>Year in Service</b>	2015
<b>Expected Useful Life (EUL)</b>	15 Year(s), Based on Industry Averages
<b>Remaining Useful Life (RUL)</b>	12 Year(s), Estimated, Based on Date of Observation
<b>Location</b>	Mechanical Room

Uniformat	Action Description	Quantity	Unit Cost	Plan Type	Priority	Year	Expenditure
<b>D2021</b>	Replace Backflow Preventer, 0.75 Irrigation	1 EA	\$1,276.01	BYL	Priority 3	2030	\$1,276

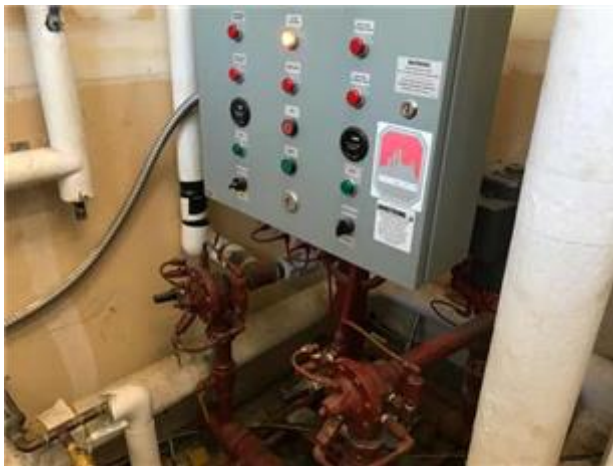
Coding / Field Name	Asset Description
<b>D2023 Domestic Water Supply Equipment</b>	Domestic BoosterPump w/ Surge Tank
<b>Condition</b>	Fair
<b>Qty / UOM</b>	1 / EA
<b>Unit Cost</b>	\$11,887.30
<b>Basis of Costing</b>	Booster Pump w/ Surge Tank, High Efficiency, 7.5 HP
<b>Year in Service</b>	2002
<b>Expected Useful Life (EUL)</b>	20 Year(s), Based on Industry Averages
<b>Remaining Useful Life (RUL)</b>	4 Year(s), Estimated, Based on Date of Observation
<b>Location</b>	Mechanical Room

Uniformat	Action Description	Quantity	Unit Cost	Plan Type	Priority	Year	Expenditure
<b>D2023</b>	Replace Domestic BoosterPump w/ Surge Tank	1 EA	\$11,887.30	BYL	Priority 2	2022	\$11,887

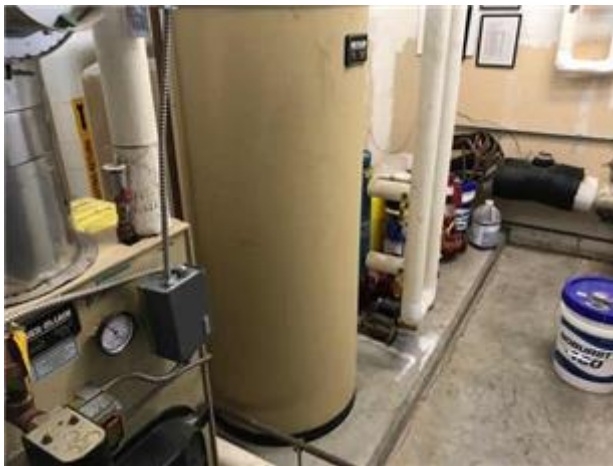
Coding / Field Name	Asset Description
<b>D2023 Domestic Water Supply Equipment</b>	Water Heater, Indirect, 46 GAL
<b>Condition</b>	Fair
<b>Qty / UOM</b>	1 / EA
<b>Unit Cost</b>	\$2,817.38
<b>Basis of Costing</b>	Water Heater, Indirect, 40 to 79 GAL
<b>Year in Service</b>	2002
<b>Expected Useful Life (EUL)</b>	15 Year(s), Based on Industry Averages
<b>Remaining Useful Life (RUL)</b>	3 Year(s), Estimated, Based on Date of Observation
<b>Location</b>	Mechanical Room

Uniformat	Action Description	Quantity	Unit Cost	Plan Type	Priority	Year	Expenditure
<b>D2023</b>	Replace Water Heater, Indirect, 46 GAL	1 EA	\$2,817.38	BYL	Priority 1	2021	\$2,817
<b>D2023</b>	Replace Water Heater, Indirect, 46 GAL	1 EA	\$2,817.38	BYL	Priority 1	2036	\$2,817

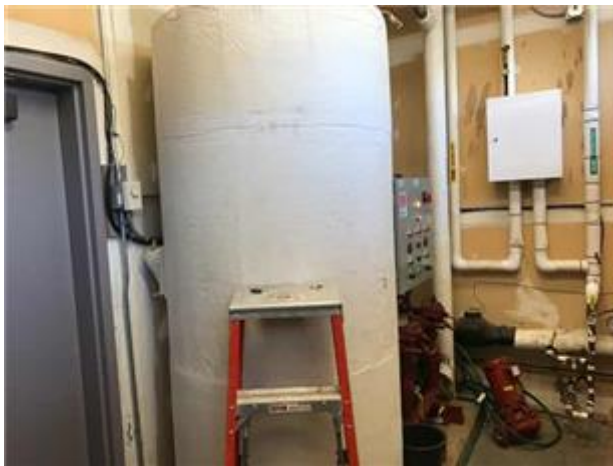
Coding / Field Name	Asset Description
<b>D2023 Domestic Water Supply Equipment</b>	Domestic Water Storage Tank, 300 GAL
<b>Condition</b>	Fair
<b>Qty / UOM</b>	1 / EA
<b>Unit Cost</b>	\$4,446.52
<b>Basis of Costing</b>	Water Storage Tank, 251 to 500 GAL
<b>Year in Service</b>	2002
<b>Expected Useful Life (EUL)</b>	20 Year(s), Based on Industry Averages
<b>Remaining Useful Life (RUL)</b>	9 Year(s), Estimated, Based on Date of Observation
<b>Location</b>	Mechanical Room

Uniformat	Action Description	Quantity	Unit Cost	Plan Type	Priority	Year	Expenditure
<b>D2023</b>	Replace Domestic Water Storage Tank, 300 GAL	1 EA	\$4,446.52	BYL	Priority 3	2027	\$4,447

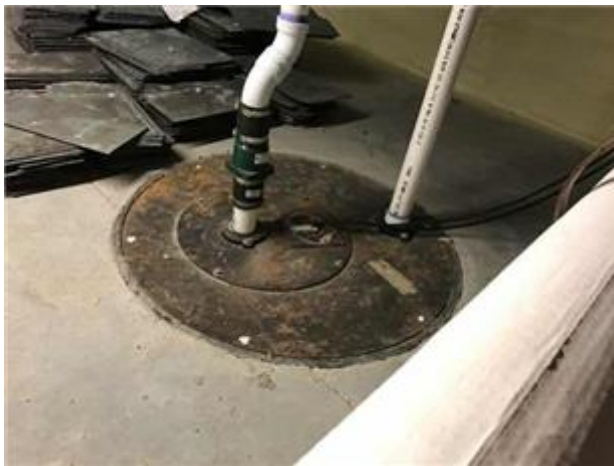
Coding / Field Name	Asset Description
<b>D2043 Rainwater Drainage Equipment</b>	Sump Pump
<b>Condition</b>	Fair
<b>Qty / UOM</b>	1 / EA
<b>Unit Cost</b>	\$2,062.81
<b>Basis of Costing</b>	Sump Pump, 3 HP
<b>Year in Service</b>	2002
<b>Expected Useful Life (EUL)</b>	15 Year(s), Based on Industry Averages
<b>Remaining Useful Life (RUL)</b>	4 Year(s), Estimated, Based on Date of Observation
<b>Location</b>	Crawlspace

Uniformat	Action Description	Quantity	Unit Cost	Plan Type	Priority	Year	Expenditure
<b>D2043</b>	Replace Sump Pump	1 EA	\$2,062.81	BYL	Priority 2	2022	\$2,063
<b>D2043</b>	Replace Sump Pump	1 EA	\$2,062.81	BYL	Priority 2	2037	\$2,063

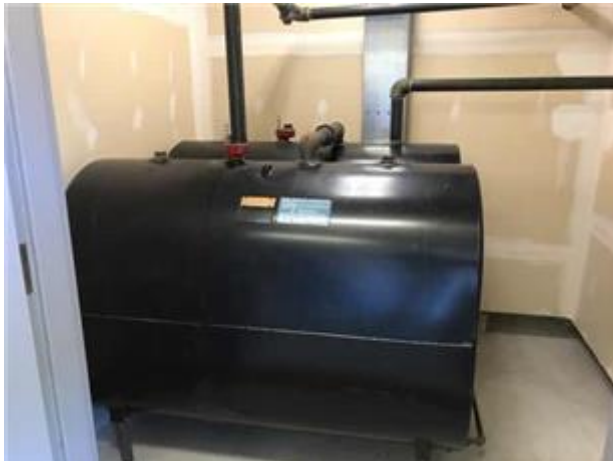
Coding / Field Name	Asset Description
<b>D3011 Oil Supply System</b>	Oil Storage Tank, 275 GAL
<b>Condition</b>	Fair
<b>Qty / UOM</b>	2 / EA
<b>Unit Cost</b>	\$935.73
<b>Basis of Costing</b>	Oil Storage Tank, 31 to 275 GAL
<b>Year in Service</b>	2002
<b>Expected Useful Life (EUL)</b>	25 Year(s), Based on Industry Averages
<b>Remaining Useful Life (RUL)</b>	14 Year(s), Estimated, Based on Date of Observation
<b>Location</b>	Oil Tank Closet
<b>Fuel Tank Type</b>	Ast

Unifomat	Action Description	Quantity	Unit Cost	Plan Type	Priority	Year	Expenditure
<b>D3011</b>	Replace Oil Storage Tank, 275 GAL	2 EA	\$935.73	BYL	Priority 3	2032	\$1,871

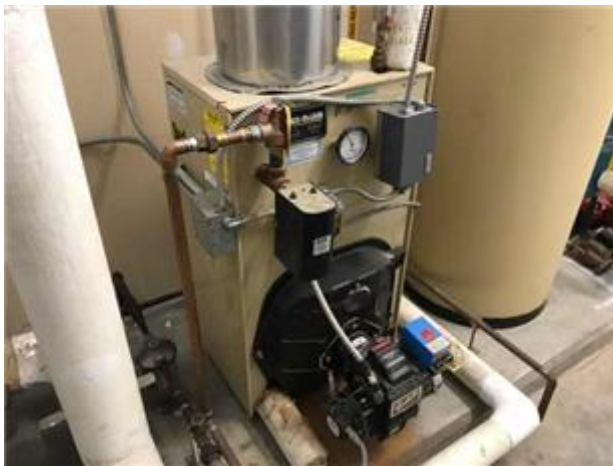
Coding / Field Name	Asset Description
<b>D3021 Boilers</b>	Domestic Boiler, Oil, 88 MBH
<b>Condition</b>	Fair
<b>Qty / UOM</b>	1 / EA
<b>Unit Cost</b>	\$12,832.31
<b>Basis of Costing</b>	Boiler, Oil, 76 to 100 MBH
<b>Year in Service</b>	2002
<b>Expected Useful Life (EUL)</b>	22 Year(s), Based on Industry Averages
<b>Remaining Useful Life (RUL)</b>	6 Year(s), Estimated, Based on Date of Observation
<b>Location</b>	Mechanical Room

Uniformat	Action Description	Quantity	Unit Cost	Plan Type	Priority	Year	Expenditure
<b>D3021</b>	Replace Domestic Boiler, Oil, 88 MBH	1 EA	\$12,832.31	BYL	Priority 2	2024	\$12,832

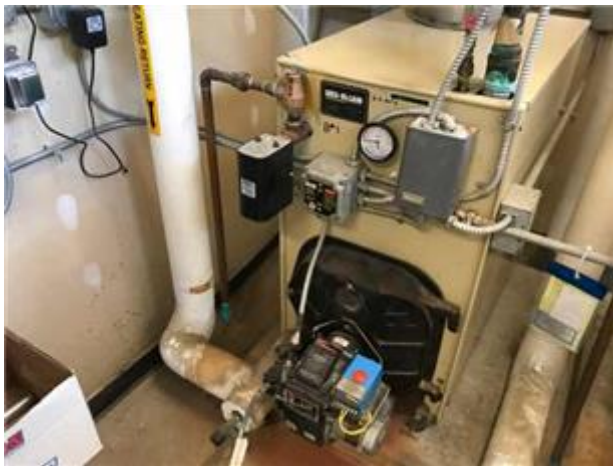
Coding / Field Name	Asset Description
<b>D3021 Boilers</b>	Boiler, Oil, 295 MBH
<b>Condition</b>	Fair
<b>Qty / UOM</b>	1 / EA
<b>Unit Cost</b>	\$18,107.75
<b>Basis of Costing</b>	Boiler, Oil, 251 to 300 MBH
<b>Year in Service</b>	2002
<b>Expected Useful Life (EUL)</b>	22 Year(s), Based on Industry Averages
<b>Remaining Useful Life (RUL)</b>	6 Year(s), Estimated, Based on Date of Observation
<b>Location</b>	Mechanical Room

Uniformat	Action Description	Quantity	Unit Cost	Plan Type	Priority	Year	Expenditure
<b>D3021</b>	Replace Boiler, Oil, 295 MBH	1 EA	\$18,107.75	BYL	Priority 2	2024	\$18,108
