# FACILITY CONDITION ASSESSMENT

FACILITY CONDITION ASSESSMENT  
OF  
WILLISTON SOUTH INFORMATION CENTER  
I-89 SOUTHBOUND MILE MARKER 83  
WILLISTON, VT 05495

December 17, 2018

May 16, 2018

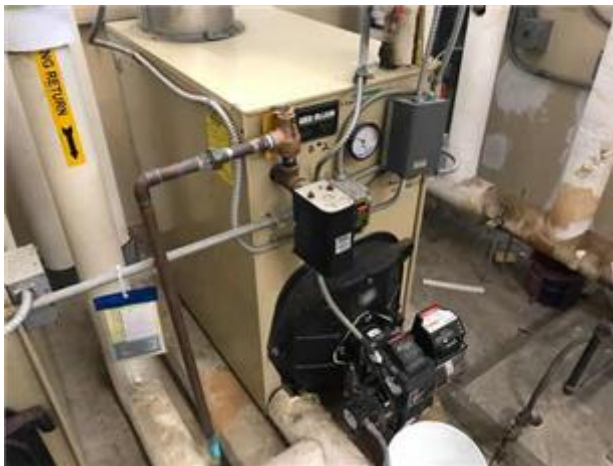
Coding / Field Name	Asset Description
<b>D3021 Boilers</b>	Boiler, Oil, 295 MBH
<b>Condition</b>	Fair
<b>Qty / UOM</b>	1 / EA
<b>Unit Cost</b>	\$18,107.75
<b>Basis of Costing</b>	Boiler, Oil, 251 to 300 MBH
<b>Year in Service</b>	2002
<b>Expected Useful Life (EUL)</b>	22 Year(s), Based on Industry Averages
<b>Remaining Useful Life (RUL)</b>	6 Year(s), Estimated, Based on Date of Observation
<b>Location</b>	Mechanical Room

Uniformat	Action Description	Quantity	Unit Cost	Plan Type	Priority	Year	Expenditure
<b>D3021</b>	Replace Boiler, Oil, 295 MBH	1 EA	\$18,107.75	BYL	Priority 2	2024	\$18,108

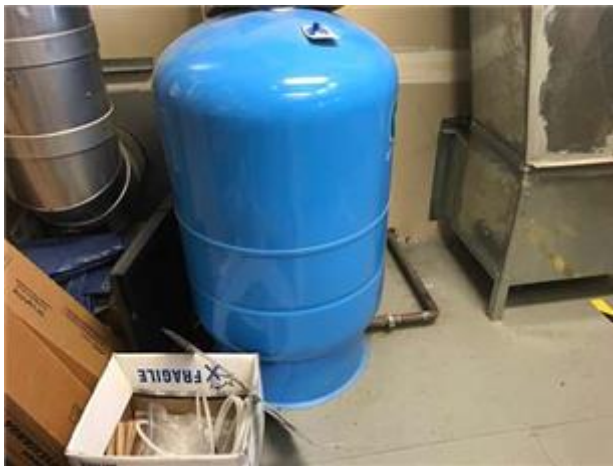
Coding / Field Name	Asset Description
<b>D3022 Boiler Room Piping &amp; Specialties</b>	Expansion Tank, Domestic Water
<b>Condition</b>	Fair
<b>Qty / UOM</b>	1 / EA
<b>Unit Cost</b>	\$1,999.43
<b>Basis of Costing</b>	Expansion Tank, 11 to 30 GAL
<b>Year in Service</b>	2004
<b>Expected Useful Life (EUL)</b>	25 Year(s), Based on Industry Averages
<b>Remaining Useful Life (RUL)</b>	11 Year(s), Estimated, Based on Date of Observation
<b>Location</b>	Loft Equipment Room

Uniformat	Action Description	Quantity	Unit Cost	Plan Type	Priority	Year	Expenditure
<b>D3022</b>	Replace Expansion Tank, Domestic Water	1 EA	\$1,999.43	BYL	Priority 3	2029	\$1,999

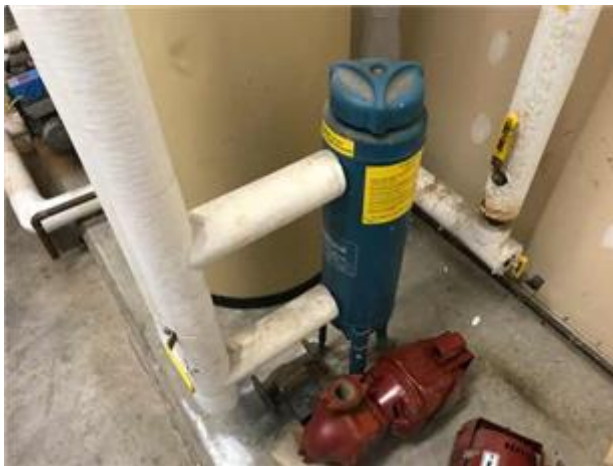
Coding / Field Name	Asset Description
D3022 Boiler Room Piping & Specialties	Shot Feed Tank, 2 GAL
Condition	Fair
Qty / UOM	1 / EA
Unit Cost	\$1,600.59
Basis of Costing	Shot Feed Tank, 5 GAL
Year in Service	2002
Expected Useful Life (EUL)	25 Year(s), Based on Industry Averages
Remaining Useful Life (RUL)	9 Year(s), Estimated, Based on Date of Observation
Location	Mechanical Room

Unifomat	Action Description	Quantity	Unit Cost	Plan Type	Priority	Year	Expenditure
D3022	Replace Shot Feed Tank, 2 GAL	1 EA	\$1,600.59	BYL	Priority 3	2027	\$1,601

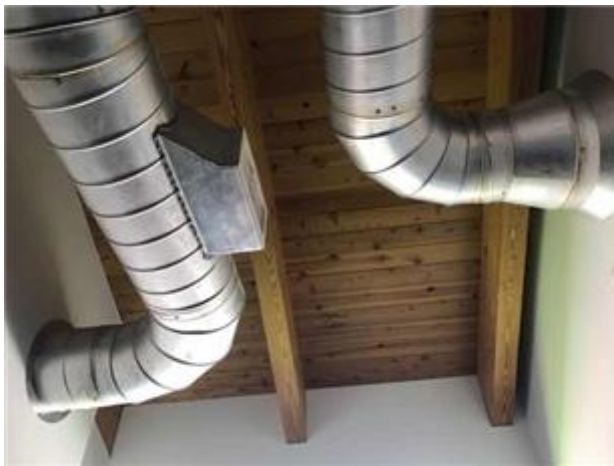
Coding / Field Name	Asset Description
<b>D3041 Air Distribution Systems</b>	HVAC System Ductwork, Sheet Metal
<b>Condition</b>	Fair
<b>Qty / UOM</b>	4600 / SF
<b>Unit Cost</b>	\$19.50
<b>Basis of Costing</b>	HVAC System Ductwork, Sheet Metal
<b>Year in Service</b>	2002
<b>Expected Useful Life (EUL)</b>	30 Year(s), Based on Industry Averages
<b>Remaining Useful Life (RUL)</b>	14 Year(s), Estimated, Based on Date of Observation
<b>Location</b>	Building Interior (General)

Uniformat	Action Description	Quantity	Unit Cost	Plan Type	Priority	Year	Expenditure
<b>D3041</b>	Replace HVAC System Ductwork, Sheet Metal	4,600 SF	\$19.50	BYL	Priority 4	2032	\$89,700

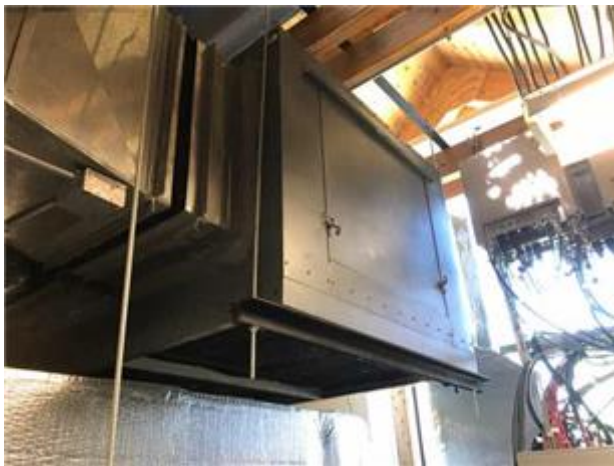
Coding / Field Name	Asset Description
<b>D3041 Air Distribution Systems</b>	Air Handler, Heat Exchanger
<b>Condition</b>	Fair
<b>Qty / UOM</b>	1 / EA
<b>Unit Cost</b>	\$14,597.03
<b>Basis of Costing</b>	Air Handler, Single Zone, 2,501 to 5,000 CFM
<b>Year in Service</b>	2002
<b>Expected Useful Life (EUL)</b>	15 Year(s), Based on Industry Averages
<b>Remaining Useful Life (RUL)</b>	7 Year(s), Estimated, Based on Date of Observation
<b>Location</b>	Loft Equipment Room

Uniformat	Action Description	Quantity	Unit Cost	Plan Type	Priority	Year	Expenditure
<b>D3041</b>	Replace Air Handler, Heat Exchanger	1 EA	\$14,597.03	BYL	Priority 2	2025	\$14,597

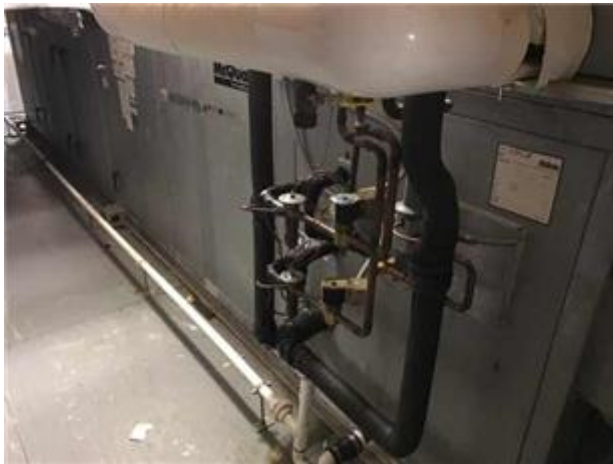
Coding / Field Name	Asset Description
<b>D3041 Air Distribution Systems</b>	Air Handler, Multizone, 7,000 cfm
<b>Condition</b>	Fair
<b>Qty / UOM</b>	1 / EA
<b>Unit Cost</b>	\$26,016.62
<b>Basis of Costing</b>	Air Handler, Multizone, 6,501 to 8,000 CFM
<b>Year in Service</b>	2002
<b>Expected Useful Life (EUL)</b>	15 Year(s), Based on Industry Averages
<b>Remaining Useful Life (RUL)</b>	5 Year(s), Estimated, Based on Date of Observation
<b>Location</b>	Loft Equipment Room

Uniformat	Action Description	Quantity	Unit Cost	Plan Type	Priority	Year	Expenditure
<b>D3041</b>	Replace Air Handler, Multizone, 7,000 cfm	1 EA	\$26,016.62	BYL	Priority 2	2023	\$26,017

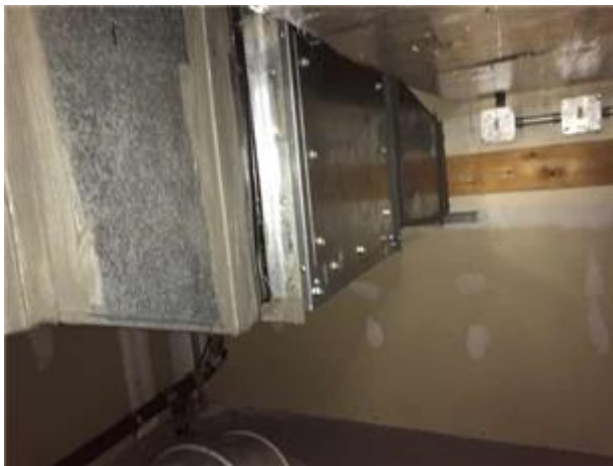
Coding / Field Name	Asset Description
<b>D3042 Exhaust Ventilation Systems</b>	Exhaust Fan, Centrifugal, EF-3
<b>Condition</b>	Fair
<b>Qty / UOM</b>	1 / EA
<b>Unit Cost</b>	\$889.90
<b>Basis of Costing</b>	Exhaust Fan, Centrifugal, 100 to 250 CFM
<b>Year in Service</b>	2002
<b>Expected Useful Life (EUL)</b>	15 Year(s), Based on Industry Averages
<b>Remaining Useful Life (RUL)</b>	3 Year(s), Estimated, Based on Date of Observation
<b>Location</b>	Loft Equipment Room

Uniformat	Action Description	Quantity	Unit Cost	Plan Type	Priority	Year	Expenditure
<b>D3042</b>	Replace Exhaust Fan, Centrifugal, EF-3	1 EA	\$889.90	BYL	Priority 1	2021	\$890
<b>D3042</b>	Replace Exhaust Fan, Centrifugal, EF-3	1 EA	\$889.90	BYL	Priority 1	2036	\$890

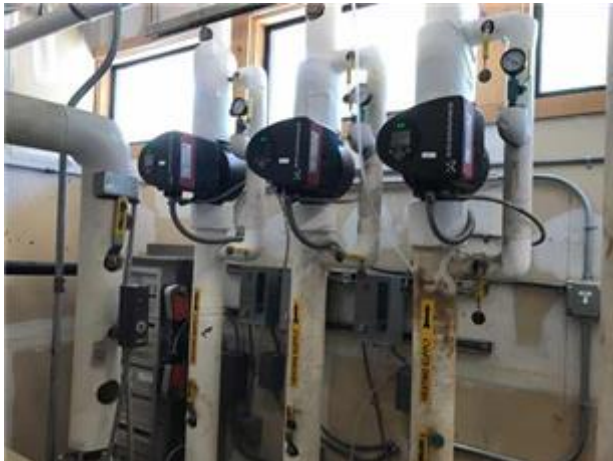
Coding / Field Name	Asset Description
<b>D3044 Hot Water Distribution</b>	Circulation Pumps, Heating Water
<b>Condition</b>	Good
<b>Qty / UOM</b>	3 / EA
<b>Cost Adjustment Factor/Reason</b>	0.45 / 0.75 hp
<b>Unit Cost (Adjusted)</b>	\$2,093.53
<b>Basis of Costing</b>	Circulation Pump, Hot Water, 3 HP
<b>Year in Service</b>	2017
<b>Expected Useful Life (EUL)</b>	20 Year(s), Based on Industry Averages
<b>Remaining Useful Life (RUL)</b>	19 Year(s), Estimated, Based on Date of Observation
<b>Location</b>	Mechanical Room

Uniformat	Action Description	Quantity	Unit Cost	Plan Type	Priority	Year	Expenditure
<b>D3044</b>	Replace Circulation Pumps, Heating Water	3 EA	\$2,093.53	BYL	Priority 3	2037	\$6,281

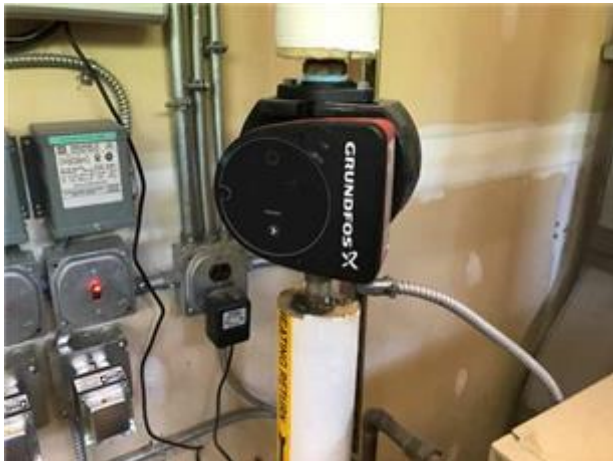
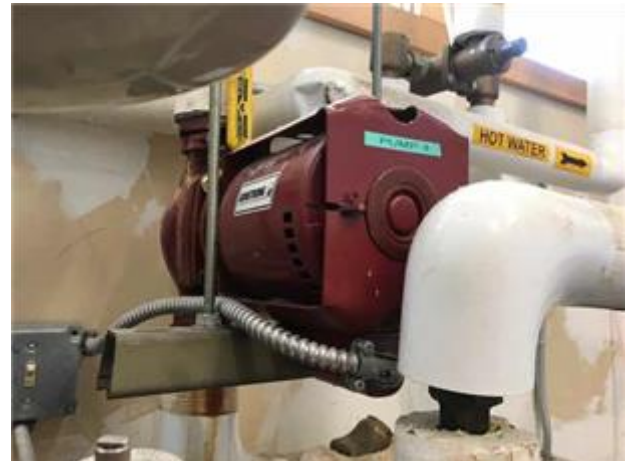
Coding / Field Name	Asset Description
<b>D3044 Hot Water Distribution</b>	Circulation Pumps, Heating Water
<b>Condition</b>	Good
<b>Qty / UOM</b>	3 / EA
<b>Cost Adjustment Factor/Reason</b>	0.25 / Fractional hp
<b>Unit Cost (Adjusted)</b>	\$1,163.07
<b>Basis of Costing</b>	Circulation Pump, Hot Water, 3 HP
<b>Year in Service</b>	2017
<b>Expected Useful Life (EUL)</b>	20 Year(s), Based on Industry Averages
<b>Remaining Useful Life (RUL)</b>	19 Year(s), Estimated, Based on Date of Observation
<b>Location</b>	Mechanical Room

Uniformat	Action Description	Quantity	Unit Cost	Plan Type	Priority	Year	Expenditure
<b>D3044</b>	Replace Circulation Pumps, Heating Water	3 EA	\$1,163.07	BYL	Priority 3	2037	\$3,489

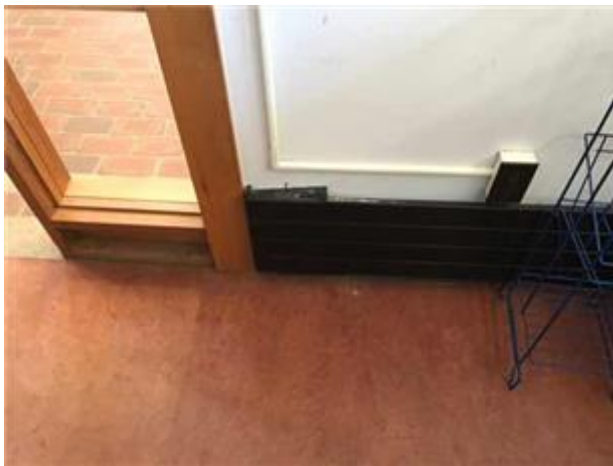
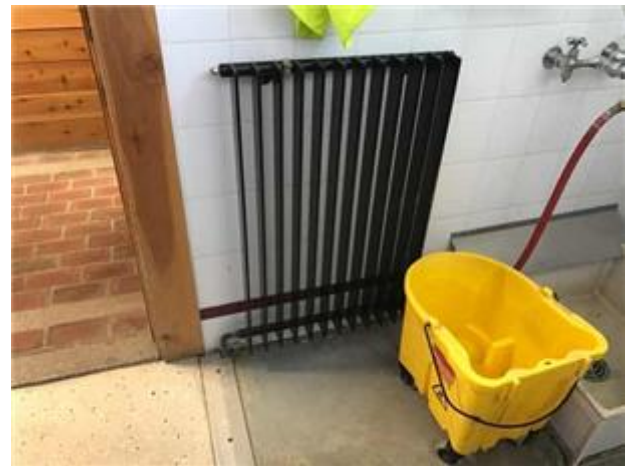
Coding / Field Name	Asset Description
<b>D3051 Terminal Self-Contained Units</b>	Radiator, Hydronic, Wall
<b>Condition</b>	Fair
<b>Qty / UOM</b>	17 / EA
<b>Unit Cost</b>	\$1,487.37
<b>Basis of Costing</b>	Radiator, Electric, Finned, Wall, 4 to 5 kW
<b>Year in Service</b>	2002
<b>Expected Useful Life (EUL)</b>	25 Year(s), Based on Industry Averages
<b>Remaining Useful Life (RUL)</b>	9 Year(s), Estimated, Based on Date of Observation
<b>Location</b>	Building Interior (General)

Uniformat	Action Description	Quantity	Unit Cost	Plan Type	Priority	Year	Expenditure
<b>D3051</b>	Replace Radiator, Hydronic, Wall	17 EA	\$1,487.37	BYL	Priority 3	2027	\$25,285

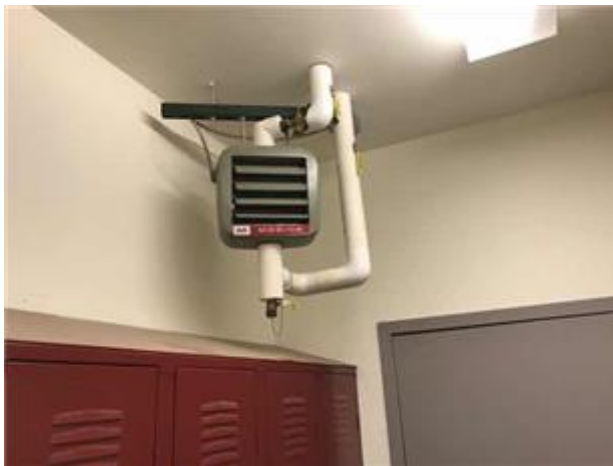
Coding / Field Name	Asset Description
<b>D3051 Terminal Self-Contained Units</b>	Unit Heater, Hydronic
<b>Condition</b>	Fair
<b>Qty / UOM</b>	8 / EA
<b>Unit Cost</b>	\$1,516.80
<b>Basis of Costing</b>	Unit Heater, Hydronic, 13 to 36 MBH
<b>Year in Service</b>	2002
<b>Expected Useful Life (EUL)</b>	20 Year(s), Based on Industry Averages
<b>Remaining Useful Life (RUL)</b>	10 Year(s), Estimated, Based on Date of Observation
<b>Location</b>	Building Interior (General)

Uniformat	Action Description	Quantity	Unit Cost	Plan Type	Priority	Year	Expenditure
<b>D3051</b>	Replace Unit Heater, Hydronic	8 EA	\$1,516.80	BYL	Priority 3	2028	\$12,134

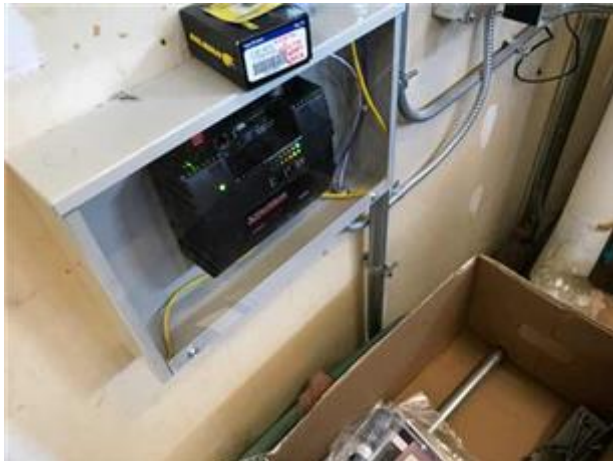
Coding / Field Name	Asset Description
<b>D3068 Building Automation Systems</b>	DDC HVAC Controls
<b>Condition</b>	Good
<b>Qty / UOM</b>	4600 / SF
<b>Cost Adjustment Factor/Reason</b>	0.5 / Small system
<b>Unit Cost (Adjusted)</b>	\$4.83
<b>Basis of Costing</b>	Building Automation System (HVAC Controls), Full Upgrade (per SF)
<b>Year in Service</b>	2017
<b>Expected Useful Life (EUL)</b>	20 Year(s), Based on Industry Averages
<b>Remaining Useful Life (RUL)</b>	19 Year(s), Estimated, Based on Date of Observation
<b>Location</b>	Building Interior (General)

Uniformat	Action Description	Quantity	Unit Cost	Plan Type	Priority	Year	Expenditure
<b>D3068</b>	Replace DDC HVAC Controls	4,600 SF	\$4.83	BYL	Priority 3	2037	\$22,195

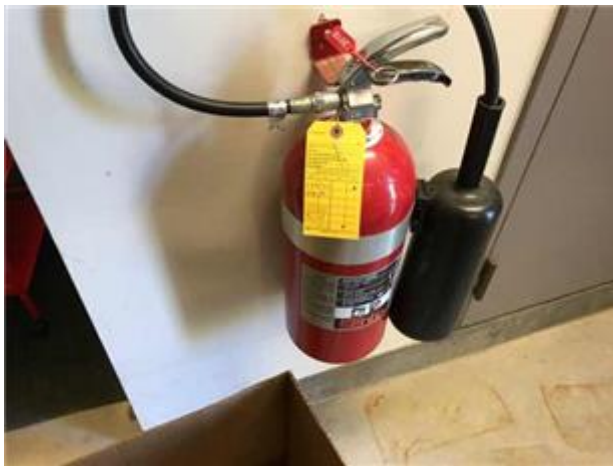
Coding / Field Name	Asset Description
<b>D4031 Fire Extinguishers</b>	Fire Extinguisher
<b>Condition</b>	Fair
<b>Qty / UOM</b>	4 / EA
<b>Unit Cost</b>	\$314.93
<b>Basis of Costing</b>	Fire Extinguisher - Type ABC
<b>Year in Service</b>	2010
<b>Expected Useful Life (EUL)</b>	15 Year(s), Based on Industry Averages
<b>Remaining Useful Life (RUL)</b>	7 Year(s), Estimated, Based on Date of Observation
<b>Location</b>	Building Interior (General)

Uniformat	Action Description	Quantity	Unit Cost	Plan Type	Priority	Year	Expenditure
<b>D4031</b>	Replace Fire Extinguisher	4 EA	\$314.93	BYL	Priority 2	2025	\$1,260

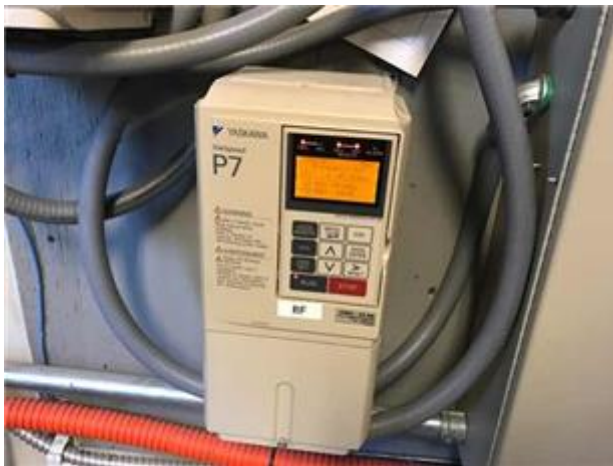
Coding / Field Name	Asset Description
<b>D5012 Low Tension Service &amp; Dist.</b>	Variable Frequency Drive, RF-1
<b>Condition</b>	Fair
<b>Qty / UOM</b>	1 / EA
<b>Unit Cost</b>	\$4,748.96
<b>Basis of Costing</b>	Variable Frequency Drive, 5 HP Motor
<b>Year in Service</b>	2002
<b>Expected Useful Life (EUL)</b>	20 Year(s), Based on Industry Averages
<b>Remaining Useful Life (RUL)</b>	4 Year(s), Estimated, Based on Date of Observation
<b>Location</b>	Loft Equipment Room

Uniformat	Action Description	Quantity	Unit Cost	Plan Type	Priority	Year	Expenditure
<b>D5012</b>	Replace Variable Frequency Drive, RF-1	1 EA	\$4,748.96	BYL	Priority 2	2022	\$4,749

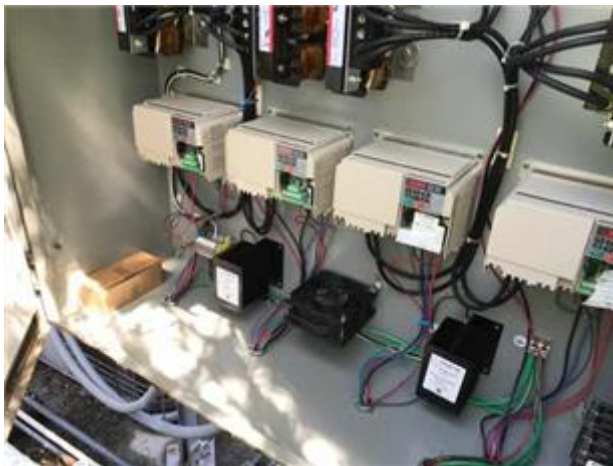
Coding / Field Name	Asset Description
<b>D5012 Low Tension Service &amp; Dist.</b>	Variable Frequency Drive, AC Condensing Units
<b>Condition</b>	Fair
<b>Qty / UOM</b>	4 / EA
<b>Unit Cost</b>	\$4,748.96
<b>Basis of Costing</b>	Variable Frequency Drive, 5 HP Motor
<b>Year in Service</b>	2008
<b>Expected Useful Life (EUL)</b>	20 Year(s), Based on Industry Averages
<b>Remaining Useful Life (RUL)</b>	10 Year(s), Estimated, Based on Date of Observation
<b>Location</b>	Site

Uniformat	Action Description	Quantity	Unit Cost	Plan Type	Priority	Year	Expenditure
<b>D5012</b>	Replace Variable Frequency Drive, AC Condensing Units	4 EA	\$4,748.96	BYL	Priority 3	2028	\$18,996

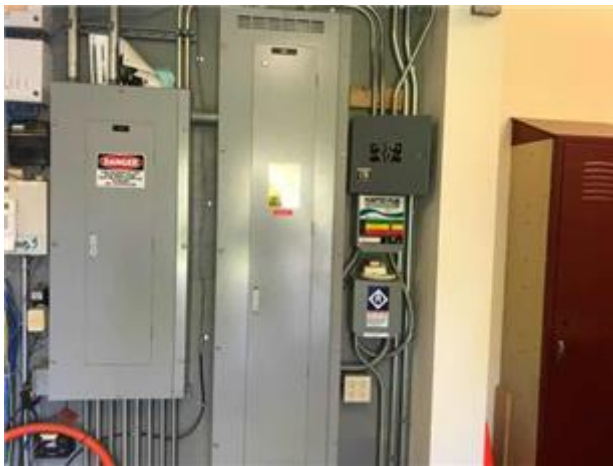
Coding / Field Name	Asset Description
<b>D5012 Low Tension Service &amp; Dist.</b>	Main Distribution Panel
<b>Condition</b>	Fair
<b>Qty / UOM</b>	1 / EA
<b>Unit Cost</b>	\$9,487.85
<b>Basis of Costing</b>	Power Panel Board, 208 Y, 120 V, 400 Amp
<b>Year in Service</b>	2002
<b>Expected Useful Life (EUL)</b>	30 Year(s), Based on Industry Averages
<b>Remaining Useful Life (RUL)</b>	14 Year(s), Estimated, Based on Date of Observation
<b>Location</b>	Electrical Room (Primary)

Uniformat	Action Description	Quantity	Unit Cost	Plan Type	Priority	Year	Expenditure
<b>D5012</b>	Replace Main Distribution Panel	1 EA	\$9,487.85	BYL	Priority 3	2032	\$9,488

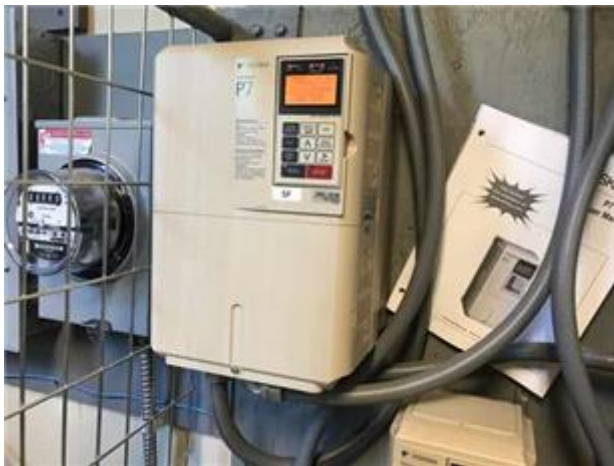
Coding / Field Name	Asset Description
<b>D5012 Low Tension Service &amp; Dist.</b>	Variable Frequency Drive, SF-1
<b>Condition</b>	Fair
<b>Qty / UOM</b>	1 / EA
<b>Unit Cost</b>	\$6,304.96
<b>Basis of Costing</b>	Variable Frequency Drive, 10 HP Motor
<b>Year in Service</b>	2002
<b>Expected Useful Life (EUL)</b>	20 Year(s), Based on Industry Averages
<b>Remaining Useful Life (RUL)</b>	4 Year(s), Estimated, Based on Date of Observation
<b>Location</b>	Loft Equipment Room

Uniformat	Action Description	Quantity	Unit Cost	Plan Type	Priority	Year	Expenditure
<b>D5012</b>	Replace Variable Frequency Drive, SF-1	1 EA	\$6,304.96	BYL	Priority 2	2022	\$6,305

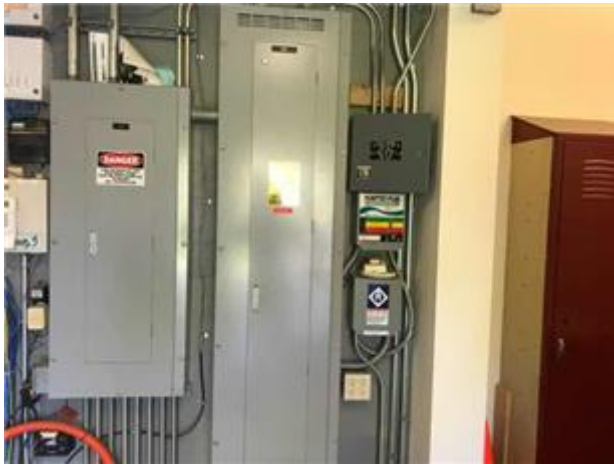
Coding / Field Name	Asset Description
<b>D5019 Electrical Systems</b>	Electrical System, Full Upgrade
<b>Condition</b>	Fair
<b>Qty / UOM</b>	4588 / SF
<b>Unit Cost</b>	\$27.25
<b>Basis of Costing</b>	Electrical System, Full Upgrade, Office (per SF)
<b>Year in Service</b>	2002
<b>Expected Useful Life (EUL)</b>	40 Year(s), Based on Industry Averages
<b>Remaining Useful Life (RUL)</b>	24 Year(s), Estimated, Based on Date of Observation
<b>Location</b>	Building Interior (General)

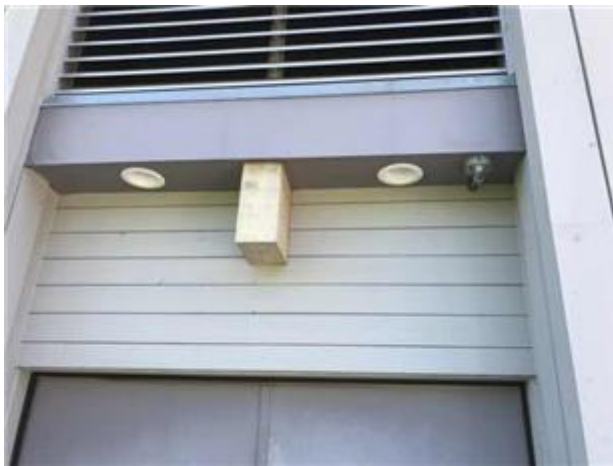
Coding / Field Name	Asset Description
<b>D5022 Lighting Equipment</b>	LED Lighting Fixture, Soffit
<b>Condition</b>	Good
<b>Qty / UOM</b>	6 / EA
<b>Unit Cost</b>	\$180.19
<b>Basis of Costing</b>	LED Lighting Fixture, Basic, 15 W
<b>Year in Service</b>	2014
<b>Expected Useful Life (EUL)</b>	20 Year(s), Based on Industry Averages
<b>Remaining Useful Life (RUL)</b>	16 Year(s), Estimated, Based on Date of Observation
<b>Location</b>	Exterior Walls

Uniformat	Action Description	Quantity	Unit Cost	Plan Type	Priority	Year	Expenditure
<b>D5022</b>	Replace LED Lighting Fixture, Soffit	6 EA	\$180.19	BYL	Priority 3	2034	\$1,081

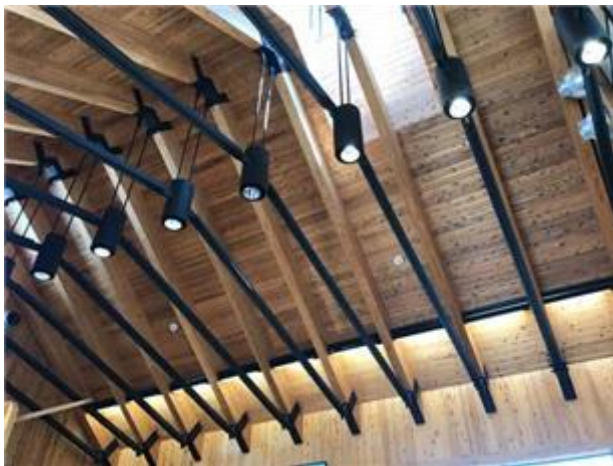
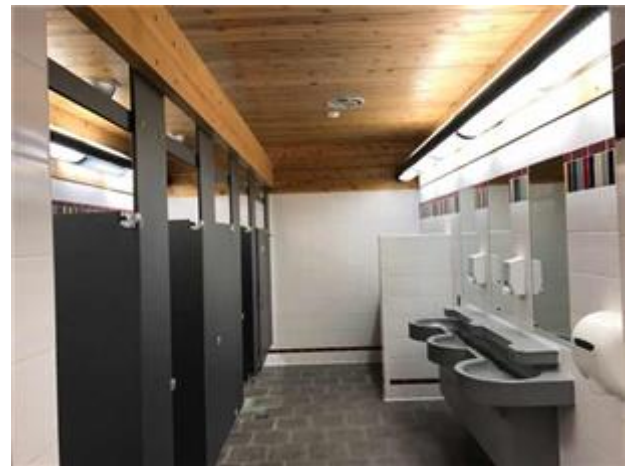
Coding / Field Name	Asset Description
<b>D5029 Lighting Systems</b>	Lighting System, Interior
<b>Condition</b>	Fair
<b>Qty / UOM</b>	4600 / SF
<b>Unit Cost</b>	\$9.24
<b>Basis of Costing</b>	Lighting System, Full Upgrade, Office (per SF)
<b>Year in Service</b>	2002
<b>Expected Useful Life (EUL)</b>	25 Year(s), Based on Industry Averages
<b>Remaining Useful Life (RUL)</b>	9 Year(s), Estimated, Based on Date of Observation
<b>Location</b>	Building Interior (General)

Uniformat	Action Description	Quantity	Unit Cost	Plan Type	Priority	Year	Expenditure
<b>D5029</b>	Replace Lighting System, Interior	4,600 SF	\$9.24	BYL	Priority 3	2027	\$42,504

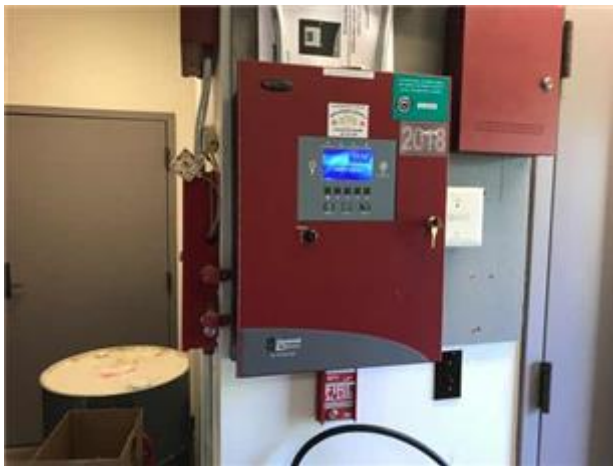
Coding / Field Name	Asset Description
<b>D5037 Fire Alarm Systems</b>	Fire Alarm System
<b>Condition</b>	Good
<b>Qty / UOM</b>	4600 / SF
<b>Unit Cost</b>	\$2.36
<b>Basis of Costing</b>	Fire Alarm System, Full Upgrade/Install, Office (per SF)
<b>Year in Service</b>	2017
<b>Expected Useful Life (EUL)</b>	20 Year(s), Based on Industry Averages
<b>Remaining Useful Life (RUL)</b>	19 Year(s), Estimated, Based on Date of Observation
<b>Location</b>	Building Interior (General)

Uniformat	Action Description	Quantity	Unit Cost	Plan Type	Priority	Year	Expenditure
<b>D5037</b>	Replace Fire Alarm System	4,600 SF	\$2.36	BYL	Priority 3	2037	\$10,856

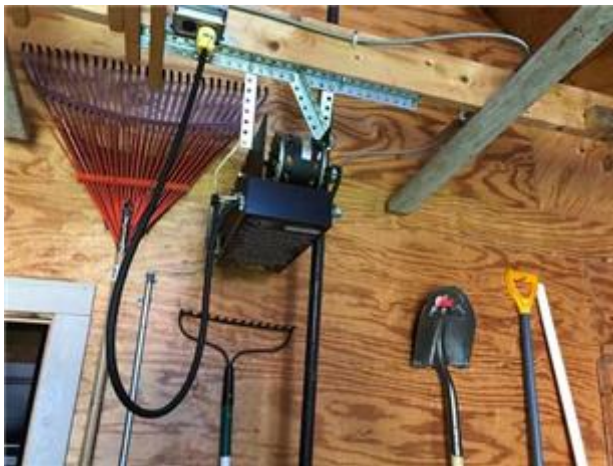
Coding / Field Name	Asset Description
<b>E1031 Vehicular Service Equipment</b>	Garage Door Opener, Belt Drive
<b>Condition</b>	Fair
<b>Qty / UOM</b>	1 / EA
<b>Unit Cost</b>	\$519.03
<b>Basis of Costing</b>	Garage Door Opener, Belt Drive, 0.5 HP
<b>Year in Service</b>	2002
<b>Expected Useful Life (EUL)</b>	15 Year(s), Based on Industry Averages
<b>Remaining Useful Life (RUL)</b>	4 Year(s), Estimated, Based on Date of Observation
<b>Location</b>	Storage Building/Map Kiosk

Uniformat	Action Description	Quantity	Unit Cost	Plan Type	Priority	Year	Expenditure
<b>E1031</b>	Replace Garage Door Opener, Belt Drive	1 EA	\$519.03	BYL	Priority 3	2022	\$519
<b>E1031</b>	Replace Garage Door Opener, Belt Drive	1 EA	\$519.03	BYL	Priority 3	2037	\$519

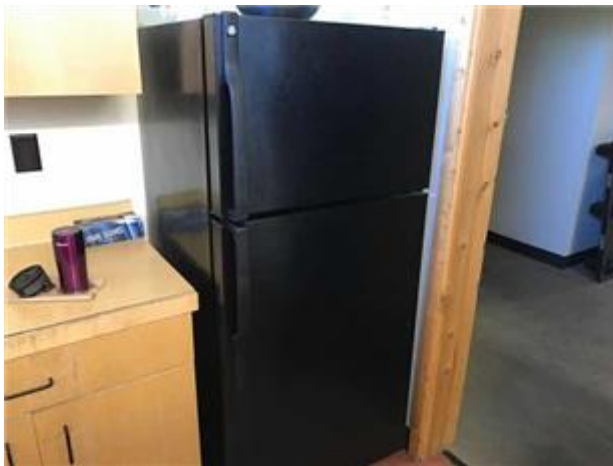
Coding / Field Name	Asset Description
<b>E1094 Residential Equipment</b>	Refrigerator, Residential
<b>Condition</b>	Good
<b>Qty / UOM</b>	1 / EA
<b>Unit Cost</b>	\$956.04
<b>Basis of Costing</b>	Refrigerator, Residential, 14-18 CF
<b>Year in Service</b>	2017
<b>Expected Useful Life (EUL)</b>	15 Year(s), Based on Industry Averages
<b>Remaining Useful Life (RUL)</b>	14 Year(s), Estimated, Based on Date of Observation
<b>Location</b>	Building Interior (General)

Uniformat	Action Description	Quantity	Unit Cost	Plan Type	Priority	Year	Expenditure
<b>E1094</b>	Replace Refrigerator, Residential	1 EA	\$956.04	BYL	Priority 3	2032	\$956

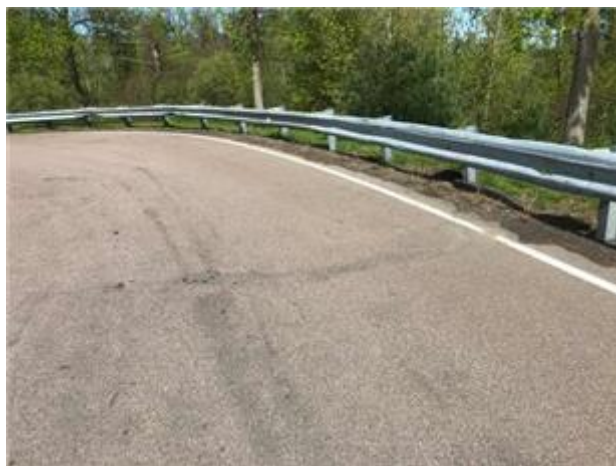
Coding / Field Name	Asset Description
<b>G2012 Paving &amp; Surfacing</b>	Steel Guard Rail
<b>Condition</b>	Fair
<b>Qty / UOM</b>	550 / LF
<b>Unit Cost</b>	\$45.42
<b>Basis of Costing</b>	Steel Guard Rail
<b>Year in Service</b>	2002
<b>Expected Useful Life (EUL)</b>	25 Year(s), Based on Industry Averages
<b>Remaining Useful Life (RUL)</b>	9 Year(s), Estimated, Based on Date of Observation
<b>Location</b>	Site

Uniformat	Action Description	Quantity	Unit Cost	Plan Type	Priority	Year	Expenditure
<b>G2012</b>	Replace Steel Guard Rail	550 LF	\$45.42	BYL	Priority 3	2027	\$24,979

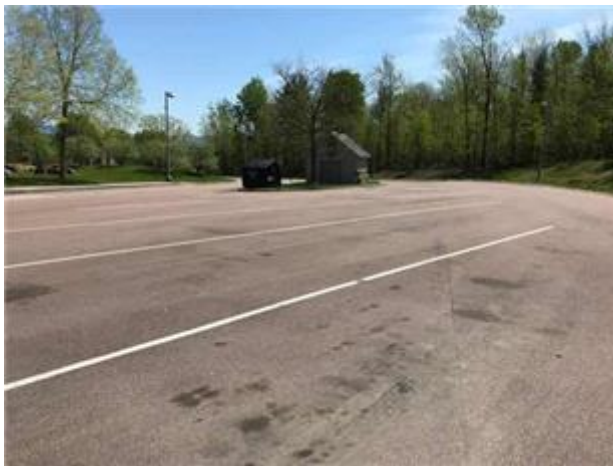
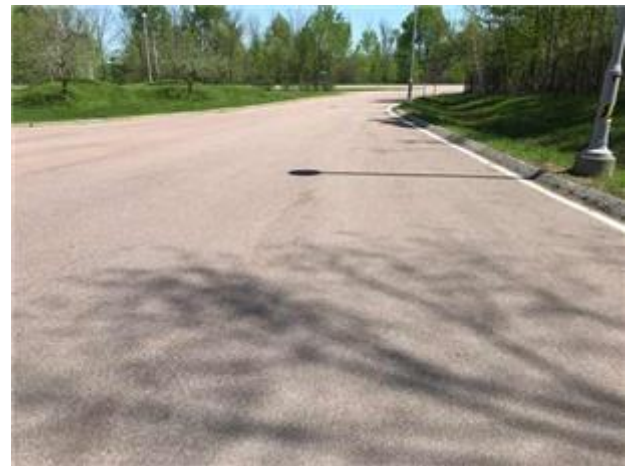
Coding / Field Name	Asset Description
<b>G2022 Paving &amp; Surfacing</b>	Asphalt Pavement, Parking Lot
<b>Condition</b>	Fair
<b>Qty / UOM</b>	43000 / SF
<b>Unit Cost</b>	\$5.90
<b>Basis of Costing</b>	Asphalt Pavement, Parking Lot
<b>Year in Service</b>	2001
<b>Expected Useful Life (EUL)</b>	25 Year(s), Based on Industry Averages
<b>Remaining Useful Life (RUL)</b>	8 Year(s), Estimated, Based on Date of Observation
<b>Location</b>	Site

Uniformat	Action Description	Quantity	Unit Cost	Plan Type	Priority	Year	Expenditure
<b>G2022</b>	Seal & Stripe Asphalt Pavement	43,000 SF	\$0.38	BYL	Priority 2	2022	\$16,340
<b>G2022</b>	Seal & Stripe Asphalt Pavement	43,000 SF	\$0.38	BYL	Priority 2	2027	\$16,340
<b>G2022</b>	Mill & Overlay Asphalt Pavement	43,000 SF	\$3.28	BYL	Priority 3	2027	\$141,040
<b>G2022</b>	Seal & Stripe Asphalt Pavement	43,000 SF	\$0.38	BYL	Priority 2	2032	\$16,340
<b>G2022</b>	Seal & Stripe Asphalt Pavement	43,000 SF	\$0.38	BYL	Priority 2	2037	\$16,340

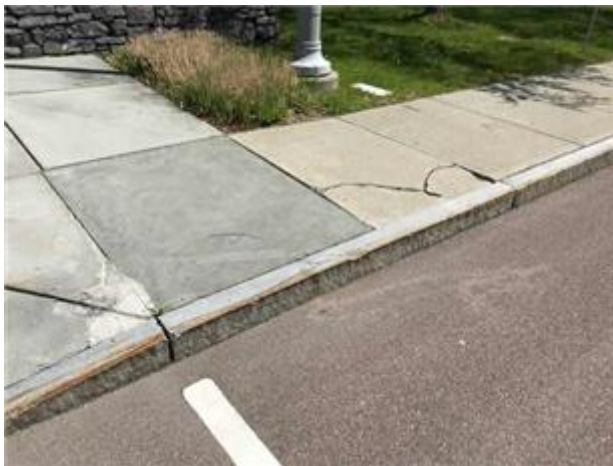
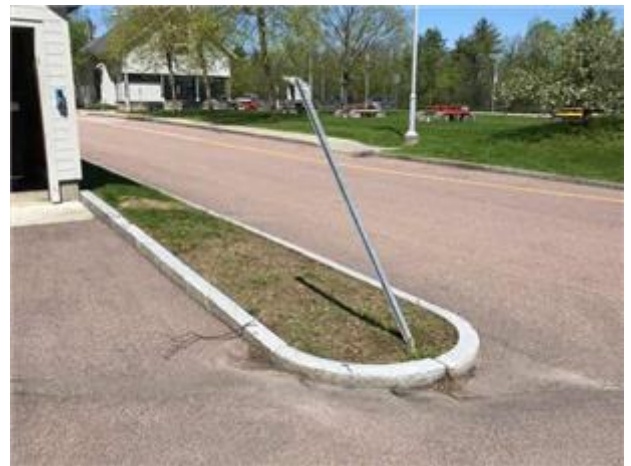
Coding / Field Name	Asset Description
<b>G2022 Paving &amp; Surfacing</b>	Curb, Granite
<b>Condition</b>	Fair
<b>Qty / UOM</b>	1100 / LF
<b>Unit Cost</b>	\$40.08
<b>Basis of Costing</b>	Curb & Gutter, Concrete, 24" by 6" straight (per LF)
<b>Year in Service</b>	2002
<b>Expected Useful Life (EUL)</b>	40 Year(s), Based on Industry Averages
<b>Remaining Useful Life (RUL)</b>	24 Year(s), Estimated, Based on Date of Observation
<b>Location</b>	Site

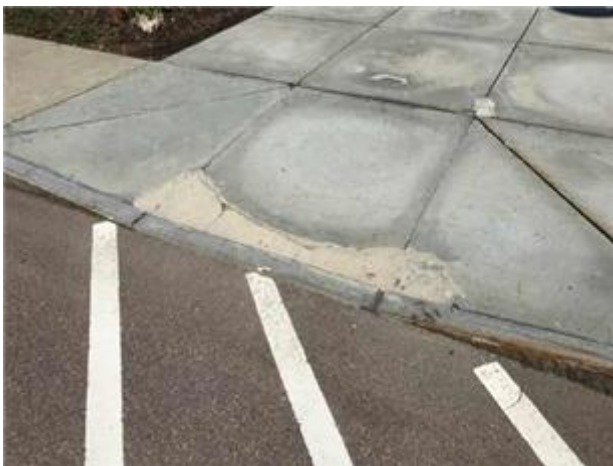
Coding / Field Name	Asset Description
<b>G2031 Paving &amp; Surfacing</b>	Bluestone / Granite Paver Sidewalk, Exterior
<b>Condition</b>	Fair
<b>Qty / UOM</b>	1700 / SF
<b>Unit Cost</b>	\$34.11
<b>Basis of Costing</b>	Clay Brick/Masonry Paver Sidewalk, Exterior
<b>Year in Service</b>	2000
<b>Expected Useful Life (EUL)</b>	30 Year(s), Based on Industry Averages
<b>Remaining Useful Life (RUL)</b>	12 Year(s), Estimated, Based on Date of Observation
<b>Location</b>	Site

Some areas deteriorating.

Deteriorated pavers

Unifomat	Action Description	Quantity	Unit Cost	Plan Type	Priority	Year	Expenditure
<b>G2031</b>	1" Pavers with 2" Sand Bedding	400 SF	\$34.02	REL	Priority 1	2019	\$13,608
<b>G2031</b>	Replace Bluestone / Granite Paver Sidewalk, Exterior	1,700 SF	\$34.11	BYL	Priority 3	2030	\$57,985

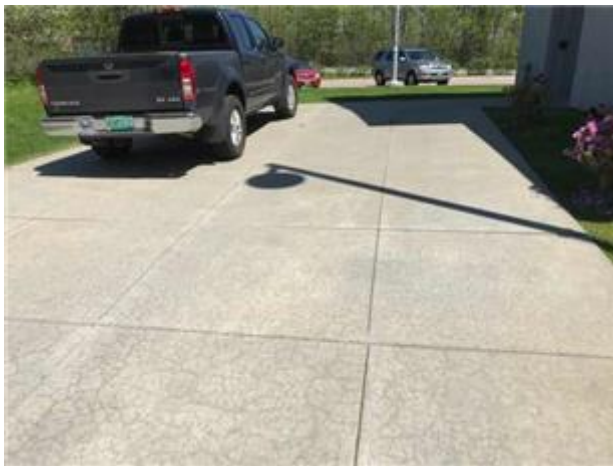
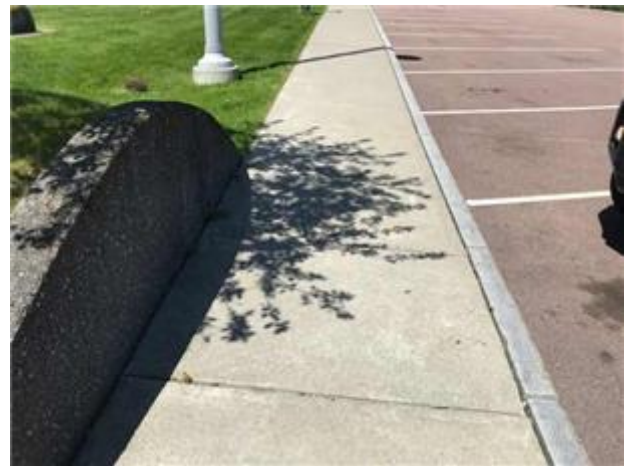
Coding / Field Name	Asset Description
<b>G2031 Paving &amp; Surfacing</b>	Concrete Sidewalk
<b>Condition</b>	Fair
<b>Qty / UOM</b>	2100 / SF
<b>Unit Cost</b>	\$19.82
<b>Basis of Costing</b>	Concrete Sidewalk
<b>Year in Service</b>	2002
<b>Expected Useful Life (EUL)</b>	30 Year(s), Based on Industry Averages
<b>Remaining Useful Life (RUL)</b>	14 Year(s), Estimated, Based on Date of Observation
<b>Location</b>	Site

Unifomat	Action Description	Quantity	Unit Cost	Plan Type	Priority	Year	Expenditure
<b>G2031</b>	Replace Concrete Sidewalk	2,100 SF	\$19.82	BYL	Priority 3	2032	\$41,626

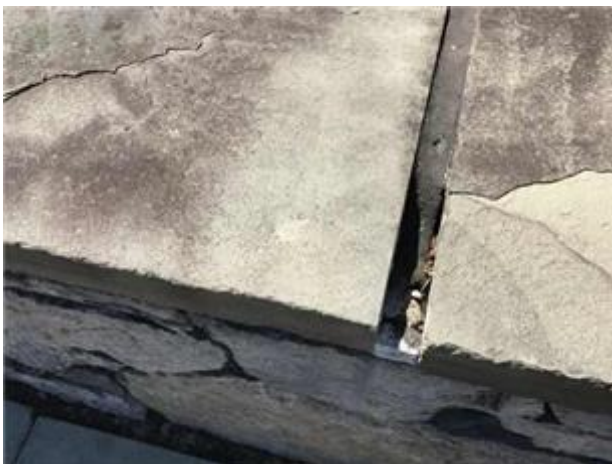
Coding / Field Name	Asset Description
<b>G2042 Retaining Walls</b>	Landscape Wall, Brick/Stone
<b>Condition</b>	Fair
<b>Qty / UOM</b>	100 / SF
<b>Unit Cost</b>	\$130.61
<b>Basis of Costing</b>	Retaining Wall, Brick/Stone (per SF Face)
<b>Year in Service</b>	2002
<b>Expected Useful Life (EUL)</b>	40 Year(s), Based on Industry Averages
<b>Remaining Useful Life (RUL)</b>	24 Year(s), Estimated, Based on Date of Observation
<b>Location</b>	Site

The joints along the tops of the landscape walls need sealer replacement.

Failed sealant

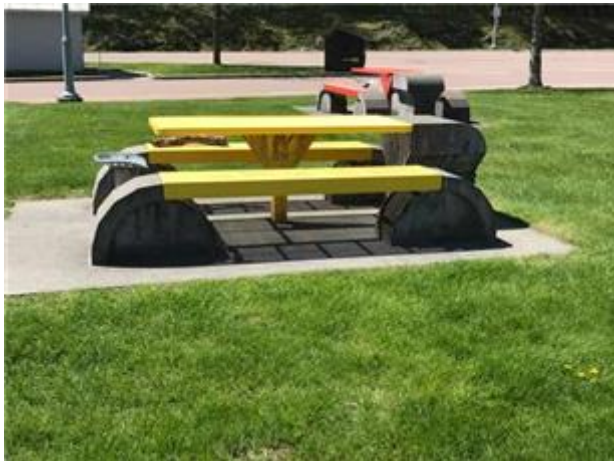
Coding / Field Name	Asset Description
<b>G2045 SITE GATES</b>	Picnic Table Concrete and Coated Steel
<b>Condition</b>	Fair
<b>Qty / UOM</b>	5 / EA
<b>Cost Adjustment Factor/Reason</b>	1.5 / Concrete base
<b>Unit Cost (Adjusted)</b>	\$2,087.25
<b>Basis of Costing</b>	Picnic Table, Expanded Metal, Plastic Coated
<b>Year in Service</b>	2002
<b>Expected Useful Life (EUL)</b>	30 Year(s), Based on Industry Averages
<b>Remaining Useful Life (RUL)</b>	14 Year(s), Estimated, Based on Date of Observation
<b>Location</b>	Site

Uniformat	Action Description	Quantity	Unit Cost	Plan Type	Priority	Year	Expenditure
<b>G2045</b>	Replace Picnic Table Concrete and Coated Steel	5 EA	\$2,087.25	BYL	Priority 3	2032	\$10,436

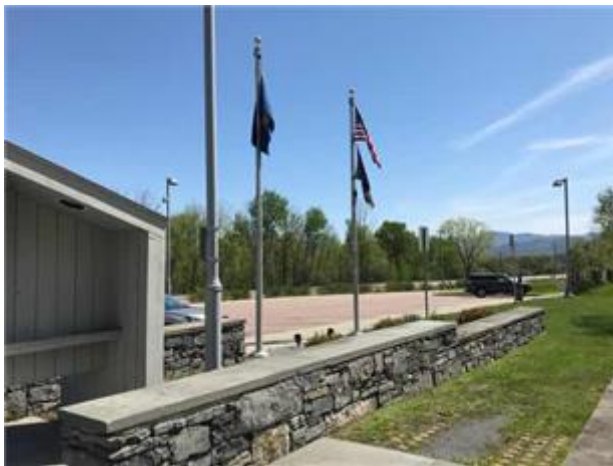
Coding / Field Name	Asset Description
<b>G2048 Flagpoles</b>	Flagpole, Metal, Internal or External Halyard
<b>Condition</b>	Fair
<b>Qty / UOM</b>	2 / EA
<b>Unit Cost</b>	\$2,530.00
<b>Basis of Costing</b>	Flagpole, Metal, Internal or External Halyard, 30' to 40' High (Pole Only)
<b>Year in Service</b>	2002
<b>Expected Useful Life (EUL)</b>	20 Year(s), Based on Industry Averages
<b>Remaining Useful Life (RUL)</b>	4 Year(s), Estimated, Based on Date of Observation
<b>Location</b>	Site

Uniformat	Action Description	Quantity	Unit Cost	Plan Type	Priority	Year	Expenditure
<b>G2048</b>	Replace Flagpole, Metal, Internal or External Halyard	2 EA	\$2,530.00	BYL	Priority 2	2022	\$5,060

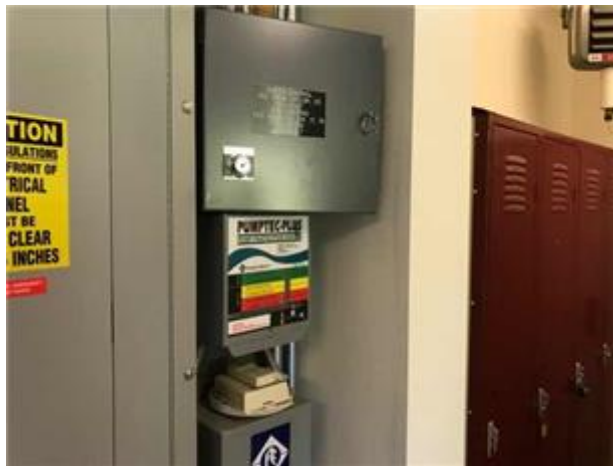
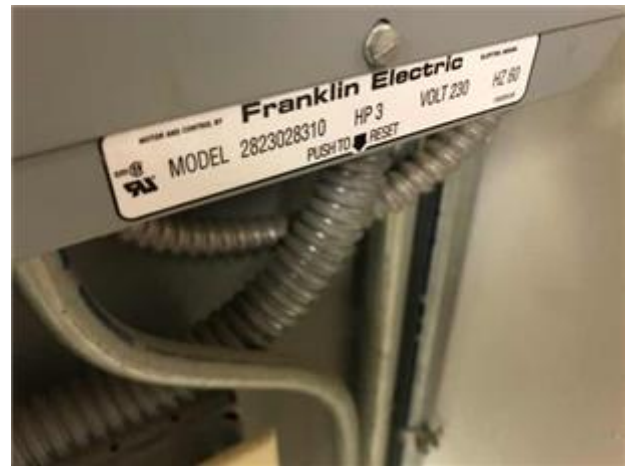
Coding / Field Name	Asset Description
<b>G3013 Well Systems</b>	Well Pump and Controls
<b>Condition</b>	Fair
<b>Qty / UOM</b>	1 / EA
<b>Unit Cost</b>	\$2,670.42
<b>Basis of Costing</b>	Well Pump, 1.5 HP
<b>Year in Service</b>	2002
<b>Expected Useful Life (EUL)</b>	20 Year(s), Based on Industry Averages
<b>Remaining Useful Life (RUL)</b>	4 Year(s), Estimated, Based on Date of Observation
<b>Location</b>	Electrical Room (Primary)

Uniformat	Action Description	Quantity	Unit Cost	Plan Type	Priority	Year	Expenditure
<b>G3013</b>	Replace Well Pump and Controls	1 EA	\$2,670.42	BYL	Priority 2	2022	\$2,670

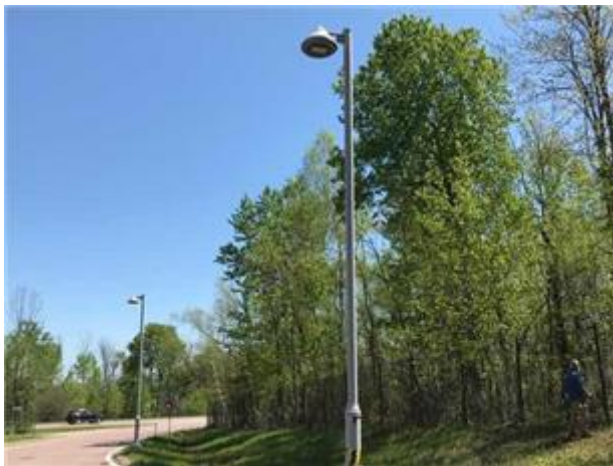
Coding / Field Name	Asset Description
<b>G4021 Fixtures &amp; Transformers</b>	Pole Light, Exterior, LED Flood
<b>Condition</b>	Good
<b>Qty / UOM</b>	19 / EA
<b>Unit Cost</b>	\$4,630.42
<b>Basis of Costing</b>	Pole Light, Exterior, 135 to 1000 W HID (Fixture Only)
<b>Year in Service</b>	2015
<b>Expected Useful Life (EUL)</b>	20 Year(s), Based on Industry Averages
<b>Remaining Useful Life (RUL)</b>	17 Year(s), Estimated, Based on Date of Observation
<b>Location</b>	Site

Uniformat	Action Description	Quantity	Unit Cost	Plan Type	Priority	Year	Expenditure
<b>G4021</b>	Replace Pole Light, Exterior, LED Flood	19 EA	\$4,630.42	BYL	Priority 3	2035	\$87,978
