# FACILITY CONDITION ASSESSMENT

June 18, 2017

FACILITY CONDITION ASSESSMENT  
OF

09250  
47098 PROSPECT ST (RT. 4)  
FAIR HAVEN, VT 05743

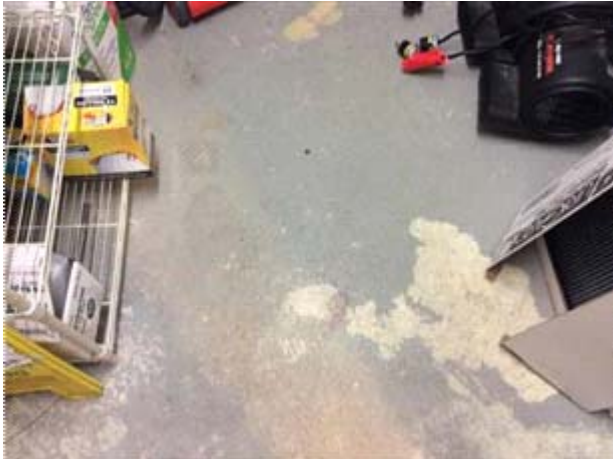
Coding / Field Name	Asset Description
A1031 Standard Slab on Grade	Slab on Grade
Condition	Fair
Qty / UOM	2390 / SF
Unit Cost	\$10.00
Basis of Costing	Concrete Slab-On-Grade
Year in Service	1980
Expected Useful Life (EUL)	50 Year(s), Based on Industry Averages
Remaining Useful Life (RUL)	30 Year(s), Estimated, Based on Date of Observation
Location	Structure
Basement Wall Construction	Concrete

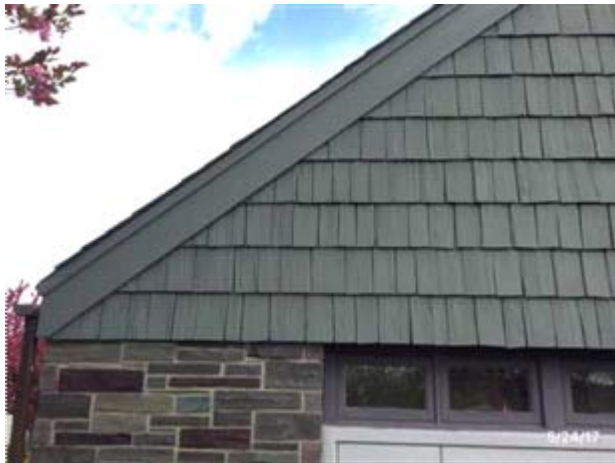
Coding / Field Name	Asset Description
<b>B2011 Exterior Wall Construction</b>	Wood Shingles
<b>Condition</b>	Fair
<b>Qty / UOM</b>	500 / SF
<b>Unit Cost</b>	\$6.69
<b>Basis of Costing</b>	Wood Shingles, 1-2 Stories
<b>Year in Service</b>	1997
<b>Expected Useful Life (EUL)</b>	20 Year(s), Based on Industry Averages
<b>Remaining Useful Life (RUL)</b>	13 Year(s), Estimated, Based on Date of Observation
<b>Location</b>	Exterior Walls
<b>Exterior Wall Construction</b>	Wood Shake Siding
<b>Parapets</b>	No
<b>Exterior Soffits</b>	Exposed

Uniformat	Action Description	Quantity	Unit Cost	Plan Type	Priority	Year	Expenditure
<b>B2011</b>	Prep & Paint Exterior Walls	500 SF	\$1.41	APP	Priority 3	2020	\$705
<b>B2011</b>	Prep & Paint Exterior Walls	500 SF	\$1.41	APP	Priority 3	2030	\$705
<b>B2011</b>	Replace Wood Shingles	500 SF	\$6.69	BYL	Priority 3	2030	\$3,345

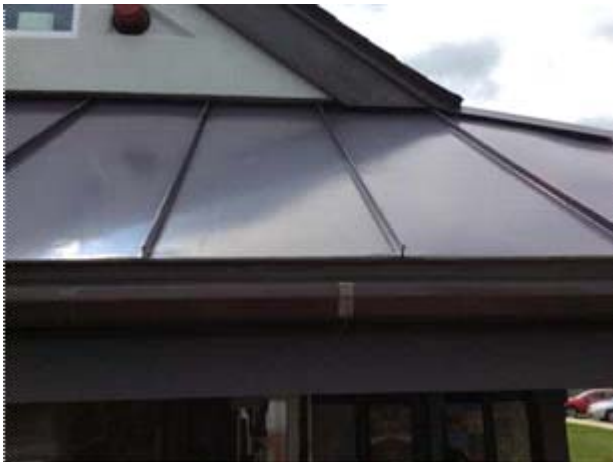
Coding / Field Name	Asset Description
<b>B3011 Roof Finishes</b>	Metal Roof
<b>Condition</b>	Fair
<b>Qty / UOM</b>	1000 / SF
<b>Unit Cost</b>	\$32.41
<b>Basis of Costing</b>	Metal Roof (Includes Tear-Off of Old)
<b>Year in Service</b>	1997
<b>Expected Useful Life (EUL)</b>	40 Year(s), Based on Industry Averages
<b>Remaining Useful Life (RUL)</b>	20 Year(s), Estimated, Based on Date of Observation
<b>Location</b>	Roof
<b>Insulation</b>	Batt
<b>Flashings and Trim</b>	Metal
<b>Roof Eaves and Soffits</b>	Yes
<b>Roof Drainage</b>	Metal Gutter And Down Spouts
<b>Roof Warranty</b>	Unknown

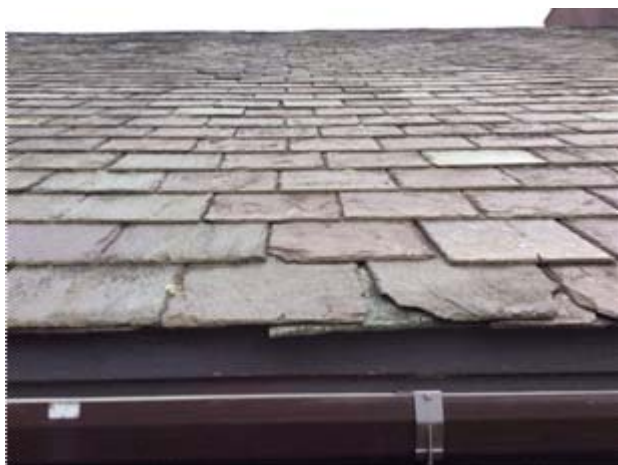
Coding / Field Name	Asset Description
<b>B3011 Roof Finishes</b>	Slate Steep Roof
<b>Condition</b>	Fair
<b>Qty / UOM</b>	3000 / SF
<b>Cost Adjustment Factor/Reason</b>	1.4 / Gable
<b>Unit Cost (Adjusted)</b>	\$41.72
<b>Basis of Costing</b>	Slate Steep Roof (Includes Tear-Off of Old)
<b>Year in Service</b>	1980
<b>Expected Useful Life (EUL)</b>	40 Year(s), Based on Industry Averages
<b>Remaining Useful Life (RUL)</b>	15 Year(s), Estimated, Based on Date of Observation
<b>Location</b>	Roof
<b>Insulation</b>	Batt
<b>Flashings and Trim</b>	Metal
<b>Roof Eaves and Soffits</b>	Yes
<b>Roof Drainage</b>	Metal Gutter And Down Spouts
<b>Roof Warranty</b>	Unknown

Uniformat	Action Description	Quantity	Unit Cost	Plan Type	Priority	Year	Expenditure
<b>B3011</b>	Replace Slate Steep Roof	3,000 SF	\$41.72	BYL	Priority 3	2032	\$125,160

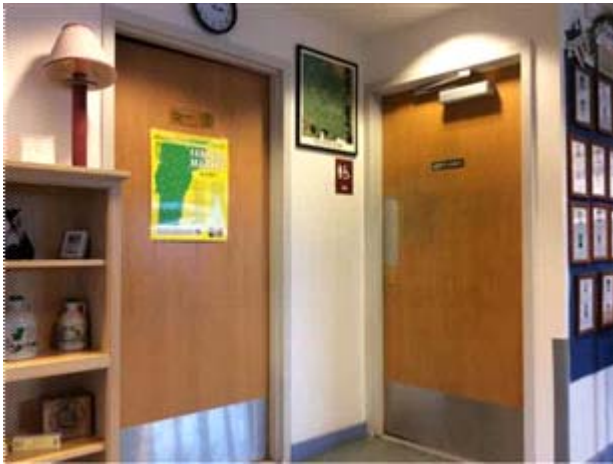
Coding / Field Name	Asset Description
<b>C1021 Interior Doors</b>	Wood Door
<b>Condition</b>	Fair
<b>Qty / UOM</b>	8 / EA
<b>Unit Cost</b>	\$1,423.11
<b>Basis of Costing</b>	Wood, Solid Core, Painted/Stained, Interior Door
<b>Year in Service</b>	1997
<b>Expected Useful Life (EUL)</b>	20 Year(s), Based on Industry Averages
<b>Remaining Useful Life (RUL)</b>	10 Year(s), Estimated, Based on Date of Observation
<b>Location</b>	Building Interior (General)

Uniformat	Action Description	Quantity	Unit Cost	Plan Type	Priority	Year	Expenditure
<b>C1021</b>	Replace Wood Door	8 EA	\$1,423.11	BYL	Priority 3	2027	\$11,385

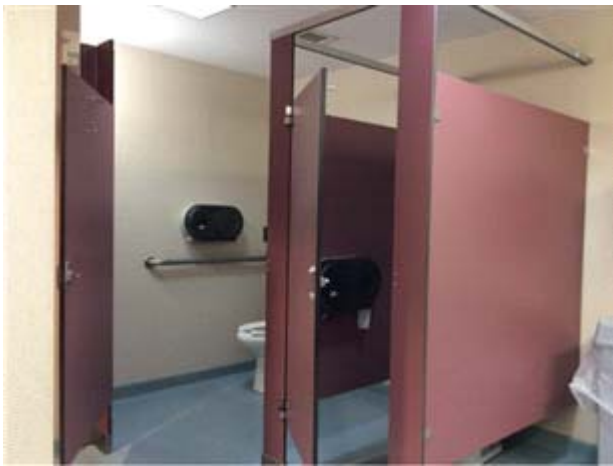
Coding / Field Name	Asset Description
<b>C1031 Fabricated Toilet Partitions</b>	Toilet Partitions, Metal
<b>Condition</b>	Fair
<b>Qty / UOM</b>	7 / EA
<b>Unit Cost</b>	\$850.00
<b>Basis of Costing</b>	Toilet Partitions, Metal, Overhead Braced
<b>Year in Service</b>	1997
<b>Expected Useful Life (EUL)</b>	20 Year(s), Based on Industry Averages
<b>Remaining Useful Life (RUL)</b>	7 Year(s), Estimated, Based on Date of Observation
<b>Location</b>	Restrooms

Uniformat	Action Description	Quantity	Unit Cost	Plan Type	Priority	Year	Expenditure
<b>C1031</b>	Replace Toilet Partitions, Metal	7 EA	\$850.00	BYL	Priority 3	2024	\$5,950

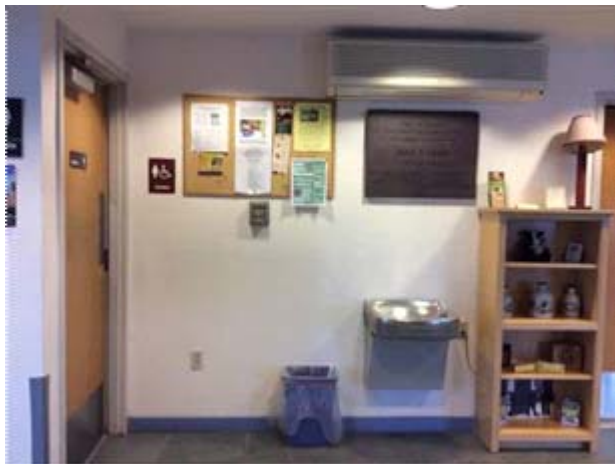
Coding / Field Name	Asset Description
<b>C3012 Wall Finishes to Interior Walls</b>	Gypsum Board, Wall
<b>Condition</b>	Fair
<b>Qty / UOM</b>	4000 / SF
<b>Unit Cost</b>	\$3.38
<b>Basis of Costing</b>	Gypsum Board/Plaster, Interior Wall
<b>Year in Service</b>	1997
<b>Expected Useful Life (EUL)</b>	40 Year(s), Based on Industry Averages
<b>Remaining Useful Life (RUL)</b>	20 Year(s), Estimated, Based on Date of Observation
<b>Location</b>	Building Interior (General)

Uniformat	Action Description	Quantity	Unit Cost	Plan Type	Priority	Year	Expenditure
<b>C3012</b>	Paint Interior Walls	4,000 SF	\$1.42	APP	Priority 4	2022	\$5,680
<b>C3012</b>	Paint Interior Walls	4,000 SF	\$1.42	APP	Priority 4	2030	\$5,680

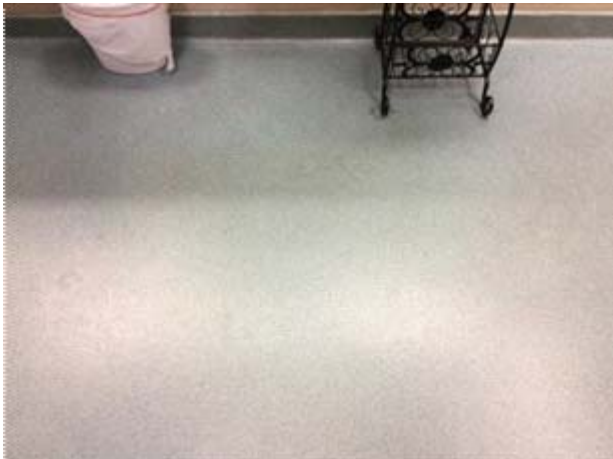
Coding / Field Name	Asset Description
<b>C3021 Floor Toppings</b>	Epoxy Floor Finish
<b>Condition</b>	Fair
<b>Qty / UOM</b>	1000 / SF
<b>Unit Cost</b>	\$8.74
<b>Basis of Costing</b>	Epoxy Floor Finish
<b>Year in Service</b>	1997
<b>Expected Useful Life (EUL)</b>	10 Year(s), Based on Industry Averages
<b>Remaining Useful Life (RUL)</b>	6 Year(s), Estimated, Based on Date of Observation
<b>Location</b>	Building Interior (General)
<b>Floor Toppings</b>	Poured Epoxy Sealant

Uniformat	Action Description	Quantity	Unit Cost	Plan Type	Priority	Year	Expenditure
<b>C3021</b>	Replace Epoxy Floor Finish	1,000 SF	\$8.74	BYL	Priority 3	2023	\$8,740
<b>C3021</b>	Replace Epoxy Floor Finish	1,000 SF	\$8.74	BYL	Priority 3	2033	\$8,740

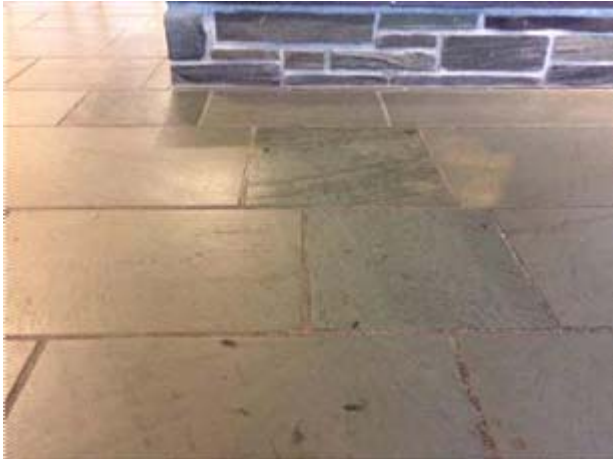
Coding / Field Name	Asset Description
<b>C3024 Flooring</b>	Slate Floor Tiles
<b>Condition</b>	Fair - Good
<b>Qty / UOM</b>	1000 / SF
<b>Cost Adjustment Factor/Reason</b>	0.5 / Slate Tile
<b>Unit Cost (Adjusted)</b>	\$34.78
<b>Basis of Costing</b>	Marble Flooring
<b>Year in Service</b>	1997
<b>Expected Useful Life (EUL)</b>	50 Year(s), Based on Industry Averages
<b>Remaining Useful Life (RUL)</b>	30 Year(s), Estimated, Based on Date of Observation
<b>Location</b>	Building Interior (General)

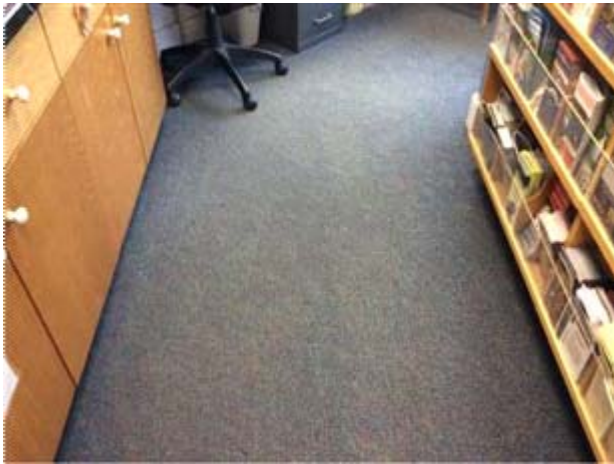
Coding / Field Name	Asset Description
<b>C3025 Carpeting</b>	Carpet, Standard Commercial, Medium Traffic
<b>Condition</b>	Fair
<b>Qty / UOM</b>	400 / SF
<b>Unit Cost</b>	\$7.26
<b>Basis of Costing</b>	Carpet, Standard Commercial, Medium Traffic
<b>Year in Service</b>	1997
<b>Expected Useful Life (EUL)</b>	10 Year(s), Based on Industry Averages
<b>Remaining Useful Life (RUL)</b>	5 Year(s), Estimated, Based on Date of Observation
<b>Location</b>	Building Interior (General)

Uniformat	Action Description	Quantity	Unit Cost	Plan Type	Priority	Year	Expenditure
<b>C3025</b>	Replace Carpet, Standard Commercial, Medium Traffic	400 SF	\$7.26	BYL	Priority 3	2022	\$2,902
<b>C3025</b>	Replace Carpet, Standard Commercial, Medium Traffic	400 SF	\$7.26	BYL	Priority 3	2032	\$2,902

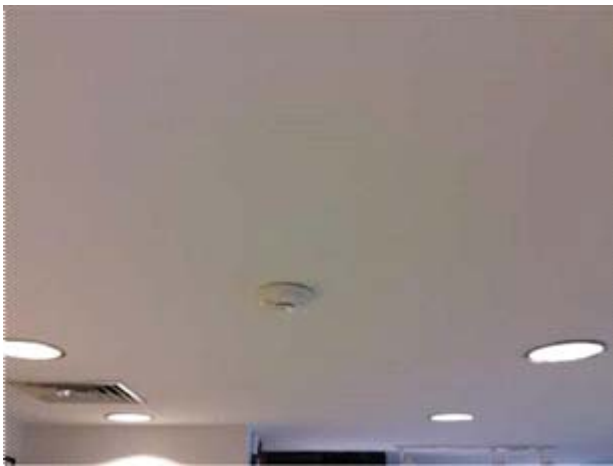
Coding / Field Name	Asset Description
<b>C3031 Ceiling Finishes</b>	Gypsum Board Ceiling
<b>Condition</b>	Fair
<b>Qty / UOM</b>	2390 / SF
<b>Unit Cost</b>	\$7.13
<b>Basis of Costing</b>	Gypsum Board/Plaster, Ceiling
<b>Year in Service</b>	1997
<b>Expected Useful Life (EUL)</b>	50 Year(s), Based on Industry Averages
<b>Remaining Useful Life (RUL)</b>	30 Year(s), Estimated, Based on Date of Observation
<b>Location</b>	Building Interior (General)

Uniformat	Action Description	Quantity	Unit Cost	Plan Type	Priority	Year	Expenditure
<b>C3031</b>	Paint Interior Ceilings	2,500 SF	\$1.94	APP	Priority 4	2022	\$4,850
<b>C3031</b>	Paint Interior Ceilings	2,500 SF	\$1.94	APP	Priority 4	2032	\$4,850

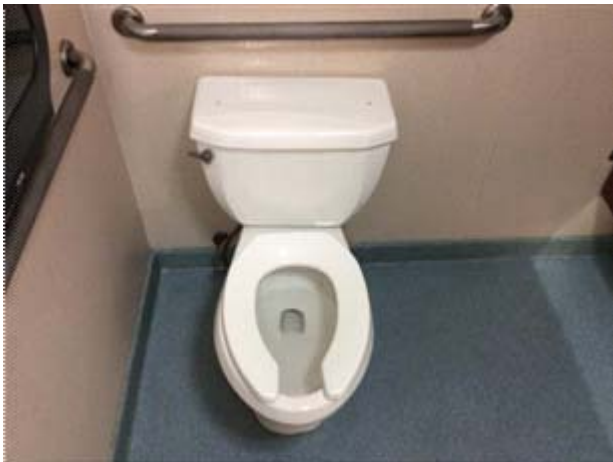
Coding / Field Name	Asset Description
<b>D2011 Water Closets</b>	Flush Tank Water Closet
<b>Condition</b>	Fair
<b>Qty / UOM</b>	7 / EA
<b>Unit Cost</b>	\$1,055.15
<b>Basis of Costing</b>	Flush Tank Water Closet, One Piece
<b>Year in Service</b>	1997
<b>Expected Useful Life (EUL)</b>	20 Year(s), Based on Industry Averages
<b>Remaining Useful Life (RUL)</b>	7 Year(s), Estimated, Based on Date of Observation
<b>Location</b>	Restrooms
<b>Low Flow Toilet</b>	Yes
<b>System Grade</b>	Commercial Grade

Uniformat	Action Description	Quantity	Unit Cost	Plan Type	Priority	Year	Expenditure
<b>D2011</b>	Replace Flush Tank Water Closet	7 EA	\$1,055.15	BYL	Priority 3	2024	\$7,386

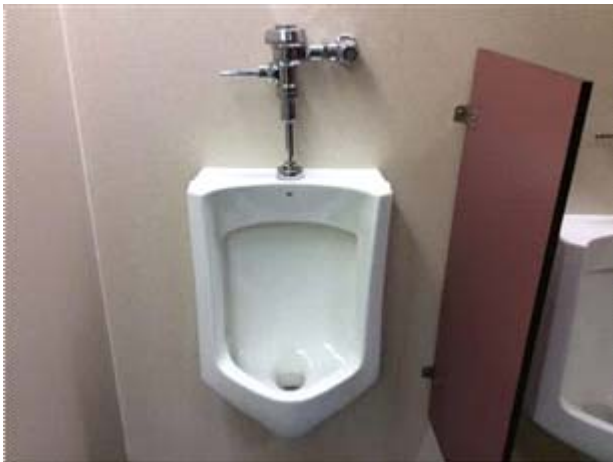
Coding / Field Name	Asset Description
<b>D2012 Urinals</b>	Urinal, Vitreous China
<b>Condition</b>	Fair
<b>Qty / UOM</b>	2 / EA
<b>Unit Cost</b>	\$1,193.44
<b>Basis of Costing</b>	Urinal, Vitreous China
<b>Year in Service</b>	1997
<b>Expected Useful Life (EUL)</b>	20 Year(s), Based on Industry Averages
<b>Remaining Useful Life (RUL)</b>	7 Year(s), Estimated, Based on Date of Observation
<b>Location</b>	Restrooms
<b>Low Flow Toilet</b>	No
<b>System Grade</b>	Commercial Grade

Uniformat	Action Description	Quantity	Unit Cost	Plan Type	Priority	Year	Expenditure
<b>D2012</b>	Replace Urinal, Vitreous China	2 EA	\$1,193.44	BYL	Priority 3	2024	\$2,387

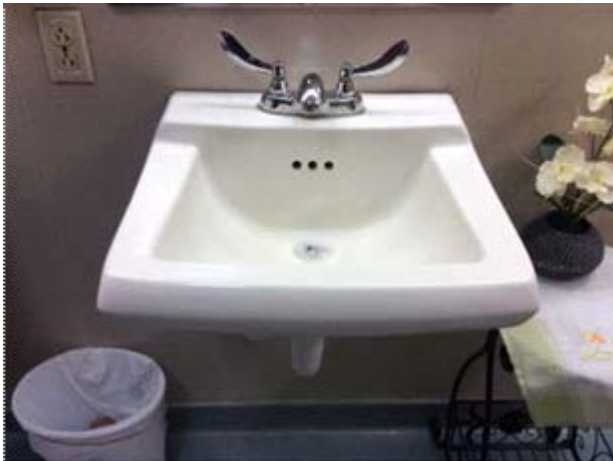
Coding / Field Name	Asset Description
<b>D2013 Lavatories</b>	Lavatory, Enameled Steel
<b>Condition</b>	Fair
<b>Qty / UOM</b>	7 / EA
<b>Unit Cost</b>	\$353.05
<b>Basis of Costing</b>	Lavatory, Enameled Steel
<b>Year in Service</b>	1997
<b>Expected Useful Life (EUL)</b>	20 Year(s), Based on Industry Averages
<b>Remaining Useful Life (RUL)</b>	7 Year(s), Estimated, Based on Date of Observation
<b>Location</b>	Restrooms
<b>System Grade</b>	Commercial Grade

Uniformat	Action Description	Quantity	Unit Cost	Plan Type	Priority	Year	Expenditure
<b>D2013</b>	Replace Lavatory, Enameled Steel	7 EA	\$353.05	BYL	Priority 3	2024	\$2,471

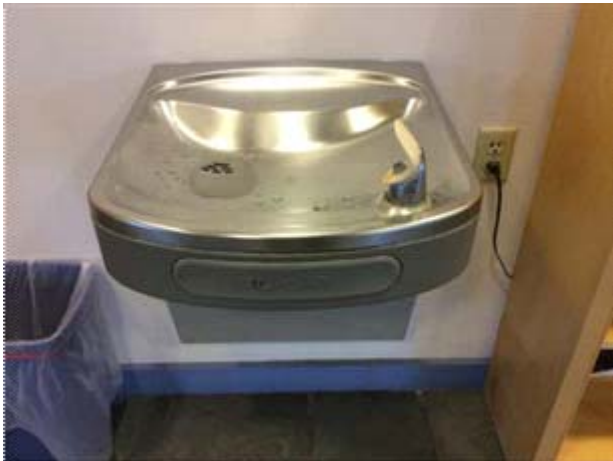
Coding / Field Name	Asset Description
<b>D2018 Drinking Fountains and Coolers</b>	Drinking Fountain, Refrigerated
<b>Condition</b>	Fair
<b>Qty / UOM</b>	1 / EA
<b>Unit Cost</b>	\$1,257.51
<b>Basis of Costing</b>	Drinking Fountain, Refrigerated
<b>Year in Service</b>	2003
<b>Expected Useful Life (EUL)</b>	10 Year(s), Based on Industry Averages
<b>Remaining Useful Life (RUL)</b>	5 Year(s), Estimated, Based on Date of Observation
<b>Location</b>	Building Interior (General)
<b>System Grade</b>	Commercial Grade

Uniformat	Action Description	Quantity	Unit Cost	Plan Type	Priority	Year	Expenditure
<b>D2018</b>	Replace Drinking Fountain, Refrigerated	1 EA	\$1,257.51	BYL	Priority 2	2022	\$1,258
<b>D2018</b>	Replace Drinking Fountain, Refrigerated	1 EA	\$1,257.51	BYL	Priority 2	2032	\$1,258

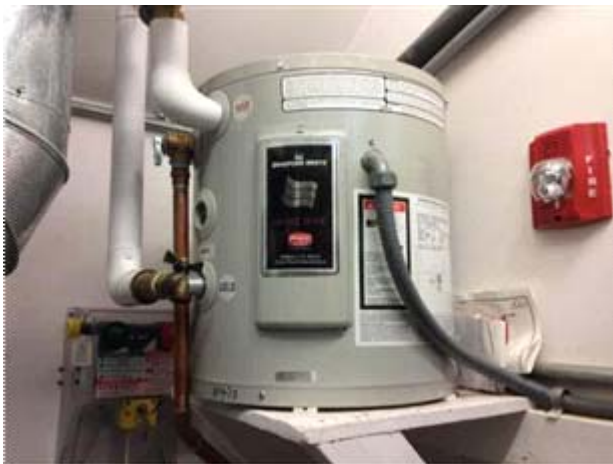
Coding / Field Name	Asset Description
<b>D2023 Domestic Water Supply Equipment</b>	Water Heater
<b>Condition</b>	Good
<b>Qty / UOM</b>	1 / EA
<b>Unit Cost</b>	\$1,014.17
<b>Basis of Costing</b>	Water Heater, Electric, Residential, 5 to 15 GAL
<b>Year in Service</b>	2013
<b>Expected Useful Life (EUL)</b>	15 Year(s), Based on Industry Averages
<b>Remaining Useful Life (RUL)</b>	11 Year(s), Estimated, Based on Date of Observation
<b>Location</b>	MEP Closet

Uniformat	Action Description	Quantity	Unit Cost	Plan Type	Priority	Year	Expenditure
<b>D2023</b>	Replace Water Heater	1 EA	\$1,014.17	BYL	Priority 3	2028	\$1,014

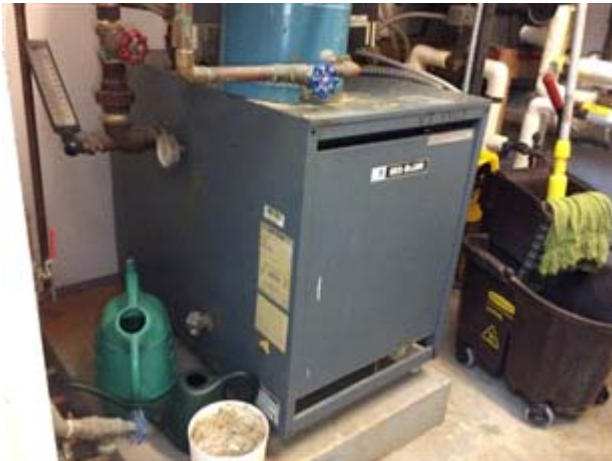
Coding / Field Name	Asset Description
<b>D3021 Boilers</b>	Boiler
<b>Condition</b>	Fair
<b>Qty / UOM</b>	1 / EA
<b>Unit Cost</b>	\$23,840.88
<b>Basis of Costing</b>	Boiler, Gas, 301 to 750 MBH
<b>Year in Service</b>	1997
<b>Expected Useful Life (EUL)</b>	25 Year(s), Based on Industry Averages
<b>Remaining Useful Life (RUL)</b>	5 Year(s), Estimated, Based on Date of Observation
<b>Location</b>	MEP Closet
<b>Boiler Draft Type</b>	Atmospheric/Induced Draft

Uniformat	Action Description	Quantity	Unit Cost	Plan Type	Priority	Year	Expenditure
<b>D3021</b>	Replace Boiler	1 EA	\$23,840.88	BYL	Priority 2	2022	\$23,841

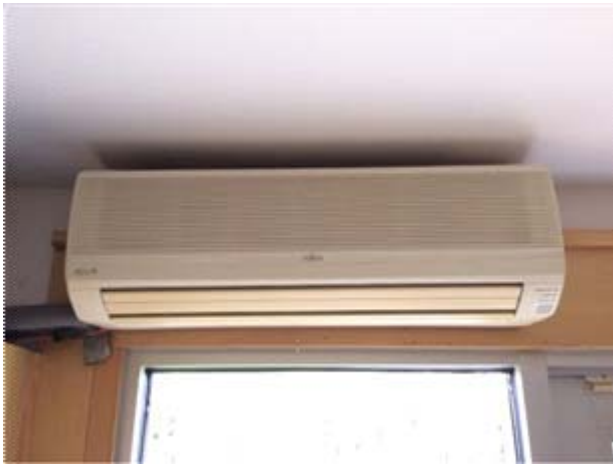
Coding / Field Name	Asset Description
<b>D3032 Direct Expansion Systems</b>	Ductless Split System
<b>Condition</b>	Fair
<b>Qty / UOM</b>	3 / EA
<b>Unit Cost</b>	\$3,578.72
<b>Basis of Costing</b>	Ductless Split System, Multi Zone (per 1 to 2 Ton Fan Coil Unit)
<b>Year in Service</b>	1997
<b>Expected Useful Life (EUL)</b>	15 Year(s), Based on Industry Averages
<b>Remaining Useful Life (RUL)</b>	4 Year(s), Estimated, Based on Date of Observation
<b>Location</b>	Building Interior (General)

Uniformat	Action Description	Quantity	Unit Cost	Plan Type	Priority	Year	Expenditure
<b>D3032</b>	Replace Ductless Split System	3 EA	\$3,578.72	BYL	Priority 2	2021	\$10,736
<b>D3032</b>	Replace Ductless Split System	3 EA	\$3,578.72	BYL	Priority 2	2036	\$10,736

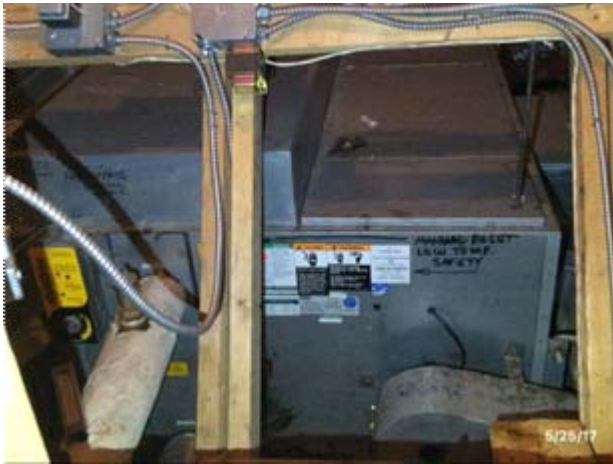
Coding / Field Name	Asset Description
<b>D3041 Air Distribution Systems</b>	Fan Coil Unit
<b>Condition</b>	Fair
<b>Qty / UOM</b>	1 / EA
<b>Unit Cost</b>	\$4,099.52
<b>Basis of Costing</b>	Fan Coil Unit, 3.5 to 5 Ton
<b>Year in Service</b>	1997
<b>Expected Useful Life (EUL)</b>	15 Year(s), Based on Industry Averages
<b>Remaining Useful Life (RUL)</b>	9 Year(s), Estimated, Based on Date of Observation
<b>Location</b>	Attic

Uniformat	Action Description	Quantity	Unit Cost	Plan Type	Priority	Year	Expenditure
<b>D3041</b>	Replace Fan Coil Unit	1 EA	\$4,099.52	BYL	Priority 3	2026	\$4,100

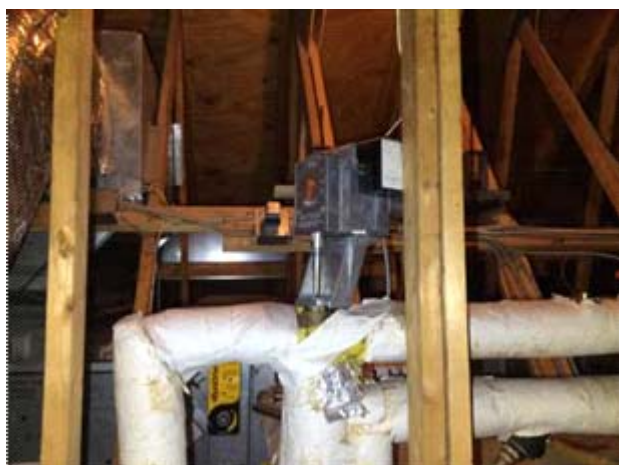
Coding / Field Name	Asset Description
<b>D3068 Building Automation Systems</b>	Direct Digital (DDC) HVAC Controls
<b>Condition</b>	Fair
<b>Qty / UOM</b>	2390 / SF
<b>Unit Cost</b>	\$5.36
<b>Basis of Costing</b>	Building Automation System (HVAC Controls), Full Upgrade (per SF)
<b>Year in Service</b>	1997
<b>Expected Useful Life (EUL)</b>	20 Year(s), Based on Industry Averages
<b>Remaining Useful Life (RUL)</b>	7 Year(s), Estimated, Based on Date of Observation
<b>Location</b>	Building Interior (General)

Uniformat	Action Description	Quantity	Unit Cost	Plan Type	Priority	Year	Expenditure
<b>D3068</b>	Replace Direct Digital (DDC) HVAC Controls	2,390 SF	\$5.36	BYL	Priority 2	2024	\$12,810

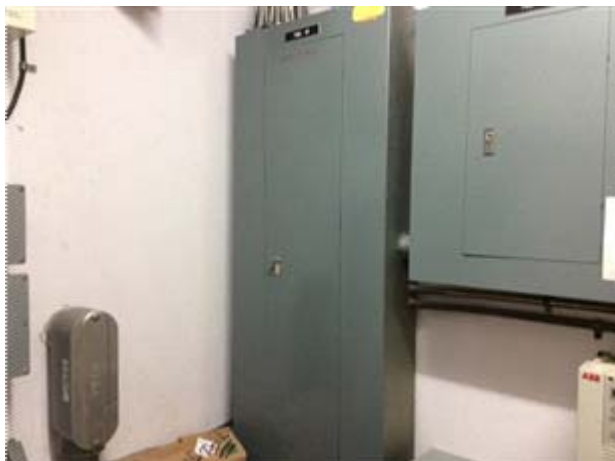
Coding / Field Name	Asset Description
D5012 Low Tension Service & Dist.	Power Panel Board
Condition	Fair
Qty / UOM	1 / EA
Unit Cost	\$7,951.00
Basis of Costing	Power Panel Board, 208 Y, 120 V, 225 Amp
Year in Service	1997
Expected Useful Life (EUL)	30 Year(s), Based on Industry Averages
Remaining Useful Life (RUL)	10 Year(s), Estimated, Based on Date of Observation
Location	Electrical Room (Primary)
Service Size (Amperage)	200
Service Voltage	120/240
Step Down Transformers	No
Electrical Distribution Panel Type	Circuit Breakers
Main Electrical Distribution Lines	Overhead
Site Electrical Transformer Location	Pad-Mounted
Electrical Wiring Material	Solid Copper
Electrical Wiring in Metal Conduit	Yes
Electrical Wiring in Non-Metal (NM) Conduit	No
Electrical Wiring in Non- Metal Sheathing (Romex)	No
Electrical Wiring in Metal Sheathing (BX)	Yes

Uniformat	Action Description	Quantity	Unit Cost	Plan Type	Priority	Year	Expenditure
D5012	Replace Power Panel Board	1 EA	\$7,951.00	BYL	Priority 3	2027	\$7,951

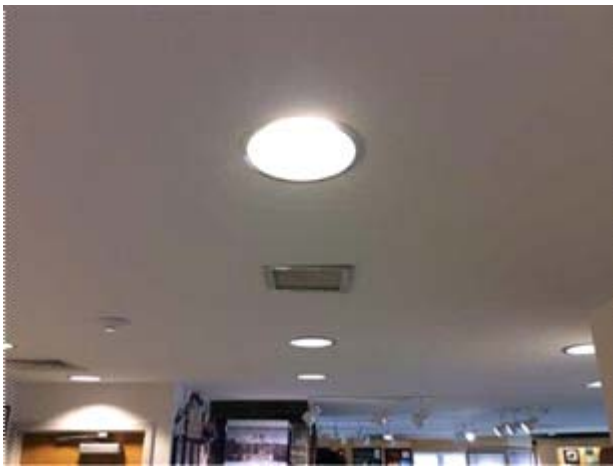
Coding / Field Name	Asset Description
<b>D5029 Lighting Systems</b>	Lighting System, Interior
<b>Condition</b>	Fair
<b>Qty / UOM</b>	2390 / SF
<b>Unit Cost</b>	\$9.24
<b>Basis of Costing</b>	Lighting System, Full Upgrade, Office (per SF)
<b>Year in Service</b>	1997
<b>Expected Useful Life (EUL)</b>	25 Year(s), Based on Industry Averages
<b>Remaining Useful Life (RUL)</b>	5 Year(s), Estimated, Based on Date of Observation
<b>Location</b>	Building Interior (General)

Uniformat	Action Description	Quantity	Unit Cost	Plan Type	Priority	Year	Expenditure
<b>D5029</b>	Replace Lighting System, Interior	2,390 SF	\$9.24	BYL	Priority 2	2022	\$22,084

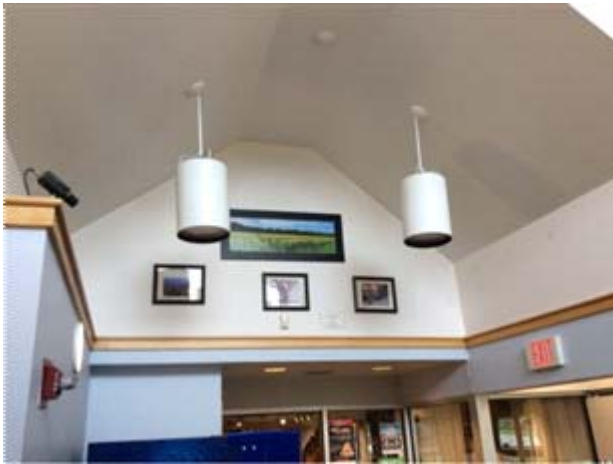
Coding / Field Name	Asset Description
<b>D5037 Fire Alarm Systems</b>	Fire Alarm System
<b>Condition</b>	Fair
<b>Qty / UOM</b>	2390 / SF
<b>Unit Cost</b>	\$2.36
<b>Basis of Costing</b>	Fire Alarm System, Full Upgrade/Install, Office (per SF)
<b>Year in Service</b>	1997
<b>Expected Useful Life (EUL)</b>	20 Year(s), Based on Industry Averages
<b>Remaining Useful Life (RUL)</b>	4 Year(s), Estimated, Based on Date of Observation
<b>Location</b>	Building Interior (General)

Uniformat	Action Description	Quantity	Unit Cost	Plan Type	Priority	Year	Expenditure
<b>D5037</b>	Replace Fire Alarm System	2,390 SF	\$2.36	BYL	Priority 2	2021	\$5,640

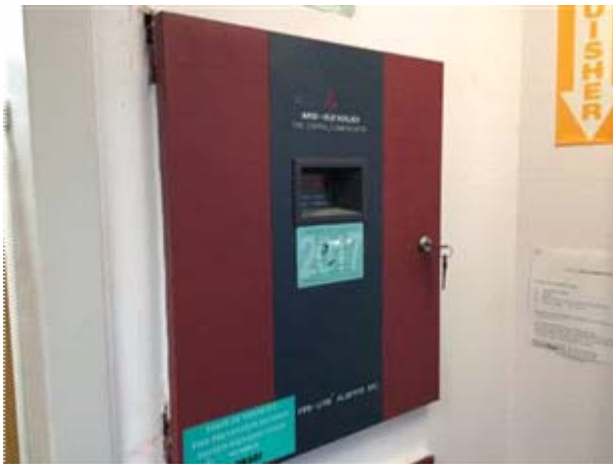
Coding / Field Name	Asset Description
<b>D5037 Fire Alarm Systems</b>	Fire Alarm Control Panel
<b>Condition</b>	Fair
<b>Qty / UOM</b>	1 / EA
<b>Unit Cost</b>	\$20,297.59
<b>Basis of Costing</b>	Fire Alarm Control Panel, Addressable
<b>Year in Service</b>	1997
<b>Expected Useful Life (EUL)</b>	15 Year(s), Based on Industry Averages
<b>Remaining Useful Life (RUL)</b>	3 Year(s), Estimated, Based on Date of Observation
<b>Location</b>	MEP Closet

Uniformat	Action Description	Quantity	Unit Cost	Plan Type	Priority	Year	Expenditure
<b>D5037</b>	Replace Fire Alarm Control Panel	1 EA	\$20,297.59	BYL	Priority 1	2020	\$20,298
<b>D5037</b>	Replace Fire Alarm Control Panel	1 EA	\$20,297.59	BYL	Priority 1	2035	\$20,298

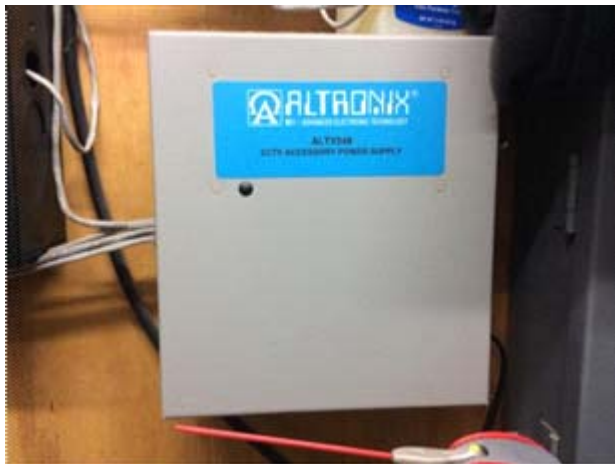
Coding / Field Name	Asset Description
<b>D5038 Security and Detection Systems</b>	Security Control Panel
<b>Condition</b>	Fair
<b>Qty / UOM</b>	1 / EA
<b>Unit Cost</b>	\$6,594.69
<b>Basis of Costing</b>	Security Control Panel
<b>Year in Service</b>	1997
<b>Expected Useful Life (EUL)</b>	15 Year(s), Based on Industry Averages
<b>Remaining Useful Life (RUL)</b>	4 Year(s), Estimated, Based on Date of Observation
<b>Location</b>	Electrical Room (Primary)

Uniformat	Action Description	Quantity	Unit Cost	Plan Type	Priority	Year	Expenditure
<b>D5038</b>	Replace Security Control Panel	1 EA	\$6,594.69	BYL	Priority 2	2021	\$6,595
<b>D5038</b>	Replace Security Control Panel	1 EA	\$6,594.69	BYL	Priority 2	2036	\$6,595

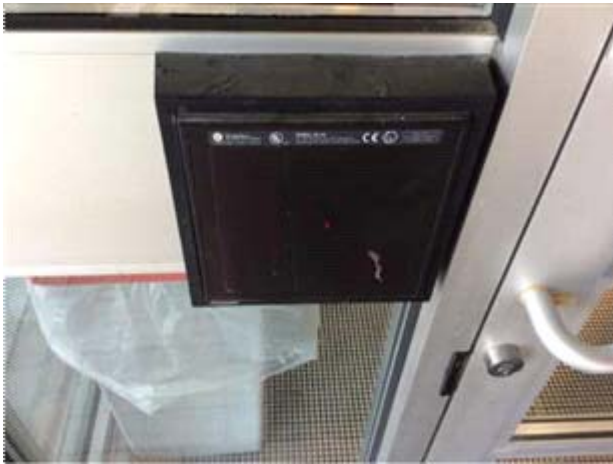
Coding / Field Name	Asset Description
<b>D5038 Security and Detection Systems</b>	Card Reader
<b>Condition</b>	Fair
<b>Qty / UOM</b>	1 / EA
<b>Unit Cost</b>	\$1,050.69
<b>Basis of Costing</b>	Card Reader
<b>Year in Service</b>	1997
<b>Expected Useful Life (EUL)</b>	10 Year(s), Based on Industry Averages
<b>Remaining Useful Life (RUL)</b>	3 Year(s), Estimated, Based on Date of Observation
<b>Location</b>	Exterior Walls

Uniformat	Action Description	Quantity	Unit Cost	Plan Type	Priority	Year	Expenditure
<b>D5038</b>	Replace Card Reader	1 EA	\$1,050.69	BYL	Priority 1	2020	\$1,051
<b>D5038</b>	Replace Card Reader	1 EA	\$1,050.69	BYL	Priority 1	2030	\$1,051

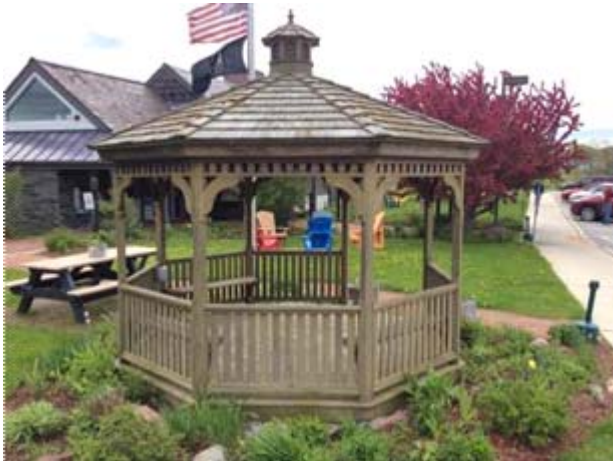
Coding / Field Name	Asset Description
<b>F1013 Other Special Structures</b>	Gazebo
<b>Condition</b>	Fair
<b>Qty / UOM</b>	130 / SF
<b>Cost Adjustment Factor/Reason</b>	0.7 / Basic Structure
<b>Unit Cost (Adjusted)</b>	\$87.64
<b>Basis of Costing</b>	Prefabricated Temporary Building, All Components
<b>Year in Service</b>	2005
<b>Expected Useful Life (EUL)</b>	30 Year(s), Based on Industry Averages
<b>Remaining Useful Life (RUL)</b>	18 Year(s), Estimated, Based on Date of Observation
<b>Location</b>	Site

Uniformat	Action Description	Quantity	Unit Cost	Plan Type	Priority	Year	Expenditure
<b>F1013</b>	Replace Gazebo	130 SF	\$87.64	BYL	Priority 4	2035	\$11,393

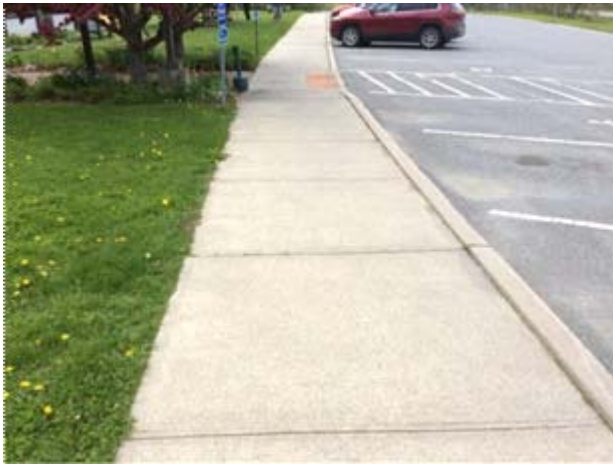
Coding / Field Name	Asset Description
<b>G2031 Paving &amp; Surfacing</b>	Concrete Sidewalk
<b>Condition</b>	Fair
<b>Qty / UOM</b>	2000 / SF
<b>Unit Cost</b>	\$19.82
<b>Basis of Costing</b>	Concrete Sidewalk
<b>Year in Service</b>	1997
<b>Expected Useful Life (EUL)</b>	30 Year(s), Based on Industry Averages
<b>Remaining Useful Life (RUL)</b>	10 Year(s), Estimated, Based on Date of Observation
<b>Location</b>	Site

Uniformat	Action Description	Quantity	Unit Cost	Plan Type	Priority	Year	Expenditure
<b>G2031</b>	Replace Concrete Sidewalk	2,000 SF	\$19.82	BYL	Priority 3	2027	\$39,644

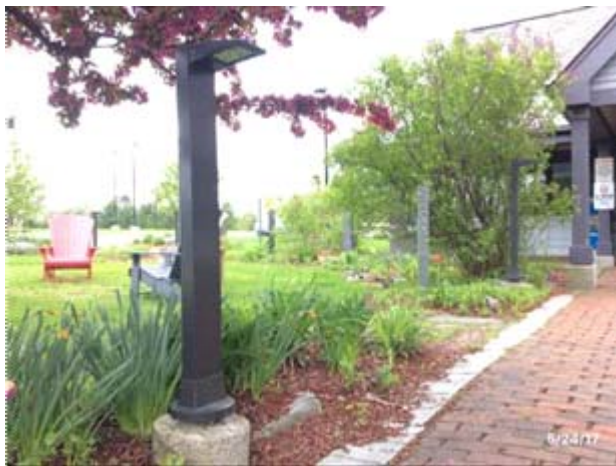
Coding / Field Name	Asset Description
<b>G4021 Fixtures &amp; Transformers</b>	Walkway Bollard Light
<b>Condition</b>	Good
<b>Qty / UOM</b>	8 / EA
<b>Unit Cost</b>	\$1,494.12
<b>Basis of Costing</b>	Walkway Bollard Light, 70 to 150 W HID
<b>Year in Service</b>	2014
<b>Expected Useful Life (EUL)</b>	20 Year(s), Based on Industry Averages
<b>Remaining Useful Life (RUL)</b>	17 Year(s), Estimated, Based on Date of Observation
<b>Location</b>	Exterior Walls
<b>Location of Site Lighting</b>	Walkways
<b>Light Pole Type</b>	Metal

Uniformat	Action Description	Quantity	Unit Cost	Plan Type	Priority	Year	Expenditure
<b>G4021</b>	Replace Walkway Bollard Light	8 EA	\$1,494.12	BYL	Priority 3	2034	\$11,953

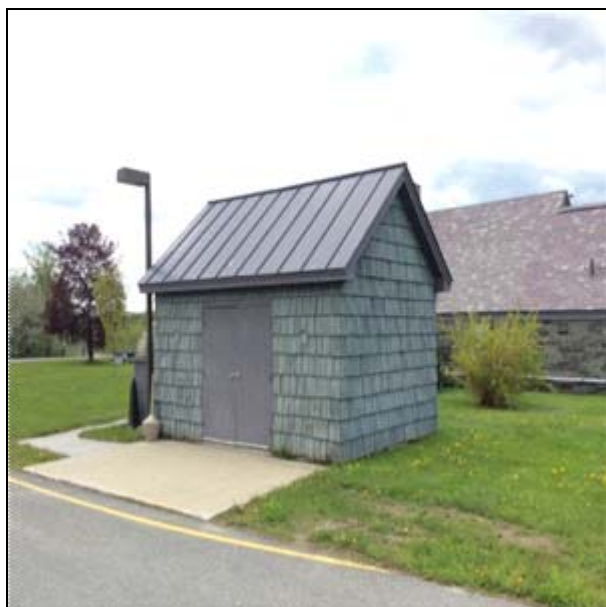
Used primarily for storage of printed materials. Paint is worn.

Uniformat	Action Description	Quantity	Unit Cost	Plan Type	Priority	Year	Expenditure
<b>F1013</b>	General Painting Cost Per SF, Minor Prep	500 SF	\$1.41	APP	Priority 3	2019	\$705
<b>F1013</b>	Replace Materials Shed	200 SF	\$62.60	BYL	Priority 4	2027	\$12,519
<b>F1013</b>	General Painting Cost Per SF, Minor Prep	500 SF	\$1.41	APP	Priority 3	2029	\$705
