FACILITY CONDITION ASSESSMENT

158982.22R000-089.379

July 23, 2023

**COLCHESTER HIGH SCHOOL - Main Building (PS072-U401)
131 Laker Lane
Colchester VT, 05446**

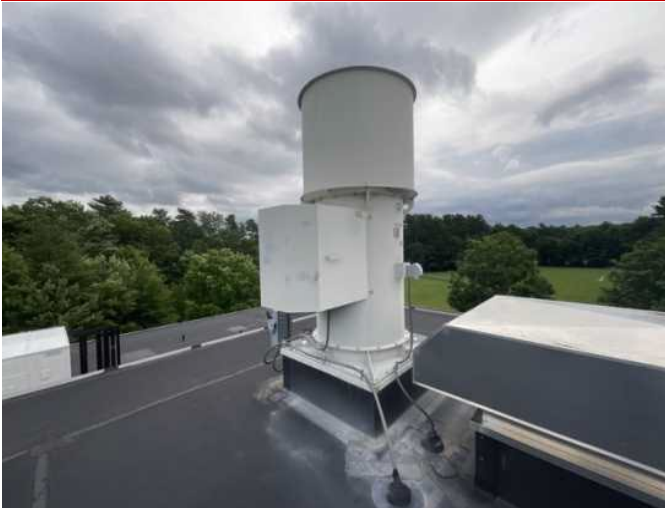
13 - EXHAUST FAN

Exhaust Fan in Poor condition.

Fan loose, flange damaged. - AssetCALC ID: 6753071

Uniformat Code: D3060
Recommendation: **Replace in 2023**
Priority Score: **85.9**
Plan Type: Performance/Integrity
Cost Estimate: \$1,400

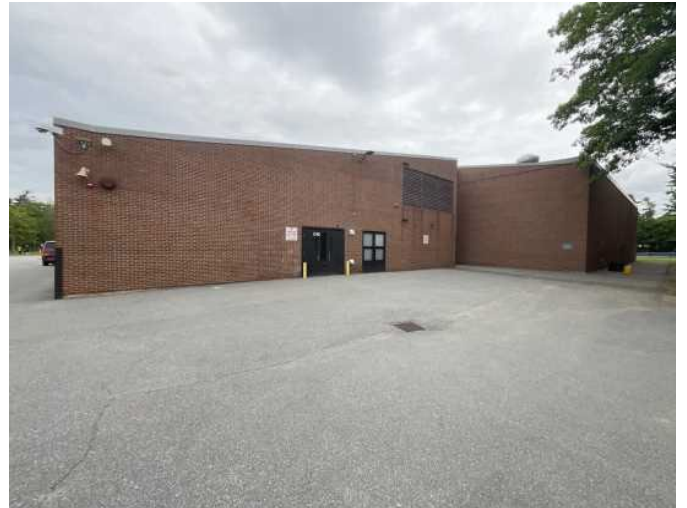
28 - FACADE OF BUILDING

The building exterior is primarily brick walls with a few areas requiring repair and repointing. The exterior windows are original and are well past their useful life. Exterior doors are a combination of glass & aluminum and steel doors with some of the doors having been replaced. The EPDM roof is reportedly at least 25 years old and has been coated with white and silver elastomeric paint in several areas. The interior finishes are primarily ACT ceilings with VCT floors and painted interior walls and have been periodically refreshed over the years.

Exterior Walls in Poor condition.

Uniformat Code: B2010
Recommendation: **Repair/Repoint in 2023**
Priority Score: **89.9**
Plan Type: Performance/Integrity
Cost Estimate: \$33,000
