FACILITY CONDITION ASSESSMENT

May 18, 2023

**UNION ELEMENTARY SCHOOL - Main Building (PS308-SU009)
1 PARK AVENUE
MONTPELIER , VT 05602**

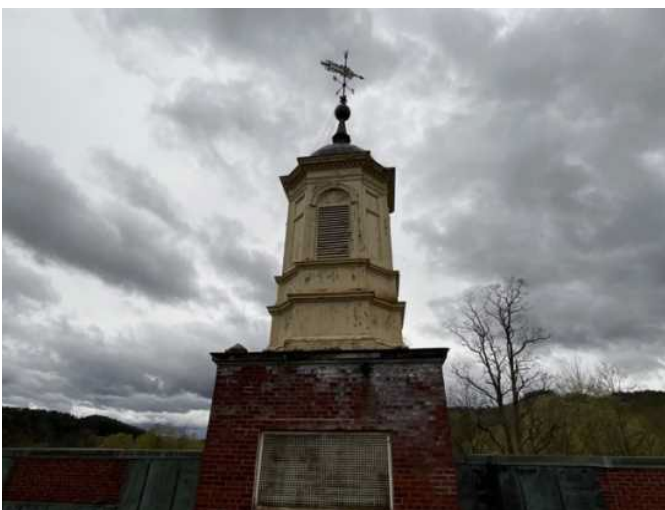
5 - ENTRANCE STEEPLE FROM ROOF

Exterior Windows, steeple, and Trim in Poor condition.

Uniformat Code: B2010
Recommendation: **Prep & Paint in 2024**
Priority Score: **89.7**
Plan Type: Performance/Integrity
Cost Estimate: \$48,000

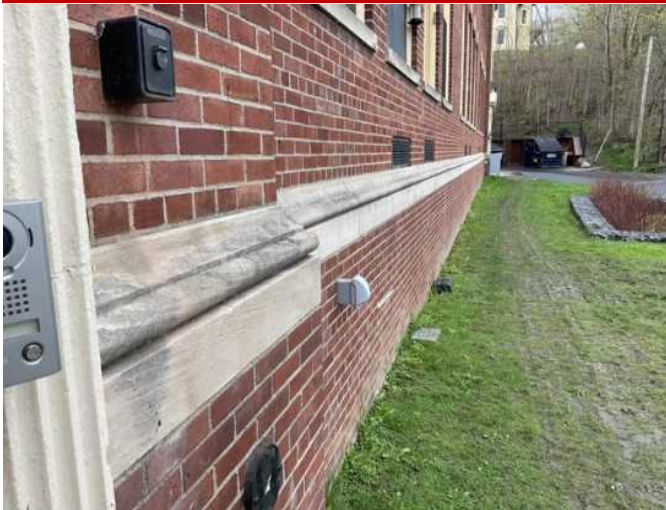
7 - BRICK MORTAR JOINTS OVERVIEW

The building is a solid brick walled and wood floor structured building with an EPDM roof. The exterior brickwork is all original and in good condition with no mortar damage, and only some minor efflorescence around the building. The interior of the building has original Terrazzo and maple strip flooring that has been immaculately maintained. There is a small gym and a beautiful assembly hall original to the building. An accessible entrance was added in 2019 on the east side of the building.

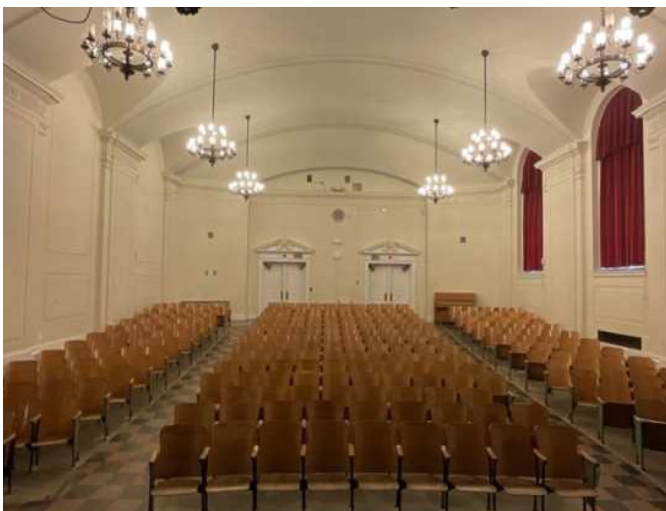
21 - AMPATHEATRE SEATING AND ARCHITECTURE

Fixed Seating in Poor condition.

Seating is original to the building, and, badly worn. It should be replaced the near future. - AssetCALC ID: 6081171

Recommendation: **Replace in 2024**

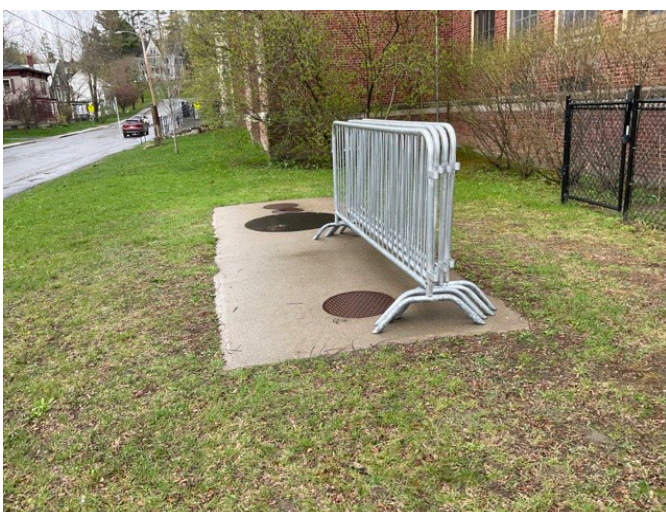
29 - UNDERGROUND STORAGE TANK ACCESS

A Phase II ESA should be conducted concurrent to the removal of the UST - AssetCALC ID: 6085551

Uniformat Code: P2030
 Recommendation: **Evaluate/Report in 2029**
 Priority Score: **72.4**
 Plan Type: Environmental
 Cost Estimate: \$12,500

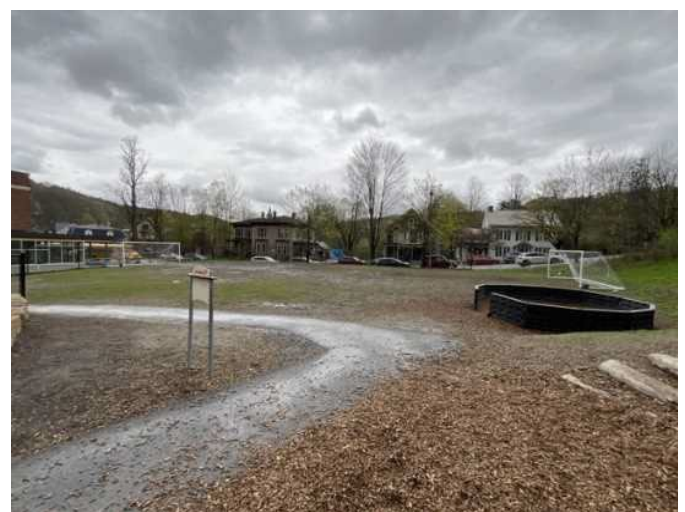
30 - SPORT FIELD

Playfield Surfaces in Poor condition.

Wood chips appear worn and and should be refreshed. - AssetCALC ID: 6081182

Recommendation: **Replace in 2023**
