# FACILITY CONDITION ASSESSMENT

**Vermont Agency of Education\_FCA Phase Two  
1 National Life Drive, Davis 5  
Montpelier, VT 05620-2501**

*September 21, 2023*

**SOUTH BURLINGTON HIGH SCHOOL - Main Building  
(PS272)  
550 Dorset Street  
S Burlington, VT 05403Z**

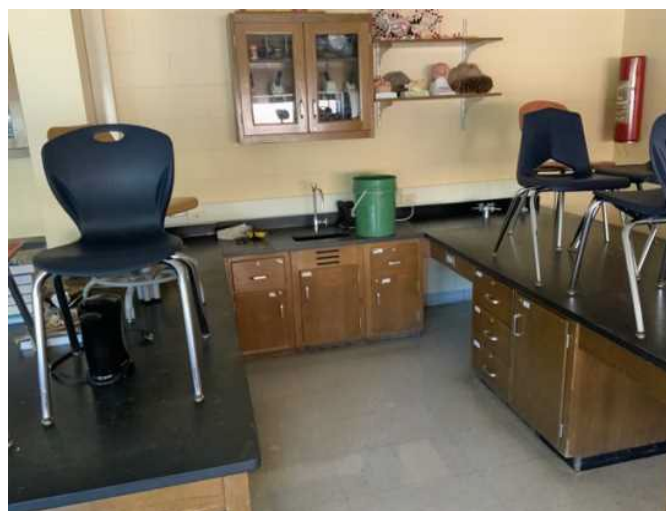
Some areas infilled with non-epoxy tops and damaged - AssetCALC ID: 6959289

16 - SCIENCE CLASSROOM CASEWORK

Recommendation: **Replace in 2024**

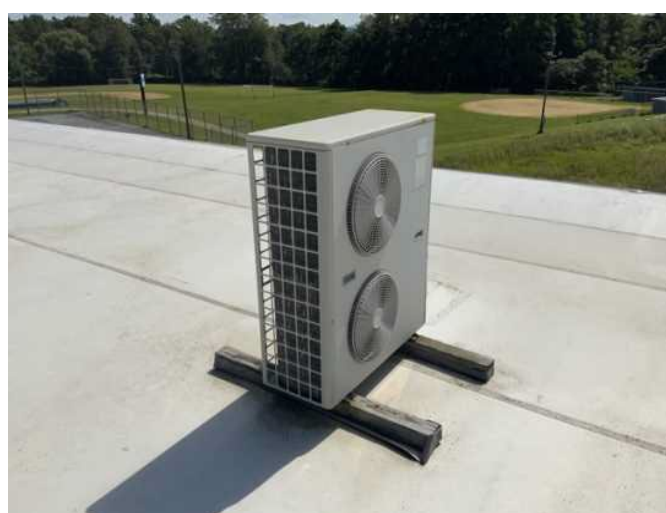
18 - SPLIT SYSTEM DUCTLESS

The mechanical equipment is end of life or nearing the end of life. The boilers are lower efficiency units and multiple smaller boilers could be installed. There are air handlers, RTUs and ductless mini-split systems in use. The equipment could be upgraded to a higher efficiency more reliable system. Electrical feed runs from the street under the school to the electrical room. During the elevator replacement project, the conduits were uncovered by accident. The school and utility are looking to reroute these around the building. The electrical distribution equipment is likely original and end of life. The same is true for most of the transformers and distribution panels. Many of the smaller transformers appear to have been overheated at some point when the paint blistered. The lighting has not been upgraded to LED, there are some areas that have a few LED fixtures. Distribution wiring is likely original and should be upgraded to the new computer environment. Plumbing leaks are starting to occur on the walls of the building. When these found that often include asbestos insulation that requires abatement. The water heaters are generally older, and replacement will be required. Plumbing fixtures could be upgraded to low flow. The sanitary and domestic piping should be replaced based on age and areas starting to have leaks. Locker rooms could be eliminated during this project. The two-pipe hydronic system could be upgraded. The school has just replaced many of the control valves. All janitor sinks should be checked for proper vacuum breakers. The building has a partial wet sprinkler system installed in the labs and library. The balance of the facility is protected with portable fire extinguishers. The building does have a complete fire alarm system with pull boxes.
