FY17 Vermont Better Roads Grant Application

Project Name: York Hill, West Hill, Gove Hill

Lincoln, Vermont Road and Culvert Inventory-2015

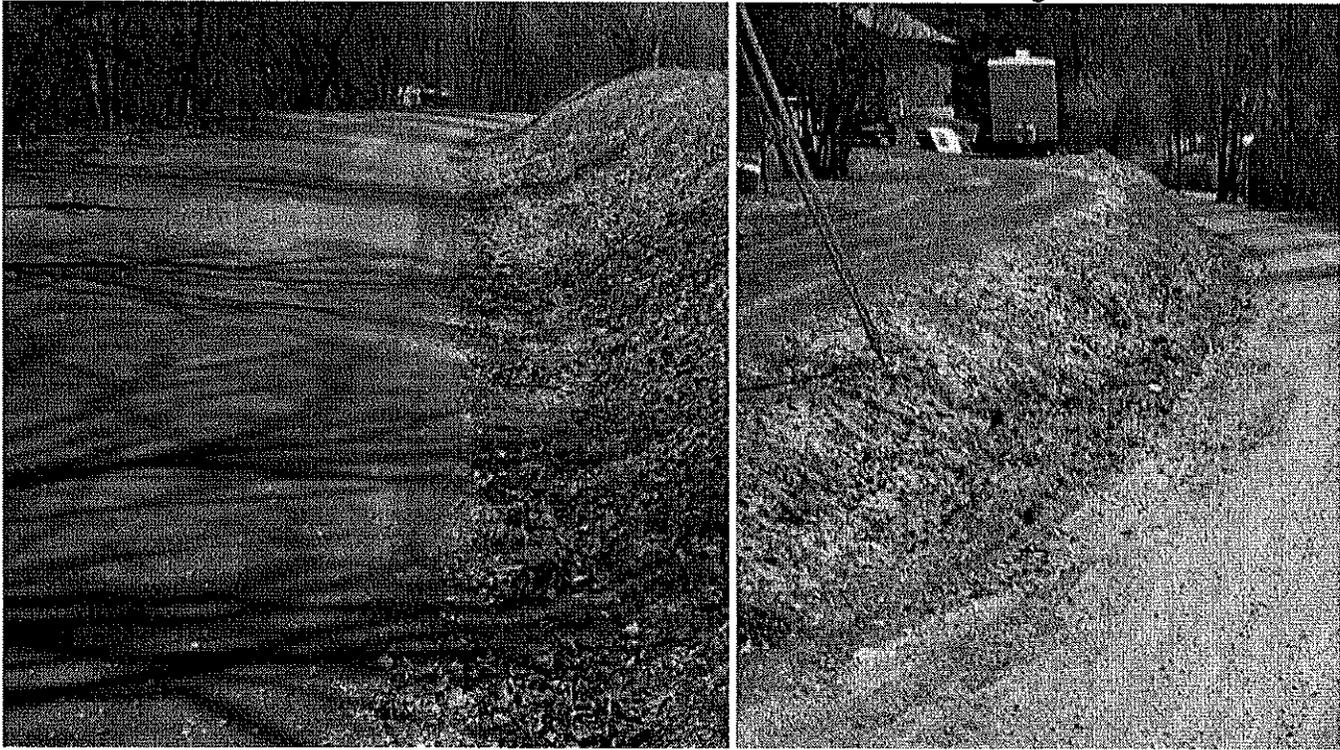
This first project on Atkins Road will excavate and stone line over 600 feet of ditching.

Atkins Road levels off just beyond the yellow guide wire anchor in the above right-hand photo.

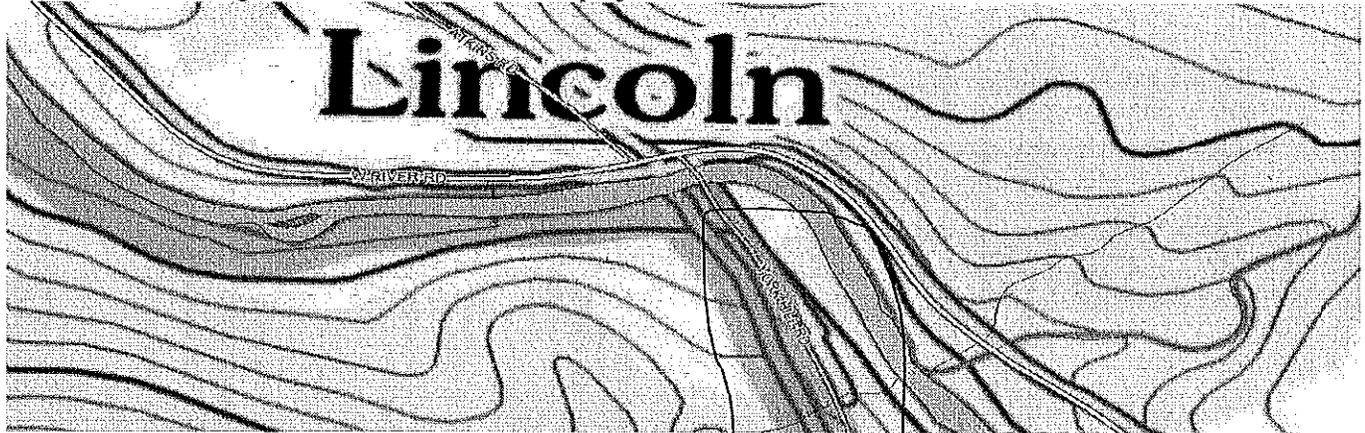
York Hill Project Area- Red Border

On the opposite side of the road from the primary drainage ditch, water sheds off the road in most places without many erosion issues occurring. However, there are a few places where some significant erosion occurs and, although York Hill leaves the New Haven River at a right angle, the river turns with the road and parallels York Hill within sight distance for most of this project area.

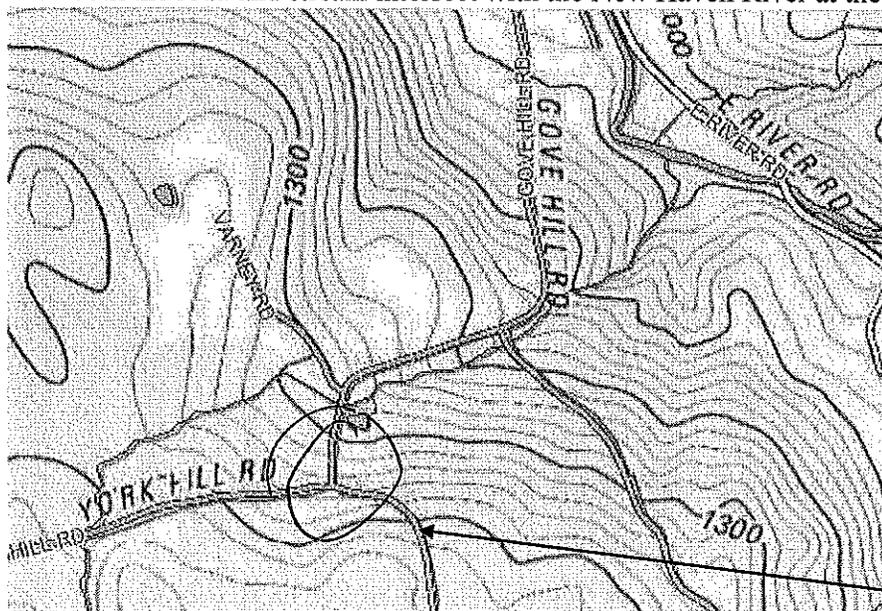
York Hill Road, West Hill Road, and Gove Hill Road intersection-The next project involves the intersection of three roads that descend on a steep grade toward a nearby branch stream feeding into the New Haven River. York Hill and West Hill descend from the east and west sides of the intersection meeting with Gove Hill Road which forms the tail of this Y shaped intersection. Gove Hill continues to descend down toward the Lincoln Village. Gove Hill has locations where grades exceed 10%. Gove Hill crosses a branch stream less than 500 feet below the three road intersection. The stream will parallel the road at varying distances until both the road and stream intersect with the New Haven River at the base of the Hill.

The project begins on the steep hills that feed the intersection from the east and west. York Hill and West Hill are both in need of ditching improvements to reduce sediment reaching the intersection. Erosion and sediment deposits are prevalent in roadside ditching on both roads. Hillside banks on the backside of ditching are unstable on West Hill approaching the intersection and in the intersection between West and York Hills.

- Replace, lengthen, and upsize primary culvert accepting run-off from York and West Hill Roads. Install a concrete Headwall
- Install 900 feet of stone lined ditch on West Hill Road on steep grade approaching intersection

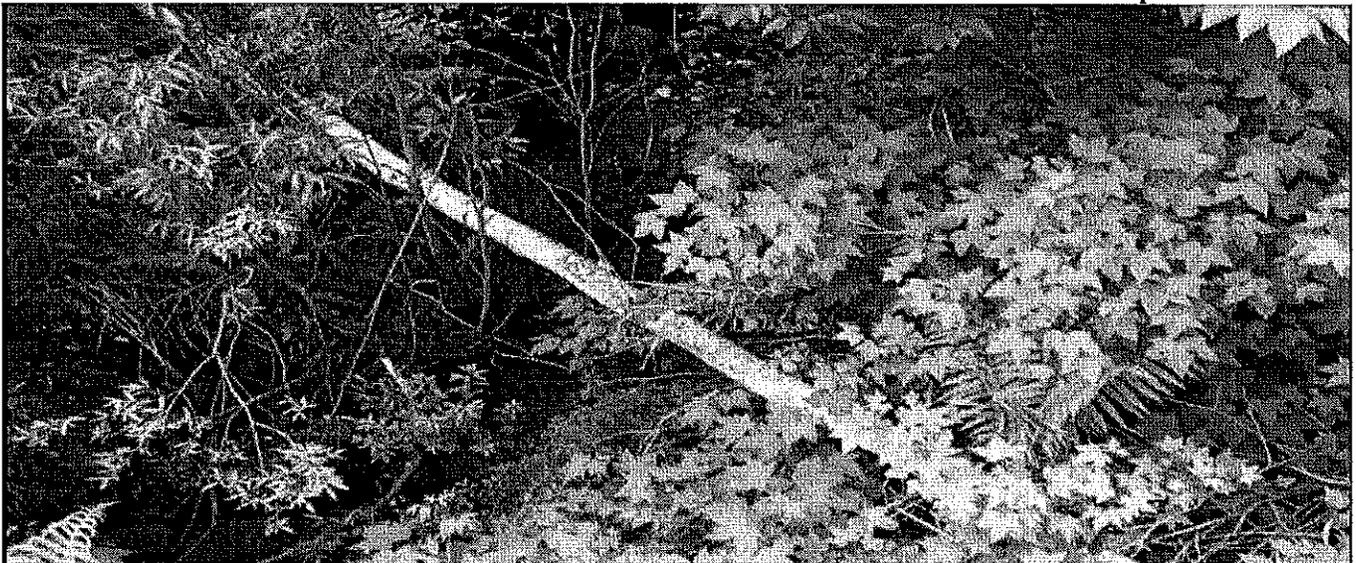
This three road intersection is located less than 500 feet above the branch stream shown in the photo below:

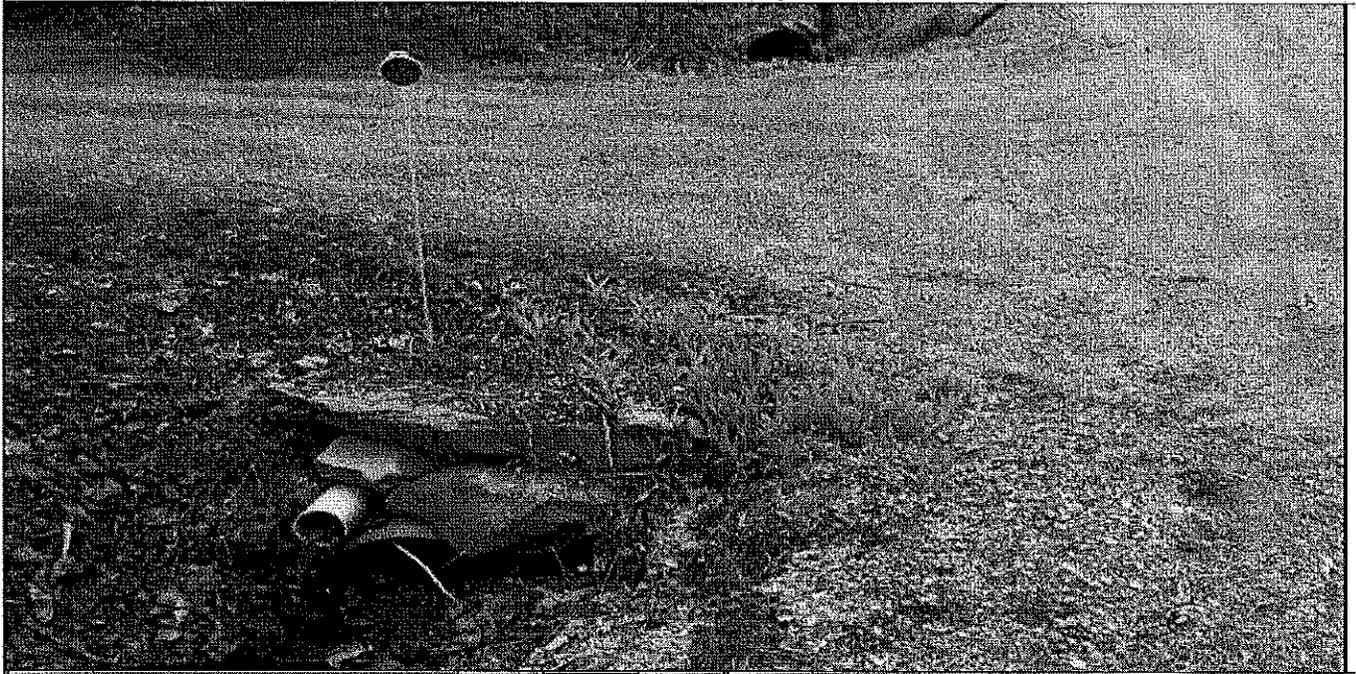
Two driveway access culverts close together and a third also very close (not shown)

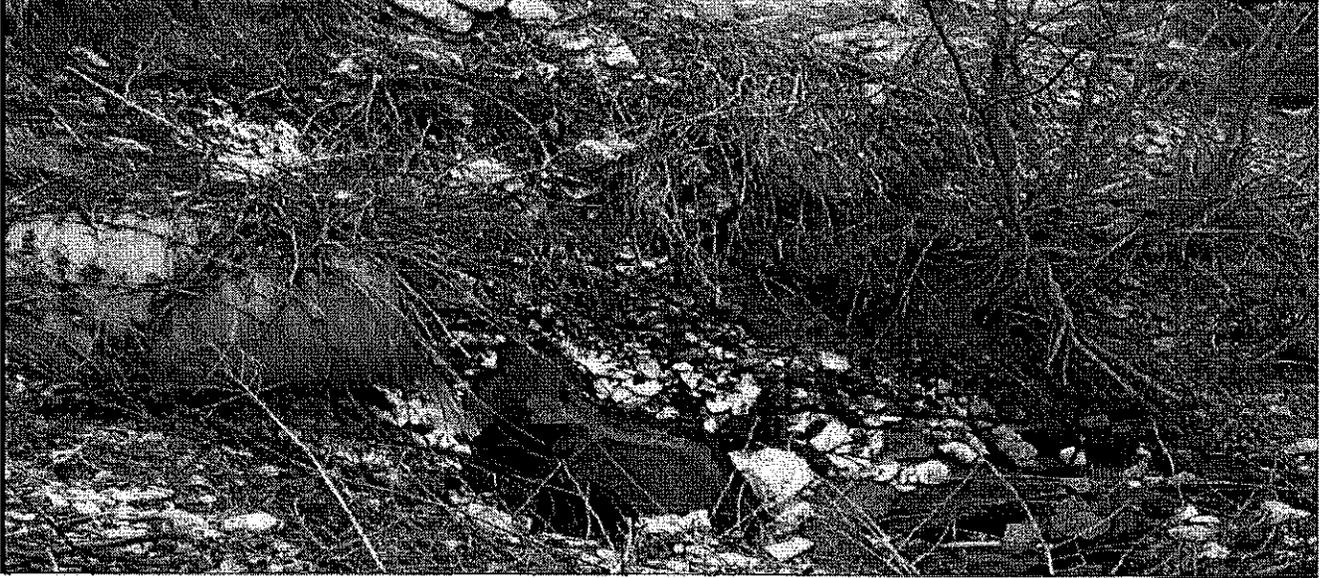
The center point of this project is a cross culvert at the base of Forge Hill Road that goes under Forge Hill Road and empties into the stream.

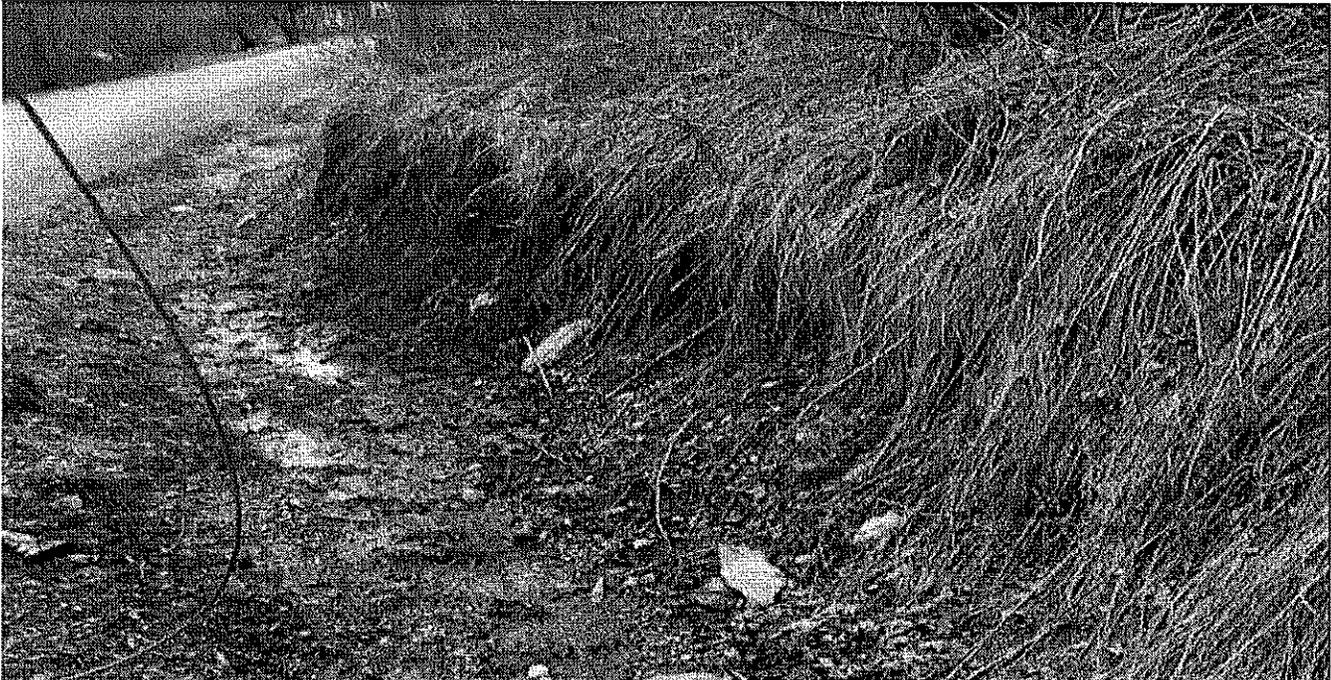
Forge Hill is a gravel road that ascends up a hill as it leaves this intersection. The ditch on this hill is neither vegetated or stone protected. The ditch tucks into the side of a hill and is bordered by unstable banks for the first 150 feet and then continues for 500 feet to the top of Forge Hill Road.

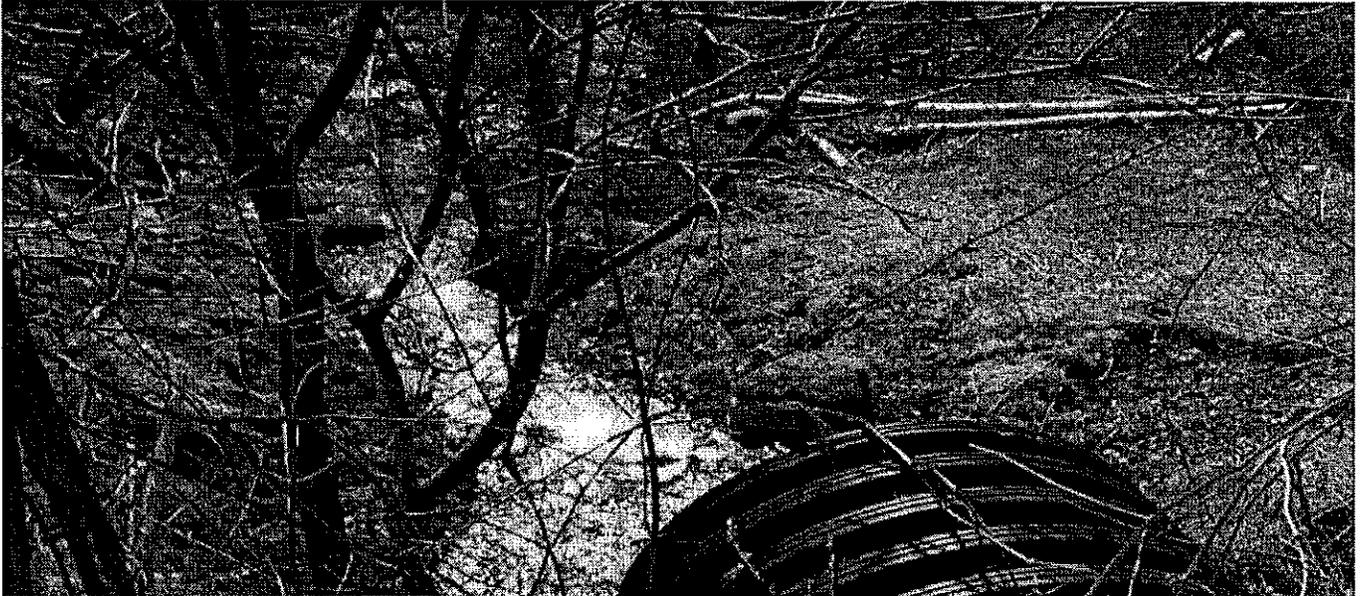
This first photo shows the outflow side of the culvert into the stream.

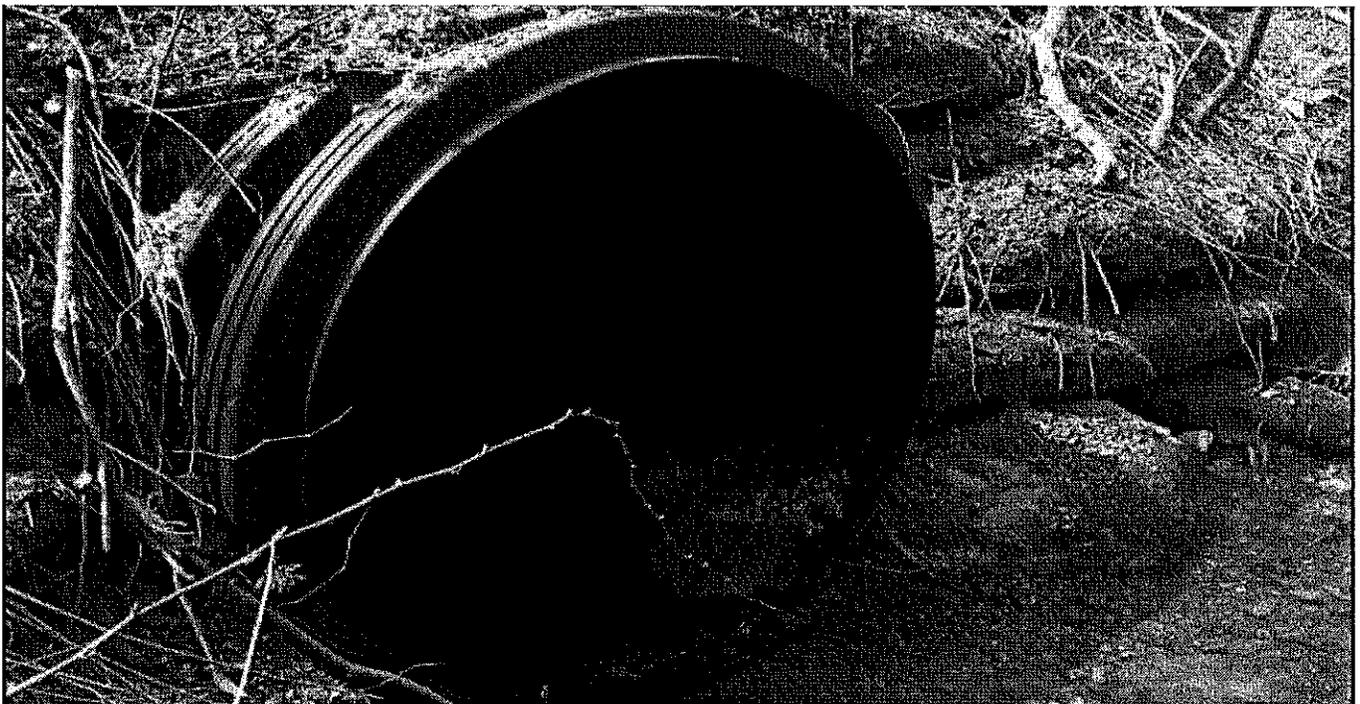
The culvert invert is shown below:

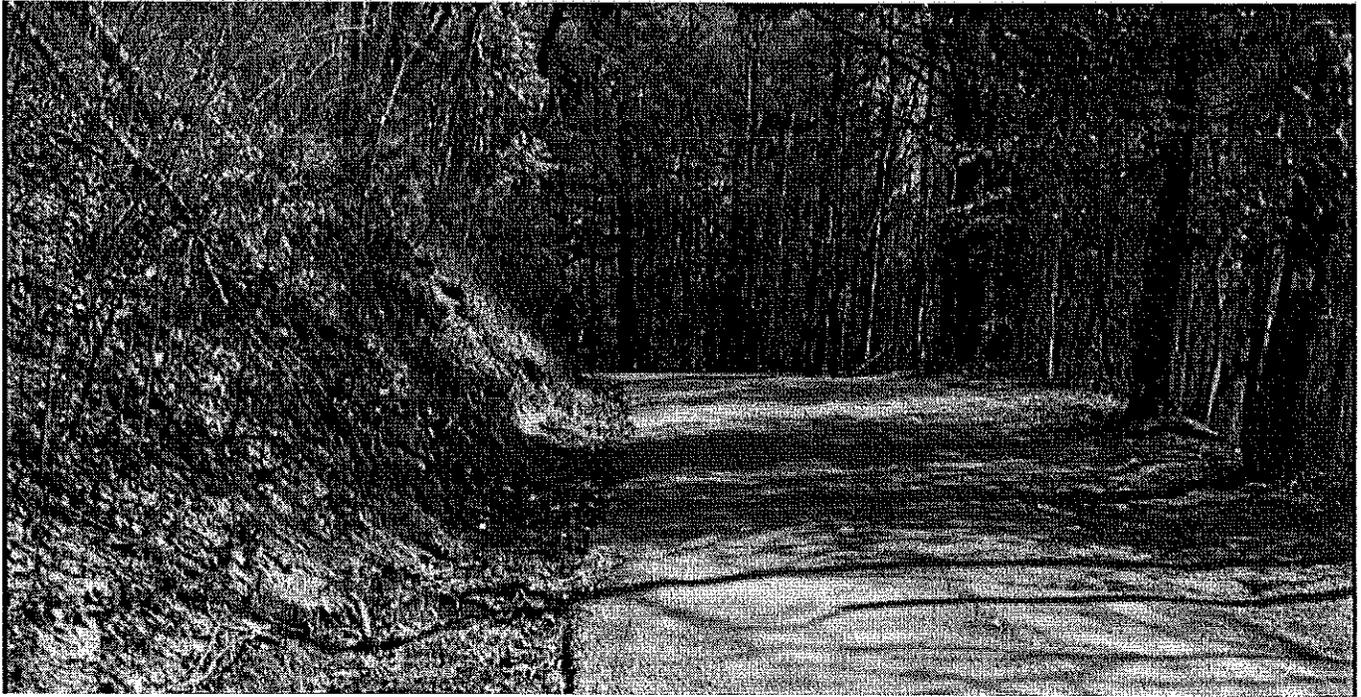
This is the ditch starting up the hill

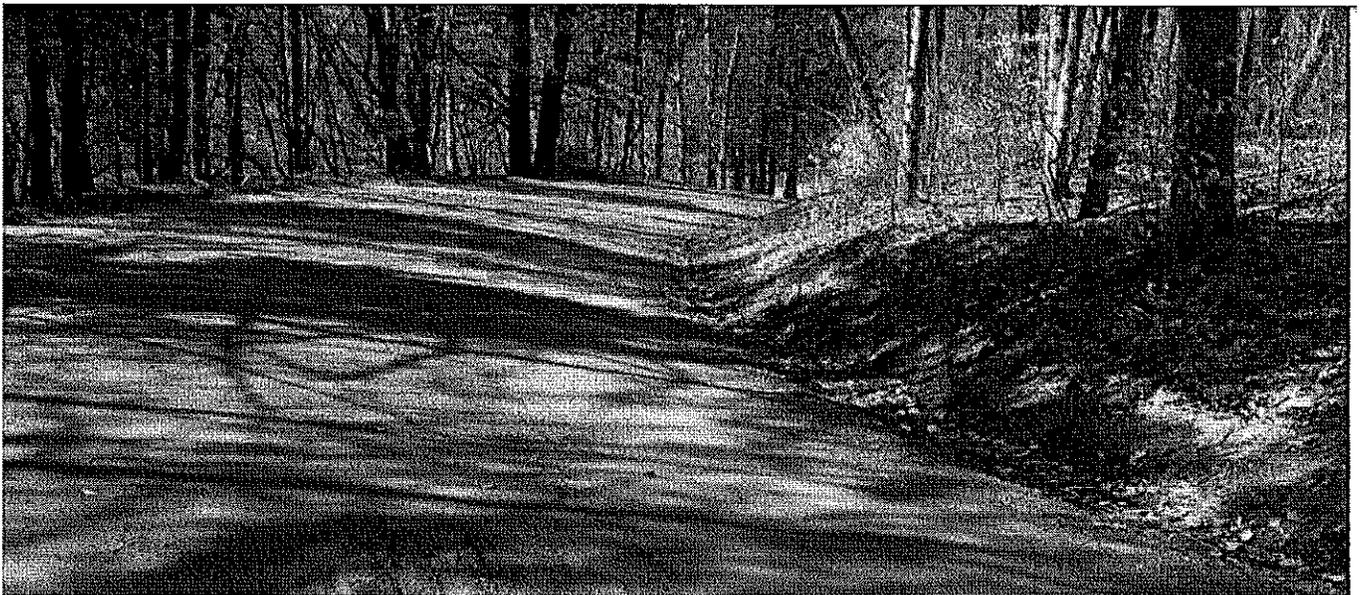
Following are several ditch photos randomly taken as ascending the hill. The pictures are very expressive of characteristics of overall ditching going up this hill to the top of the grade (1700 ft.)

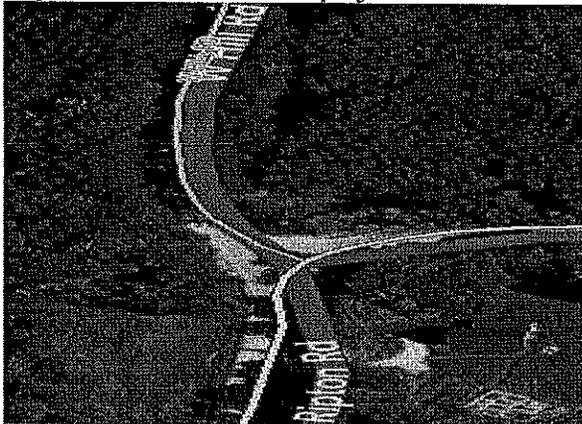
The photo below shows the project site location in relation to the stream:

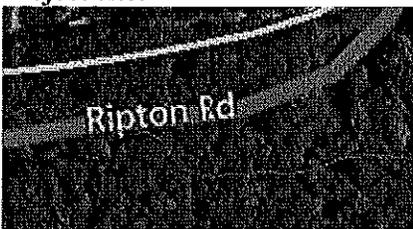
Project site:

The road culvert is located less than 100 feet up hill from this stream crossing. The invert side is constantly filling with sediment which can reach the stream from the outflow side. Also, on the other side of the road there is one drainage turnout that is close to the stream and needs to be addressed because sediment is leaving the road at this location.

Ripton Road Project Details-Project #3:

- Replace the cross culvert with an 18 inch metal arch culvert (50 feet)
- Install end section on invert side
- Stone line the uphill ditch fully on the invert side (500 feet)
- Stone line ditch (200 feet) and install stone two stone turnouts on the outflow side
- Rip Rap in turnouts and outflow of new culvert

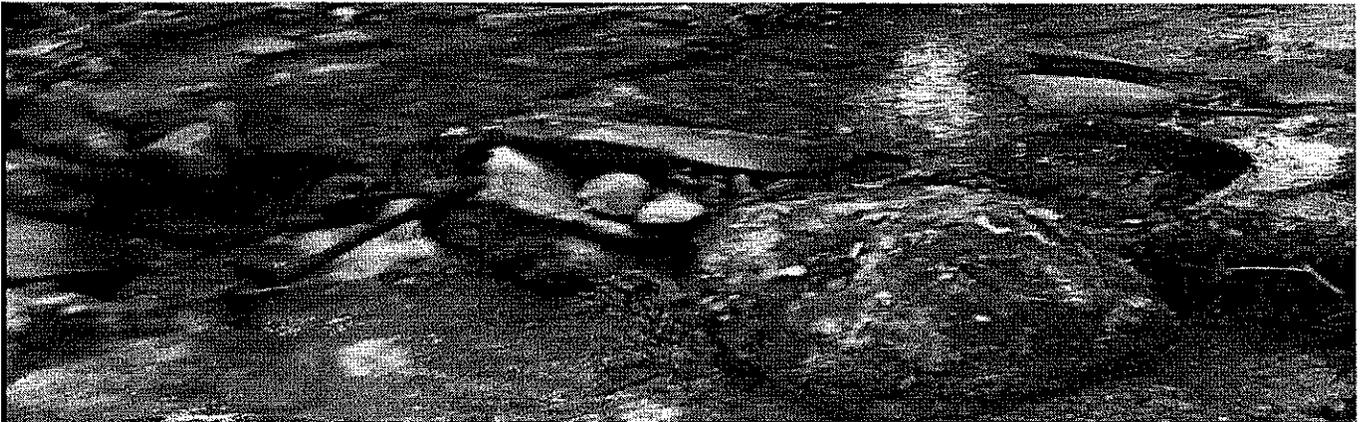
Above is a photo of the branch stream that first parallels the project area and then crosses the road downhill from the work site.
