STATE OF VERMONT  
AGENCY OF TRANSPORTATION

Scoping Report

FOR  
Wardsboro BF 013-1(22)  
VT ROUTE 100, BRIDGE 73 OVER UNNAMED BROOK

July 30, 2013

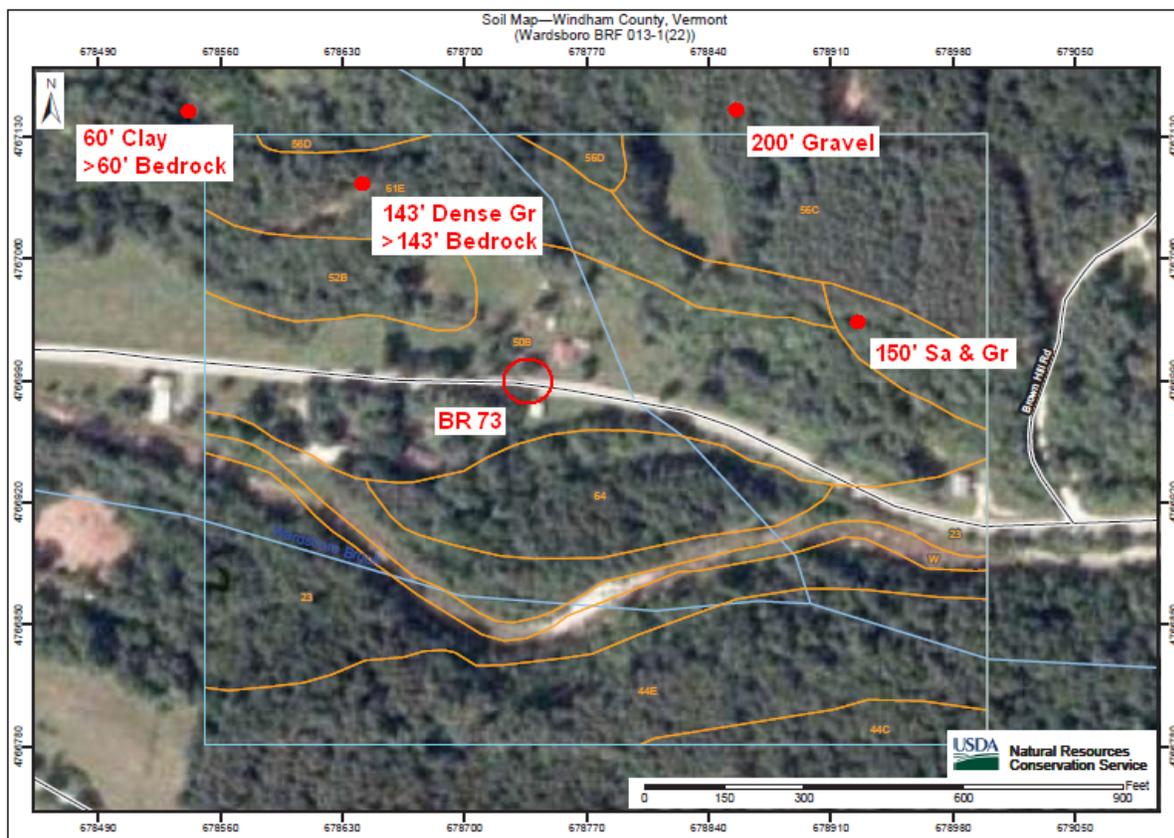
**Figure 1, USDA Soil Survey and ANR Well Data near Bridge 73.**

approximation. Based on subsurface information reported by well drilling reports on file at ANR and the USDA web soil survey, the surficial geology in the vicinity of the subject area is expected to consist of a mixture of clay, sand and gravel. Bedrock was encountered in two of the four wells, with 60 feet being the shallowest depth below the ground surface. USDA soil descriptions and four well locations within 1000 feet of the culvert are shown in Figure 1.

The Natural Resources Conservation Service USDA soil descriptions from Figure 1 indicate that the subject area is classified as Colton loamy fine sand. These deposits are usually found along floodplains and are evidenced in the water well records nearby and the 1970 Surficial Geologic Map of Vermont. Bedrock in the area is expected to be Schist according to the new 2011 Bedrock Map of Vermont. No exposed bedrock outcrops were seen near Bridge 73. Cobbles can be seen along the stream bottom from the bridge inspection photos.
