STATE OF VERMONT
AGENCY OF TRANSPORTATION

Scoping Report

Colchester IM 089-3(69)
I-89 Bridges 76 N&S over Bay Rd (TH 1) and
I-89 Bridges 77 N&S over Mallett's Creek

January 16, 2015

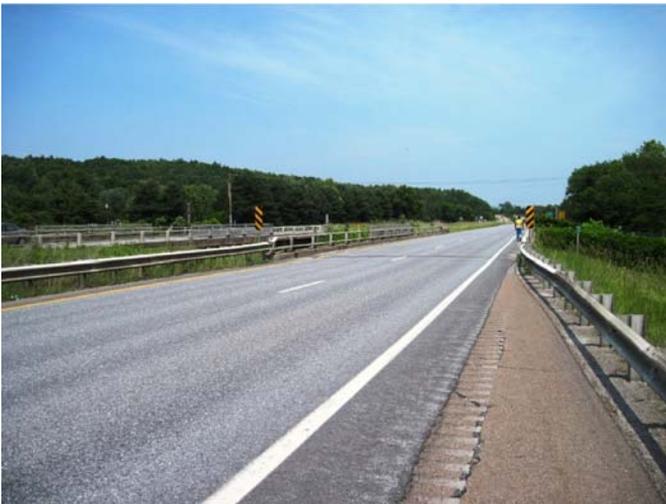
Bridge 76 North

Bridge 76 N: 06/12/2014 - Bridge deck has advancing deterioration and needs to be programmed for replacement within the next 10 years. Sliding plate joint leaks heavily at the southern abutment and is causing deterioration along the steel superstructure and substructure. Plate joint is secure for now, but consider removing completely, as it may come loose again before the deck is replaced. South abutment bearing seat and the northern pier cap needs some concrete repair work. Standard heavy guard rail along the outside of the corner to protect the northern pier columns from impact is needed. ~ MJ/JS

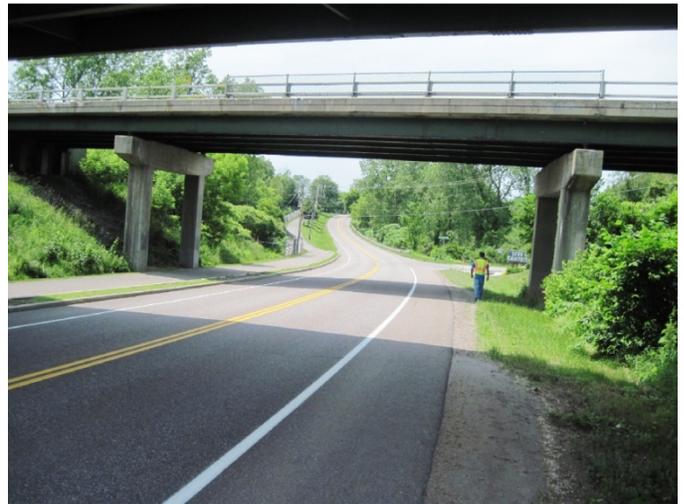
Bridge 76 South

Bridge 76 S: 06/12/2014 - Bridge deck has advancing deterioration and needs to be programmed for replacement within the next 10 years. Sliding plate joint leaks heavily at the southern abutment and is causing deterioration along the steel superstructure and substructure. Standard heavy guard rail along the outside of the corner to protect the northern pier columns from impact is needed. ~ MJ/JS

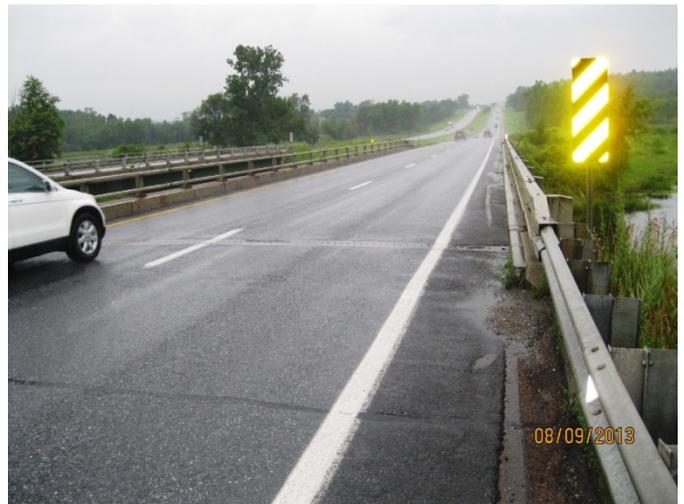
Bridge 77 South

Bridge 77S is in poor condition. It should be assumed that a “patch” would be so extensive for this bridge, that a deck replacement would be more economical. Therefore, the rehabilitation alternative will only be considered for Bridge 76N and Bridge 76S.

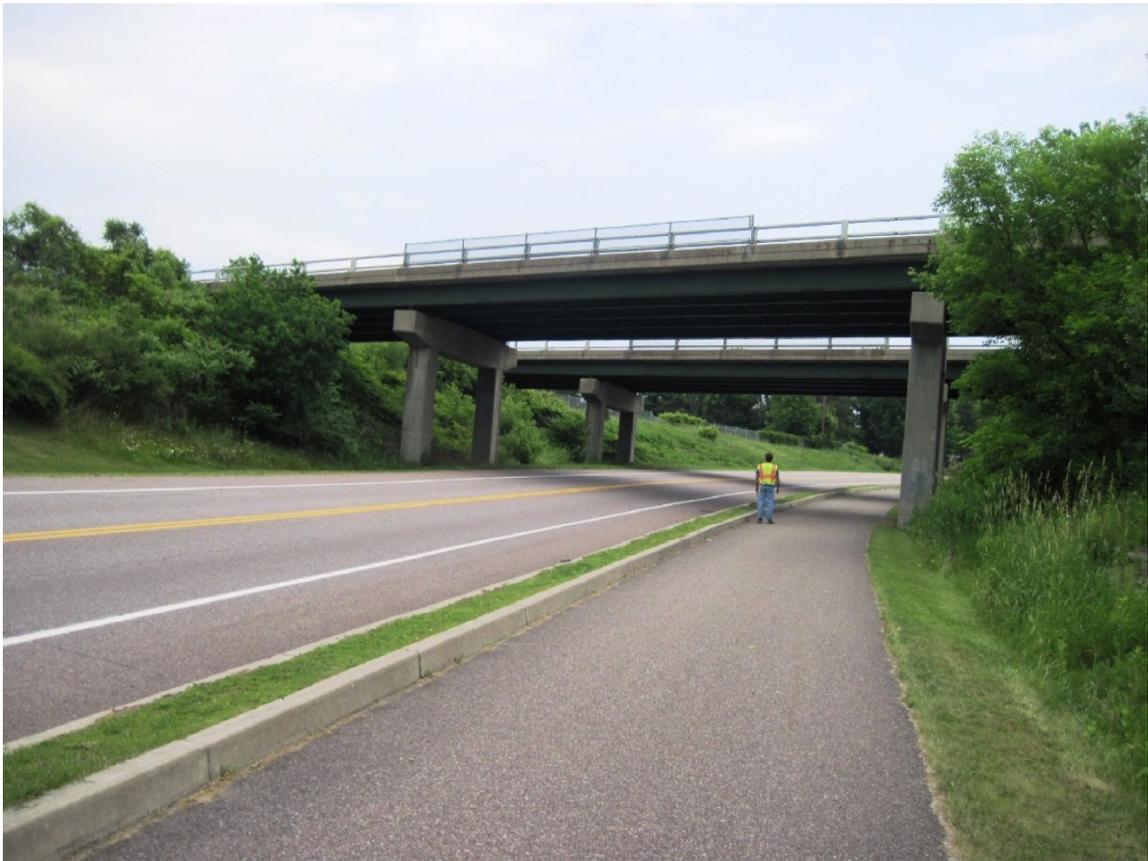
Looking east under Bridge 76 N&S

This rehabilitation option includes the minimal amount of work necessary to extend the useful lives of the bridges. Appropriate guardrail would be installed under Bridges 76 N&S to protect the piers from vehicular impact. The loose concrete on the underside of Bridges 76 N&S would be removed and replaced.
