Development, Field Testing, and Implementation of Improved Bridge Parapet Designs

Prepared for:
The Ohio Department of Transportation,
Office of Statewide Planning & Research

State Job Number **134818**

Final Report

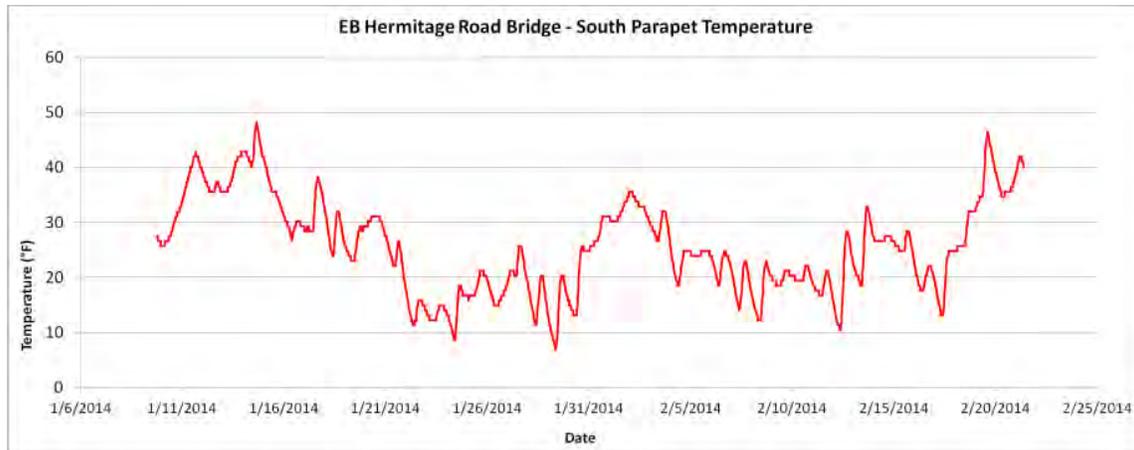
Figure 37: EB Hermitage south parapet winter temperature fluctuations

The wires from the three maturity sensors placed on this bridge were still intact during the site visit; however, only one of the sensors was able to provide readings from January 9, 2014 to February 21, 2014. A graph of the temperature fluctuations the parapet experienced during this time is shown in Figure 37. Within this time, the parapet experienced a maximum temperature of 48.2°F (9°C) and a minimum temperature of 6.8°F (-14°C). Over the span of time since the parapet was placed in October, there was enough freeze-thaw action to cause the concrete to crack. With no cracks discovered along the length of the parapet, the parapet functioned as it was designed by limiting cracking to the joints.

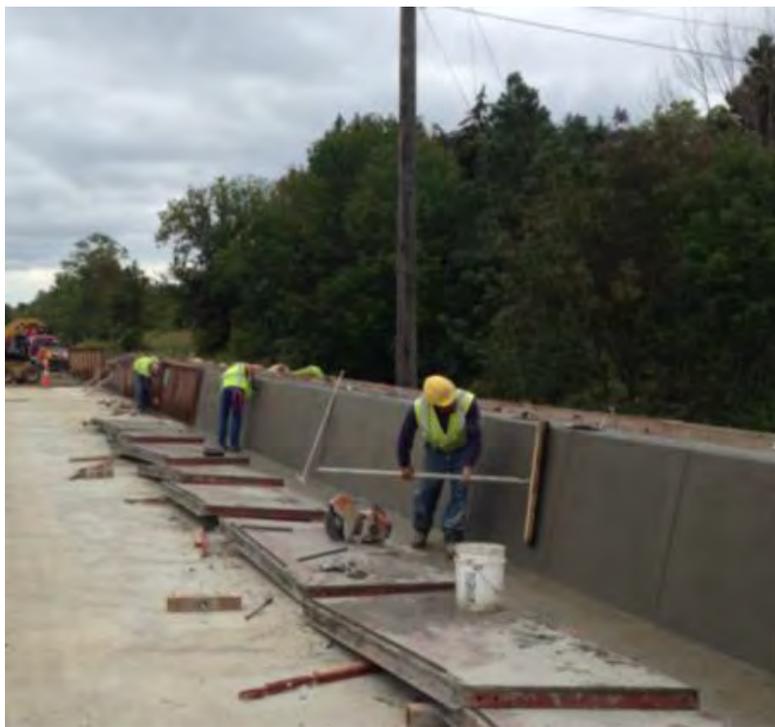
Figure 39: Rubbing the WB Paine Road north parapet (Photograph by Amy Kalabon)

Once concrete placement was finished, formwork removal and saw cuts were performed while the concrete was still green as shown in Figure 38. The control joints were cut 3 ½ inches (88.9 mm) deep through the horizontal field cut steel rebar. The joints were spaced 4.5 to 5.7 feet (1.37 to 1.74 m) in negative moment areas, and 11.25 to 13.7 feet (3.43 to 4.18 m) in positive moment areas. Right before the wall was covered with burlap to cure for seven days, the wall was rubbed (Figure 39).

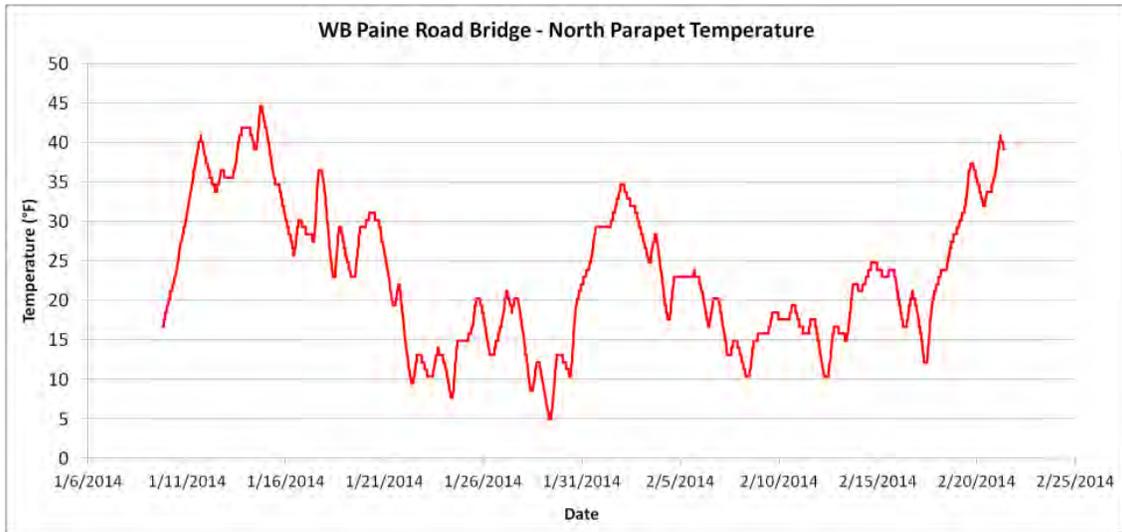
Figure 40: WB Paine Road north parapet winter temperature fluctuations

On February 21, 2014, a site visit was made to check the parapet for cracks. No cracks were found, and one of the maturity sensors was in good condition. It provided temperature readings from January 9, 2014 to February 21, 2014. During this time, the parapet experienced a maximum temperature of 44.6°F (7°C) and a minimum temperature of 5°F (-15°C). Figure 40 shows the temperature changes the concrete experienced. Since the parapet was placed in September, it has been through a lot of freeze-thaw cycles that might induce cracking. Just like the south parapet of the eastbound Hermitage Road Bridge, the design of this parapet functioned properly by limiting cracking to the control joints.

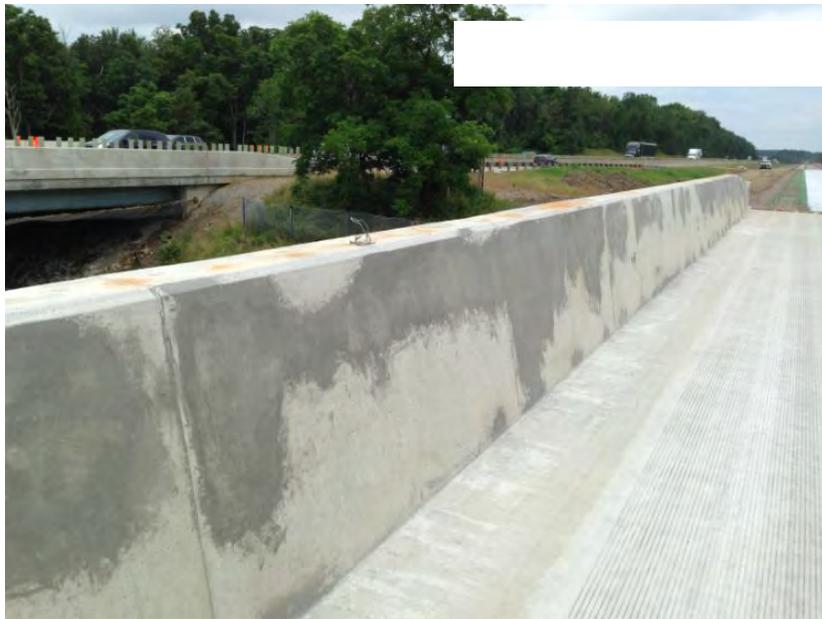
Figure 44: WB Paine Road rubbed south parapet (Photograph by Amy Kalabon)

One vibrator was used during placement. It could not be used close to the surface of the wall without hitting the reinforcement. With a low slump of 3 ½ inches (89 mm), the concrete consolidated poorly along the surface of the wall. This became more apparent once the forms were pulled. A way to address this is to rub the wall immediately after stripping the forms to make a continuous surface, removing any holes or pits. Stripping of the forms and saw cutting of the 1.5 inch (38 mm) deep control joints occurred 24 hours after concrete placement. Figures 42 and 43 show the holes and surface cracks that were found after stripping the forms. The pits were found all the way across the wall ranging from ¼ to ¾ inches (6 to 19 mm) in diameter and ½ inches (13 mm) deep. These holes, as well as the flaws created by the formwork, were not rubbed out by the construction workers before placing the burlap on the wall. Typically, the wall is rubbed immediately after form removal before allowing the wall to cure for seven days. In this case, the parapet was “rubbed” sometime after the seven day cure. Since the concrete hardened by this point, paste was added to the wall to cover up the holes and flaws. Figure 44 shows how the parapet looked when the parapet is rubbed after the concrete has hardened.

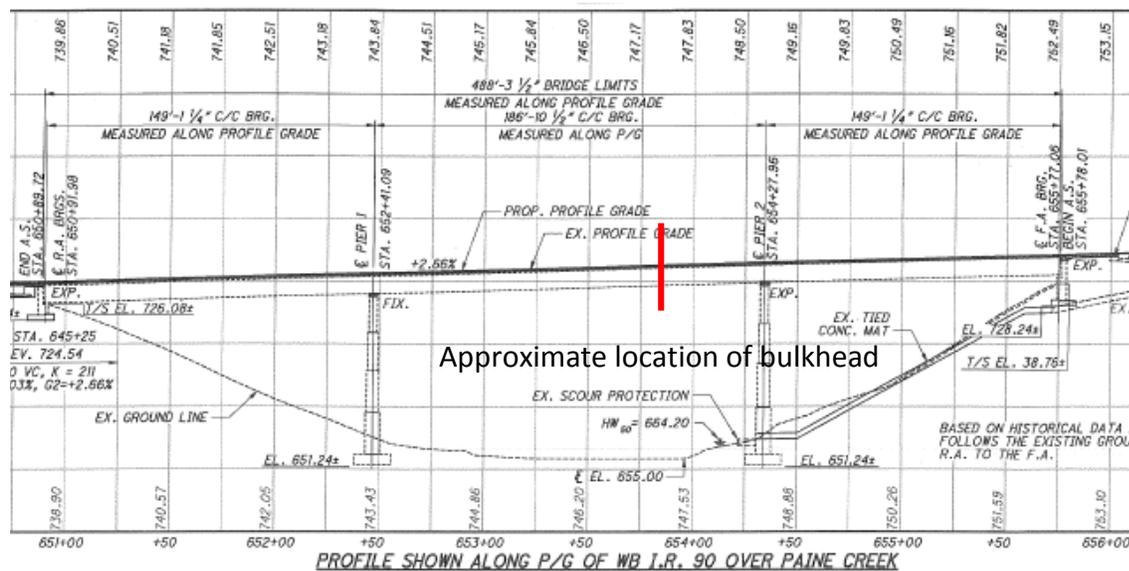
Figure 50: WB Paine Creek Bridge Profile

Looking more closely, the majority of the joints that did not crack were located at the west end of the bridge, including the joints located over the west end pier or pier 1 shown in Figure 50. About 40% of the joints located in between the piers, pier 1 and pier 2, did not crack. Between the east end of the bridge and pier 2, only 16% of the joints did not crack. With this significant difference between the sides of the bridge, the joints were analyzed again, but in two sections in regards to the two pours that took place. Fewer of the joints, about 26%, did not crack within the first 288 feet (88 m), from the east end of the bridge to the bulkhead, shown in Figure 50, where the first pour was finished. The second half of the parapet was poured on June 24, 2013. The second half was between the bulkhead and the west end of the bridge, and 72% of joints that did not crack within this section.

The control joint spacing on this bridge was 4 feet (1.2 m) over negative tension areas, and 8 feet (2.4 m) over the rest of the bridge. The 4 foot (1.2 m) spacing was extended out from each of the piers between 32 and 44 feet (9.8 and 13.4 m). The total parapet length is approximately 490 feet (150 m) long with 81 control joints. If conventional spacing was used, only 49 joints would have been cut. However, despite the number of control joints that were cut on this bridge, nearly 50% of them did not crack. It is not known whether this is due to the high amount of fibers used in the concrete mix, the shallow saw cut, the use of many closely spaced
