# MILLER CONSTRUCTION, INC.

COPIES	NUMBER	DESCRIPTION	CODE
1		FRP Fabrication NCR 7 - Pontoon 3 Dry Spots	H

**Brookfield BRF FLBR (2)**

Nonconformance

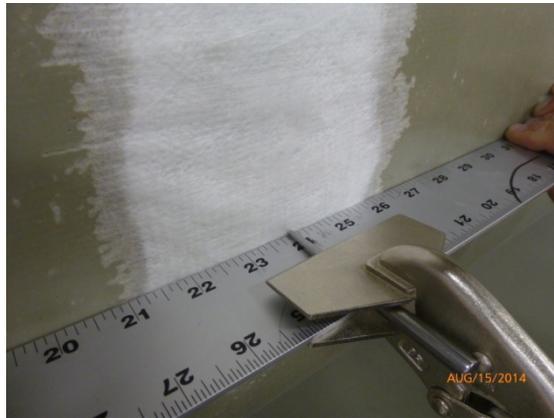
**Figure 1 – Dry Fabric Measurement Tool**

A measurement method was developed and used to quantify the depth of dry fabric in poorly infused areas as shown in Figures 1 and 2. A compass point is lightly tapped into the dry side of the laminate until it stops against cured resin. The point is clamped to a steel straight edge and the distance from the tip to the straight edge is measured with digital calipers. These values are transposed to a photo of each defect.
