# ROUTINE PERFORMANCE CHECK REPORT

DataMaster DMT: 122206  
 Location: Franklin County SO Enosburgh  
 Calibration Date: 01/09/2012  
 Certification Date: 01/10/2012  
 Installation Date: 01/27/2012  
 RPC Date: 06/23/2014  
 Supervisor Name: JAY H SWEENEY

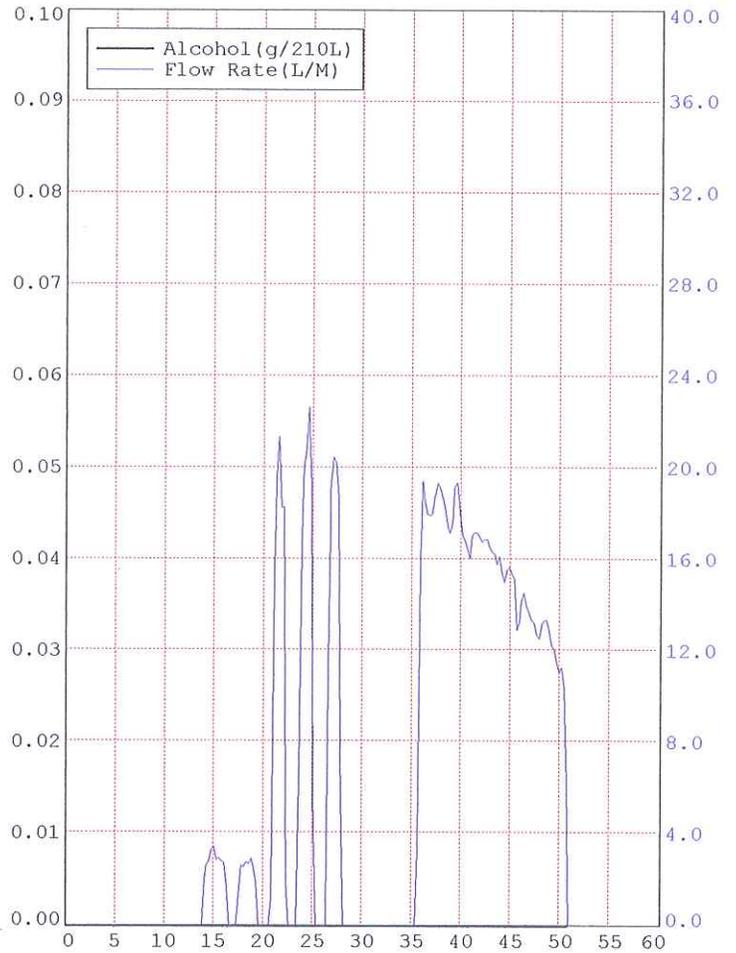
CHECK-IN CONFIRMATION TEST

The Enosburg blip was caused by me sucking hard and then releasing which caused a little release of air into the unit. It was operator error and not the Machine.

I noticed a "blip" in the alcohol line in both Richford and Enosburg's RPC. During the "suck back" test you need to **very gently** suck back on the mouth piece. There is a rubber flap built into the breath tube that we are checking the function of. If you suck too hard the instrument will give an error and can sometimes cause the alcohol line to "blip". Can you please perform a "check-in" on both instruments including all 4 breath types so that we have an accepted breath sample for each, as we cannot pass the current RPC's as is. If when you suck back gently you don't feel the air in the breath tube resist, we will have to look further into the issue. If you have any questions feel free to contact me.
