VERMONT FORENSIC LABORATORY

DATAMASTER TECHNICAL SUPPORT INQUIRY

Agency/Site: <u>Franklin CSO Richford</u>	DataMaster Serial #: <u>300386</u>
Date: <u>6/24/2014</u>	Requestor: <u>Jay Sweeny</u>
Instrument Supervisor: <u>Jay Sweeny</u>	Phone #: <u>(802)524-2121</u>
Taken By: <u>Rob Driscoll</u>	
Problem: <u>Suck back error during June RPC.</u>	
Laboratory Response: <u>DMT technician to troubleshoot on site.</u>	
Work Performed: <u>Tried to gently suck back on breath tube and noticed little resistance. Removed breath tube and found one-way valve not fully closing. Replaced breath tube and completed June RPC.</u>	
<input checked="" type="checkbox"/> On Site <input type="checkbox"/> In-house	Attachments: <u>5</u> pages
Performed By: <u>Rob Driscoll</u> <i>RD</i>	Date: <u>7/2/2014</u>
Final Review: <u><i>[Signature]</i></u>	Date: <u>7/15/2014</u>

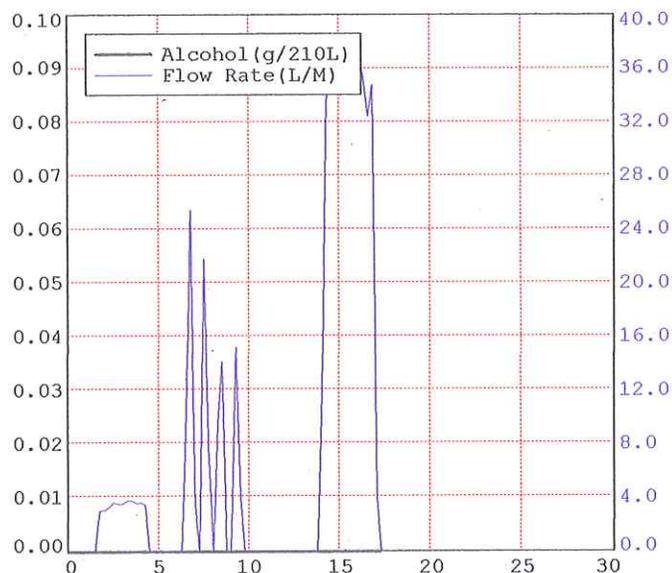
The Enosburg blip was caused by me sucking hard and then releasing which caused a little release of air into the unit. It was operator error and not the Machine.

I noticed a "blip" in the alcohol line in both Richford and Enosburg's RPC. During the "suck back" test you need to **very gently** suck back on the mouth piece. There is a rubber flap built into the breath tube that we are checking the function of. If you suck too hard the instrument will give an error and can sometimes cause the alcohol line to "blip". Can you please perform a "check-in" on both instruments including all 4 breath types so that we have an accepted breath sample for each, as we cannot pass the current RPC's as is. If when you suck back gently you don't feel the air in the breath tube resist, we will have to look further into the issue. If you have any questions feel free to contact me.

Routine Performance Check Passed
