STATE OF VERMONT Division for Historic Preservation  VERMONT ARCHITECTURAL RESOURCE INVENTORY  Individual Property Survey Form	SURVEY NUMBER: 263 St. Paul (Assigned by VDHP)
	Listed in State Register <input checked="" type="checkbox"/> 1993 Eligible for State Register Yes <input type="checkbox"/> -or- No <input checked="" type="checkbox"/> Date: October 30, 2024 SHPO LVT
	PRESENT FORMAL NAME:
	ORIGINAL FORMAL NAME:
COUNTY: Chittenden	PRESENT USE: Residential dwelling
TOWN: Burlington	ORIGINAL USE: Residential dwelling
PHYSICAL ADDRESS: 263 Saint Paul St	ARCHITECT/ENGINEER:
COMMON NAME:	BUILDER/CONTRACTOR:
PROPERTY TYPE: Residential	DATE BUILT: prior to 1869
OWNER: Robert Rich / 263 St Paul LLC MAILING ADDRESS: 9 Duchess Ave, So Burlington, VT 05401	
	PHYSICAL CONDITION OF STRUCTURE: Good <input type="checkbox"/> Fair <input checked="" type="checkbox"/> Poor <input type="checkbox"/>
	STYLE:
GENERAL DESCRIPTION: <b>Structural System:</b> 1. <u>Foundation:</u> Stone <input checked="" type="checkbox"/> Brick <input type="checkbox"/> Concrete <input type="checkbox"/> Concrete Block <input type="checkbox"/> 2. <u>Wall Structure</u> a. Wood Frame: Post & Beam <input type="checkbox"/> Plan

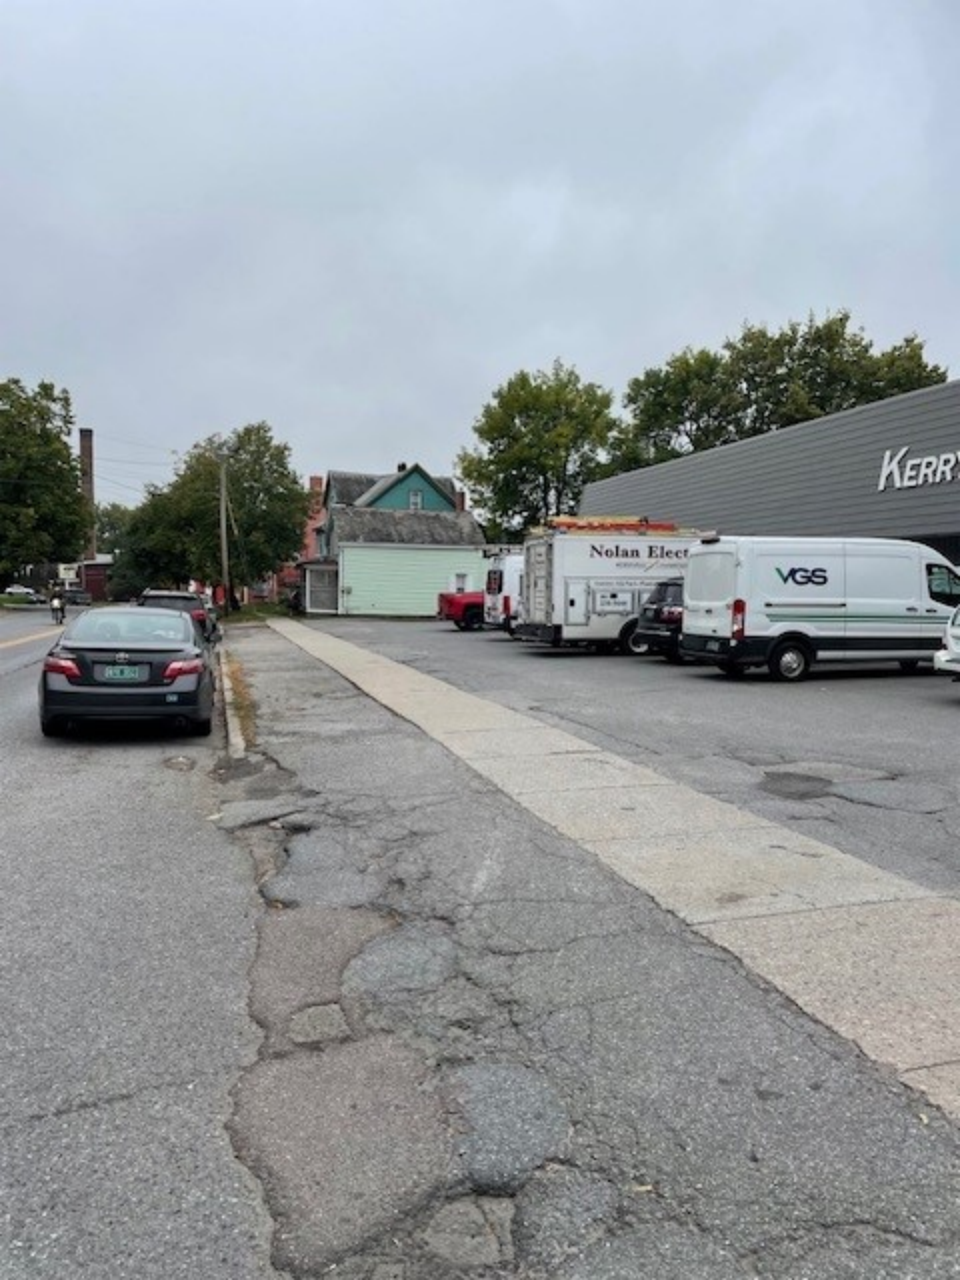
Depth of the window and door openings is suggesting the vinyl siding was placed over the veneer.

Reconstructed interior chimney

Eaves and returns covered in vinyl siding

Windows and doors replaced, fanlight over main entry covered or infilled; fake shutters

Reconstructed front porch with square posts replacing turned posts noted in 1977 HSSS

1977 survey indicated turned posts on porch – porch was replaced early 1980s and the turned posts were replaced with standard 4x4s. 1977 survey also indicated aluminum siding which was incorrect. Other than slate roof there are no distinguishing features, and slate roofs are common on non-historical structures in Vermont. North side of property is bordered by asphalt parking lot owned by Kerry's Kwik Stop.
