Lowell BF 029-2(14)

Regional Concerns Meeting

VT Route 100– Bridge #234 over the East Branch of Missisquoi River

July 9, 2019

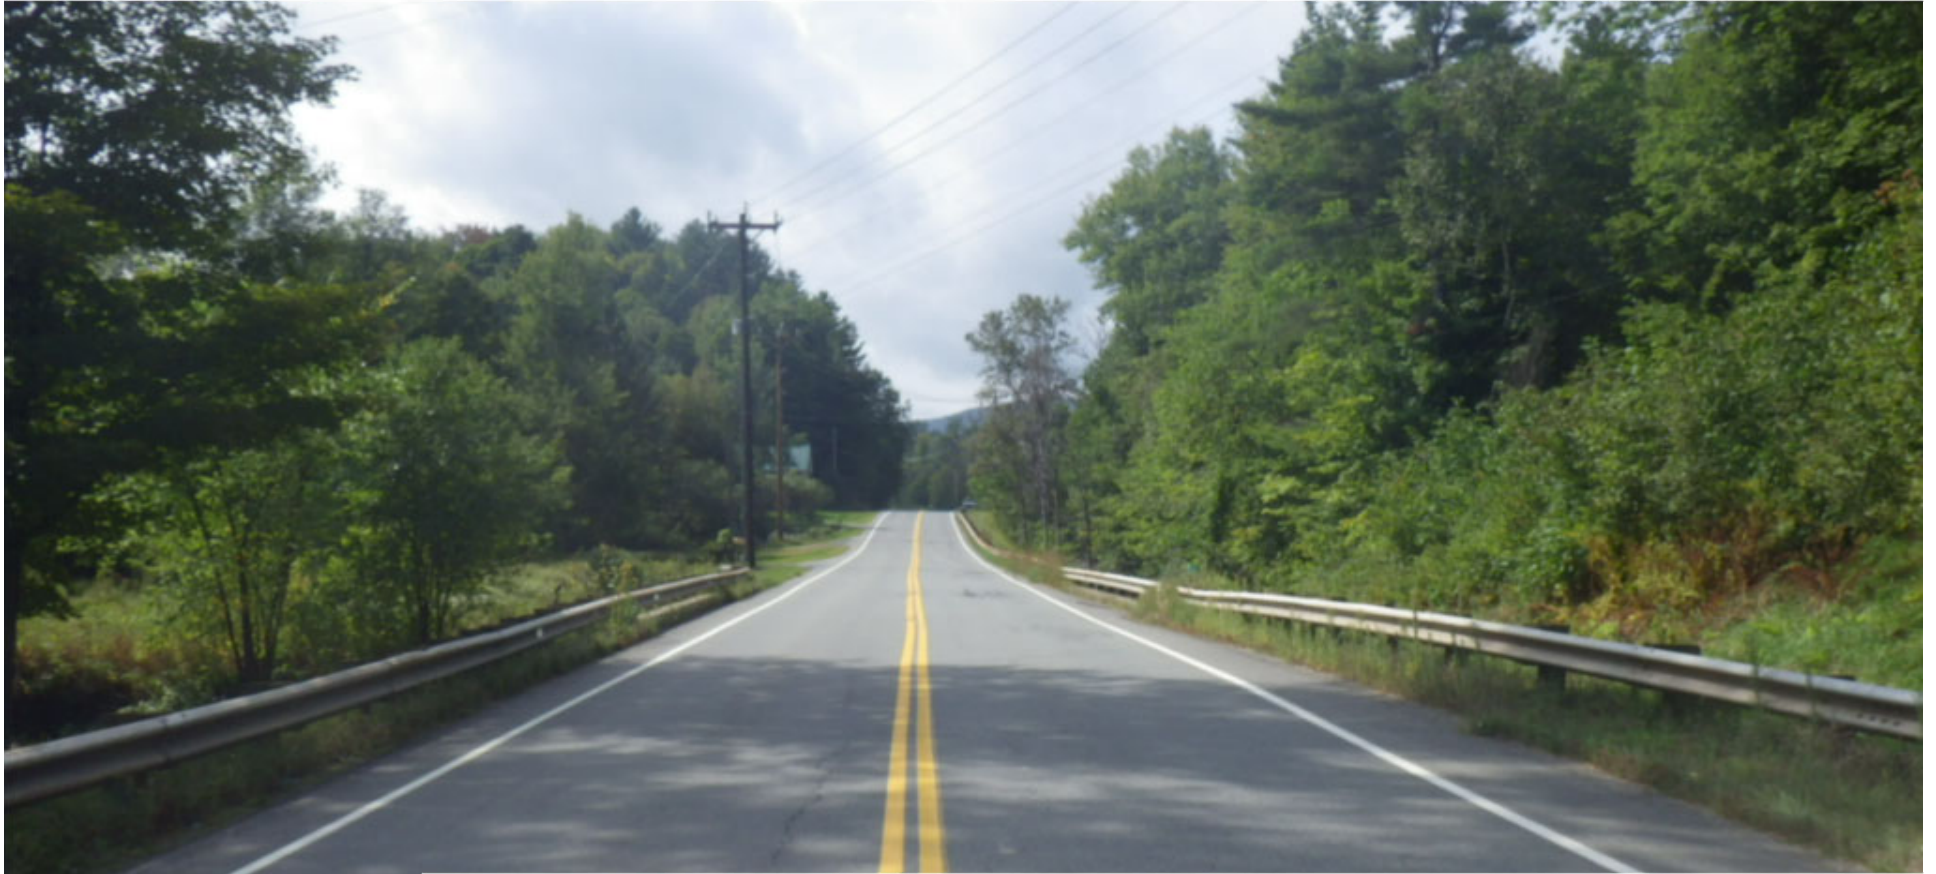
Existing Conditions – Bridge #234

- 11'¼' Existing Typical Section
 - Meets the minimum standard for safety and service
 - Does not meet the minimum shared-use standard of 5-feet
- 30-Degree skew

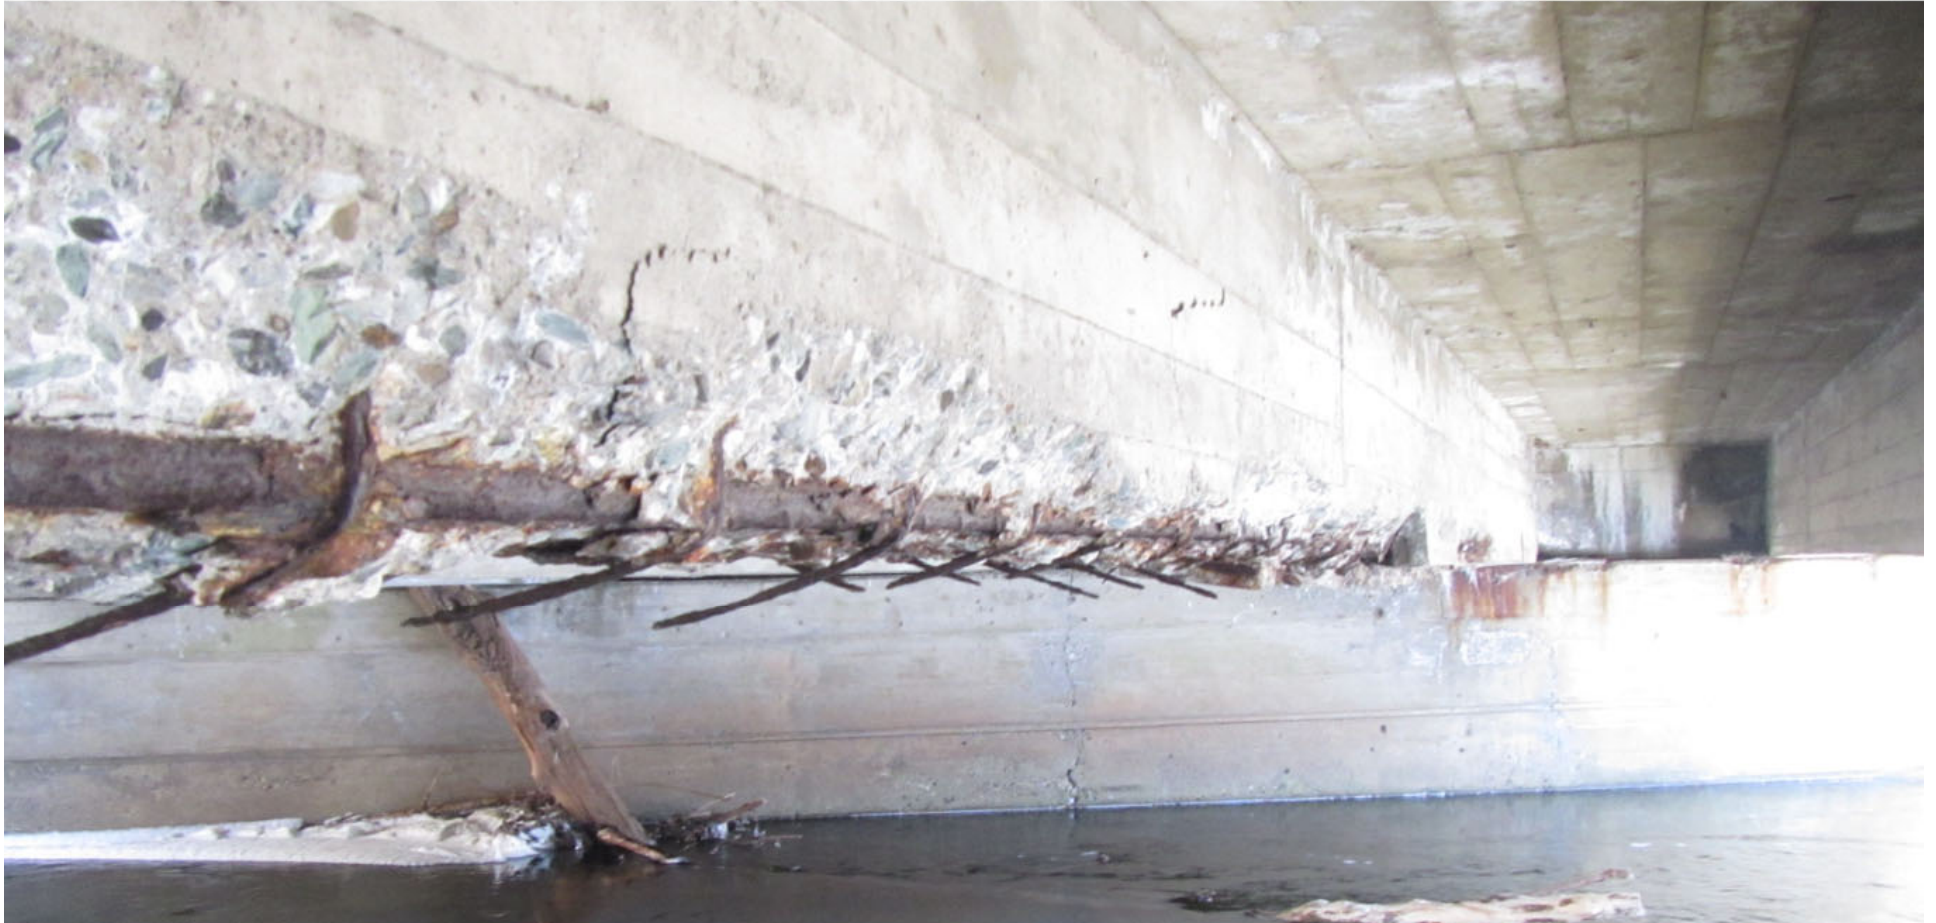
Condition Ratings

Existing Conditions - Bridge #234

| ■ Deck Rating | 5 (Fair) |
| ■ Superstructure Rating | 4 (Poor) |
| ■ Substructure Rating | 6 (Satisfactory) |

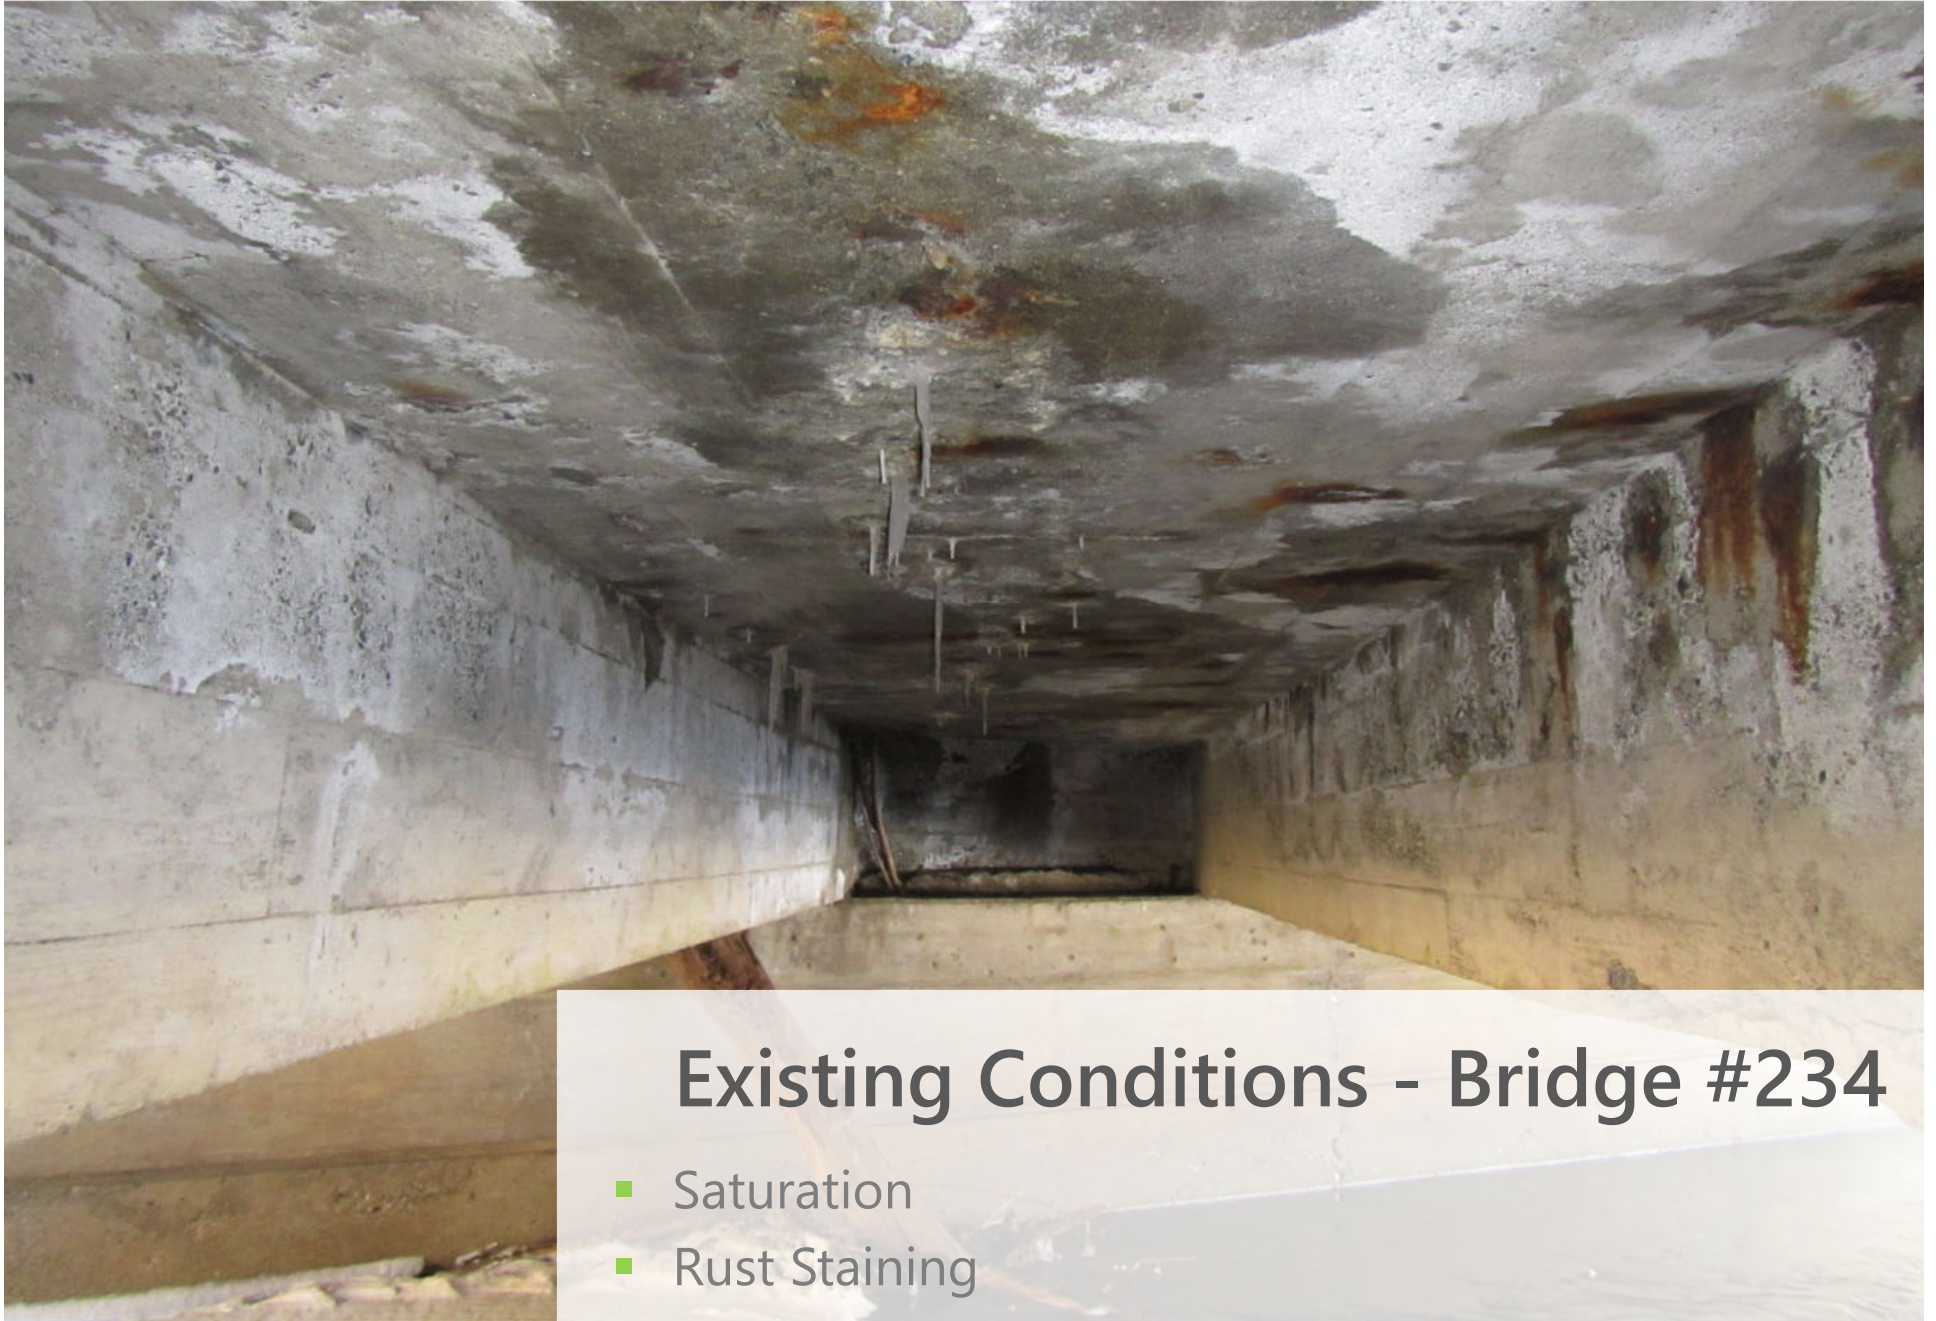
Deck Condition

Existing Conditions - Bridge #234

- Saturation
- Rust Staining

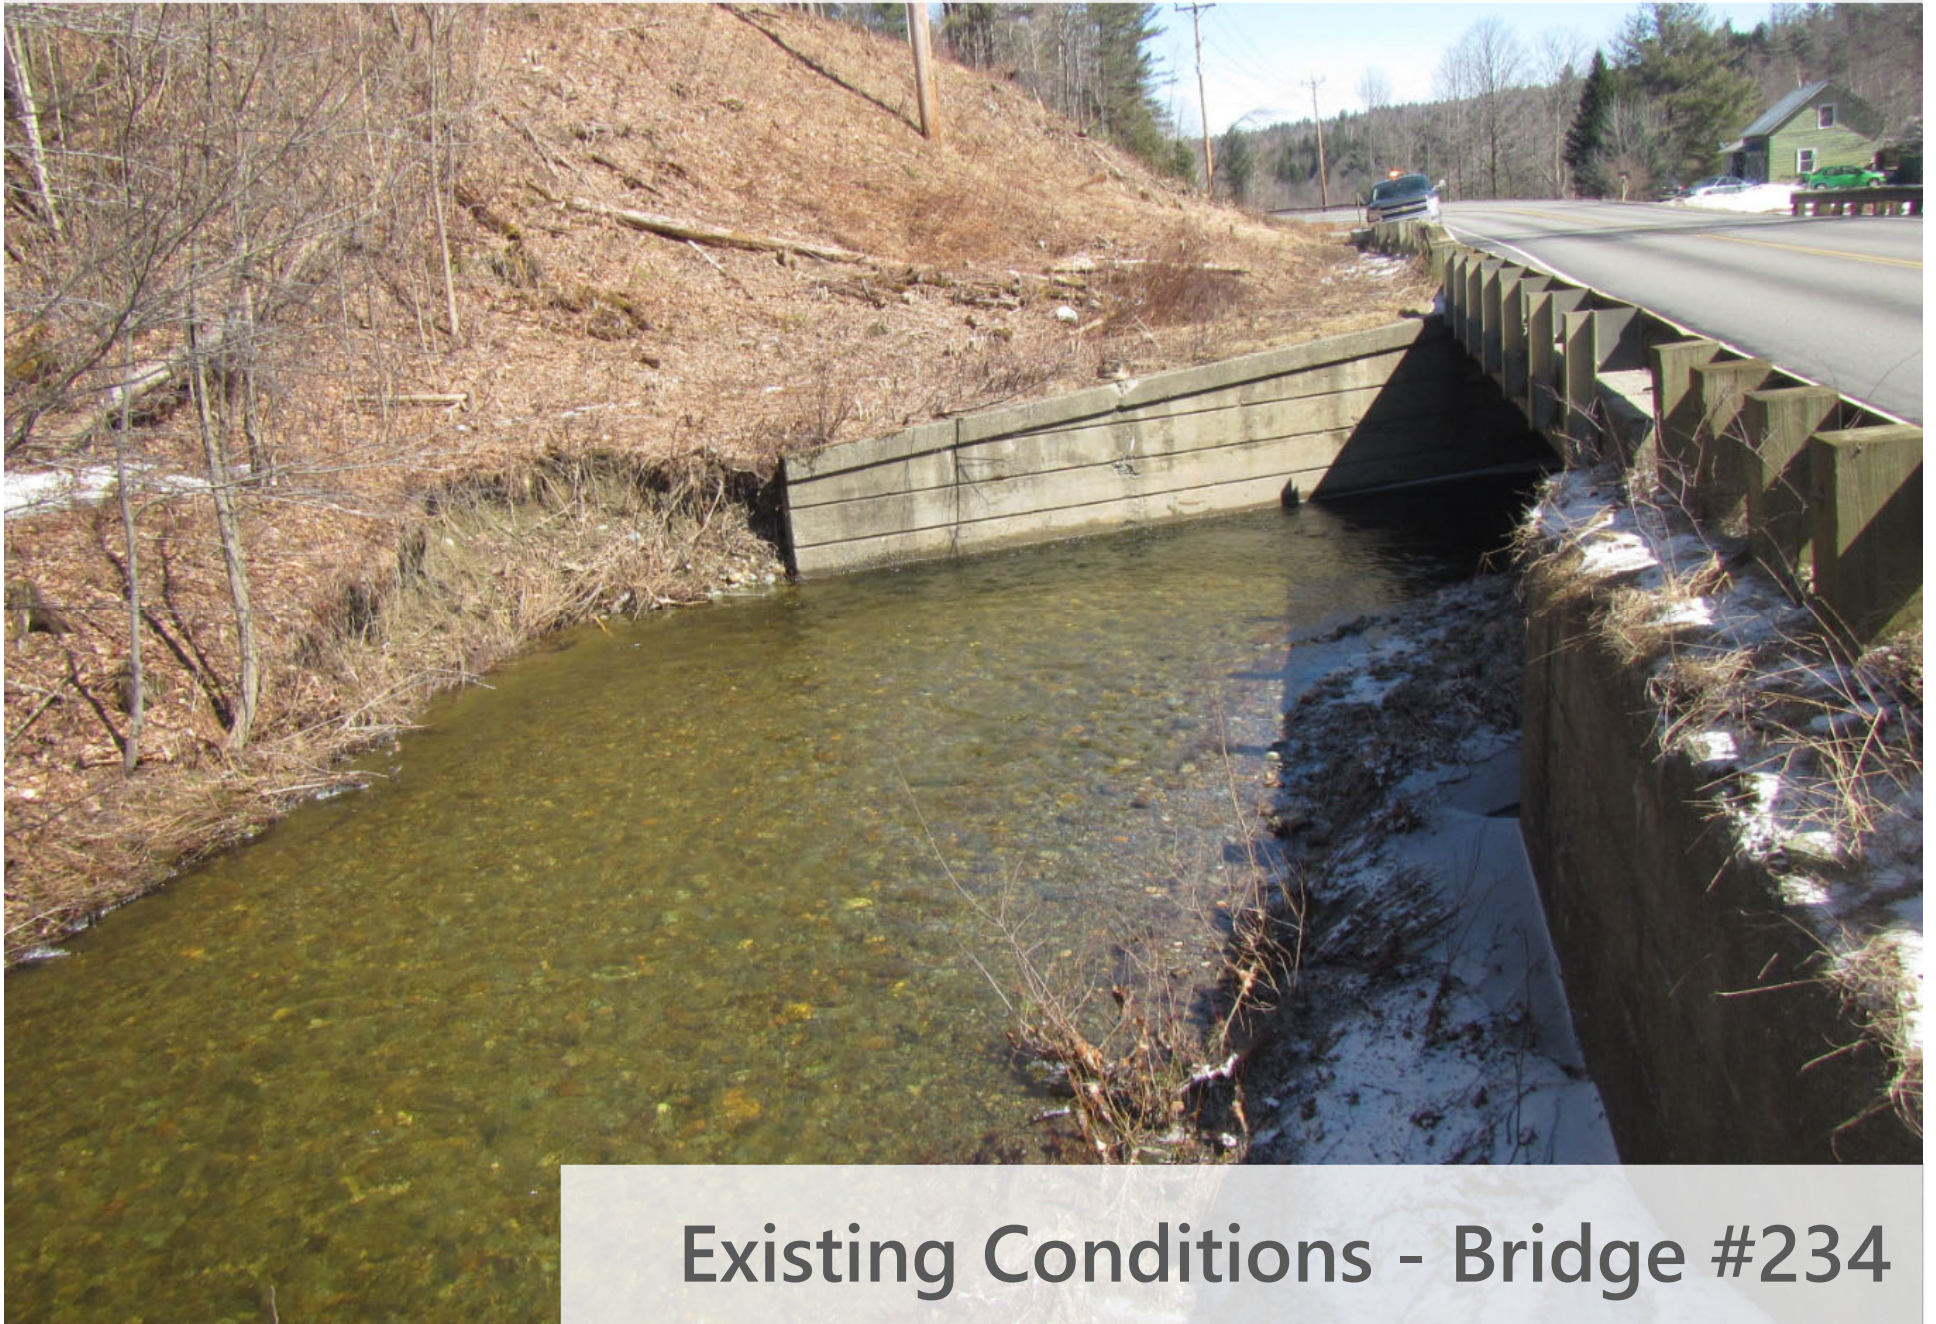
Scour Issues

Existing Conditions - Bridge #234

Looking Upstream from Bridge 234

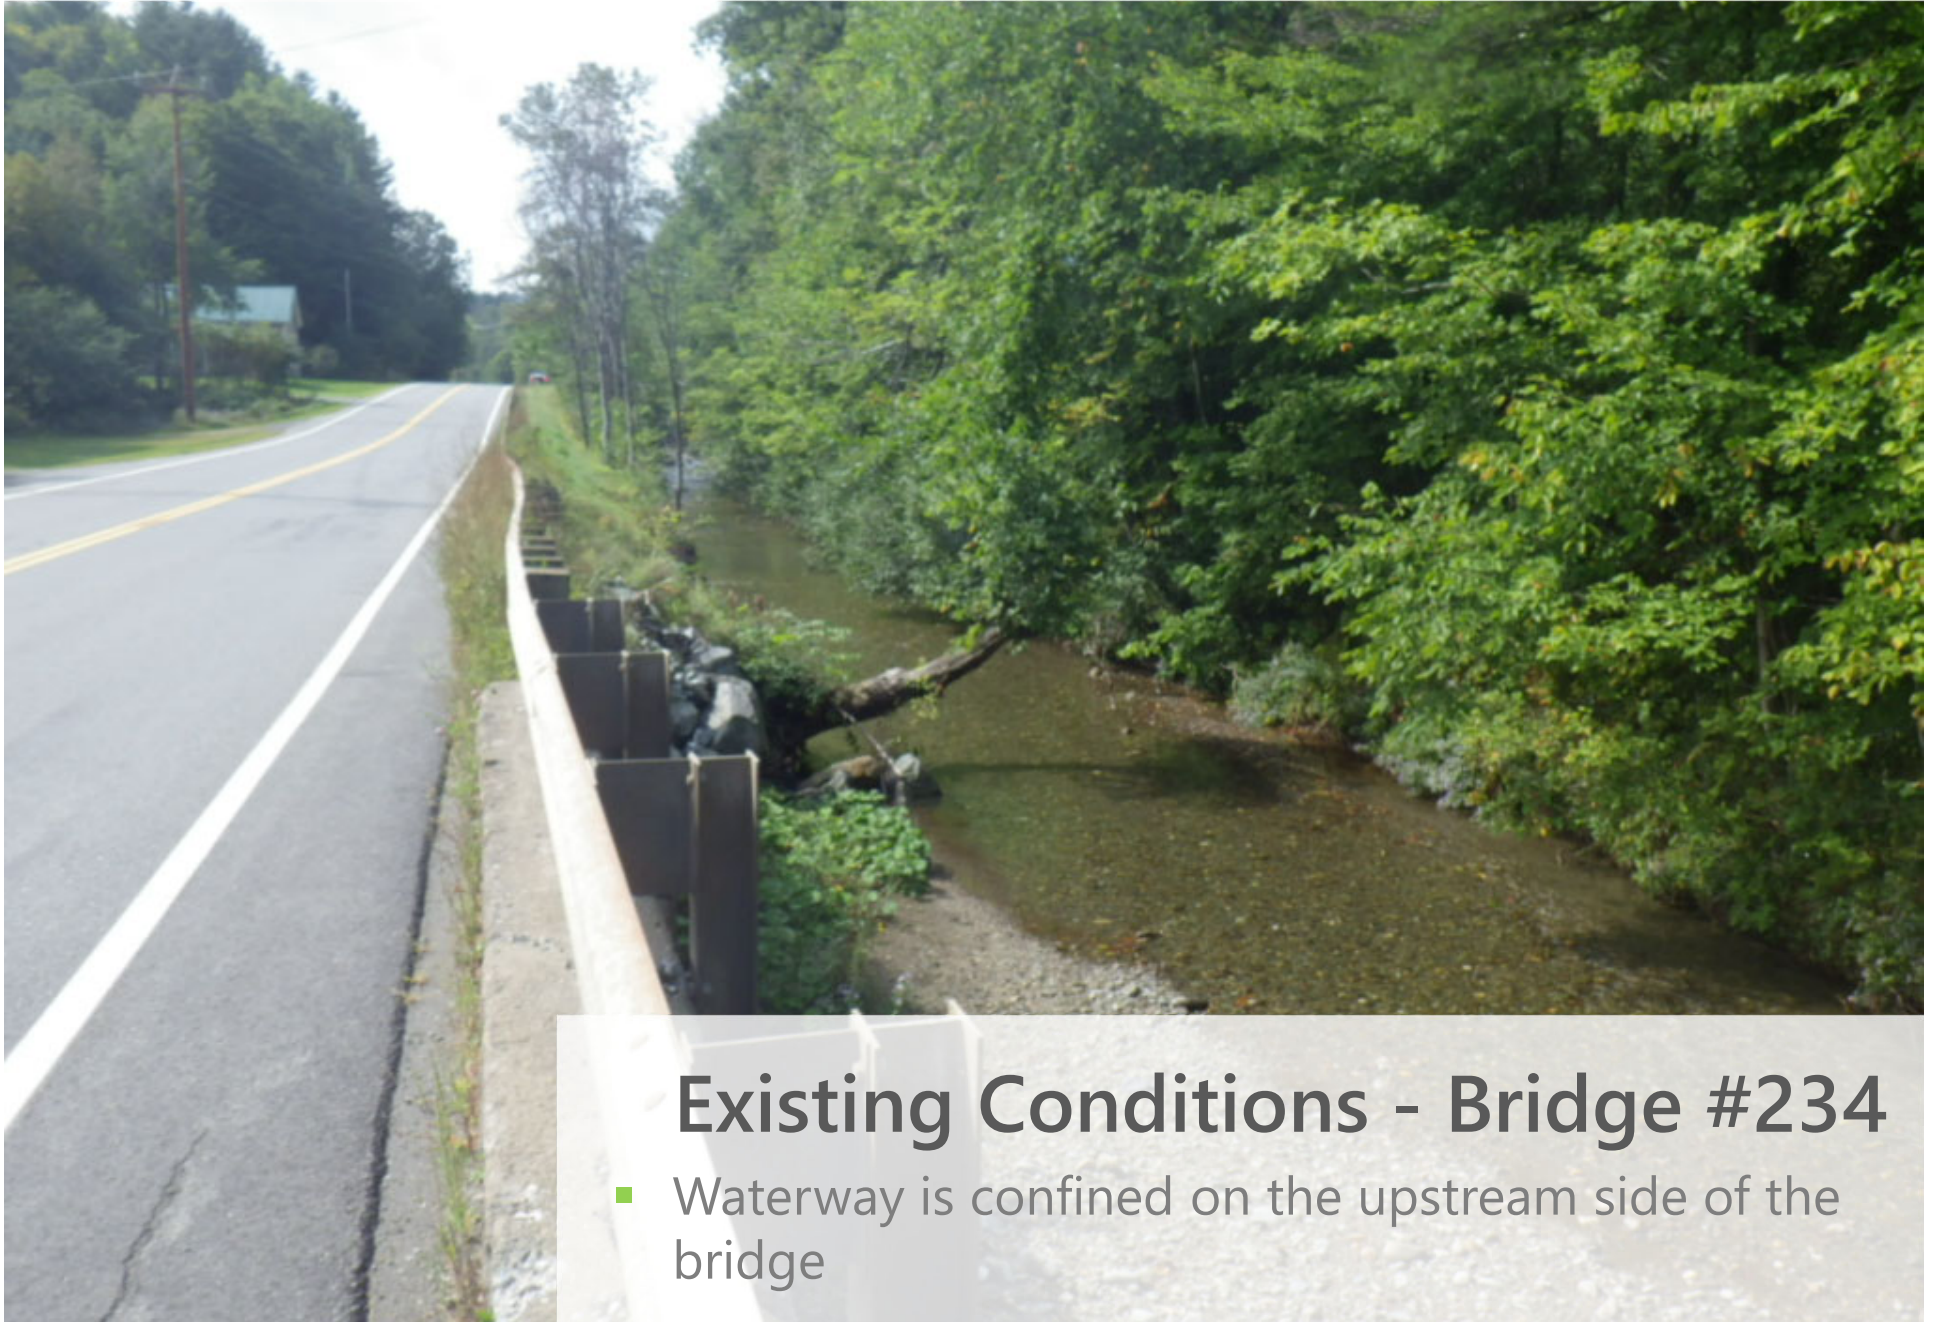
Existing Conditions - Bridge #234

- Waterway is confined on the upstream side of the bridge

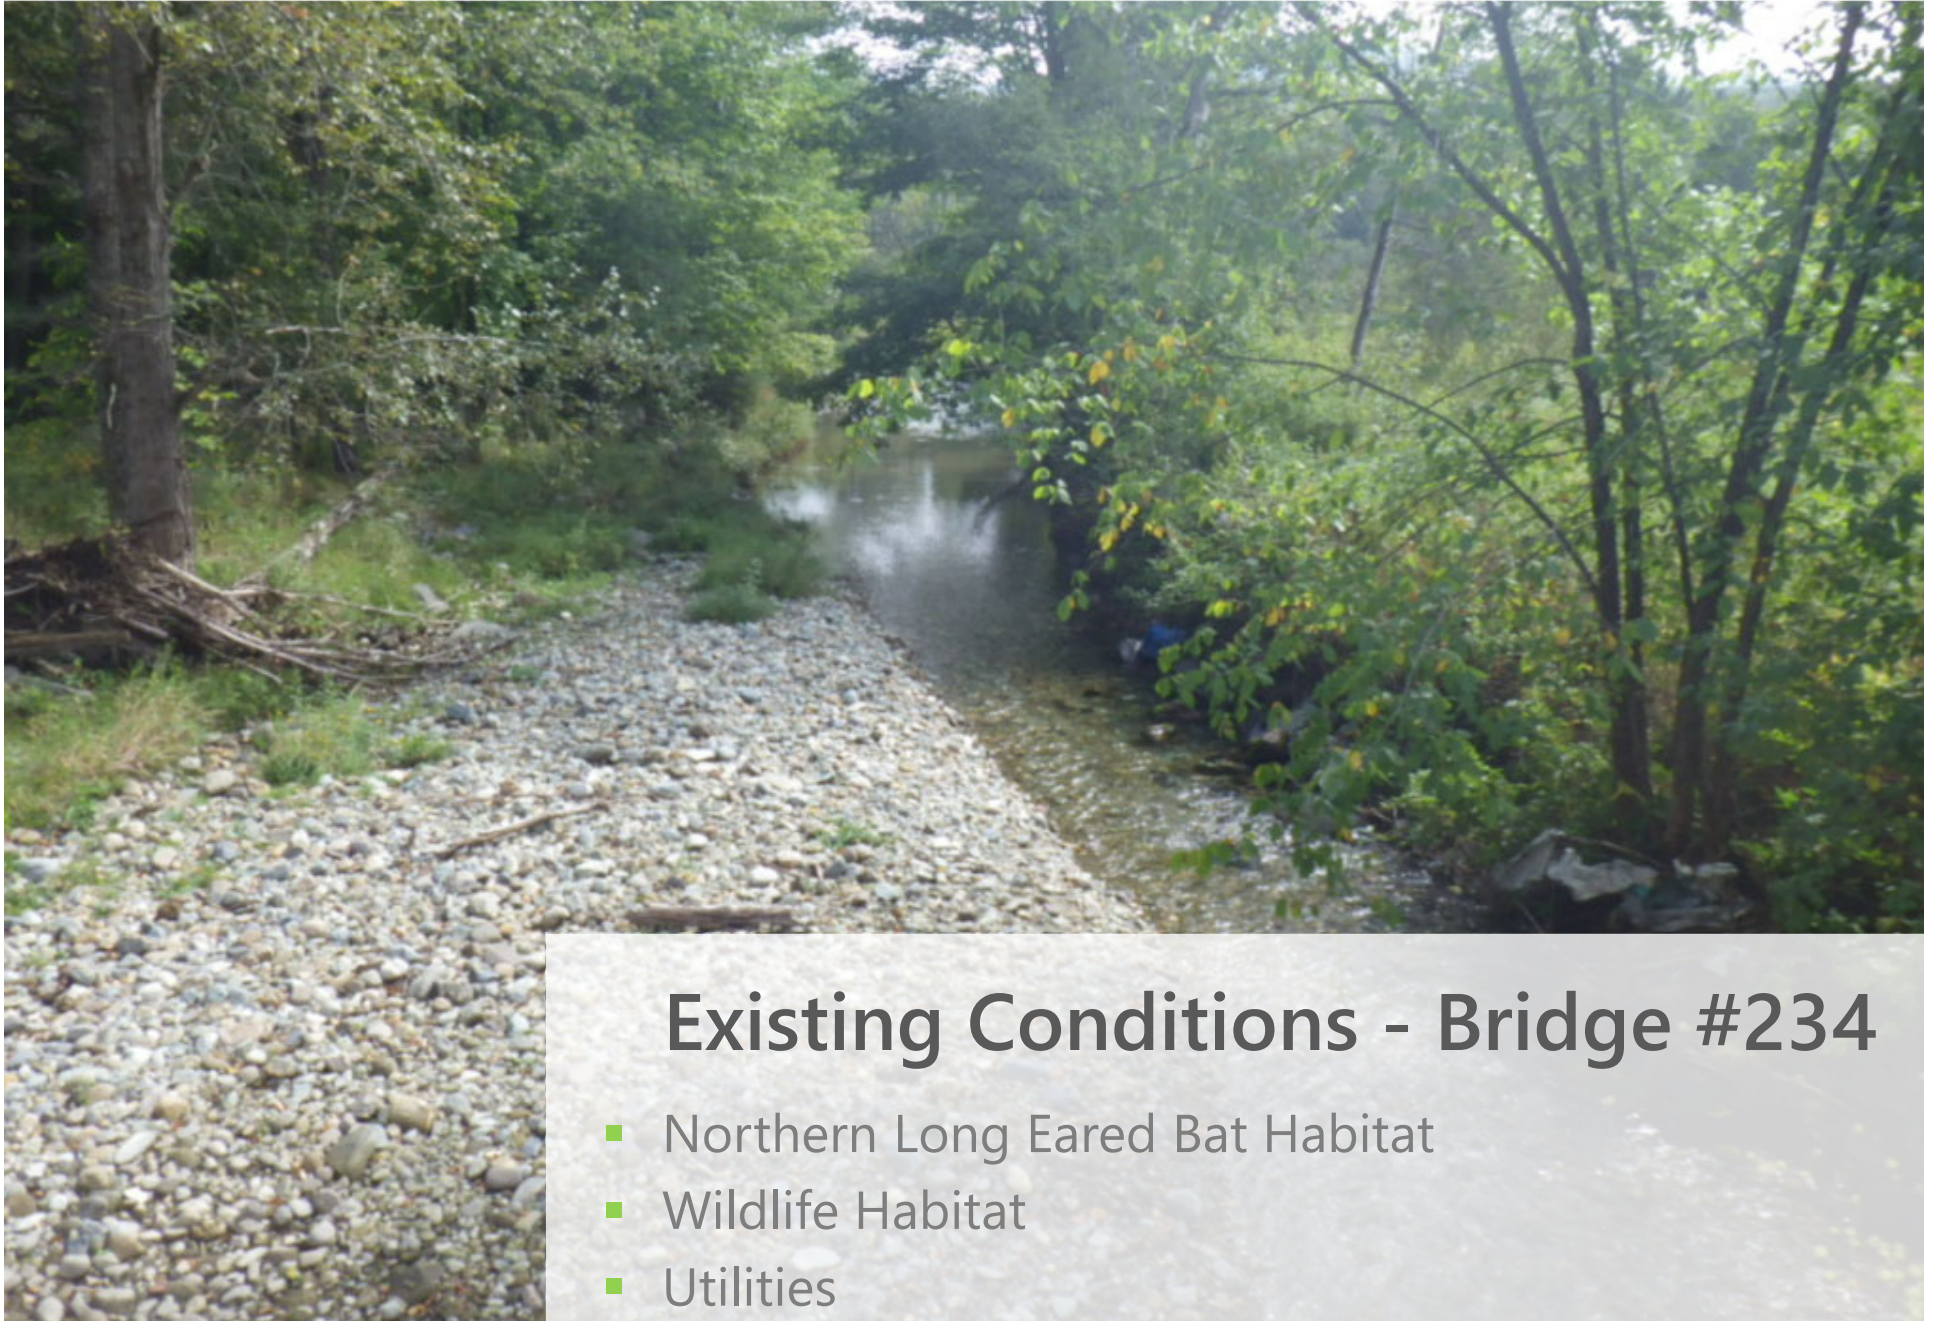
Resources – Looking Downstream

Existing Conditions - Bridge #234

- Northern Long Eared Bat Habitat
- Wildlife Habitat
- Utilities

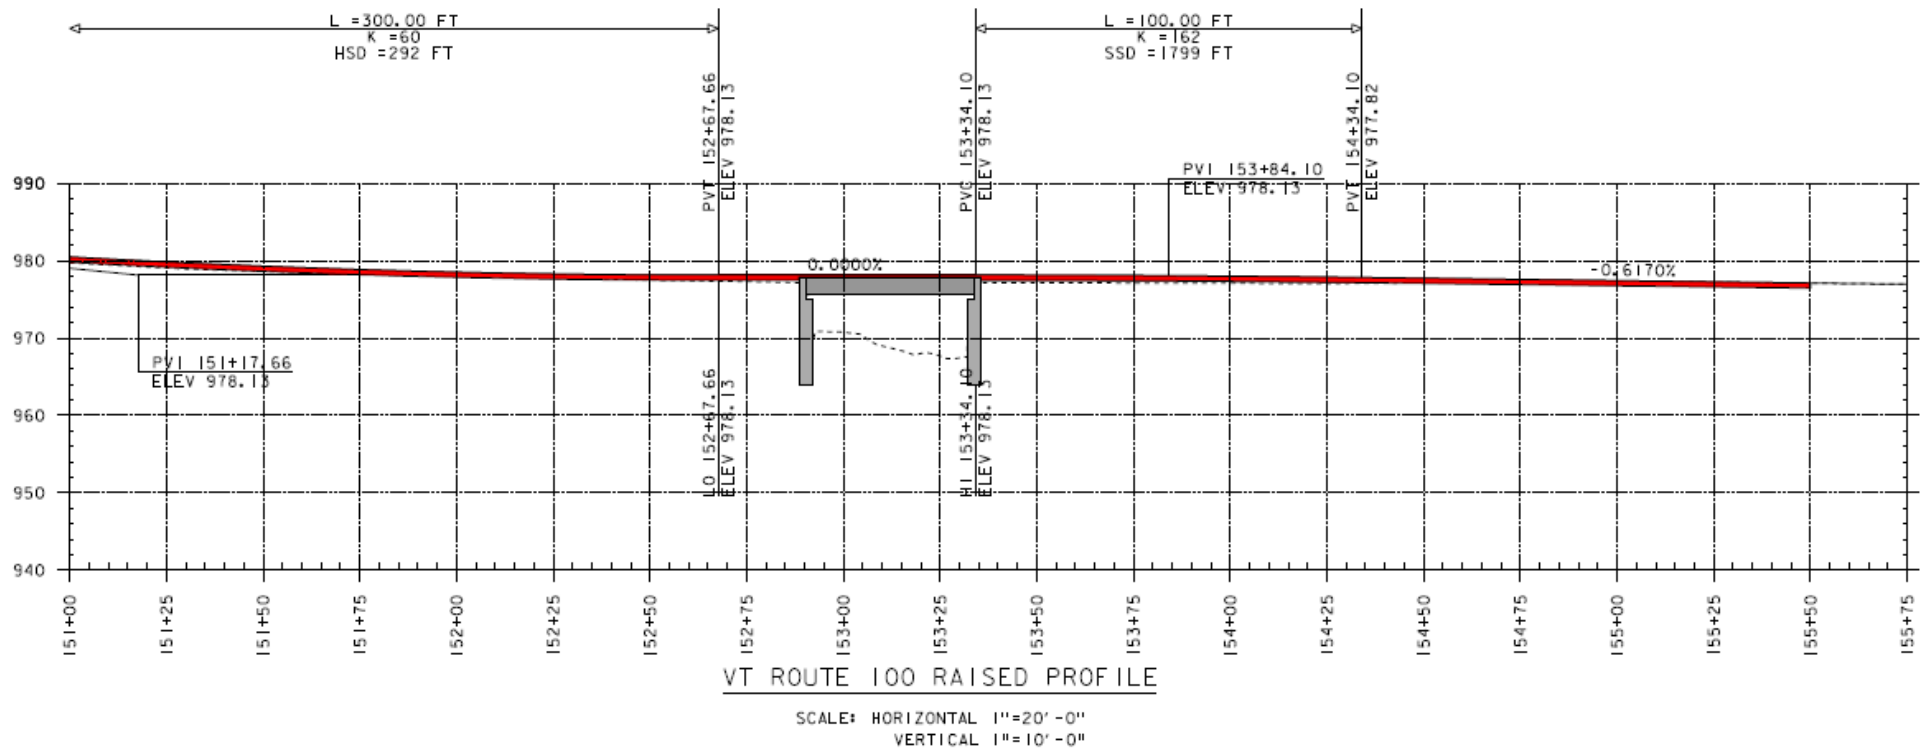
Proposed Profile

- Maintain horizontal alignment
- Raise vertical alignment by approx. 1 foot to meet minimum hydraulic standard
- 75 year design life

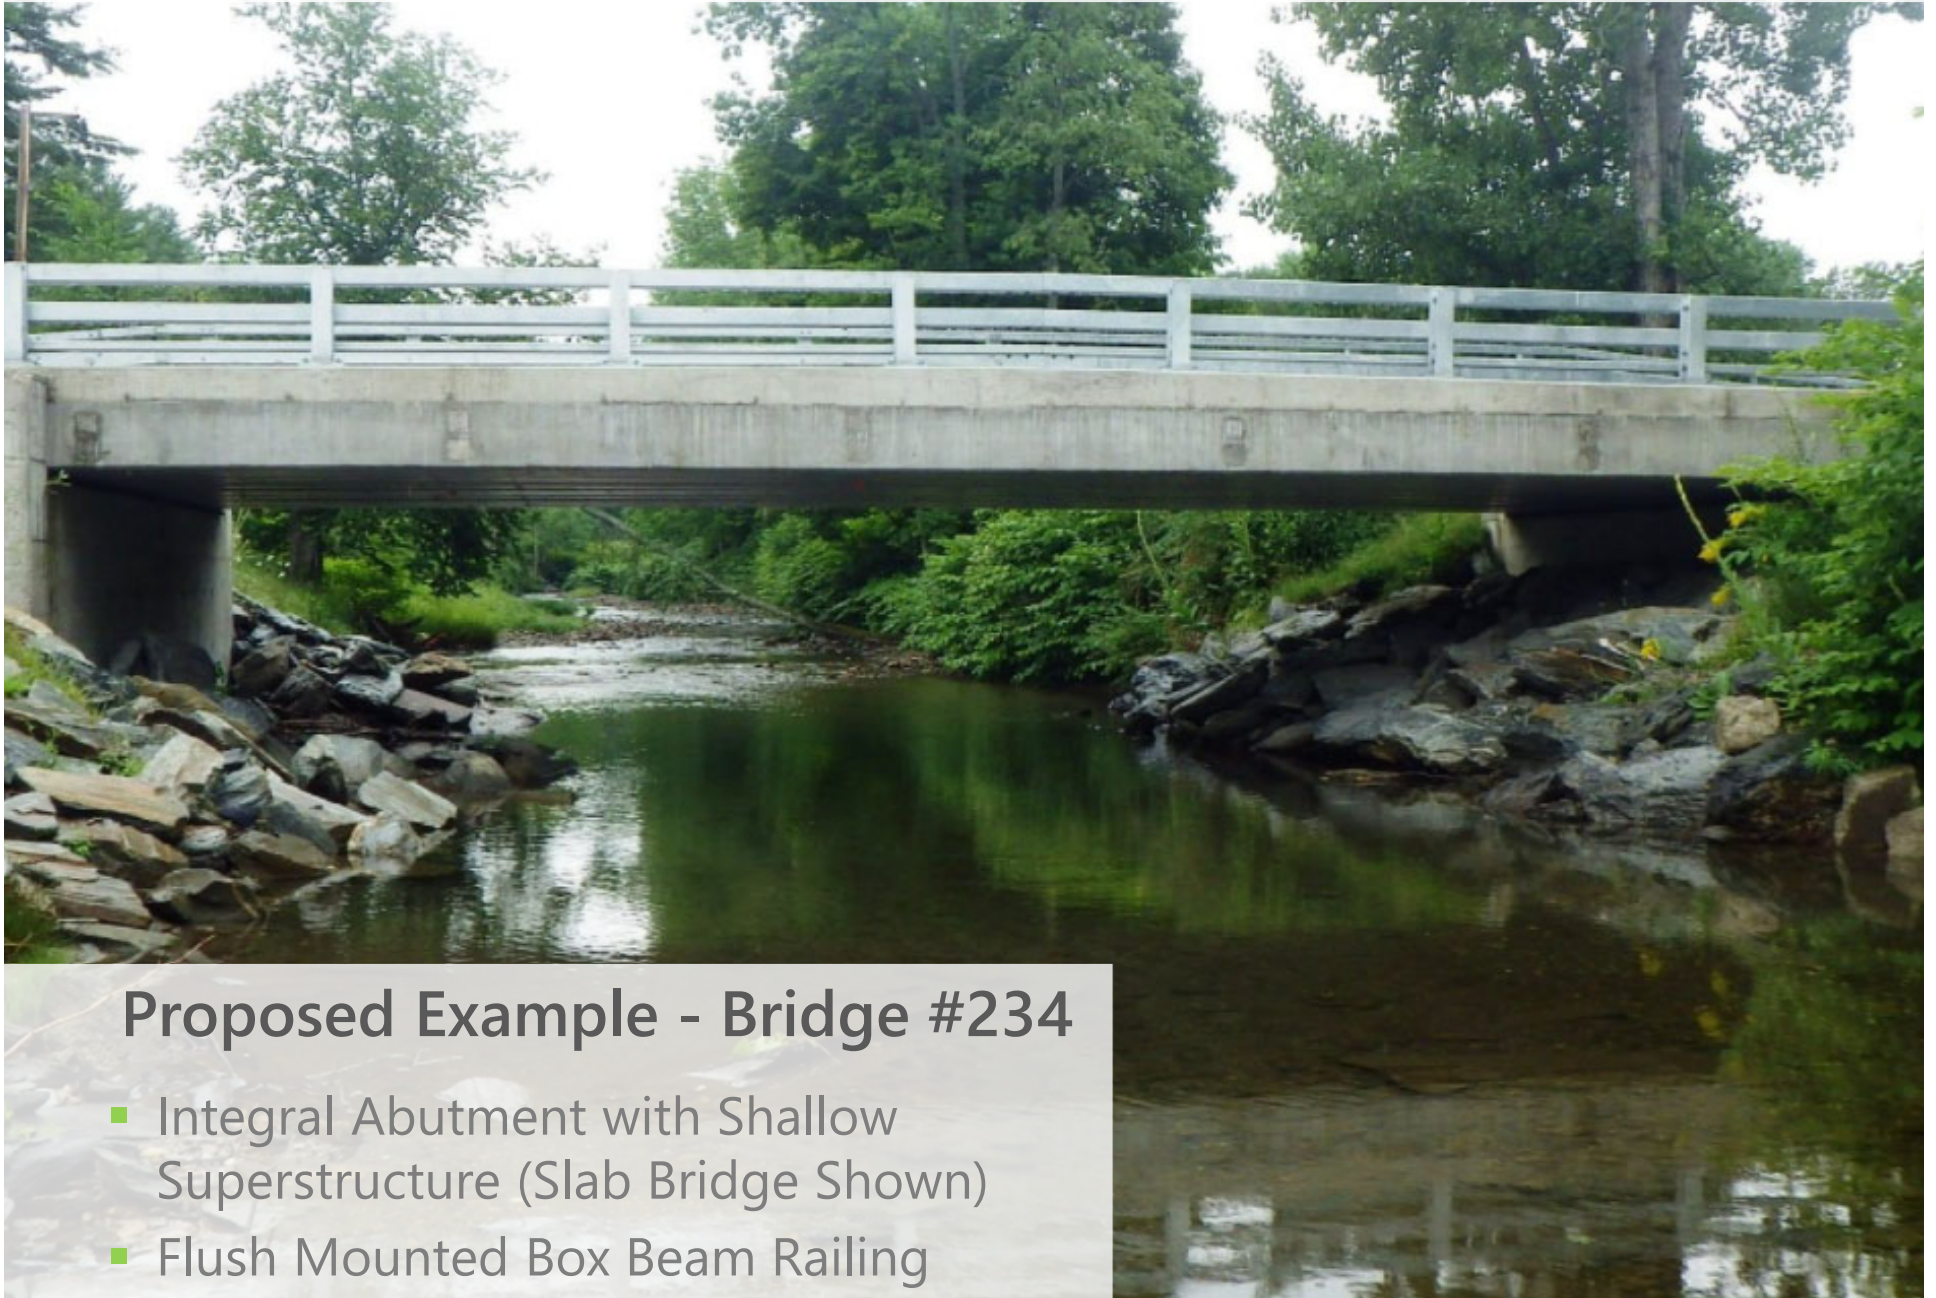
What Will the New Bridge Look Like?

Proposed Example - Bridge #234

- Integral Abutment with Shallow Superstructure (Slab Bridge Shown)
- Flush Mounted Box Beam Railing

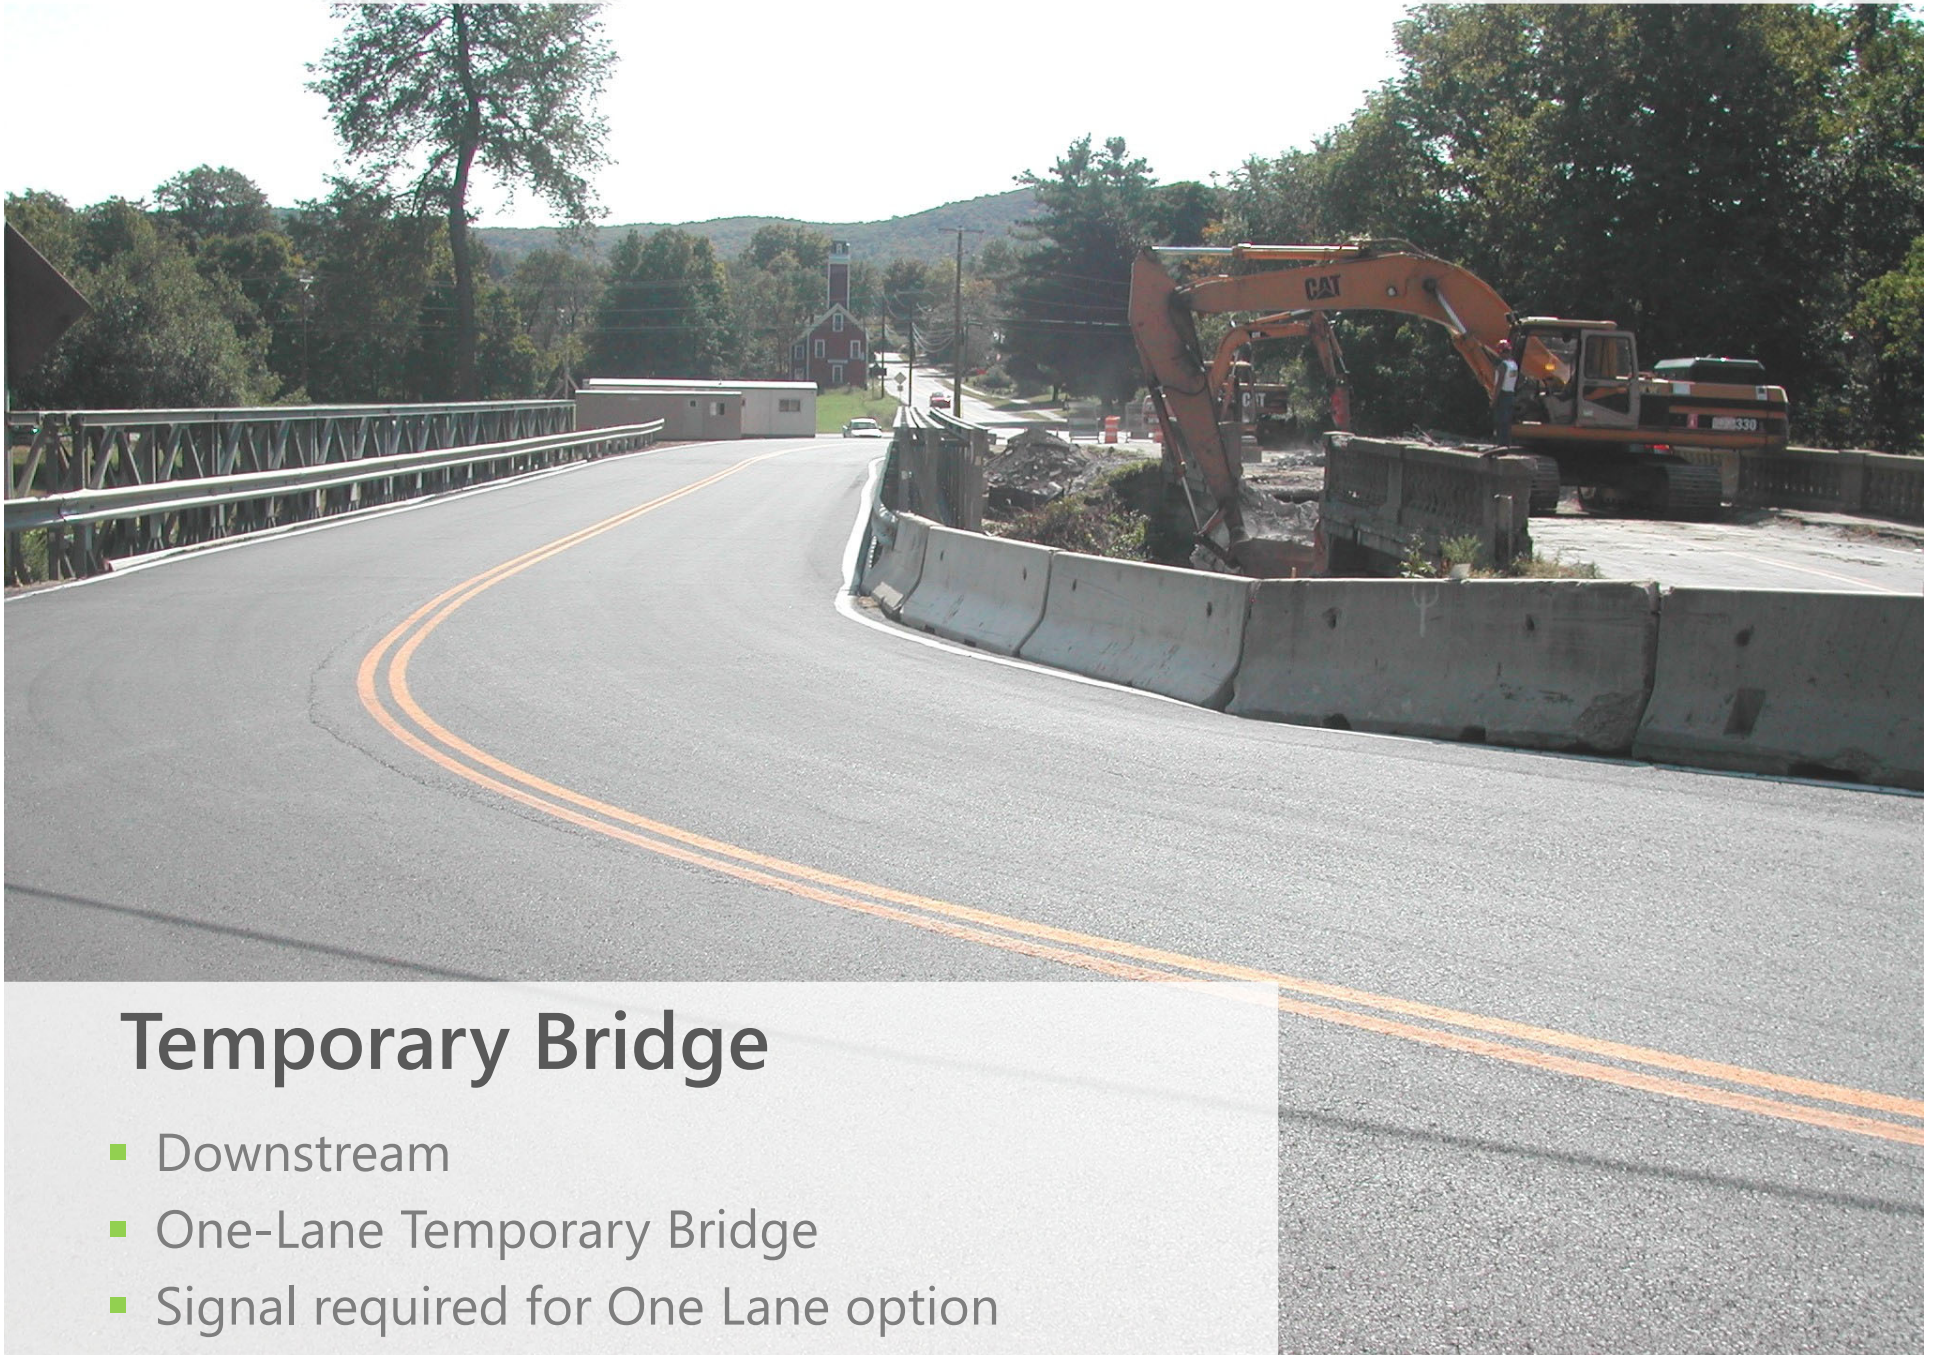
Selected Method of Traffic Maintenance

Temporary Bridge

- Downstream
- One-Lane Temporary Bridge
- Signal required for One Lane option
