Mount Holly - BF 013-3(12)

Public Information Meeting

Vermont Route 155 – Bridge #7 over Mill River

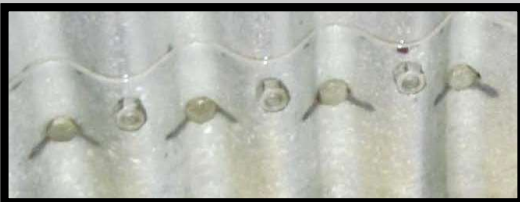
Existing Conditions

- This culvert has a rating of 4, "Poor" and has bolt line cracking.
- The existing culvert does not meet state stream equilibrium standards for bankfull width.
- There are perforations throughout the invert of the pipe. The culvert has settled 1' +/- from the mid-span to the outlet due to undermining.

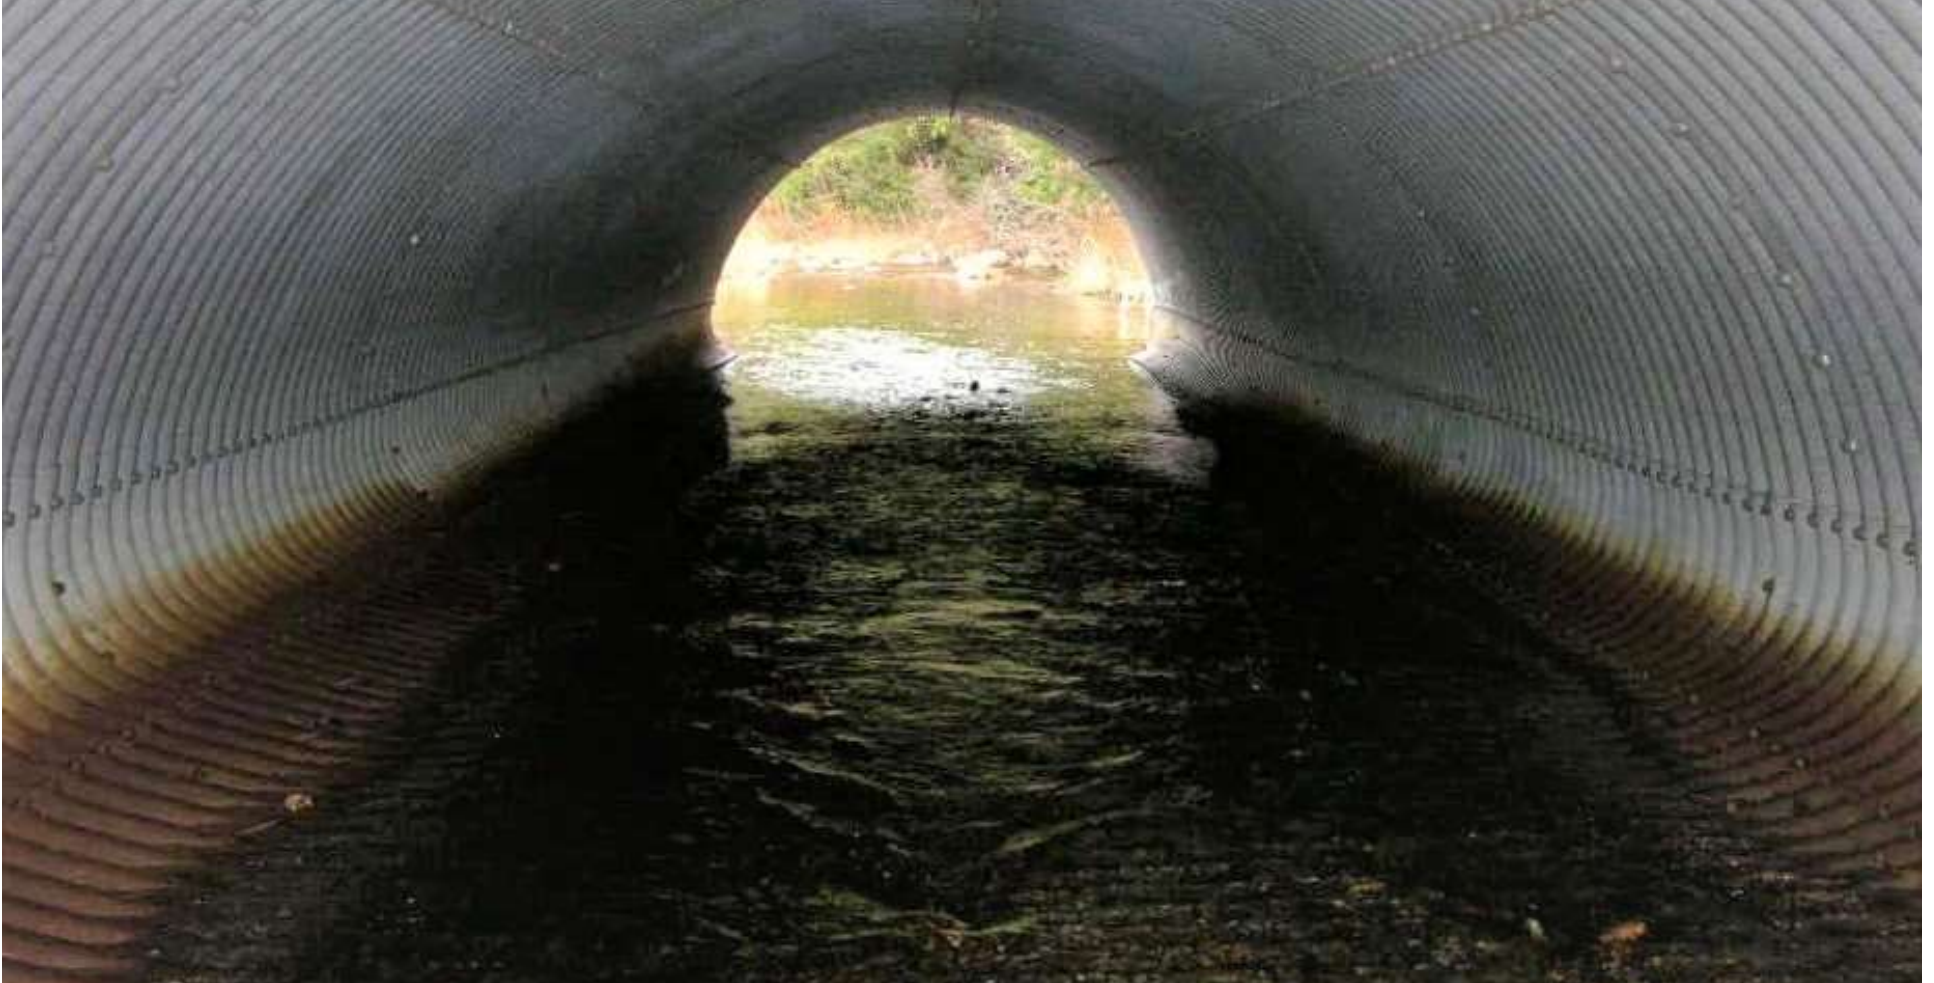
Typical Corrosion Deterioration

Inspector's comments urge action. The invert has failed allowing for undermining and resulting in a 1' +/- settlement of the downstream end of the structure.

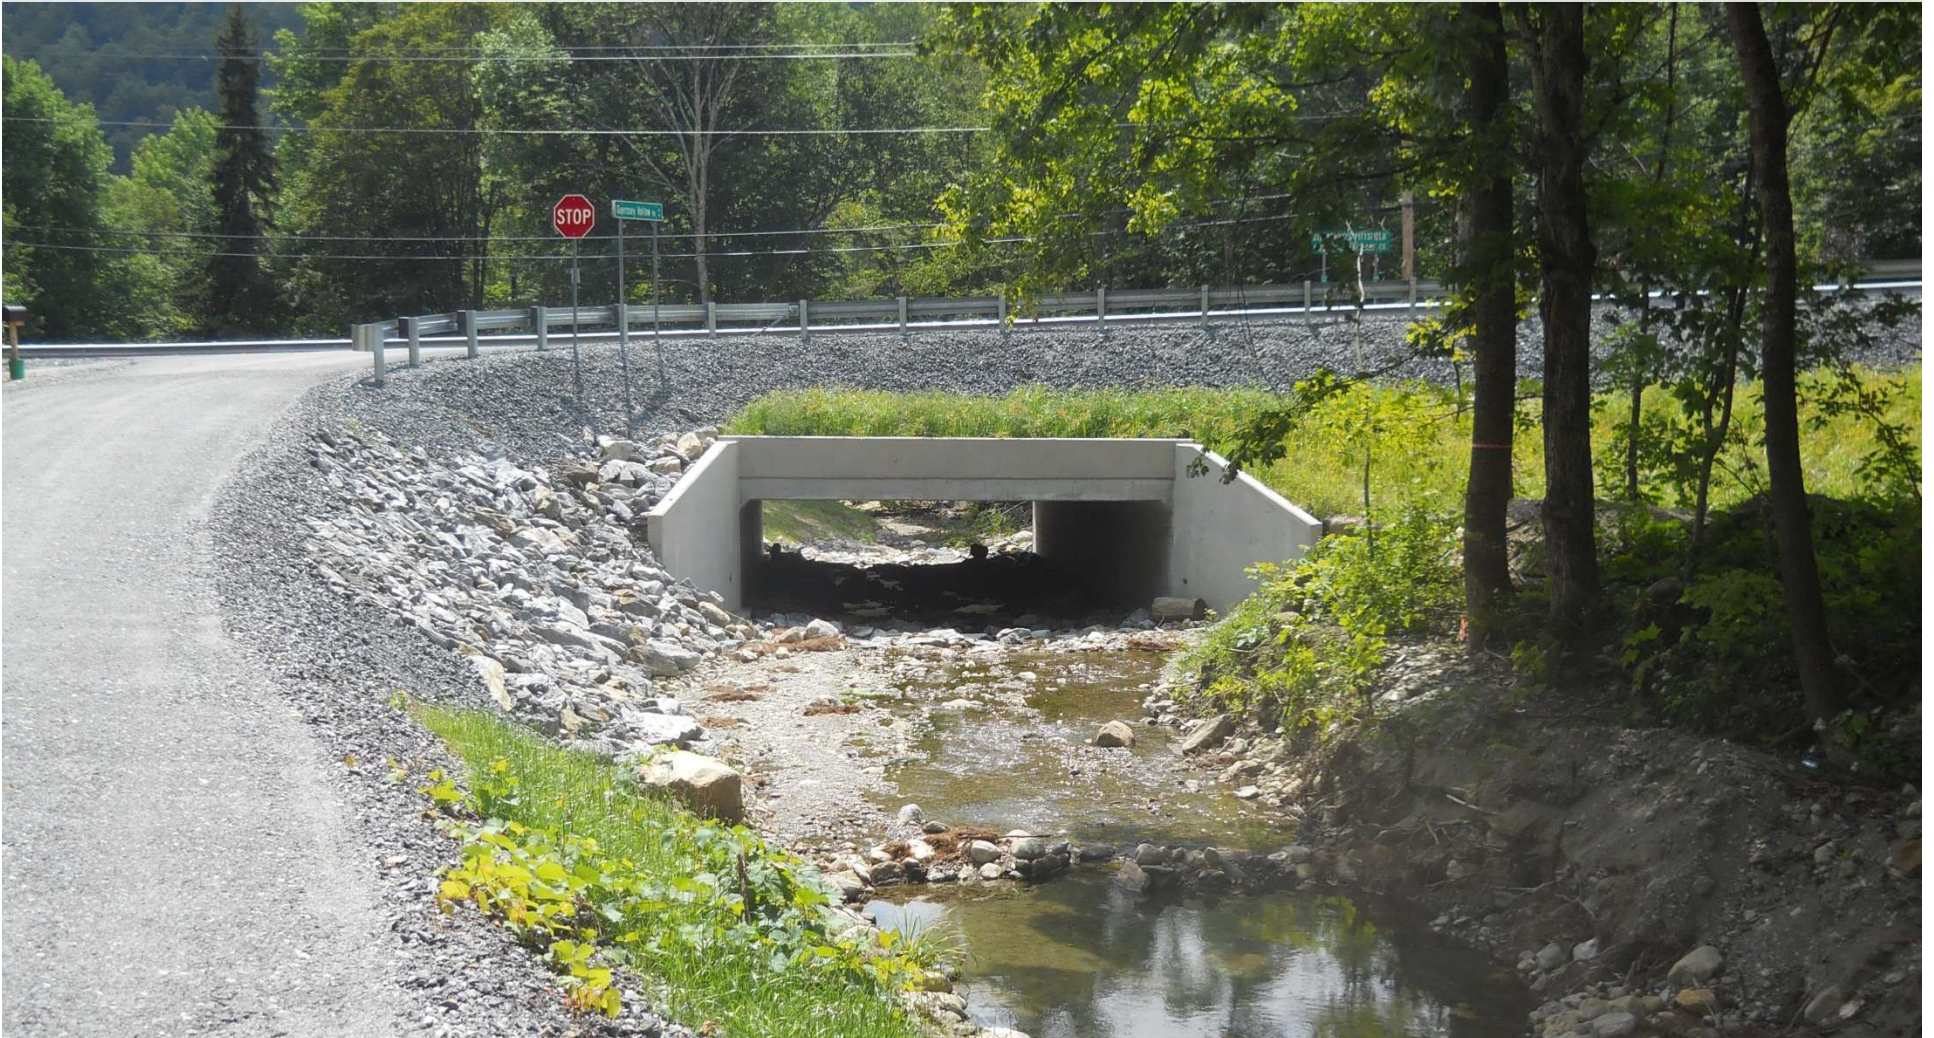
Proposed Example

- Reinforced Concrete Frame
- Natural Stream Bottom
