SCOPING REPORT

No. Hero-Grand Isle Bridge BHF 028-1(26)

Vermont Agency of Transportation

Re: North Hero-Grand Isle BHF028-1(26)
Final Scoping Report

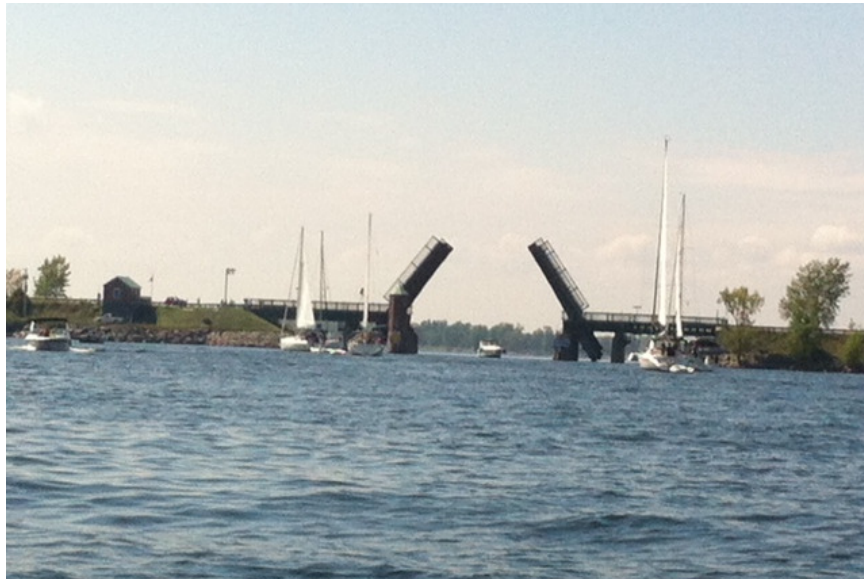
Photo showing the draw bridge opening

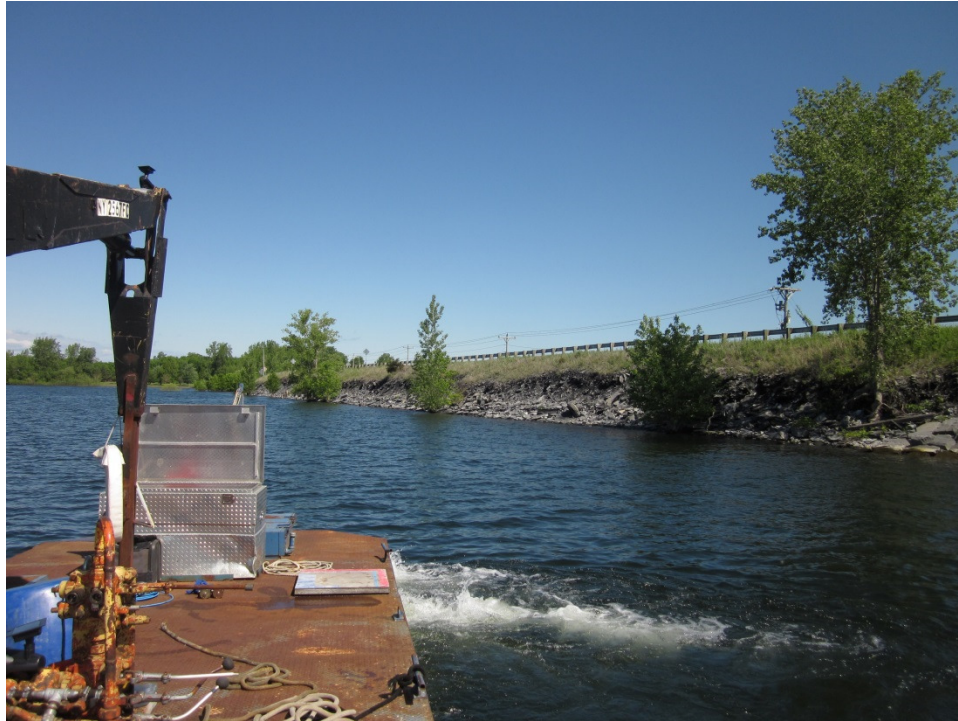
Photo showing the causeway is exposed, rolling, and open

The North Hero-Grand Isle project includes the causeway and Bridge Number 8 crossing Lake Champlain on US Route 2 between the Towns of North Hero and Grand Isle. The terrain within the project area is considered “rolling” with Lake Champlain on each side of the causeway. Lake Champlain is very large and wide so the bridge structure and causeway is exposed to all the elements with no protection.

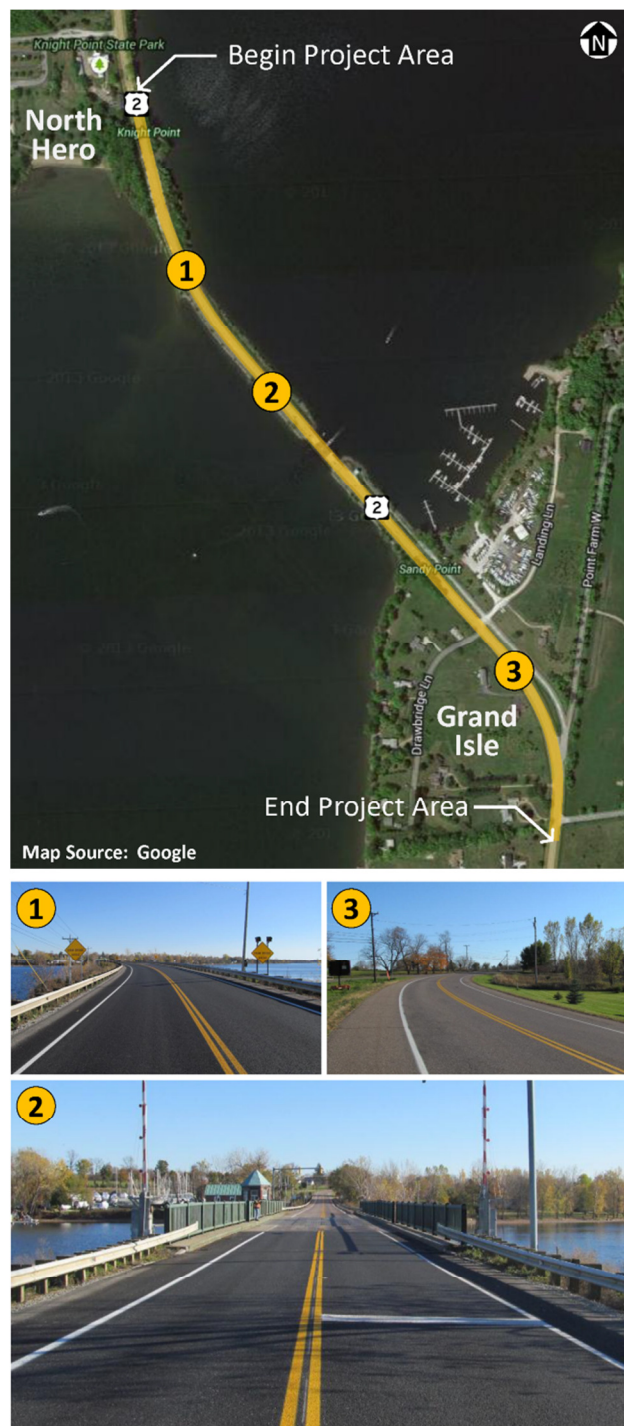
Figure 1. Top: Project Area Map illustrating location of existing US Route 2 horizontal alignment features. Bottom: Site photos corresponding to numbered features on Project Area Map.

As illustrated in Figure 1, the horizontal alignment of US Route 2 in the project area consists of three main features (described traveling in the eastbound direction):

- (1) 1910-foot radius curve superelevated down left at approximately 7.7%.
- (2) 1980-foot tangent section over the bridge.
- (3) 920-foot radius curve superelevated down right at approximately 6.0% on the high side (consistent with VTTrans design guidance for superelevation at a side road intersection) and 8% on the low side.

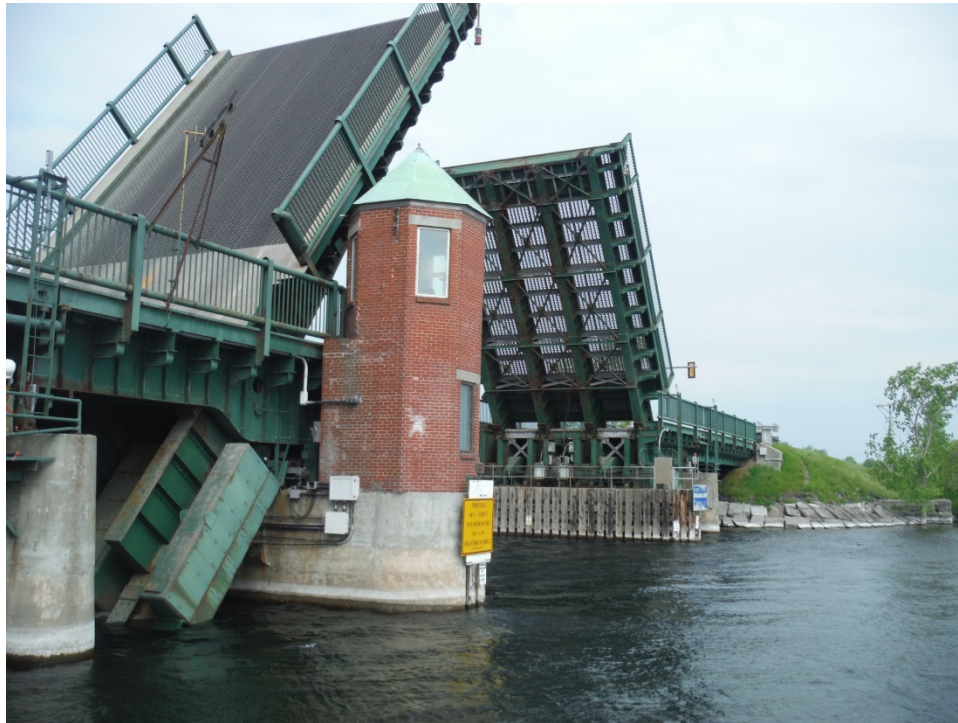
Photo showing the drawbridge back spans in the water

HDR investigated rehabilitating the current twin leaf bascule span in place and determined during the inspection that the structural steel needs extensive repairs and it would be more cost effective and beneficial to perform a replacement of the bascule leaves. HDR developed this alternative that will incorporate building the replacement twin leaf bascule spans remotely and then shipping the units to the project site. In an effort to reduce the impacts of construction on the traveling public, the replacement of the twin leaf bascule span would take place during the winter months over planned weekend outages. HDR estimates that the rehabilitation alternative would be completed over two construction seasons. The first season to rehab the approach spans while the new bascule spans are being fabricated. The bascule spans will be replaced during the winter months and then the next construction season the bridge structure rehabilitation will be completed.
