Rockingham BF 0125-1(48)
Regional Concerns Meeting
VT Route 103– Bridge #3 over Unnamed Brook

October 6, 2021

Rockingham NH CULV(66)
Regional Concerns Meeting
VT Route 103– Bridge #6 over Unnamed Brook

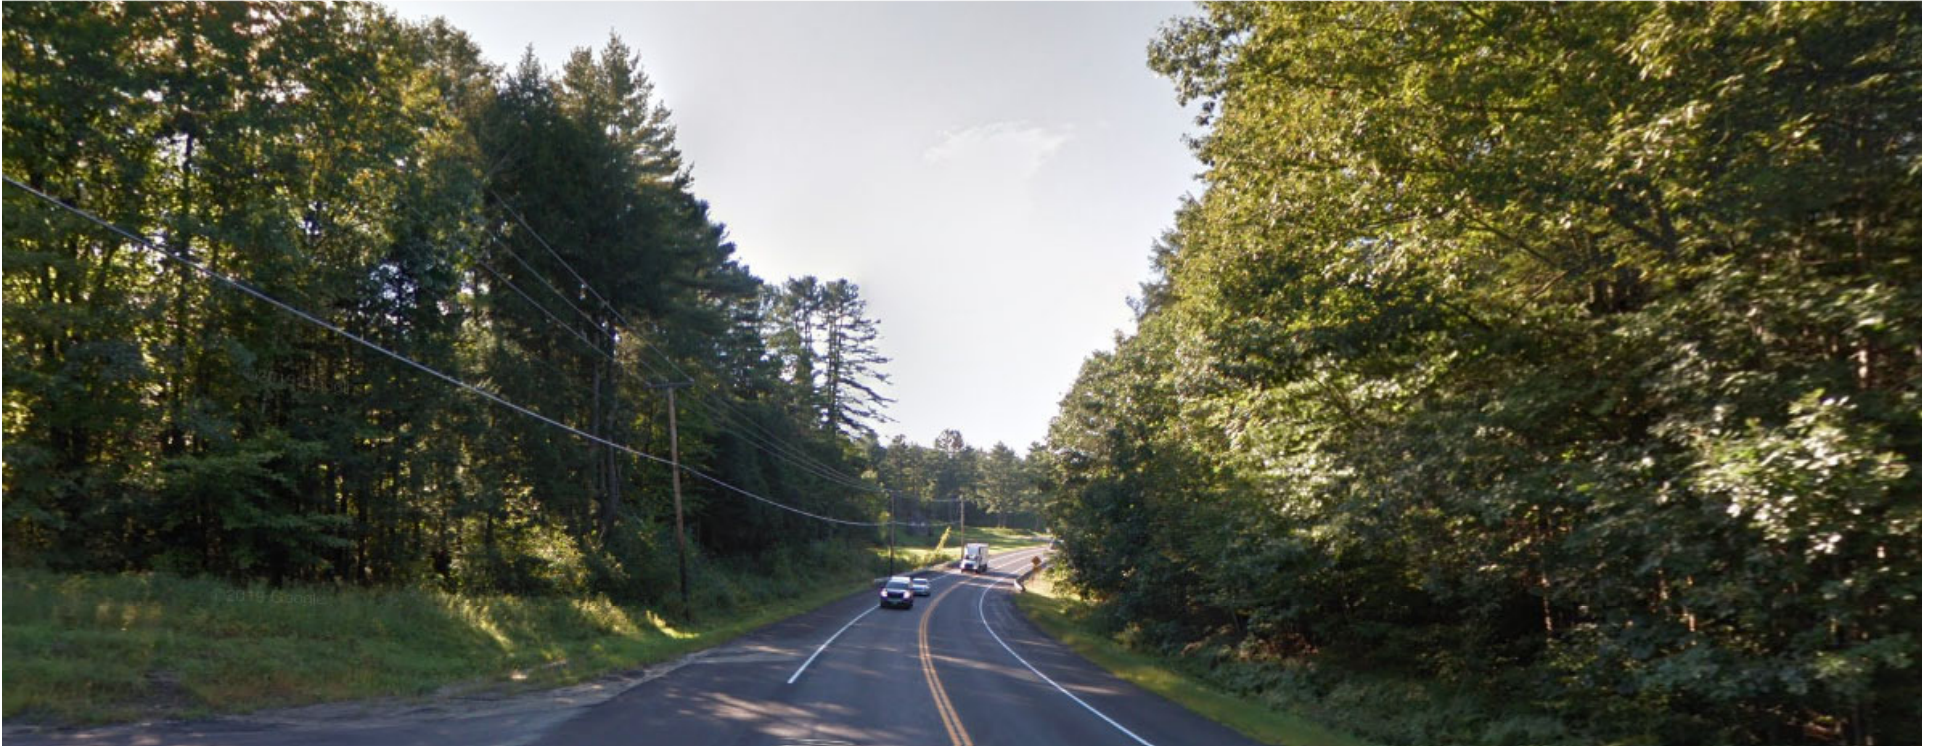
Looking North over Bridge 3

Existing Conditions – Bridge #3

- Roadway Classification – Rural Principal Arterial, NHS
- Bridge Type – 7' Span CGMPP (Corrugated Galvanized Metal Plate Pipe)
- Culvert Length – 264 feet
- Fill Over Culvert – 40 feet
- Ownership – State of Vermont
- Constructed in 1958

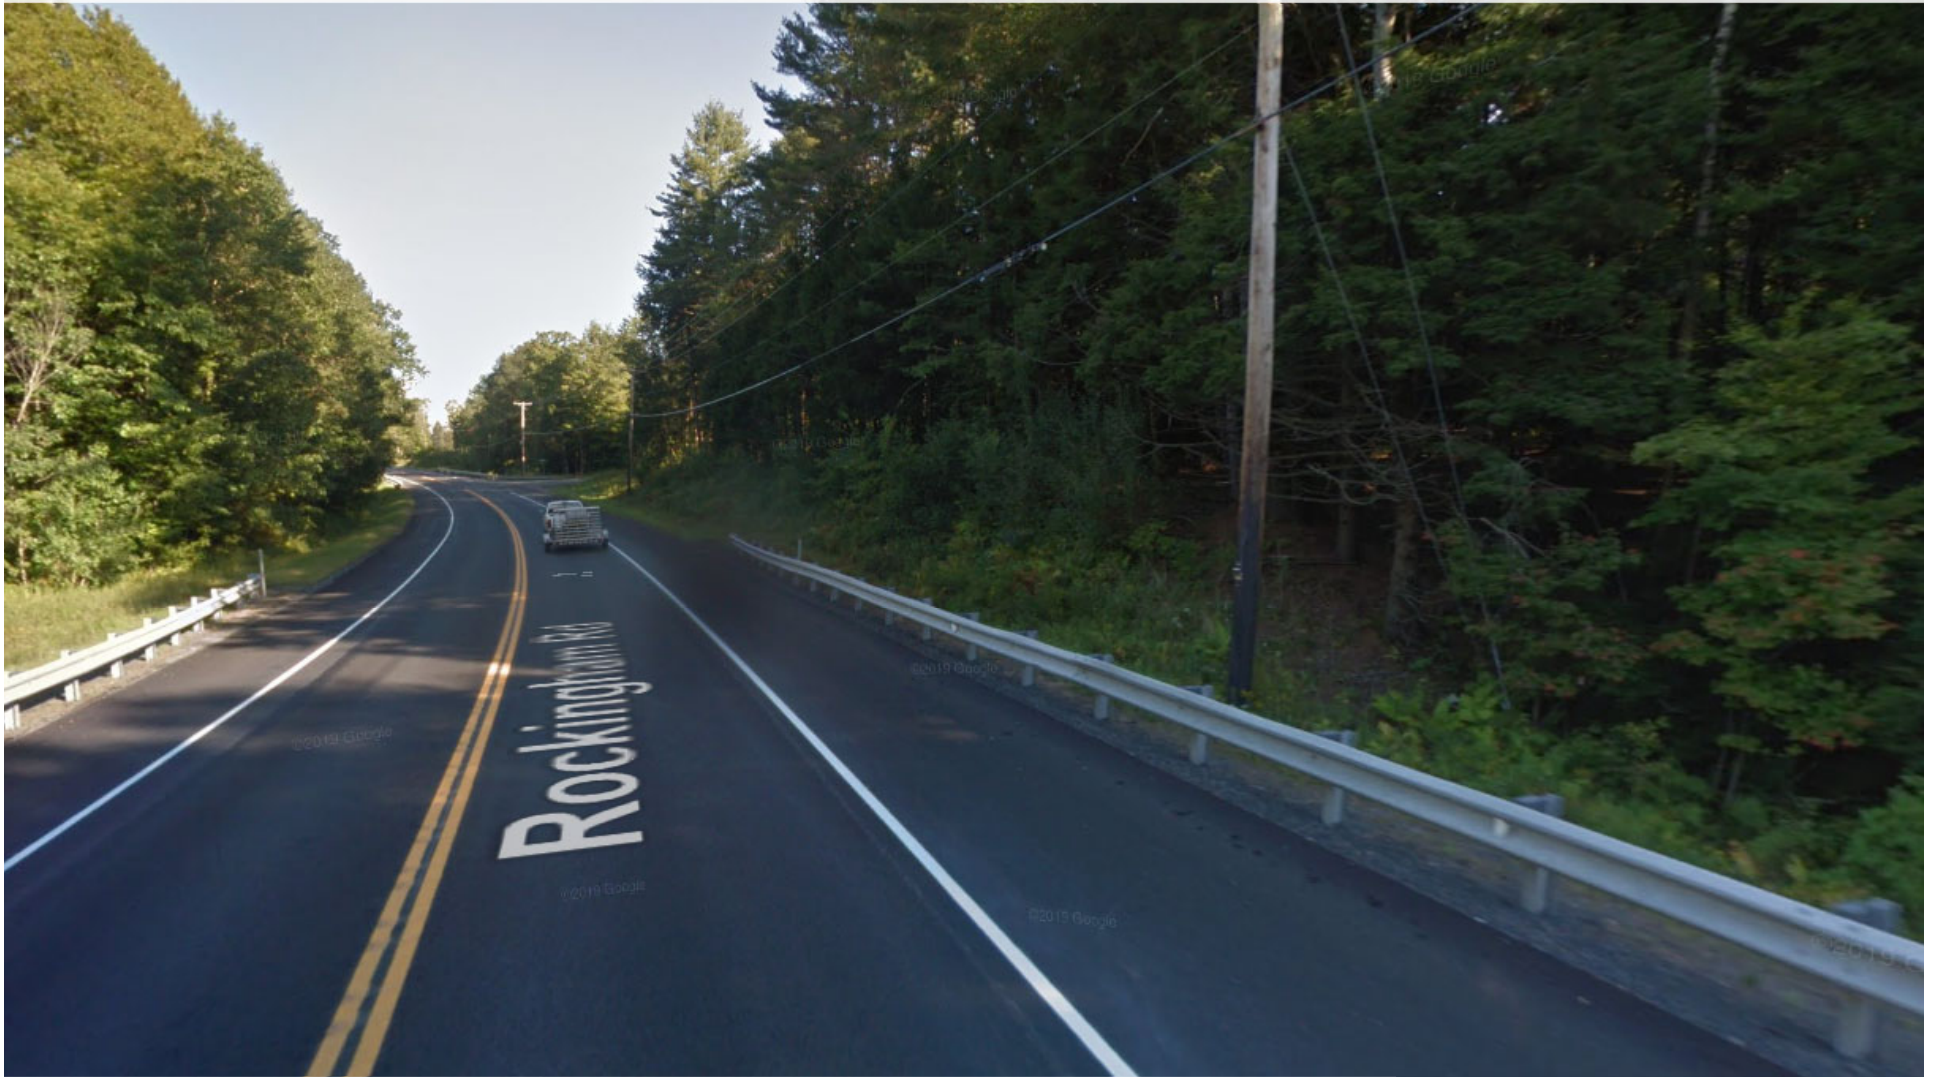
Looking South over Bridge 3

Existing Conditions – Bridge #3

- Steep slopes upstream and downstream

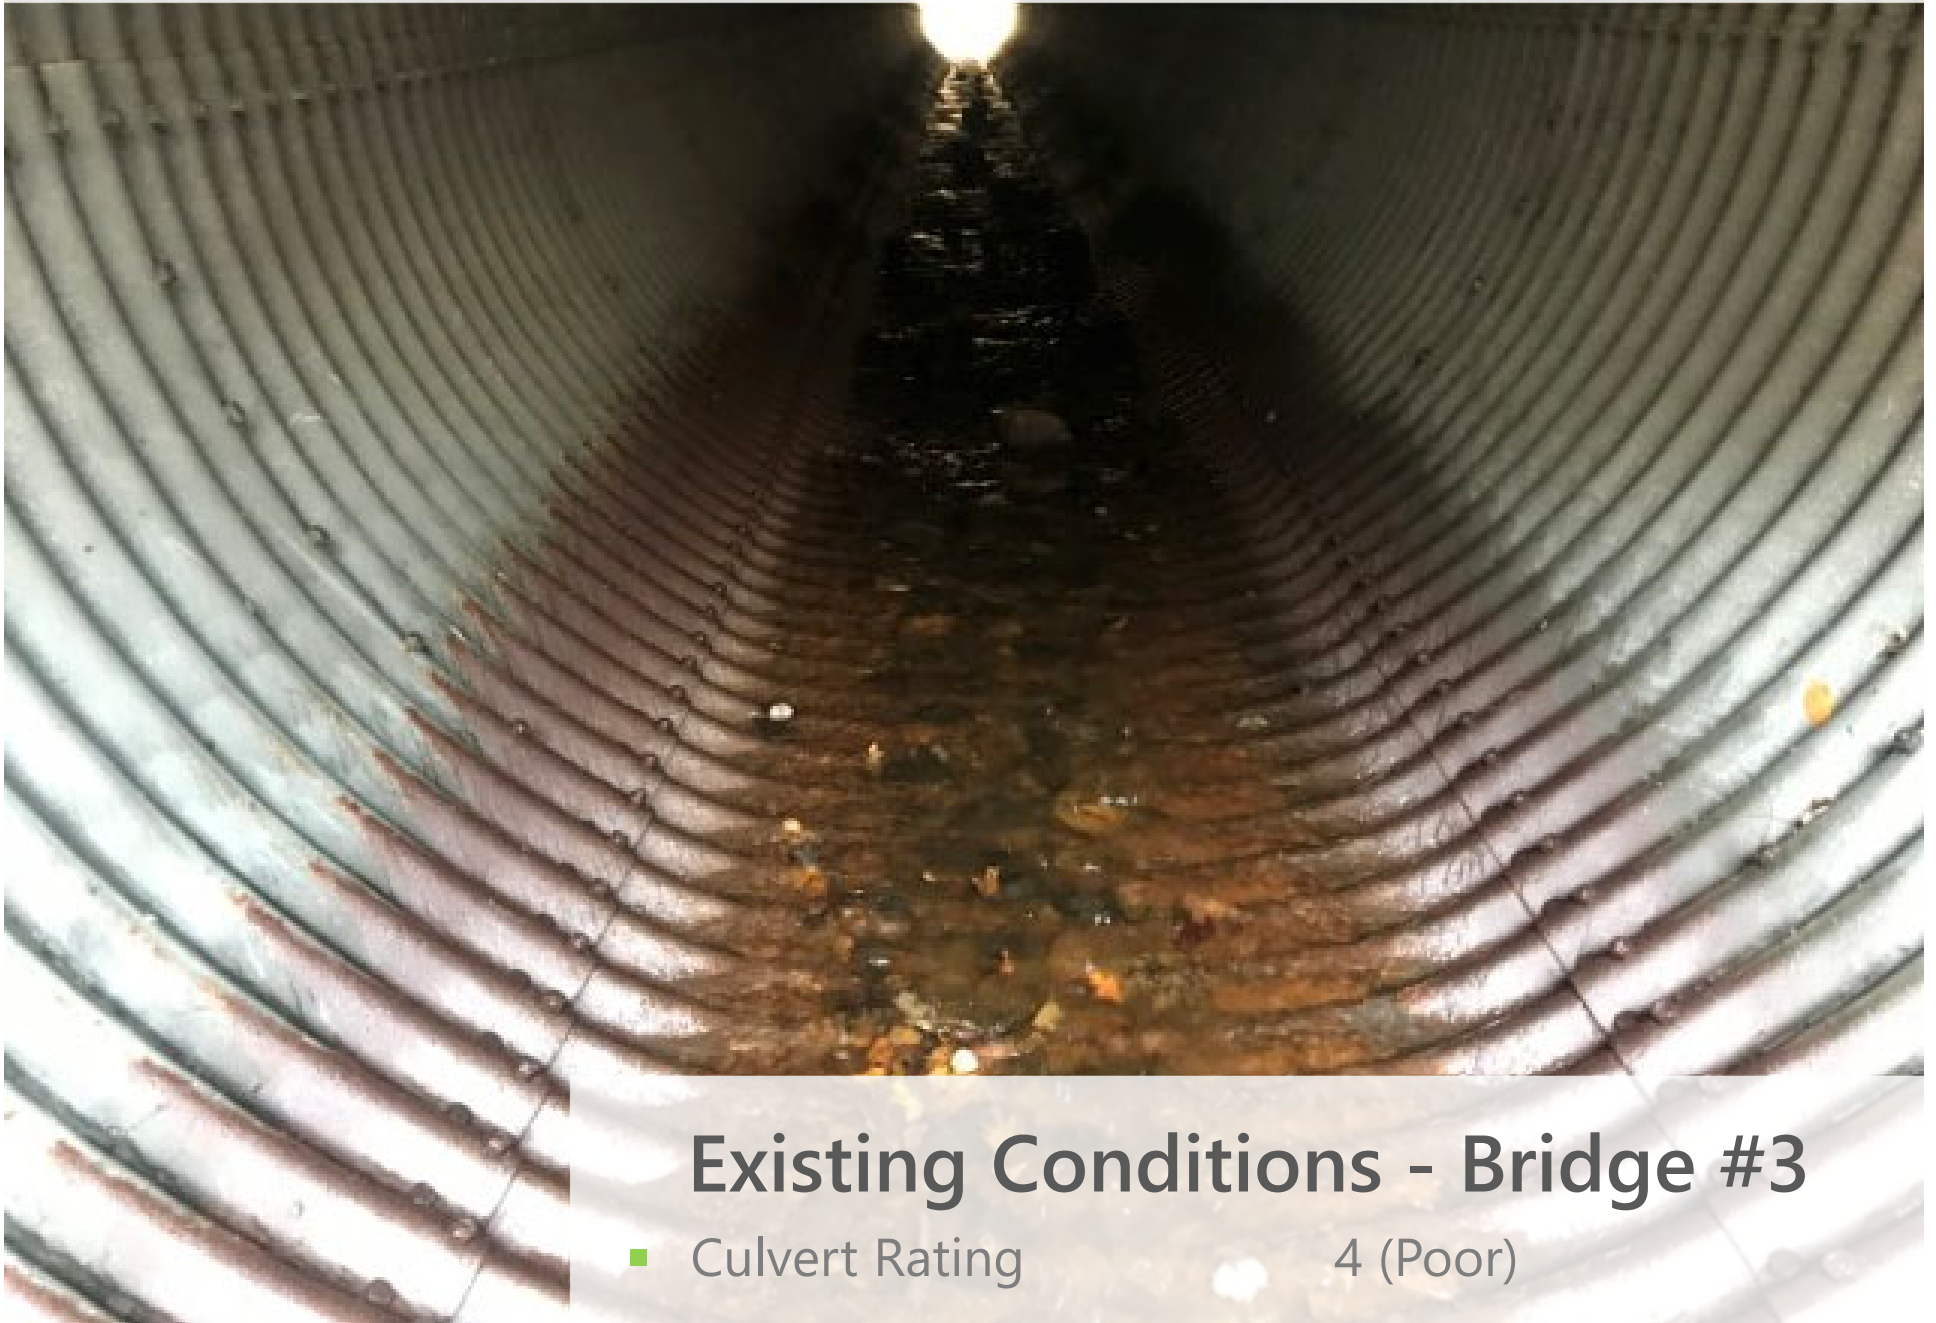
Condition Ratings

- The existing culvert is rated as poor. The first 70 feet of the inlet end has large rust holes along the haunch areas. Beyond that the pipe has only minor small holes. Additionally, there is heavy erosion on the embankments.
- The culvert does not meet the minimum bank full width.
- The shoulders along VT Route 103 are substandard by 2 feet.

Existing Conditions - Bridge #3

■ Culvert Rating 4 (Poor)

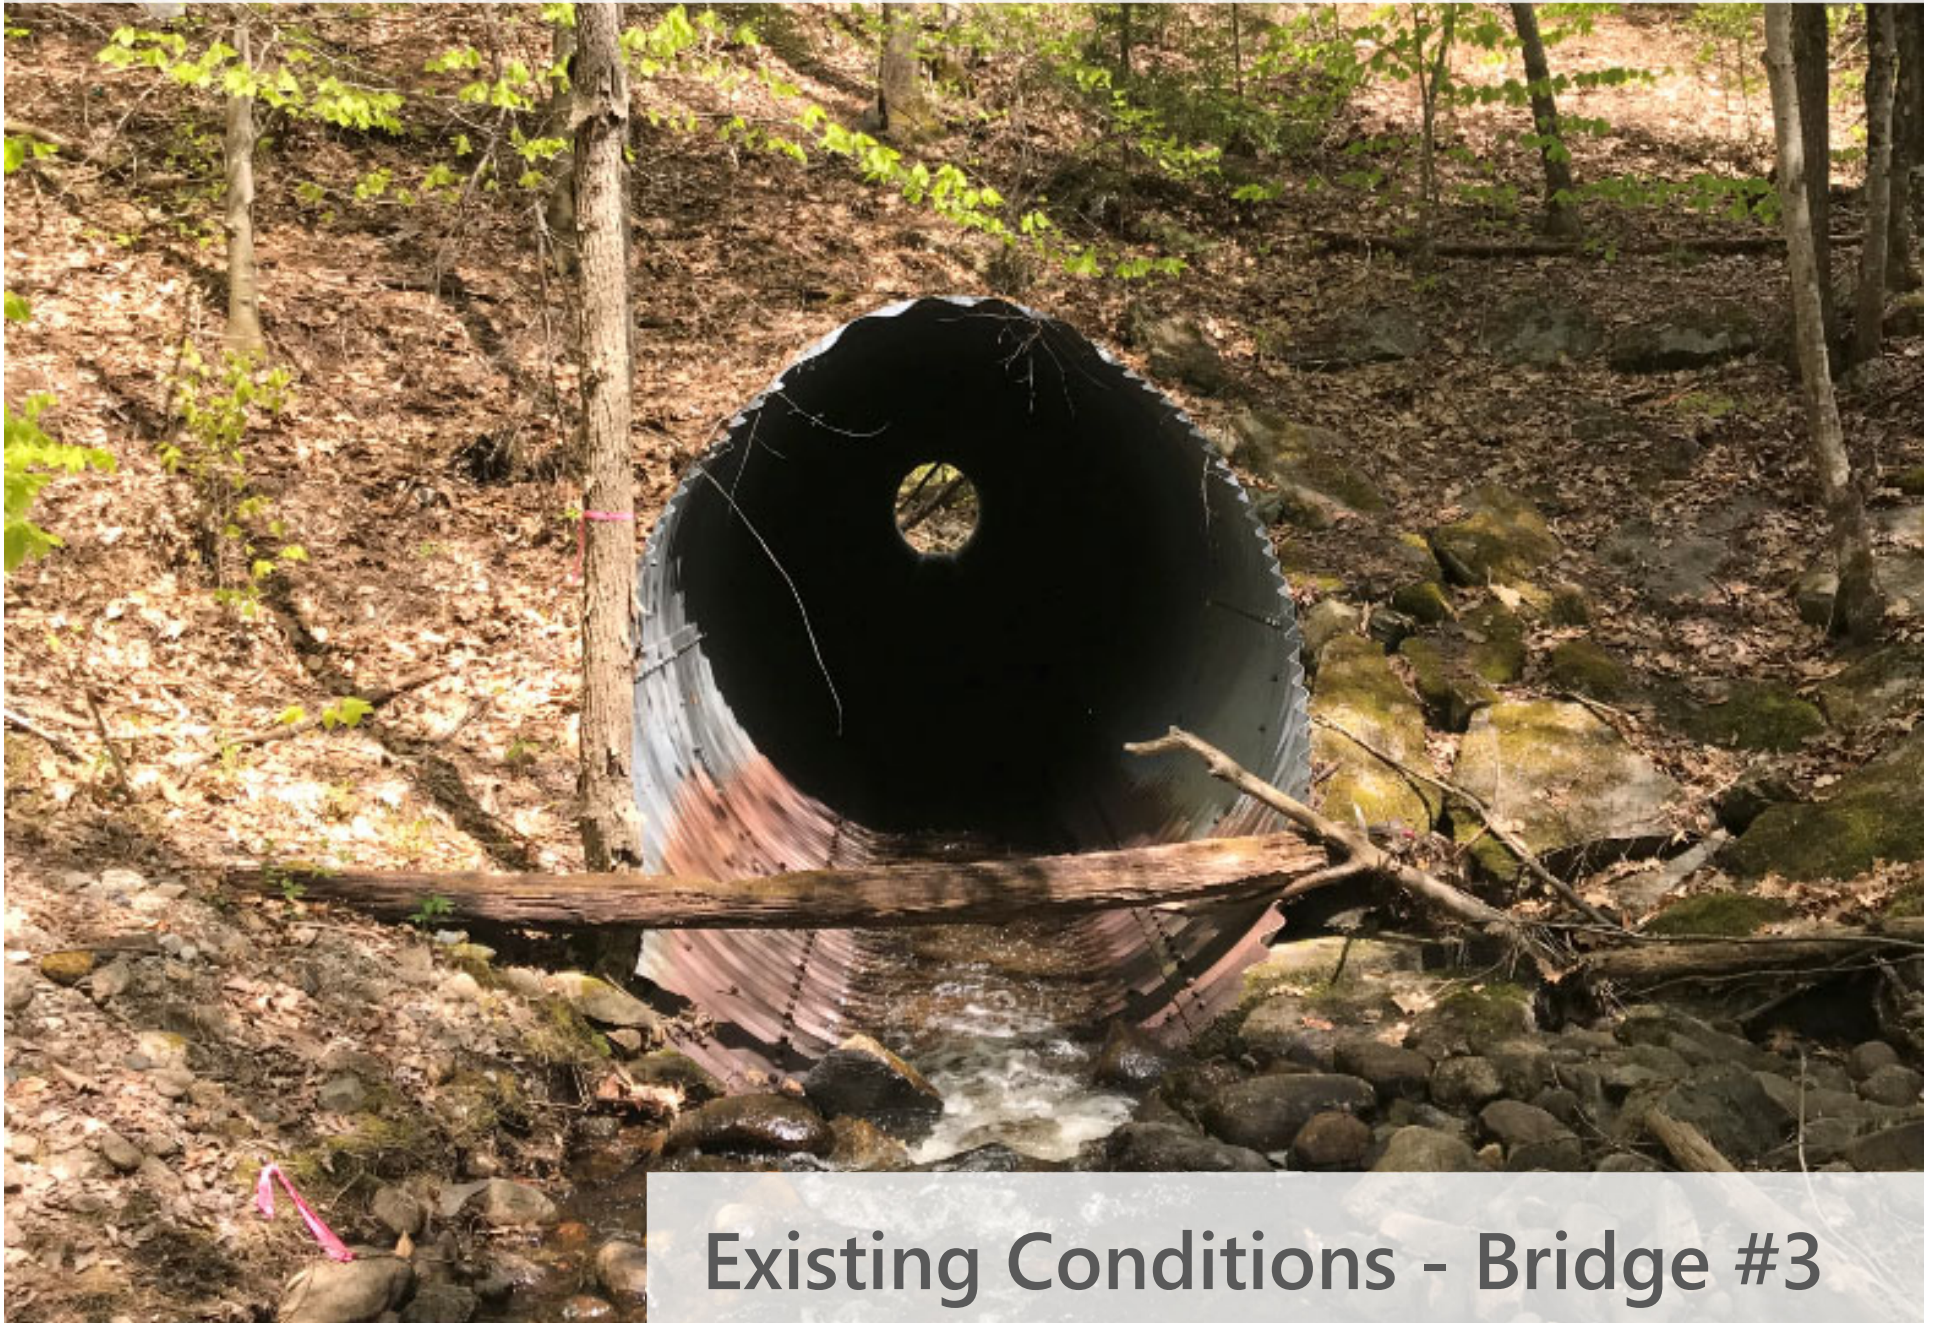
Inlet

Existing Conditions - Bridge #3

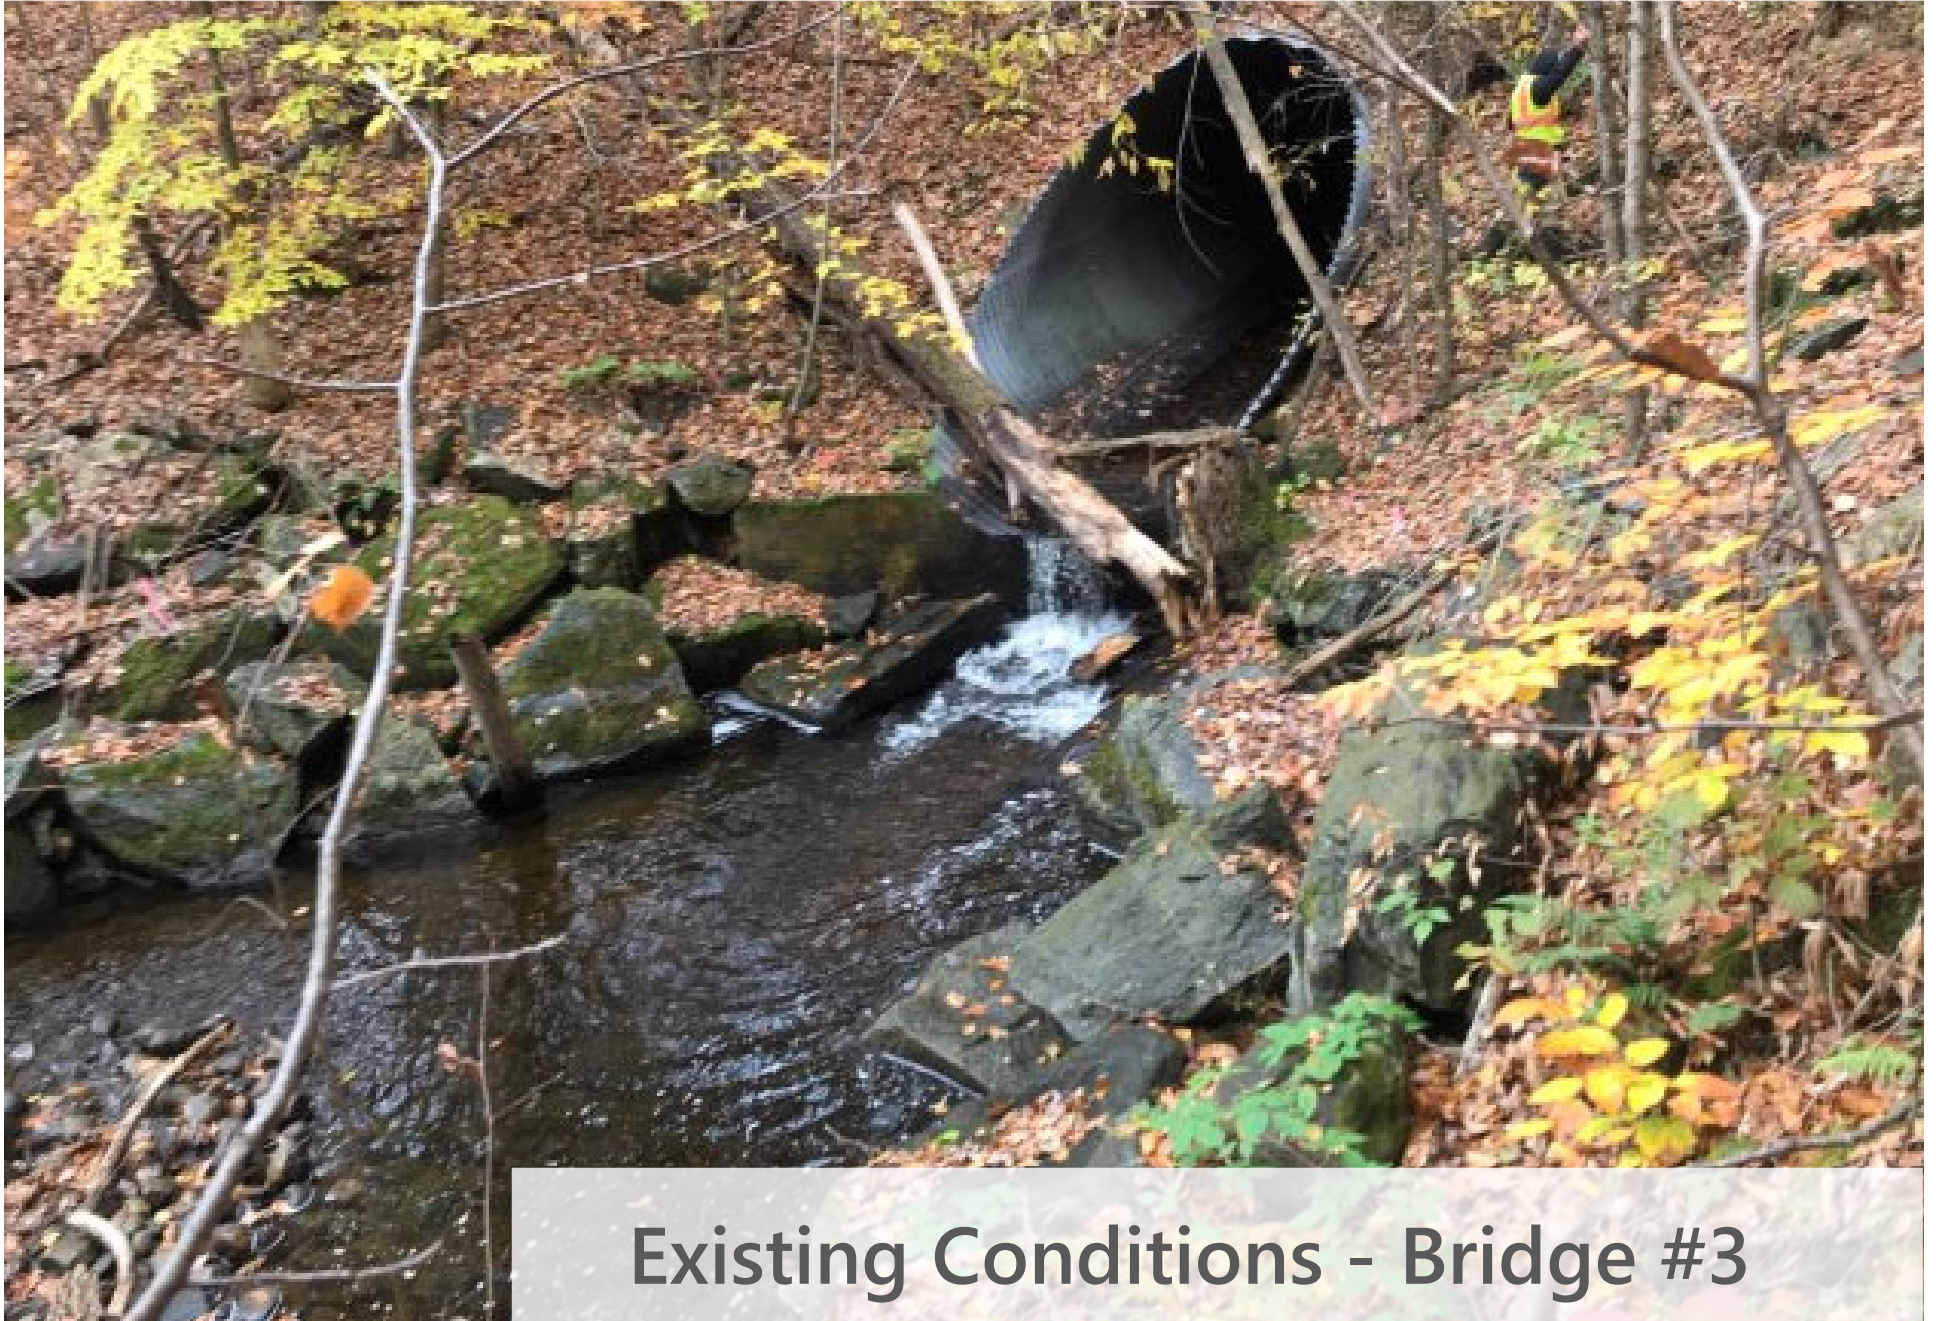
Outlet

Existing Conditions - Bridge #3

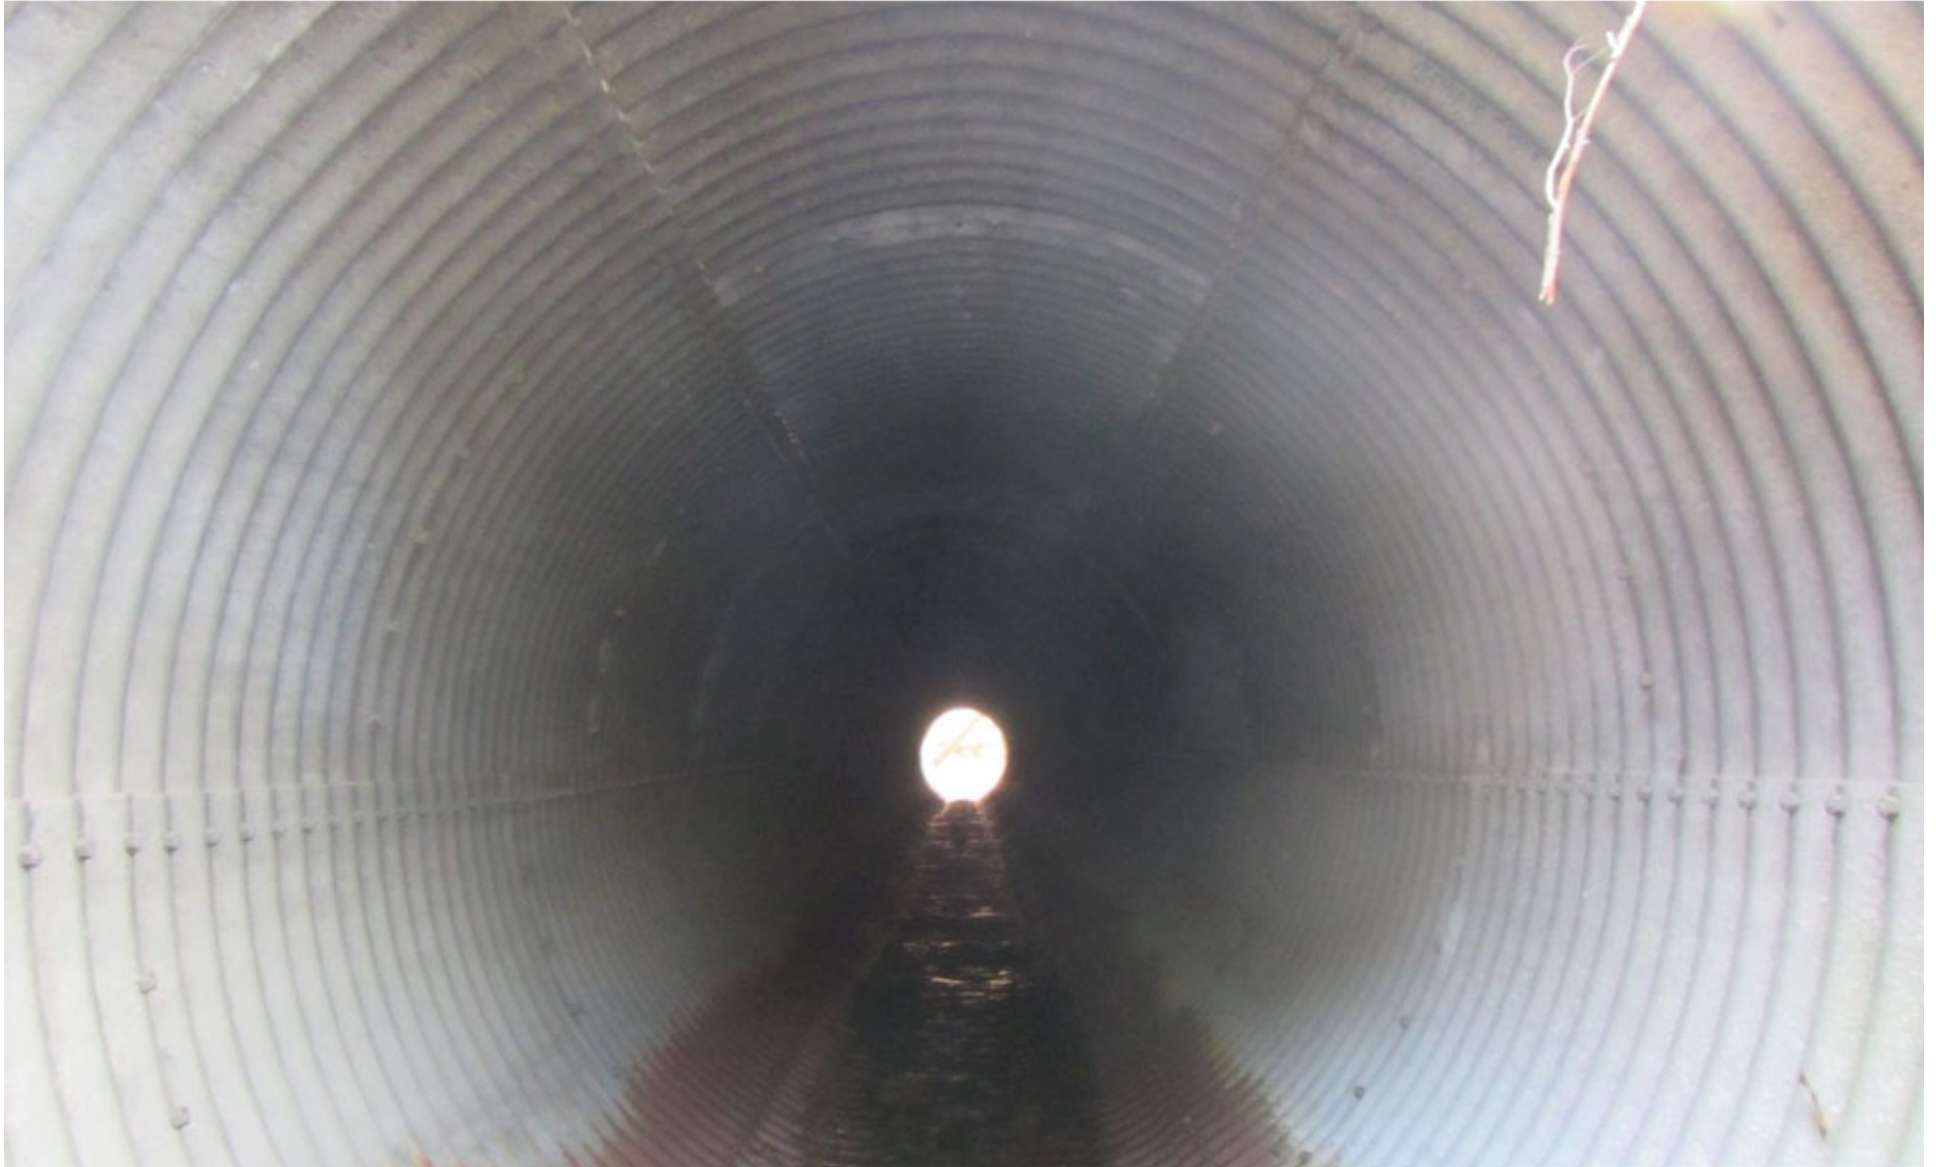
Barrel

Existing Conditions - Bridge #3

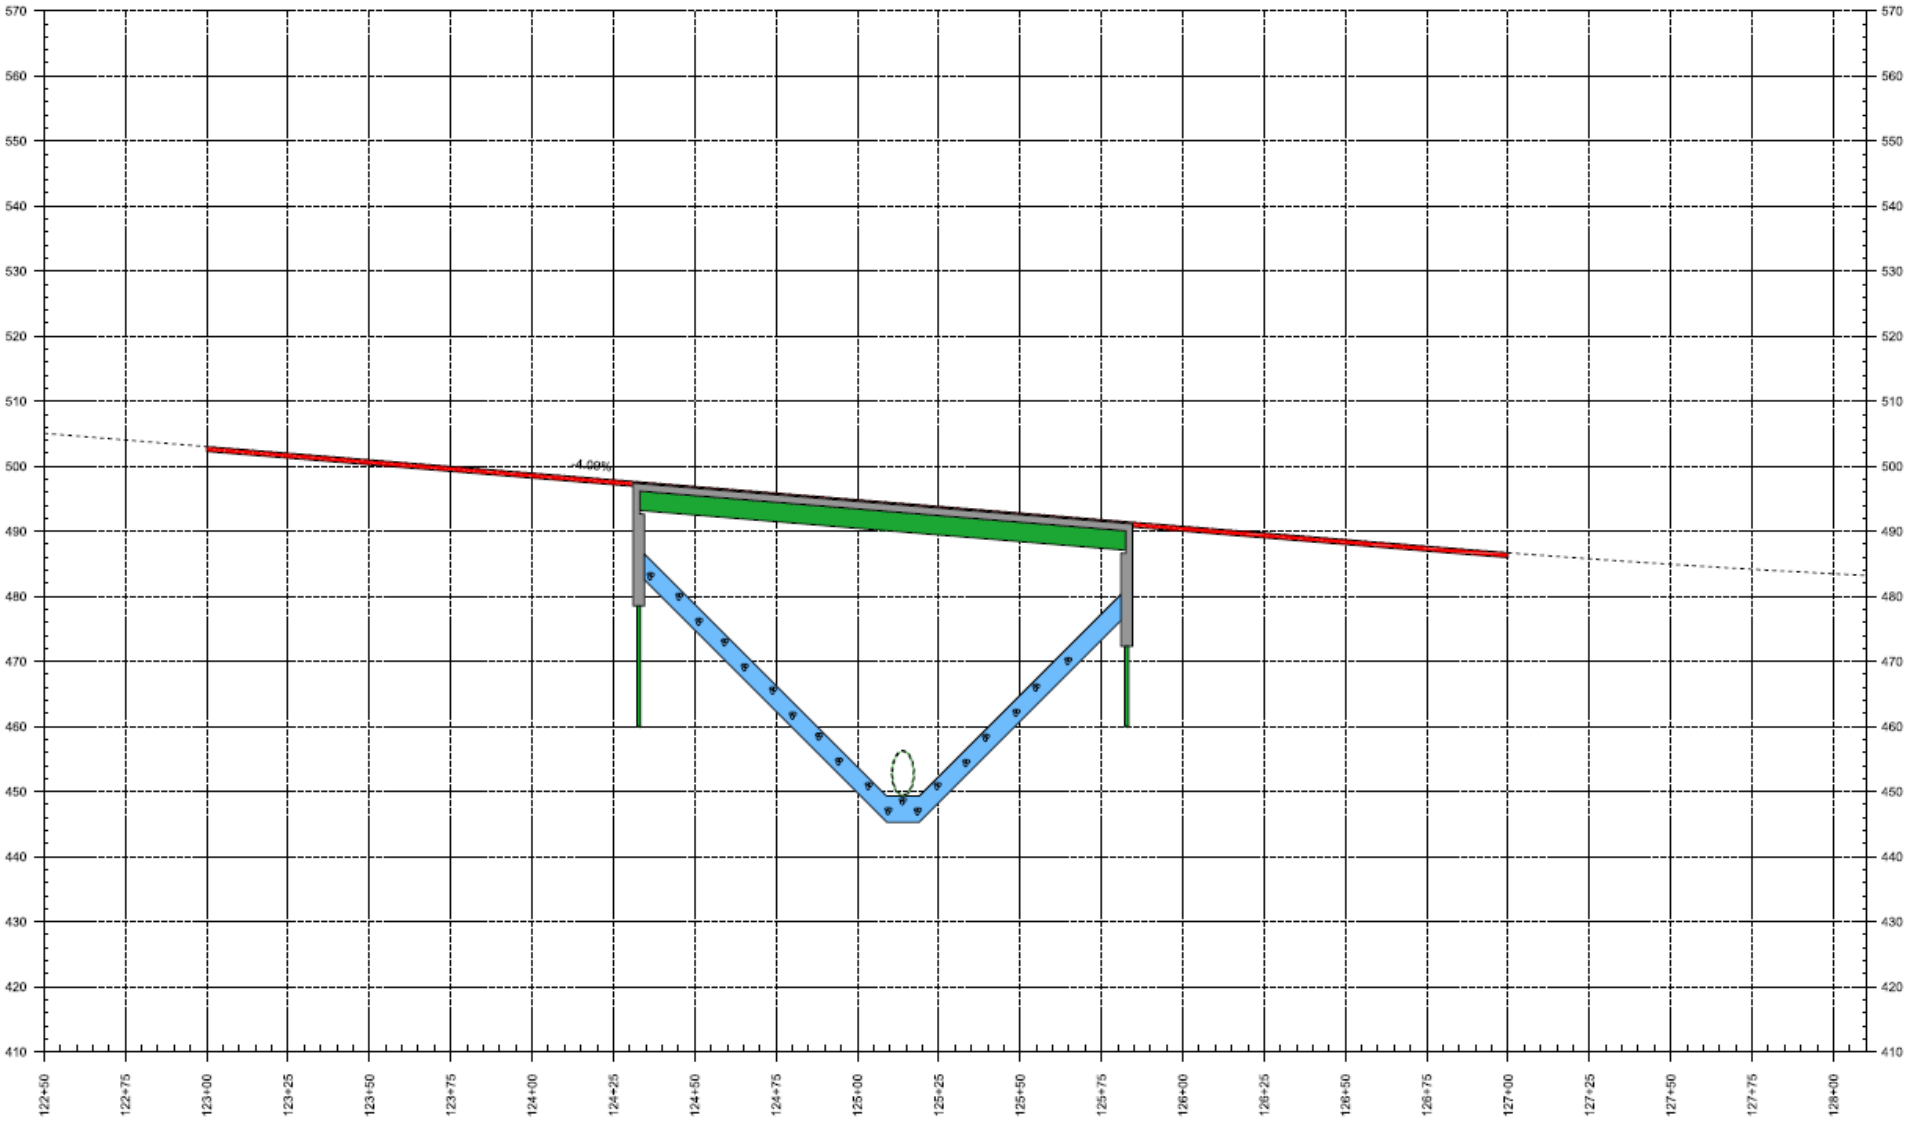
Proposed Profile

VT ROUTE 103 NEW BRIDGE PROFILE

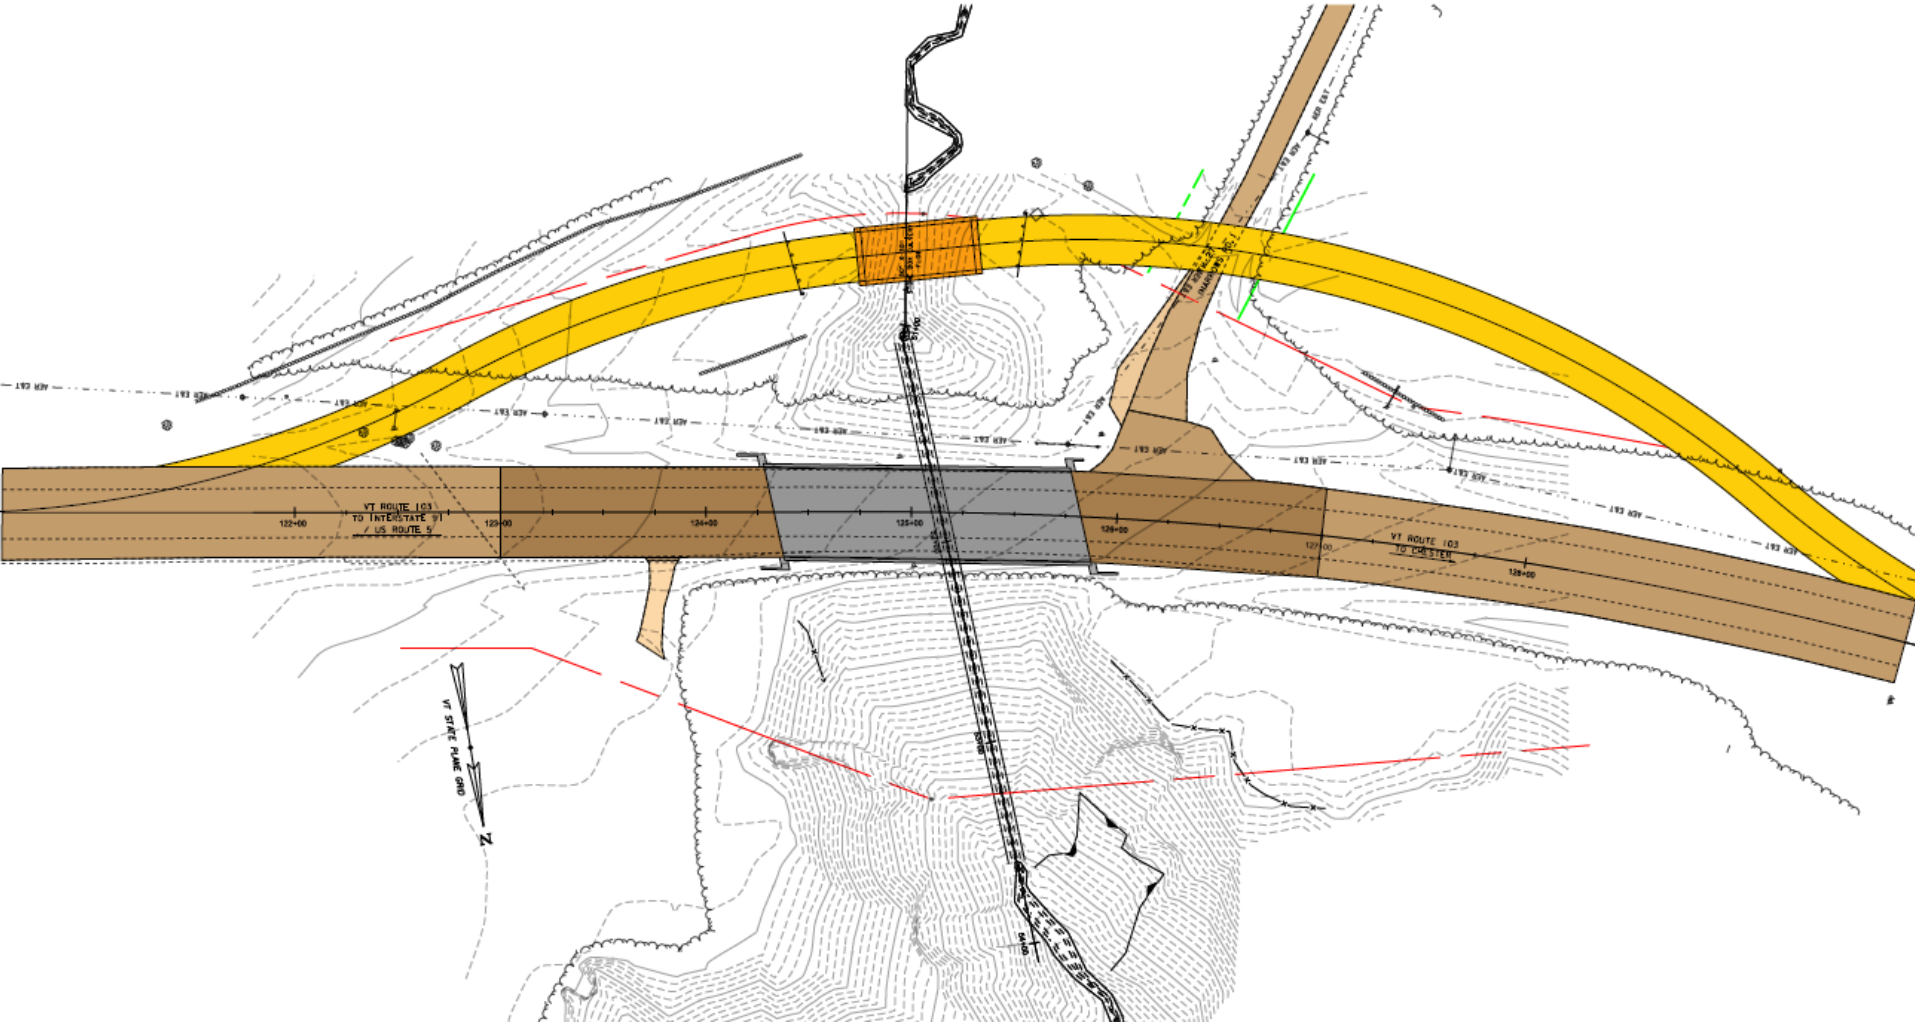
Upstream Temporary Bridge Layout

- Two Lane Temporary Bridge constructed on Upstream or Downstream side of VT Route 103

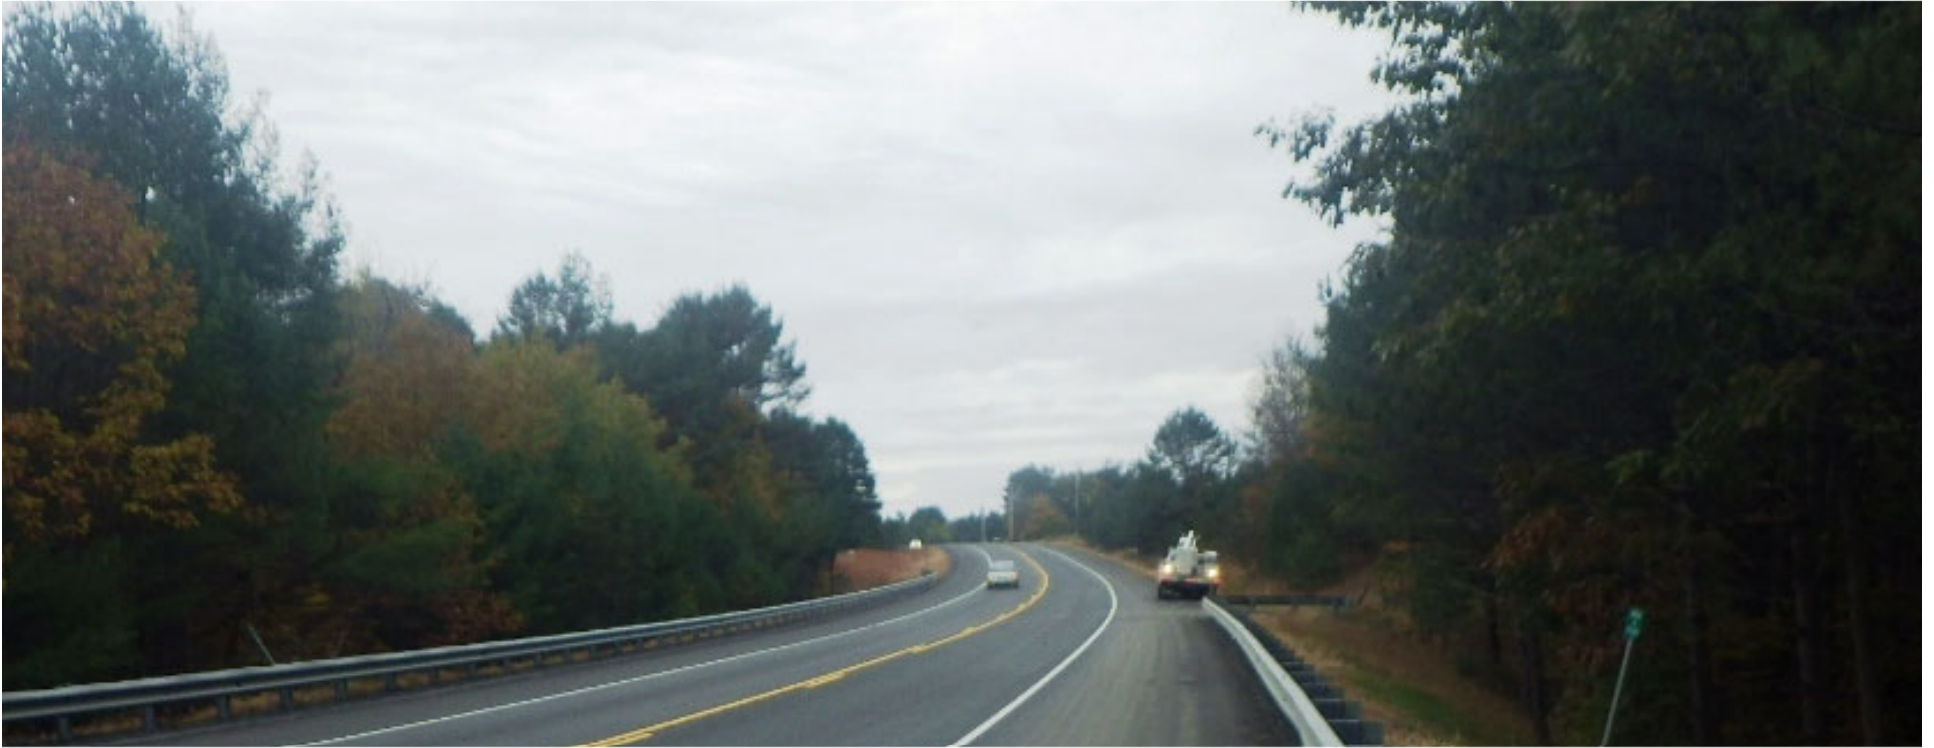
Looking North over Bridge 6

Existing Conditions – Bridge #6

- Roadway Classification – Rural Principal Arterial, NHS
- Bridge Type – 10' Span CGMPP (Corrugated Galvanized Metal Plate Pipe)
- Culvert Length – 222 feet
- Fill Over Culvert – 40 feet
- Ownership – State of Vermont
- Constructed in 1962

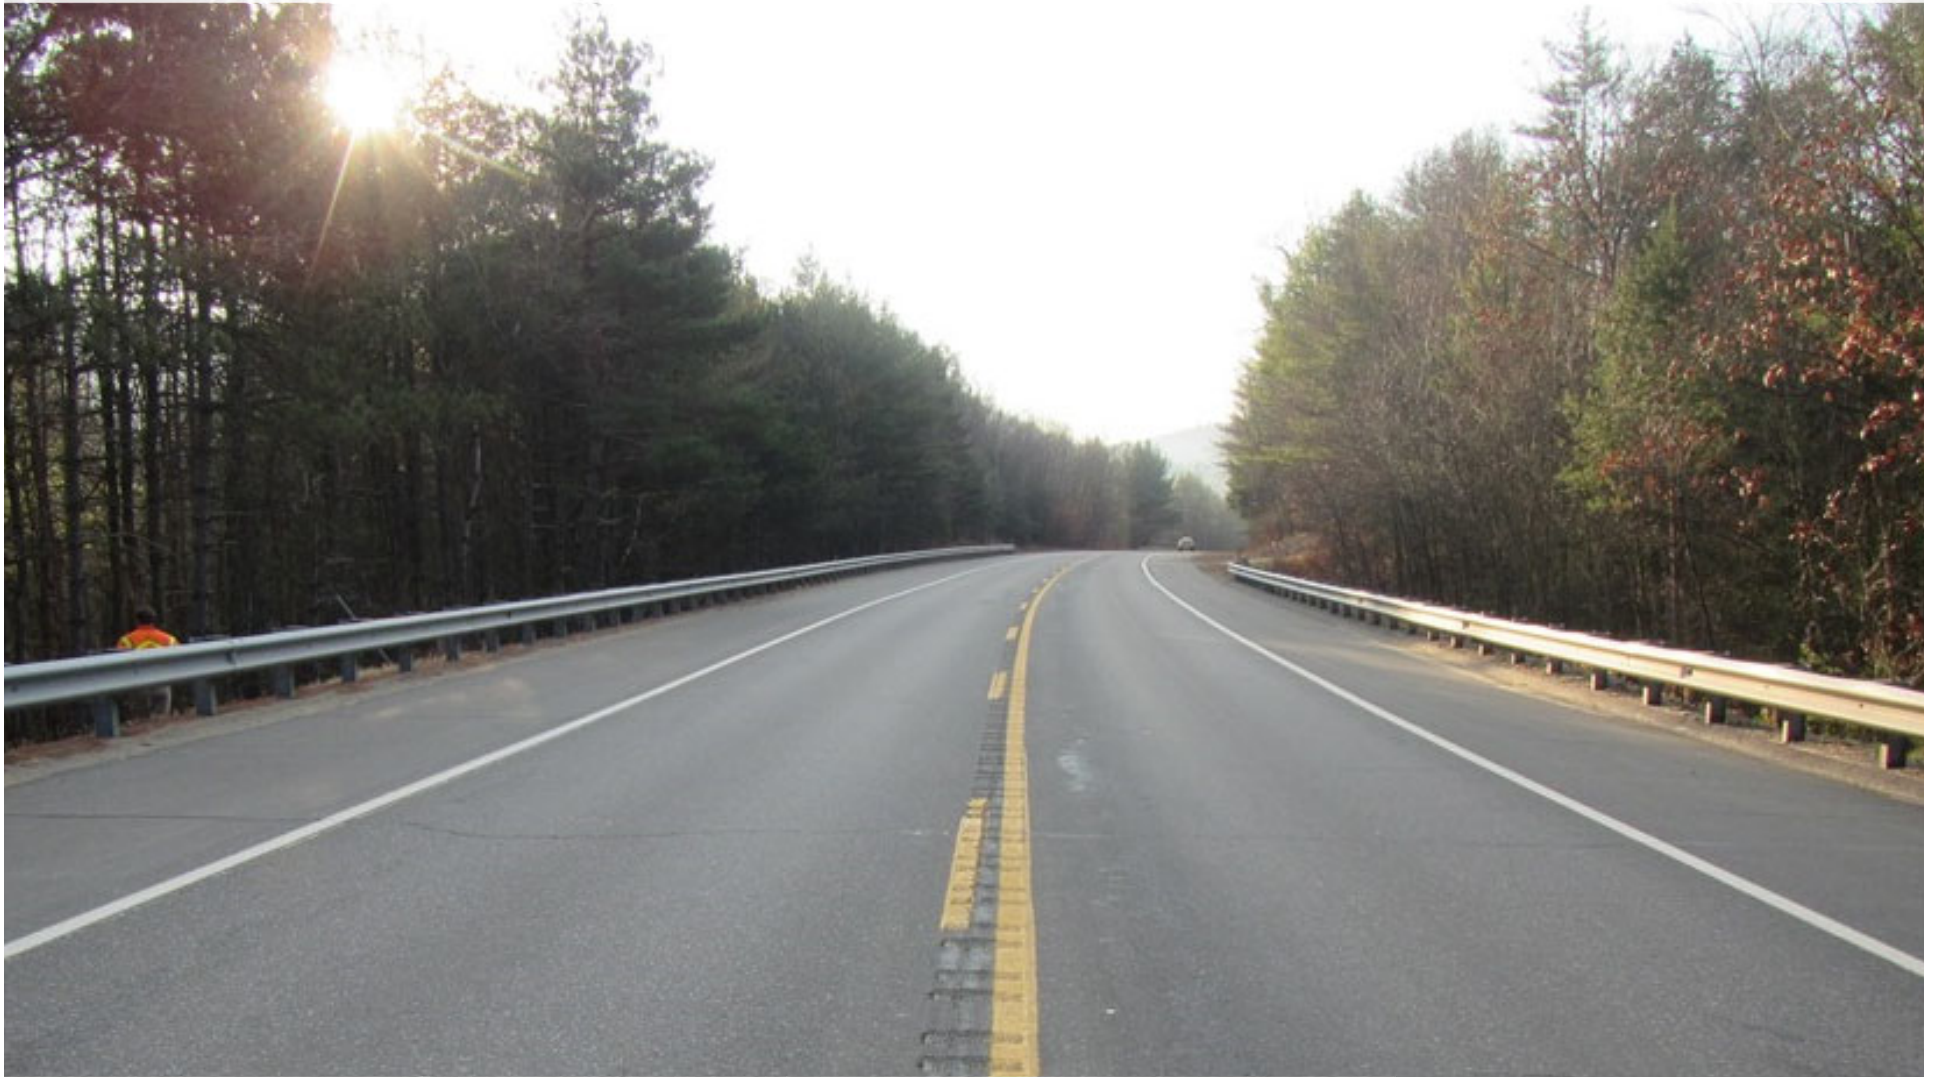
Looking South over Bridge 6

Existing Conditions – Bridge #6

- Steep slopes upstream and downstream
